Building and Timber Pest Inspection Report

Inspection Date: Fri, 6 Mar 2026

Property Address: 52 Old Punt Rd, Seelands NSW 2460,
Australia

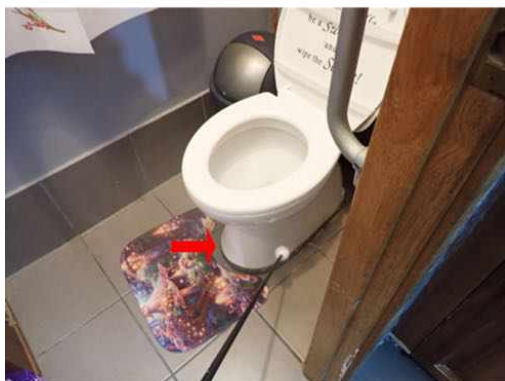
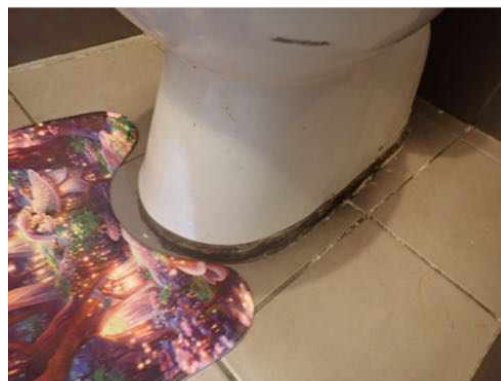
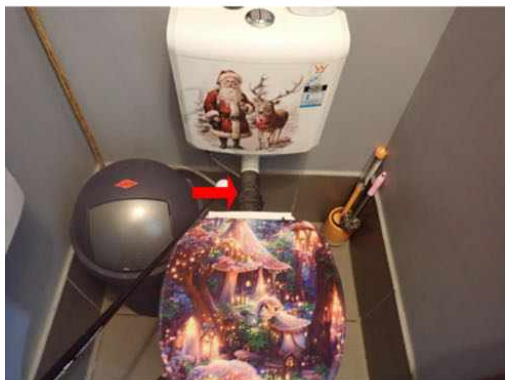
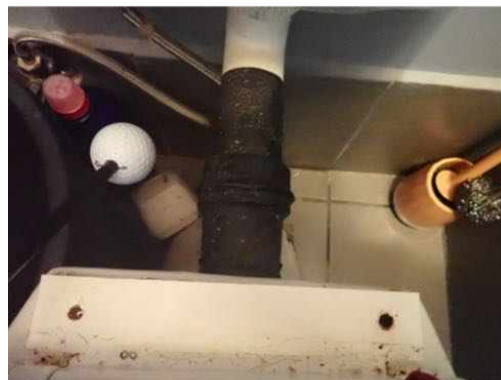
Finding 3.08

Finding: Loose Toilet Suite with Duct Tape Around Plumbing Connection

Information: The toilet suite was found to be loose at the time of inspection, and duct tape had been wrapped around the plumbing connection. A loose toilet can lead to movement of the fixture, potential leaks, and damage to surrounding flooring or plumbing

components if not addressed. The duct tape around the plumbing connection may indicate a previous or ongoing leak. It is recommended that a qualified plumber inspect the toilet installation and plumbing connections and carry out repairs or reinstallation as required to ensure the fixture is secure and functioning correctly. Repairs should be carried out as deemed necessary.

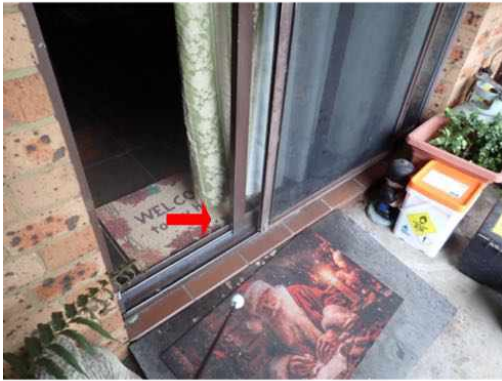
Finding 3.09

Building:	Main Building
Location:	Rear sliding doors
Finding:	Rear Sliding Doors Difficult to Operate
Information:	The rear sliding doors were found to be hard to slide during normal operation at the time of inspection. Difficulty operating sliding doors can be caused by worn rollers, misalignment, debris in the tracks, or general wear over time. It is recommended that a qualified carpenter or suitably experienced handyman inspect the doors and carry out adjustments, repairs, or replacement of worn components as required to ensure the doors operate smoothly. Repairs should be carried out as deemed necessary.

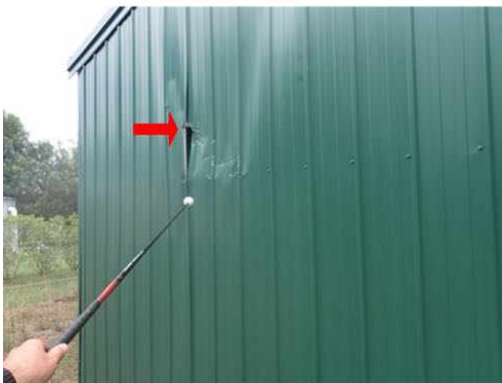
Finding 3.10

Building:	Shed
Location:	Left hand side
Finding:	Impact Damage to Right-Hand Wall Cladding of Green Shed
Information:	Impact-related damage was identified to the right-hand wall cladding of the green shed at the time of inspection. Damage of this nature can compromise the protective function of the cladding and may allow moisture to enter the wall structure if not repaired. This condition may have been caused by accidental impact. It is recommended that a qualified builder or handyman assess the affected cladding and carry out repairs or replacement as required to prevent further deterioration. Repairs should be carried out as deemed necessary.

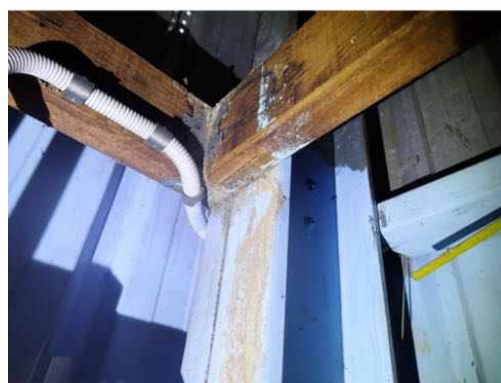
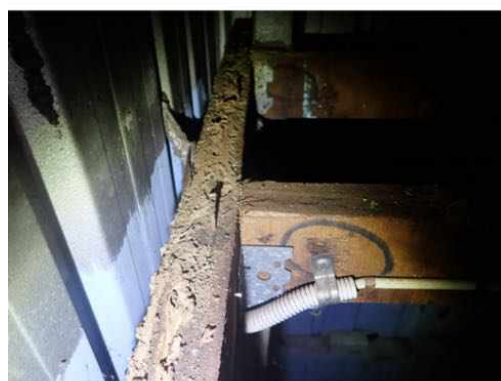
Location:	Shed
Finding:	Termite Damage to Timber at Right-Hand Front Corner of Shed Near Toilet
Information:	Termite damage was identified to timber at the right-hand front corner of the shed near the toilet at the time of inspection. Timber affected by termite activity may have reduced structural strength. This condition indicates previous or possible ongoing termite activity in the area. It is recommended that a licensed pest control specialist carry out a further assessment and implement appropriate termite management measures, and that a qualified carpenter or builder repair or replace any damaged timber as required. Further investigation and rectification works should be carried out as deemed necessary.

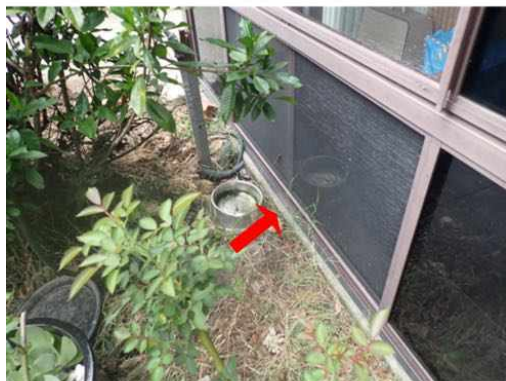
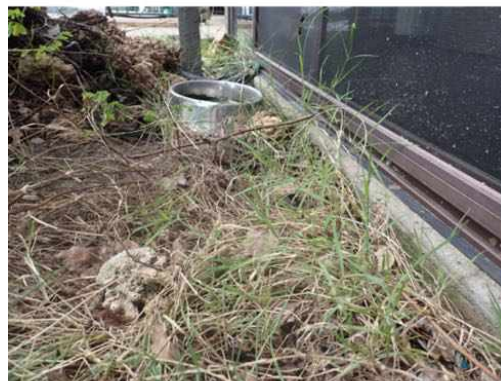
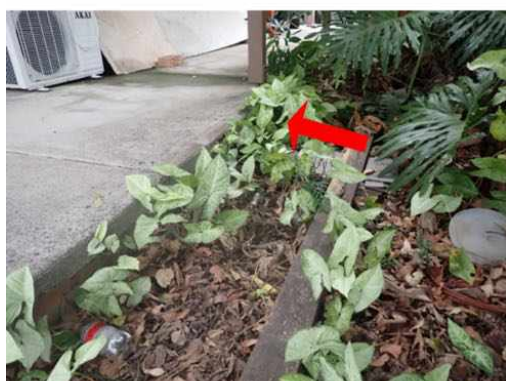
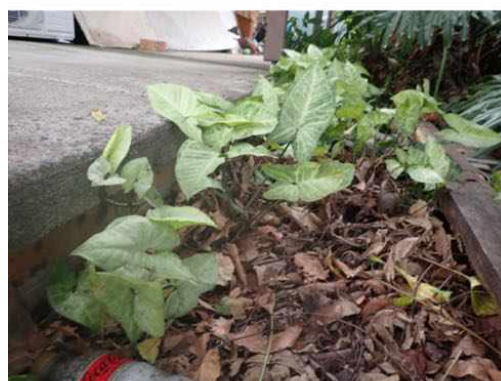
Finding 6.01

Building:	Main Building
Location:	Patio area
Finding:	No Slab Edge Inspection Zone – Conditions Conducive to Termite Attack
Information:	No visible slab edge inspection zone was identified around sections of the building at the time of inspection. The lack of a clear inspection zone can conceal termite activity and creates conditions conducive to termite attack, as it restricts the ability to visually inspect the slab edge for termite entry points or activity. This condition may be due to

surrounding ground levels, paving, garden beds, or other materials covering the slab edge. It is recommended that a qualified builder, landscaper, or pest control specialist expose an adequate slab edge inspection zone around the perimeter of the building to allow for proper inspection and reduce the risk of concealed termite entry. Maintaining a clear inspection zone will assist in early detection and prevention of termite activity. Rectification should be carried out as deemed necessary.

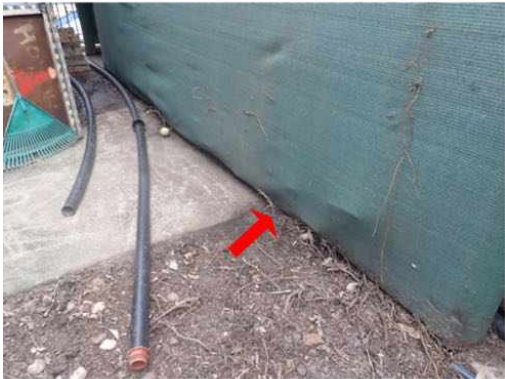
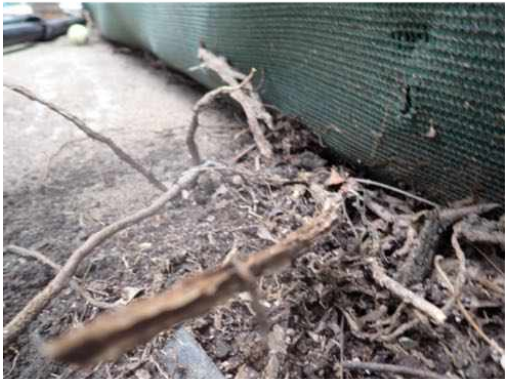
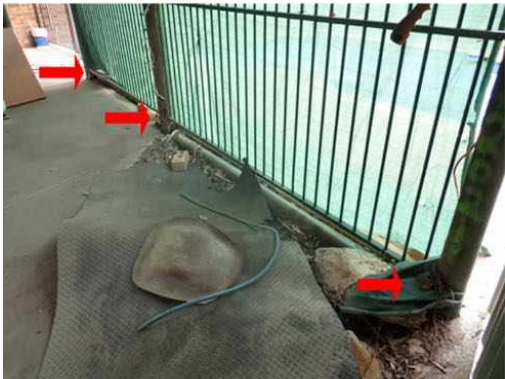
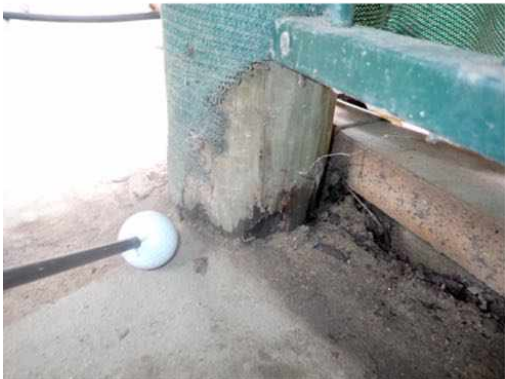
Finding 6.02

Building:	Carport
Location:	Carports
Finding:	Timber in Contact with Ground at Carport Posts – Conditions Conducive to Timber Pest Attack
Information:	Timber elements were observed to be in direct contact with the ground at the carport posts and to timber located along the ground near the posts at the time of inspection. Timber in ground contact is considered a condition conducive to timber pest attack and may also lead to accelerated timber deterioration due to ongoing moisture exposure. It is recommended that a qualified carpenter or builder modify or replace the affected timber to ensure adequate clearance from the ground and reduce the risk of termite activity and timber decay. Rectification should be carried out as deemed necessary.

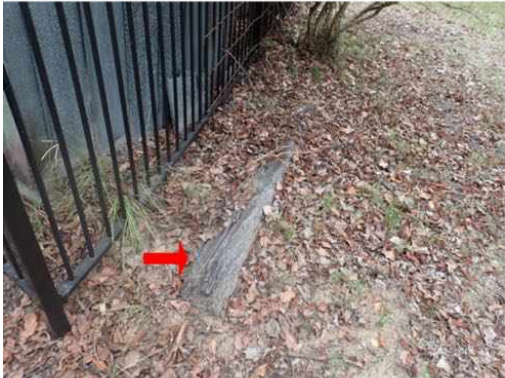
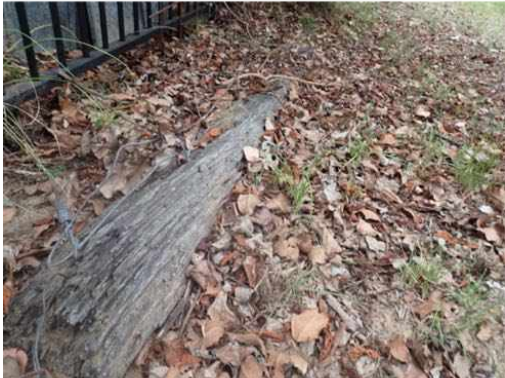
Finding 6.03

Building: Yard
Location: Yard
Finding: Timber in Contact with Ground Near Main Building – Conditions Conducive to Termite Attack
Information: Timber was observed to be in direct contact with the ground near the main building at the time of inspection. Timber in ground contact is considered a condition conducive to termite attack and may also lead to accelerated timber deterioration due to ongoing moisture exposure. It is recommended that any timber in contact with the ground around the building should be removed to reduce the risk of termite activity and timber decay. Rectification should be carried out as deemed necessary.

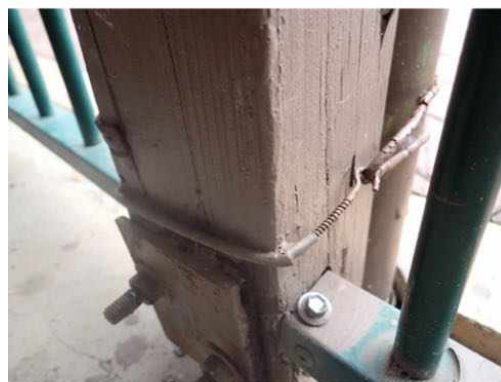
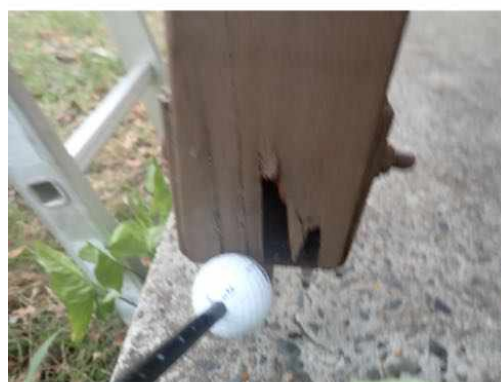
Finding 7.01

Building:	Main Building
Location:	Patio area
Finding:	Wood Rot to Bottom of Timber Veranda Posts
Information:	Wood rot was identified to the bottom of the timber veranda posts at the time of inspection. Deterioration to structural timber elements can reduce the strength and durability of the posts and may worsen if left unaddressed. This condition is commonly caused by prolonged moisture exposure, timber in close proximity to ground level, or inadequate protection of the timber from weather and moisture. It is recommended that a qualified carpenter or builder assess the affected posts and carry out repairs or replacement as required. Ensuring timber posts are adequately sealed, protected from moisture, and maintained will assist in preventing further deterioration. Repair or replacement should be carried out as deemed necessary.

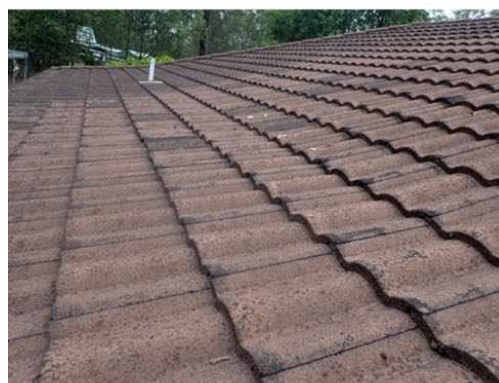
Building:	Main Building
Location:	External roof
Finding:	Roof Tiles Faded but in Fair Condition
Information:	The roof tiles were found to be in fair condition at the time of inspection, however general fading of the tile surface was noted. Fading of roof tiles commonly occurs over time due to ageing and prolonged exposure to the elements and is typical for roof coverings of this age. It is recommended that the roof covering continue to be maintained and monitored as part of normal property maintenance. Any repairs or replacement of damaged tiles should be carried out by a qualified roofer as deemed necessary.

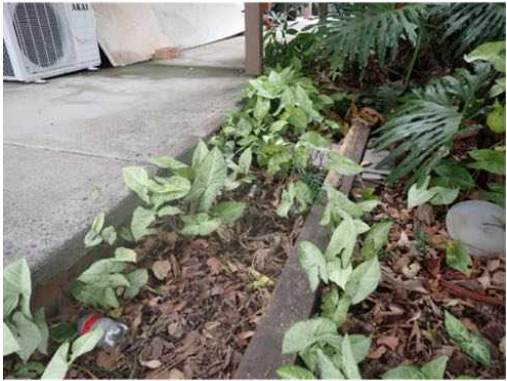
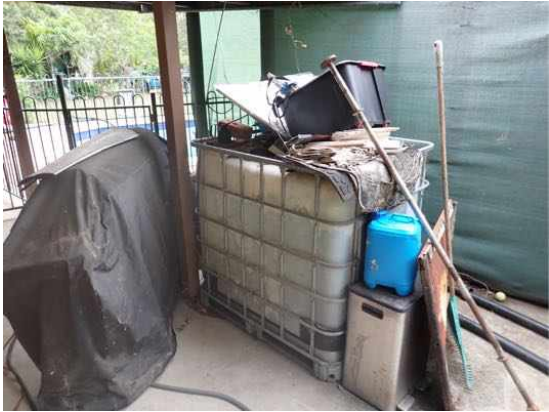
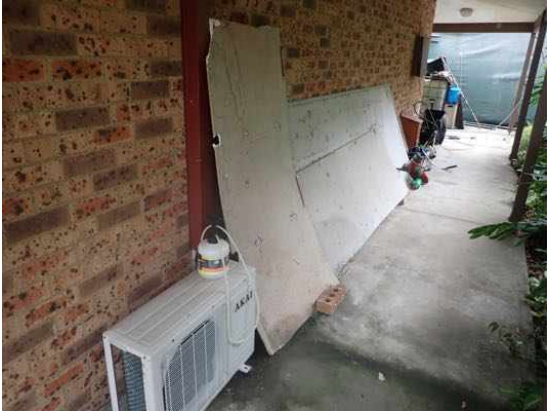
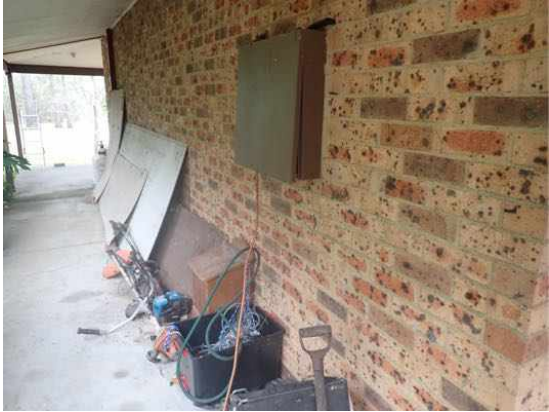
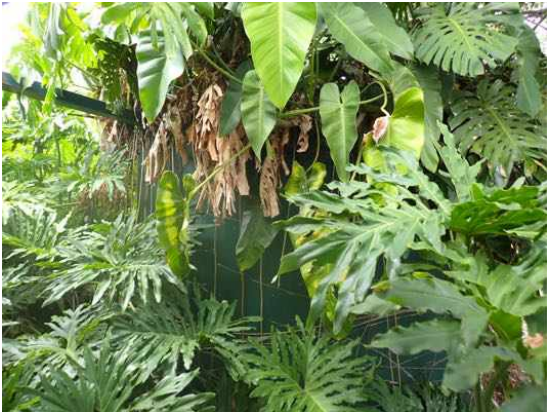
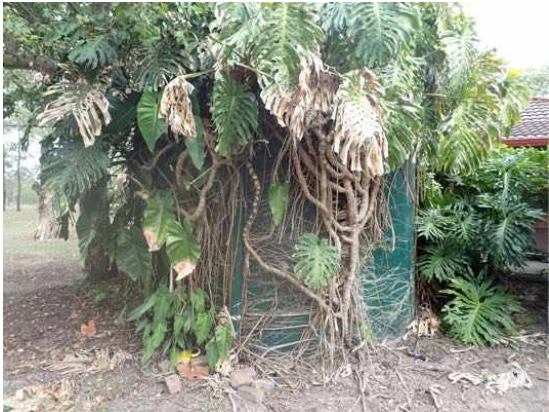
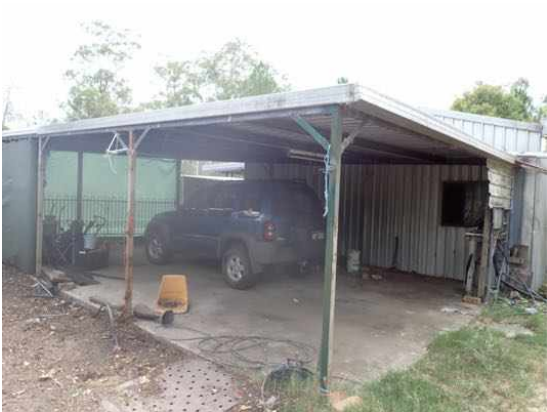
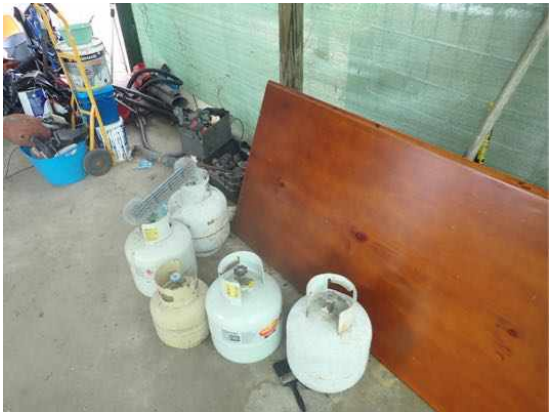
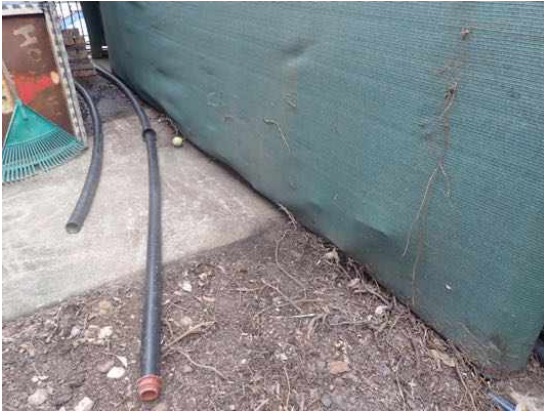
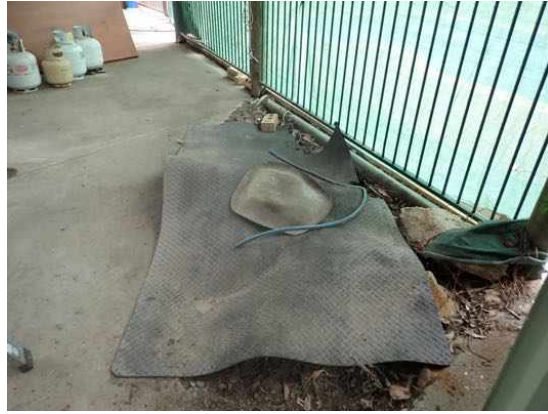
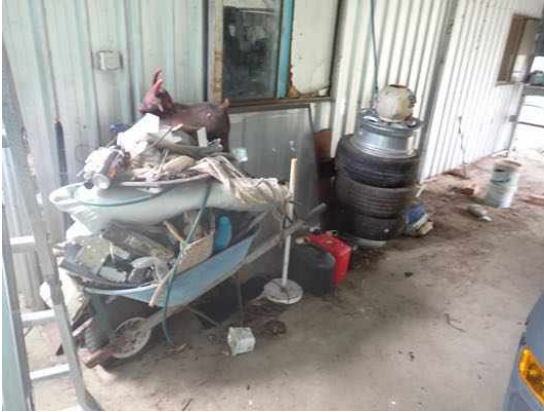
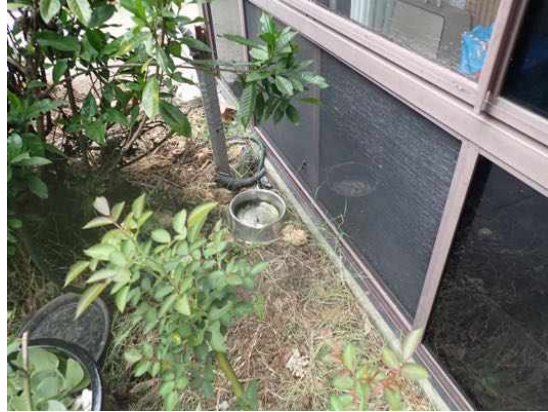
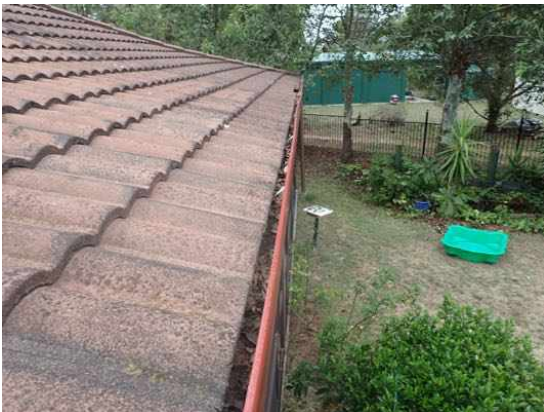
Building:	Not Applicable
Location:	All Areas
Finding:	Additional Photos - Obstructions and Limitations
Information:	These photographs are an indication of the obstructions and limitations which impeded full inspection of the area at the time of inspection. These obstructions can hide an array of defects and should be removed to allow full inspection to be carried out. A re-inspection is recommended once the areas are made accessible.

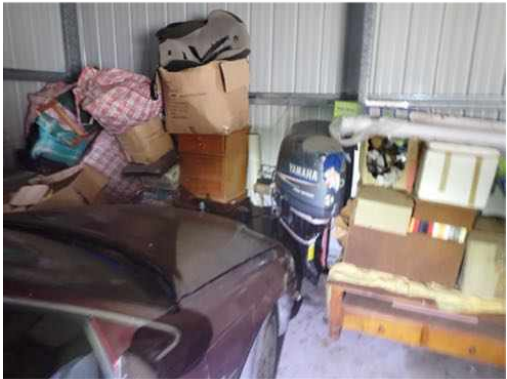
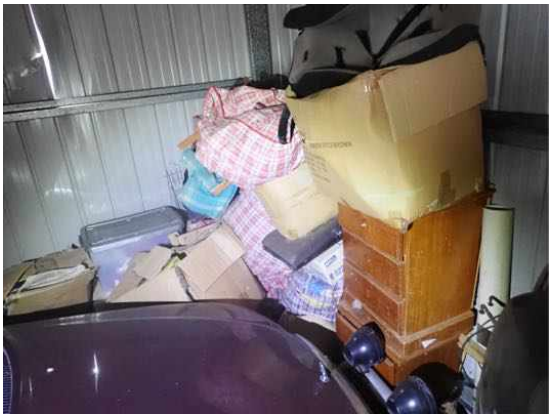
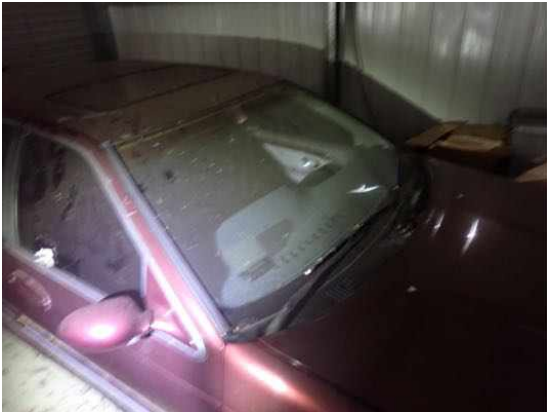
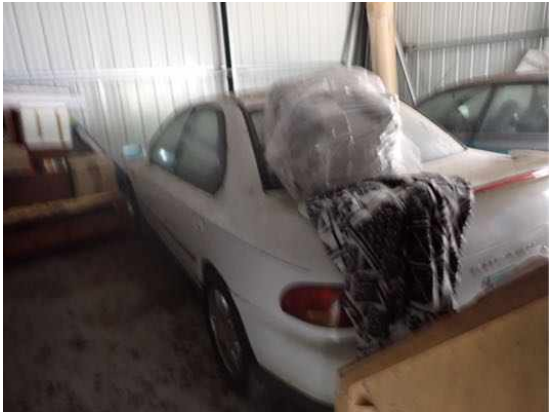
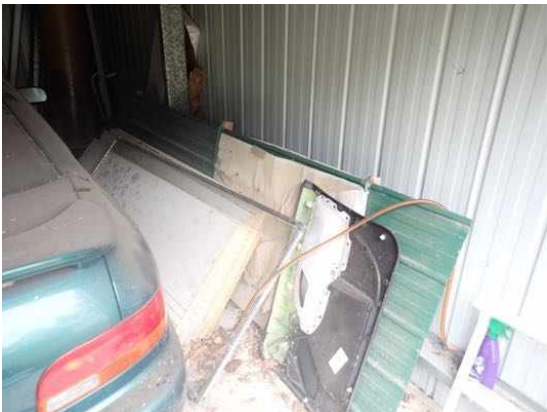
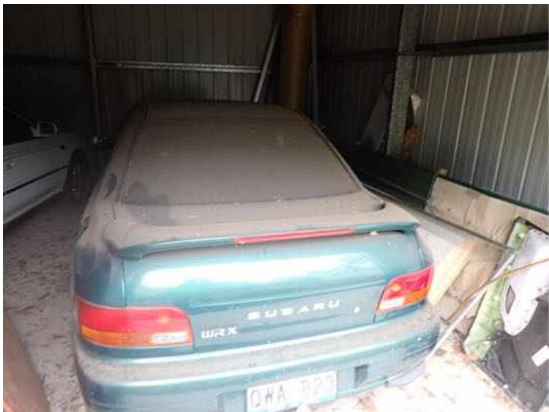
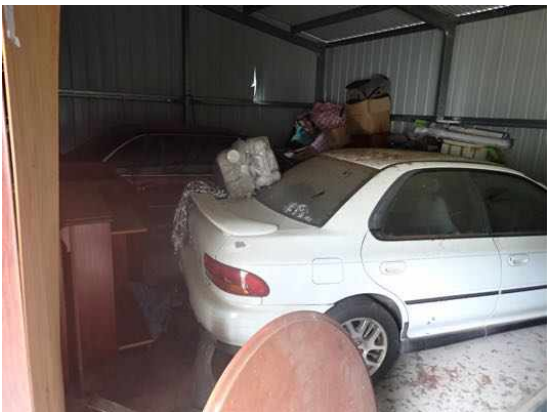
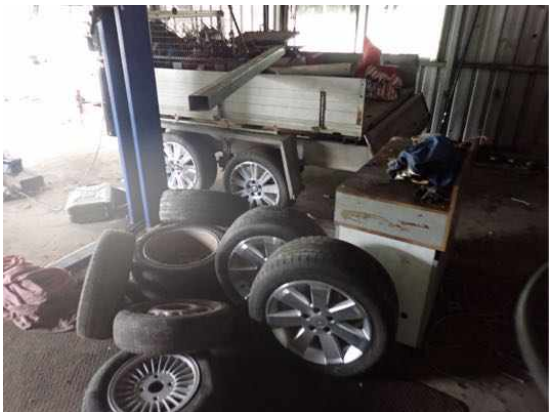
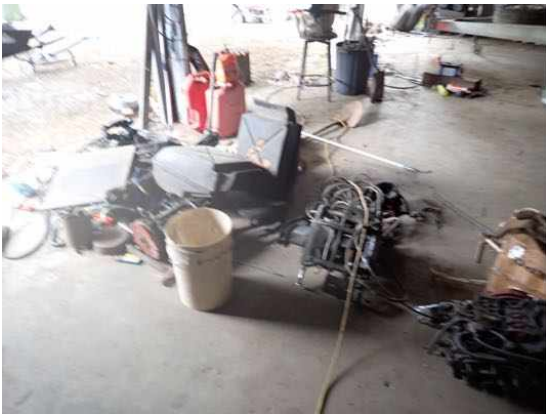
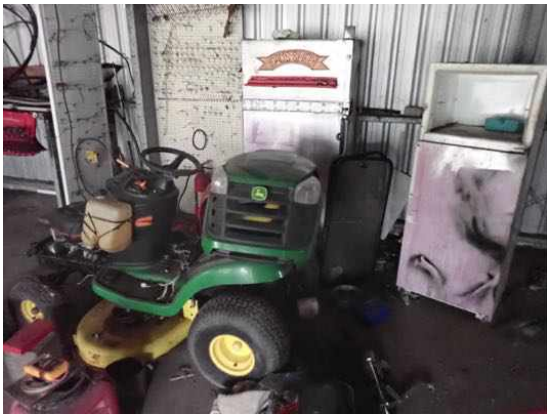
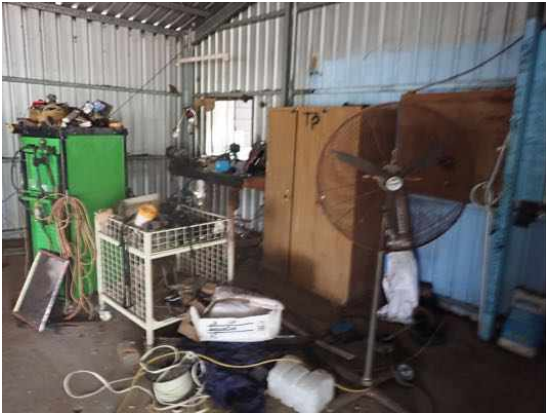
Building:	Shed
Location:	All Areas
Finding:	Additional Photos - Obstructions and Limitations
Information:	These photographs are an indication of the obstructions and limitations which impeded full inspection of the area at the time of inspection. These obstructions can hide an array of defects and should be removed to allow full inspection to be carried out. A re-inspection is recommended once the areas are made accessible.

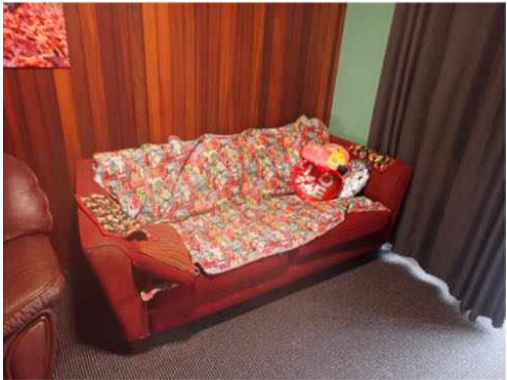
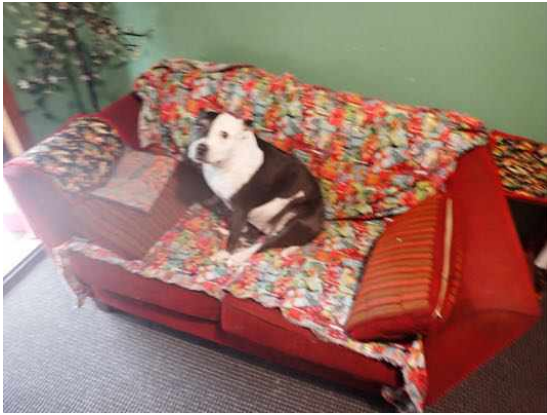
Building: Main Building
Location: All Areas
Finding: Additional Photos - Obstructions and Limitations
Information: These photographs are an indication of the obstructions and limitations which impeded full inspection of the area at the time of inspection. These obstructions can hide an array of defects and should be removed to allow full inspection to be carried out. A re-inspection is recommended once the areas are made accessible.
