## Building and Timber Pest Inspection Report

Inspection Date: Wed, 11 Mar 2026

Property Address: 2/43 Cambridge Ave, Vaucluse NSW 2030,  
Australia

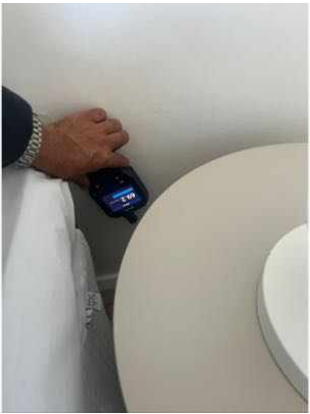
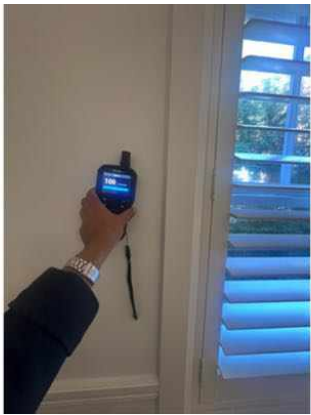
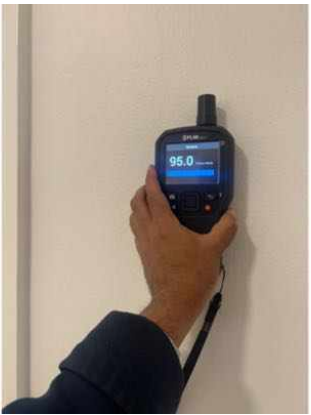
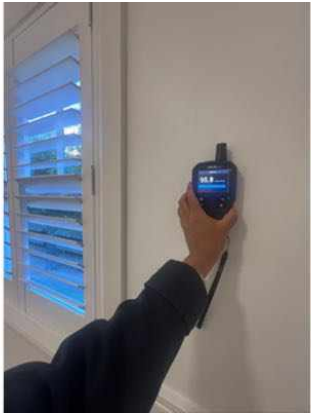
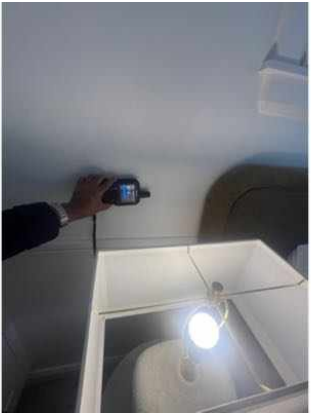
Building: Main Building  
Location: Garage , Internal Exterior walls  
Finding: Damp  
Information: Damp (or structural damp) refers to the presence of unwanted moisture in the structure of a building, either as the result of intrusion from outside, or condensation from within the structure. Generally, structural damp is caused by rain penetration, rising damp, and leaks from plumbing pipes.

Unmanaged damp facilitates the formation and development of mould, fungi growth and wood rot, decaying associated building materials and compromising their structural integrity. Damage to finishes is also likely to occur, including lifting, bubbling, peeling and staining of paint, plaster and wallpaper.

The first step in addressing damp is to diagnose the cause. The identified cause should be addressed first prior to repairing the appearance and other defects which have resulted from the rising damp. If the original cause is not resolved, further cases of damp are likely to ensue, resulting in secondary defects.

Consultation with a qualified plumber is advised immediately to identify the cause of damp and perform remedial works as required. Where excessive mould growth is present, further inspection by a specialist environmental health inspector should also be considered.

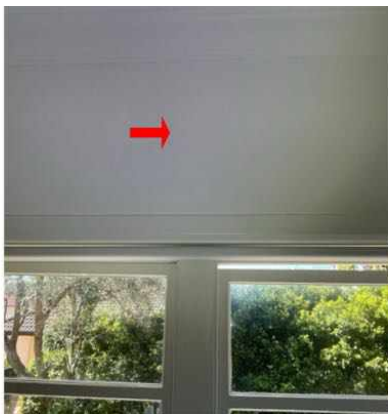
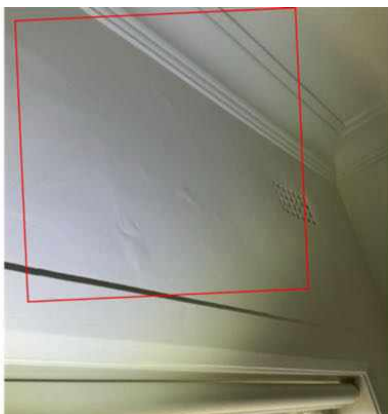
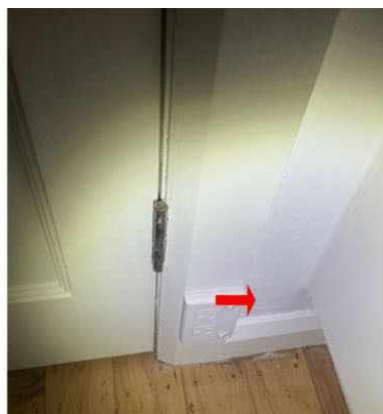
### Finding 3.01

Building: Main Building  
Location: All Internal Areas - Rear bedroom , bedroom front  
Finding: Painted surface - Bubbling to some areas  
Information: Sections of paint in this area was found to have bubbled and deteriorated. Paint bubbling is generally an indication of excessive moisture in the area, that is currently hidden by the painted surface.

The presence of excessive moisture can have major implications on associated building elements if left unattended. While only seemingly minor at this stage, the damage cannot be determined due to the paint obstructing any further inspection of the damage.

It is highly advised that the affected paint be cleaned to allow a further, more invasive inspection by a licensed plumber. Failure to act on this defect may necessitate major works in the future.

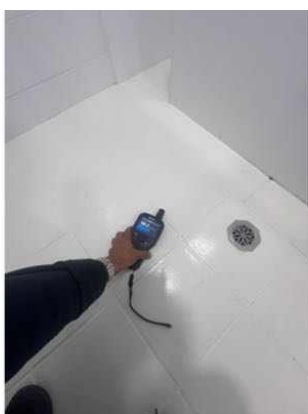
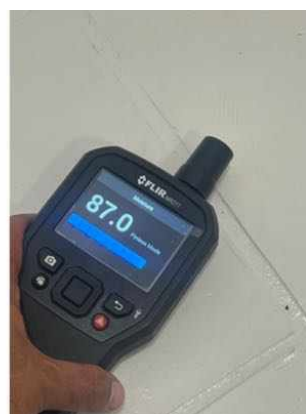
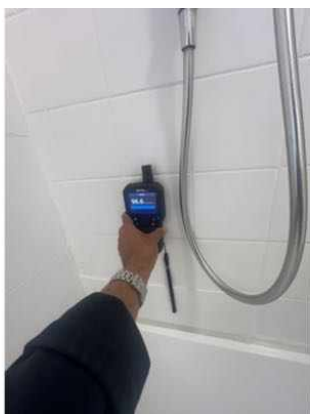
### Finding 3.02

Building:	Main Building
Location:	Bathroom
Finding:	Elevated Moisture Bathroom (No visible deterioration noted)
Information:	Elevated moisture levels were detected to tiled surfaces in bathroom/shower areas. Persistent moisture ingress can lead to concealed damage, including timber rot and mould growth.

Elevated moisture readings in tiled wet areas can occur from normal shower use, age/deterioration of waterproofing membranes, plumbing leaks or moisture absorption through grout lines. While no damage was visible, elevated readings may indicate moisture retention behind tiles, which can be a conducive condition for future deterioration if not monitored.

No immediate action required. Monitor the area over time for signs of drumming, efflorescence, tile movement, or grout deterioration. If concerns arise, a licensed waterproofing specialist can perform further investigation (e.g., pressure testing, membrane assessment).

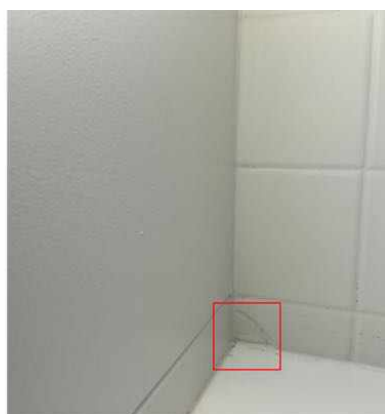
### Finding 3.03

Building:	Main Building
Location:	All Internal Areas - kitchen , bathroom
Finding:	Tiles - Cracked or damaged
Information:	Cracking was evident to the tiling in this area at the time of inspection. While the cracking appears to be minor, this area is frequently exposed to water, allowing potential for water penetration into adjoining sections of walls or flooring.

If left unmanaged, water penetration to these areas may lead to subsequent water damage, which is likely necessitate repair work to affected building elements.

A tiling contractor should be appointed to ensure that no further water damage occurs. The re-application of silicone and grouting throughout remaining tile work is also advised, to further protect the area against water penetration.

Where water penetration has led to water damage, appointment of a relevant tradesperson may be required to repair damaged building elements.

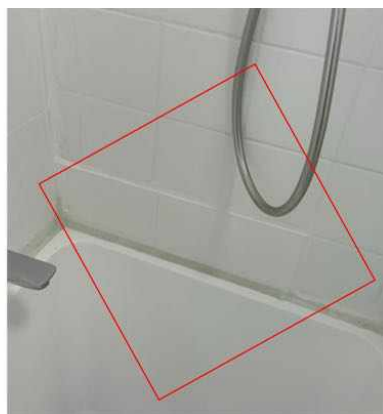
Finding 3.04

Building: Main Building  
Location: Bathroom  
Finding: Installation - substandard or incomplete - Excessive sealant , uneven tiles  
Information: The installation of this building element appears to have been completed to a substandard level of workmanship or is incomplete. Generally substandard repairs or installation are related to poor workmanship, the use of inappropriate materials, or a failure to complete installation to a suitable standard.

Where installation is substandard and/or incomplete, the client should contact the responsible trade to undertake rectification. Unfinished and substandard building works are likely to degrade more quickly and may create potential for secondary defects to associated building elements.

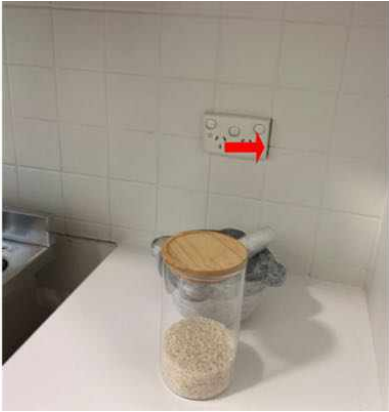
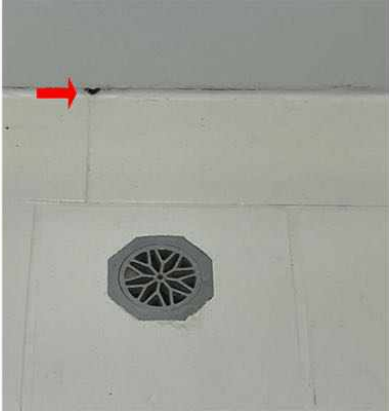
### Finding 3.05

Building:	Main Building
Location:	All Internal Areas
Finding:	Sealant and grouting - Missing or degraded
Information:	It was noted on inspection that sealant or grout is degraded. There is also evidence of poor workmanship and excessive use of sealant. Silicone should never be used as a first line of defence against waterproofing. Further inspection by a licensed waterproofing contractor is highly recommended.

Different materials and floor areas move at different rates, generally causing cracking to grout or sealant at this point. A flexible sealant is required to allow for expected expansion and contraction, while keeping the joint water tight and protective of all associated building materials.

There appears to be excessive mould to the sealant and grout which will likely require scraping out and replacement.

Flexible and mould resistant materials should be applied to affected areas to prevent any subsequent water damage that is likely to occur. Regular maintenance and replacement of damage or missing or damaged sealant and grout is highly recommended to the wet areas, as this is a regular wear and tear defect. Sealant and grouting in areas that come into regular contact with water should be maintained for the long term care of your property.

A sealant specialist or tiling contractor should be appointed to complete these works as soon as possible.

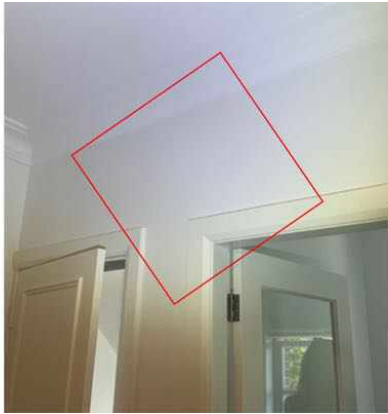
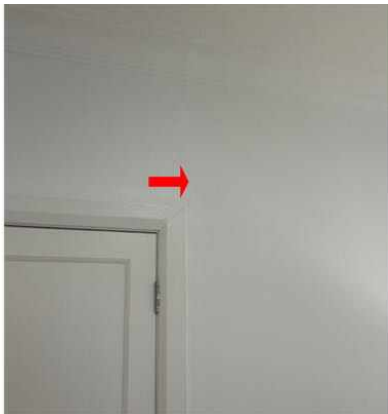
**Finding 3.06**

Building: Main Building  
Location: All Internal Areas  
Finding: Cracking & Past Repairs  
Information: Cracking and evidence of past repairs were noted in this area. The extent and adequacy of any previous repair work cannot be confirmed during a visual inspection. Ongoing monitoring is recommended, and further evaluation by a suitably qualified contractor or structural engineer may be required if concerns persist.

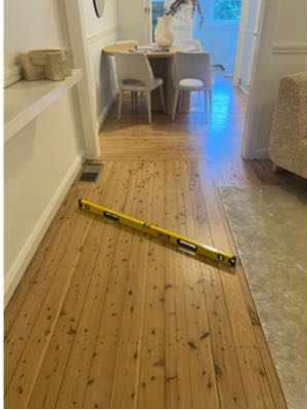
### Finding 3.07

Information: The internal flooring in this area is out of level and uneven. Uneven flooring is likely to indicate minor defects such as expected movement of the foundations of the property, but may also indicate subsidence of the associated subfloor stumps.

It is advised that the flooring be closely monitored to identify any further movement. Where flooring remains relatively unchanged for an extended period of time (i.e. several months), it is likely that this defect has been caused by expected movement of the foundations of the property.

However, where flooring is uneven further, potentially invasive inspection of the subfloor structures and stumps in this area is required. In this case, works to repair are likely to be required, and would be carried out by a registered builder specialising in re-stumping.

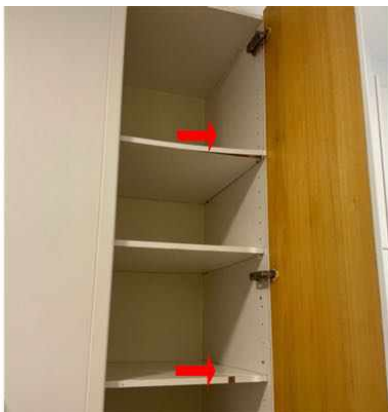
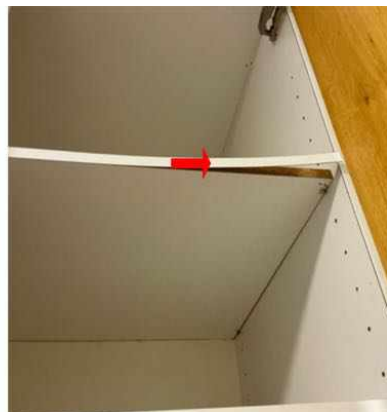
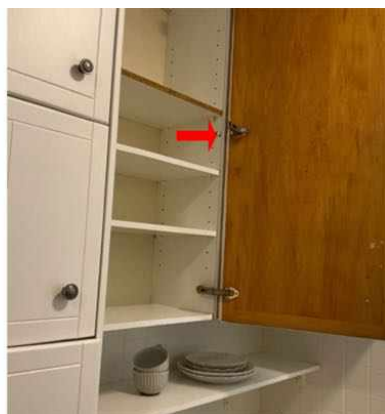
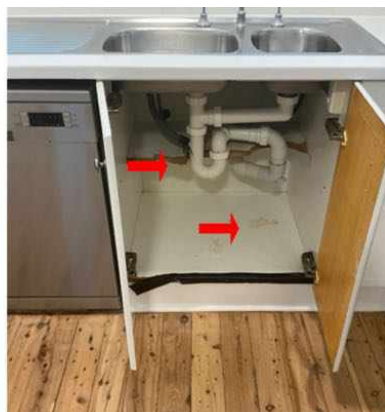
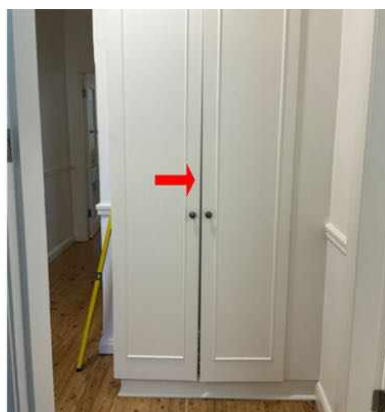
### Finding 3.08

Building:	Main Building
Location:	All Internal Areas
Finding:	Building element - Damaged - kitchen cupboard chipping , hallway misaligned doors
Information:	Breakage occurs generally when the building materials have either aged and decayed, or as a result of damage (accidental or deliberate).

Repair and/or replacement of broken elements is advised to ensure that additional secondary defects do not arise as a consequence. Such works are necessary, as all building elements play a key role in the operation and function of the overall structure and its performance.

A relevant tradesperson should be appointed to repair or replace the affected building element prior to any subsequent damage being caused.

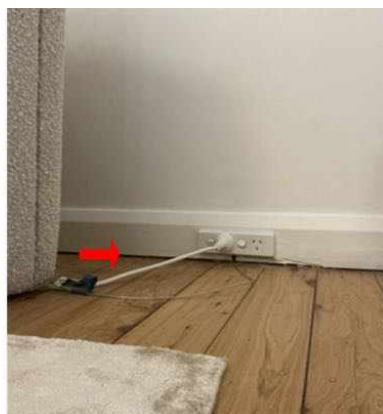
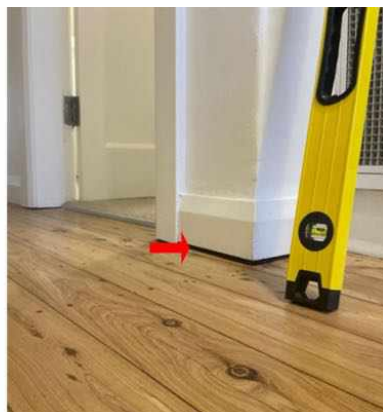
### Finding 3.09

Building:	Main Building
Location:	All Internal Areas
Finding:	Gap between skirting and Floor to some areas
Information:	A localised gap is visible between the skirting board and the laminate/timber floor finish, indicating minor floor level variation or movement of the floating floor system. This condition is most consistent with minor slab/floor unevenness, floor finish movement or shrinkage. While primarily cosmetic/serviceability in nature, monitoring is recommended and further assessment may be warranted by a licensed builder if additional signs of structural movement become apparent.

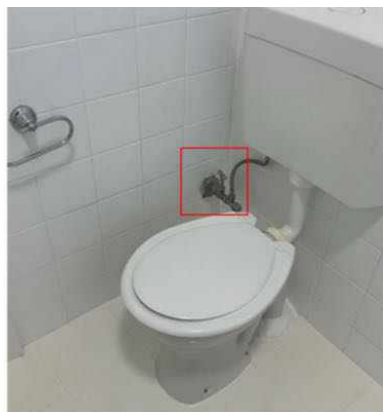
Building: Main Building  
Location: All Internal Areas  
Finding: Installation - substandard or incomplete - Oven not fixed possible safety , Fixing not flush to wall  
Information: The installation of this building element appears to have been completed to a substandard level of workmanship or is incomplete. Generally substandard repairs or installation are related to poor workmanship, the use of inappropriate materials, or a failure to complete installation to a suitable standard.

Where installation is substandard and/or incomplete, the client should contact the

responsible trade to undertake rectification. Unfinished and substandard building works are likely to degrade more quickly and may create potential for secondary defects to associated building elements.

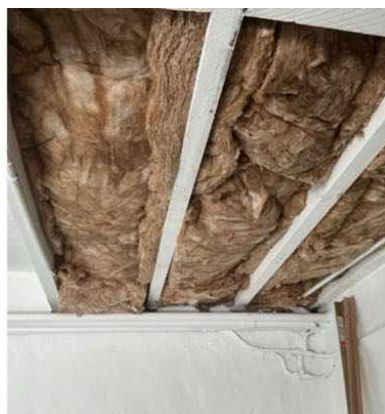
### Finding 3.12

Building:	Main Building
Location:	Garage
Finding:	Installation - substandard or incomplete - Exposed insulation
Information:	The installation of this building element appears to have been completed to a substandard level of workmanship or is incomplete. Generally substandard repairs or installation are related to poor workmanship, the use of inappropriate materials, or a failure to complete installation to a suitable standard.

Where installation is substandard and/or incomplete, the client should contact the responsible trade to undertake rectification. Unfinished and substandard building works are likely to degrade more quickly and may create potential for secondary defects to associated building elements.

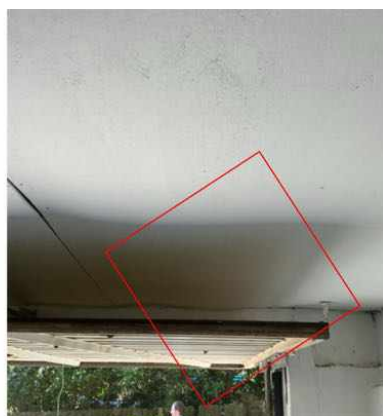
### Finding 3.13

Information: Sections of the ceiling were found to be sagging at the time of inspection. Sagging to the fixed ceiling structure generally indicates that the building materials have swollen, due to contact with water, or that fixings (e.g. nails or glue) have become loose and require reattachment.

Where minor sagging is evident, comparatively minor works, such as re-gluing of ceiling sheets, may be required. Such works may be performed by relevant tradespeople, such as plasterers and painters. Where excessive moisture has caused the roofing structure to swell and sag, the source of the water leak should primarily be identified prior to any remedial works being performed.

In some cases, sagging ceiling linings may also indicate that there are structural issues, causing surfaces to warp, twist or sag. Where sagging appears to be major, appointment of a structural engineer is advised to further inspect the property and identify the source and rectification works required.

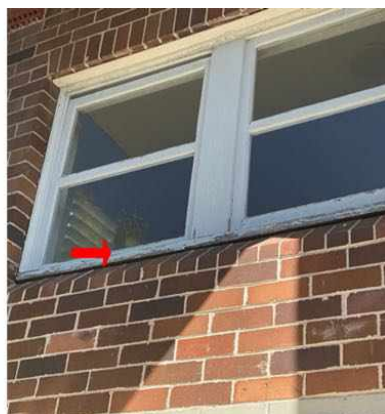
### Finding 3.14

Building:	Main Building
Location:	All External Areas
Finding:	External painting deteriorated (Windows)
Information:	Whilst incomplete or missing paint finish is generally an appearance defect, it can also lead to the development of secondary building defects over time. Incomplete areas of paint finish expose the area to moisture, potentially accelerating the deterioration of underlying building materials.

Degraded paint finishes should be sanded back, filled, leveled and painted, as applicable. Where inadequate or missing paint protection has led to the deterioration of the associated building element, repair and/or replacement of this building element may be required.

A painting contractor should be appointed as soon as possible to perform necessary works to aid the appearance of the affected area and to ensure the area is protected against further deterioration. Alternatively, the homeowner following manufacturer instructions may perform these works.

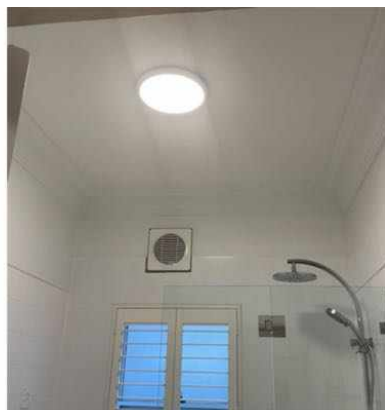
### Finding 3.15

Building:	Main Building
Location:	Bathroom
Finding:	Building element - Missing - no ventilation
Information:	Although some building elements may seem irrelevant or unnecessary, all building elements play a key role in the operation and function of the overall structure and its performance.

Replacement of any missing building element should be conducted as soon as possible to ensure that no damage or functional issues occur to associated building materials.

The appropriate tradesperson should be appointed as soon as possible to replace the missing building element.

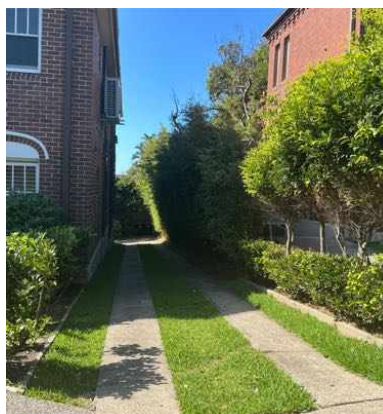
### Finding 6.01

Building:	Main Building
Location:	All External Areas
Finding:	Trees within 50m
Information:	Trees within 50m of the property can be conducive to termite activity. It is recommended an invasive inspection of all trees with 50m to the property be carried out by a qualified pest control expert.

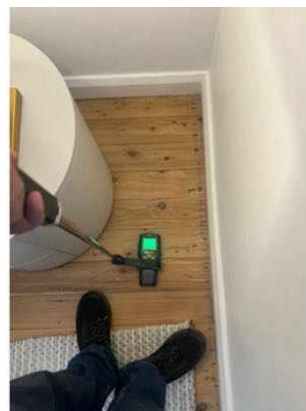
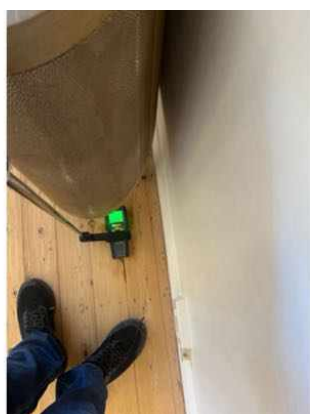
### Finding 6.02

Building:	Main Building
Location:	All External Areas
Finding:	Damp
Information:	Damp (or structural damp) refers to the presence of unwanted moisture in the structure of a building, either as the result of intrusion from outside, or condensation from within the structure. Generally, structural damp is caused by rain penetration, rising damp, and leaks from plumbing pipes.

Unmanaged damp facilitates the formation and development of mould, fungi growth and wood rot, decaying associated building materials and compromising their structural integrity. Damage to finishes is also likely to occur, including lifting, bubbling, peeling and staining of paint, plaster and wallpaper.

The first step in addressing damp is to diagnose the cause. The identified cause should be addressed first prior to repairing the appearance and other defects which have resulted from the rising damp. If the original cause is not resolved, further cases of damp are likely to ensue, resulting in secondary defects.

Consultation with a qualified plumber is advised immediately to identify the cause of damp and perform remedial works as required. Where excessive mould growth is present, further inspection by a specialist environmental health inspector should also be considered.

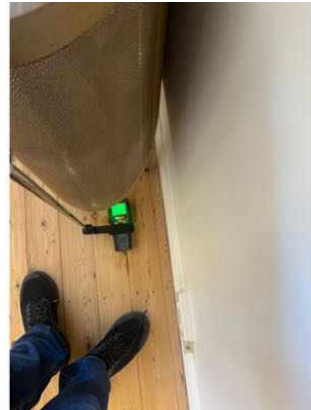
### Finding 6.03

Building:	Main Building
Location:	All Internal Areas - Skirting , Flooring to some areas
Finding:	Elevated moisture - identified
Information:	Elevated moisture can attract termites and produce conditions that promote fungal growth and wood decay.

Prior to any remedial works being performed a qualified plumber should be appointed to further inspect the property and to identify the cause of the excessive moisture.

Works to remove affected building elements may then be necessary and should be performed by an appropriate tradesperson.

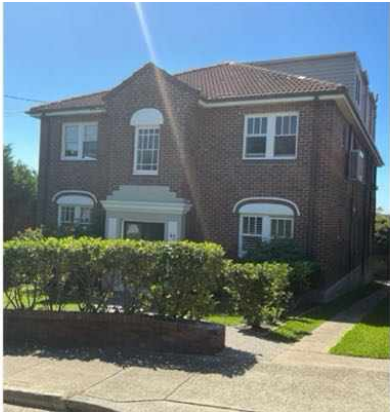
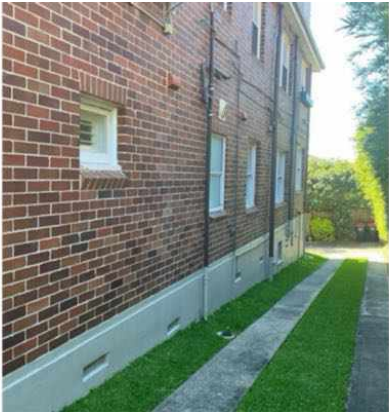
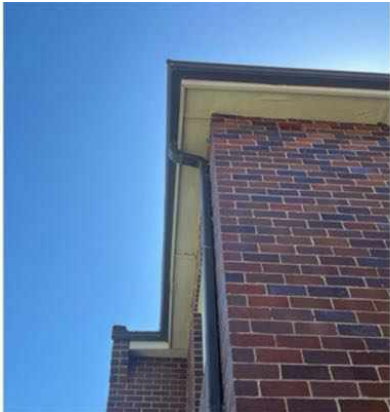
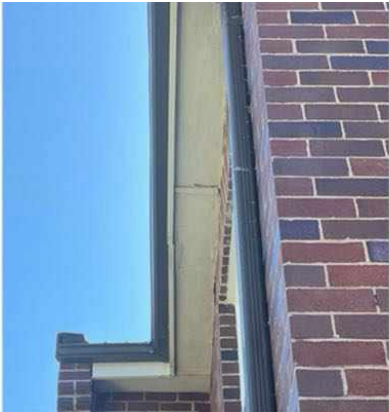
#### Noted Item

Building: Main Building  
Location: All External Areas  
Finding: Additional Photos - Obstructions and Limitations  
Information: These photographs are an indication of the obstructions and limitations which impeded full inspection of the property at the time of inspection. These obstructions can hide an array of defects and should be removed to allow full inspection to be carried out. A re-inspection is recommended once the areas are made accessible.

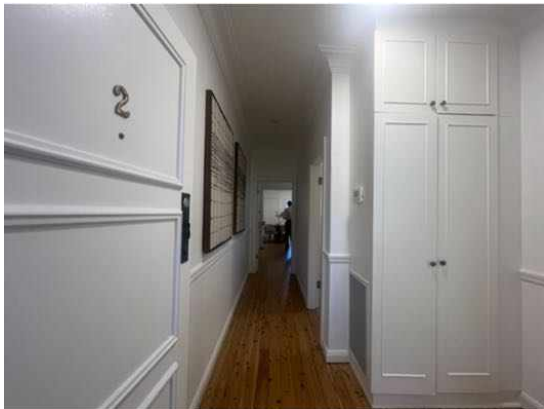
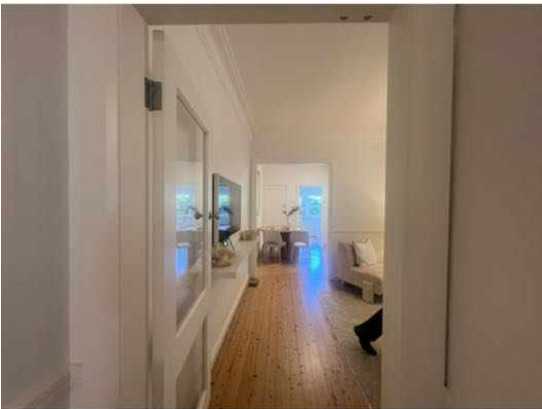
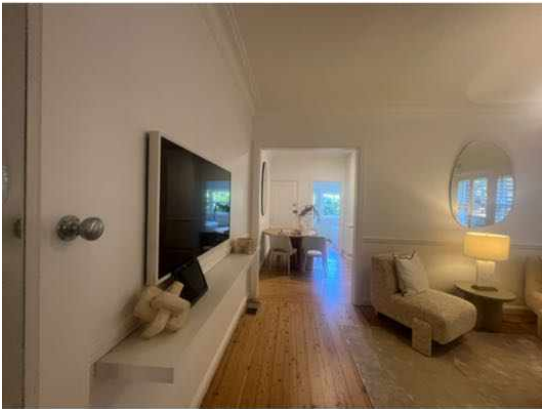
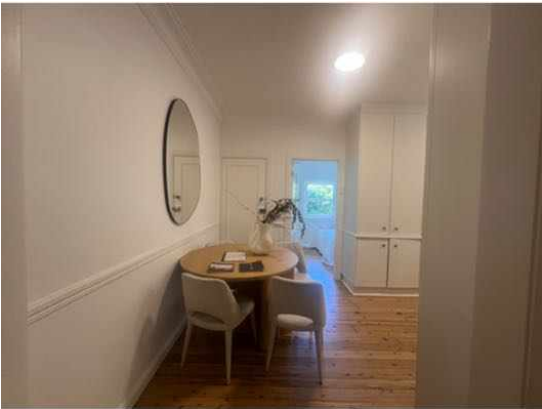
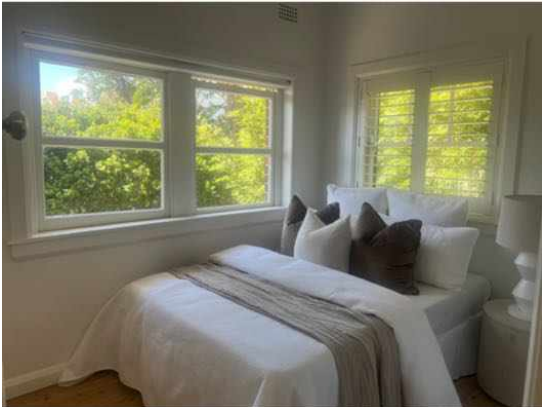
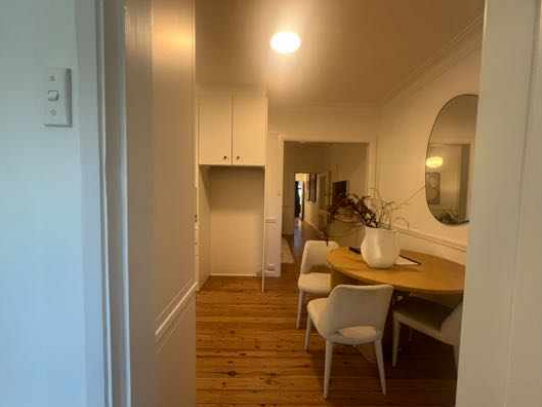
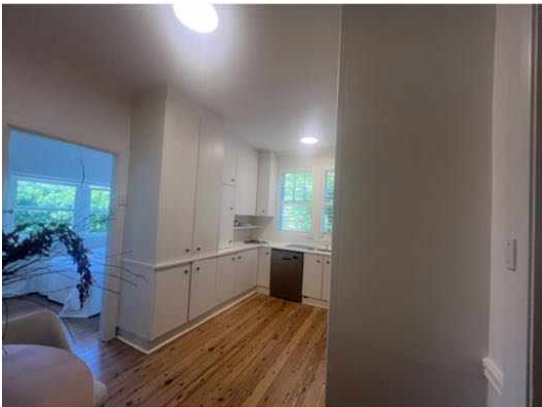
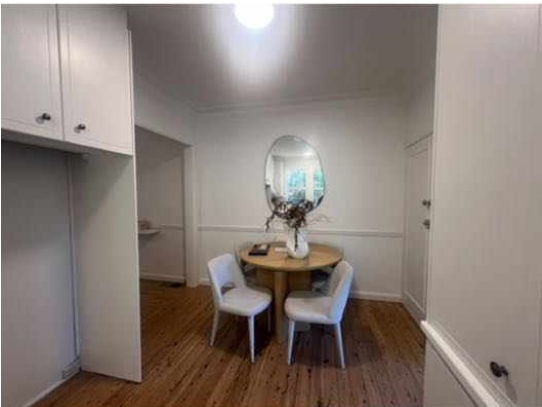
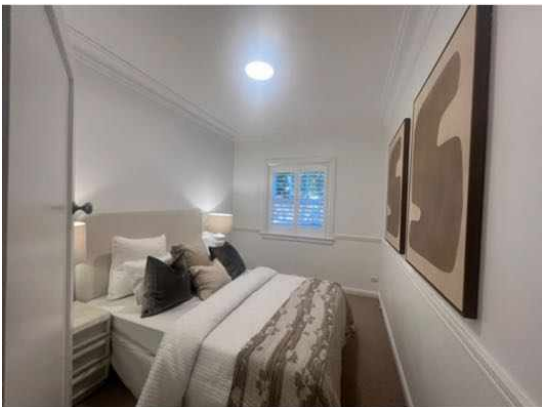
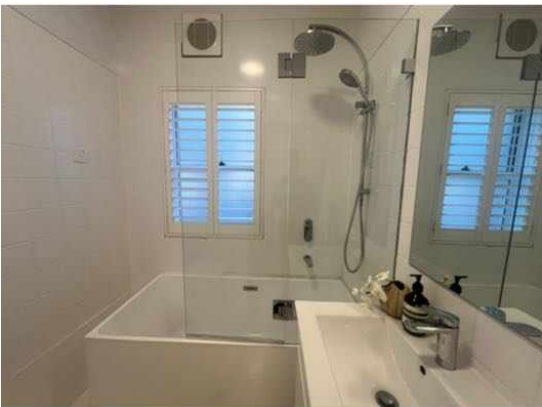
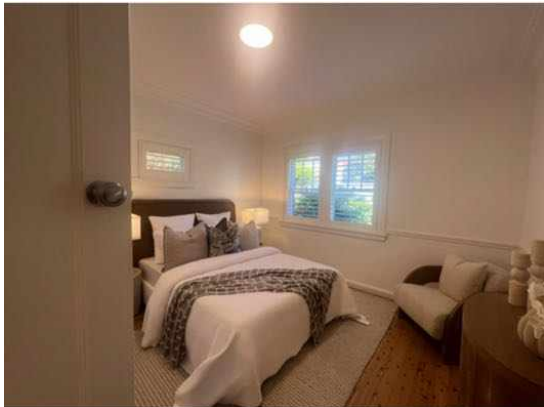
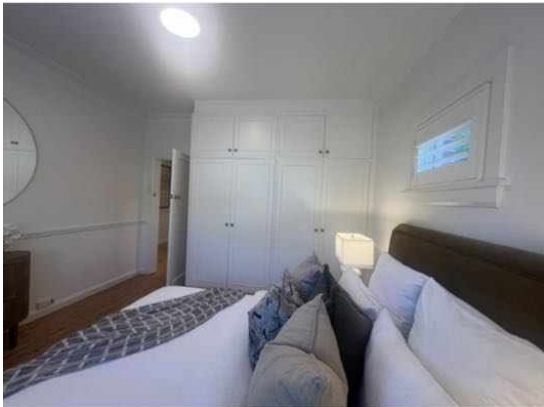
Building: Main Building  
Location: All Internal Areas  
Finding: Additional Photos - Obstructions and Limitations  
Information: These photographs are an indication of the obstructions and limitations which impeded full inspection of the property at the time of inspection. These obstructions can hide an array of defects and should be removed to allow full inspection to be carried out. A re-inspection is recommended once the areas are made accessible.

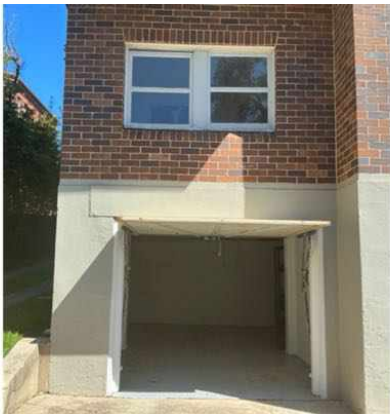
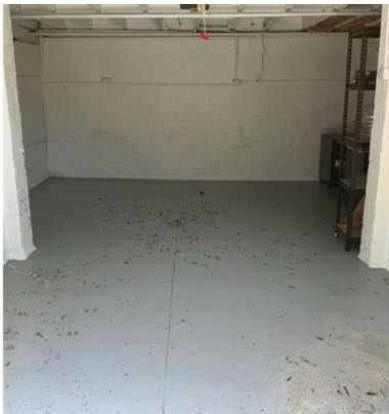
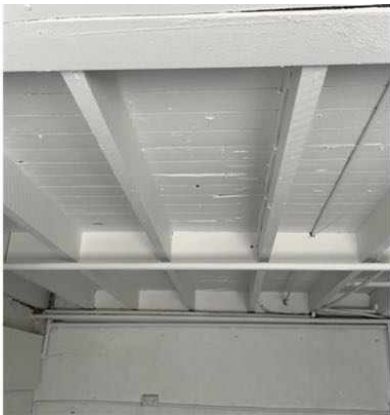
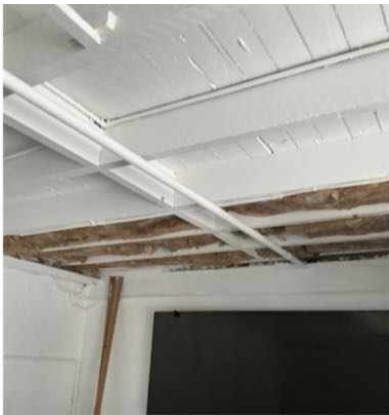
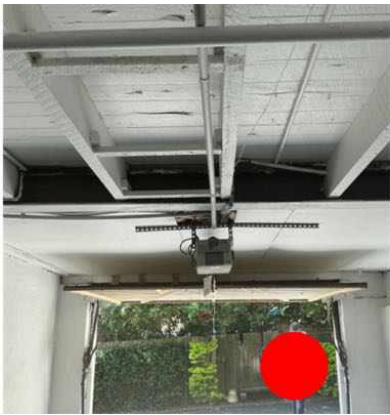
Building: Main Building  
 Location: Garage  
 Finding: Additional Photos - Obstructions and Limitations  
 Information: These photographs are an indication of the obstructions and limitations which impeded full inspection of the property at the time of inspection. These obstructions can hide an array of defects and should be removed to allow full inspection to be carried out. A re-inspection is recommended once the areas are made accessible.
