# Building and Timber Pest Inspection Report

Inspection Date: Tue, 13 Jan 2026

Property Address: 2/198 Old Kent Rd, Greenacre NSW 2190,  
Australia

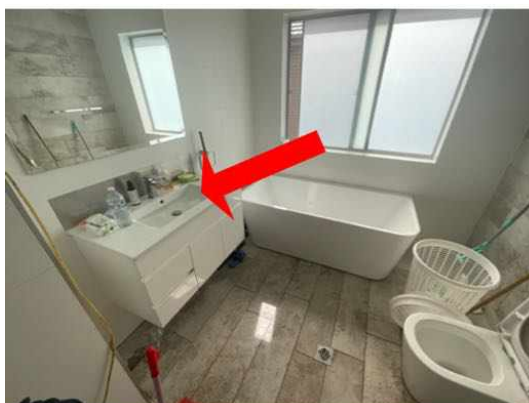
Building: Main Building  
 Location: Bathroom  
 Finding: Internal drains (vanity) - Blockages  
 Information: Vanity drains throughout the property have blocked at the time of the inspection. Vanity drains are vital in removing the water in vanity bowl and should be fully functional. Minor blockages create potential for the development of moisture damage over time.

All vanity drains should be assessed by the building contractor and cleared or replaced where applicable.

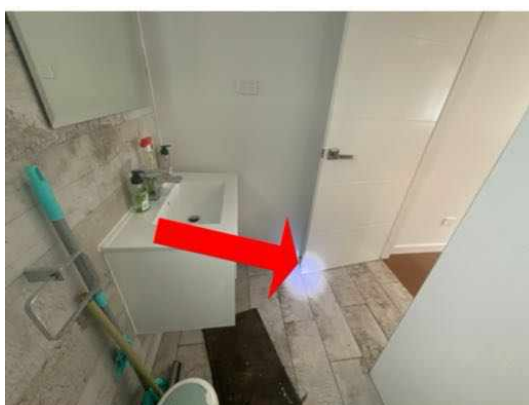
### Finding 3.02

Building: Main Building  
 Location: All Internal Areas > Ground Level  
 Finding: Door - swelling and damage at the bottom edge  
 Information: Swollen and damaged door base in bathroom due to moisture exposure. Edges show fraying and surface degradation.

Replace or seal the affected door. Ensure door edges are properly sealed to prevent future water damage.

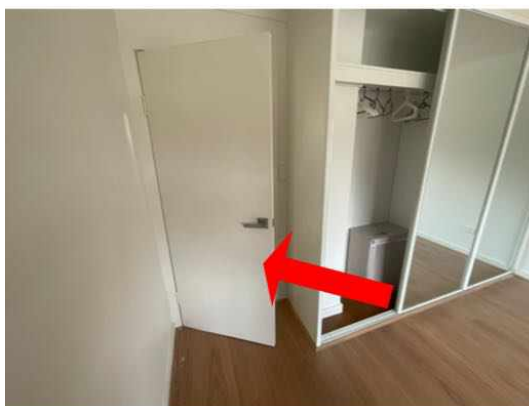
### Finding 3.03

Building: Main Building  
 Location: All Internal Areas  
 Finding: Door frames - not square  
 Information: It appears that one and / or more doors have been installed in a manner which is not consistent with acceptable standards of workmanship. The door frames are not square and or plumb and require rectification.

Deviation from the manufacturer's installation instructions is considered a defect with reference to Standards and Tolerances.

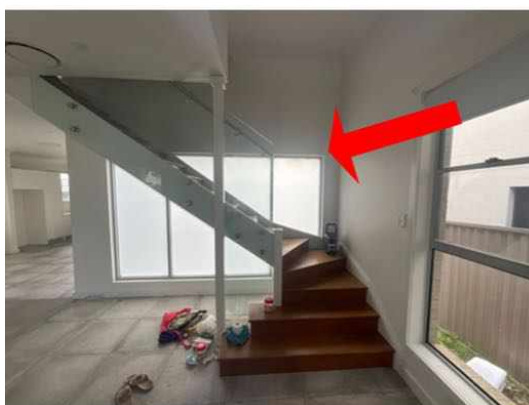
### Finding 3.04

Building:	Main Building
Location:	All Internal Areas
Finding:	Cracking - Damage Category 1 - Fine (up to 1mm)
Information:	Although fine cracks are quite noticeable, they are often only considered to be an appearance defect, and usually do not indicate any structural damage. Generally, the cause of a fine crack is indicative of a separation between building materials and finishes (e.g. paint, plaster, etc.) along joins.

Cracking of this nature can generally be repaired with minor sanding, filling and/or repainting. Such works should be performed by a qualified painter or a general handyman.

Monitoring of all cracking should be conducted frequently. Always contact a building inspector should cracks widen, lengthen, or become more numerous.

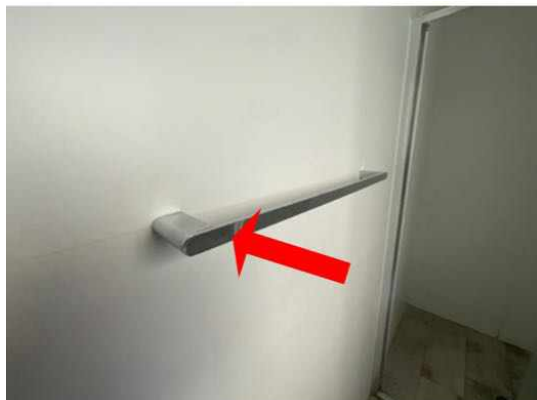
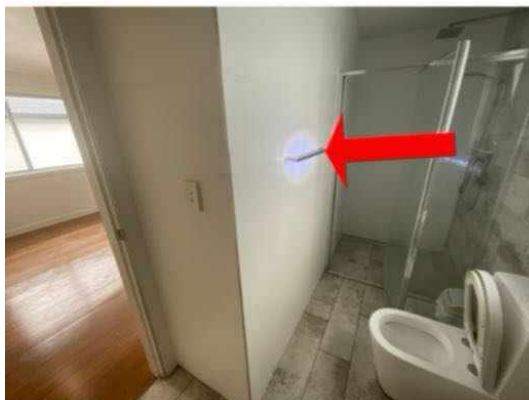
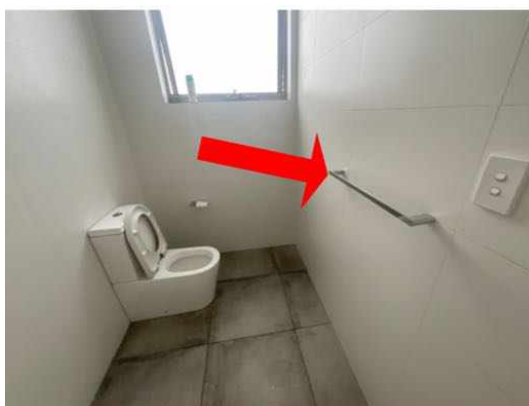
### Finding 3.05

Building:	Main Building
Location:	Powder Room / Ensuite
Finding:	Bathroom holders - Loose
Information:	The bathroom holder was found to be loose at the time of inspection. While not a

major operational defect, function can deteriorate if the problem is left unmanaged.

It is advised that the homeowner performs remedial works to re-attach the bathroom holder to its original fixing. A general handyman may be required to perform these works.

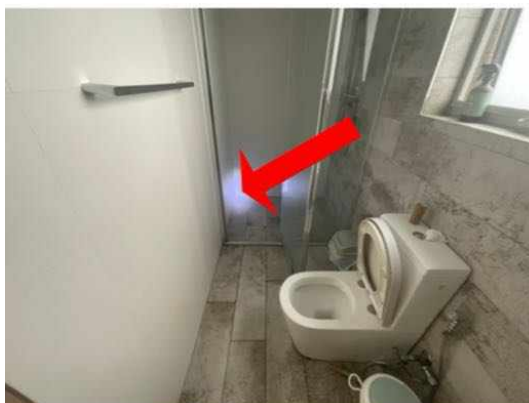
### Finding 3.06

Building:	Main Building
Location:	Ensuite
Finding:	Sealant and grouting - Missing or damaged
Information:	It was noted on inspection that sealant or grout is degraded to the tiled shower alcove and or other areas of the bathroom.

Different materials and floor areas move at different rates, generally causing cracking to grout or sealant at this point. A flexible sealant is required to allow for expected expansion and contraction, while keeping the joint water tight and protective of all associated building materials.

There appears to be excessive mould to the sealant and grout which will likely require scraping out and replacement.

Flexible and mould resistant materials should be applied to affected areas to prevent any subsequent water damage that is likely to occur. Regular maintenance and

replacement of damage or missing or damaged sealant and grout is highly recommended to the wet areas, as this is a regular wear and tear defect. Sealant and grouting in areas that come into regular contact with water should be maintained for the long term care of your property.

A sealant specialist or tiling contractor should be appointed to complete these works as soon as possible

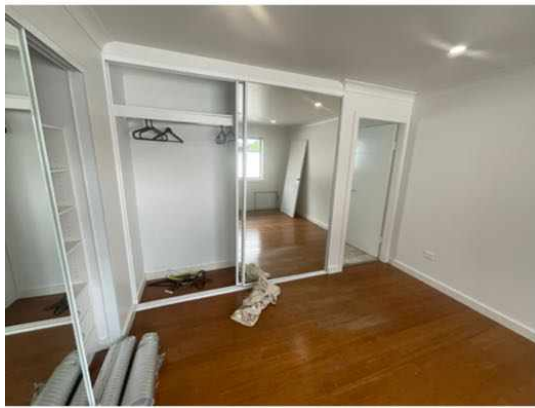
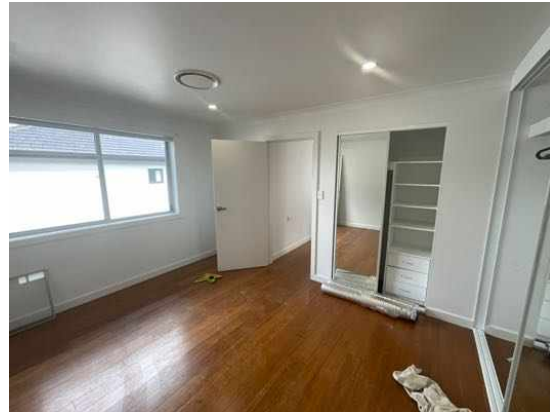
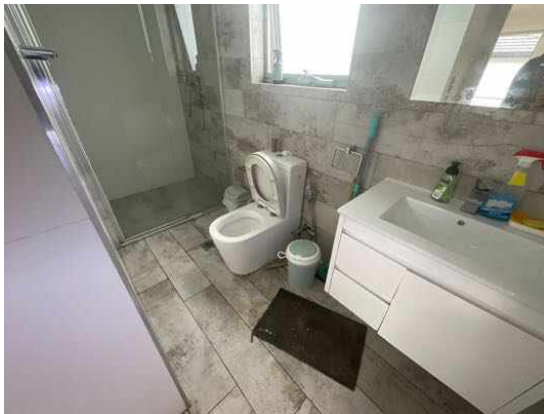
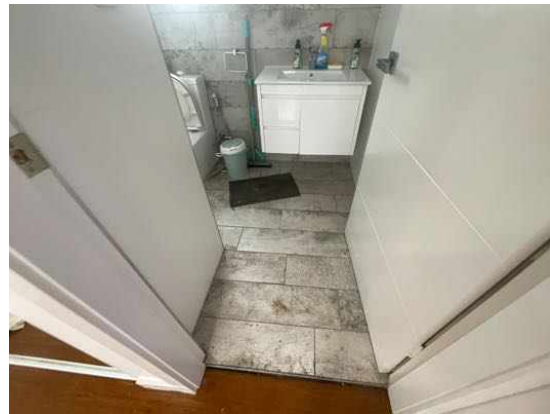
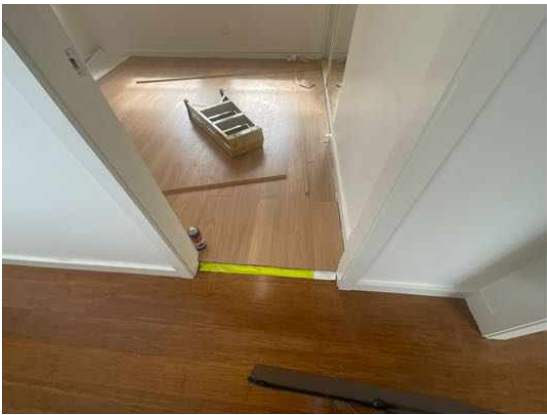
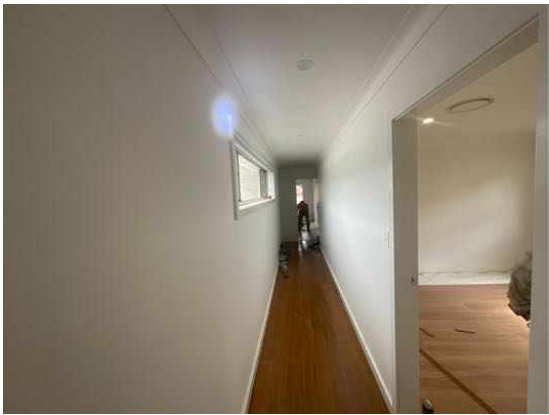
#### Noted Item

Building: Main Building  
Location: All Areas  
Finding: Additional Photos - Obstructions and Limitations  
Information: These photographs are an indication of the obstructions and limitations which impeded full inspection of the property at the time of inspection. These obstructions can hide an array of defects and should be removed to allow full inspection to be carried out. A re-inspection is recommended once the areas are made accessible.

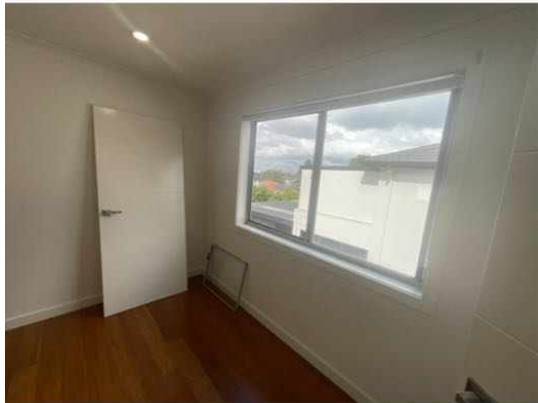
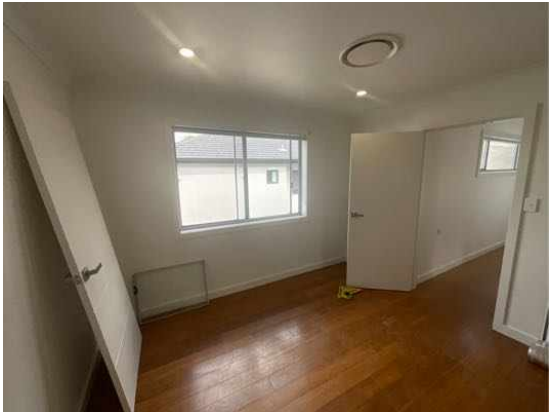
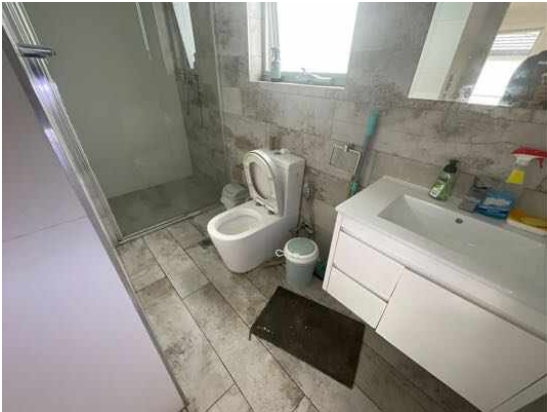
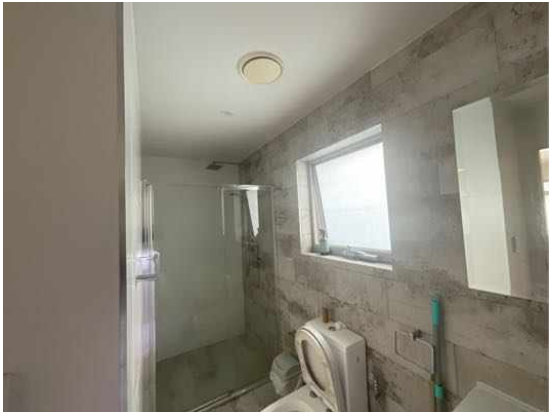
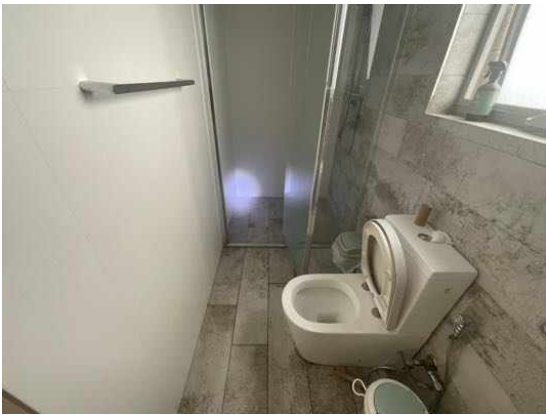
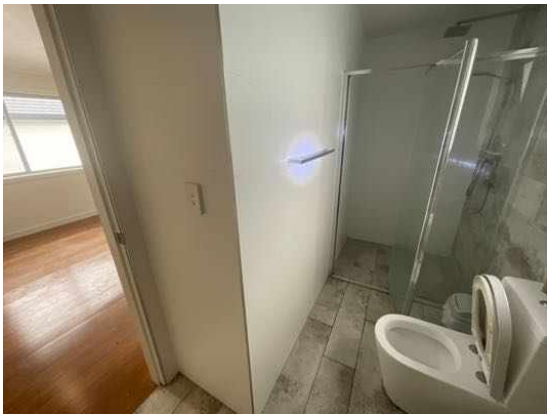
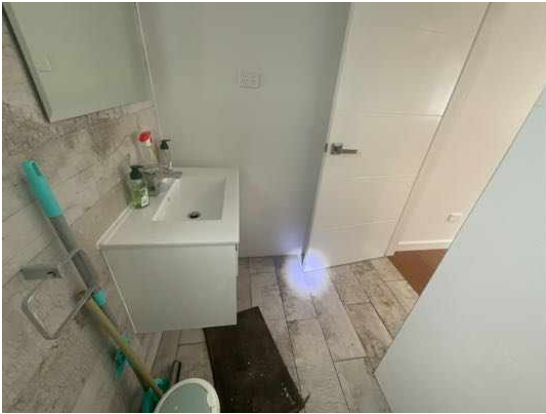
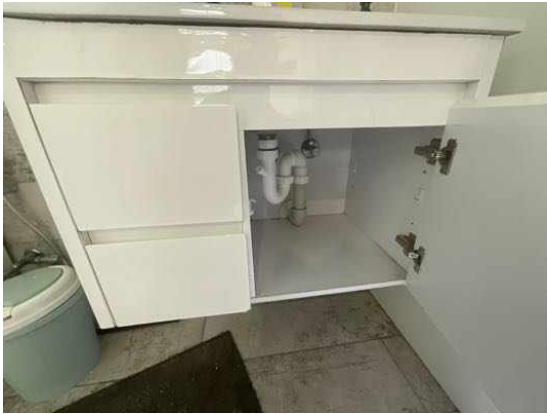
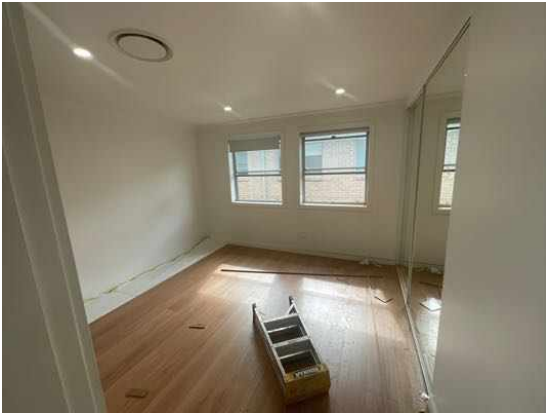
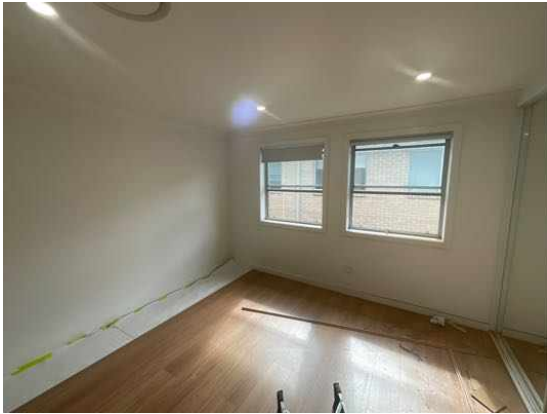
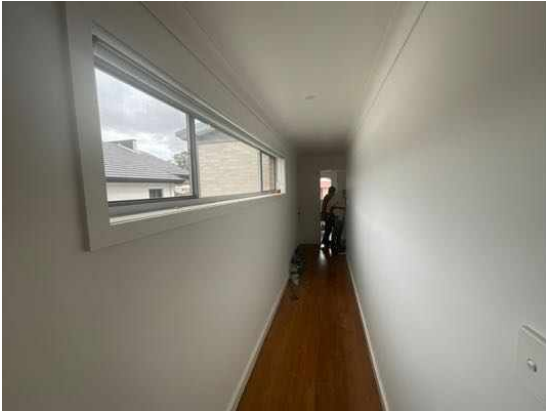
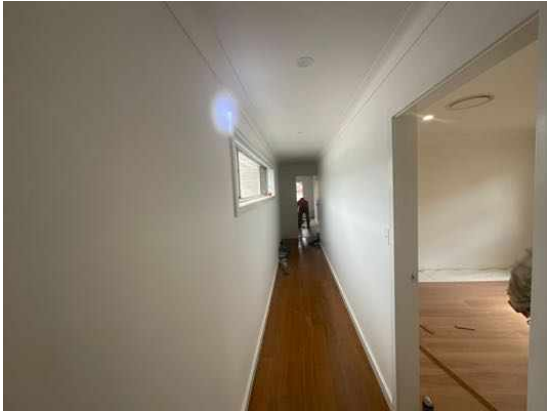
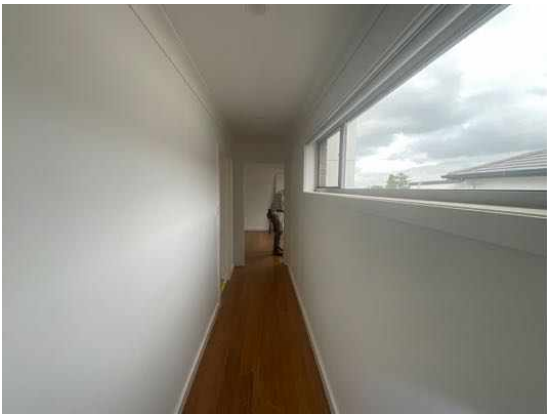
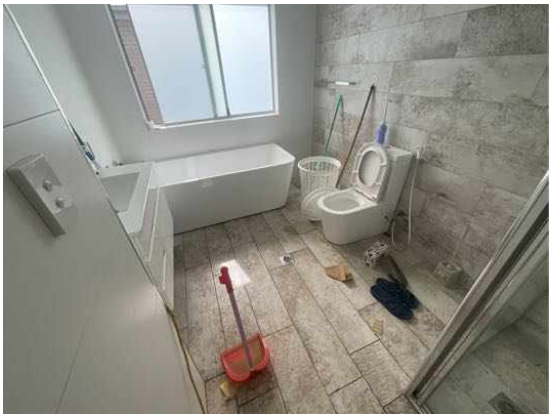
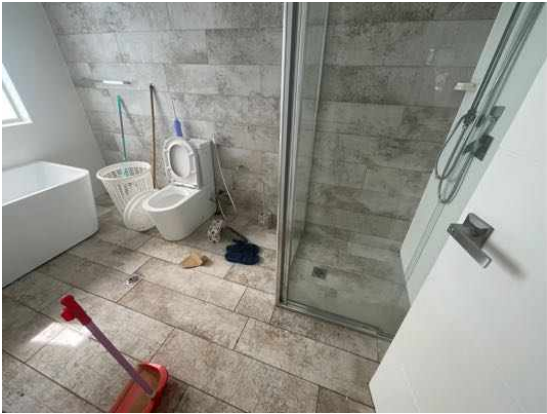
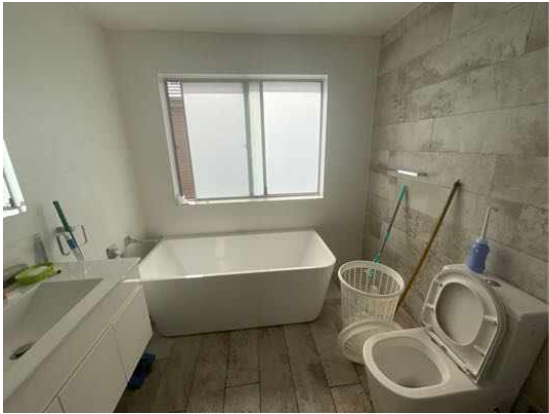
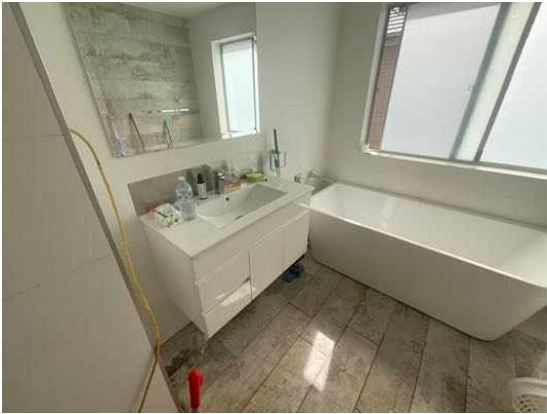
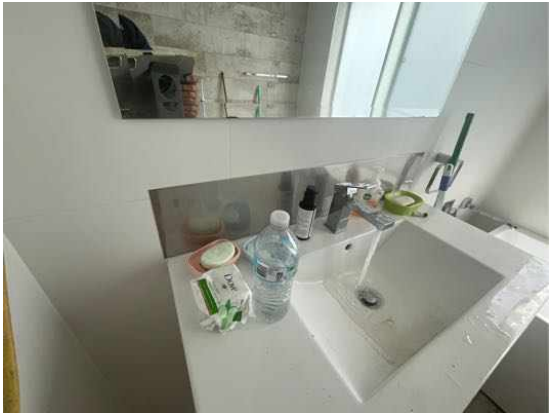
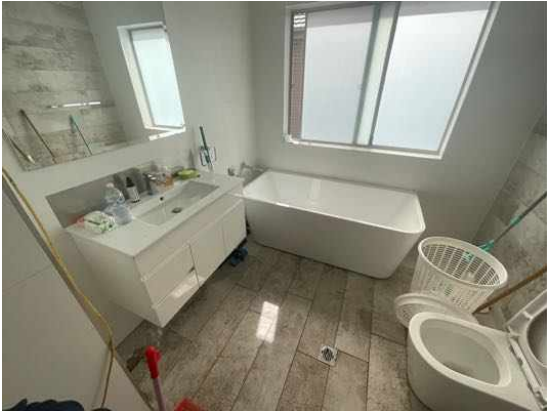
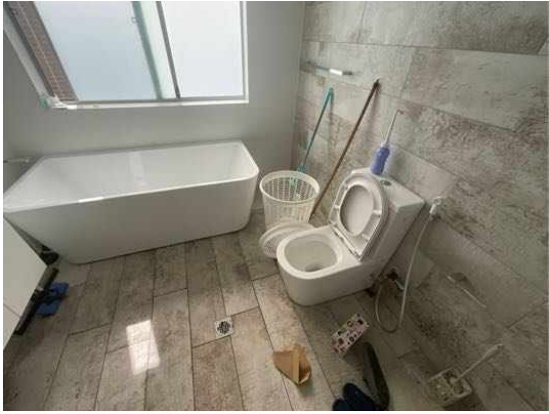
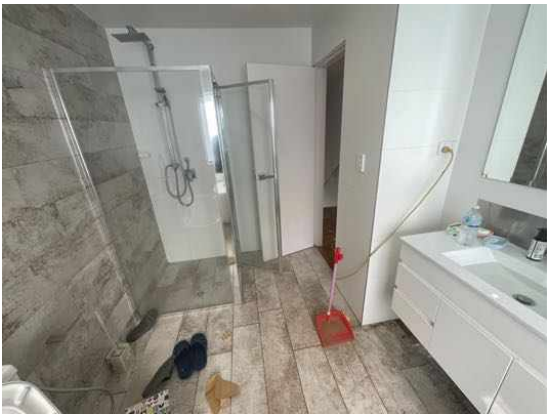
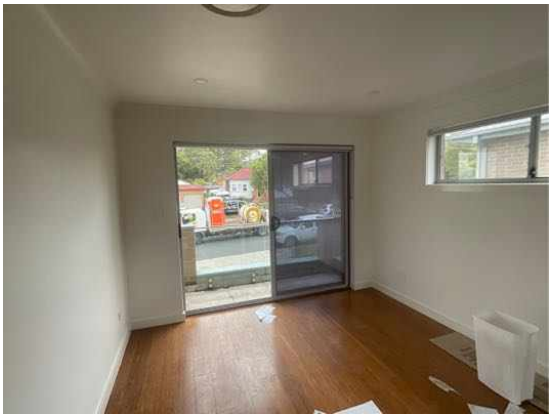
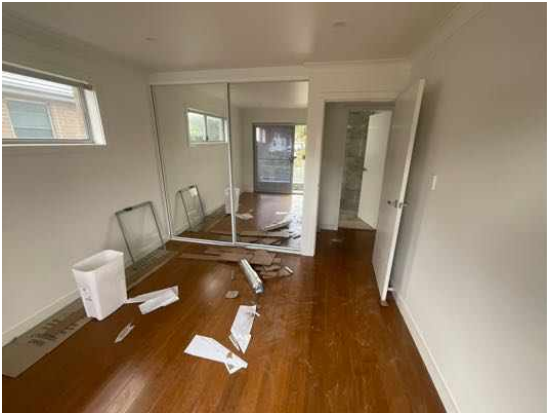
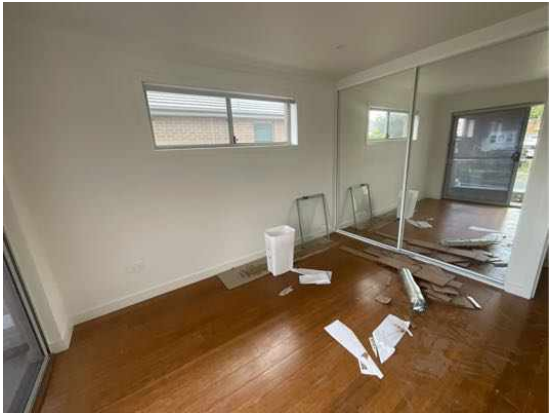
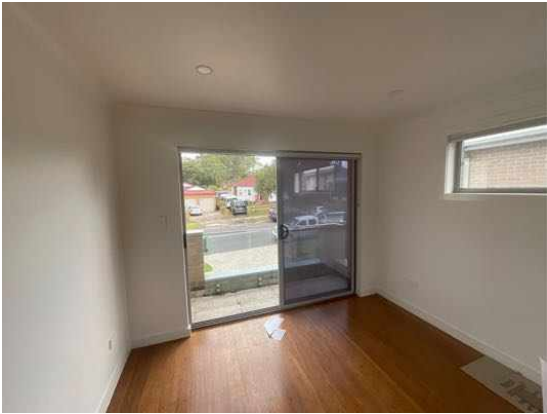
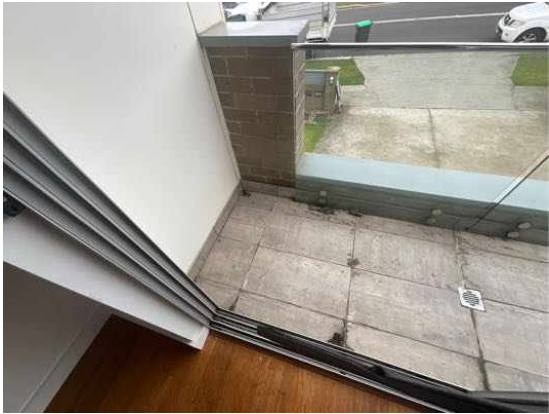
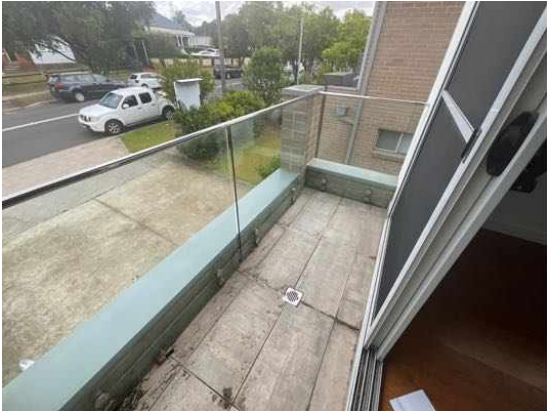
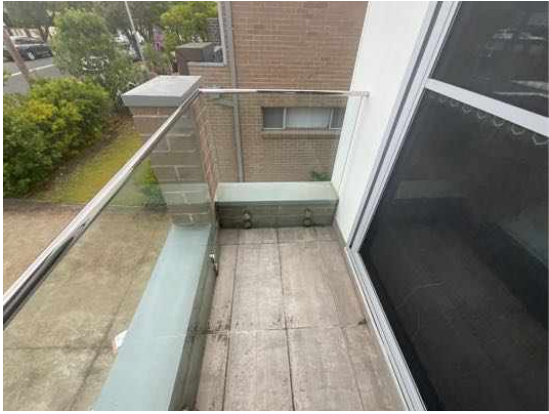
Building: Main Building  
Location: All Areas  
Finding: Additional Photos  
Information: Additional photos are provided for your general reference
