Building Inspection Report

Inspection Date: Tue, 17 Mar 2026

Property Address: Unit 6/12 Brennand St, FITZROY NORTH,
VIC, 3068, Australia

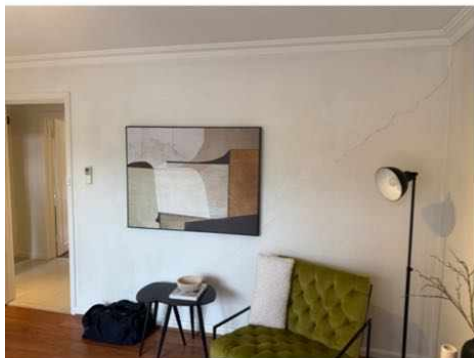
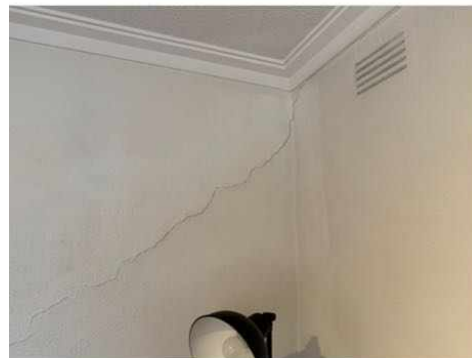
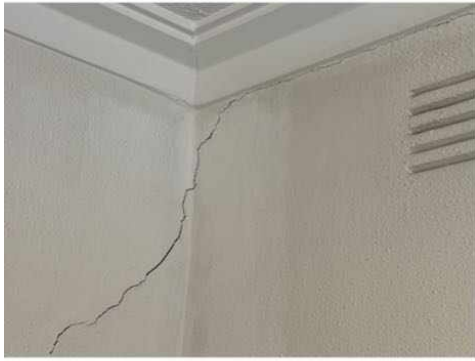
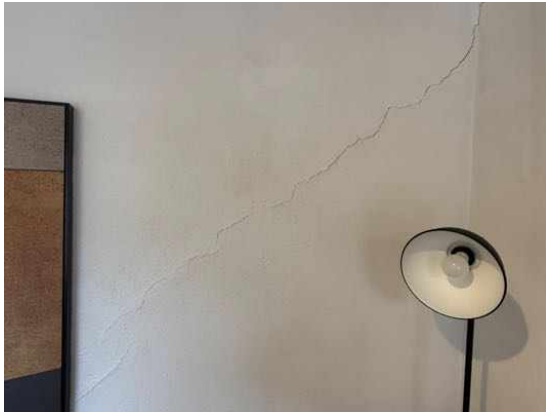
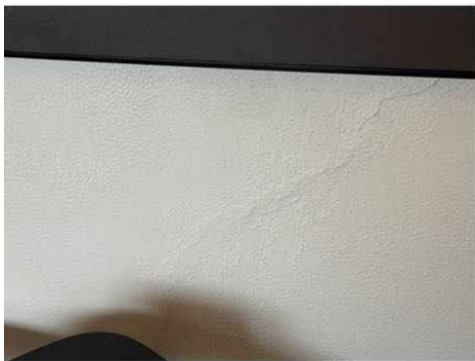
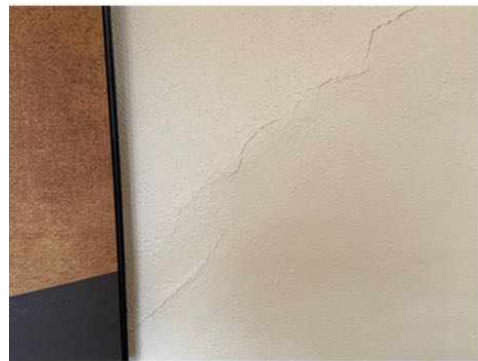
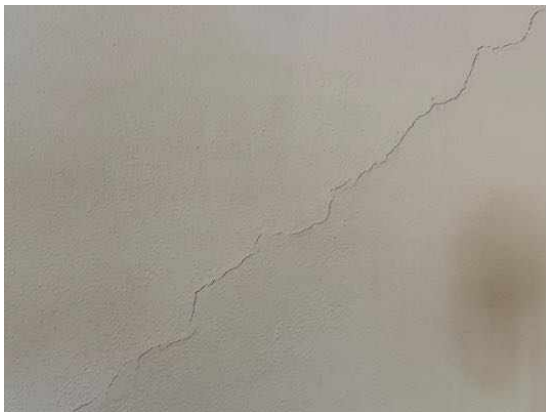
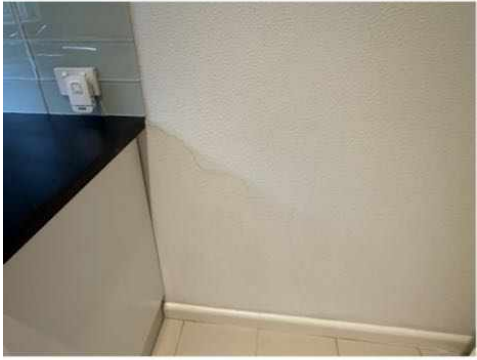
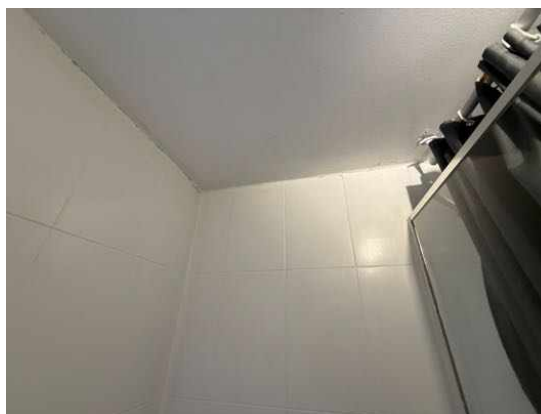
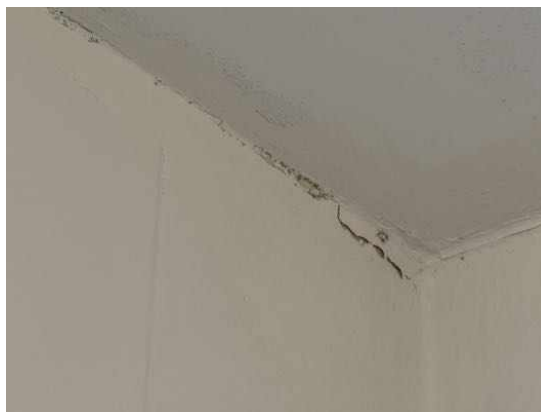
Defects 2.01

Building: Building 1
Location: Living Room > All Areas
Finding: Major wall cracks to the Living room plaster walls
Information: Major wall cracks was observed to the Living room plaster walls at the time of the inspection. This crack is very noticeable and requires the client to appoint a Structural Engineer to further inspect this area. It is considered to be a crack which cannot be just repaired and painted over.

Cracks of this type are suspected and likely to have been caused by expected movement throughout the unit /home. Movement and cracking of this degree may result in further damage and deterioration and or the development of secondary defects. It is highly recommended to appoint a Structural engineer before any repairs and restoration works are carried out. Always contact a Structural engineer or a licensed builder should cracks widen, lengthen or become more numerous.

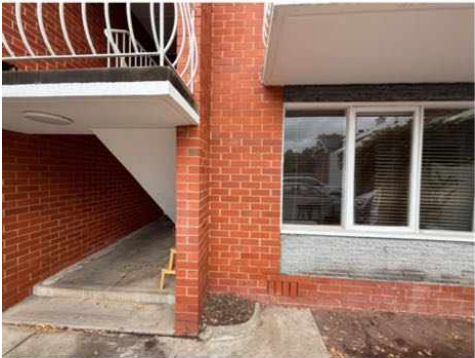
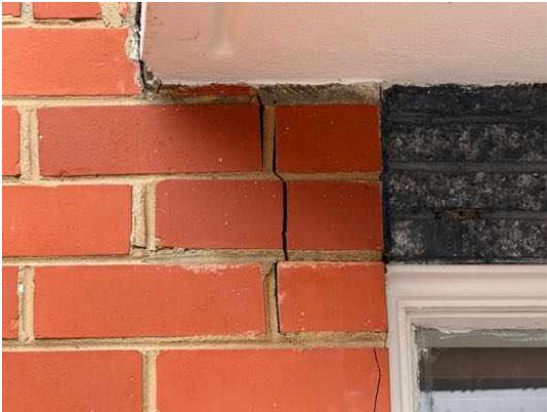
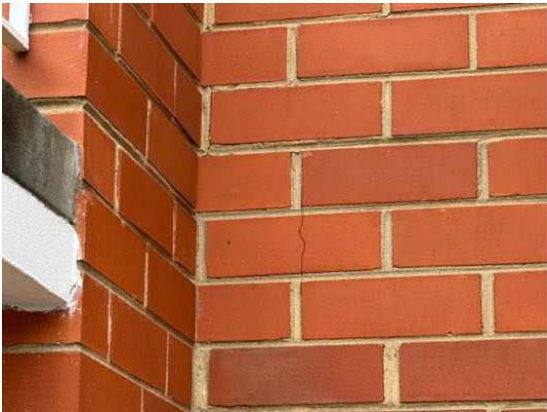
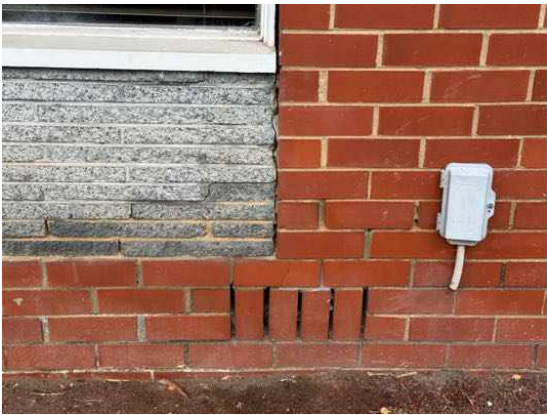
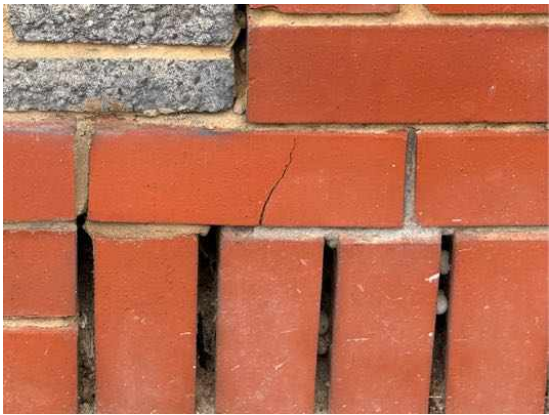
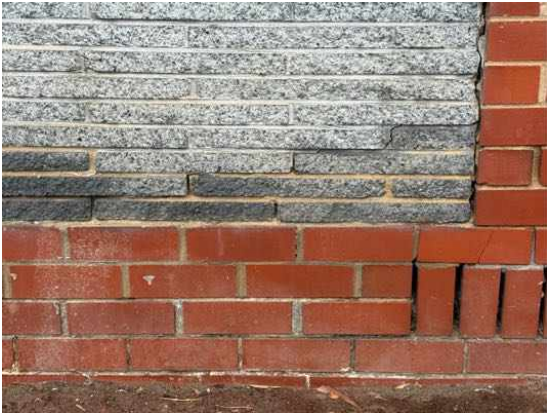
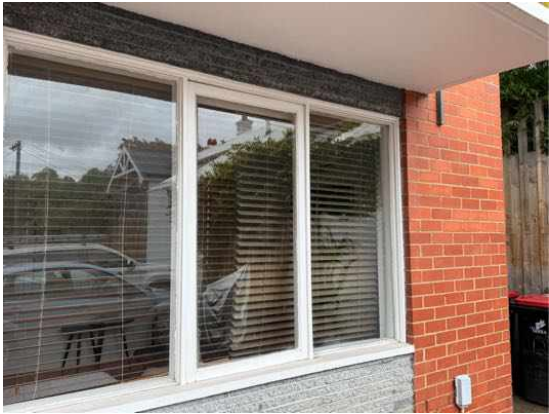
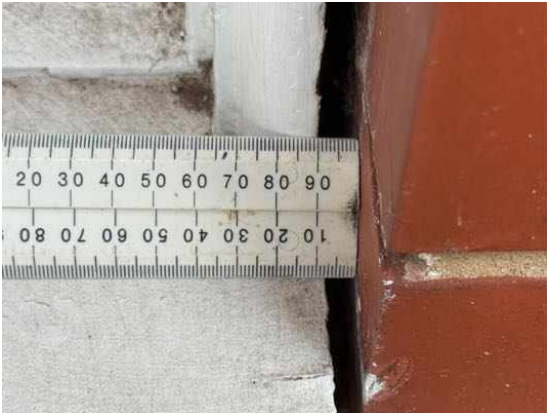
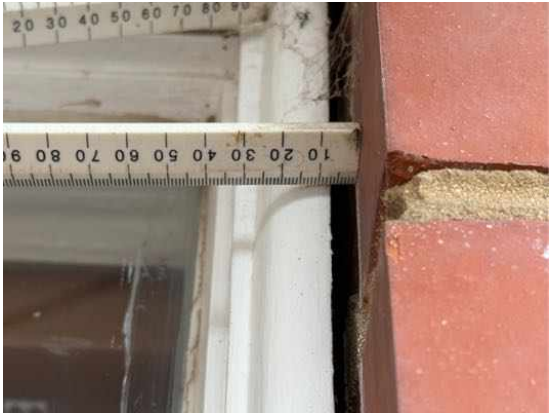
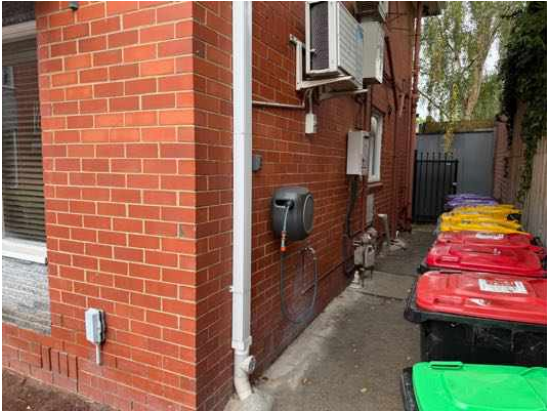
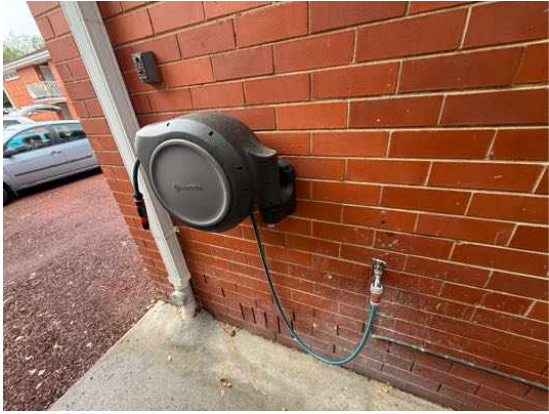
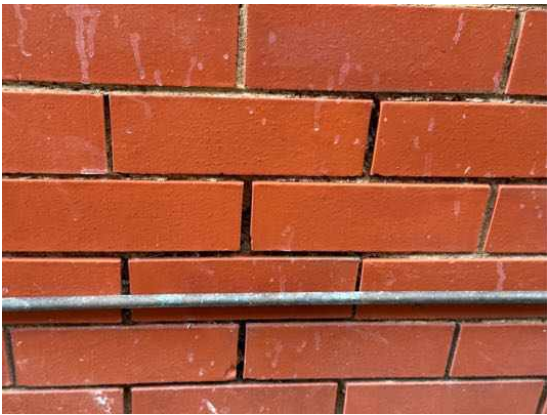
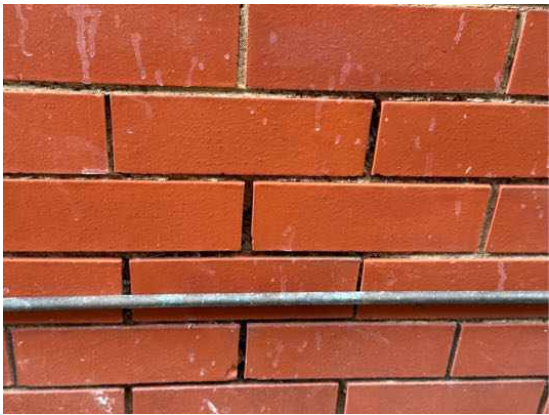
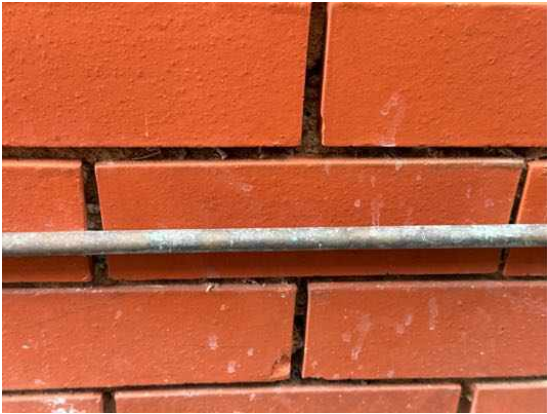
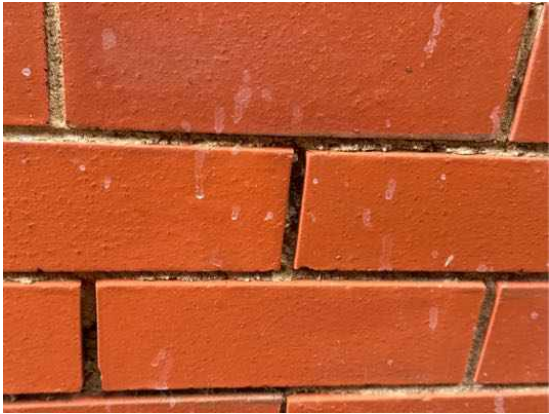
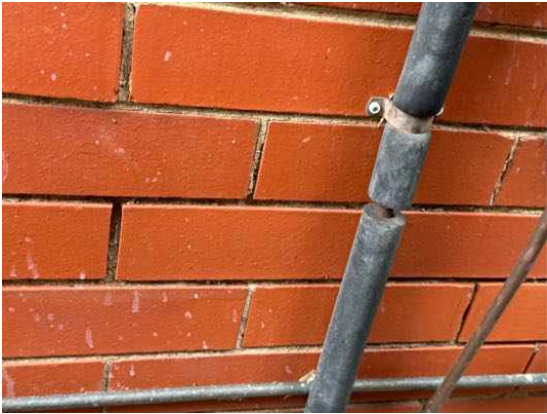
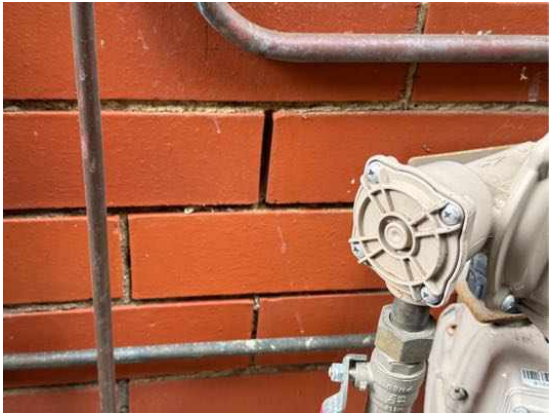
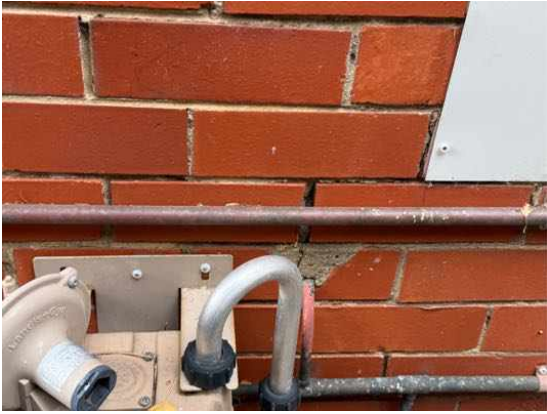
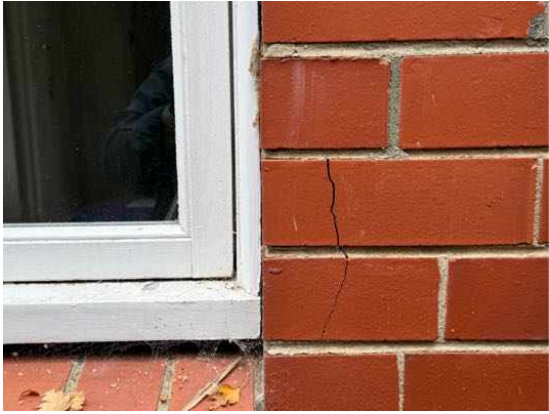
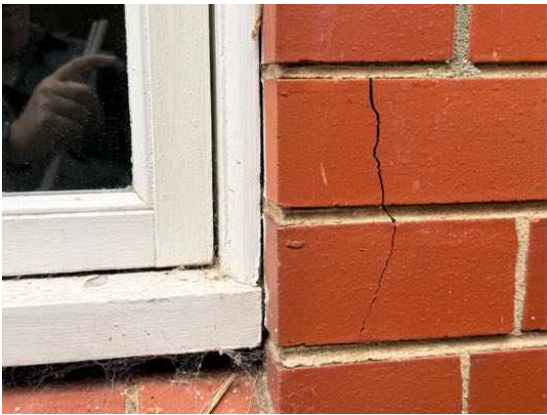
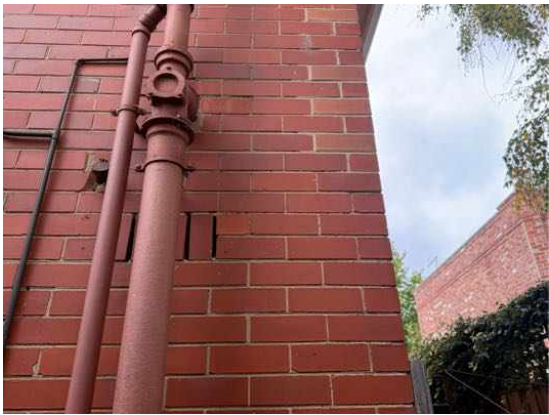
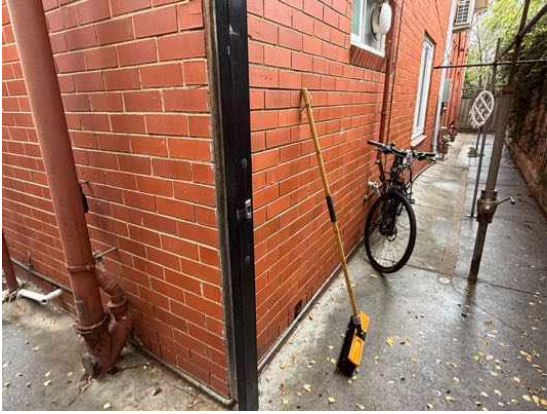
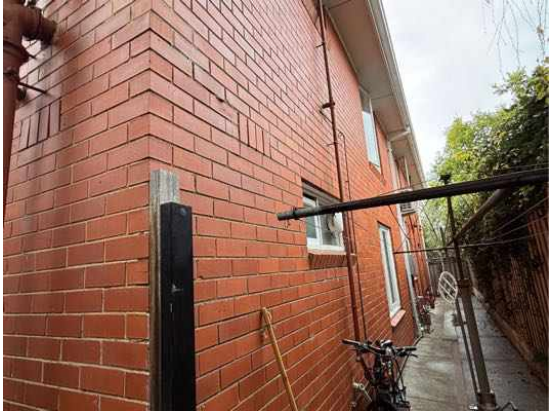
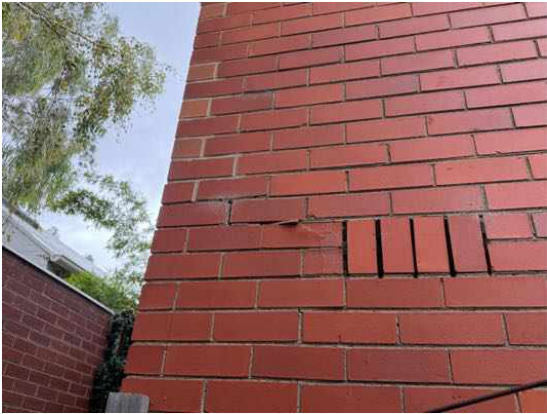
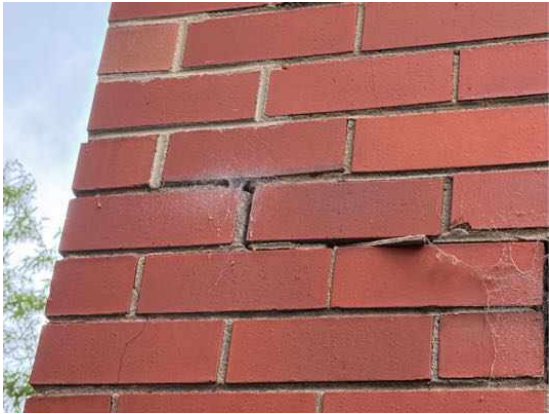
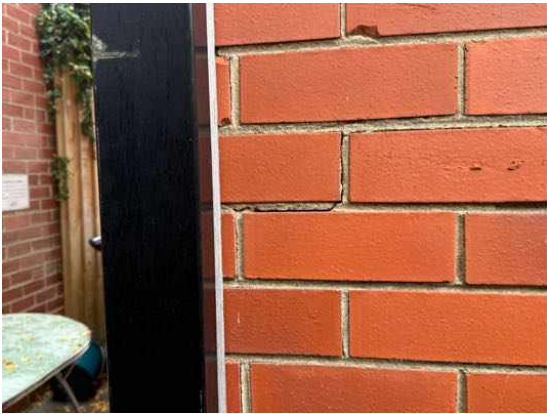
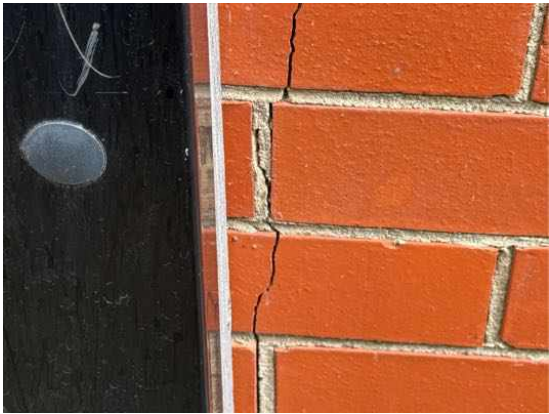
Defects 2.02

Building:	Building 1
Location:	All Areas > All Areas
Finding:	Brickwork - Cracking and movement
Information:	Major and minor areas of brickwork cracking were observed throughout the exterior brickwork of the unit and the unit above. These types of structural issues would require consultation and suspected permission from the Body corporate in charge of these premises. When managing this degree of cracking, major expensive repair work is generally required. If client was intending to repair these areas it is likely to involve the client appointing a structural engineer to advise on the repair or replacement of sections of affected brickwork.

Structural issues are generally the underlying cause of such cracking. It is suspected that this damage has been created due to movement of key structural elements and or general subsidence of associated footings. A structural engineer and bricklayer should be appointed immediately to inspect the structural integrity of the affected brickwork and to assess the safety of the associated structures. The engineer can also nominate a scope of works required for rectification. Always contact a building engineer should cracks widen lengthen or become more numerous, even after repair works have been completed.

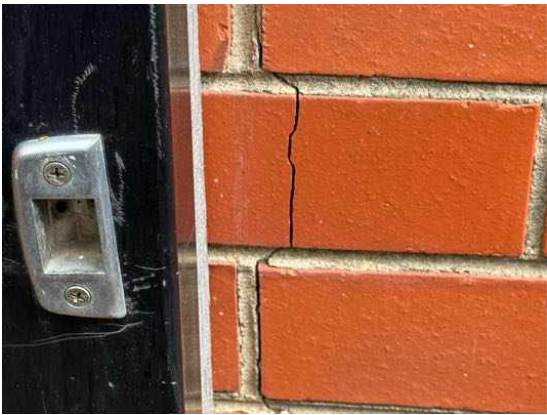
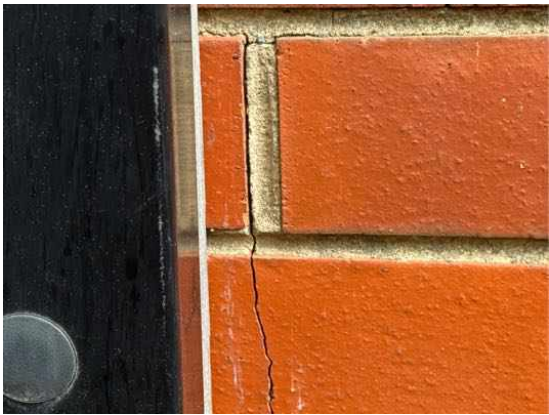
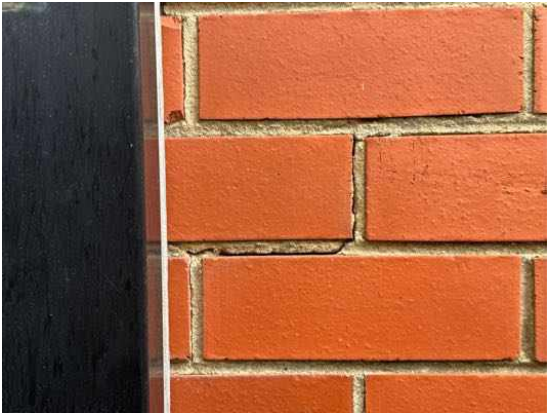
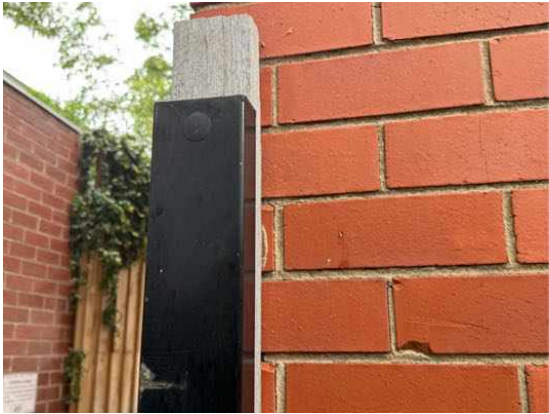
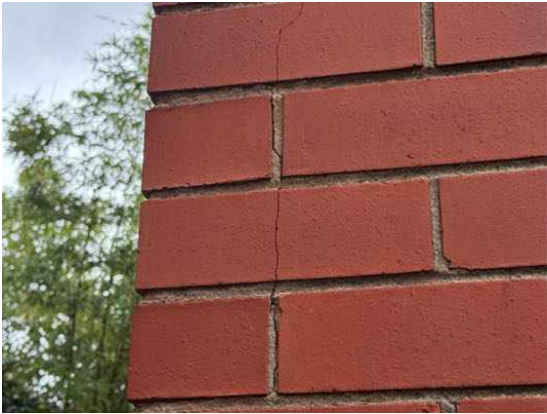
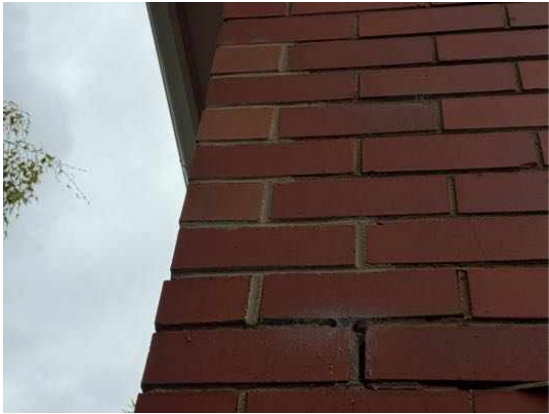
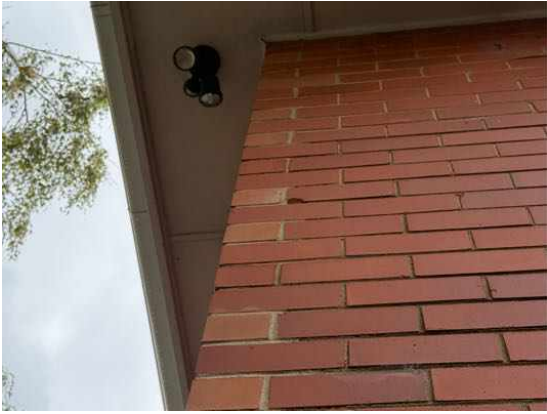
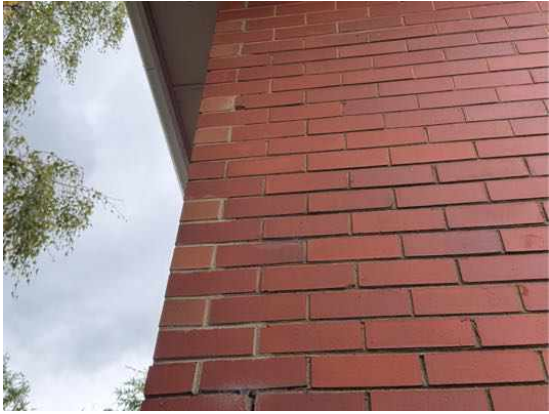
For the client's attention, major and minor areas of brickwork cracking were observed throughout the exterior brickwork of the unit and the unit above. These types of structural issues would require consultation and suspected permission from the Body corporate in charge of these premises. When managing this degree of cracking, major expensive repair work is generally required. If client was intending to repair these areas it is likely to involve the client appointing a structural engineer to advise on the repair or replacement of sections of affected brickwork. Structural issues are generally the underlying cause of such cracking. It is suspected that this damage has been created due to movement of key structural elements and or general subsidence of associated footings. A structural engineer and bricklayer should be appointed immediately to inspect the structural integrity of the affected brickwork and to assess the safety of the associated structures. The engineer can also nominate a scope of works required for rectification. Always contact a building engineer should cracks widen lengthen or become more numerous, even after repair works have been completed.

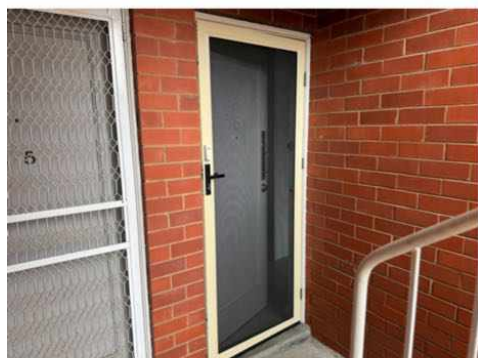
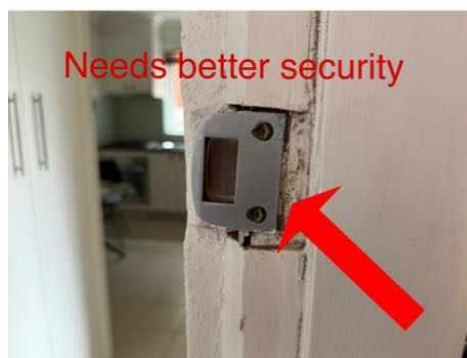
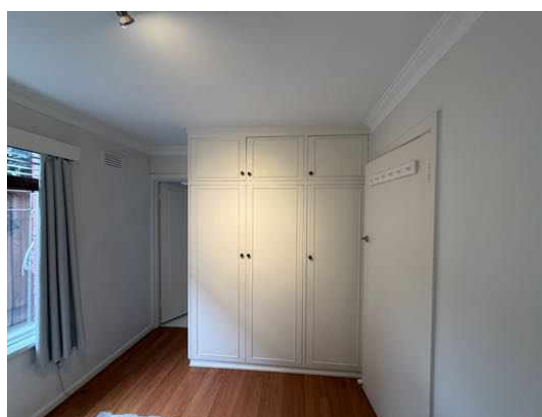
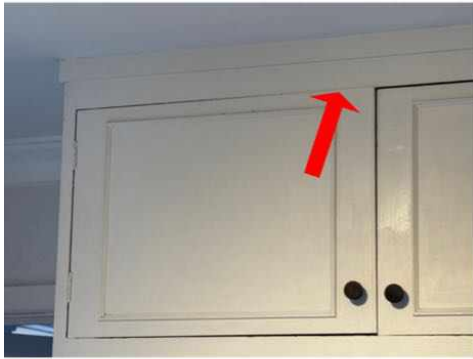
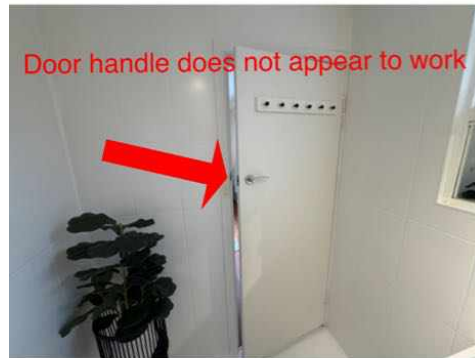
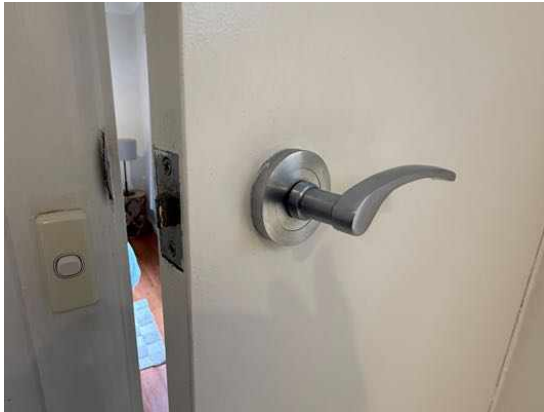
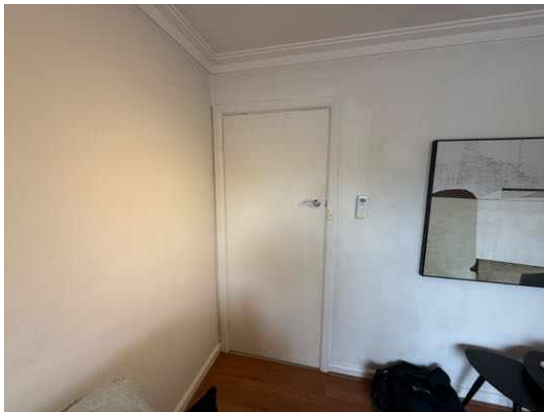
Defects 3.01

Building: Building 1
Location: Bedroom > All Areas
Finding: Door handles and latches
Information: It was noted that the door into bathroom was not operating and not latching as it should during normal operation. The bathroom door handle or latch was observed to be stuck. This door should not be shut until this door receives the immediate remedial work to repair or replace this door handle. If left unmanaged, someone or occupants will eventually be stuck in this area and unable to exit. Whilst detracting from the functionality of this building element, this minor defect may also be a safety hazard to all occupants, and may therefore have serious implications if occupants were not able to egress at the time of an emergency.

It is suspected that this defect has occurred due to minor issues after poor installation and or through general wear and tear, which is expected for building elements of this age. A qualified carpenter may be appointed to perform rectification works as necessary. If left unattended, further functional impairment is likely to occur.

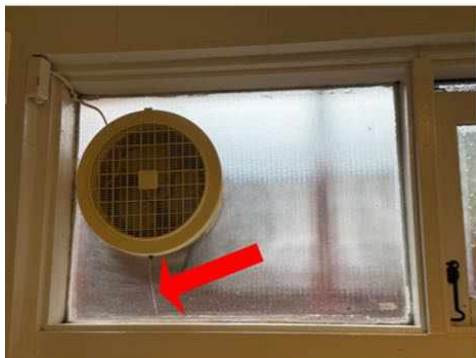
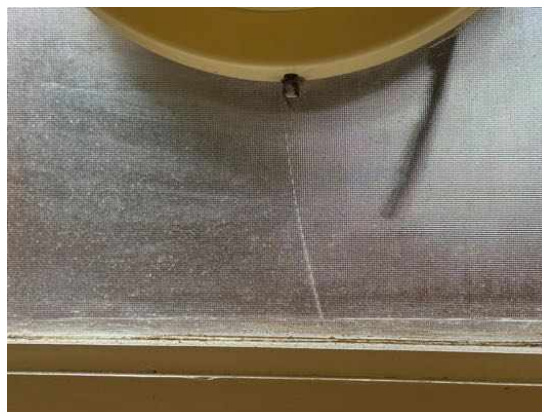
Defects 3.02

Building: Building 1
 Location: Bathroom > All Areas
 Finding: Minor broken - cracked glass
 Information: Broken - cracked glass to the rear bathroom window was observed at the time of inspection, this damage is suspected to have been caused by some impact damage at some time. While the cracked or broken window may be in some cases considered to be minor, any further impact damage sustained to the glass may lead further damage and deterioration or injury to occupants and or additional cracking.

As the cracking provides potential secondary damage to the glass or associated building elements and building materials, repair of the glass may be deemed

necessary in the future. Consultation with a glazier to the replacement or other remedial works may be required to protect against any further damage.

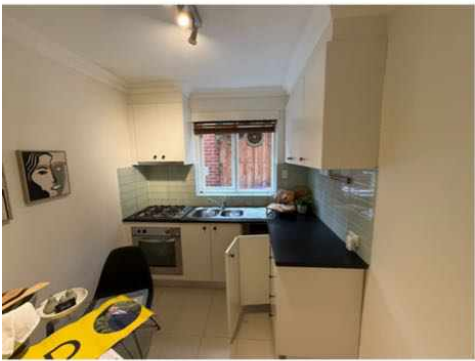
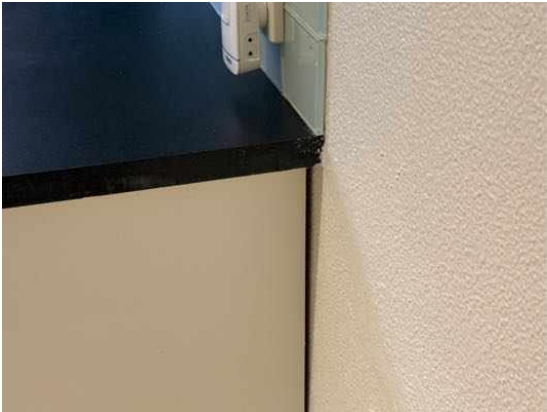
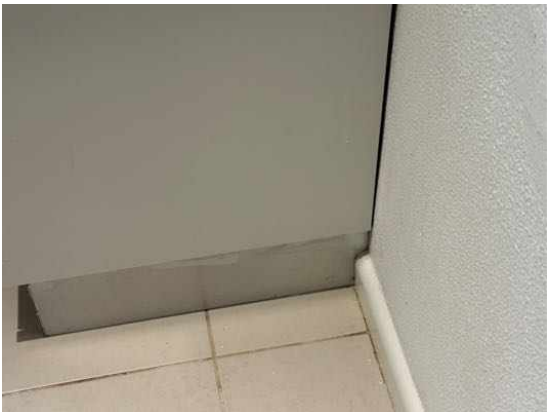
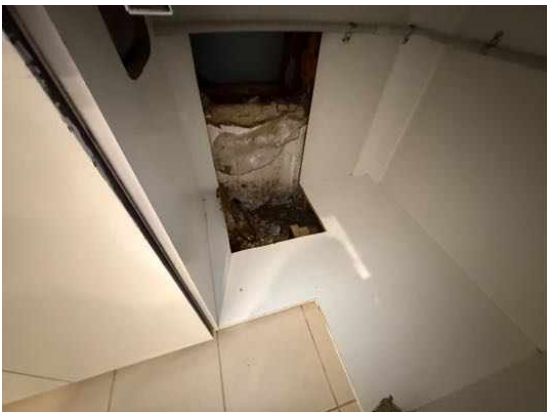
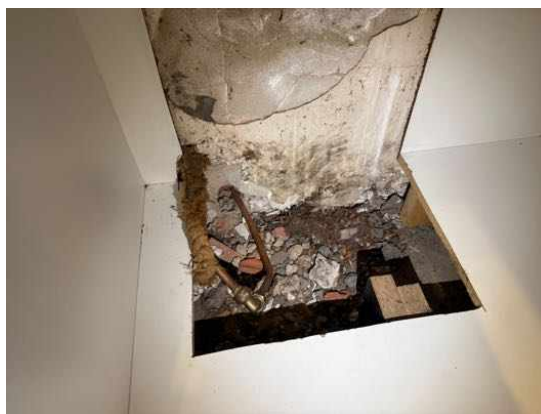
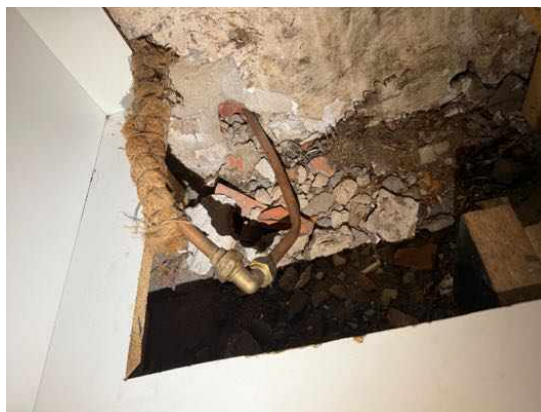
Defects 3.03

Building:	Building 1
Location:	Kitchen > All Areas
Finding:	Kitchen cabinetry
Information:	The kitchen cabinetry to the right hand side of the kitchen sink showed signs a suspected hot water service had been previously removed. No remedial work to repair the large opening and hole left by the HWS had taken place. Client will therefore be required to appoint a cabinet maker or other relevant tradespersons to rectify the kitchen cabinets to make good. If left unmanaged this area has a high likelihood of attracting vermin and pests into these areas. Immediate repair of this area is highly recommended.

All were observed to have some wear and deterioration, they are considered to require some maintenance, remedial work or repair to ensure further deterioration does not continue further. Although these defects may detract from the overall looks of the cabinetry, in most cases it does not necessarily affect the operational state of the cabinetry.

To improve the operation of these affected cabinets, cabinet doors or drawers, a qualified cabinet maker or carpenter may be appointed to rejuvenate rectify or repair any cabinetry as deemed to be necessary. Such works should be completed at discretion of the client.

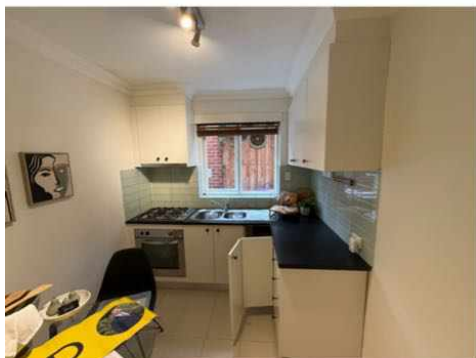
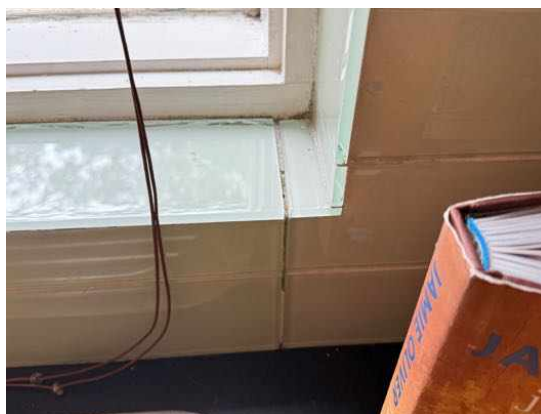
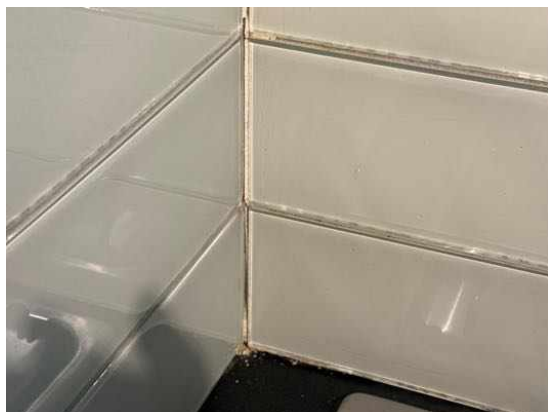
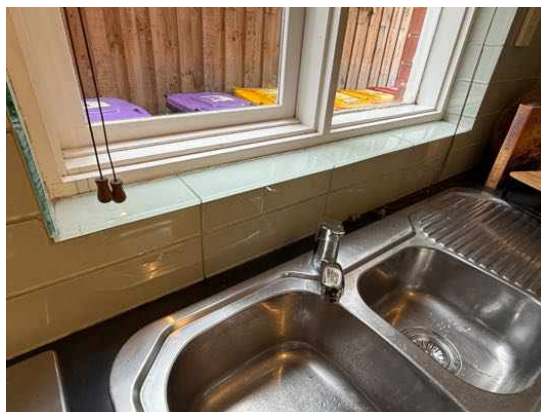
Defects 3.04

Building:	Building 1
Location:	Kitchen > All Areas
Finding:	Sealant and grouting - Missing or damaged
Information:	It was noted on inspection that some sealant and grout is missing or degraded on the tiled splash-back in the kitchen. Different materials and floor areas move at different rates, generally causing cracking to grout or sealant at this point. A flexible sealant is required to allow for expected expansion and contraction, while keeping the joint water tight and protective of all associated building materials.

Flexible and mould resistant materials should be applied to affected areas to prevent any subsequent water damage that is likely to occur. Regular maintenance and replacement of damage or missing or damaged sealant and grout is highly recommended to the wet areas, as this is a regular wear and tear defect. Sealant and grouting in areas that come into regular contact with water should be maintained for the long term care of your property. A sealant specialist or tiling contractor should be appointed to complete these works as soon as possible.

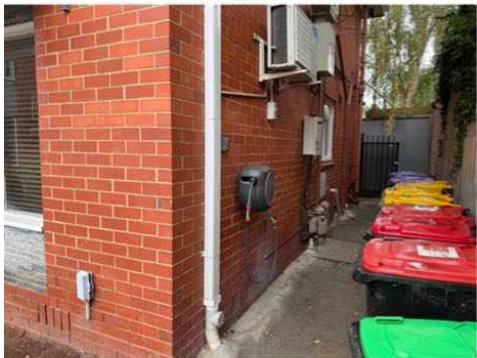
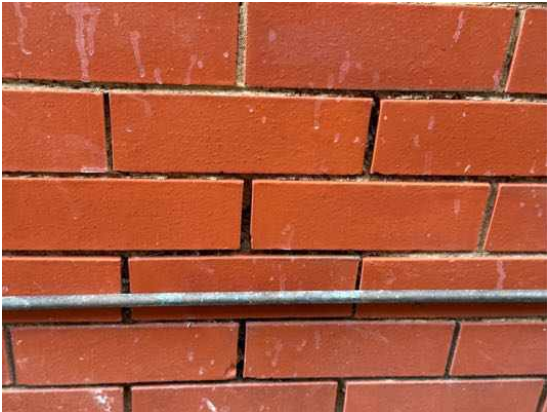
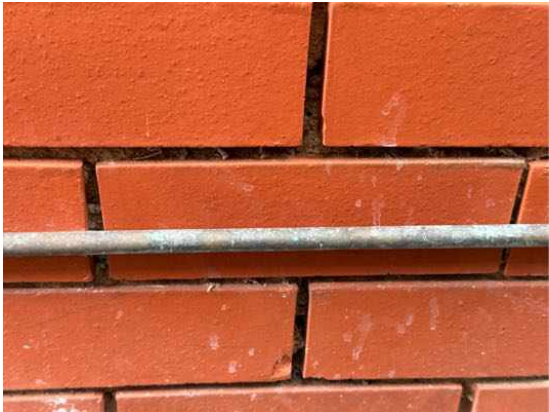
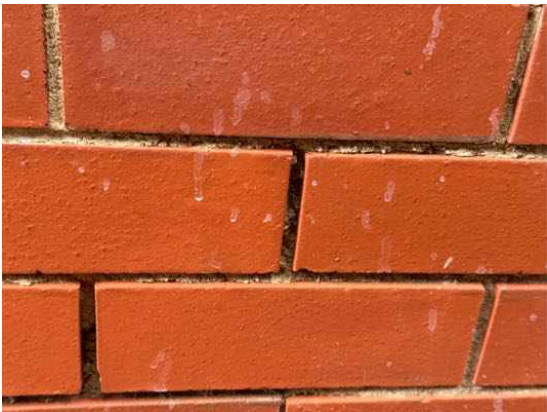
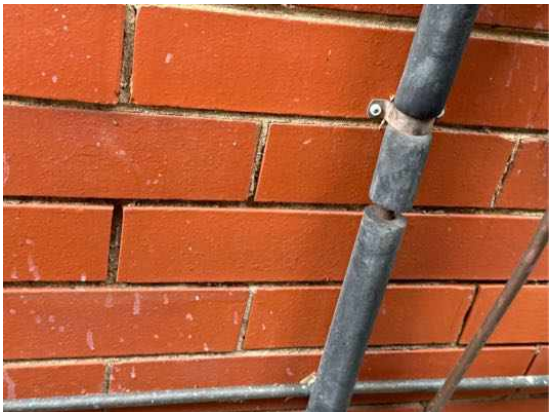
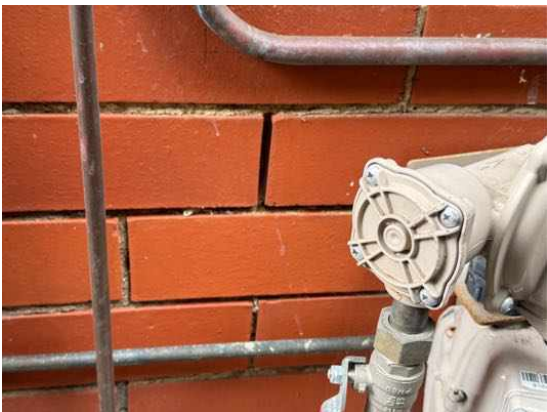
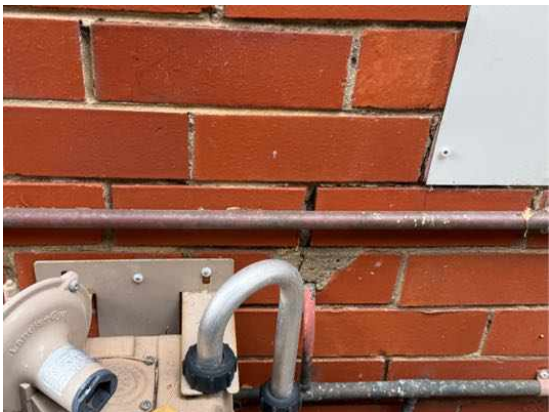
Defects 3.05

Building:	Building 1
Location:	All Areas > All Areas
Finding:	Brickwork - holes or minor voids
Information:	At the time of the inspection of the brickwork, some holes or voids were observed in the right hand side brickwork. Any missing mortar or voids or holes should be filled and patched to ensure that bricks remain in their intended location. All exterior brickwork in masonry walls and structures are required to be fully filled in and patched to prevent frequent exposure to weathering. Gaps, holes and voids will allow insect, pests, vermin, water or moisture to ingress into the wall cavities. If left unmanaged this type of defect can create secondary defects and damage as a result in the future.

When mortar is found to be missing in brickwork it is normally as a result of poor installation procedures, poor trade practices or where trades have fitted other external fixtures etc. Holes and voids should always be properly filled or patched by a qualified bricklayer or other relevant tradespersons to ensure further deterioration does not develop further in the future. When these repairs are carried out, the bricklayer must ensure the mortar colour and consistency are as near as possible to the existing mortar and remains as close as possible to the original installation of the brickwork.

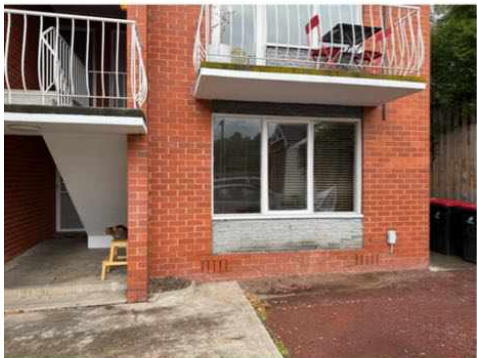
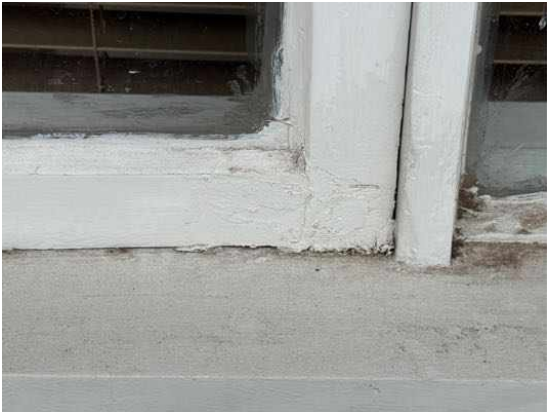
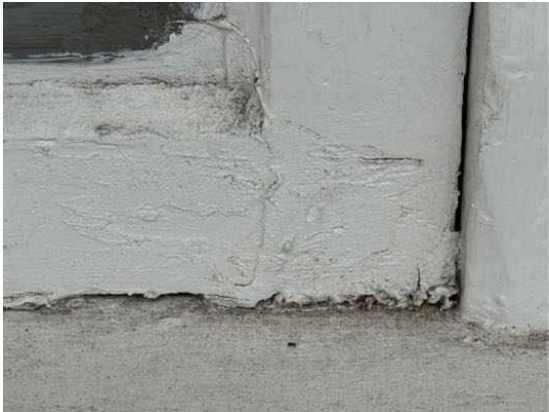
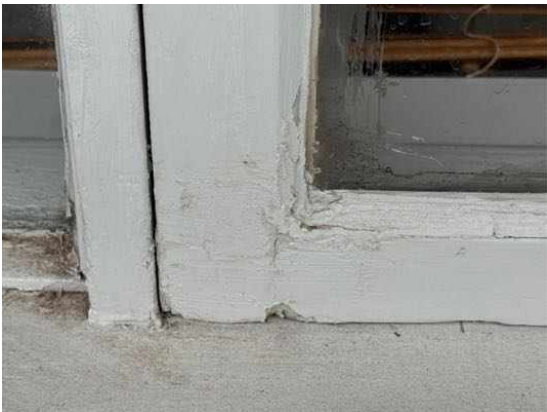
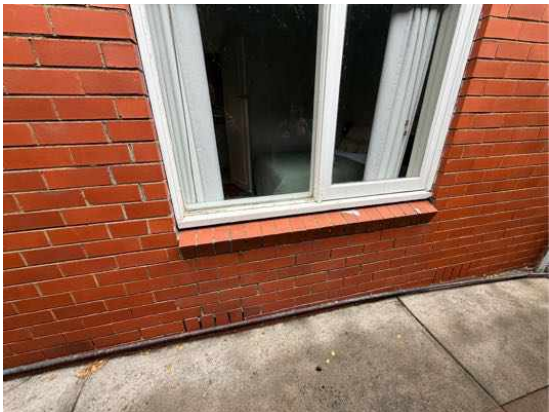
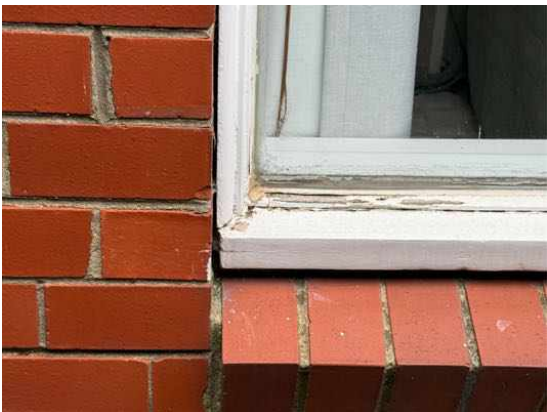
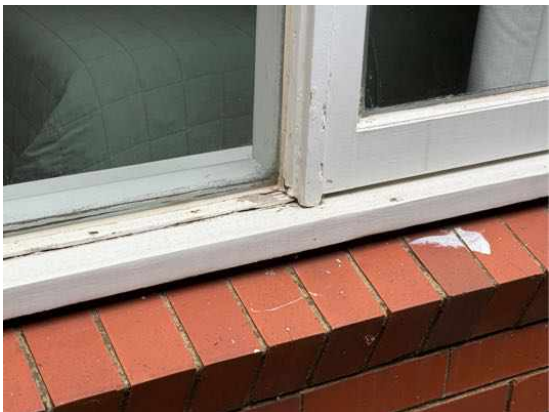
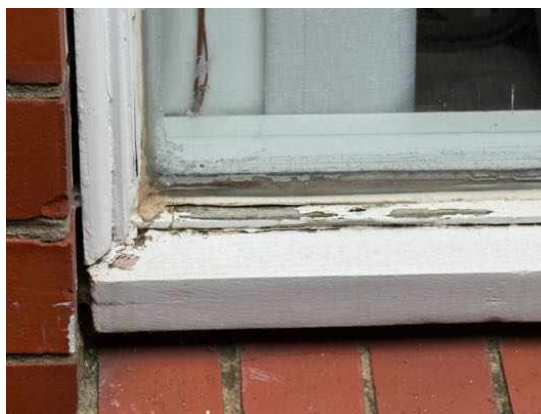
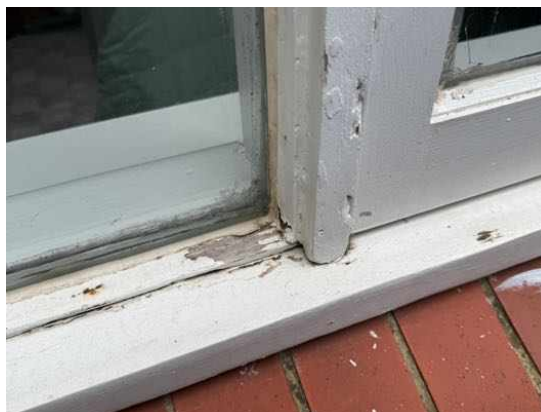
Defects 3.06

Building:	Building 1
Location:	All Areas > All Areas
Finding:	Wood rot
Information:	Wood rot was observed to be affecting the rear exterior windows of the home. Wood rot, also known as Fungal Decay, occurs when timbers and other cellulose building materials are exposed to damp conditions on an ongoing basis.

Due to exterior, extreme weather conditions and frequent exposure these types of building elements are highly susceptible to accelerated damage and deterioration. Keeping timber and other susceptible building elements away from excessive moisture and providing early intervention and regular maintenance such as painting will prolong the useful life of these building elements. Prior to any works being performed, the cause of the moisture that has created the visible wood rot should be identified and addressed in a suitable manner.

It is advised that the relevant tradespersons be appointed to inspect and subsequently identify the cause of the numerous areas of wood rot. Replacement of affected building elements and materials may then be a necessary step in protecting surrounding areas from secondary damage and deterioration. A qualified carpenter or builder and other specialists may be appointed to assess the cause of excessive moisture and to provide advice on any remedial works as required. A qualified carpenter or registered builder may also be required to replace affected building materials.

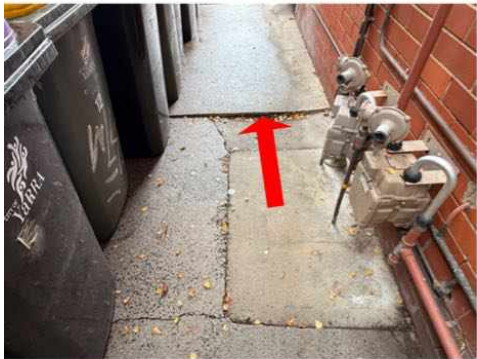
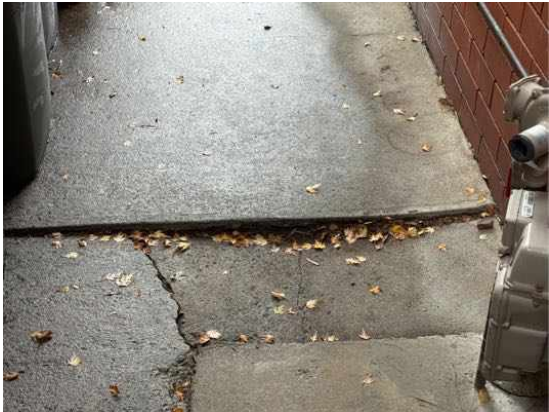
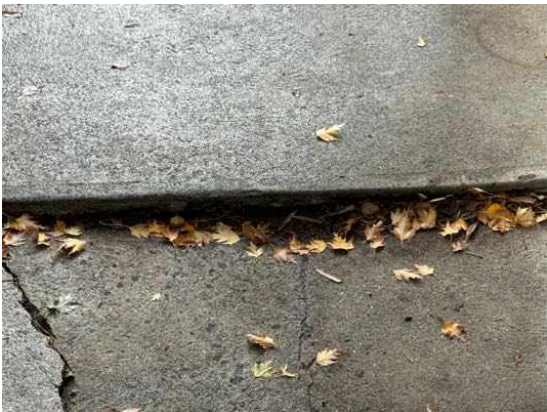
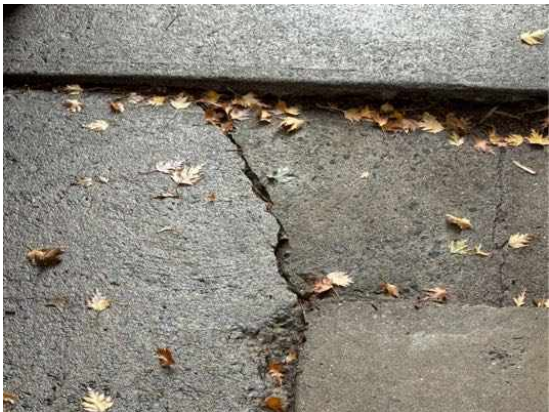
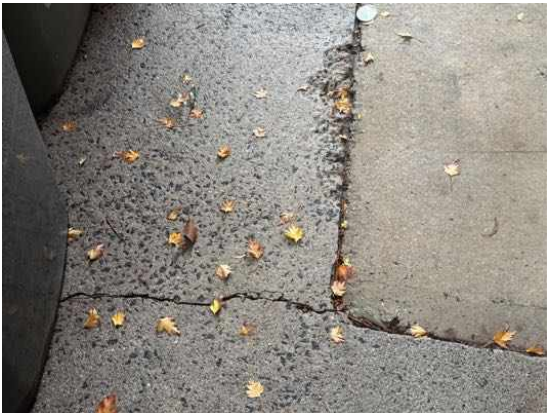
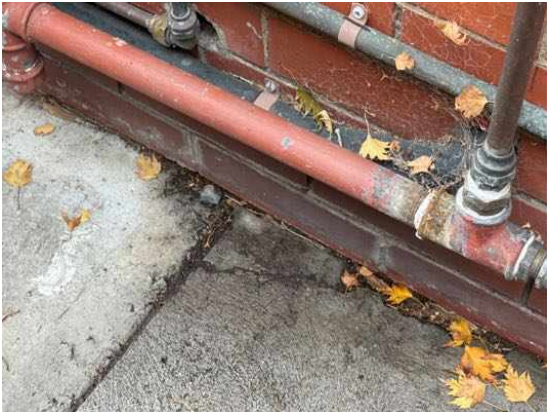
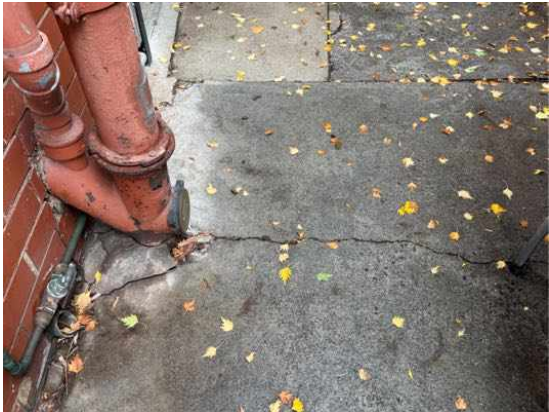
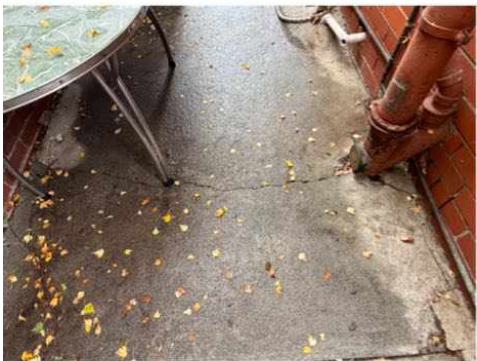
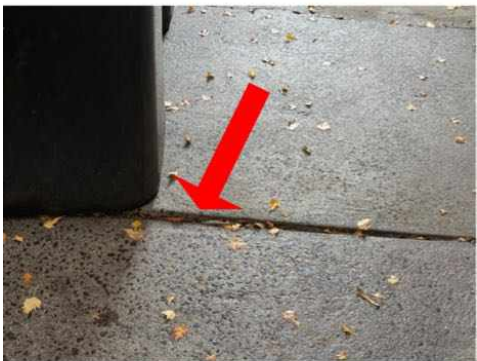
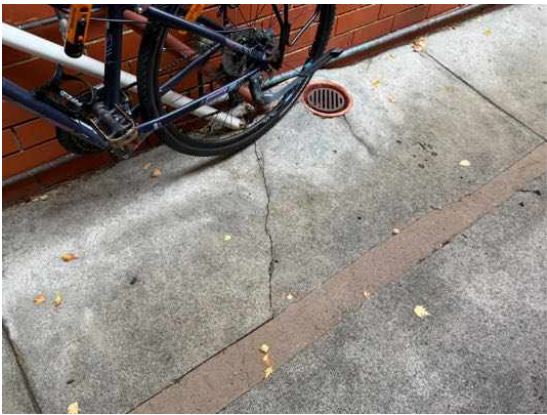
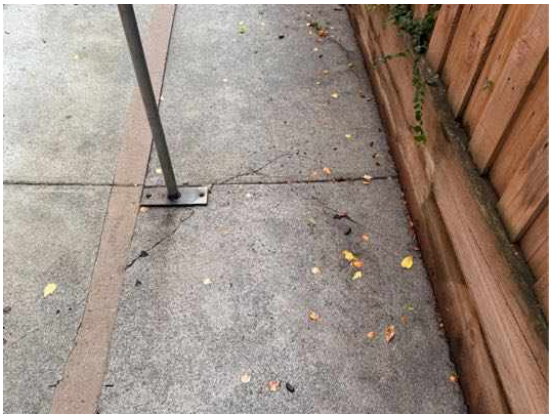
Defects 3.07

Building:	Building 1
Location:	All Areas > All Areas
Finding:	Paving tripping hazards - Uneven and undulations
Information:	Sections of the external concrete paved areas were observed to be uneven and undulating, creating a potential trip hazards. It appears as though the paved areas has been subject to suspected some movement, either from surrounding tree roots or poor installation, sections of the concrete have dropped or lifted due to surrounding trees or poor preparation in the substrate before concrete is laid.

Numerous concrete cracks were observed in the rear and RHS concrete at the time of the inspection. Concrete cracks are a common occurrence as a result of many primary defects. Such causes may include age, general wear and tear, expected movement, general expansion/contraction of building materials in different weather conditions, and/or minor failings in the installation or application of building materials. Monitoring of all cracks should be conducted periodically. Contact a relevant tradespersons should cracks widen, lengthen, or become more numerous.

Where paving creates a trip hazard, personal injury may ensue if due caution is not taken by occupants and all other persons within this area. Client may consider re-concreting these areas, where required or deemed necessary to remedy these types of situations. Further consultation with a concreter, landscaper or other specialists in these areas is recommended.
