Building Inspection Report

Inspection Date: Tue, 17 Mar 2026

Property Address: Unit 6/12 Brennand St, FITZROY NORTH,
VIC, 3068, Australia

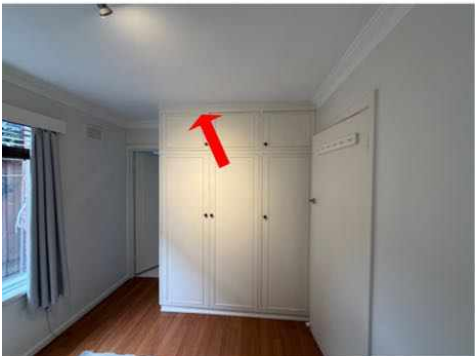
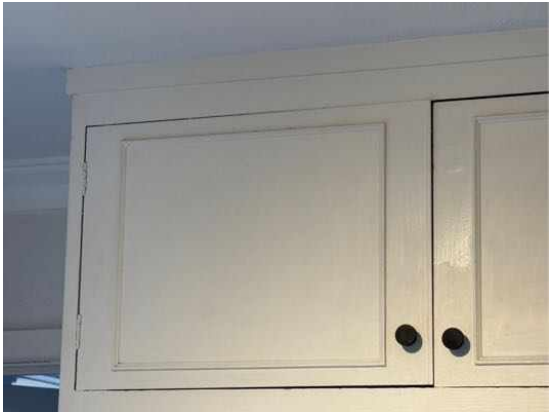
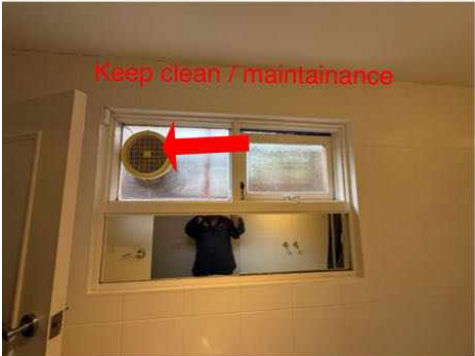
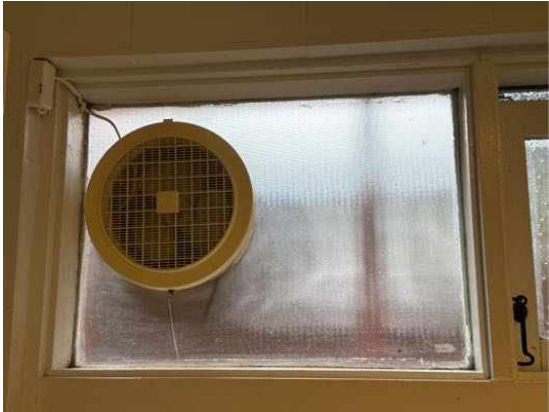
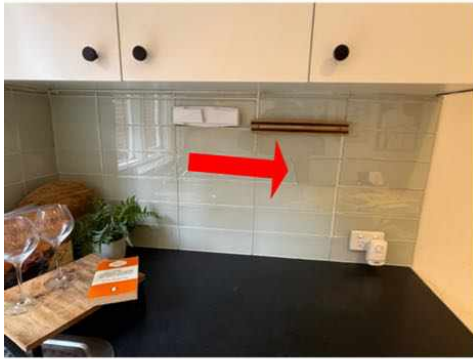
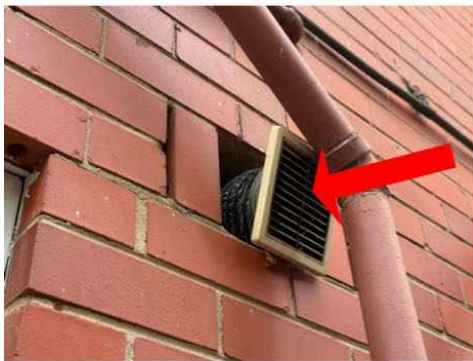
Noted Item

Building: Building 1
Location: All Areas > All Areas
Finding: Additional Photos
Information: Additional photos are provided for either future maintenance items for clients attention and or general reference. Arrows may have been included to highlight areas of importance. Please discuss these photos with your building consultant for clarification.

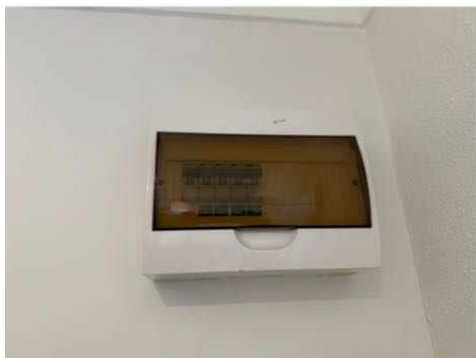
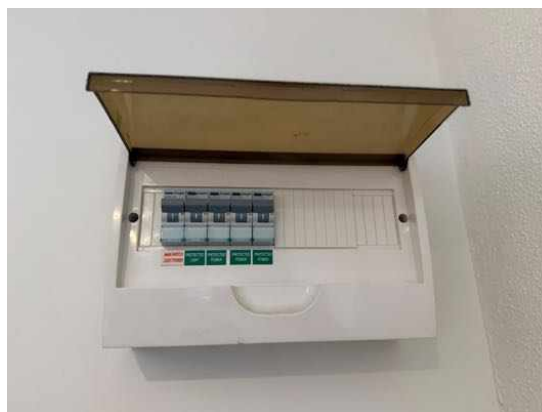
Noted Item

Building: Building 1
 Location: All Areas > All Areas
 Finding: Termite Management System - no evidence of a chemical installation or durable notice
 Information: At the time of the inspection no application of a chemical termite barrier or durable notice was observed. Such barriers are highly effective and highly recommended for all properties in preventing termite attack on any timber building elements throughout the property.

A durable notice should be placed in the switchboard unit or in the another accessible area to indicate current termite barriers. At the time of inspection, no evidence to suggest preventative works taking place. The client may consider gaining further advice from builders or a pest controller and as to the costs and procedures involved with this application. It is recommended that obtaining such advice be a short-term future.

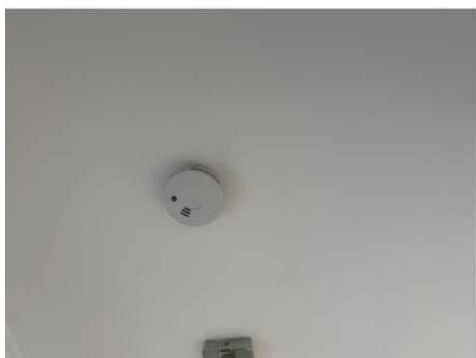
Noted Item

Building: Building 1
 Location: All Areas > All Areas
 Finding: Smoke detectors and alarms
 Information: Reporting on Smoke Detectors or Alarms, including hard wired smoke detection systems and their legislative requirements, is outside the Scope of this Report. Please note that this defect is highlighted as a caution only. We suspect, based on our experience in the building industry, that smoke detectors are sometimes get overlooked, or they may be in a poor condition, so we recommend that they always should be addressed prior to occupation to improve occupant safety.

Always ensure sufficient working and suitable smoke detectors are installed prior and during to occupying any building. Additionally, it is advised that all smoke detectors be tested by the homeowner on a monthly basis.
