# Building and Timber Pest Inspection Report

Inspection Date: Mon, 16 Mar 2026

Property Address: 53 Gericke Rd, Woondum QLD 4570,  
Australia

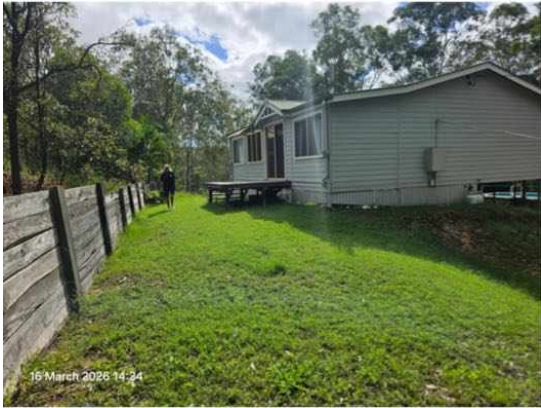
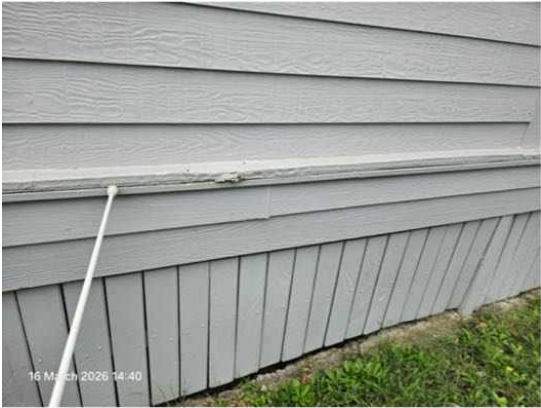
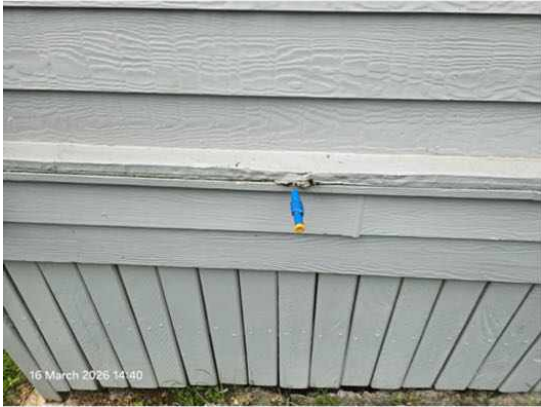
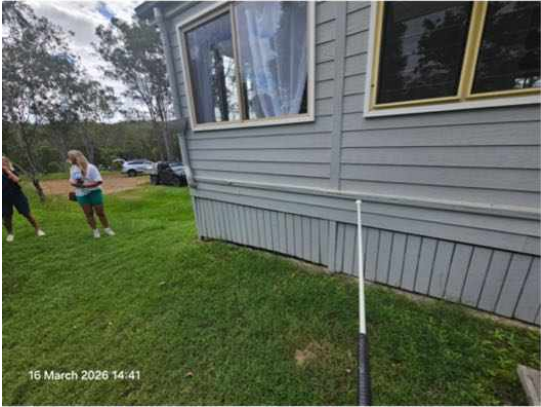
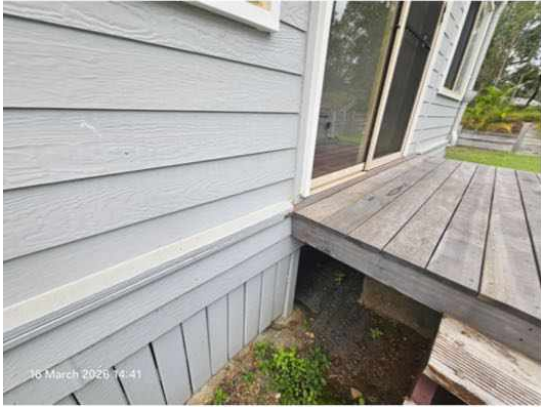
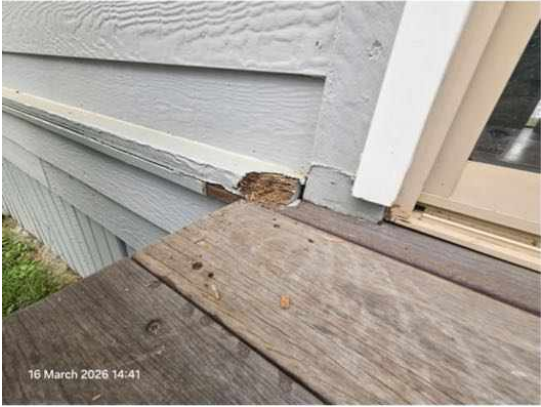
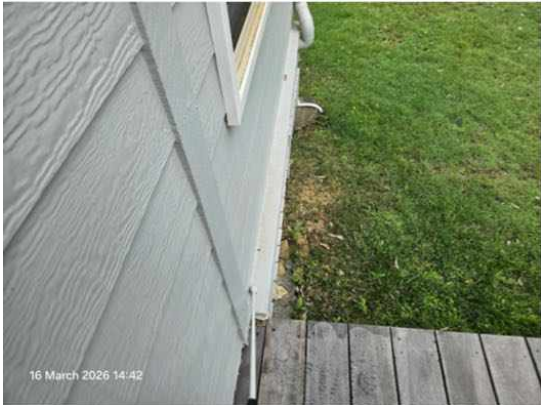
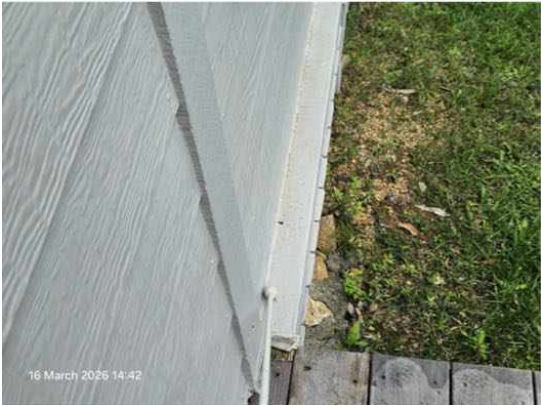
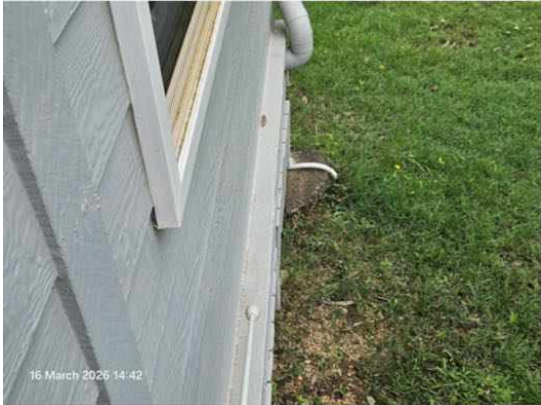
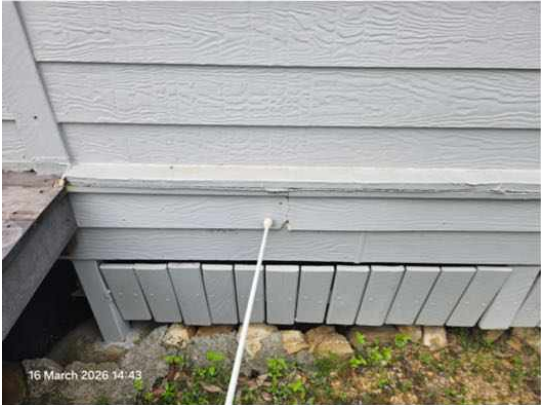
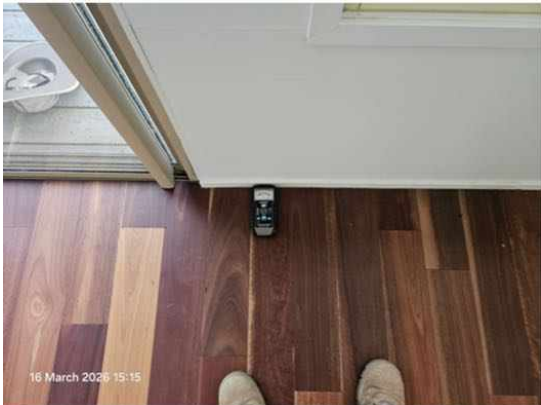
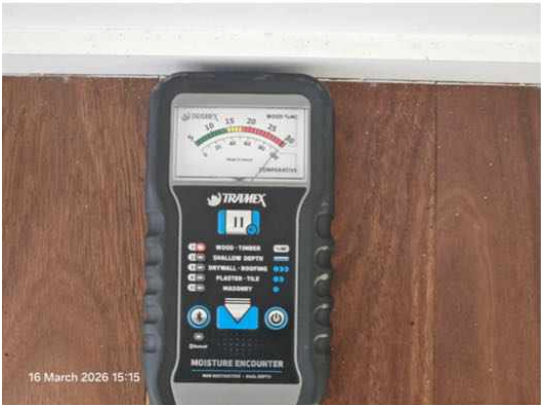
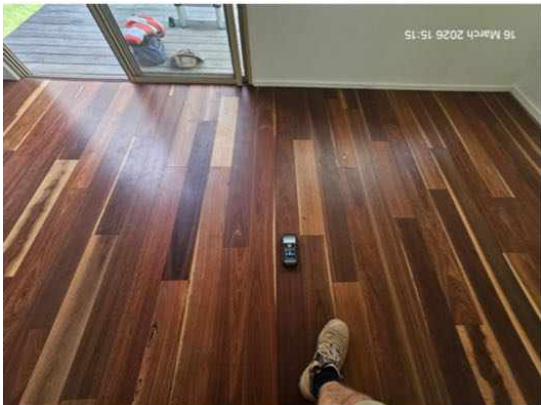
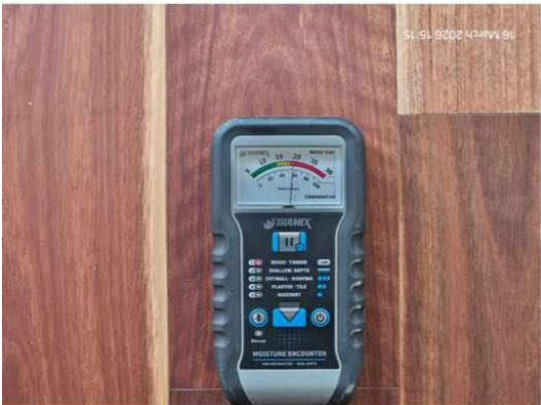
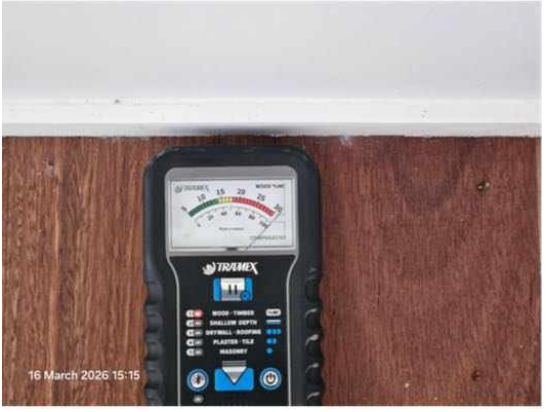
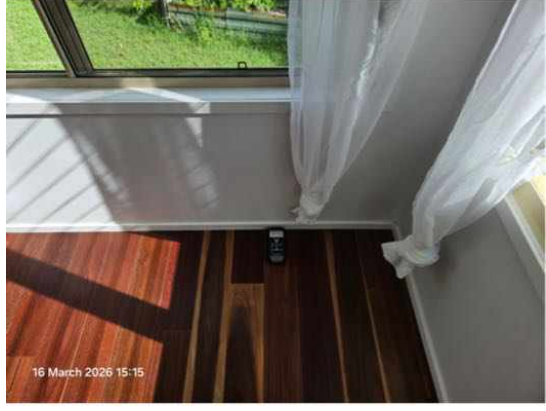
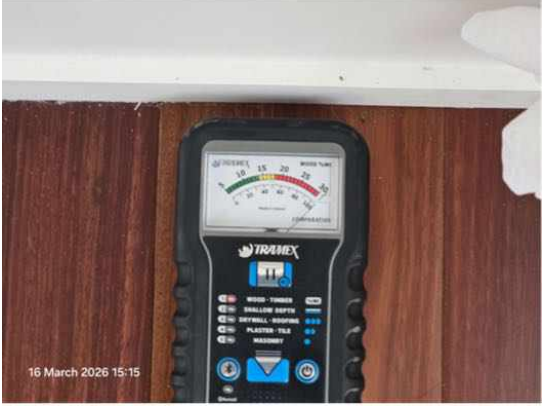
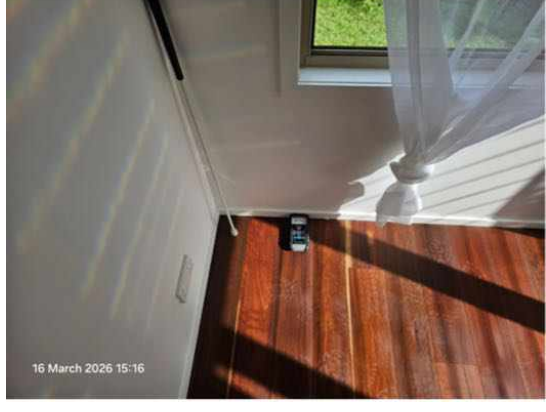
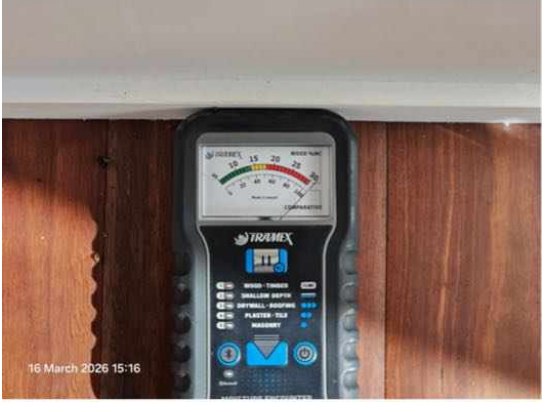
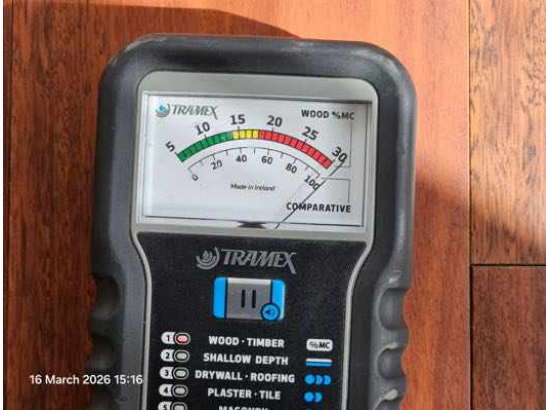
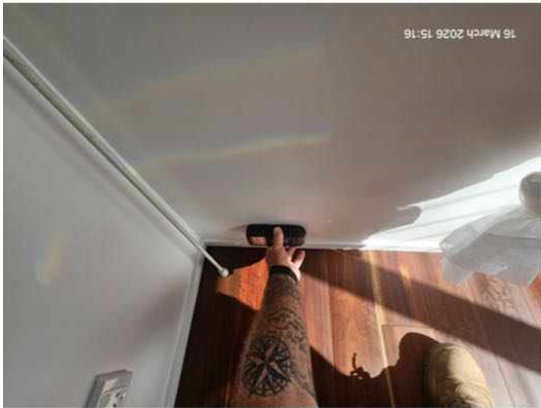
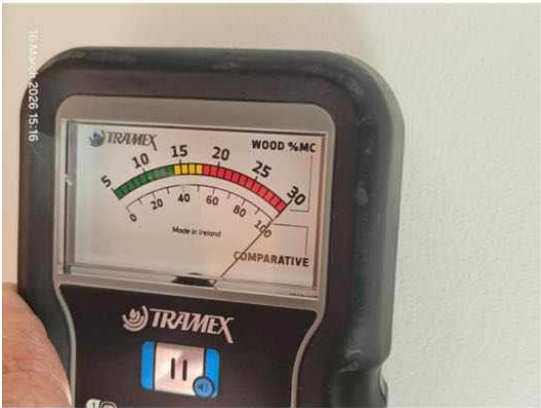
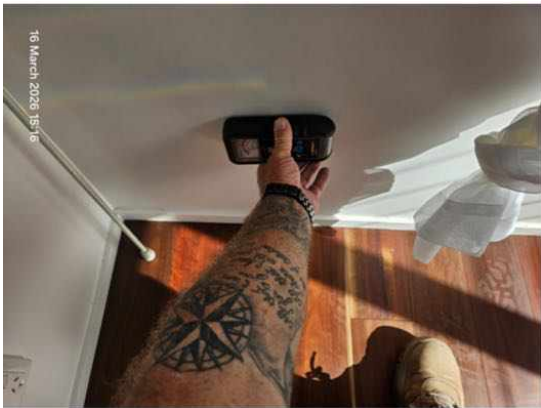
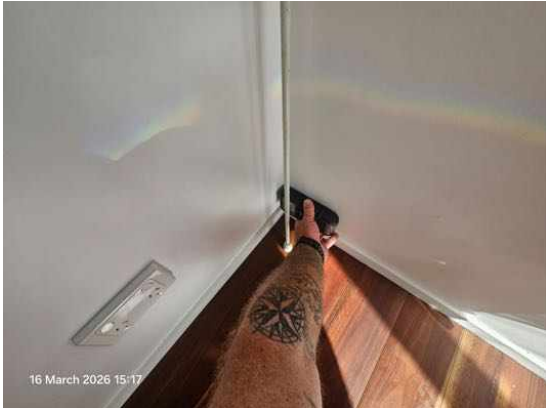
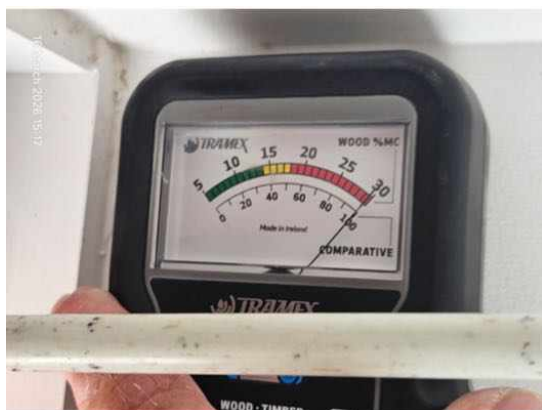
Wood rot, also known as Fungal Decay, occurs when timbers and other cellulose building materials are exposed to damp conditions on an ongoing basis. This could be

The flooring will require cutting back and the installation of suitable flashing such as colorbond will be required to provide adequate water resistance and protection.

A licensed carpenter or licensed builder should be consulted to advise on a solution for the affected building materials.

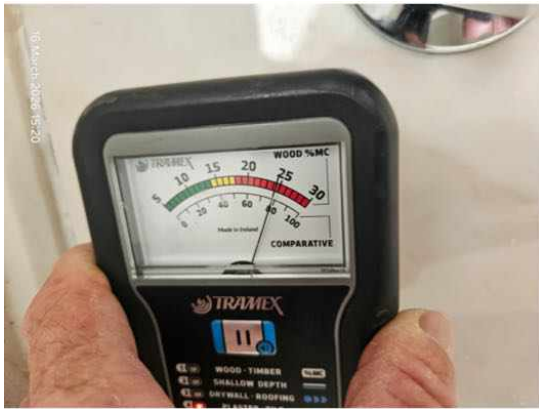
**Finding 3.03**

Building: Main Building  
 Location: Laundry  
 Finding: Moisture noted around taps - laundry  
 Information: During the inspection elevated moisture was observed around the taps of the laundry splashback.

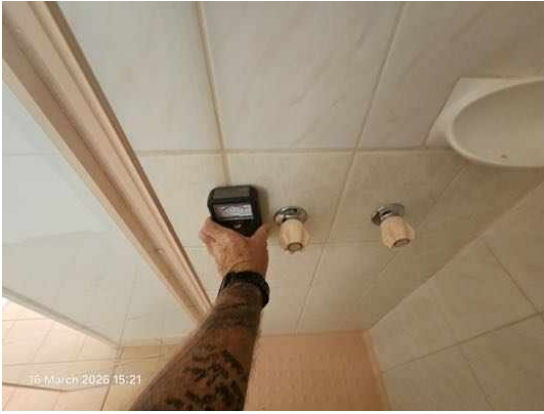
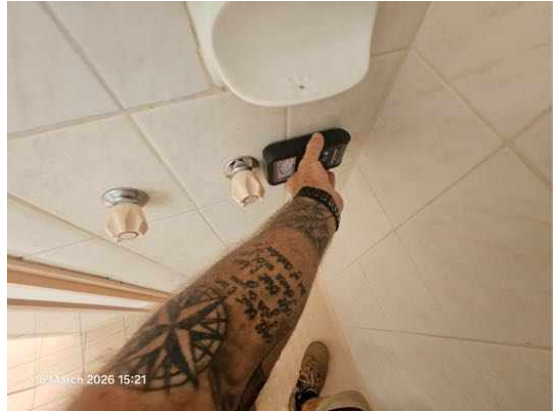
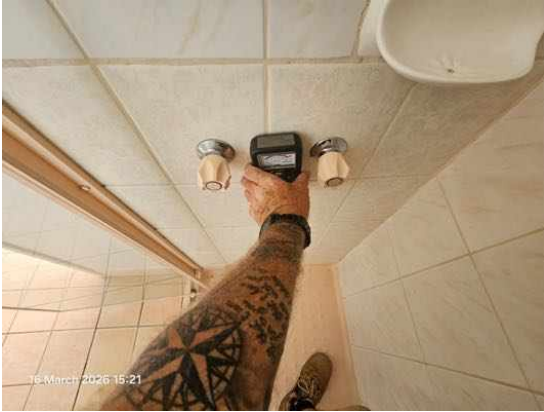
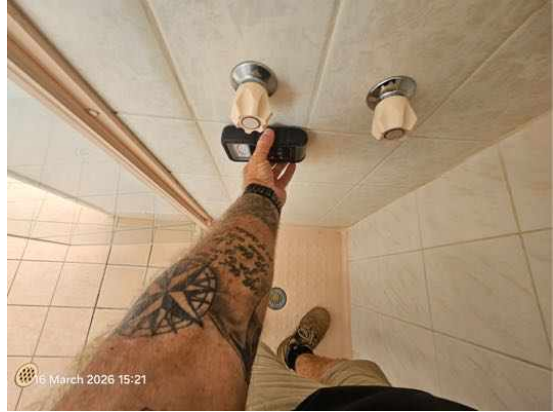
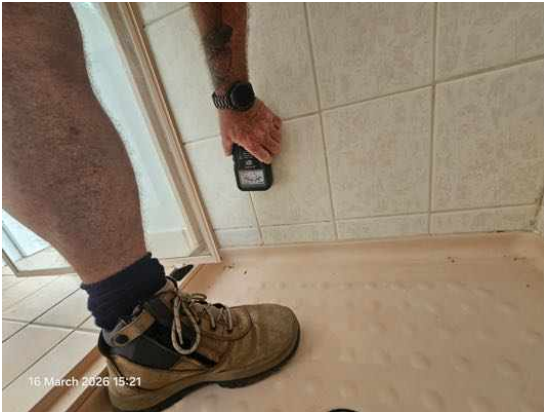
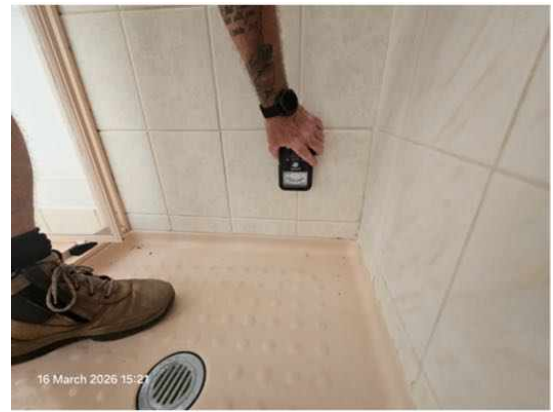
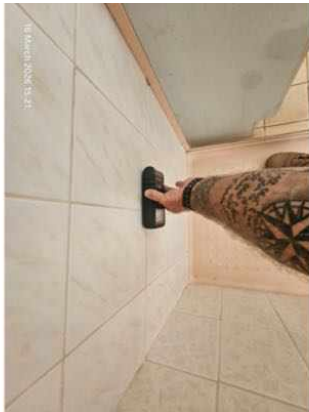
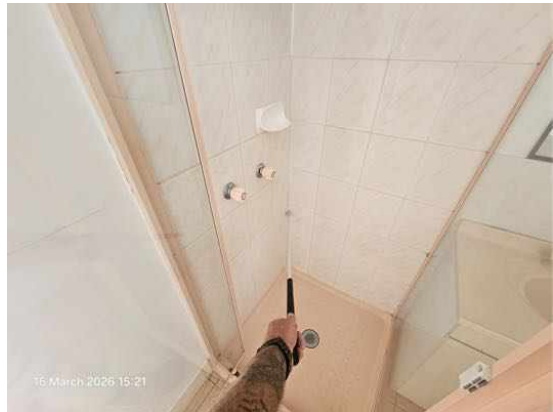
Building: Main Building  
Location: Bathroom  
Finding: No moisture detected in bathroom  
Information: On the day of inspection the shower in the bathroom was measured for moisture using a "Tramex" moisture meter. During this inspection no moisture was detected in this area and the tiled / sheeted surfaces appear to be in reasonably good order. Some silicone is missing and will require replacement.

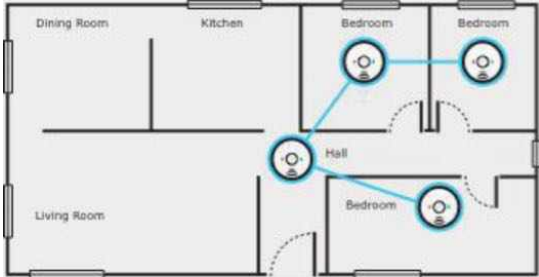
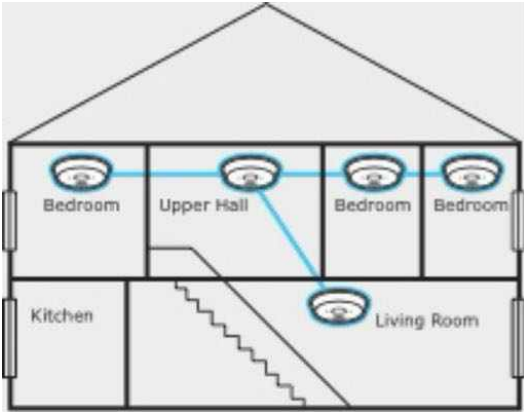
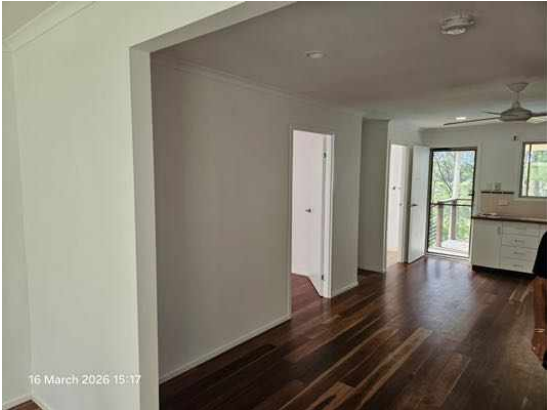
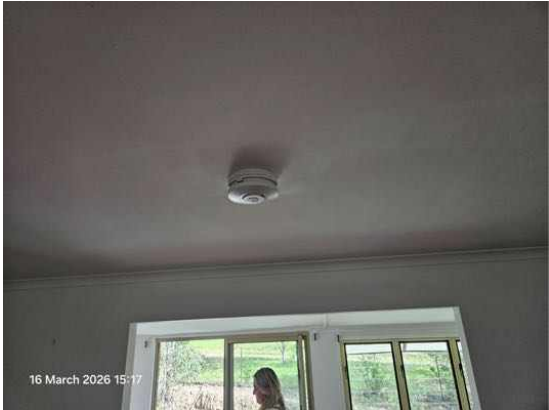
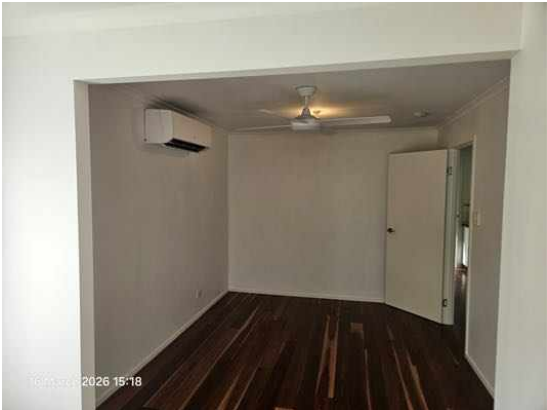
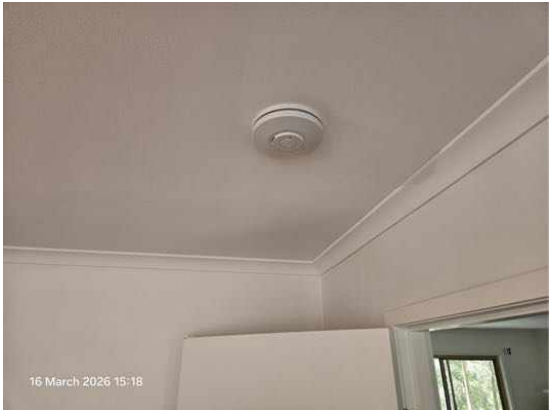
Avoid installing smoke alarms in dead air space. This is an area in which trapped hot

air will prevent smoke from reaching the alarm. The space generally occurs at the apex of cathedral ceilings, the corner junction of walls and ceiling, and between exposed floor joists.

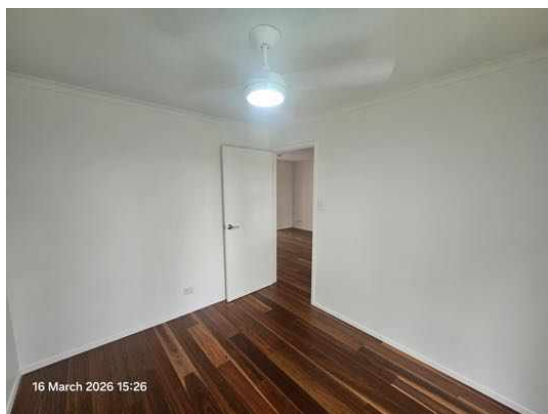
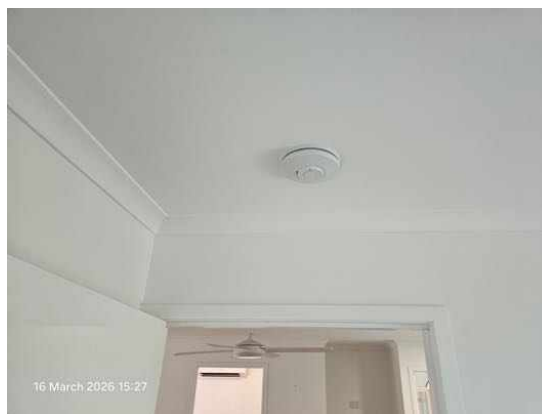
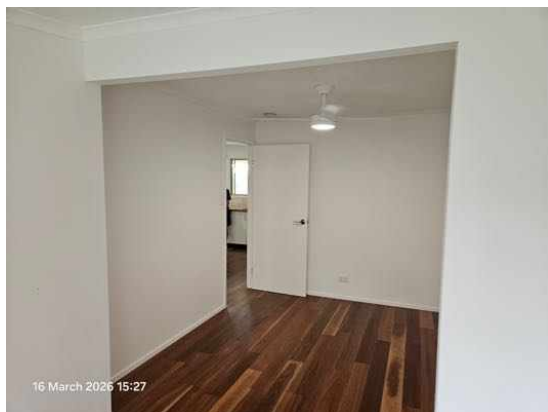
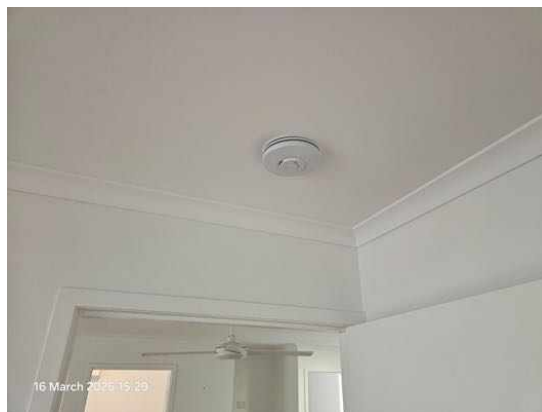
### Noted Item

Building: Main Building  
 Location: All Areas  
 Finding: Additional Photos - Obstructions and Limitations  
 Information: These photographs are an indication of the obstructions and limitations which impeded full inspection of the property at the time of inspection. These obstructions can prevent full inspections of the areas shown.

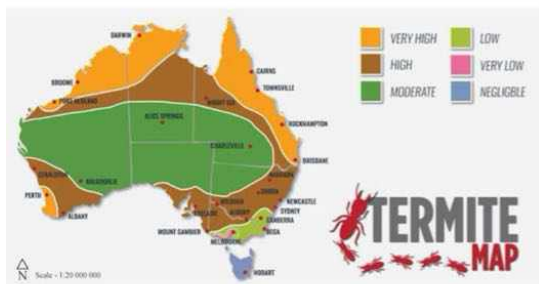
Building: Main Building  
 Location: Meter box, kitchen cupboard  
 Finding: Durable pest inspection notice - not assessable  
 Information: On the day of inspection it was noted that the durable timber pest inspection / treatment notice was missing, not visible or out of date. These notices / stickers are to

Annual, or more regular, inspections are crucial in maintaining and managing the properties timber pest risk profile. By not having regular inspections of the property raises the properties risk of undetected defects and damage. Without regular inspection at intervals of not greater than annually the buildings risk profile will be categorised as high. Properties with trees within 50m and with gardens close to the building are at greater risk and will have a high risk profile.

It is recommend that a licensed timber pest controller be contacted to assess the properties needs and provide costings for an annual inspection programme.

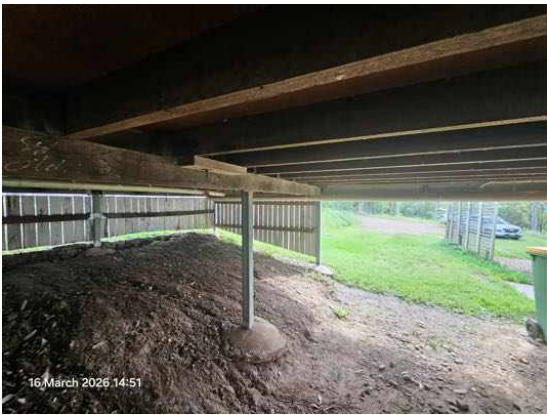
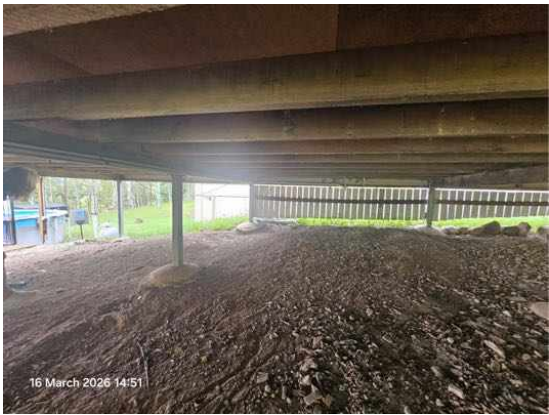
Where a Termite Management System has been identified you should refer to the type of barrier, date of installation, warranty conditions and any documentation provided by a builder or past owner. Consult the company who installed the barrier to confirm whether the system is still under warranty.

In order for a barrier system to be effective, the property must have regular inspections at intervals of not greater than 12 months. Depending on the risk profile attributed to the property, these inspections may be recommended at lesser time periods.
