Building and Timber Pest Inspection Report

Inspection Date: Tue, 18 Nov 2025

Property Address: 193 Birrell St, Waverley NSW 2024,
Australia

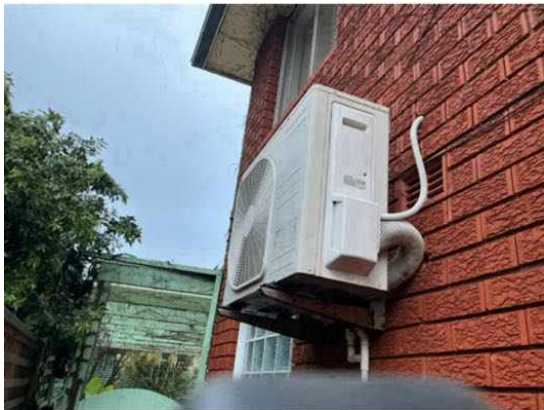
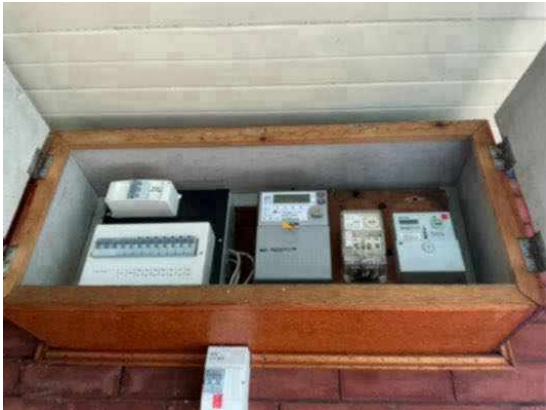
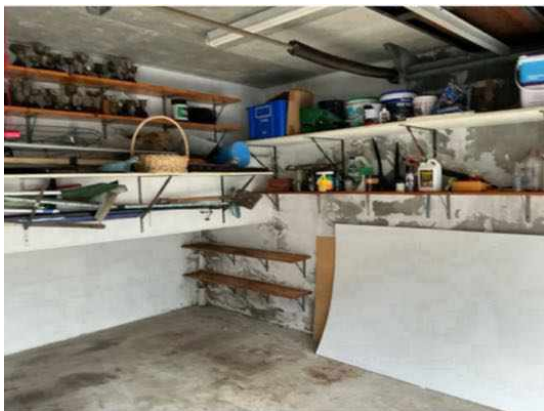
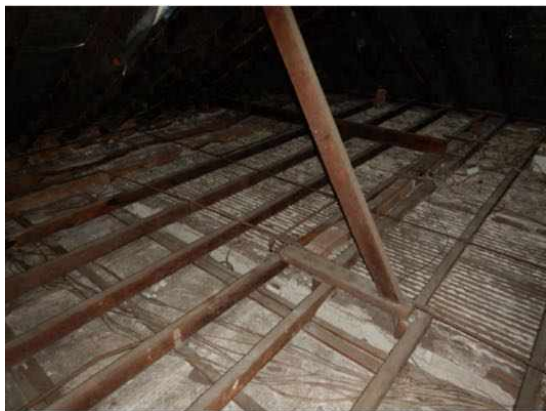
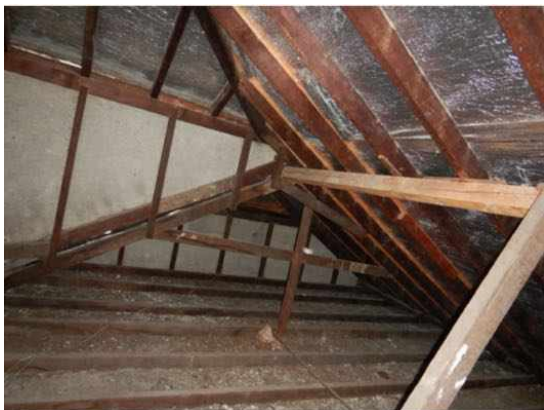
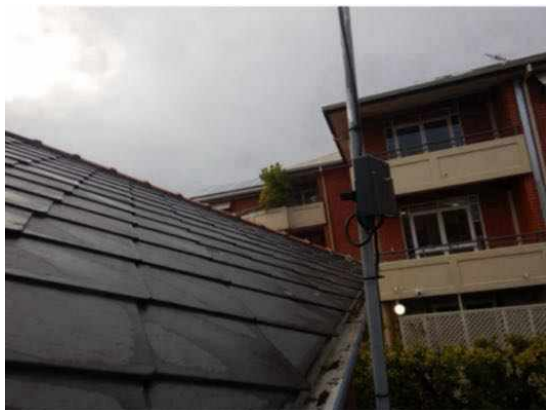
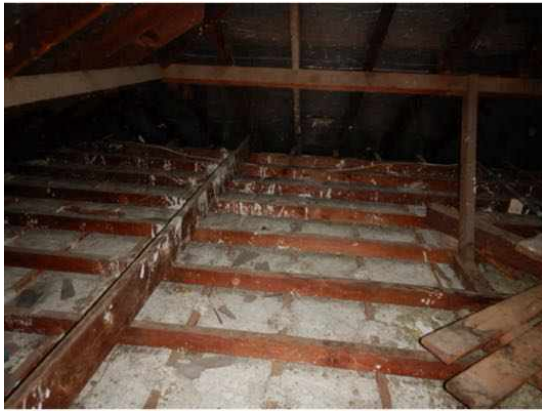
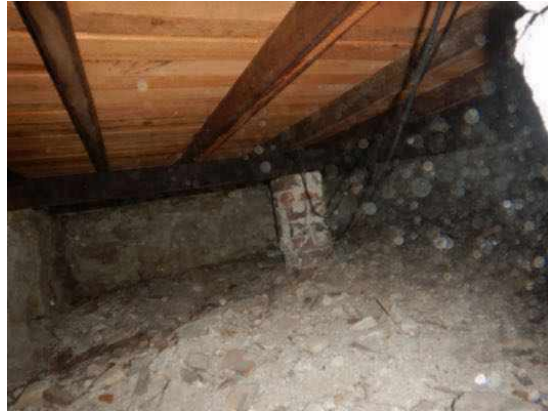
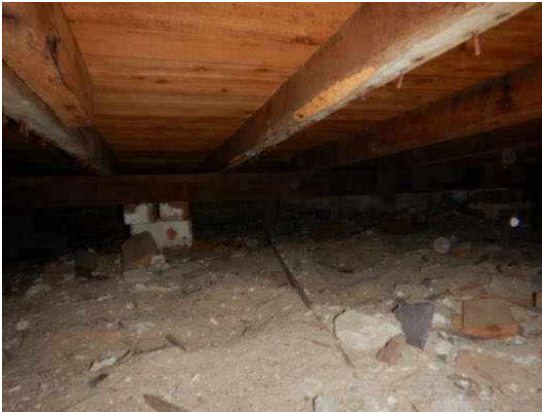
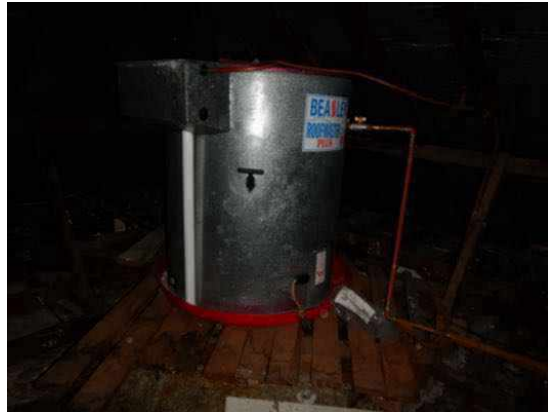
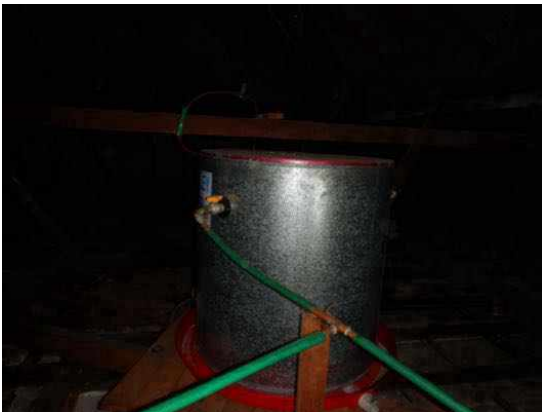
Some photos may also show obstructions and limitations which impeded full inspection of the property at the time of inspection. Additional photos also show other elements such as hot water systems, air conditioning units and RCD switches (electrical safety switches) on power boxes.

This property has no insulation in the roof void as shown in the additional photos.
