Building and Timber Pest Inspection Report

Inspection Date: Wed, 1 Apr 2026

Property Address: 114 Armoury Road, Jordan Springs NSW
2747

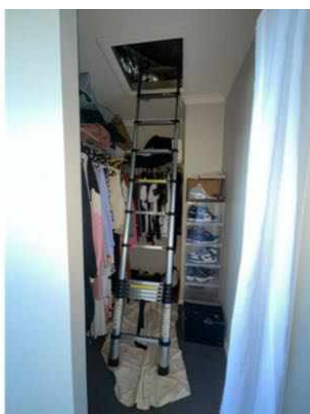
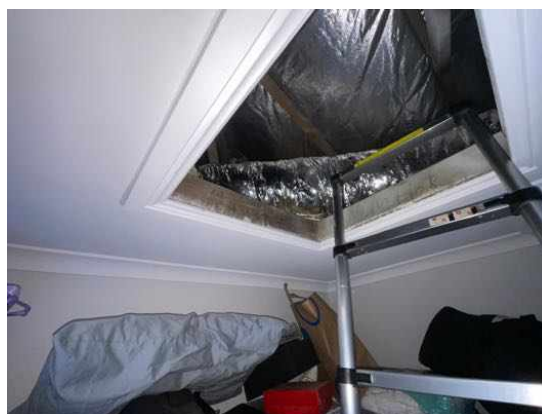
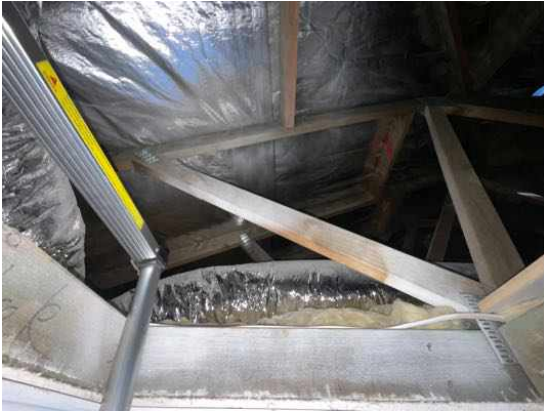
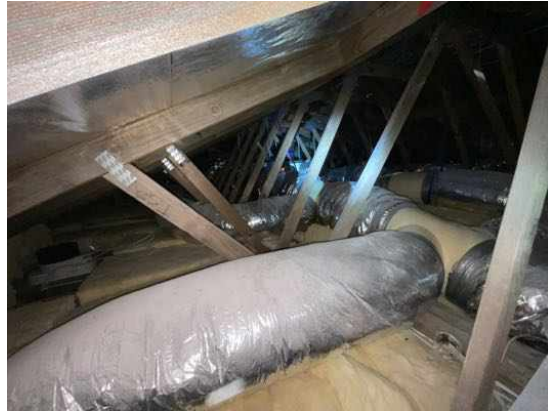
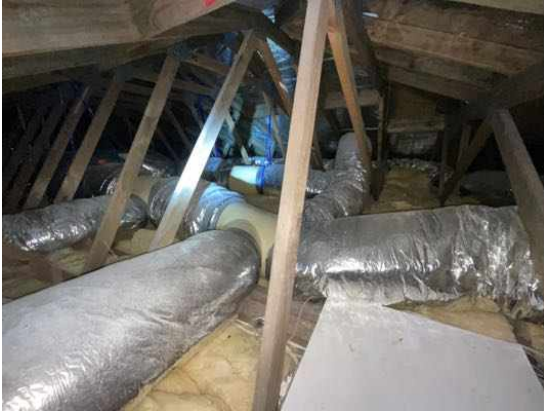
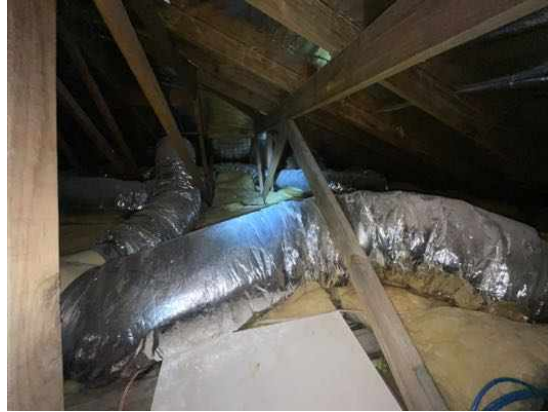
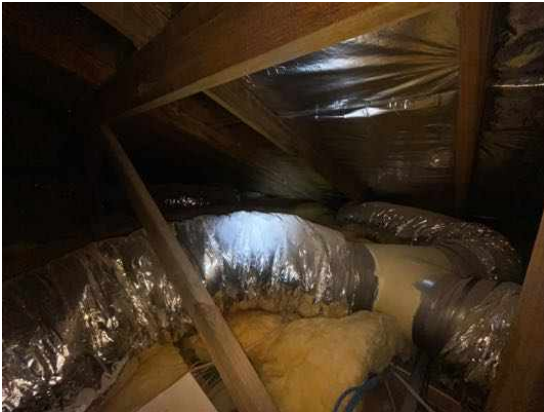
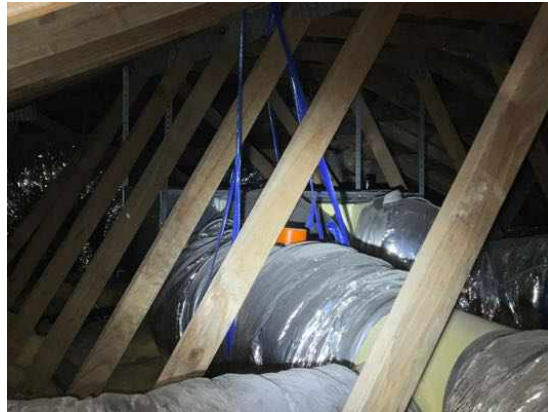
Inspector's Comments:

This assessment of the roof void was significantly limited by restricted access due to installed services and the inability to safely enter the space. Accordingly, the findings are based solely on observations made from accessible vantage points and should not be relied upon as a comprehensive evaluation of all concealed components.

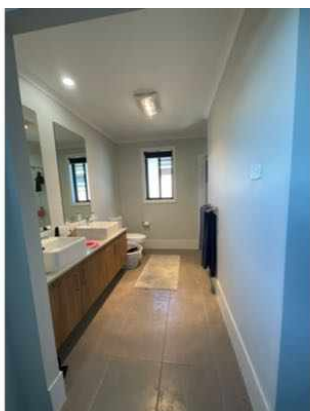
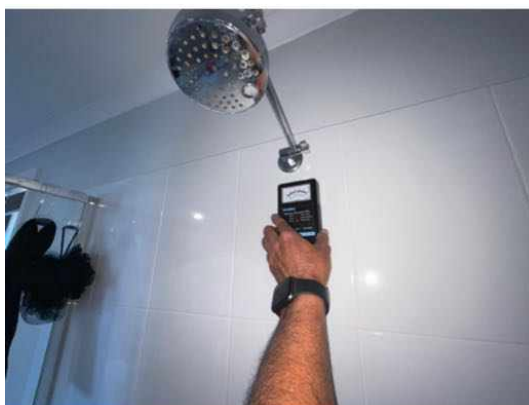
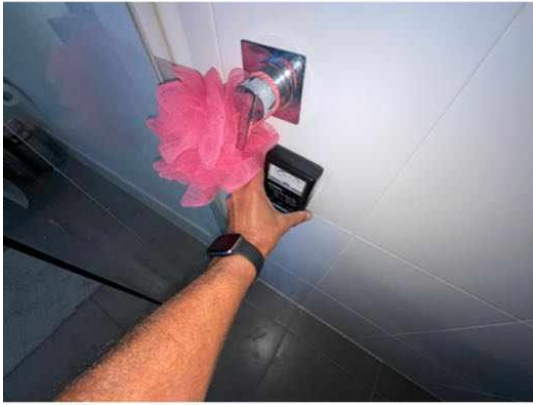
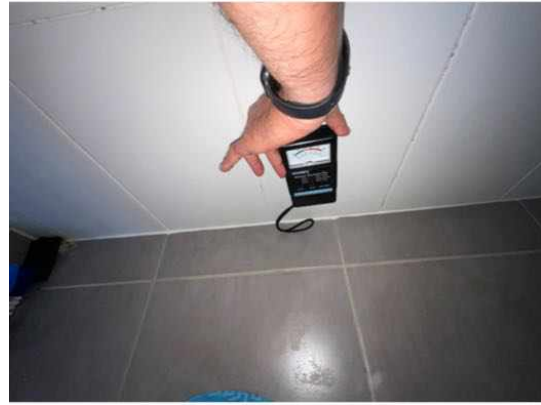
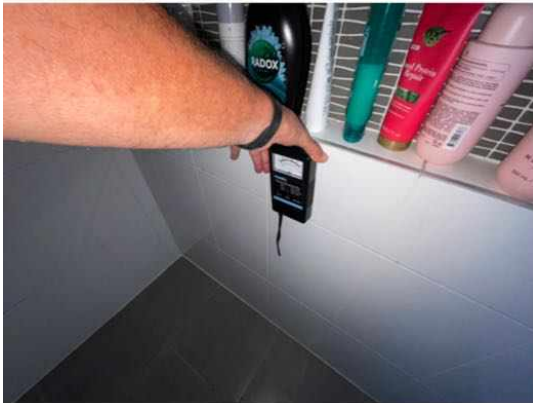
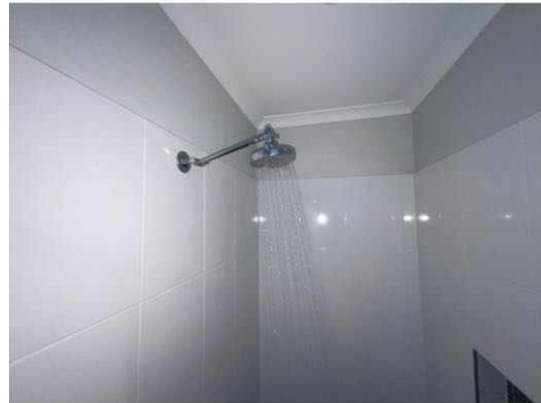
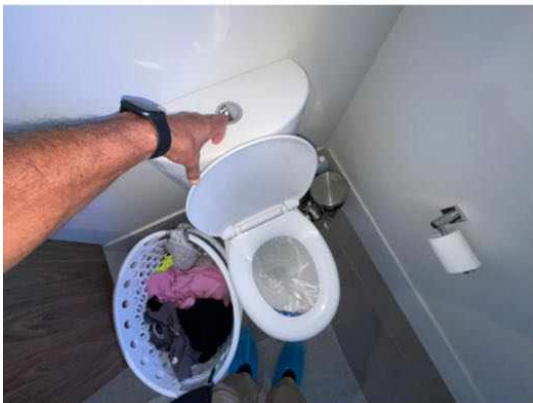
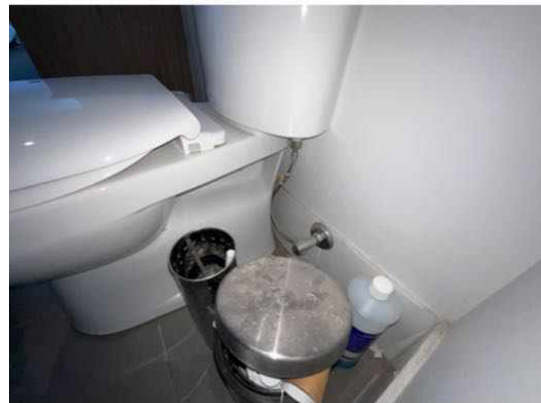
Building: Main Building
 Location: Ensuite
 Finding: Wet Areas - Bathroom(s) - Overall Condition & Recommendations.
 Information: Overall Condition & Recommendations

It is not possible under the visual inspection criteria of a standard pre-purchase report to categorically determine if leaks are present. If a more detailed or accurate assessment is required, a special-purpose inspection should be undertaken.

Alternatively, the assumption should be made that leakage may occur, particularly where historical or environmental conditions are conducive. The visual nature of this inspection cannot detect issues concealed behind wall/floor linings or cabinetry, and invasive investigation may be necessary to confirm the true condition of adjacent or hidden structures.

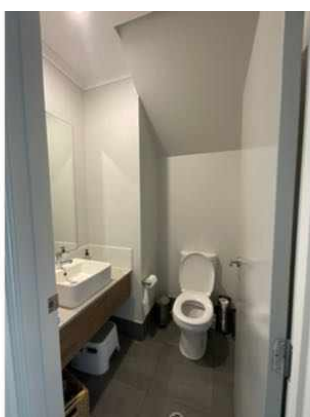
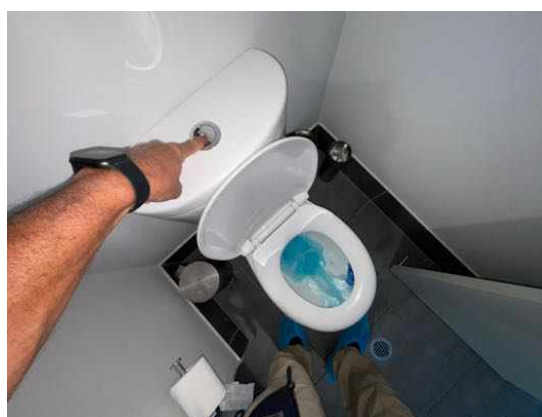
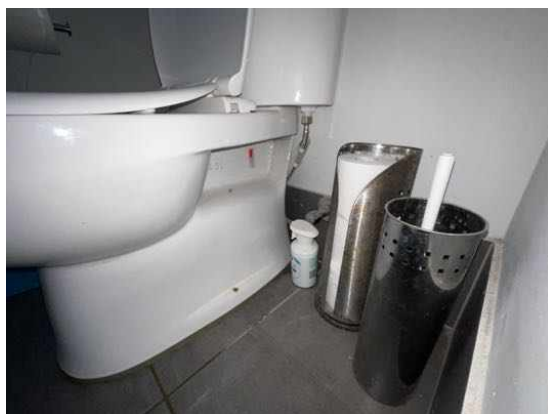
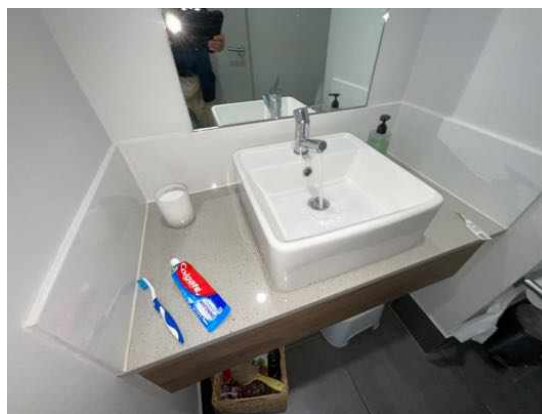
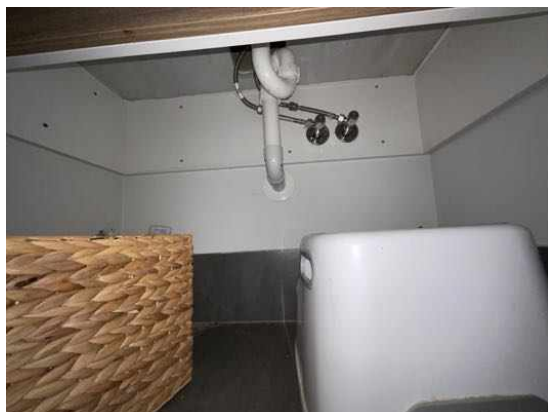
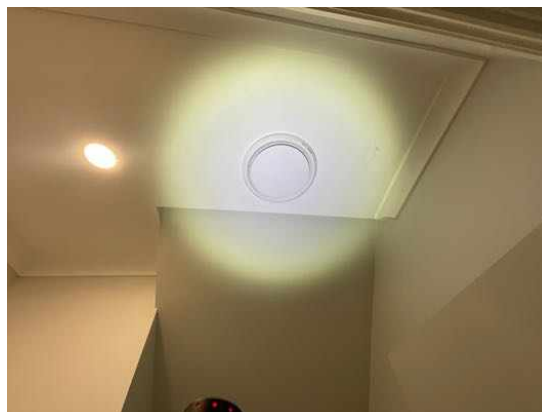
Building: Main Building
Location: Toilet (WC)
Finding: Overall Condition: Toilet & Basin.
Information: TOILET & BASIN ASSESSMENT

Sealant:

- Sealant around the basin and wall junctions appeared to be in serviceable condition.
- It is recommended that flexible, mould-resistant sealant be applied or replaced where missing or degraded to prevent future water ingress.
- Regular maintenance of sealant and grouting in wet areas is essential to prolong the life of surrounding materials and reduce the risk of water damage.

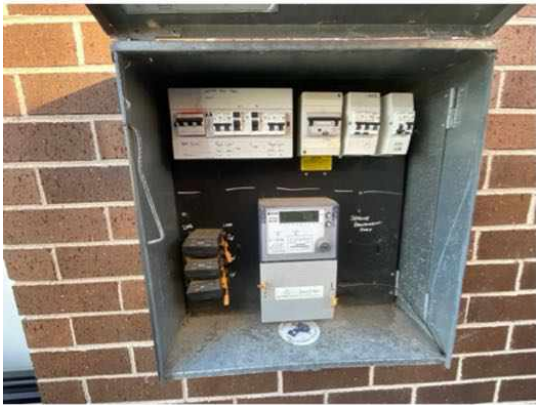
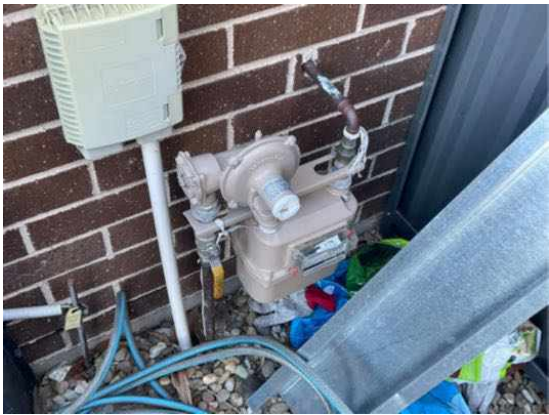
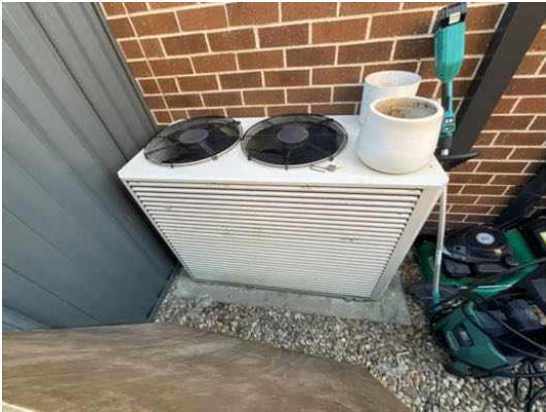
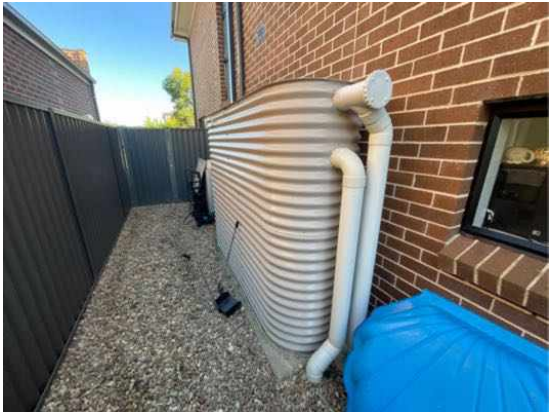
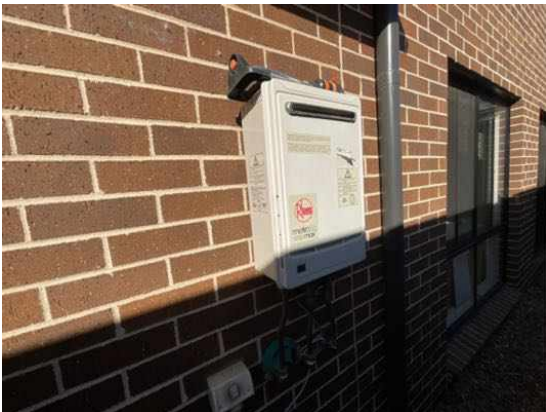
Finding: Plumbing, Electrical & Gas Installations – Scope and Recommendations.

- Any gas appliances (if applicable) must be inspected by a licensed gas plumber to confirm they are operating safely and efficiently.
- We also recommend that all other plumbing and electrical installations be thoroughly checked by qualified professionals to ensure they are functioning correctly and meet current safety and compliance standards.

While this inspection includes observations of visually apparent defects relating to plumbing and electrical elements, it does not assess compliance with current regulations. Legislation requires that any such assessment be undertaken and documented by licensed electricians and plumbers.

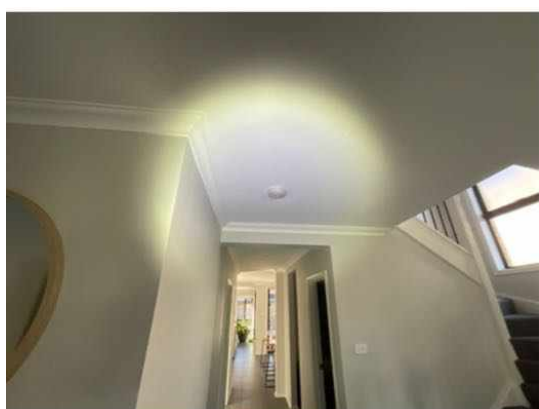
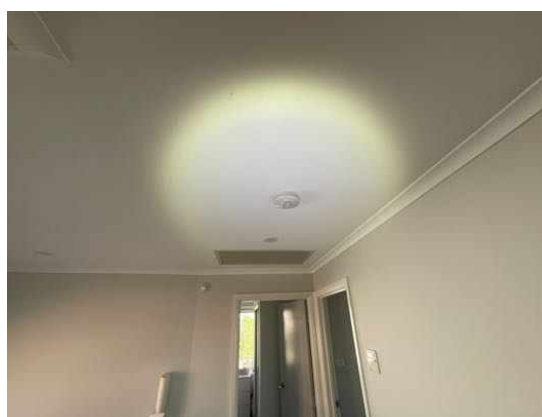
Building: Main Building
Location: All Areas
Finding: Smoke Detectors / Alarms.
Information: Reporting on the presence, type, location, or compliance of smoke detectors or alarms, including hard-wired smoke detection systems and their legislative requirements, is outside the scope of this inspection report.

To ensure compliance and safety, further inspection and/or advisory services from a qualified specialist are recommended. These services can confirm the sufficiency, type, location, and functionality of all smoke detection devices within the property.

- All smoke detectors be tested monthly by the homeowner.
- All systems comply with the requirements of AS 3786 and any applicable state-based legislation.
