Building and Timber Pest Inspection Report

Inspection Date: Thu, 9 Apr 2026

Property Address: 1-41 Paxton st Malvern east

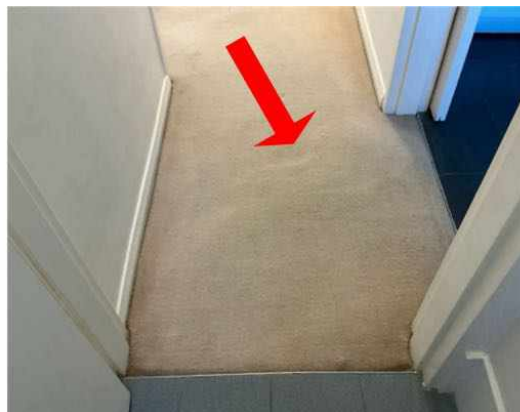
If left unaddressed these defects may result in progressive slab failure, increased risk of trip hazards and occupant injury, compromise structural integrity of the unit and potentially adjoining units and reduce the property value.

The defects identified are consistent with a major structural issue affecting the slab system. Given the buildings age and the nature of the symptoms observed, urgent professional assessment is required by a structural engineer to determine the extent of the damage and appropriate remediation measures.

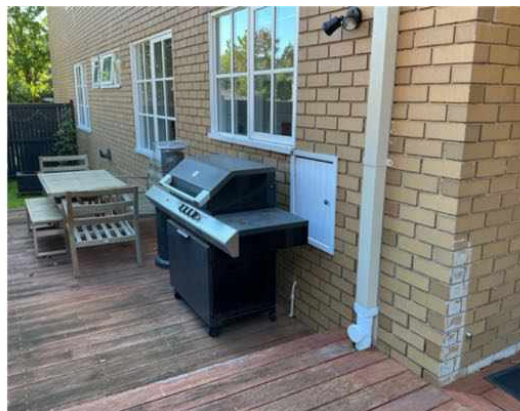
a clear gap of not less than 25mm from building, bridging occurs. Attachments to buildings such as hot water services, downpipes, verandahs, decks, steps, fences, service conduits and the like provide the opportunity for concealed entry.

Building attachments of this nature need to be frequently inspected for termite activity by a qualified inspector.
