# Building and Timber Pest Inspection Report

Inspection Date: Wed, 28 Jan 2026

Property Address: 25 Mariners Way, Hastings VIC 3915,  
Australia

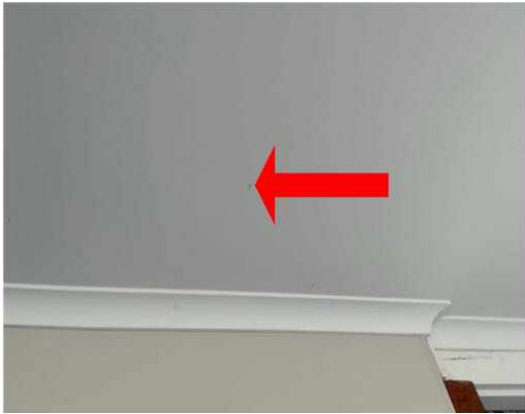
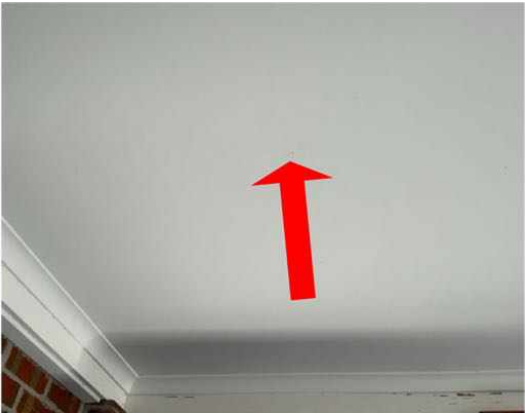
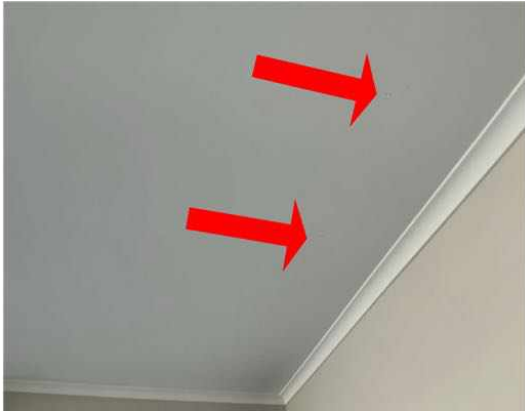
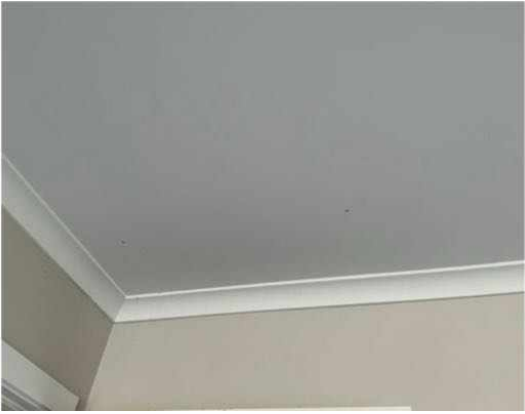
Building: Main Building  
Location: Garage  
Finding: Ceiling -fixings popping/coming loose  
Information: Sections of the garage ceiling were found to have fixings popping/coming loose at the time of inspection. Popped fixings to the fixed ceiling structure generally indicates that the building materials/fixings (e.g. nails or glue) have become loose and require reattachment. This is quite a common defect in garages of this age. It is suspected that internal plaster is used where wet board plasterboard should be used and it gets affected by the moisture and condensation in the air. There is normally no insulation in the ceiling allowing the moisture to accelerate the deterioration.

Where sagging is evident repairs such as re-gluing or replacing of ceiling sheets, may be required. Such works may be performed by relevant tradespeople, such as plasterers and painters.

The appropriate action should be taken by the client as soon as possible to ensure that any potential further damage is limited.

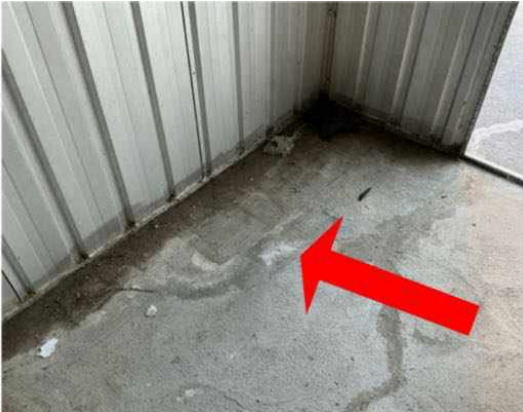
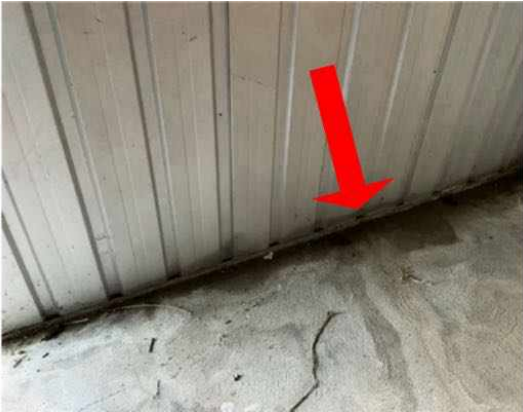
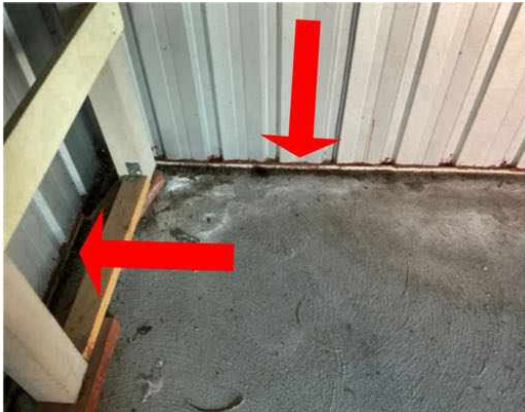
**Finding 3.02**

Building: Main Building  
Location: Yard - Back  
Finding: Water ingress to shed  
Information: The current site grading directs surface water run-off towards the shed rather than away from it which is causing rust and corrosion to the base of the shed. Ongoing moisture ingress may lead to deterioration and increased risk of corrosion and potential damage to stored items. It is recommended that a suitably qualified contractor be engaged to re-grade the surrounding ground to direct water away from the shed or improve surface drainage with spoon drains or aggie drains and assess and repair any damage caused by water ingress at the owners discretion.

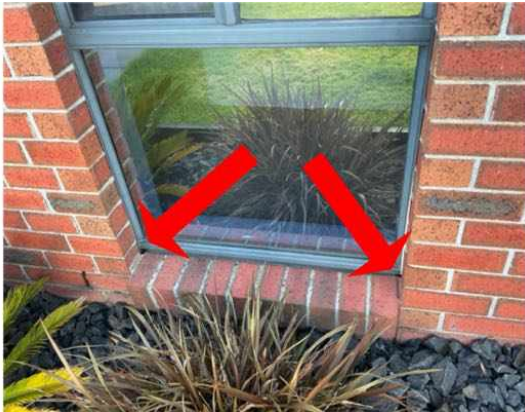
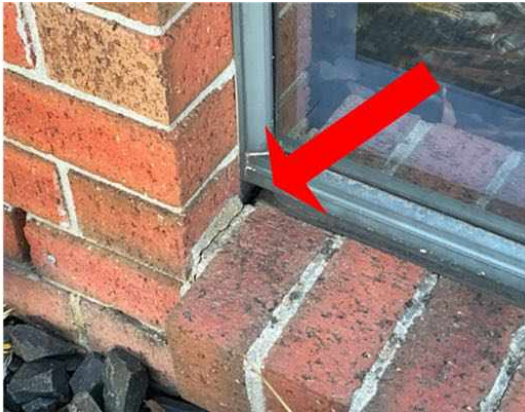
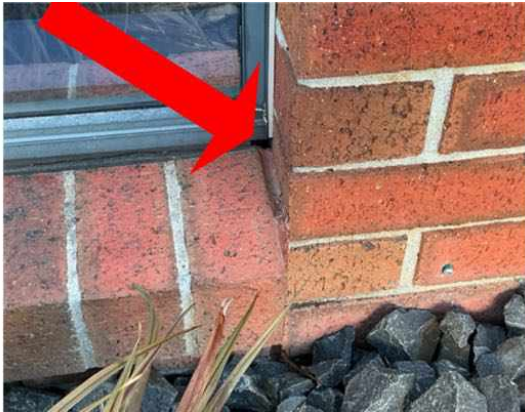
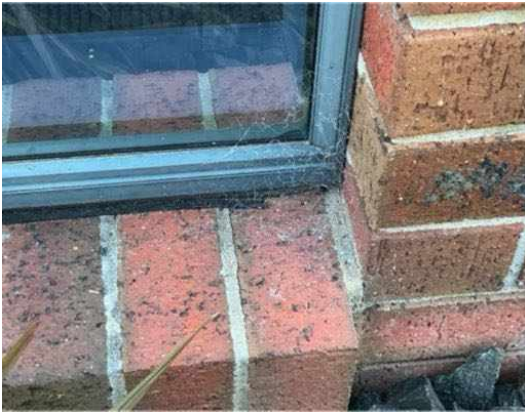
**Finding 3.03**

Building: Main Building  
Location: Various parts of the building  
Finding: A few gaps to the exterior walls/windows  
Information: A few gaps were noticed to some of the exterior walls/windows to the building. These gaps can let in water, drafts, and pests. Overtime moisture ingress may cause damage to internal walls, mould growth, or structural issues. Gaps also reduce the energy efficiency of the property. Recommend engaging a caulker to seal gaps with an exterior grade flexible sealant that is UV and weather resistant to reduce the risk of pest/water penetration to the building as soon as possible.

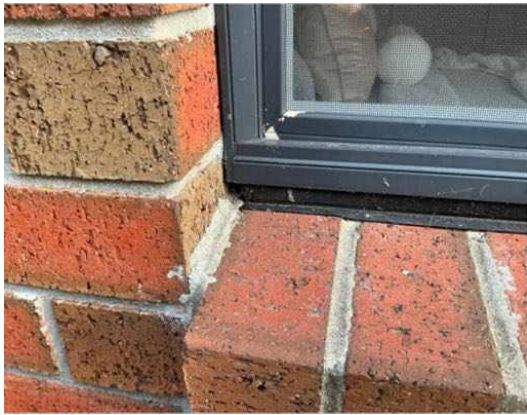
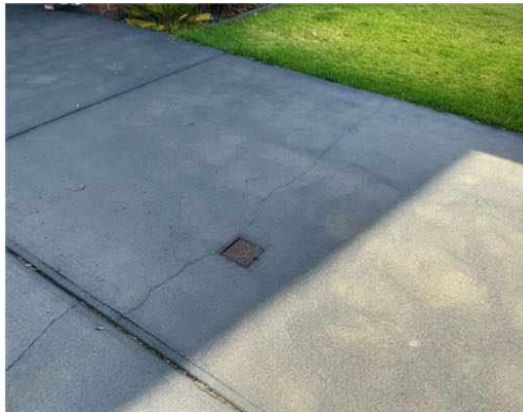
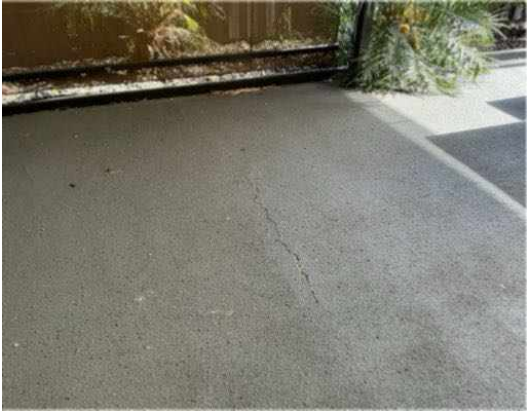
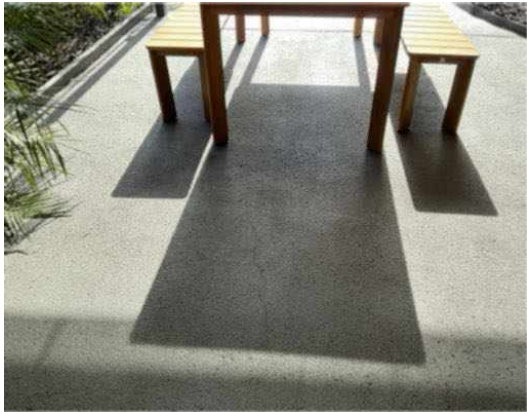
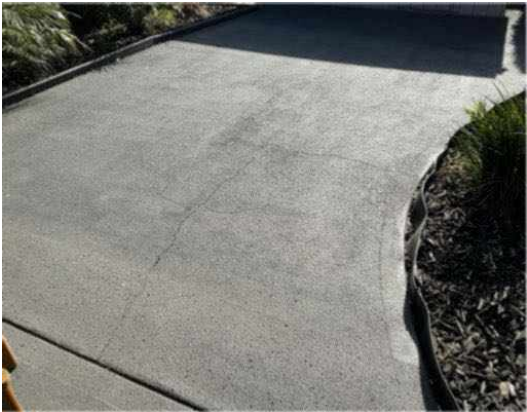
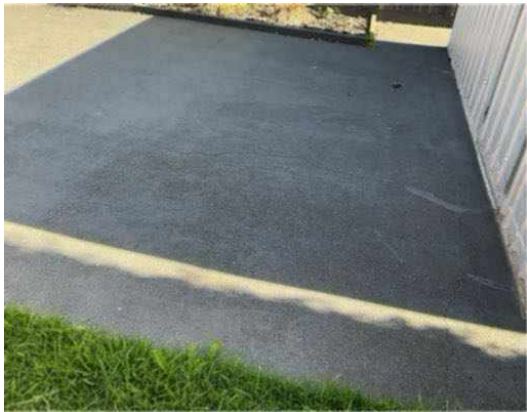
Finding 3.04

Building: Main Building  
Location: Driveway and pathways  
Finding: Driveway/pathway Cracking  
Information: Cracks were identified in the driveway and pathways external concrete paving. Although cracks are quite noticeable, they are often only considered to be an appearance defect, and usually do not indicate any structural damage.

Generally the cause of the cracks in existing concrete paving such as driveways and pathways is indicative of the expansion and contraction of the concrete. Such causes are generally due to environmental factors, such as moisture levels, weather conditions, root systems of nearby trees or the soil types on which they are laid.

Cracks may also be due to poor original installation of the concrete. Factors such as poor compaction of the sub surface and/or inadequate reinforcing of the slab may create cracking and other secondary defects.

Monitoring of all cracking should be conducted frequently. Always contact a building inspector should cracks widen, lengthen, or become more numerous.

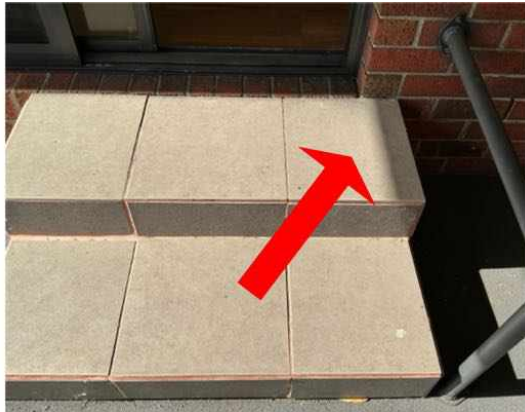
### Finding 3.05

Finding: Cracked tile

Information: A cracked tile was evident to the rear steps at the time of inspection. It is suspected that this cracking has occurred as a result of minor settlement or shrinkage of the building but could also be to poor installation of the tiles in the first place.

Cracked tiles to the household detract from the overall appearance of the affected areas however it is unlikely to create or lead to any secondary defects.

While not considered a matter of urgency, replacement of cracked tiles is

recommended at the clients discretion. A tiling contractor may be appointed to perform these works. Where cracks become more numerous, contact a licensed building inspector for further investigation.

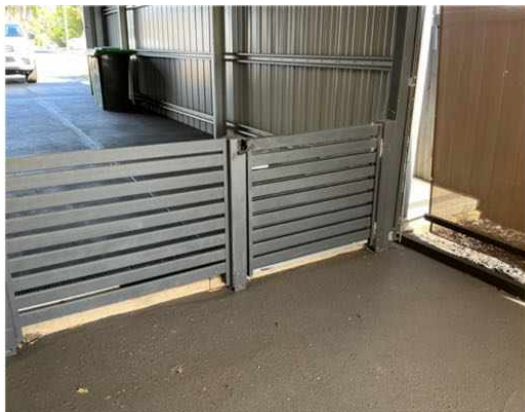
### Finding 3.06

Building: Main Building  
 Location: Yard - Back  
 Finding: Gate latch needs adjustment  
 Information: The latch to the side gate was found to be binding and needs adjustment.

Repair is advised to improve the operational state of the associated gate.

A qualified carpenter or general handyman should be appointed to repair at the client's discretion.

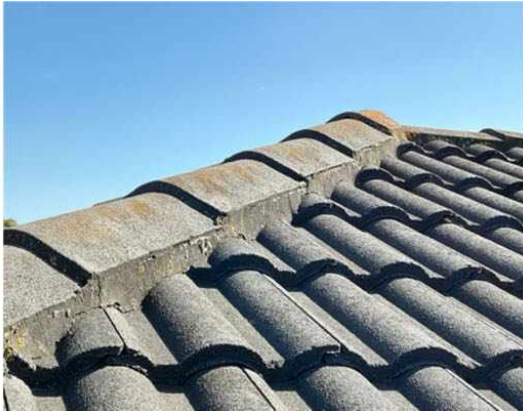
Building:	Main Building
Location:	Roof Exterior
Finding:	Roof tile mortar deterioration and cracking
Information:	Cracking and deterioration was observed in the ridge and hip tile mortar bedding. The mortar has separated in several areas, with visible gaps forming between ridge tiles

and the underlying bedding. This condition indicates age-related degradation and exposure to the elements, which has caused the mortar to become brittle and lose its bonding integrity.

Compromised mortar may lead to further deterioration, potentially allowing water ingress and structural damage to the roof structure below.

Recommend engaging a qualified roofing contractor to carry out repointing or full re-bedding of affected ridge and hip tiles as necessary. All deteriorated mortar should be removed and replaced with new flexible roof bedding compound in accordance with current Australian Standards (AS 2050).

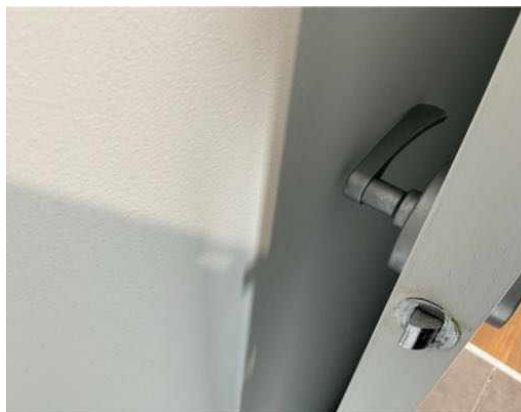
Finding: Door stop- missing  
 Information: The laundry doorstop is missing and is unable to stop the door handle from damaging the wall. Although some building elements may seem irrelevant or unnecessary, all building elements play a key role in the operation and function of the overall structure and its performance.

Re-installation or replacement of the door stop is advised as soon as possible to prevent any subsequent damage to the door or associated structures. A general handyman may be appointed to perform these works at client discretion.

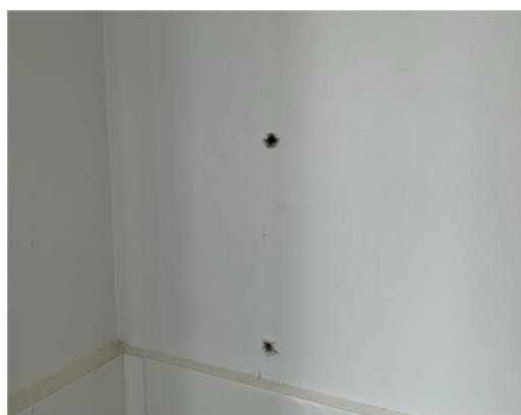
### Finding 3.13

Building: Main Building  
 Location: Laundry  
 Finding: Hole in plaster  
 Information: There is some holes in the plaster to the laundry walls. Recommend engaging a plasterer/painter to repair to make more aesthetic at the owners discretion.

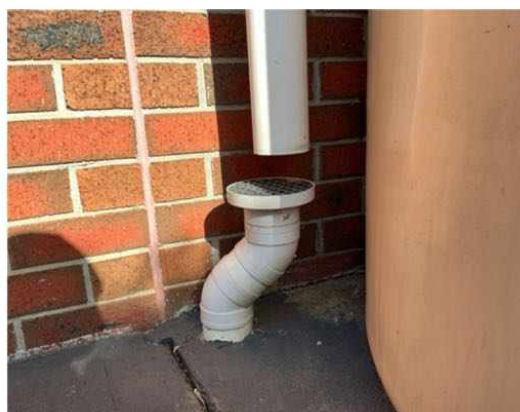
Where plumbing doesn't drain adequately, the area at the base perimeter can become excessively damp, potentially creating an environment that is susceptible to rust and corrosion of surrounding building elements, as well as attracting termites and other pests.

It is highly recommended that a plumber be appointed to further inspect the area and to install adequate drainage equipment immediately where necessary.

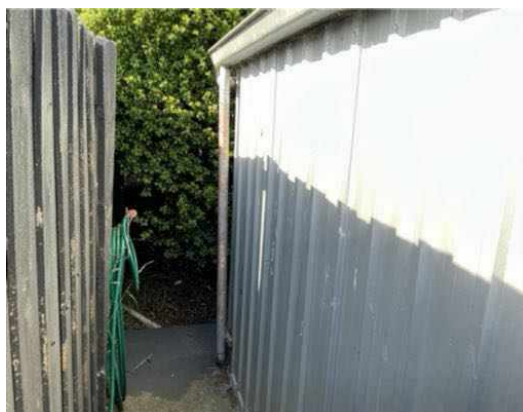
#### Finding 6.02

Building:	Main Building
Location:	Shed
Finding:	downpipe not connected to stormwater
Information:	The shed down pipe is not connected to stormwater. This disconnection negatively impacts the functional capacity of the plumbing.

Where plumbing doesn't drain adequately, the area at the base perimeter can become excessively damp, potentially creating an environment that is susceptible to rust and corrosion of surrounding building elements, as well as attracting termites and other pests.

It is highly recommended that a plumber be appointed to further inspect the area and to install adequate drainage equipment immediately where necessary.

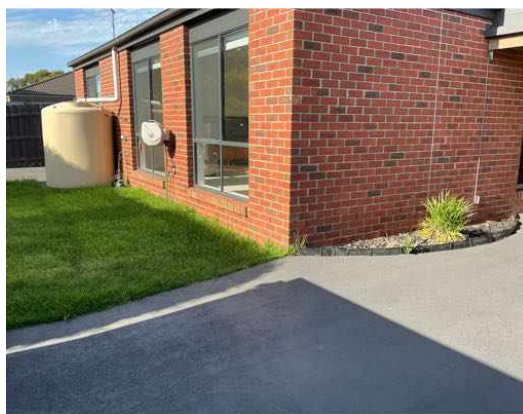
**Finding 6.03**

Building: Main Building  
 Location: Yards  
 Finding: Site drainage - poor/inadequate  
 Information: The site drainage to parts of the yards was found to be inadequate at the time of inspection, creating potential for subsequent water damage to associated building elements. Excessive moisture will attract termites.

It is important that water does not lie against the base of walls; surrounding paths and ground levels should be sloped to drain water away from walls. Downpipes should not discharge stormwater onto lower walls or plinths. Stormwater should be carried away by large, regularly cleaned drains. Ground levels may need to be lowered to expose a buried DPC.

Where site drainage is inadequate, installation of an Agricultural (Aggie) Drain may be required. A qualified plumber should be appointed to further inspect the property and perform any remedial works as necessary. Water damage and secondary defects are likely to occur if left unmanaged.

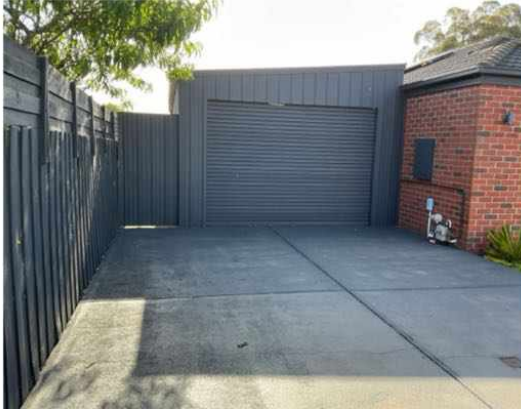
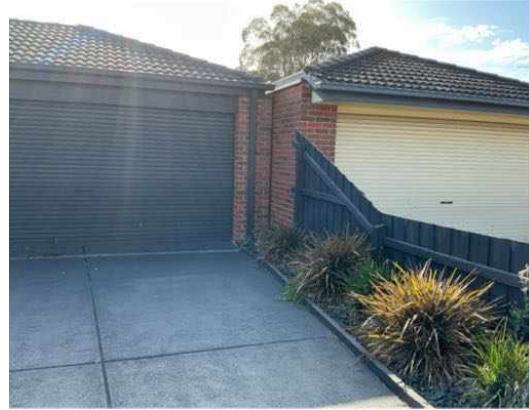
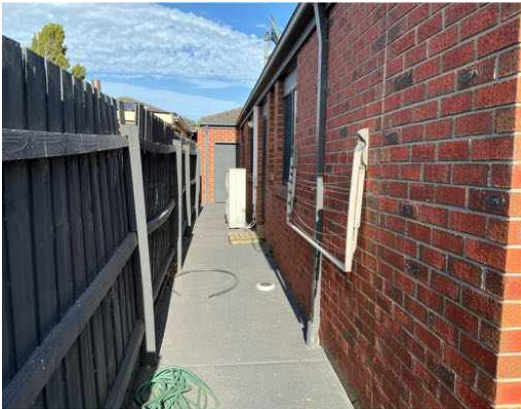
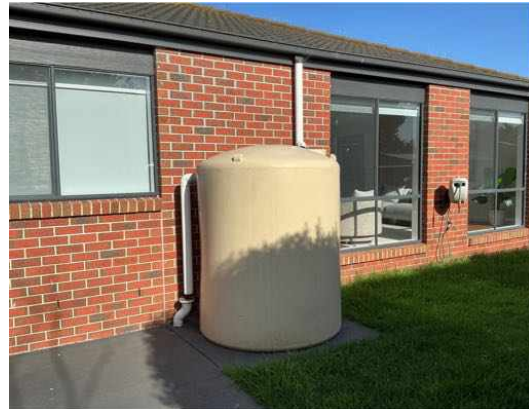
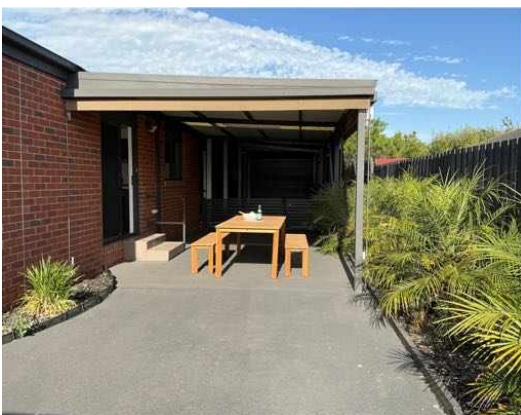
buildings such as hot water services, downpipes, verandahs, decks, steps, fences, service conduits and the like provide the opportunity for concealed entry.

Building attachments of this nature need to be frequently inspected for termite activity by a qualified inspector.

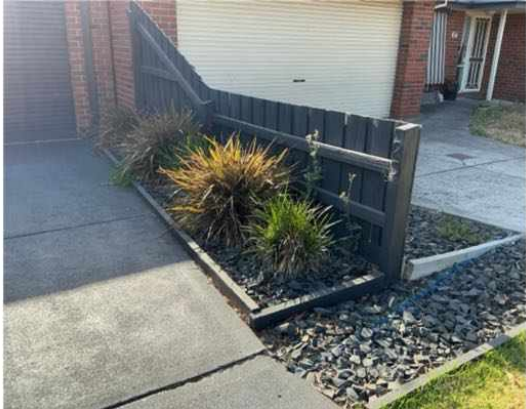
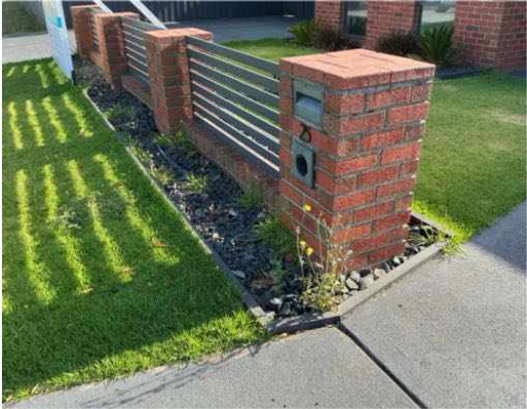
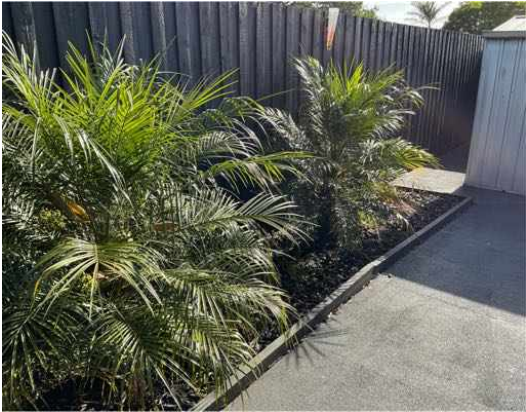
and are likely to be subject to premature rot and decay as the soil retains moisture or damp conditions against the timbers.

Remove untreated timber that is in direct contact with external grounds. Consider replacement with more durable materials i.e. treated timber or non timber elements. Frequent pest inspections are advised to readily identify any termite activity in these areas.

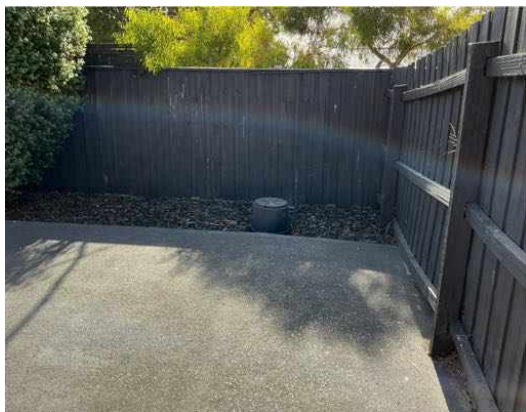
### Finding 6.07

Building:	Main Building
Location:	Yard - Back
Finding:	Air conditioning unit overflow -Not plumbed for drainage
Information:	The overflow to the air conditioning unit is not plumbed or connected to suitable drainage, which has resulted in the surrounding area becoming excessively damp. These damp conditions can lead to secondary defects such as rot, rust or corrosion of associated building elements, the formation of fungal decay, or even the creation of potential slip hazards. When coupled with poor site drainage, pooling of water may also attract termite activity to this area. It is highly recommended that a qualified plumber be appointed to install adequate drainage to the overflow. These works will ensure that the area remains dry and free of any secondary defects.

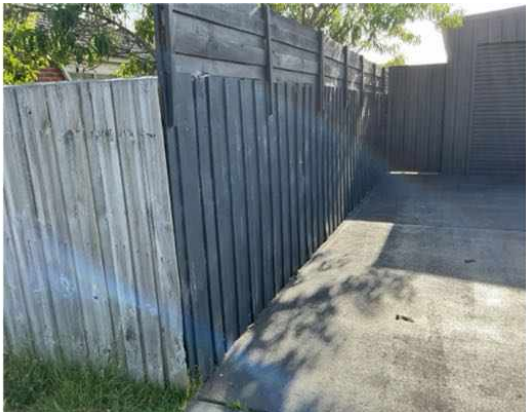
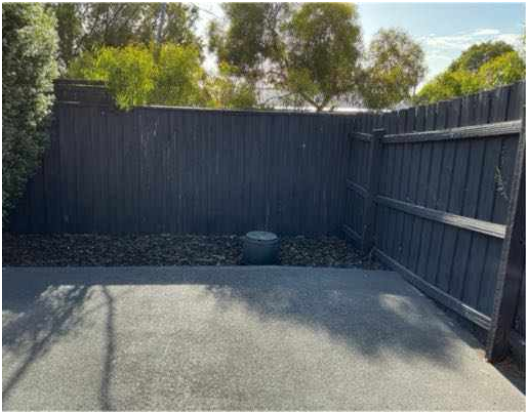
Building:	Main Building
Location:	Yards
Finding:	Fencing - wood rot-fungal decay
Information:	It was noted at the time of inspection that sections of the fencing to the property have

deteriorated and have fungal decay/wood rot present. Typically fencing deteriorates due to age and or wear, rot and or rust which is generally expected for a structure of this age, due to prolonged exposure to weather conditions. Sometimes inadequate installation or maintenance can be to blame.

If left unattended, it is likely that further damage will occur. It is suspected that repair of several elements of the fencing may be required however replacement may be a consideration of the client also.

A licensed fencing contractor should be appointed to provide further advice and perform rectification works as necessary.

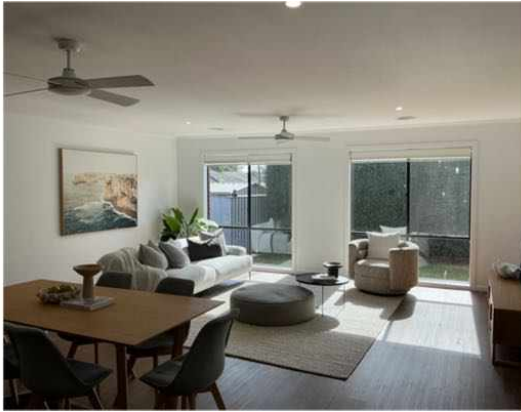
Building: Main Building  
Location: All Internal Areas  
Finding: Additional Photos - Obstructions and Limitations  
Information: These photographs are an indication of the obstructions and limitations which impeded full inspection of the property at the time of inspection. These obstructions can hide an array of defects and should be removed to allow full inspection to be carried out. A re-inspection is recommended once the areas are made accessible.

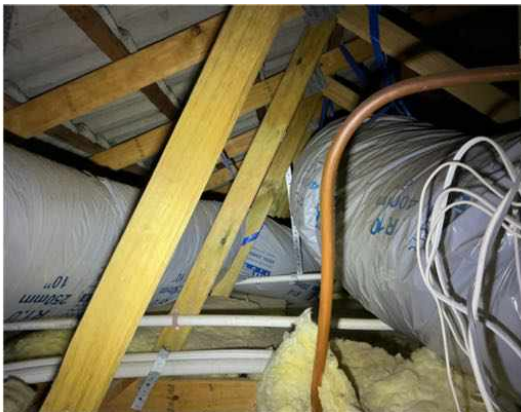
Building:	Main Building
Location:	Roof Void
Finding:	Obstructions and Limitations -roof cavity
Information:	These photographs are an indication of the obstructions and limitations which impeded full inspection of the roof cavity at the time of inspection. These obstructions can hide an array of defects and should be removed to allow full inspection to be carried out. A re-inspection is recommended once the areas are made accessible.

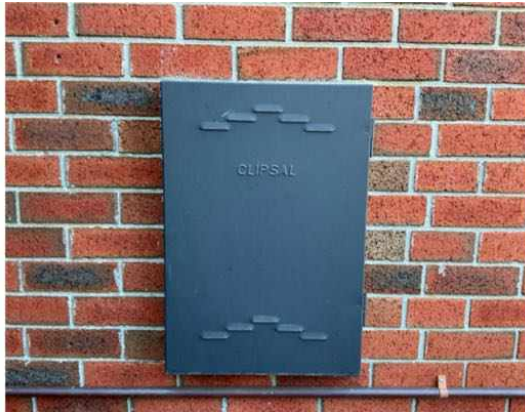
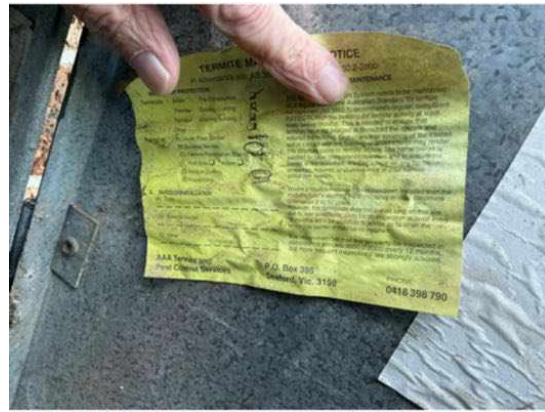
Where a Termite Management System has been identified you should refer to the type of barrier date of installation warranty conditions and any documentation provided by a builder or past owner. Consult the company who installed the barrier to confirm whether the system is still under warranty.

Most chemical termite management systems expire and require replenishment and all physical systems are primarily designed to prevent concealed entry.
