# Building and Timber Pest Inspection Report

Inspection Date: Tue, 10 Mar 2026

Property Address: 44 Beverley Ave, Unanderra NSW 2526,  
Australia

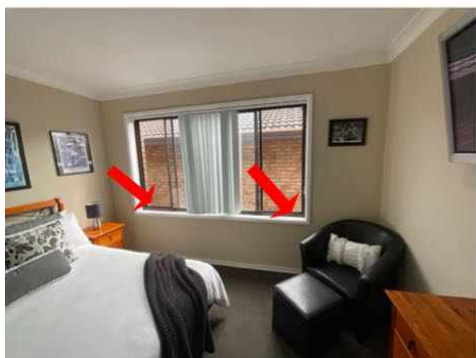
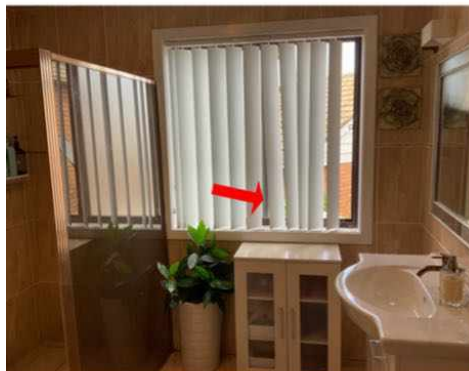
Building:	Building 1
Location:	Many upper windows
Finding:	Window opening restrictors missing.
Information:	The Building Code of Australia rules require all openable windows (where the internal floor is more than 2m above the ground outside) in residential rooms to be fitted with a suitable screen or restrictor. Windows located 1.7m above the floor level do not require protection.

Window restrictors are required where people who are vulnerable to the risk of falling have access to windows. This means all windows above ground level which do not have another fall prevention safety measure in place, such as a balcony or balustrade should have a restrictor.

These need to be added urgently for the safety of all persons.

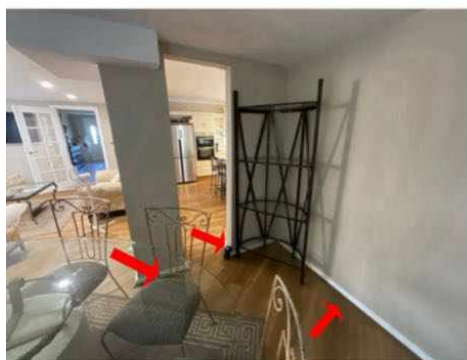
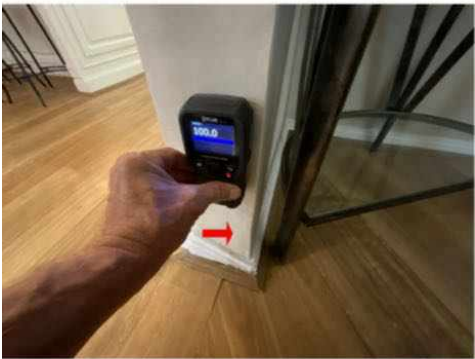
Rising damp is generally managed by the installation of a damp proof course during construction. A Damp Proof Course (DPC) is an impermeable barrier at the base of the wall above ground level. However, many 19th Century buildings have no damp course installed, or the materials have failed. The DPC may have been omitted as a consequence of poor workmanship, or it may have been bridged where materials built up against the side of the house allow moisture ingress above the DPC level.

The first step in addressing rising damp is to diagnose the cause. The identified cause should be addressed first before addressing the appearance and other defects which have resulted from the rising damp. If the original cause is not resolved, further cases of damp are likely to ensue, resulting in secondary defects.

Consultation with a qualified plumber is advised immediately to identify the cause of the damp and perform remedial works as required.

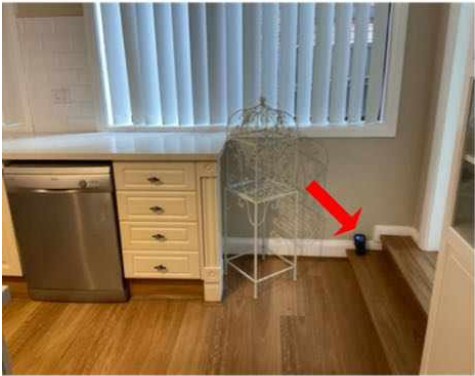
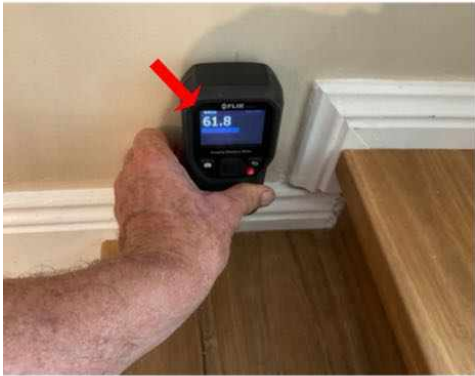
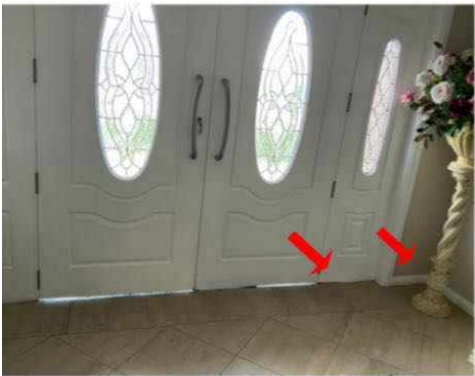
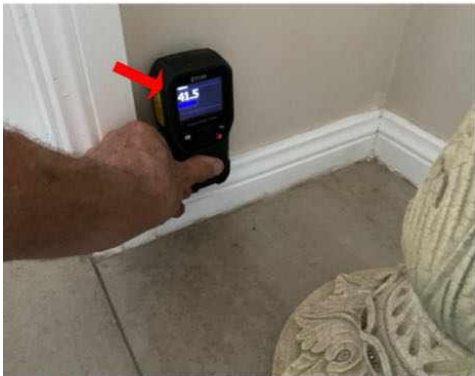
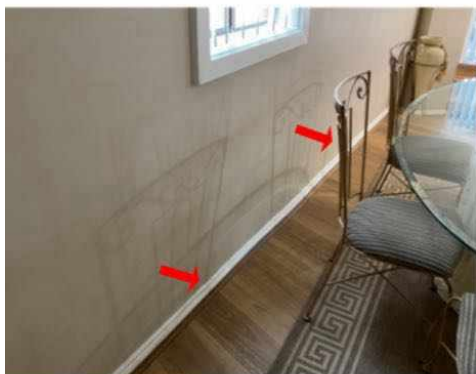
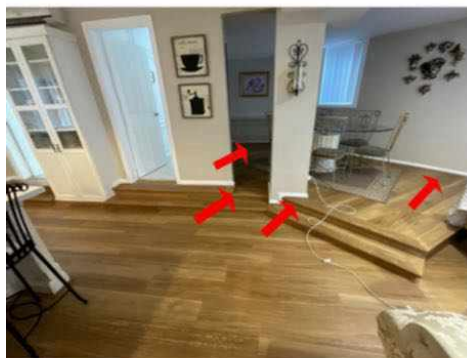
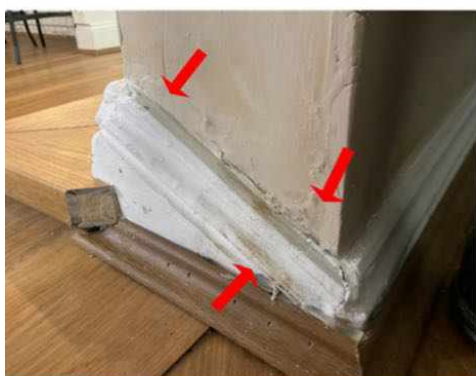
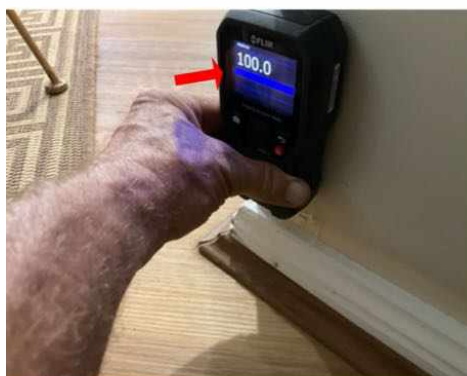
Finding 3.02

Building: Building 1  
Location: Entry, kitchen, dining room  
Finding: Evidence of excessive moisture was present at the time of inspection  
Information: Excessive moisture was found in these pictured areas. Maximum readings of 100 were found in the dining room and medium readings in the other pictured areas.

This can attract termites and produce conditions that promote termite attack, fungal growth and wood decay. Excessive moisture is generally caused by deteriorated, inadequate or missing roof drainage, rising damp, damaged external sealant, leaking plumbing pipes or fixtures, poorly plumbed HWS overflows or condenser units and poor site drainage. It is highly recommended that all plumbing and drainage fixtures and fittings be maintained regularly in order to prevent excessive moisture being present in the internal property. See rising damp defect at top of this report.

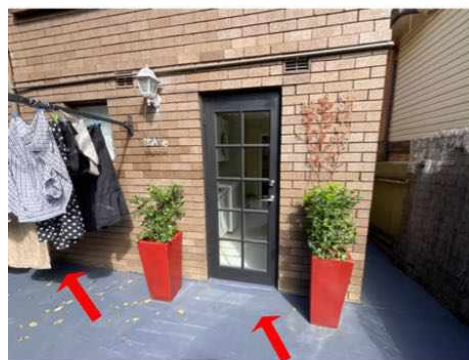
### Finding 3.03

Building:	Building 1
Location:	Rear Walls
Finding:	Site drainage - Inadequate
Information:	The site drainage in this rear area was found to be inadequate at the time of inspection, creating potential for subsequent water damage to associated building elements.

No drainage was found in this area and it is thought rainwater is ingressing the rear wall causing the rising damp found in internal areas.

It is important that water does not lie against the base of walls; surrounding paths and ground levels should be sloped to drain water away from walls. Downpipes should not discharge stormwater onto lower walls or plinths. Stormwater should be carried away by large, regularly cleaned drains. Ground levels may need to be lowered to expose a buried DPC.

Where site drainage is inadequate, installation of an Agricultural (Aggie) Drain may be required. A qualified plumber should be appointed to further inspect the property and perform any remedial works as necessary. Secondary defects are likely to occur if left unmanaged.

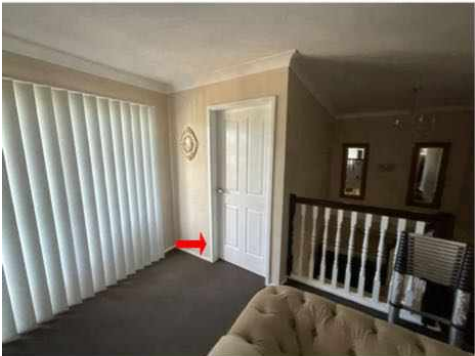
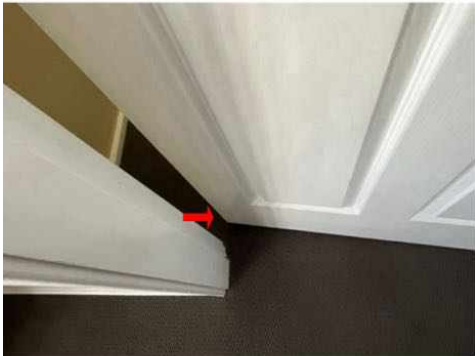
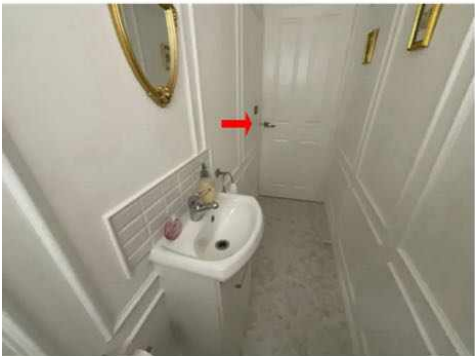
### Finding 3.04

Building:	Building 1
Location:	Many doors
Finding:	Doors - Binding/jamming and one damaged
Information:	Binding and/or jamming of these doors is evident during standard operation. This defect inhibits the functionality of the affected doors as well as creating potential for secondary defects to associated building elements, such as damage to the floor covering or the adjoining door jamb.

A door that binds to flooring or to the associated door frame may have several causes, ranging from minor defects, such as poor installation of the door or deteriorated hinges, through to major structural issues, such as damage to subfloor structures.

Two doors are starting to come apart at joints. One lounge room door needs urgent repair. The left front door and the laundry door may need repair/ replacement in the next 1-2 years.

For these apparent minor causes, a qualified carpenter should be appointed to perform minor rectification works at client discretion.

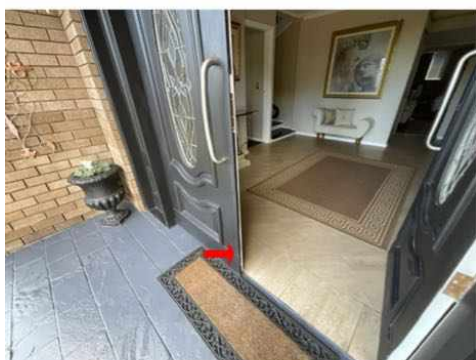
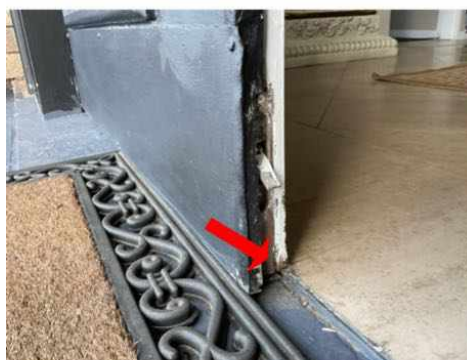
Finding 3.05

Building: Building 1  
 Location: Entry  
 Finding: Lock - Loose  
 Information: The fitting in this left door area is loose and requires adjustment to tighten. This is stopping the left door from opening.

If left unmanaged, the fitting may further deteriorate, causing potential for the development of other minor secondary defects.

A carpenter should be appointed to perform these rectification works at discretion of the client.

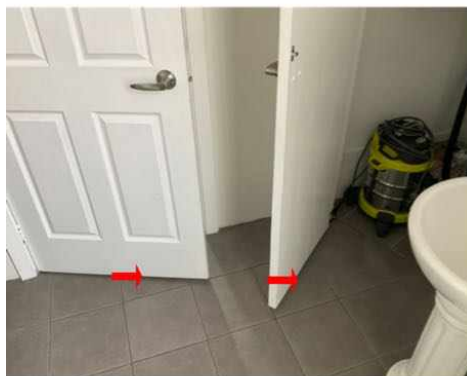
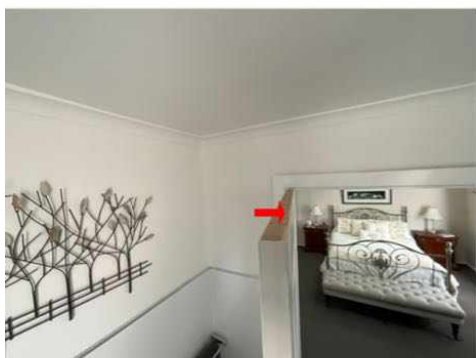
### Finding 3.06

Building: Building 1  
 Location: Wet areas  
 Finding: Paint finish on doors - Incomplete  
 Information: The paint finish on the wet area doors was identified as being incomplete at the time of inspection.

NSW Guide to Standards and Tolerances 9.6 states that “door leaves are defective if they do not have all sides, top and bottom edges sealed/painted

Whilst incomplete or missing paint finish is generally an appearance defect, it can also lead to the development of secondary building defects over time. Incomplete areas of paint finish expose the area to moisture, potentially accelerating the deterioration of underlying building materials.

Incomplete paint finishes should be sanded back, filled, leveled and painted, as applicable. Where inadequate or missing paint protection has led to the deterioration of the associated building element, repair and/or replacement of this building element may be required.

A painting contractor should be appointed as soon as possible to perform necessary works to aid the appearance of the affected area and to ensure the area is protected against further deterioration. Alternatively, the homeowner following manufacturer instructions may perform these works.

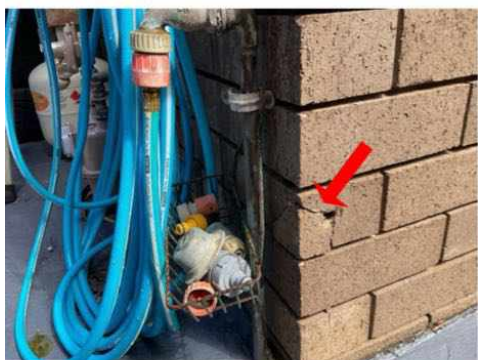
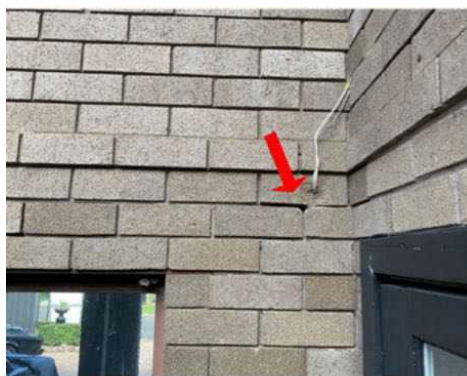
### Finding 3.07

Building: Building 1  
 Location: Pictured external areas  
 Finding: Building elements - Damaged  
 Information: Evidence of minor missing or damaged areas was identified at the time of the inspection. These include -

1. Some damaged bricks in the rear walls and small damaged areas of mortar was found in other areas not yet affecting these walls but require annual monitoring.
2. One cracked tile was found above the laundry tub.

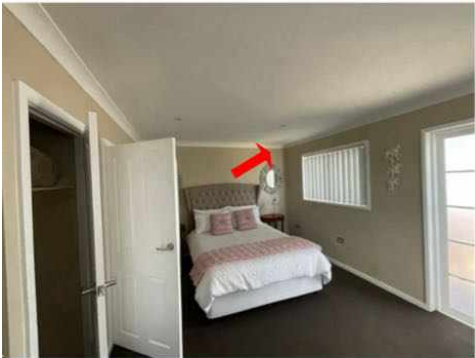
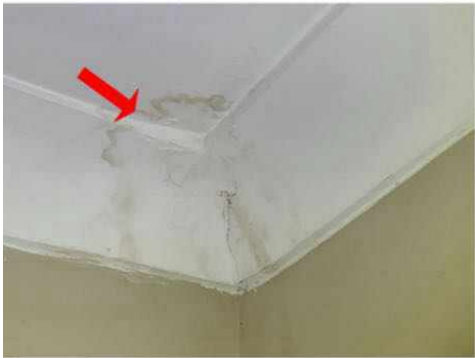
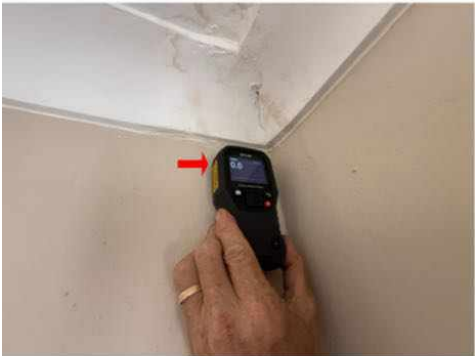
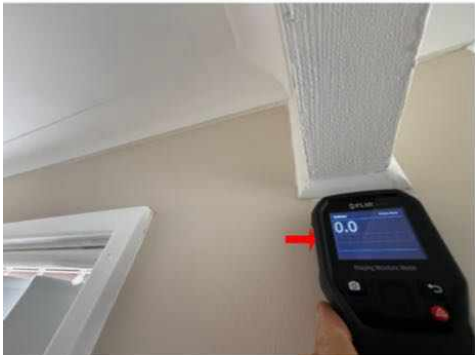
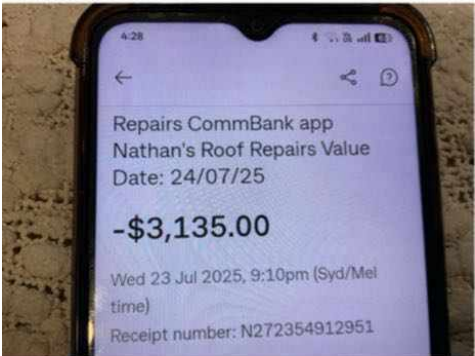
### Finding 3.08

Building: Building 1  
 Location: East bedroom and foyer  
 Finding: Ceilings - Water stained  
 Information: Water staining to ceiling linings in these 2 areas was evident at the time of inspection. Water staining indicates that surfaces have been exposed to excessive moisture over time. The minerals and other elements in the water lead to staining, which may graduate to corrosion and deterioration if left unmanaged.

While mostly an appearance defect, water staining can be indicative of more serious defects, which may be currently concealed by interior ceilings.

The owner advised the gutters were leaking last year and had them replaced in 2025. See attached receipt.

No moisture has found in these areas after 10 readings were taken.

Where water staining is active, a licensed plumber must be consulted to identify the cause of the staining and to provide advice on any reparation works that may be required. Replacement of any damaged structures is advised.

Conversely, where water staining appears to be inactive, affected building materials may be repaired or replaced at client discretion.

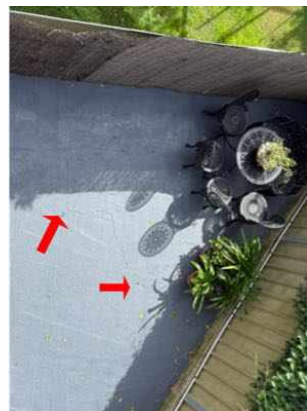
### Finding 3.09

Building:	Building 1
Location:	Yard - front and back
Finding:	Crack in concrete slabs - Category 1
Information:	Small cracks coded as Category 1 was identified in the property slabs. A Category 1 crack is described as a fine but noticeable crack, with the slab at an otherwise reasonable level. To be considered Category 1, the approximate width of the crack is less than 1.0mm, or a less than 10mm change in offset when a 3m straight edge is placed over the defect.

Category 1 cracks should be monitored for a period of 12 months. At the end of the monitoring period, identified cracks that are rated greater than Category 2 are considered defects, and require rectification.

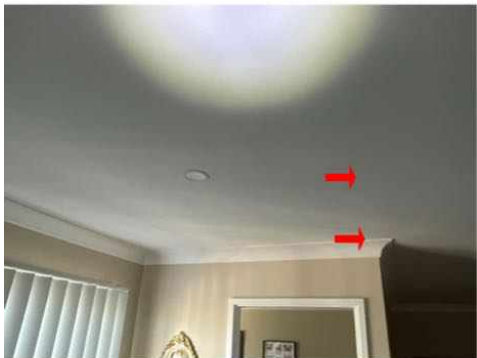
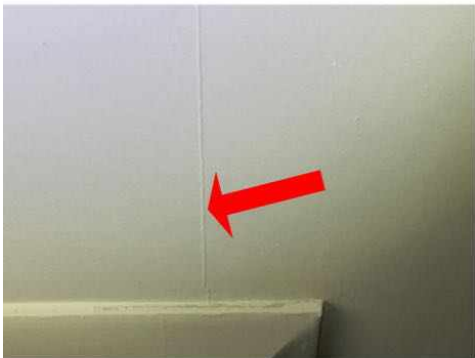
### Finding 3.10

Building:	Building 1
Location:	Lounge Room & bedroom - upstairs
Finding:	Cracking - Damage Category 0 - Hairline (less than 1mm)
Information:	Hairline cracks are very minor in nature and generally are only ever an appearance defect. While such cracking may be noticeable in some cases, it is quite common and does not indicate any structural damage.

Cracking of this nature can generally be repaired with minor sanding, filling and/or repainting. Such works should be performed by a qualified painter or a general handyman.

Monitoring of all cracking should be conducted frequently. Always contact a building inspector should cracks widen, lengthen, or become more numerous.

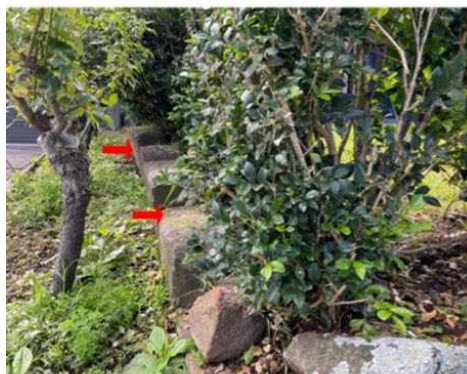
### Finding 3.12

Building:	Building 1
Location:	Yard - front
Finding:	Render (external) cracking.
Information:	It has been observed that cracking to some external rendered surfaces. The degree of damage is described as "slight" noticeable cracks which are easily filled. Cracking of this size are generally less than 5mm in width.

Always contact your building inspector should cracks widen, lengthen, or become more numerous.

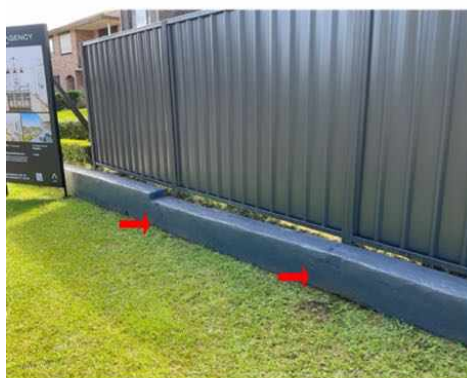
### Finding 3.13

Building:	Building 1
Location:	Exterior front left wall
Finding:	Step cracking to brickwork (minor under 1mm)
Information:	Step cracking was identified to the brickwork in this area at the time of inspection. Step cracking, which is similar to other forms of cracking, has a variety of possible causes. However, the most common is the subsidence of adjacent footings.

Step cracking is a relatively common defect, and is most likely to occur adjacent to windows, doors and other openings. Mortar failure in the gaps between affected

bricks indicates the stresses and tensions affecting the wall.

Where step cracking is extensive or severe, the client is advised to consult a structural engineer. This very minor step cracking can be used as a warning sign to address factors causing stress to the wall, which can include the effect of surrounding trees, water leaks, soil erosion, or even the presence of reactive soils in the surrounding area.

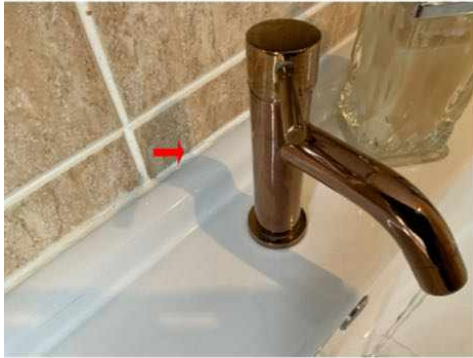
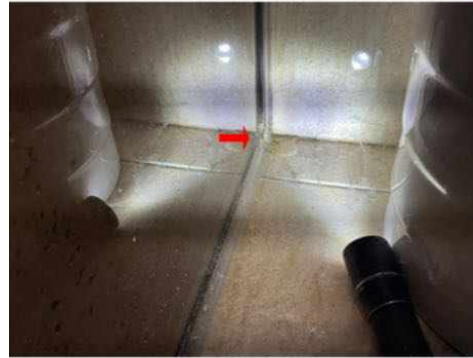
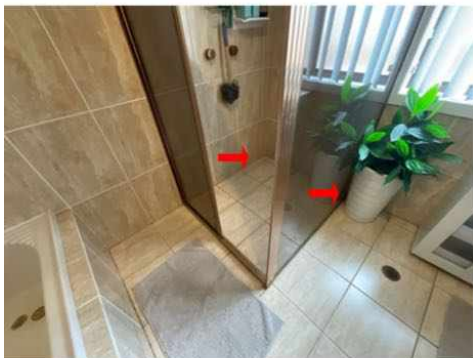
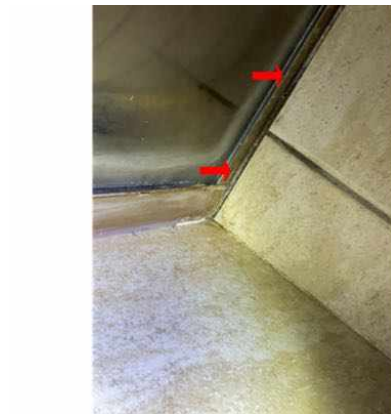
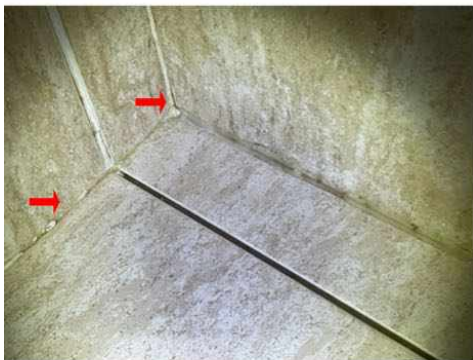
### Finding 3.18

Building:	Building 1
Location:	Bathroom areas
Finding:	Sealant and grouting - Missing or damaged
Information:	It was noted on inspection that sealant or grout is degraded to the tiled shower alcove and or other areas of the bathroom.

Different materials and floor areas move at different rates, generally causing cracking to grout or sealant at this point. A flexible sealant is required to allow for expected expansion and contraction, while keeping the joint water tight and protective of all associated building materials.

There appears to be excessive mould to the sealant and grout which will likely require scraping out and replacement.

Flexible and mould resistant materials should be applied to affected areas to prevent any subsequent water damage that is likely to occur. Regular maintenance and replacement of damage or missing or damaged sealant and grout is highly recommended to the wet areas, as this is a regular wear and tear defect. Sealant and grouting in areas that come into regular contact with water should be maintained for the long term care of your property.

A sealant specialist or tiling contractor should be appointed to complete these works

as soon as possible

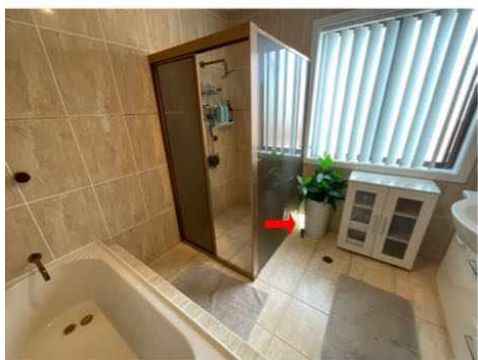
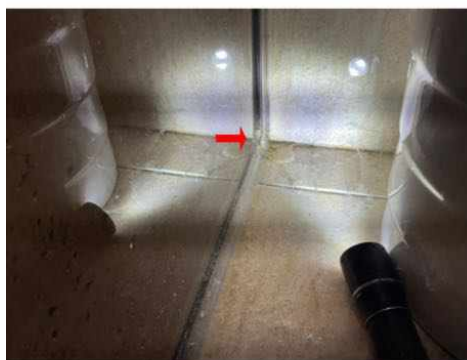
### Finding 3.19

Building:	Building 1
Location:	Bathrooms
Finding:	Shower screen - Leaking
Information:	Leaking was evident to the shower screening at the time of inspection. It is suspected that the leaking has occurred as a result missing sealant. Leaking from the shower , where left unattended, is likely to lead to water damage to adjoining flooring and walls. Such damage can lead to water damage and necessitate extensive remedial works being required. Active water leaks may also create an environment that is susceptible

to the formation and development of mould.

Appointment of a sealant expert is required to repair or replace this missing sealant. Such works should be performed as soon as possible to ensure that no further damage occurs.

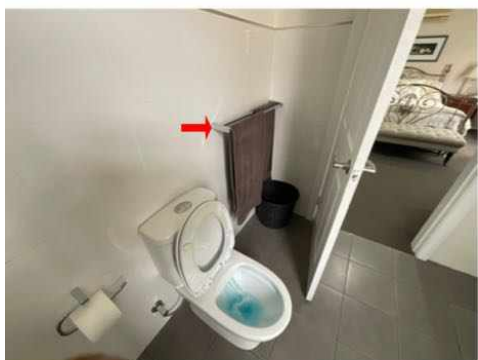
### Finding 3.20

Building:	Building 1
Location:	Bathroom
Finding:	Towel rail loose
Information:	The towel rail was found to be loose at the time of inspection. While not a major operational defect, function can deteriorate if the problem is left unmanaged.

It is advised that the homeowner performs remedial works to re-attach the towel rail to its original fixing. A general handyperson may be required to perform these works.

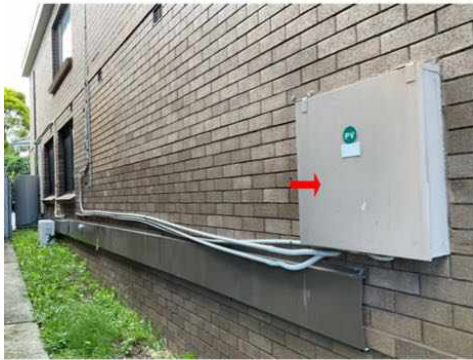
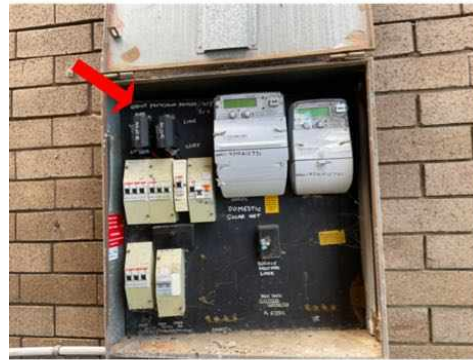
Building:	Building 1
Location:	Meter Box
Finding:	Termite Management System - no evidence of a chemical installation
Information:	The application of a post-construction chemical termite barrier is highly recommended for all properties. Such barriers are highly effective in preventing termite attack on any timber building elements throughout the property.

The client may consider gaining further advice from a pest controller as to the costs and procedures involved with a 'chemical' application. It is recommended that

obtaining such advice be a short-term priority.

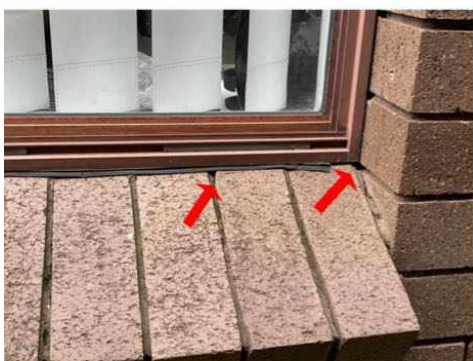
### Finding 6.02

Finding: Sealant (external) - missing and attractive to termites

Information: It was noted on inspection that areas of external sealant was missing to small areas of the external walls. A flexible sealant or flashing is required to protect the associated building materials from rainwater ingress. Any moisture ingress into the property is very attractive to termites. Flexible sealants or flashing should be applied to these affected areas to prevent termite activity.

A sealant specialist or skilled handy person should be appointed to complete these works as soon as possible.

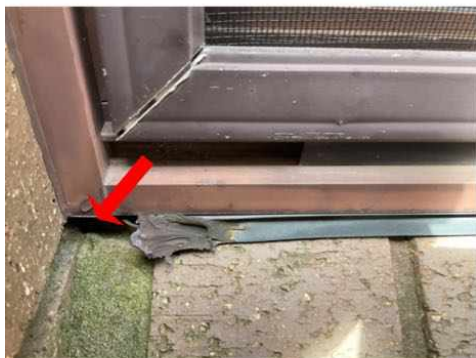
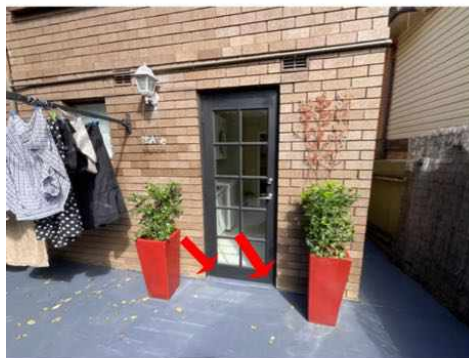
Building:	Building 1
Location:	Exterior walls
Finding:	Slab Edge - Exposure
Information:	An inspection zone of at least 75mm in relation to the exposed slab edge, between the bottom brick and the perimeter pavement, is required. This inspection zone should be maintained in order to force termites into the open where they can be detected more readily during regular inspections. The slab edge should not be concealed by anything that may prevent inspection of the area, including render, landscaping, soil, turf, paving, concrete cladding or other structures.

If the slab edge is not properly exposed there is a high risk of termite attack. Sometimes, in order to determine the type of slab, a suitably qualified person such as an architect or builder may be required to consult the construction plans.

Where the slab edge cannot be properly inspected, it is highly recommended that termite or timber pest inspections be carried out every 6-12 months to aid protection of the property against infestation.

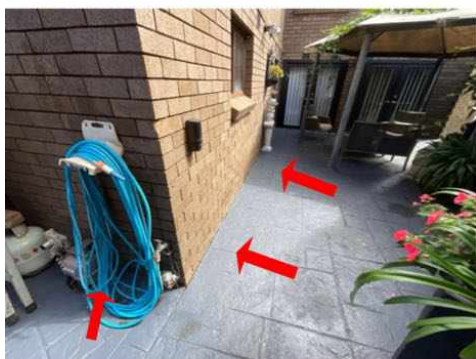
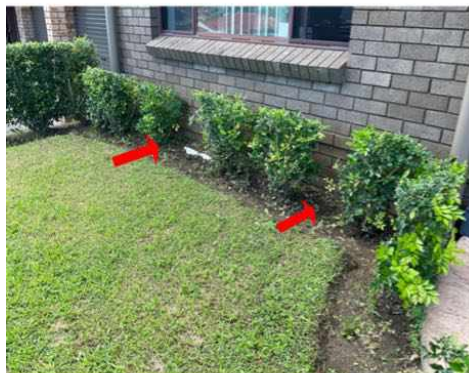
### Finding 6.04

Finding: Timber in contact with the ground  
 Information: Any timbers in direct ground contact provide opportunity for concealed termite entry and are likely to be subject to premature rot and decay as the soil retains moisture or damp conditions against the timbers.

Removal of all waste timber that is in direct contact with ground is highly advised. This timber is promoting mould and wood rot and is very attractive to termites.

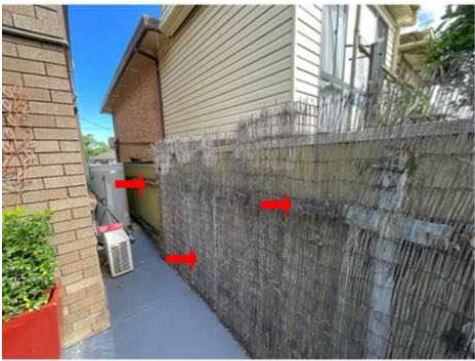
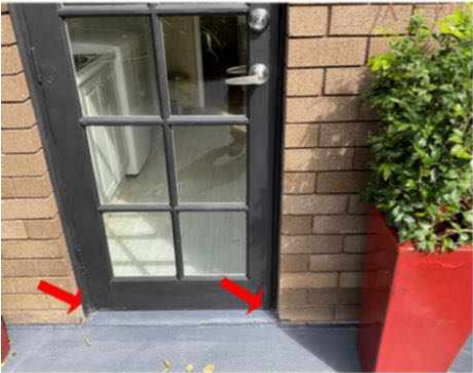
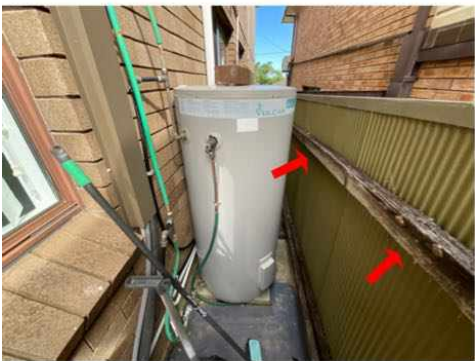
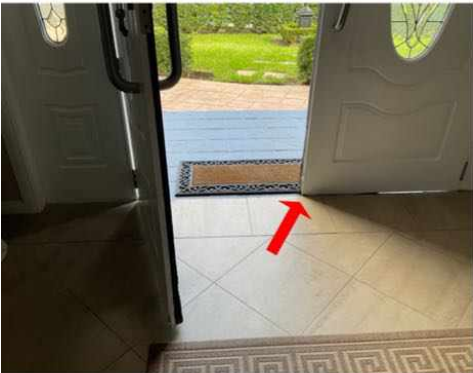
Building: Building 1  
 Location: Pictured areas  
 Finding: Fungal decay - present (localised)  
 Information: Fungal decay also known as wood decay or wood rot generally refers to the deterioration of timber elements when in contact with excessive levels of moisture for a prolonged period of time.

The development of fungal decay is accelerated by temperatures from 5degreeC to 40degreeC as well as the presence of oxygen. Generally fungal decay develops on timber elements that are in use in an external environment which are exposed to rain penetration.

In this case, the affected timber element is in a decaying state and will need replacement by a carpenter or licensed builder.

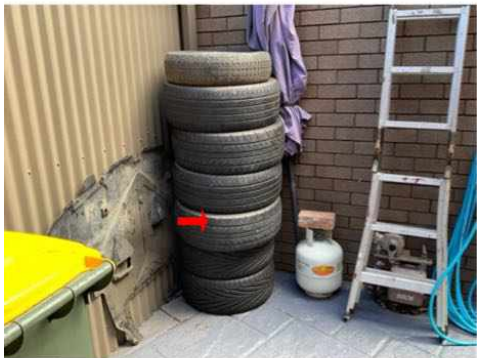
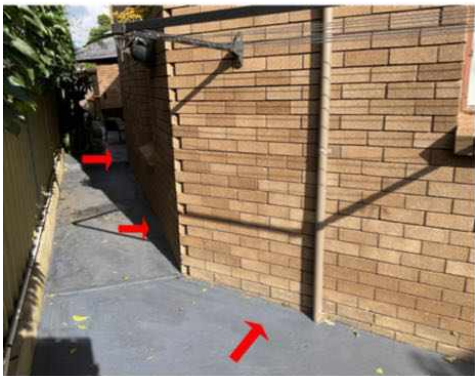
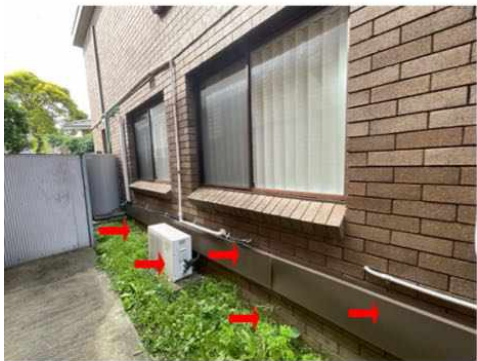
Building: Building 1  
 Location: All External Areas  
 Finding: Additional Photos - Obstructions and Limitations of EXTERNAL AREAS  
 Information: These photographs are an indication of the obstructions and limitations which impeded full inspection of external areas at the time of inspection. These obstructions can hide an array of defects and should be removed to allow full inspection to be carried out. A re-inspection is recommended once the areas are made accessible.

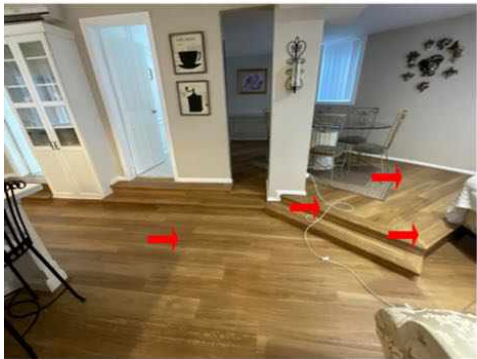
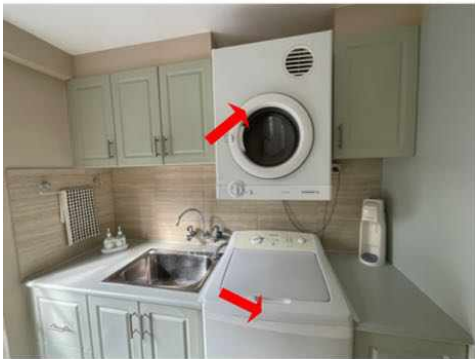
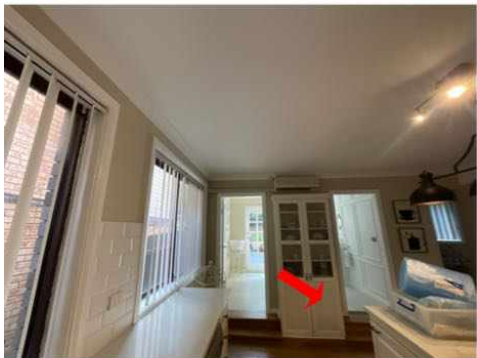
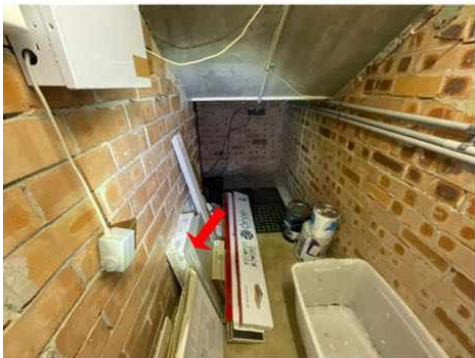
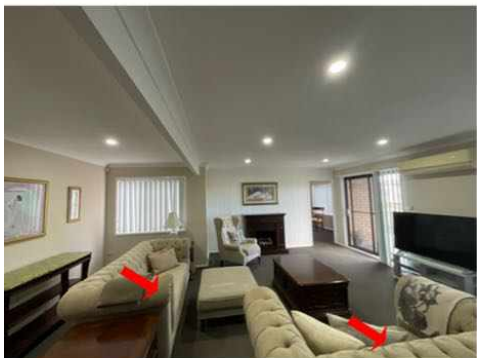
Building: Building 1  
Location: All Internal Areas  
Finding: Additional Photos - Obstructions and Limitations of INTERNAL AREAS  
Information: These photographs are an indication of the obstructions and limitations which impeded full inspection of Internal areas at the time of inspection. These obstructions can hide an array of defects and should be removed to allow full inspection to be carried out. A re-inspection is recommended once the areas are made accessible.

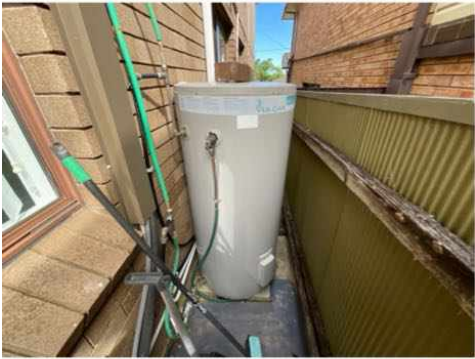
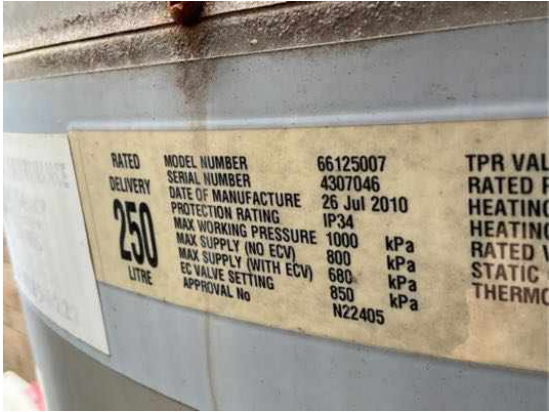
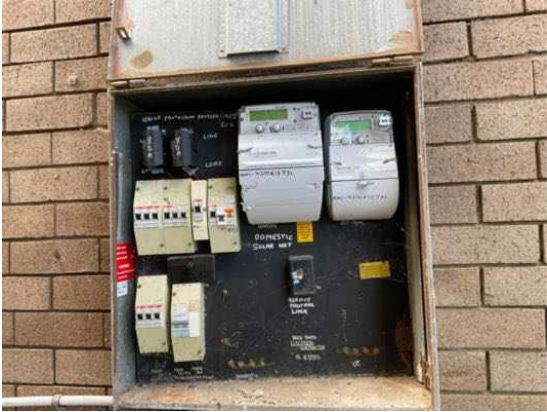
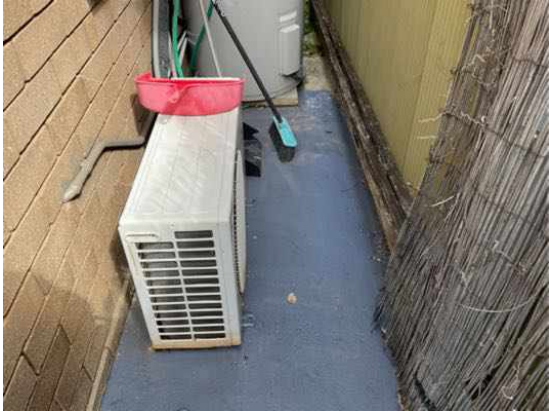
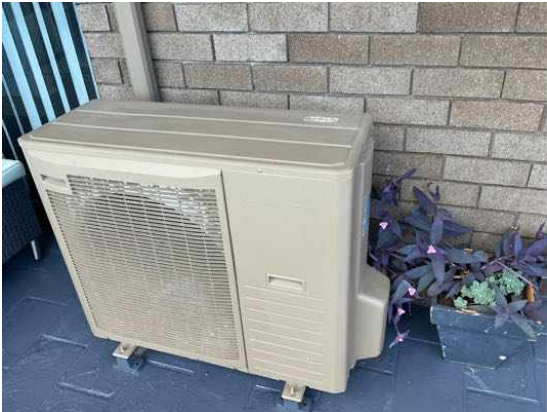
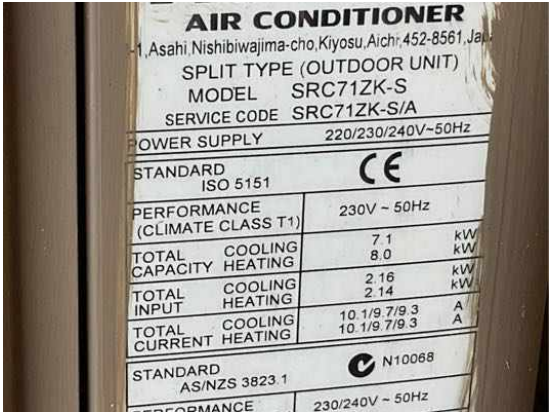
Building: Building 1  
Location: All External Areas  
Finding: Additional Photos  
Information: Additional photos are provided for your general reference

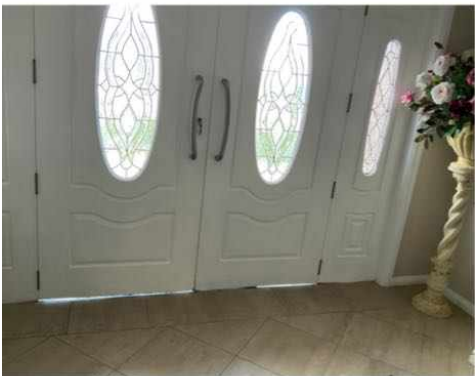
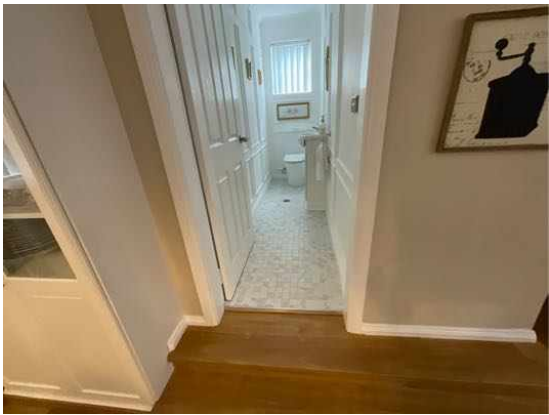
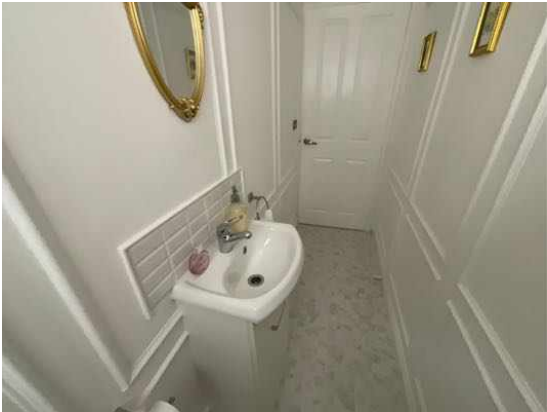
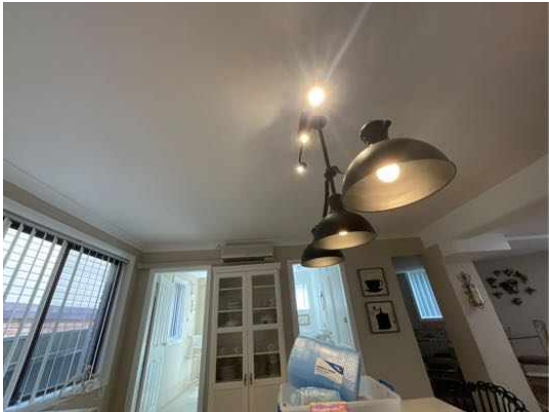
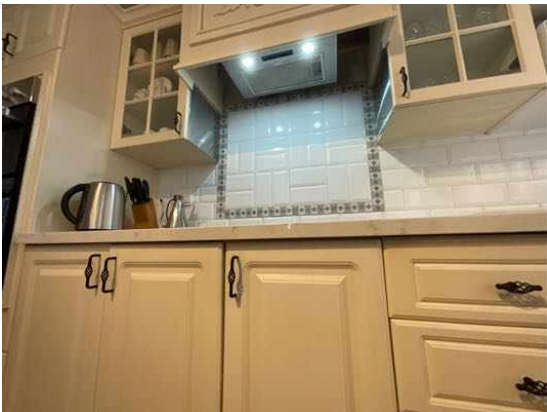
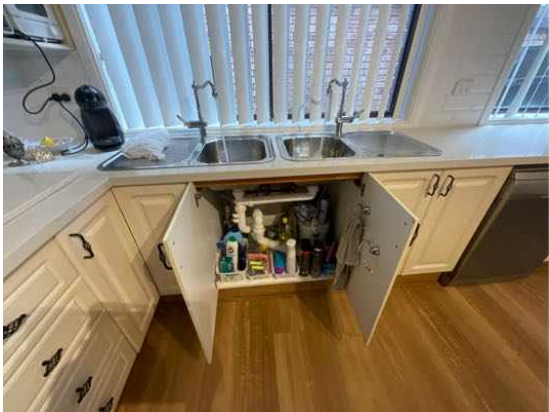
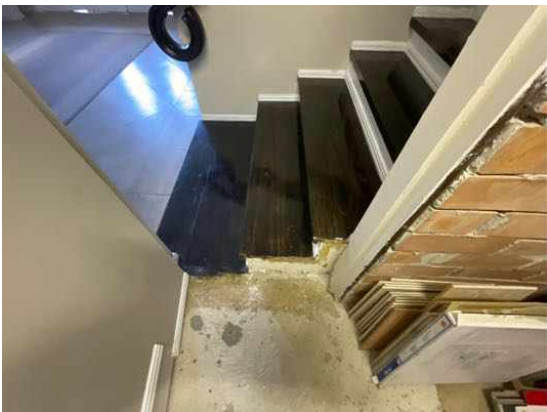
Building: Building 1  
 Location: All Internal Areas  
 Finding: Additional Photos  
 Information: Additional photos are provided for your general reference

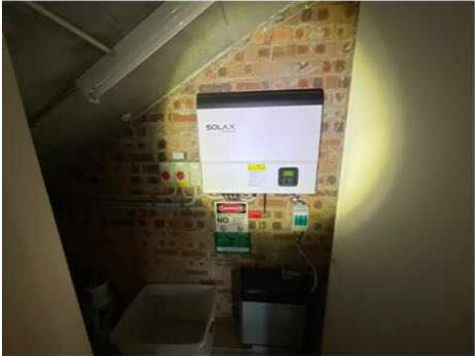
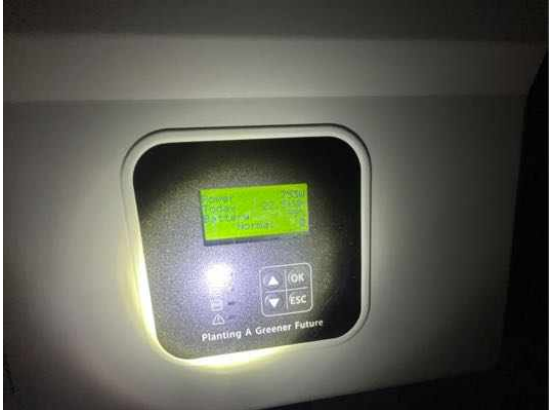
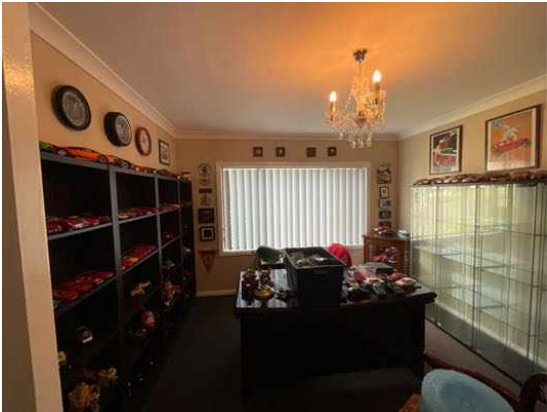
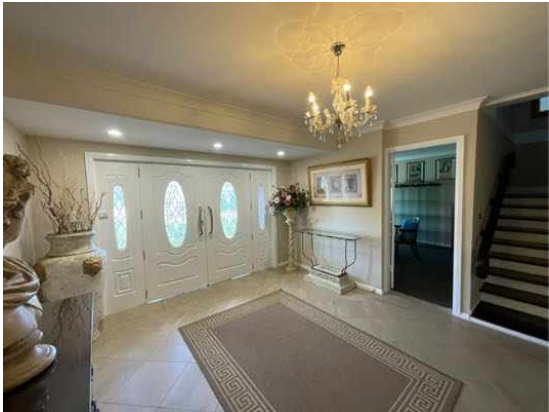
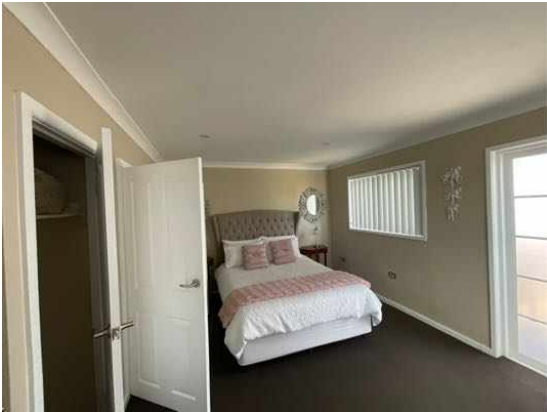
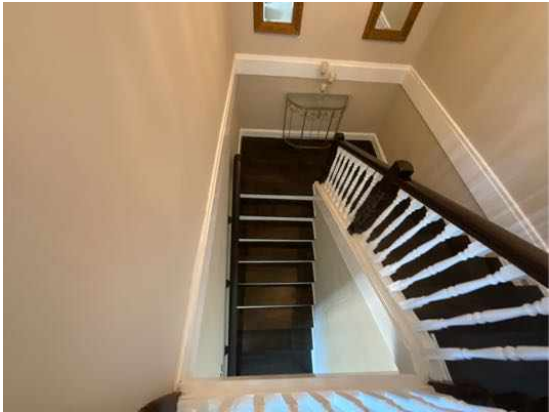
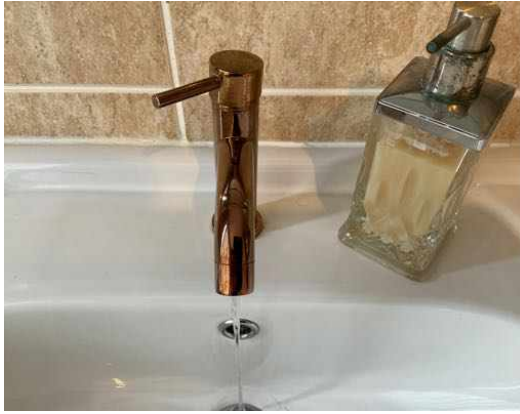
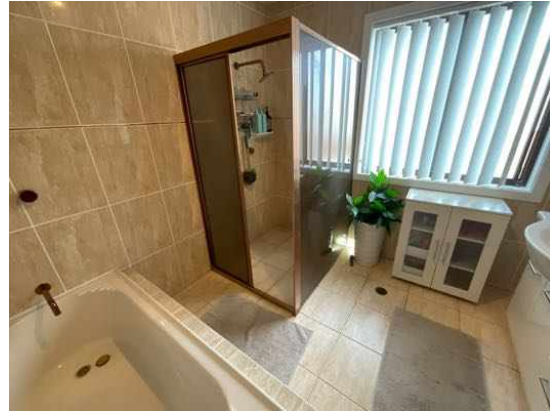
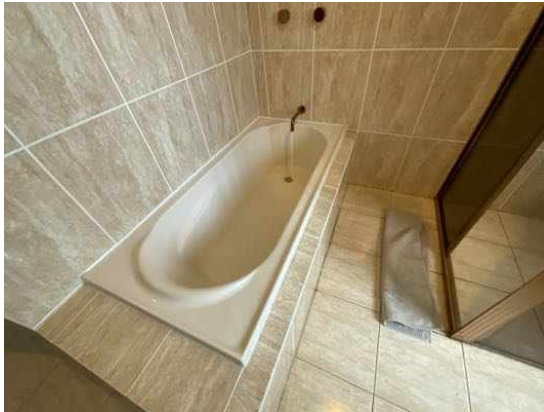
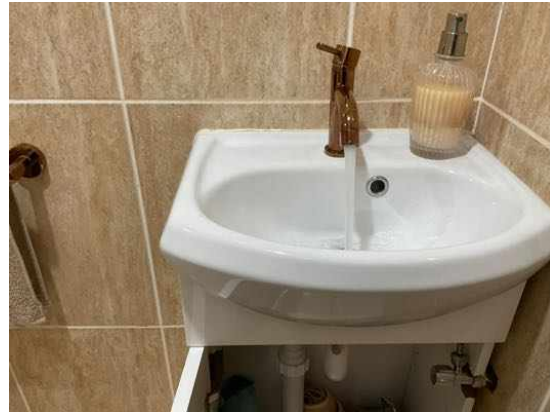
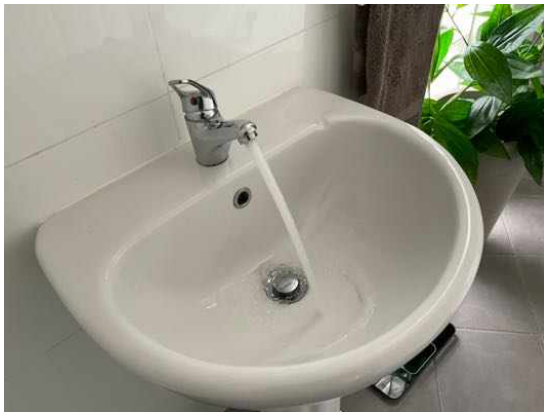
Building: Building 1  
Location: All Internal Areas  
Finding: Additional Photos  
Information: Additional photos are provided for your general reference

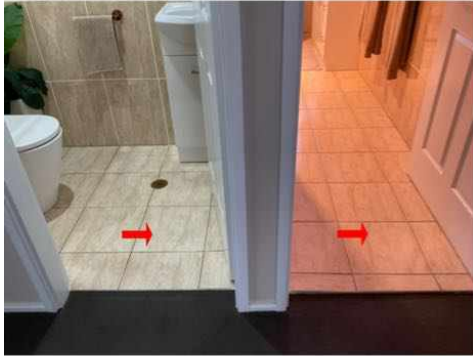
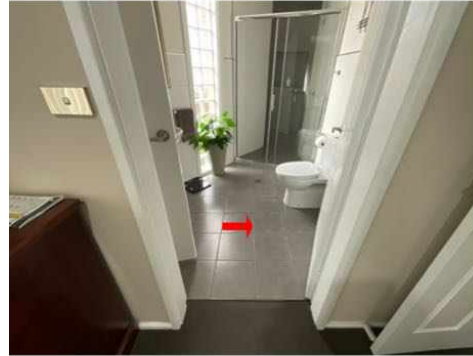
Building: Building 1  
Location: Bathrooms and laundry  
Finding: Waterproofing membranes - Information Only  
Information: Internal Water Proofing Membranes, are crucial in preventing water ingress into the property is important to know that the Membrane System used is to Australian Standards and has been installed correctly.

With older property's where this information is unavailable all wet areas should be monitored. If any leaks, water staining, peeling or bubbling of the paint become evident to any adjacent walls or ceilings below a licensed builder or waterproofing specialist is recommended to investigate further.
