## Building Inspection Report

Inspection Date: Wed, 25 Feb 2026

Property Address: 38 Stanton St, Doncaster VIC 3108,  
Australia

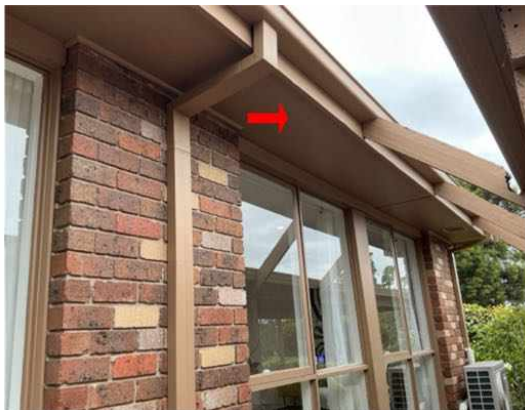
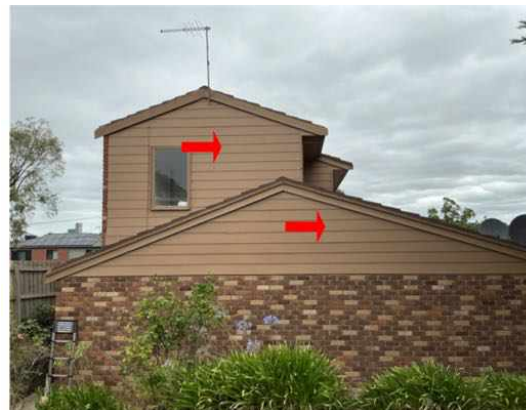
#### Defects 1.01

Building:	Main Building
Location:	Eaves and cladding
Finding:	Asbestos - Suspected ACM Identified on Site
Information:	Reporting on Asbestos is outside the Scope of this Report. This suspected defect is highlighted as a caution only. We suspect, based on our experience in the building industry, that there is a higher risk of the identified building element containing asbestos.

As Asbestos Reporting is outside the scope of this report, we advise that you consider a separate Asbestos Inspection and Condition Audit, which can include the taking of samples for definitive confirmation of the presence of Asbestos.

In the interim, the client is advised to act with caution, especially when considering any damage to building materials general wear and tear renovations extensions demolition and general maintenance activities due to the suspected presence of Asbestos.

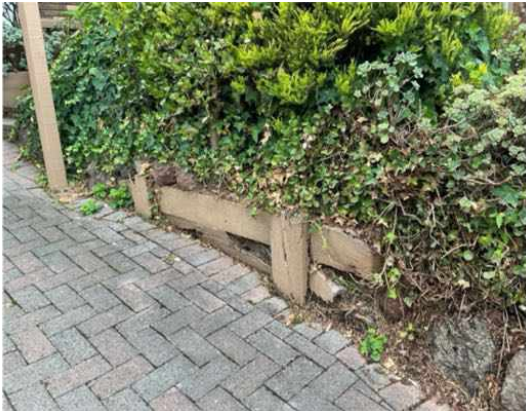
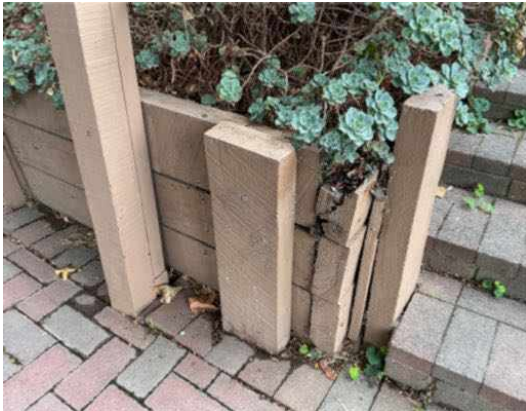
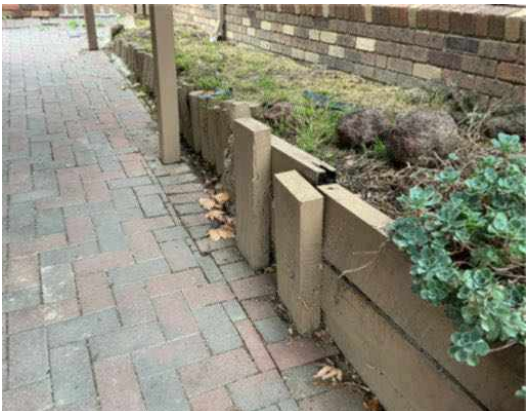
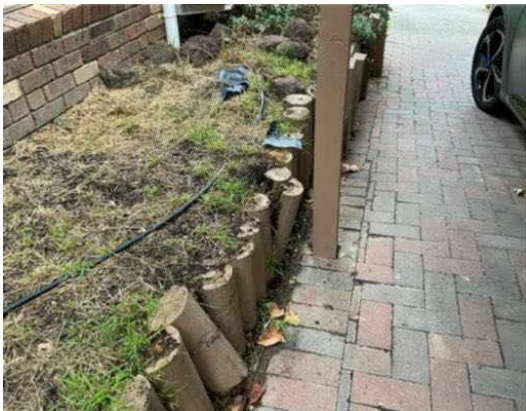
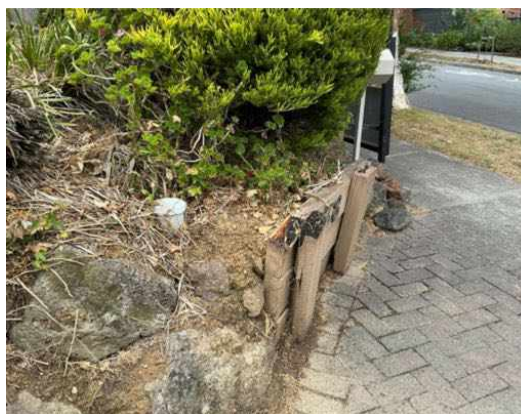
**Defects 3.01**

Building: Main Building  
Location: All Areas  
Finding: Retaining wall - Defective  
Information: The retaining wall in this are was found to be defective at the time of inspection. Generally, defective retaining walls are caused by poor original design or material use. However, deteriorated retaining walls may also be a result of substandard construction, poor site drainage or unmanaged stormwater flows.

If left unmanaged, the retaining wall may become a safety hazard if it continues to destabilise. Where retaining walls further rot and decay, an environment is created that is conducive to termite and pest infestation.

Significant repair and replacement should be expected. Where retaining walls are considered structural walls, a structural engineer / surveyor should be consulted regarding required remedial works. Otherwise, a landscaper or retaining wall installer may be appointed to repair or replace the wall, at the discretion of the client.

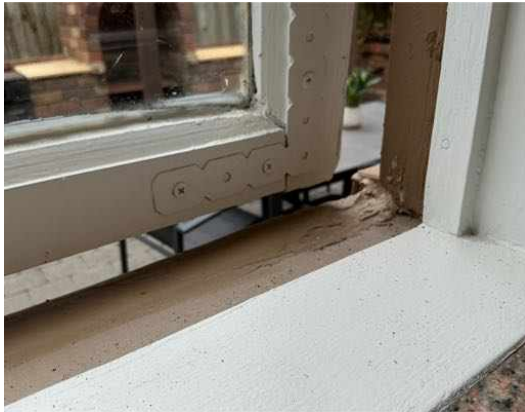
### Defects 3.02

Building:	Main Building
Location:	Windows and external doors
Finding:	Windows - Wood rot most windows
Information:	Wood rot was found to be affecting external windows. Wood rot, also known as Fungal Decay, occurs when timbers and other cellulose building materials are exposed to damp conditions on an ongoing basis.

It is likely that this wood rot has developed as a result of frequent exposure to rain and other weather conditions. It is suspected that failure to maintain the window frames over a prolonged period has resulted in them deteriorating at an accelerated rate, increasing their susceptibility to the development of wood rot. Leaks in roof plumbing or associated pipework may have also contributed to the formation of the wood rot in this area.

Early intervention and regular maintenance will prolong the useful life of these building elements. Prior to any works being performed, any associated pipework or roof plumbing should be inspected by a licensed plumber for faults or leaks.

Repair and/or replacement of affected window frames may be a necessary step in protecting surrounding building elements from such deterioration. Remedial works should be performed by a qualified carpenter or registered builder as soon as possible to prevent any further damage.

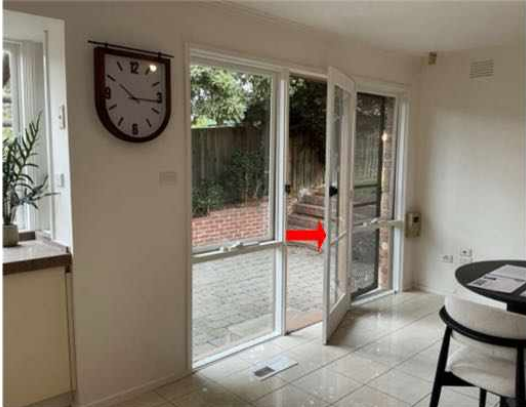
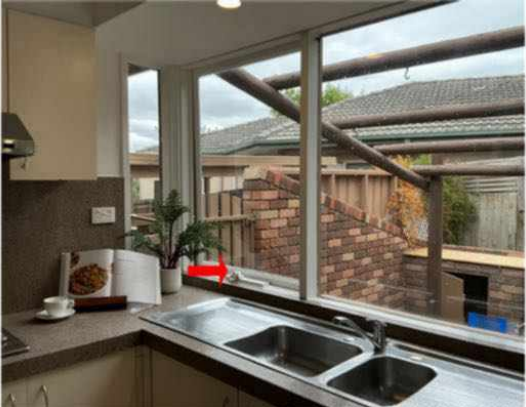
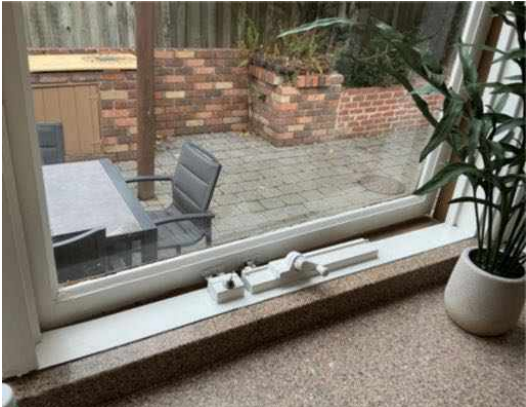
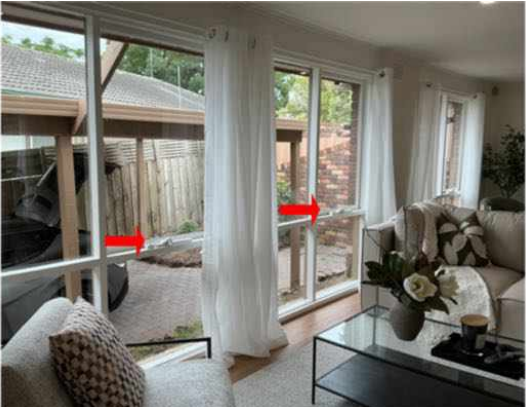
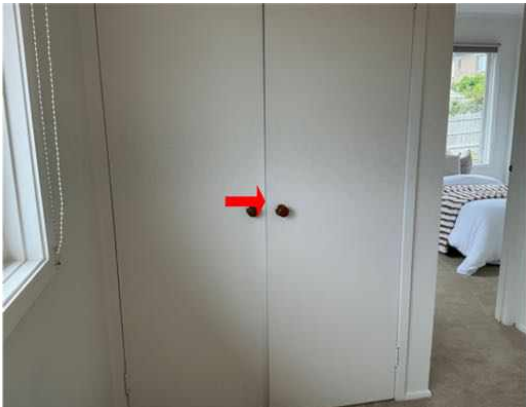
### Defects 3.03

Building:	Main Building
Location:	All Areas
Finding:	Sticking or jamming
Information:	Building elements which are sticking or jamming are difficult to operate and don't function as intended. There are a variety of causes for sticking and jamming.

The most usual causes are swelling of timbers due to moisture, bulging or bowing of metal frames, or general material deterioration. Generally, sticking and jamming building elements indicate that their frames are uneven or out of level, generally as result of movement to surrounding walls and floors.

Easement will be required, which usually depends on the building materials used. This may involve some sanding and/or application of a lubricant. It will almost always include ensuring the areas are cleaned and free of any debris that may be detrimental to their operational state.

Appointment of a carpenter or general handyman is recommended to rectify any sticking/jamming building elements.

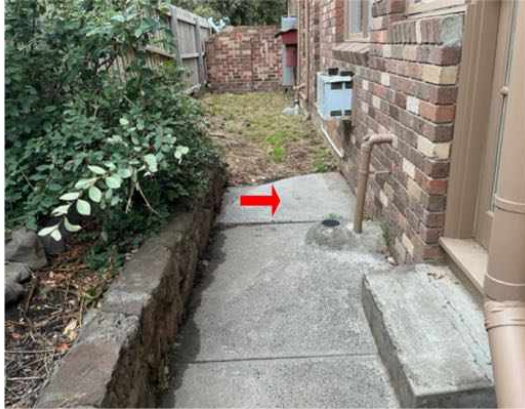
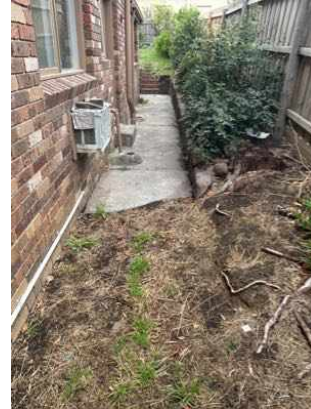
### Defects 3.07

Building:	Main Building
Location:	Exterior walls - right side
Finding:	Perimeter Paving - Insufficient Fall
Information:	The perimeter paving or ground levels were found to have an inadequate slope away from the adjoining building structure, creating potential for water pooling in this area.

metre and bare ground should fall away from the house by 50mm in the first meter. This standard ensures that excessive moisture does not pool around the base of building structures, which creates potential for water and structural damage, as well as making the area susceptible to termite and timber pest activity.

Where paving or ground levels do not have adequate fall, a licensed paving contractor should be appointed to install or remove and re-level pavement.

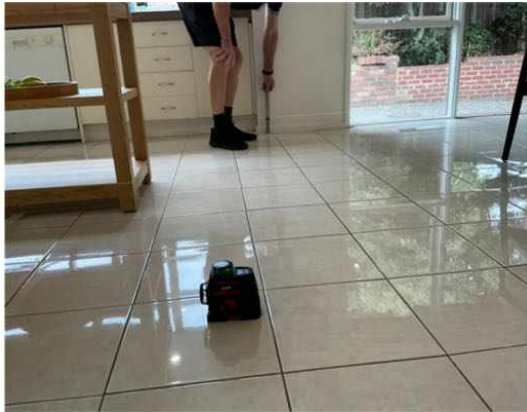
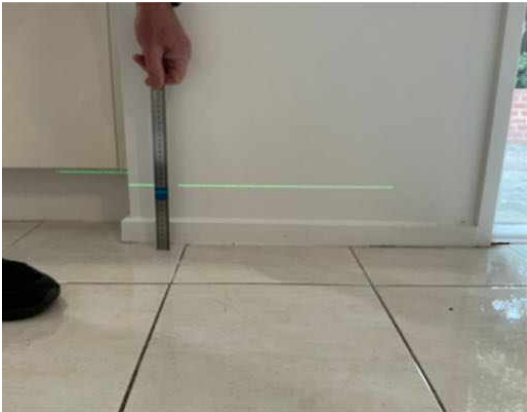
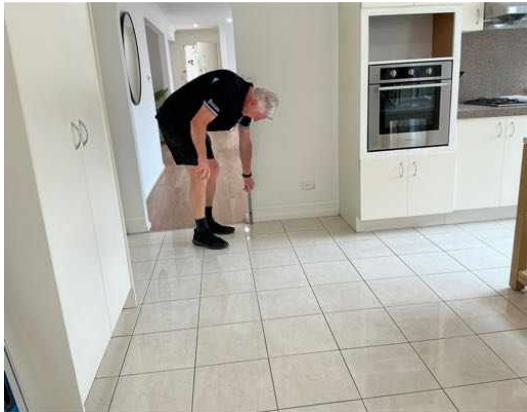
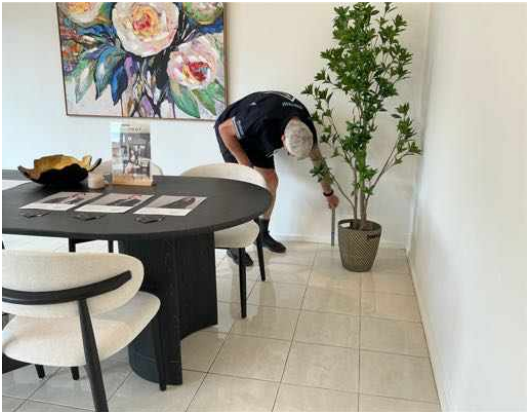
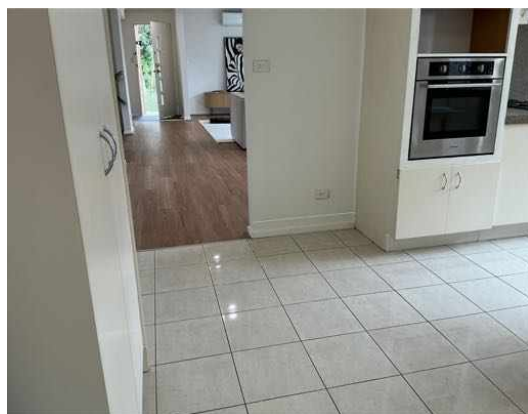
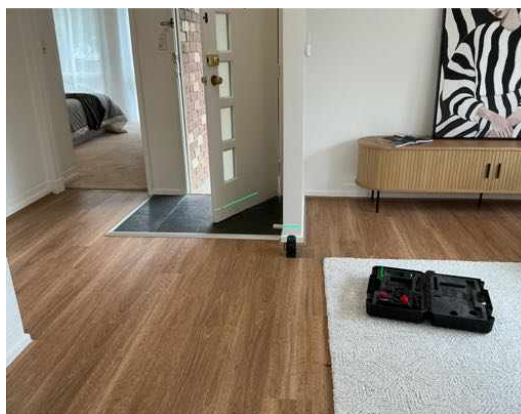
**Defects 3.09**

Building: Main Building  
Location: All Areas  
Finding: Additional Photos  
Information: Floor levels were taken and found to be within tolerance

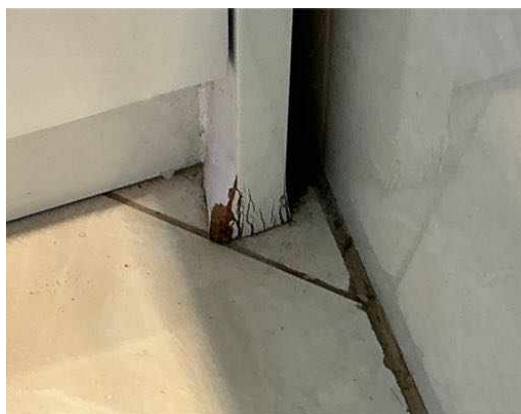
### Defects 3.10

Building:	Main Building
Location:	Bathroom
Finding:	Building element - Swollen
Information:	Swollen building elements generally indicate that the building materials have been affected by excessive moisture over a prolonged period of time, and have swollen as a result. The formation and development of mould/fungi or mildew is also a likely consequence of excessive moisture, which may pose major respiratory issues for occupants, particularly the elderly, the very young and those with existing illnesses and could be potential health safety hazards. In these cases an appropriately qualified inspector/tester should also be contacted for advice and/or technical assistance.

The structural integrity of swollen building elements can not be guaranteed, and further damage is likely to develop if left unmanaged. Excessive moisture is likely to lead to the development of secondary damage to any associated building elements, which may necessitate major reparation works if prolonged.

Rectification of the cause of the water leak should be addressed prior to any remedial works to the swollen building elements. A licensed plumber should be appointed immediately to identify the cause of the leak and provide advice on remedial works as necessary. Repair and/or replacement of swollen building elements should be conducted as a matter of urgency by a registered builder or qualified carpenter.

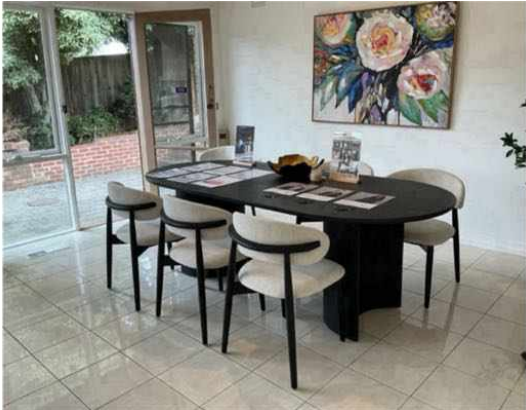
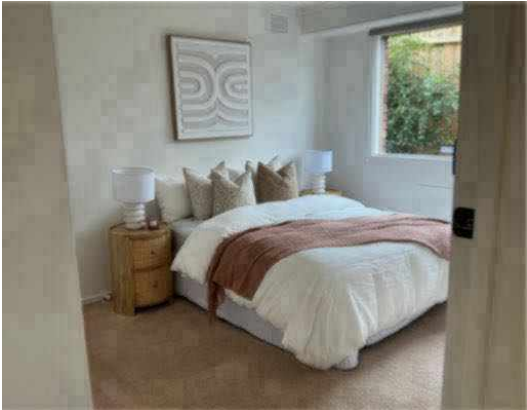
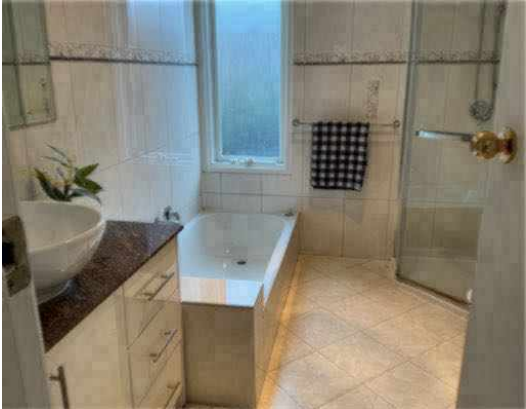
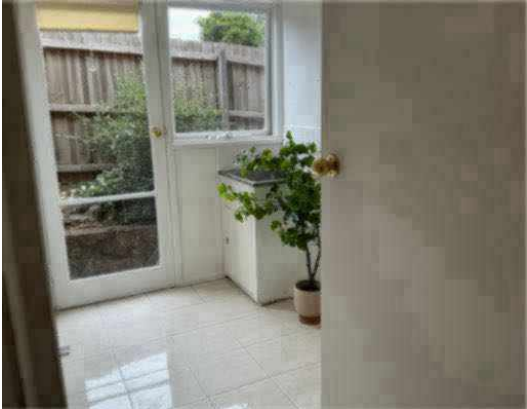
##### Noted Item

Building: Main Building  
Location: All Areas  
Finding: Additional Photos and Obstructions and Limitations  
Information: These are additional photographs and photographs of the obstructions and limitations inside and outside (furniture, landscaping etc) which may impede full inspection of the property at the time of inspection. These obstructions can hide an array of defects and may be removed to allow full inspection to be carried out. A re-inspection may be made if clients require once the areas are made accessible.

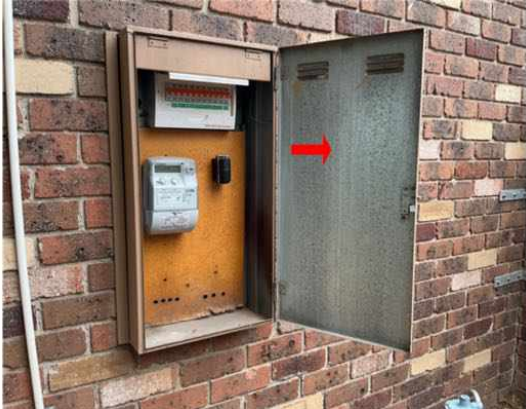
Building: Main Building  
 Location: Electrical Switchboard  
 Finding: Termite Management System - no evidence of a chemical installation  
 Information: The application of a post-construction chemical termite barrier is highly recommended for all properties, particularly if live termite activity has been found on the site previously. Such barriers are highly effective in preventing termite attack on any timber building elements throughout the property.

The client may consider gaining further advice from a pest controller as to the costs and procedures involved with this application. It is recommended that obtaining such advice be a short-term priority.

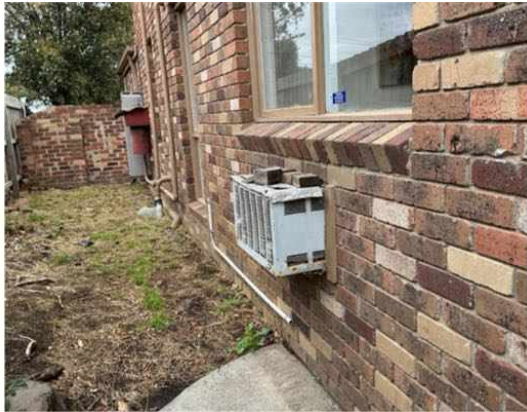
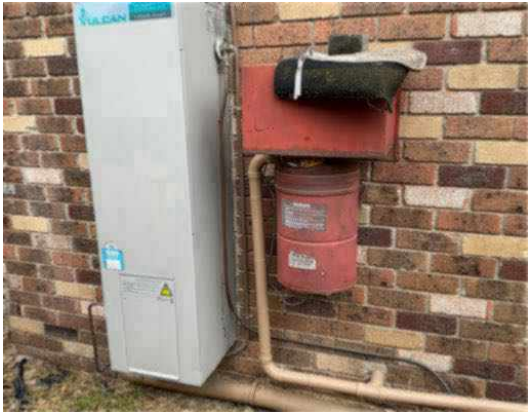
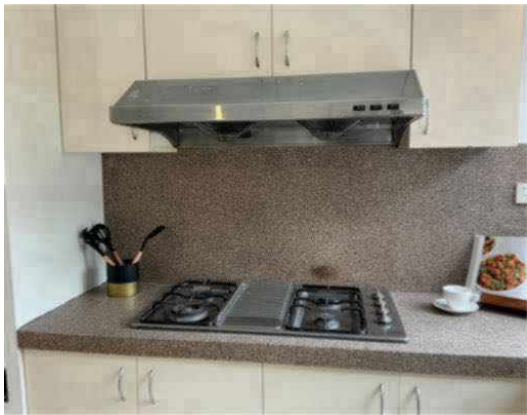
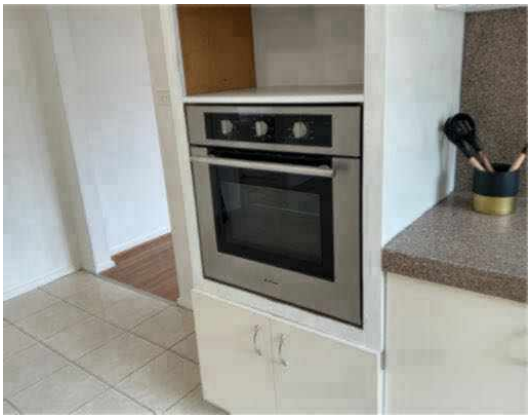
Building: Main Building  
Location: Appliances  
Finding: Warranty - Expired  
Information: Where appliances are beyond their warranty period, the owner should be prepared to meet the cost of replacement or repair of the item at any time. The operation of the appliance can not be guaranteed and further inspection by an appropriately qualified tradesperson may be required.

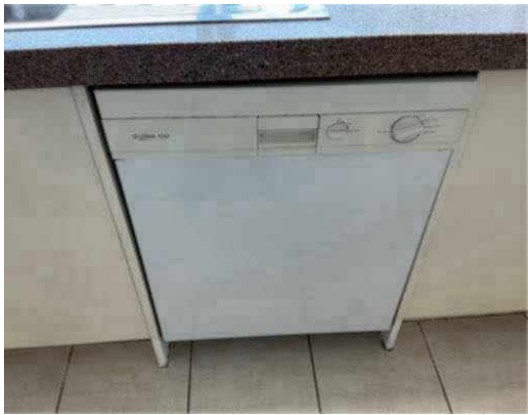
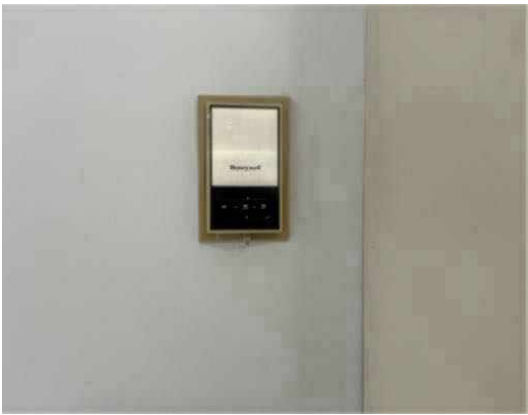
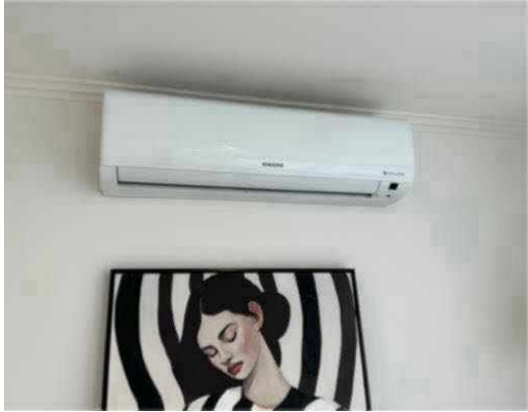
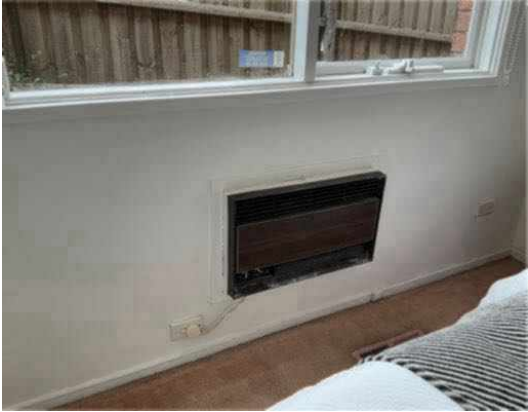
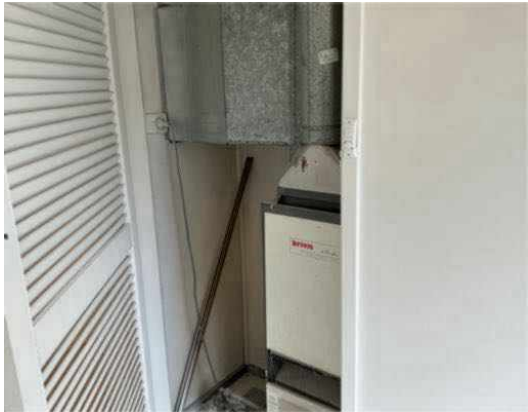
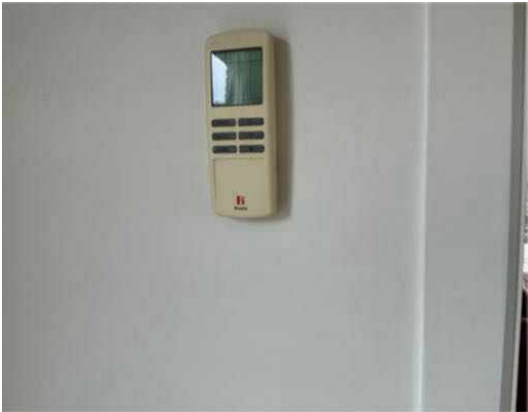
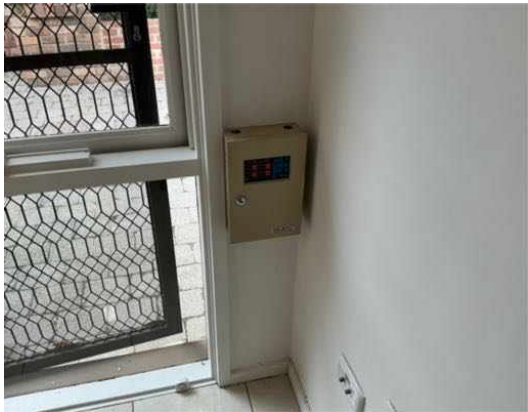
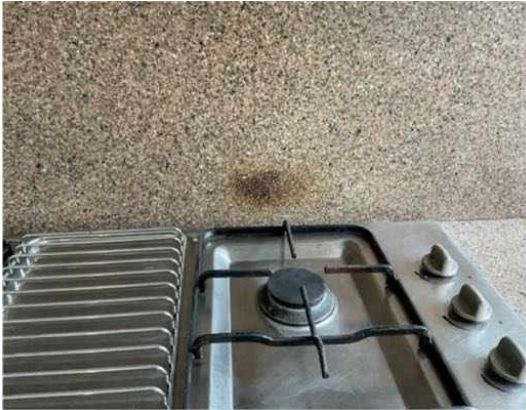
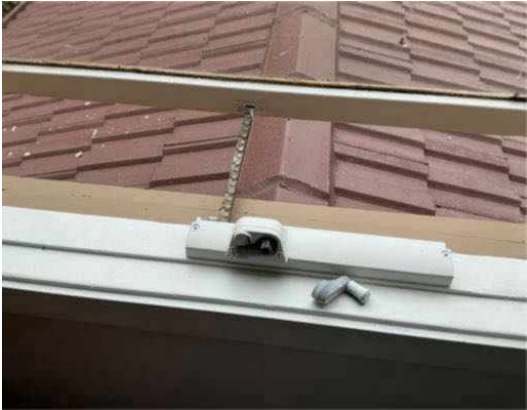
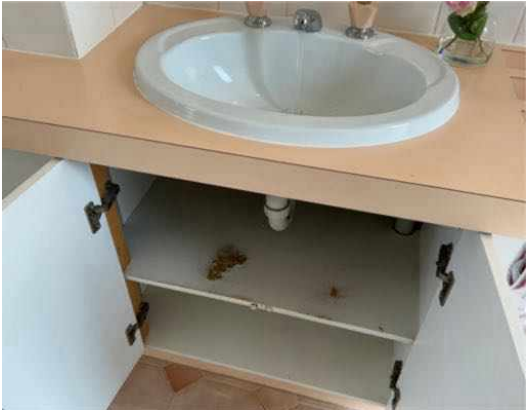
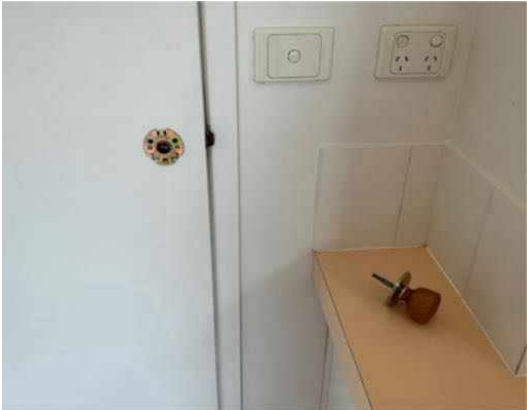
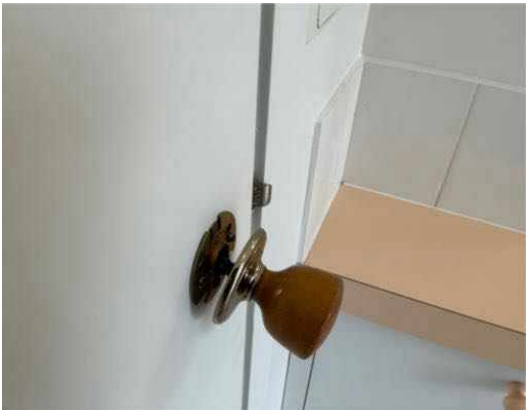
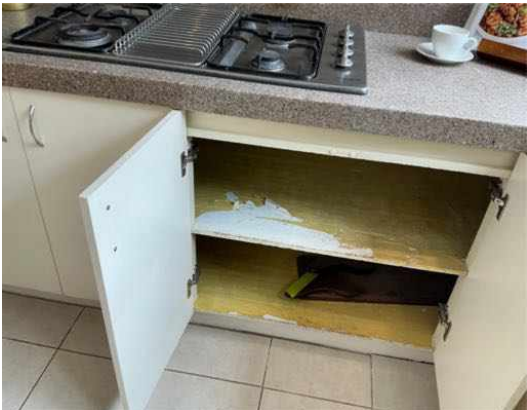
Building: Main Building  
Location: All Areas  
Finding: Deteriorated elements  
Information: It was identified that some items around the home have suffered from environmental effects and wear and tear with replacement required.

Secondary defects are likely if the issue is not addressed.

Elements such as bolts and structural brackets may require the services of a builder where replacement is required other wise a carpenter or handy man can attend to the more general replacement requirements such as loose hinges, door handles, fixtures etc.

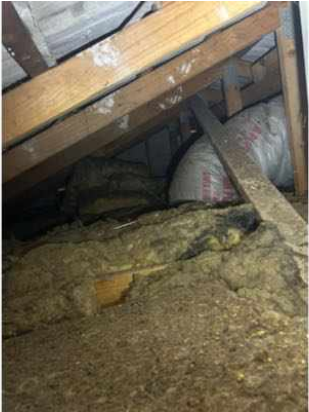
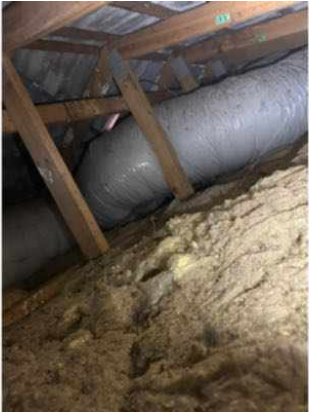
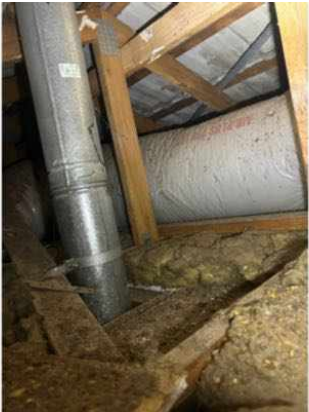
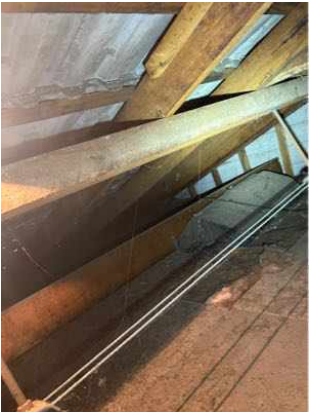
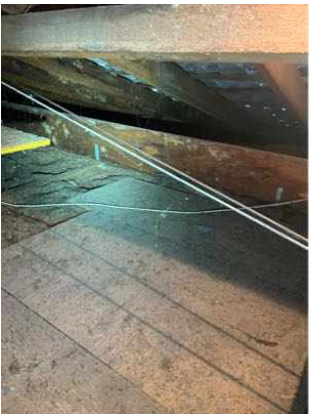
Building: Main Building  
Location: All Areas  
Finding: Additional Photos - Obstructions and Limitations  
Information: These photographs are an indication of the obstructions and limitations which impeded full inspection of the property at the time of inspection. These obstructions can hide an array of defects and should be removed to allow full inspection to be carried out. A re-inspection is recommended once the areas are made accessible.
