Building and Timber Pest Inspection Report

Inspection Date: Mon, 12 Jan 2026

Property Address: 947 Centaur Rd, Hamilton Valley NSW
2641, Australia

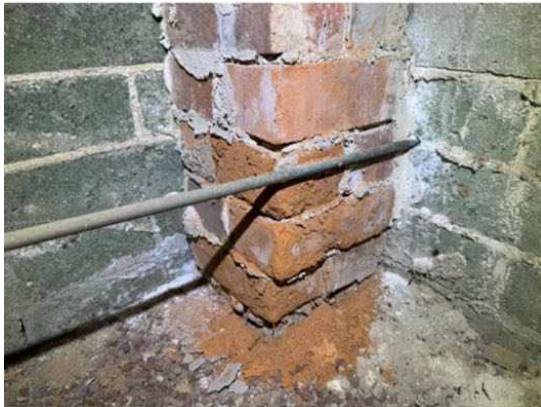
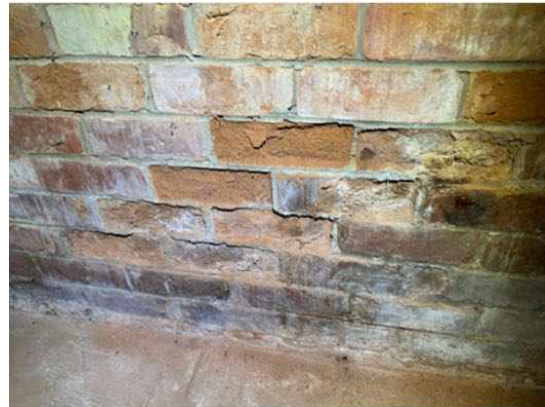
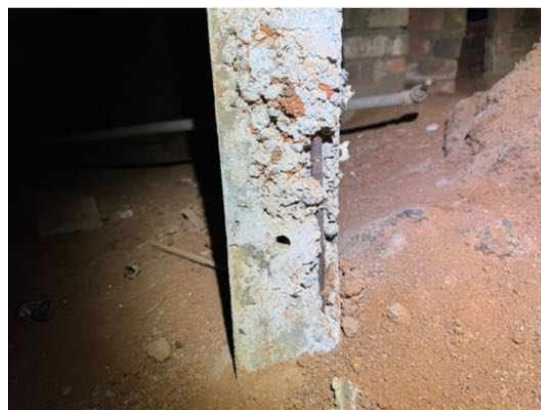
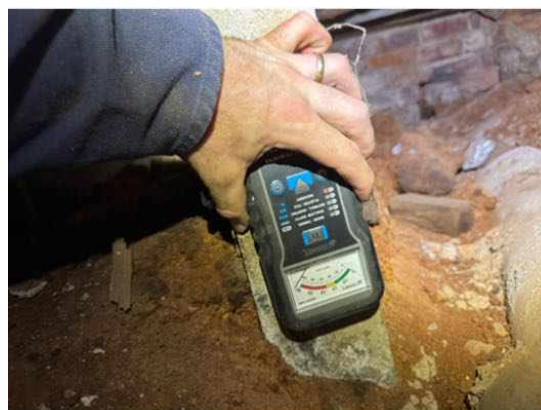
Building: Main Building
Location: Carport, Subfloor
Finding: Brickwork & Concrete Piers - Deterioration (Fretting) & Rising Damp
Information: Deterioration (fretting), was evident in some areas of the carport brickwork and some concrete piers. High moisture (Rising damp) was also evident in these areas.

Recommend engaging a damp proofing specialist in the short term, to provide further advice and remedial works. The client should monitor the fretting. Should further deterioration occur, a structural engineer should be engaged to provide further advice. Further deterioration is likely to occur, if neglected.

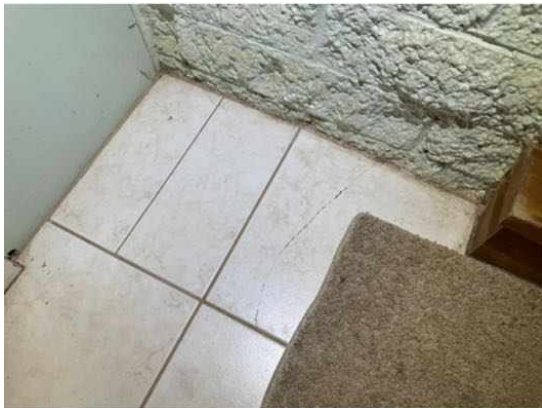
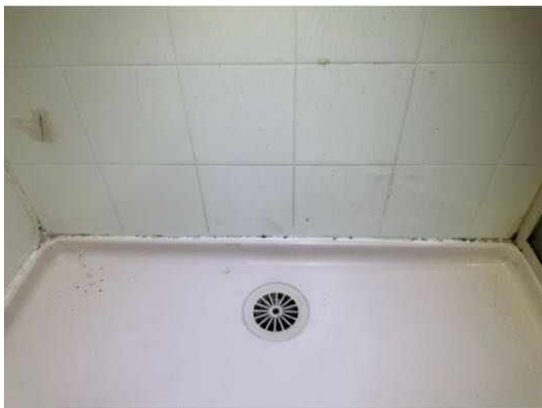
Finding: Sealant / grouting - deteriorated or missing & Cracked Tiles

Information: It appears that the sealant and grout has deteriorated in some tiled areas, a common defect in buildings of a similar age. Areas of cracked tiles were also noted. Sealant and grouting in areas that come into regular contact with water should be maintained for the long term care of your property.

Recommend engaging a licensed tiling contractor in the short term, to provide maintenance works where necessary.

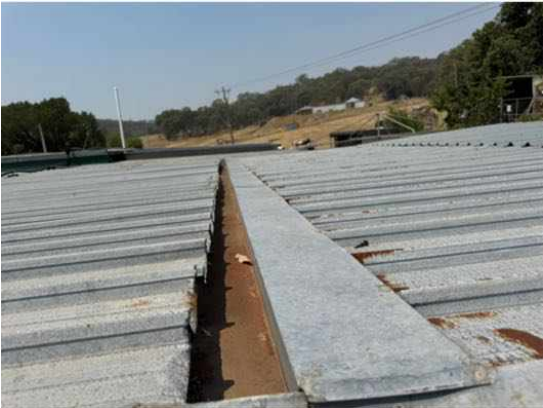
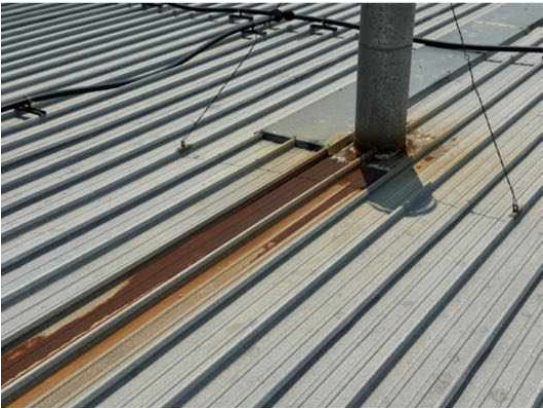
Building: Main Building
Location: Roof Exterior, Gutters
Finding: Roof Exterior & Roof Plumbing - Weathered, Rust
Information: Rust and weathering was identified to areas of the roof exterior and roof plumbing. While weathering of the roof exterior & plumbing is consistent with the age of the property, maintenance works are advised. Areas of roof sealant were also found to be weathered and should be maintained.

Where left unmanaged, rusted & weathered roof sheeting and plumbing is likely to lead to secondary defects, including water leaks. Recommend that the client consult with a licensed roofing contractor in the short term, to provide further advice on maintenance works required.

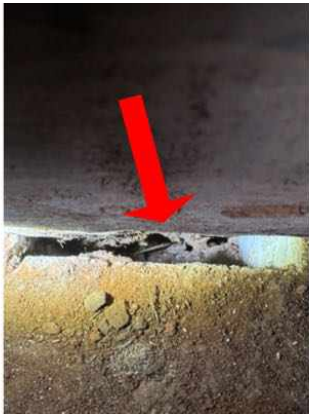
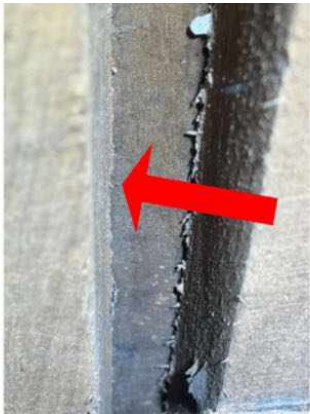
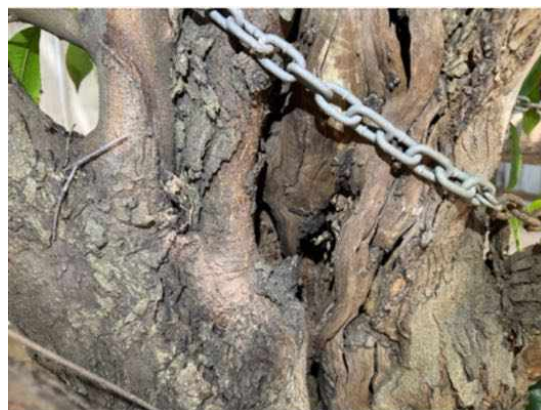
- Building: Main Building
- Location: Tree, Landscaping Timbers, Subfloor
- Finding: Evidence of termite workings & damage
- Information: Evidence of termite damage & workings were identified at, but not limited to, areas throughout the subfloor, external landscaping timbers, and a tree next to the shed.

The client should engage a licensed pest controller in the short term, to provide further advice regarding installation of a termite treatment. 6 monthly termite inspections, conducted by a qualified termite inspector, are also recommended

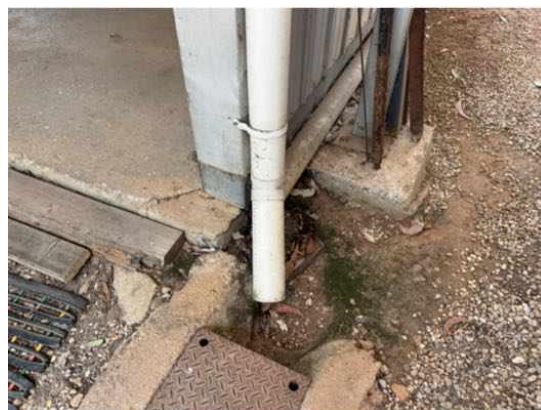
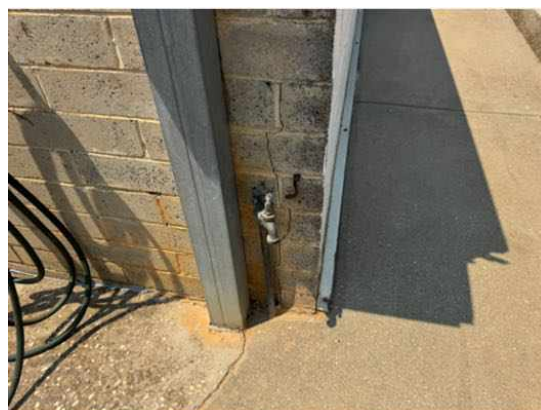
Building:	Main Building
Location:	All external areas, Downpipes
Finding:	Potential Water pooling - against property
Information:	It appears that there are potential areas around the perimeter of the property that could be susceptible to water pooling. Some down-pipes were also found to be disconnected from drainage.

Where insufficient drainage of taps, roof plumbing, and hot water system & aircon overflows are present, water pooling is likely to occur, and can create areas conducive to timber pests and potential damage to the subfloor structure overtime, if neglected.

Recommend engaging a licensed plumber to provide further advice & remedial works.

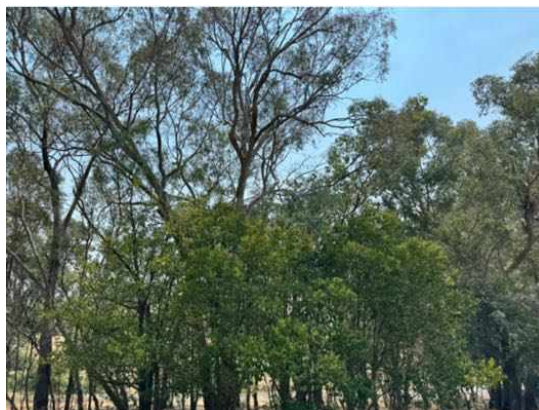
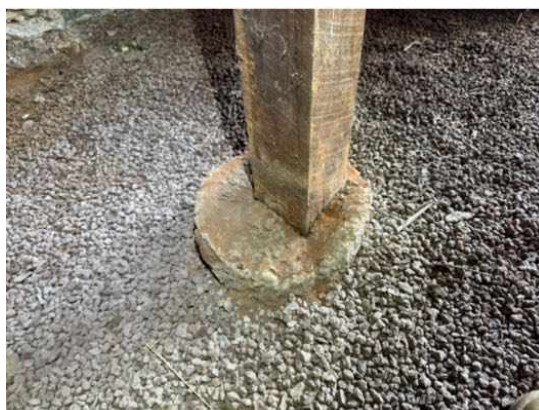
Building:	Main Building
Location:	All External Areas, Subfloor
Finding:	Timber in direct ground contact & trees - conducive to termites
Information:	Where timber materials are in direct contact with the ground and consequently moisture, they become conducive to termite activity. The timber piers, timber debris in the subfloor, tree stumps, and trees surrounding the building create an environment conducive to termite infestation.

Where feasible, any timbers in direct contact with the ground should be removed and any trees in close proximity to the building should be removed or test drilled (inspected) at least annually to reduce the risk of termite infestation & detect any early signs of termite activity.

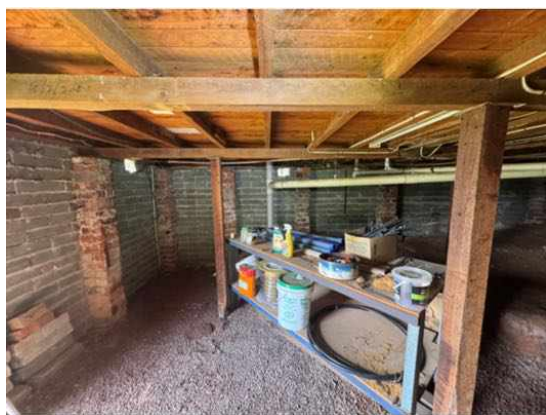
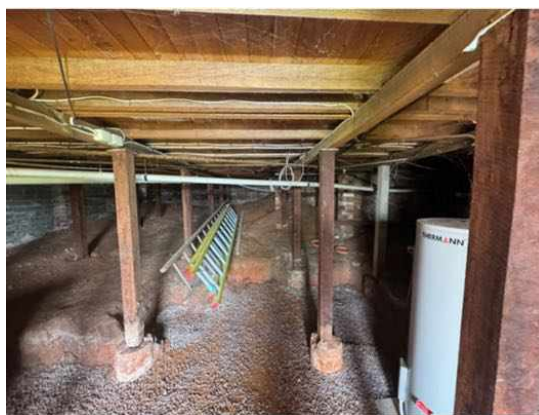
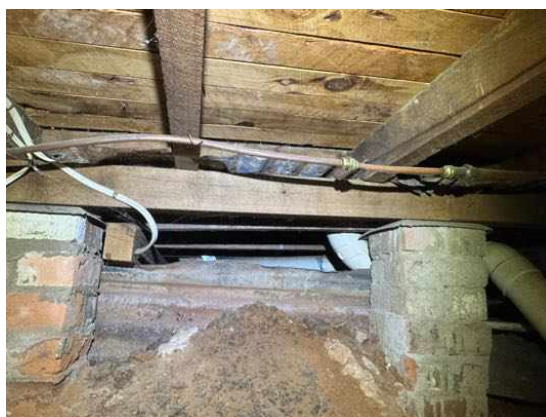
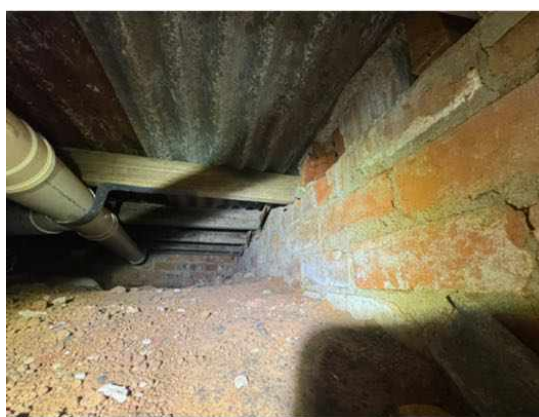
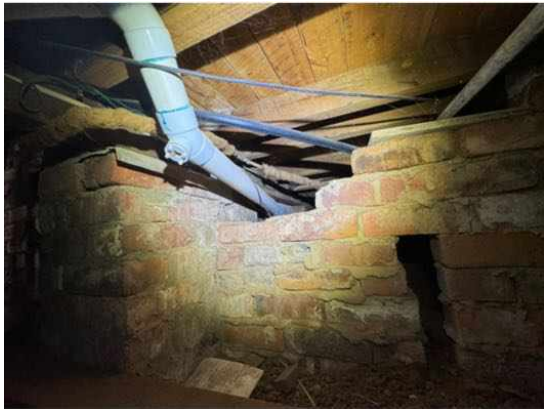
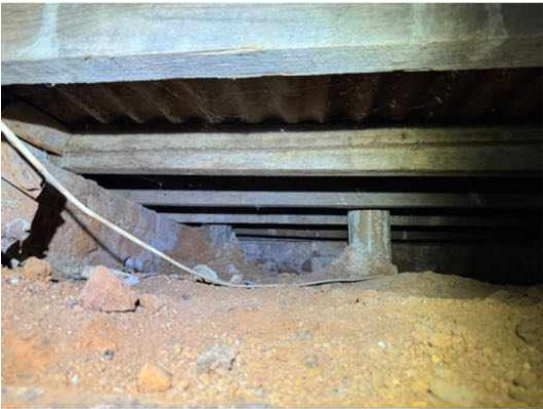
Building: Main Building
Location: All Areas
Finding: Additional Photos - Obstructions and Limitations
Information: These photographs are an indication of the obstructions and limitations which impeded full inspection of the property at the time of inspection. These obstructions can hide an array of defects and should be removed to allow full inspection to be carried out. A re-inspection is recommended once the areas are made accessible.

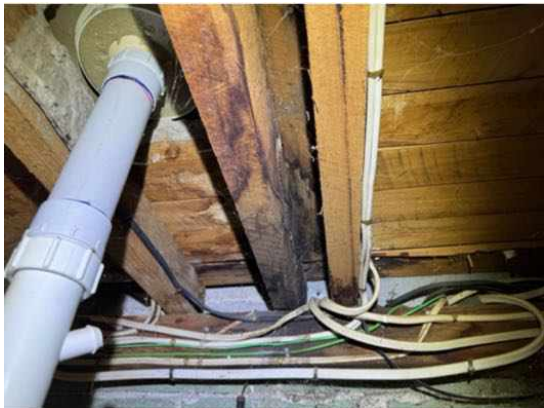
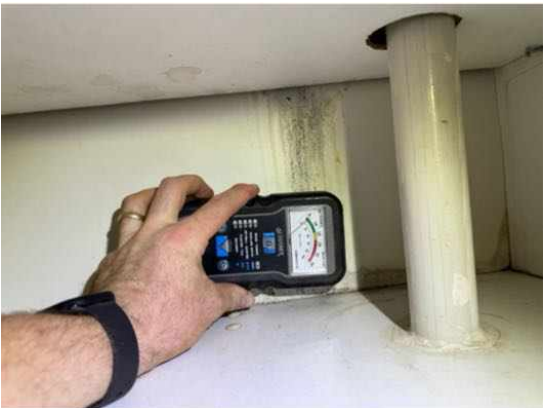
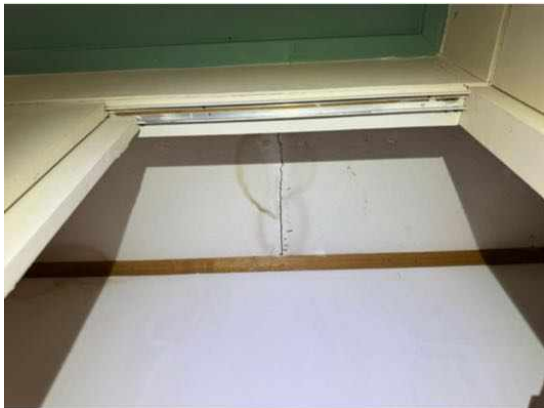
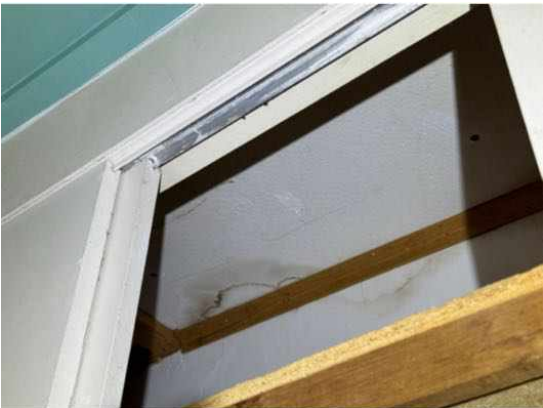
Building: Main Building
 Location: Bedroom Cupboards, Lounge Room Ceiling, Bathroom & Ensuite Vanities
 Finding: Water Staining Present
 Information: It appears that water staining was present including but not limited to, the bedroom cupboards, lounge room ceiling, and the bathroom & ensuite vanities. Potential causes of leaking include deteriorated roof cladding or damaged plumbing fittings and fixtures. No high moisture was evident in these areas at the time of inspection.

It is recommended that the client monitor these areas and engage a licensed plumber promptly, should the leak persist or return.
