# Building and Timber Pest Inspection Report

Inspection Date: Fri, 20 Feb 2026

Property Address: 2/40 Markham Ave, Runaway Bay QLD  
4216, Australia

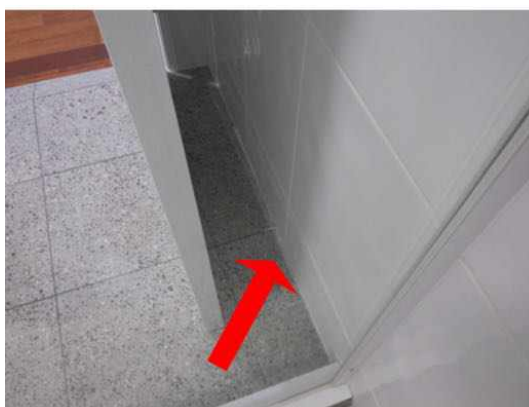
### Finding 3.15

Building: Main Building  
 Location: Bathroom > Centre Left  
 Finding: Sealant Missing  
 Information: It was noted on inspection that sealant is missing from the shower floor/hob tile intersection, it is important this area is sealed to prevent moisture from penetrating these areas.

A flexible sealant is required to allow for expected expansion and contraction, while keeping the joint water tight and protective of all associated building materials.

A sealant specialist or tiling contractor should be appointed to complete these works.

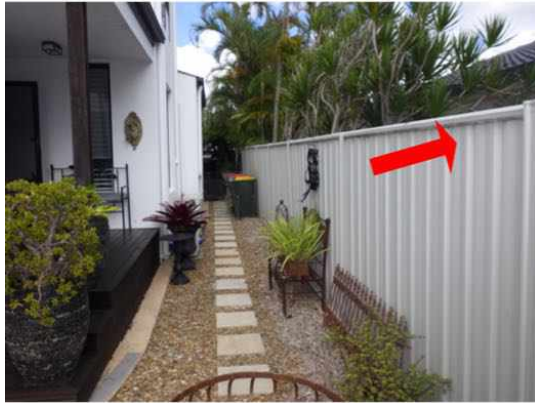
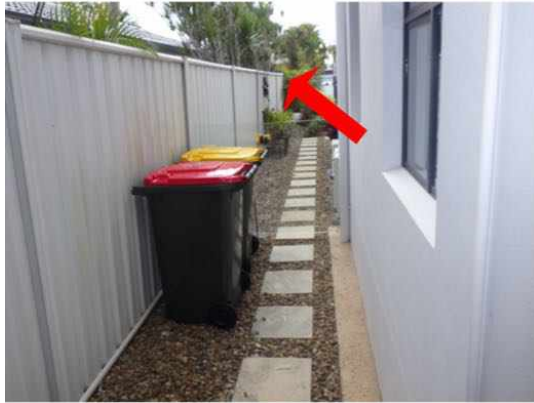
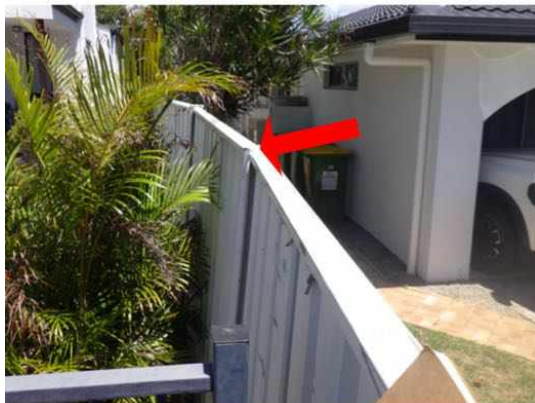
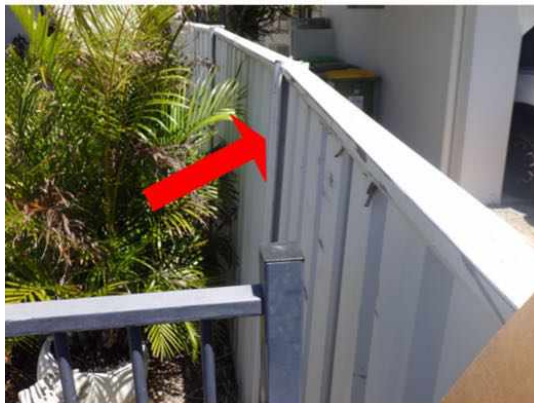
### Finding 3.21

Building: Main Building  
 Location: Yard - Side > Existing  
 Finding: Fencing - Movement  
 Information: It was noted at the time of inspection that sections of the fabricated metal fencing to the right side of the property have moved significantly. Typically fencing movement of this type is due to ground erosion, subsidence, vegetation growth or prolonged exposure to weather conditions. Sometimes inadequate installation or maintenance can be to blame.

If left unattended, it is likely that further movement will occur. It is suspected that repair of several elements of the fencing footings may be required and construction of a retaining wall to limit ground erosion may be a consideration of the client also.

A licensed fencing contractor should be appointed to provide further advice and perform rectification works as necessary.

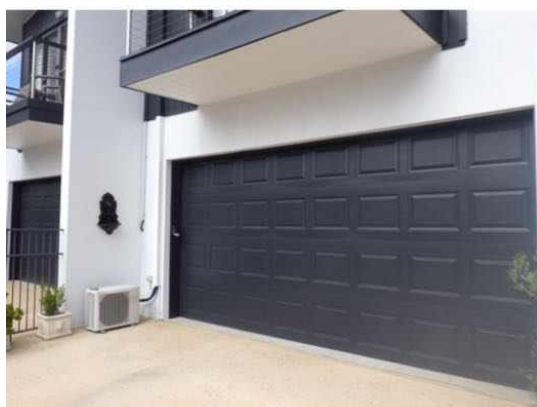
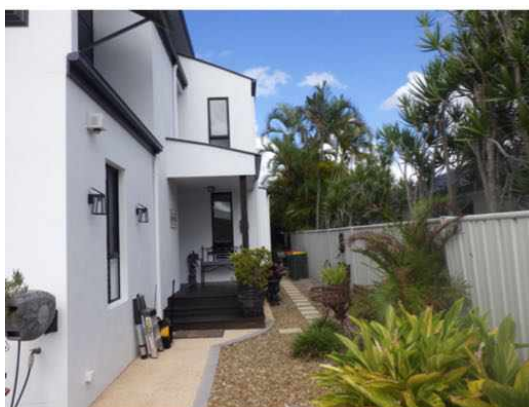
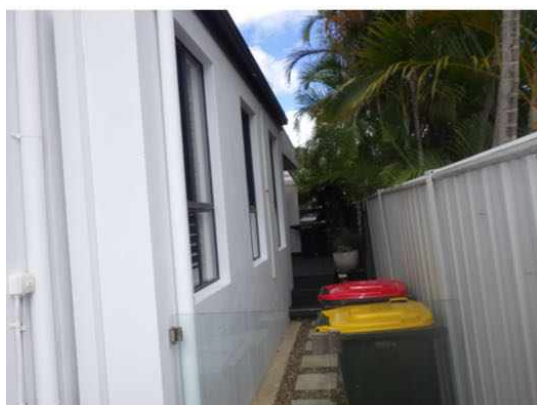
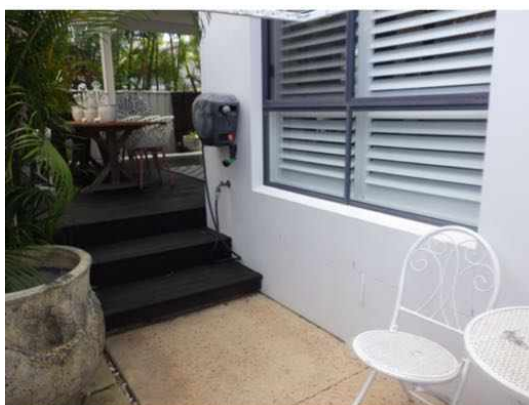
The application of a post-construction chemical termite barrier is highly recommended for all properties, particularly if live termite activity has been found on the site previously. Such barriers are highly effective in preventing termite attack on any timber building elements throughout the property.

A durable notice should be placed in the switchboard unit or the under sink cabinetry to indicate current termite barriers.

The client should consider gaining further advice from a licensed timber termite pest technician as to the costs and procedures involved with this application. It is highly recommended that obtaining such advice be a short-term priority.

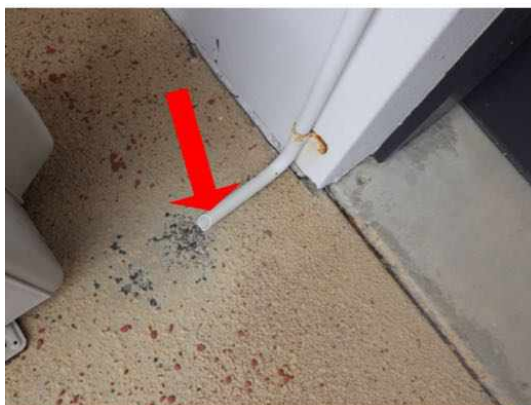
## Finding 6.02

Building: Main Building  
 Location: Exterior walls - front > Front Left  
 Finding: Overflow - Not plumbed for drainage  
 Information: The air conditioning unit overflow is not plumbed or connected to suitable drainage, which can result in the surrounding area becoming excessively damp. These damp

conditions can lead to secondary defects such as rot, rust or corrosion of associated building elements, the formation of fungal decay, or even the creation of potential slip hazards. When coupled with poor site drainage, pooling of water may also attract termite activity to this area. It is highly recommended that a qualified plumber be appointed to install adequate drainage to the overflow. These works will ensure that the area remains dry and free of any secondary defects.

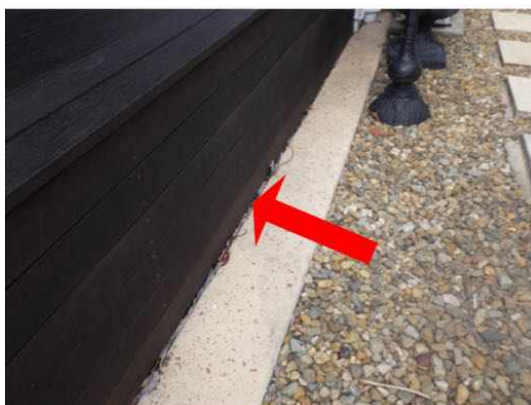
**Finding 6.03**

Building: Main Building  
 Location: Entry > Existing  
 Finding: Deck - In ground contact  
 Information: At the time of inspection it was noted the timber steps and deck area to the entry area of the property is in direct contact with the finished ground level.

Any timbers in direct ground contact provide opportunity for concealed termite entry and are likely to be subject to premature rot and decay as the soil retains moisture or damp conditions against the timbers.

Frequent pest inspections every 1 - 2 months are highly advised to readily identify any termite activity in these areas.

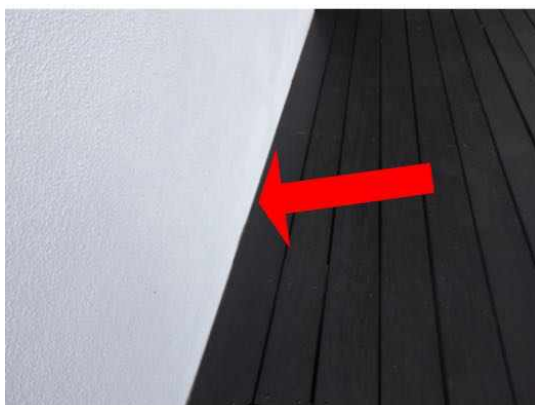
**Finding 6.04**

Building: Main Building  
 Location: Entry > Existing  
 Finding: Inspection Zone Exposure  
 Information: At the time of inspection the timber deck to the entry area at the front of the property finished tight against the exterior wall cladding.

An inspection zone of 20mm between the timber decking to the slab edge or wall exterior is required. This inspection zone should be maintained in order to force termites into the open where they can be detected more readily during regular inspections. The slab edge or wall exterior inspection zone should not be concealed by anything that may prevent inspection of the area, including render, landscaping, soil, turf, paving, concrete, cladding, timber decking or other structures. If the slab edge or wall exterior inspection zone is not properly exposed, it is considered a high risk area of termite attack.

It is highly recommended that timber termite pest inspections be carried out every 1 - 2 months to aid protection of the property against infestation.

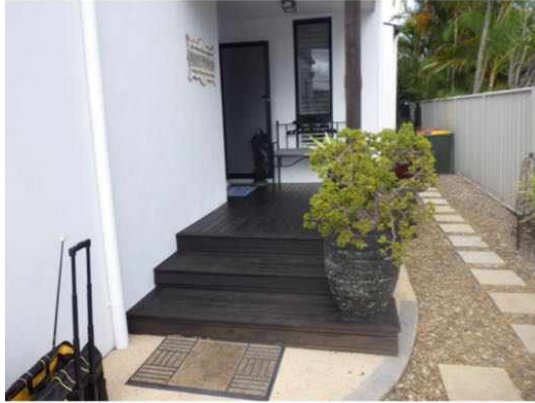
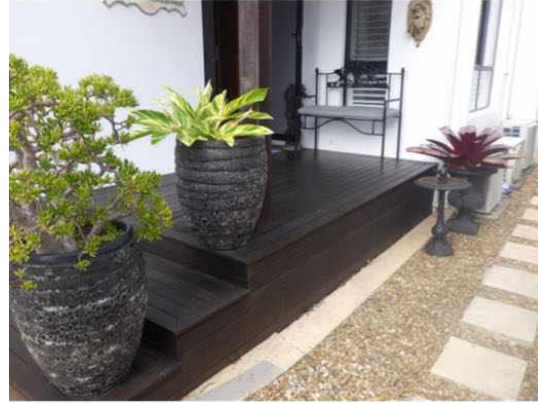
### Finding 6.05

Building: Main Building  
 Location: Entry > Existing  
 Finding: No Access

Areas with limited or no access point severely restrict the full inspection of the area.

The client should consult with a licensed builder regarding provision of a hatch or access door to the timber deck sub floor area.

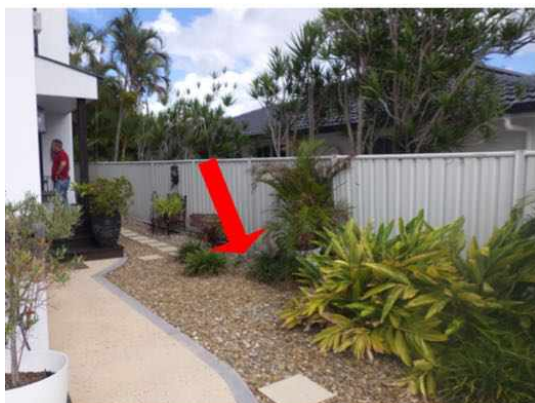
### Finding 6.06

Finding: Garden Beds - Conditions Conducive to Termites

Information: Garden beds and external landscape areas were found to contain timber, stumps, debris and garden waste at the time of inspection (as per example photos). These garden beds can include untreated timber, and with a combination of moisture from watering hosing can make conditions conducive to termite activity and termite ingress. Removal of any garden debris or vegetation is highly advised. Frequent pest inspections are advised to readily identify any termite activity in these areas.

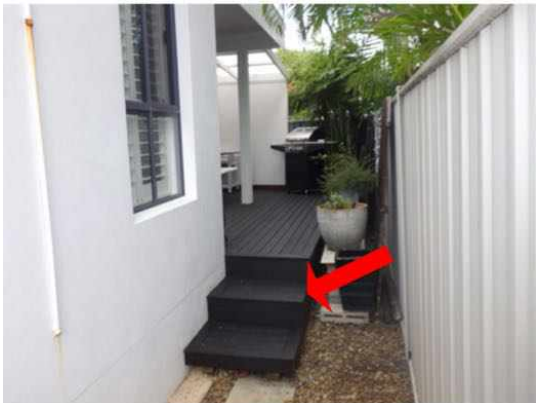
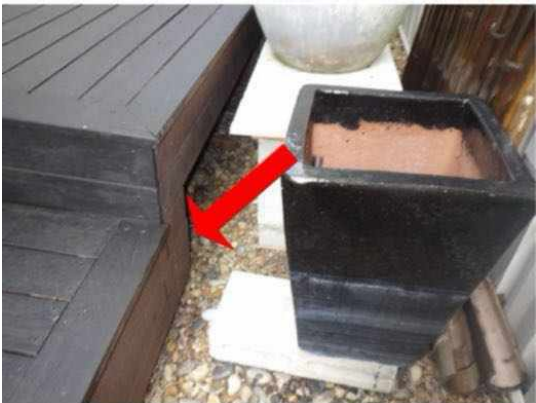
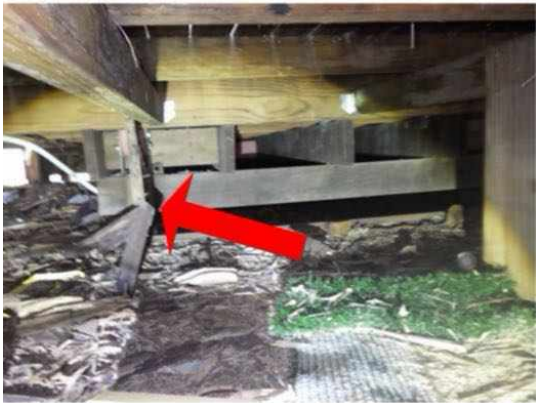
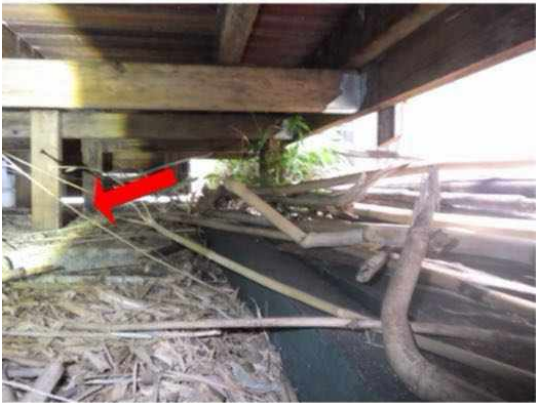
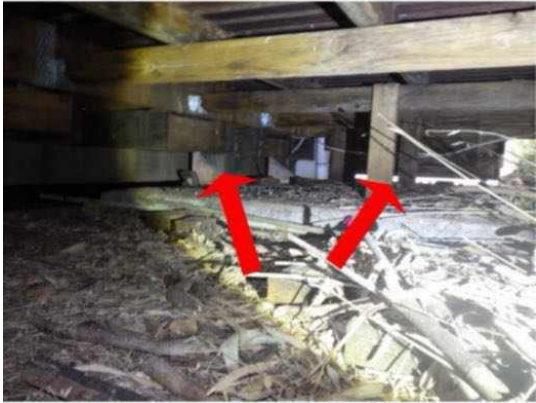
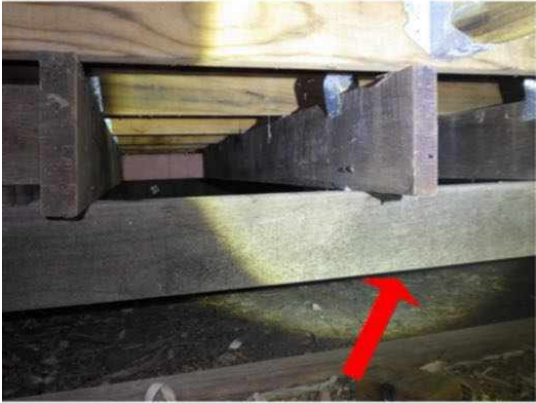
**Finding 6.07**

Building: Main Building  
Location: Deck > Rear  
Finding: Deck - In ground contact  
Information: At the time of inspection it was noted the timber deck area to the rear of the property is in direct contact with the finished ground level.

Any timbers in direct ground contact provide opportunity for concealed termite entry and are likely to be subject to premature rot and decay as the soil retains moisture or damp conditions against the timbers.

Frequent pest inspections every 1 - 2 months are highly advised to readily identify any

termite activity in these areas.

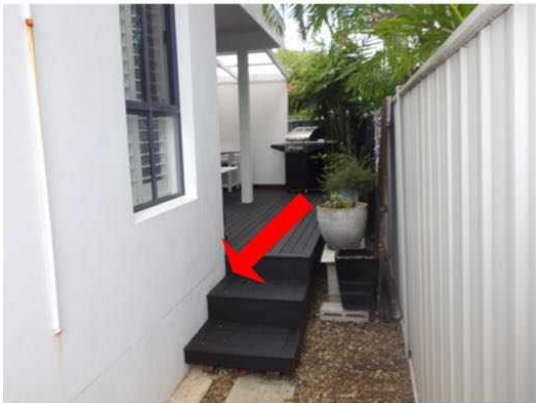
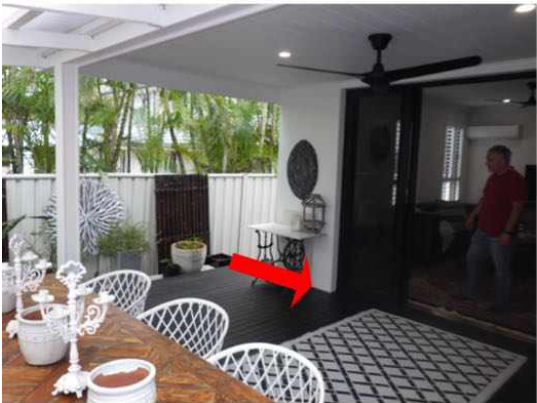
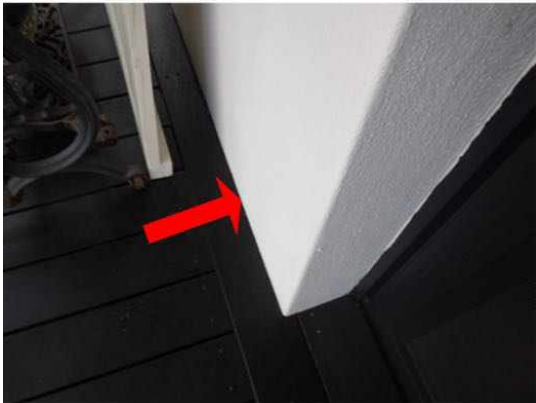
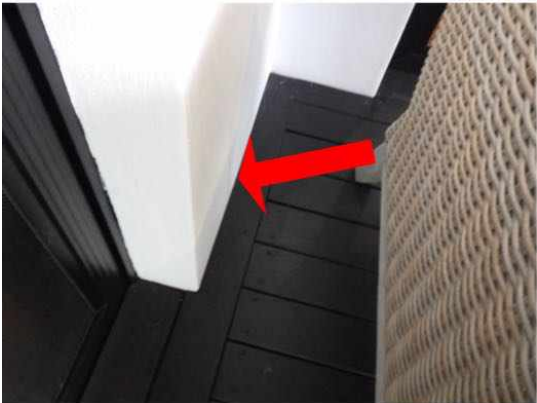
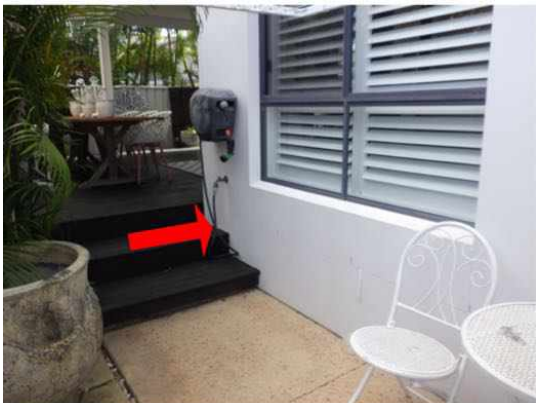
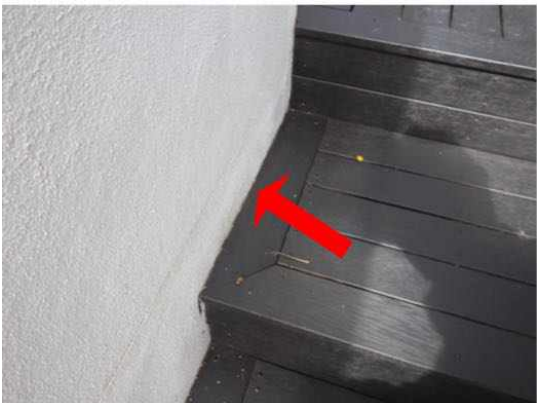
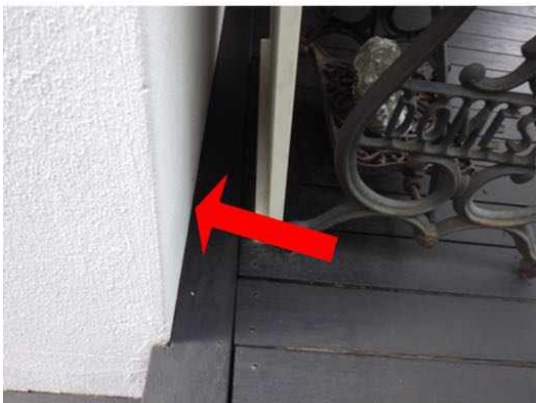
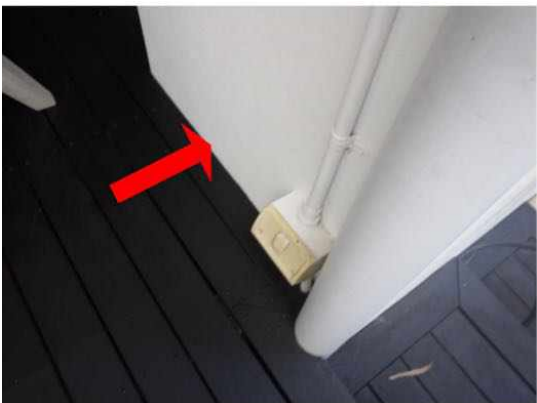
An inspection zone of 20mm between the timber decking to the slab edge or wall exterior is required. This inspection zone should be maintained in order to force termites into the open where they can be detected more readily during regular inspections. The slab edge or wall exterior inspection zone should not be concealed by anything that may prevent inspection of the area, including render, landscaping, soil, turf, paving, concrete, cladding, timber decking or other structures. If the slab edge or wall exterior inspection zone is not properly exposed, it is considered a high risk area of termite attack.

It is highly recommended that timber termite pest inspections be carried out every 1 - 2 months to aid protection of the property against infestation.

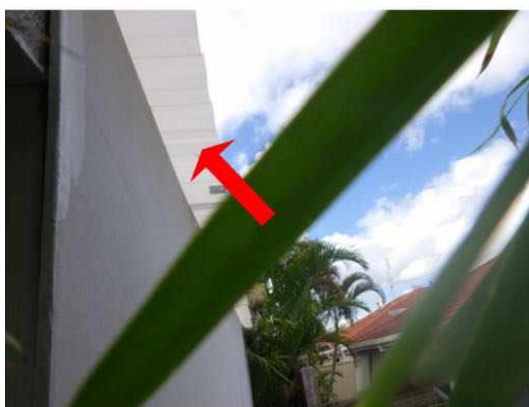
Finding 6.09

Building:	Main Building
Location:	Alfresco > Rear
Finding:	Roof Guttering Missing
Information:	At the time of inspection there was no roof guttering installed to alfresco area roof.

Although some building elements may seem irrelevant or unnecessary, all building elements play a key role in the operation and function of the overall structure and its performance. Roof areas missing gutters are likely to lead to high levels of moisture in the ground areas directly below. Such moisture will not only cause rust and decay of the associated building materials, but can also provide conditions that are conducive to termite and timber pest activity.

Installation of roof guttering and stormwater downpipes should be conducted as soon as possible to ensure that no damage or functional issues occur to associated building materials.

A qualified roof plumber should be appointed to replace the missing guttering.

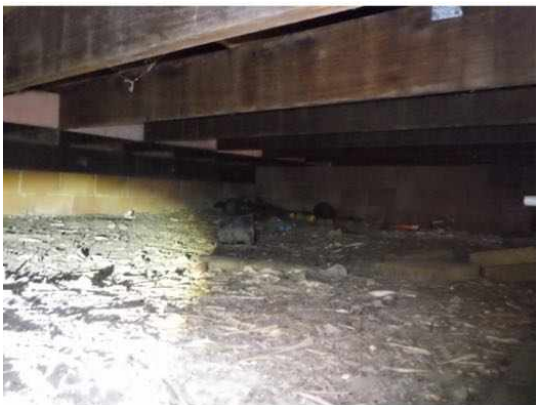
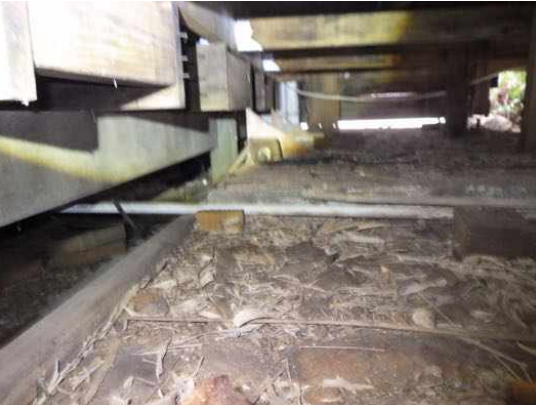
### Finding 6.10

Building:	Main Building
Location:	Deck > Existing
Finding:	Obstructions and Limitations Subfloor
Information:	These photographs are an indication of the obstructions and limitations which impeded full inspection of the Subfloor at the time of inspection. These obstructions can hide an array of defects and should be removed to allow full inspection to be carried out. A re-inspection is recommended once the areas are made accessible.

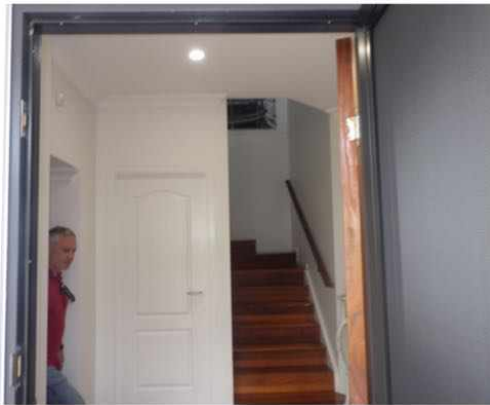
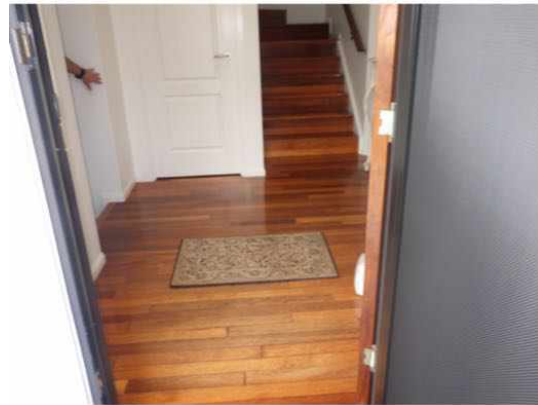
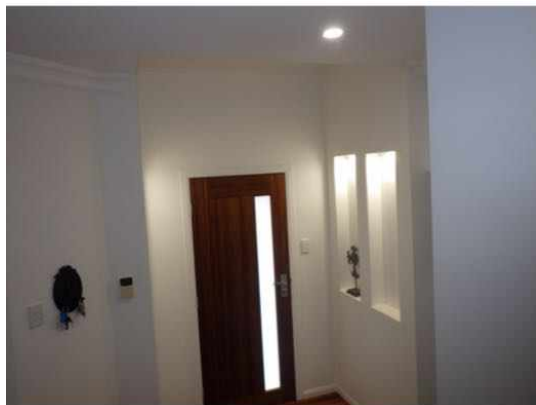
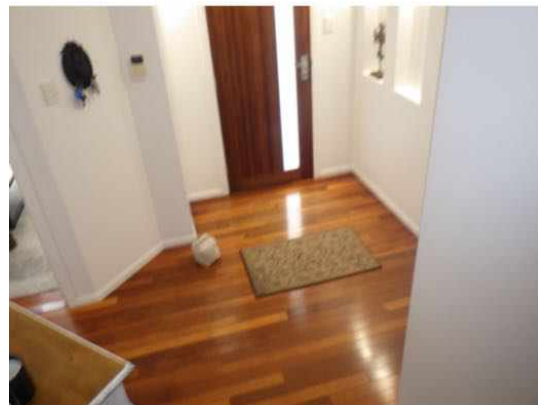
Building: Main Building  
Location: Entry > Existing  
Finding: No obvious defect  
Information: No obvious defects found at the time of inspection.

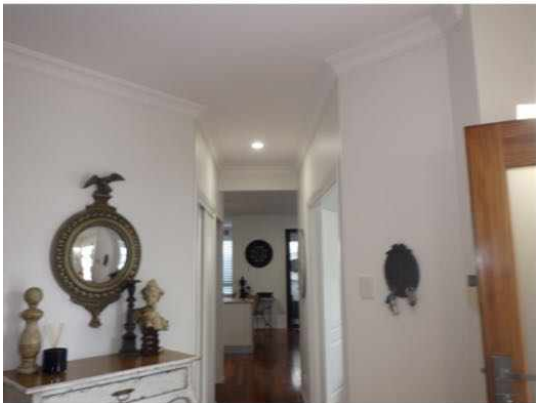
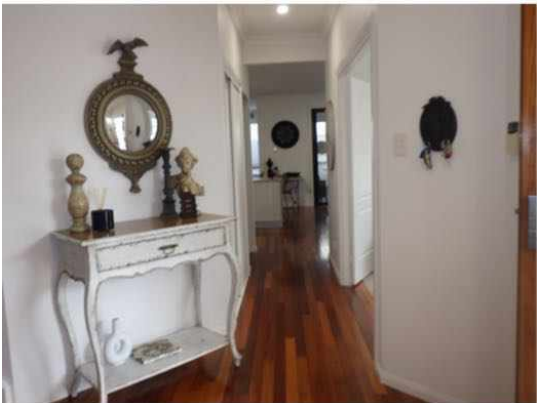
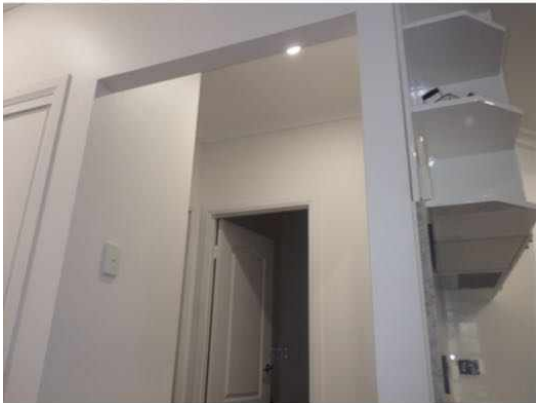
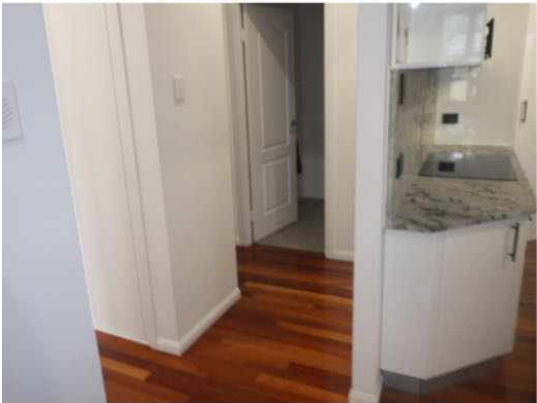
Building: Main Building  
Location: Hallway > Existing  
Finding: No obvious defect  
Information: No obvious defects found at the time of inspection.

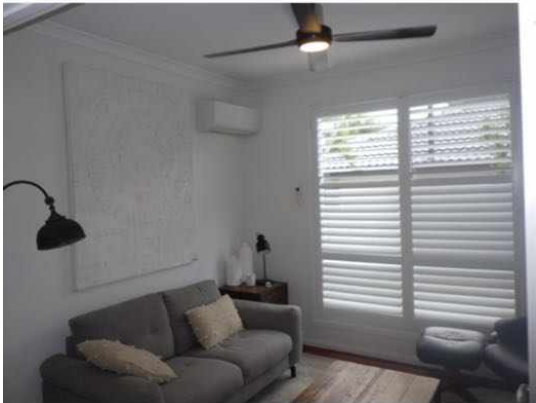
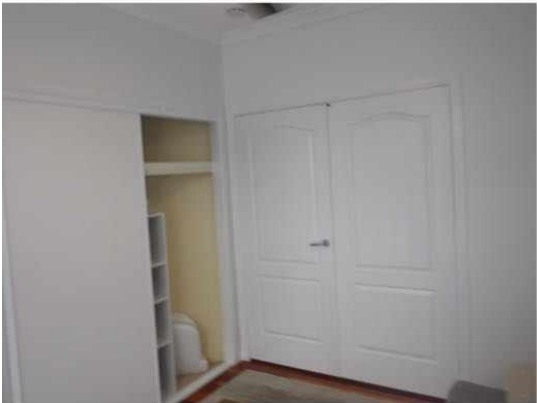
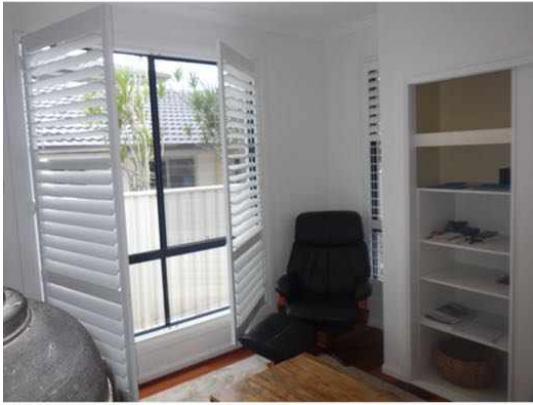
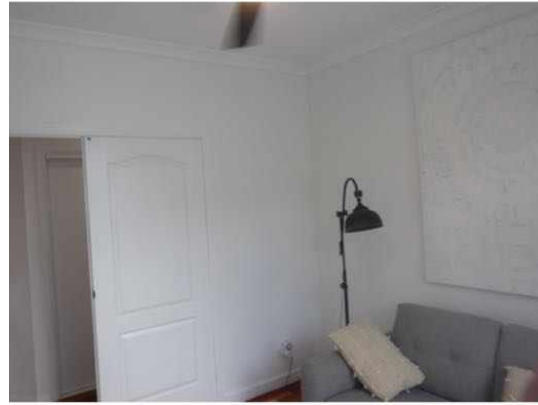
Building: Main Building  
Location: Media/Bedroom > Existing  
Finding: No obvious defect  
Information: No obvious defects found at the time of inspection.

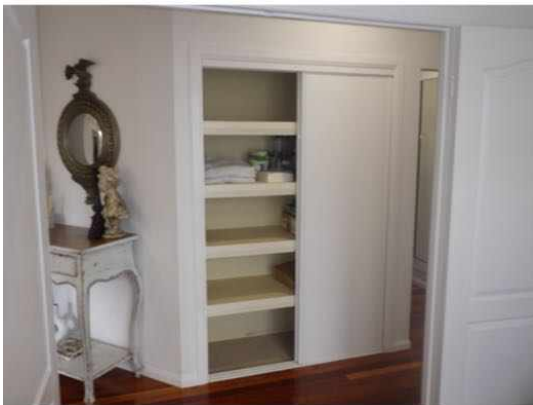
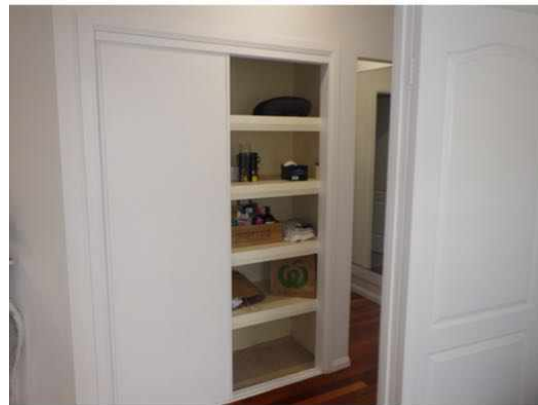
Building: Main Building  
Location: Linen Cupboard > Existing  
Finding: No obvious defect  
Information: No obvious defects found at the time of inspection.

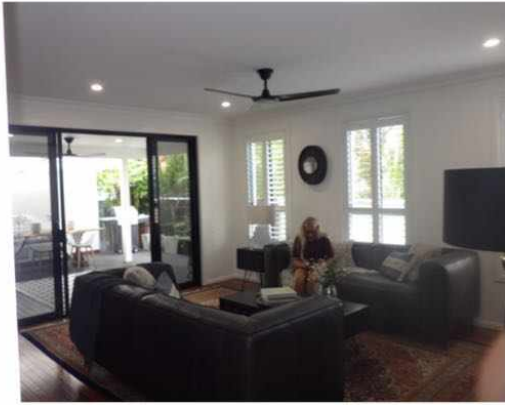
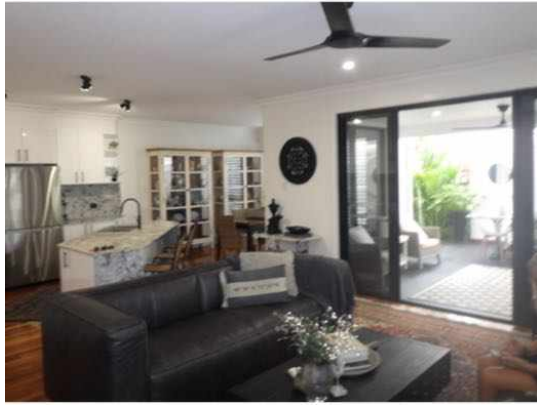
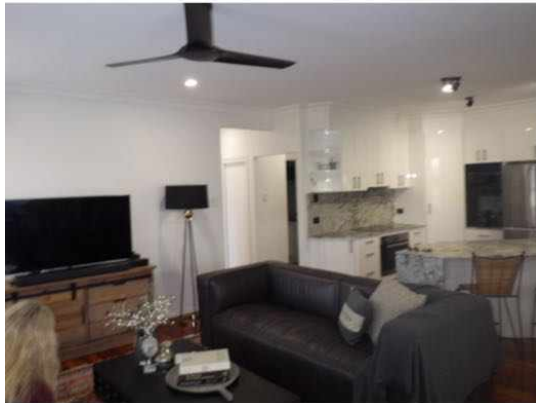
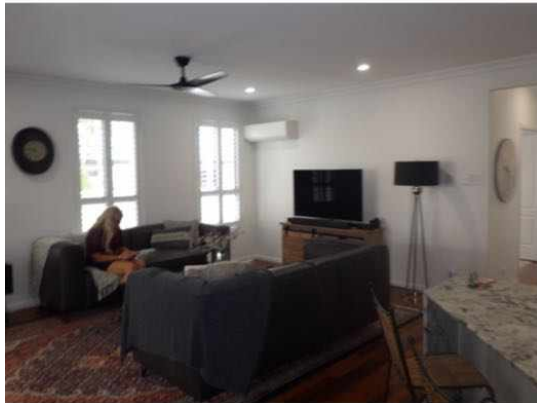
Building: Main Building  
Location: Living Room > Existing  
Finding: No obvious defect  
Information: No obvious defects found at the time of inspection.

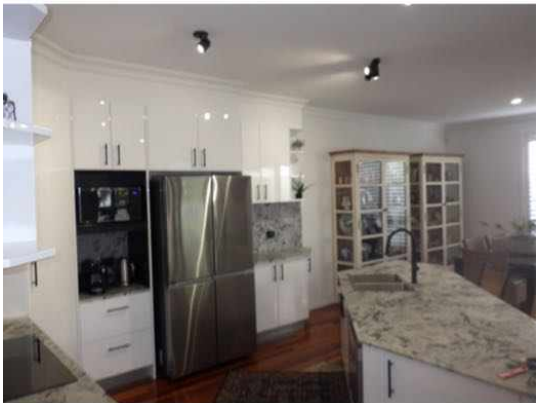
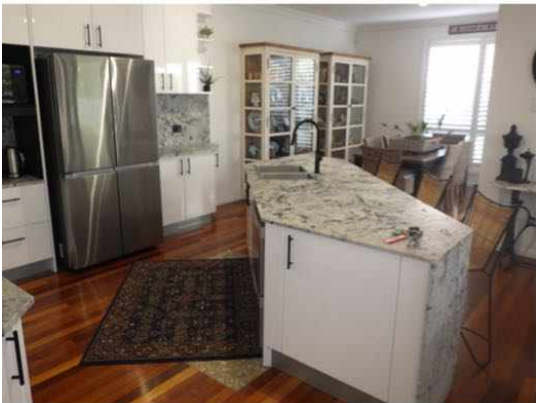
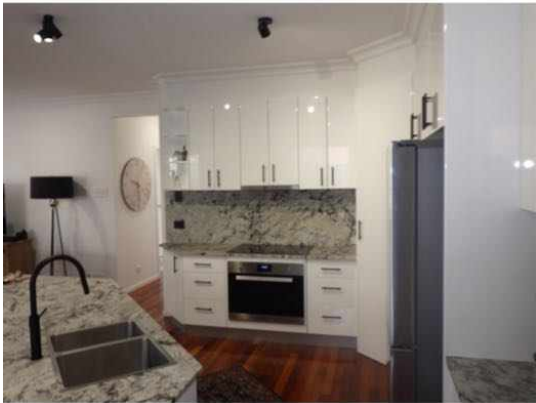
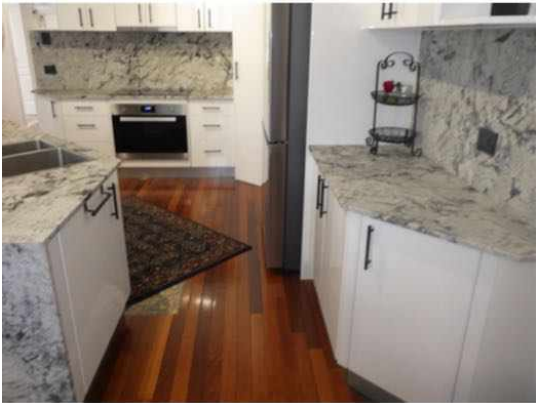
Building: Main Building  
Location: Kitchen > Existing  
Finding: No obvious defect

Information: No obvious defects found at the time of inspection.

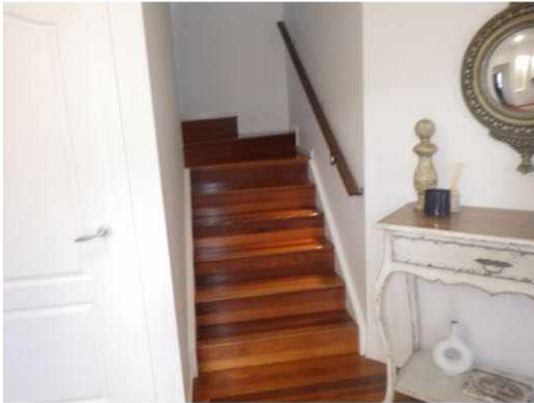
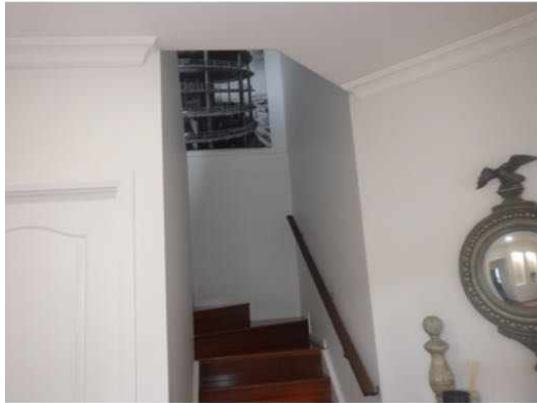
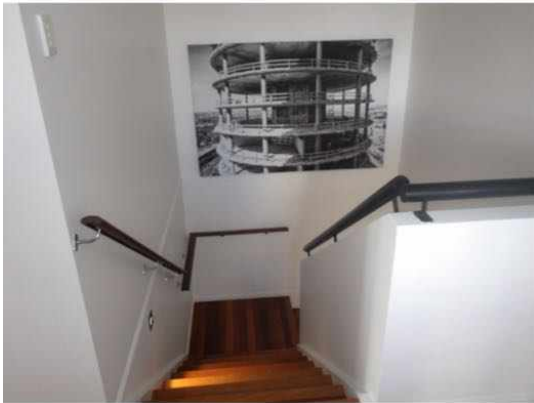
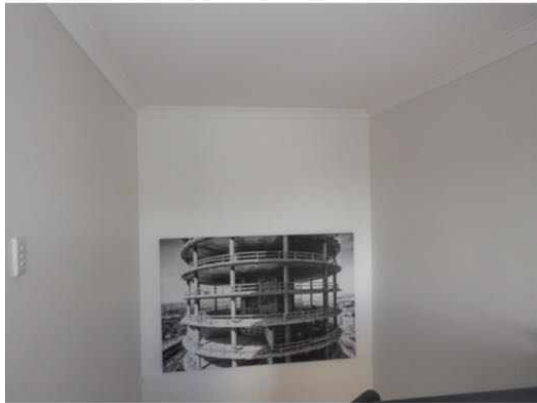
Location: Stairs - Internal > Existing  
Finding: No obvious defect  
Information: No obvious defects found at the time of inspection.

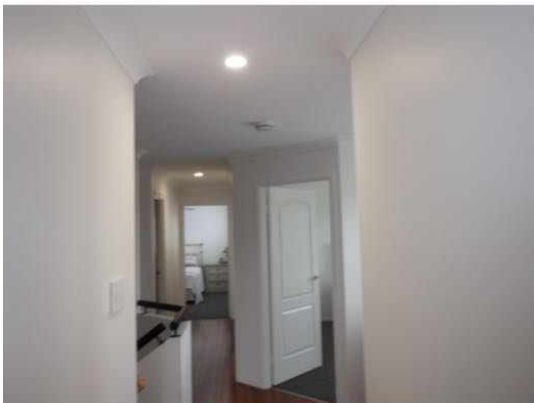
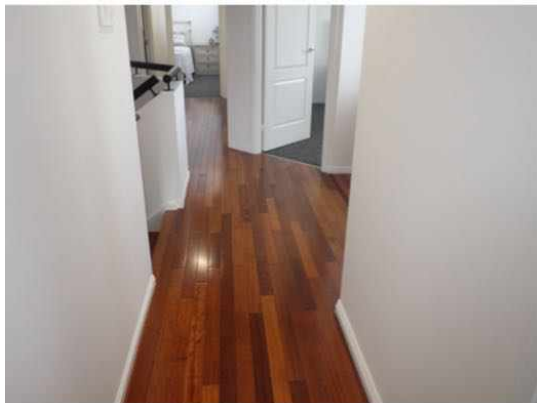
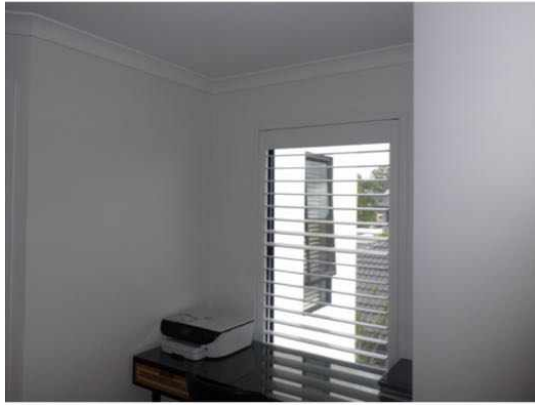
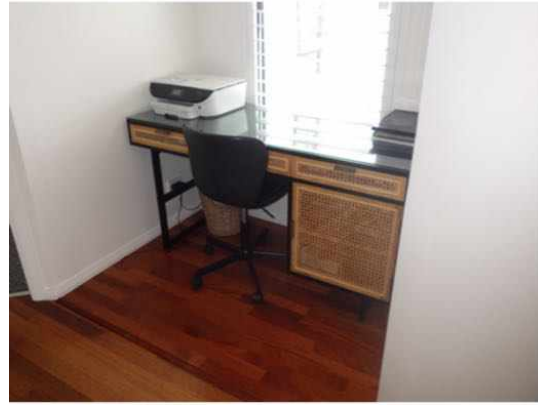
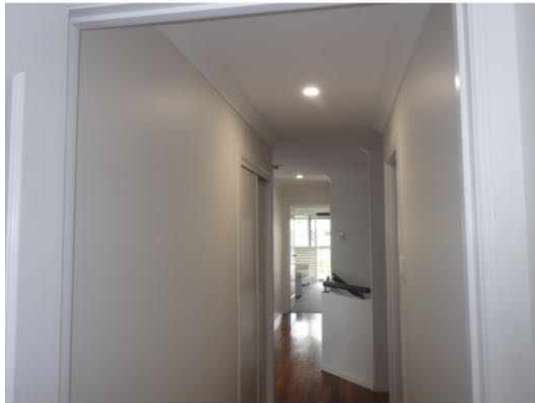
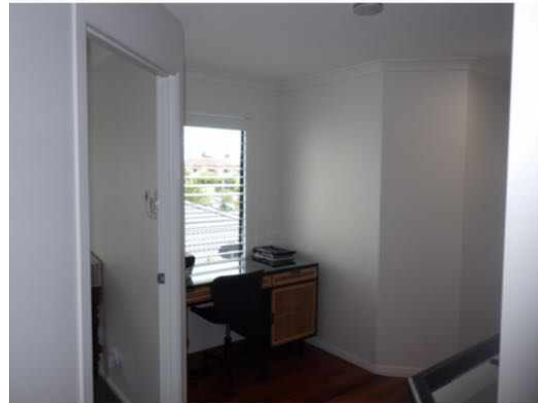
Building: Main Building  
Location: Stair Landing > Existing  
Finding: No obvious defect  
Information: No obvious defects found at the time of inspection.

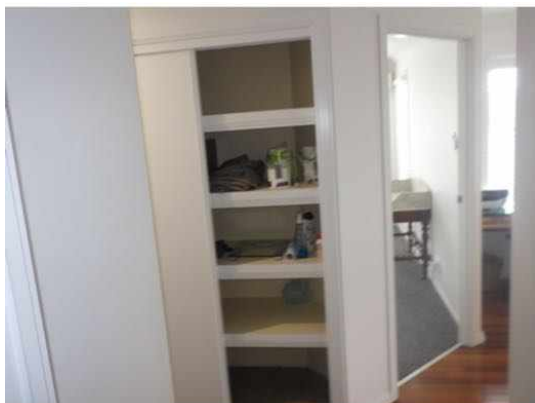
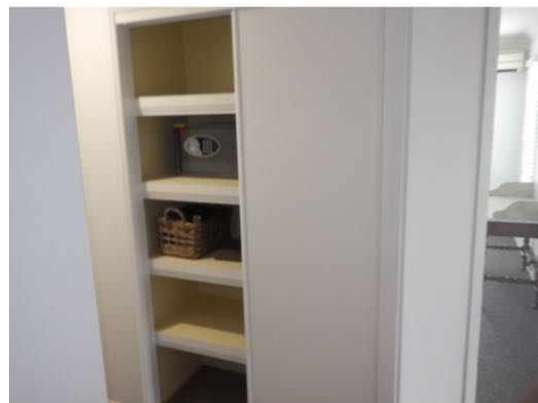
Building: Main Building  
Location: Linen Cupboard > Existing  
Finding: No obvious defect  
Information: No obvious defects found at the time of inspection.

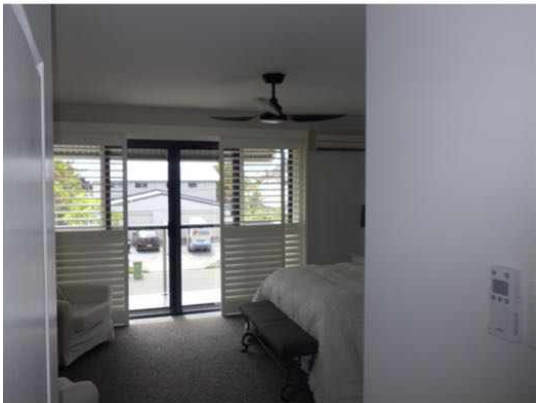
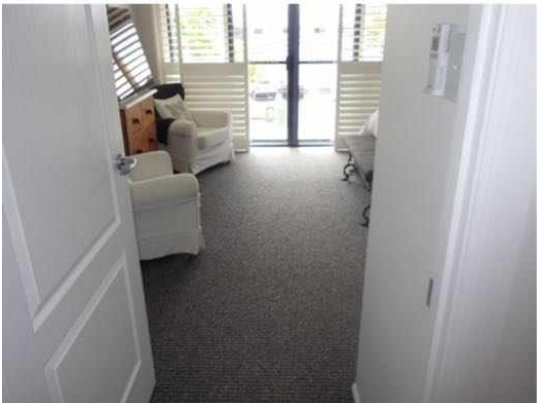
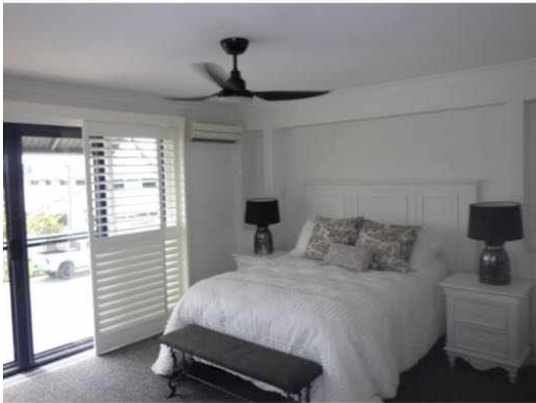
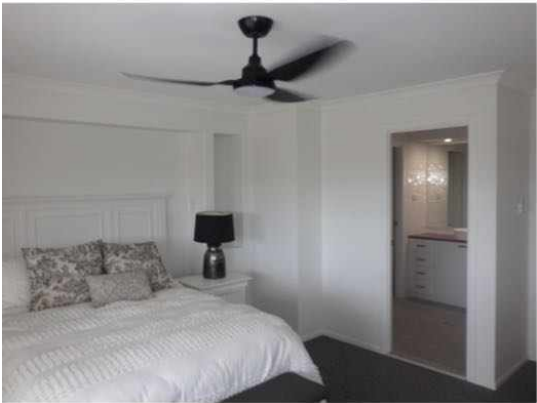
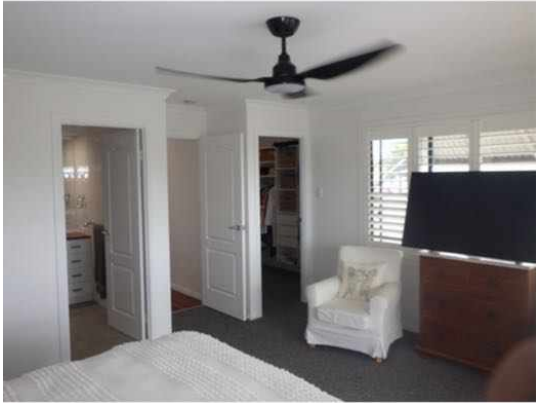
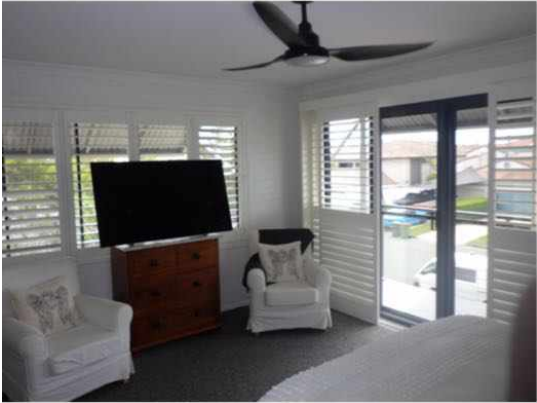
Building: Main Building  
Location: Bedroom - Master > Existing  
Finding: No obvious defect

Information: No obvious defects found at the time of inspection.

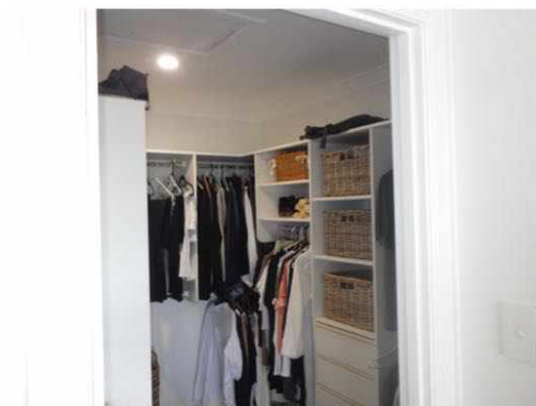
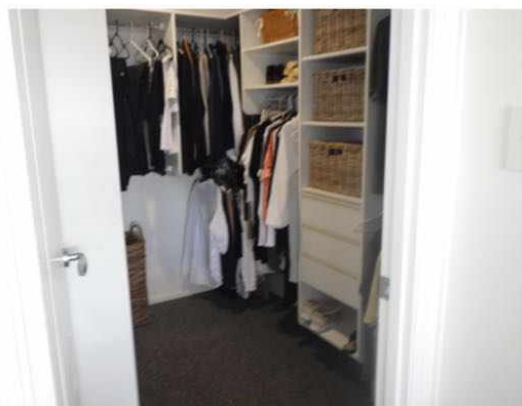
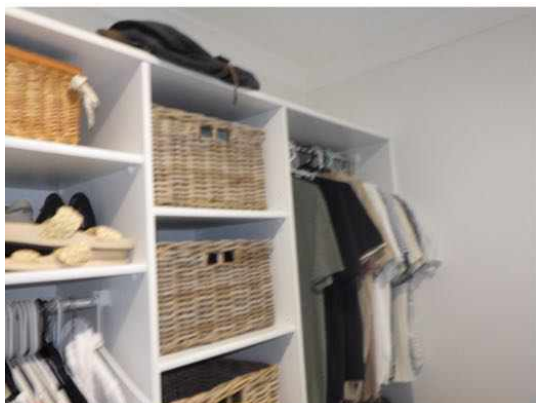
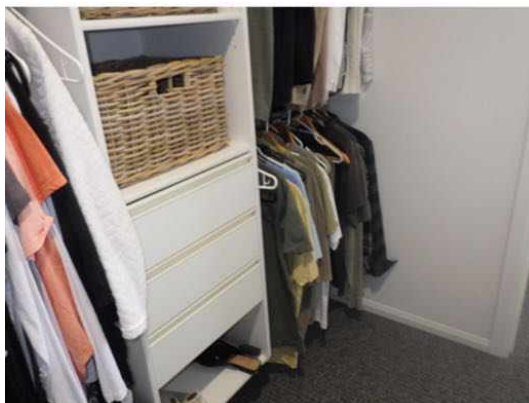
Building: Main Building  
Location: Walk In Robe > Existing  
Finding: No obvious defect  
Information: No obvious defects found at the time of inspection.

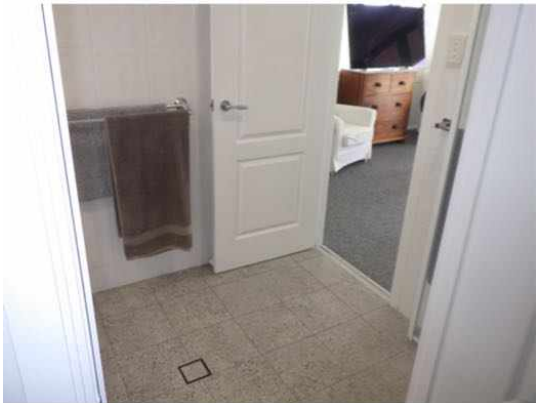
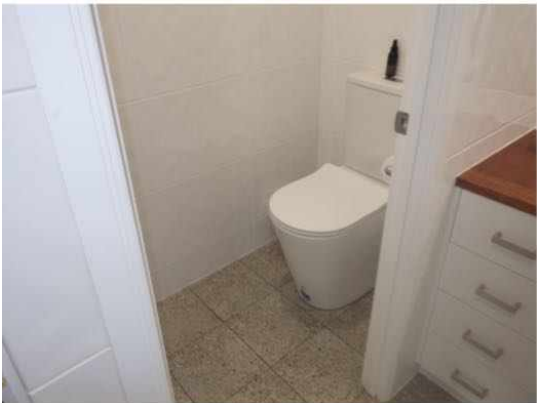
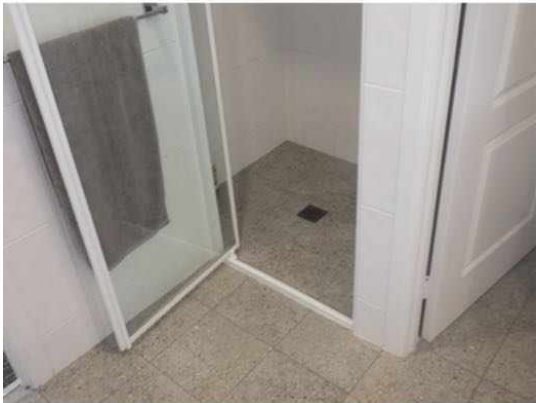
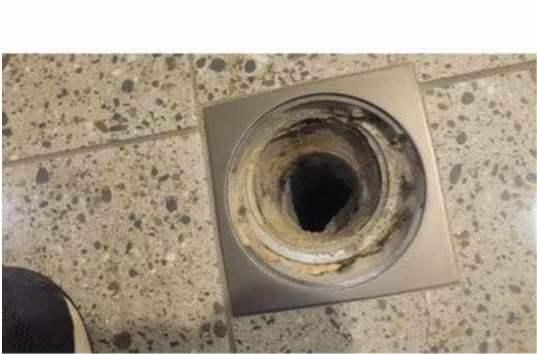
Information: At the time of inspection it was suspected new floor tiles have been laid directly over existing floor tiles in the ensuite and ensuite shower cubicle areas. Although no drummy or deteriorated tiles were observed, tiling over existing tiles can mask underlying issues such as water damage or mould. If the original waterproofing membrane is compromised, it may lead to future problems or issues.

Regular monitoring of the area is advised and if any visual signs of excessive moisture appear (peeling paint, mould) then consultation with a qualified builder or bathroom specialist would be advised.

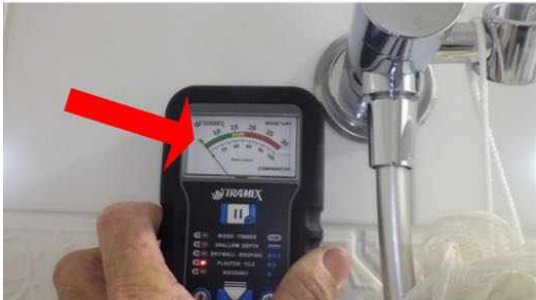
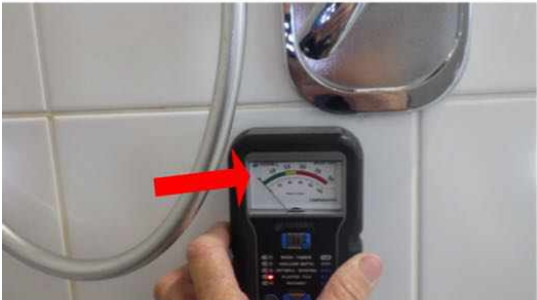
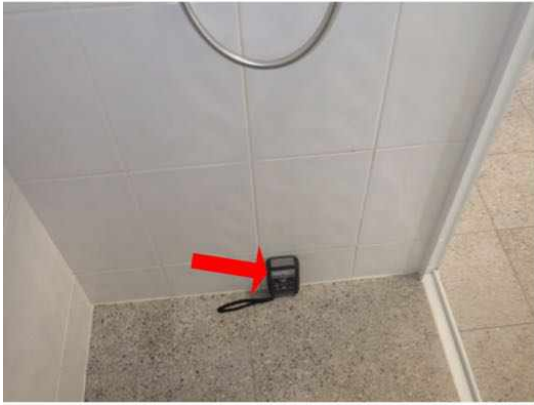
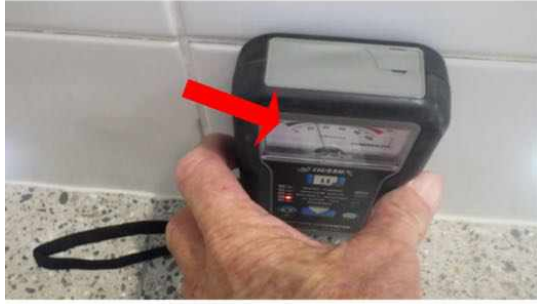
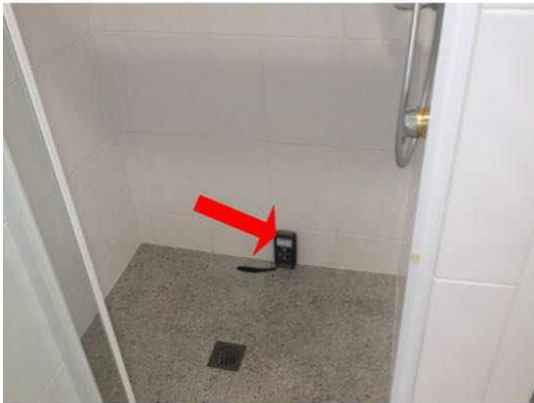
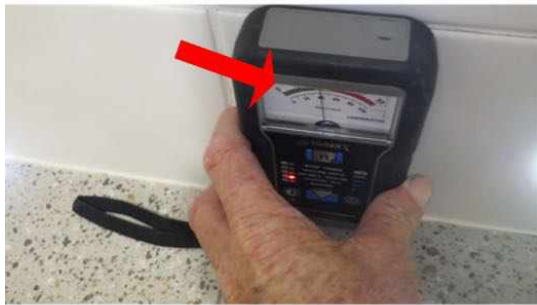
Building: Main Building  
Location: Ensuite > Existing  
Finding: Moisture Level Readings  
Information: At the time of inspection the ensuite shower cubicle areas checked with the Tramex Moisture Meter returned low - normal moisture level readings.

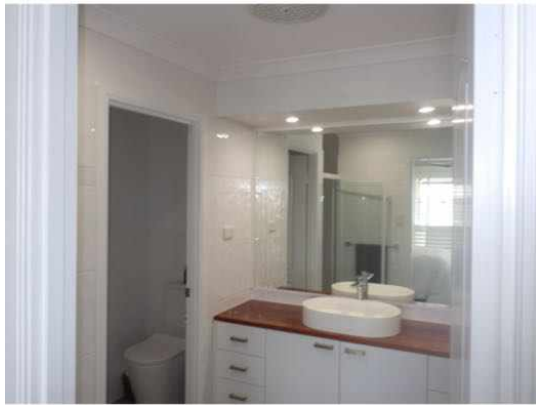
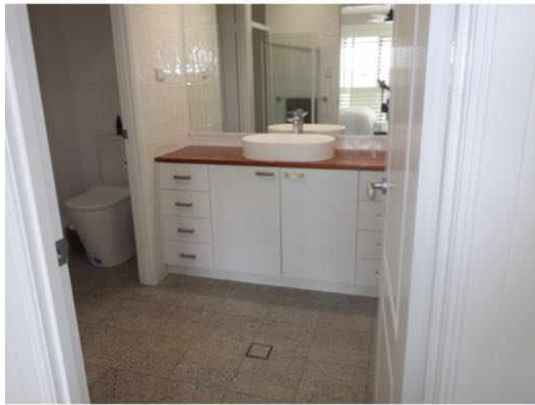
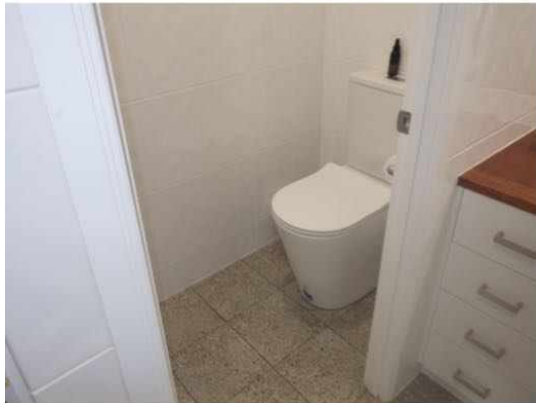
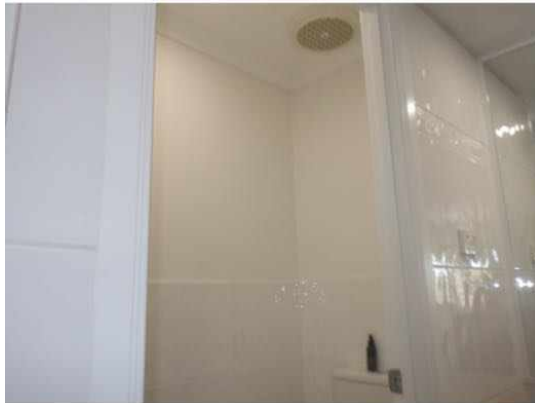
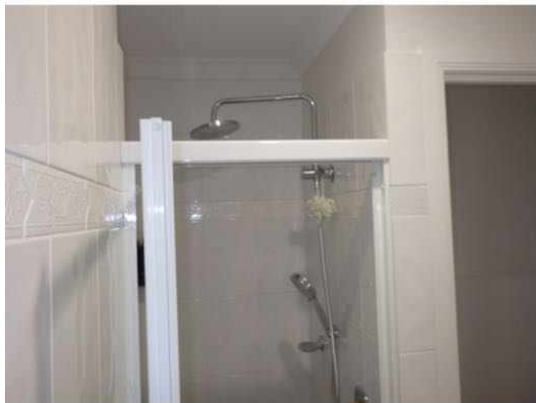
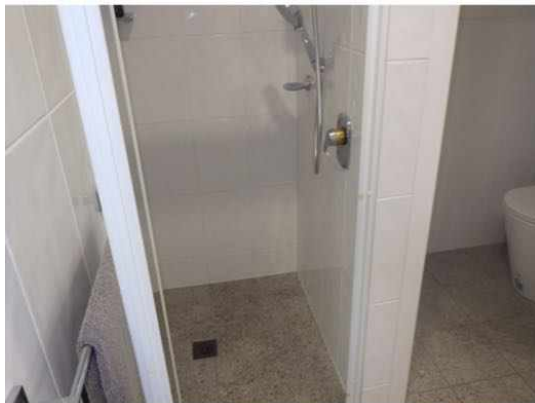
Building: Main Building  
Location: Ensuite > Existing  
Finding: Additional Photos  
Information: Additional photos are provided for your general reference
