# Building and Timber Pest Inspection Report

Inspection Date: Fri, 20 Feb 2026

Property Address: 2/40 Markham Ave, Runaway Bay QLD  
4216, Australia

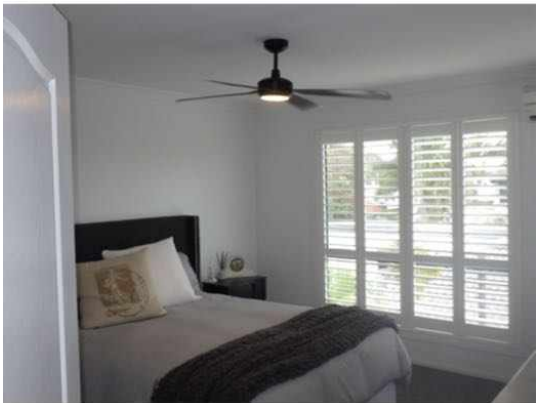
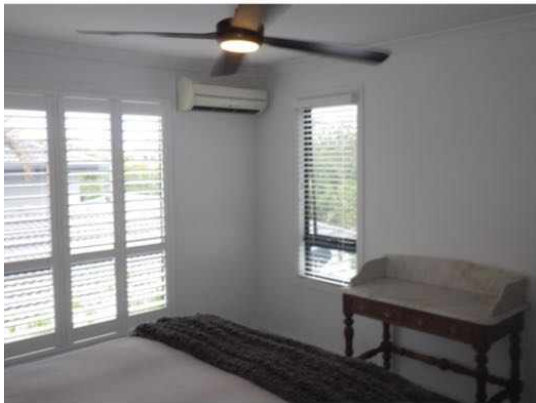
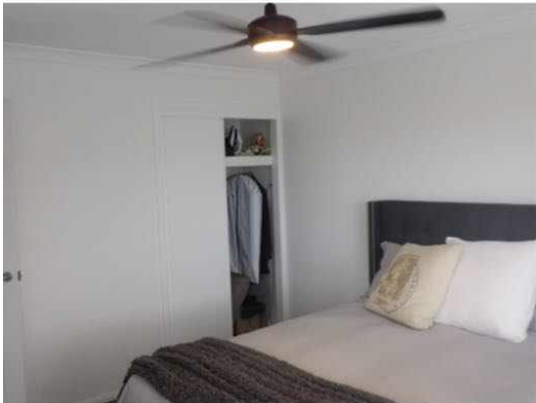
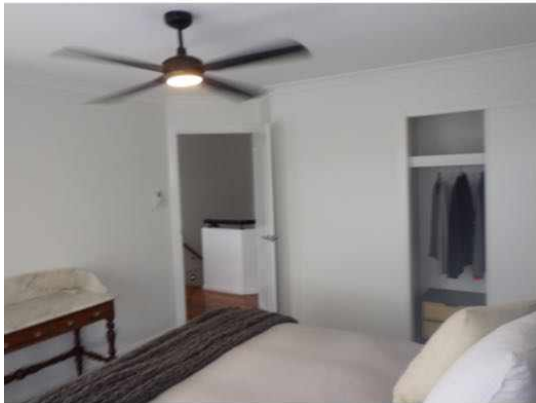
Building: Main Building  
Location: Bedroom 2 > Existing  
Finding: No obvious defect  
Information: No obvious defects found at the time of inspection.

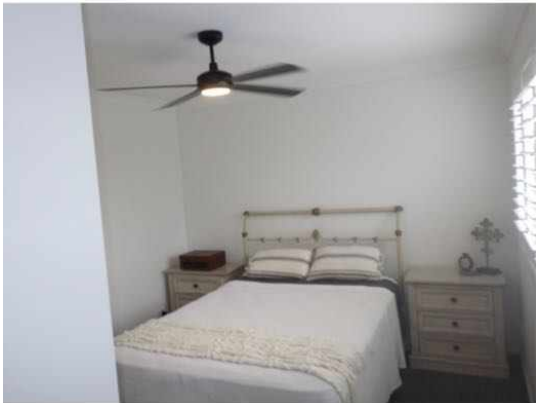
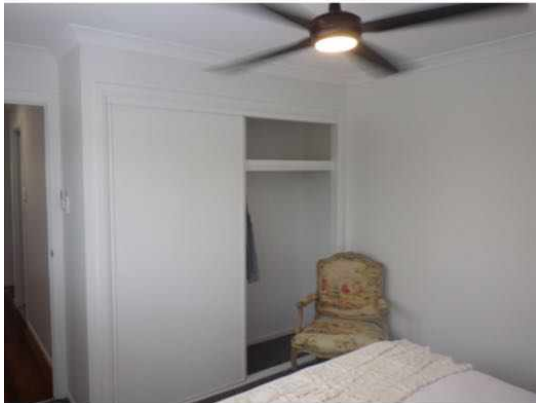
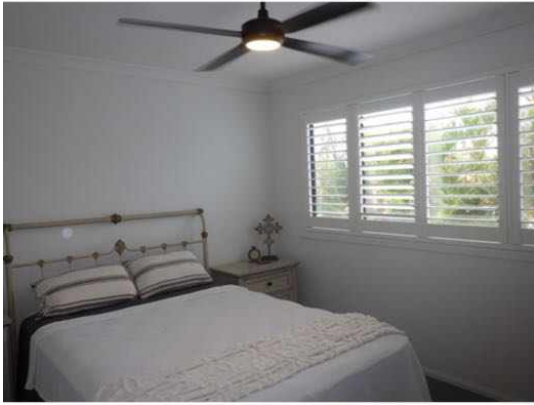
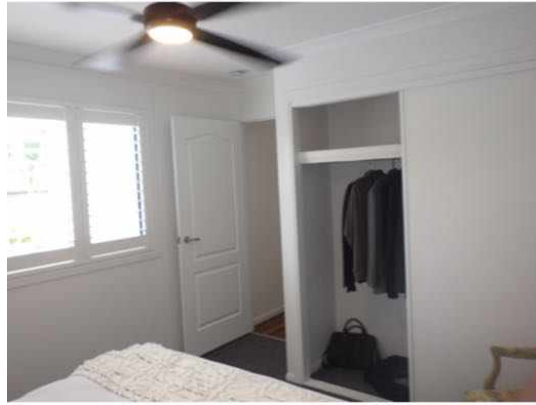
Building: Main Building  
Location: Bedroom 3 > Existing  
Finding: No obvious defect  
Information: No obvious defects found at the time of inspection.

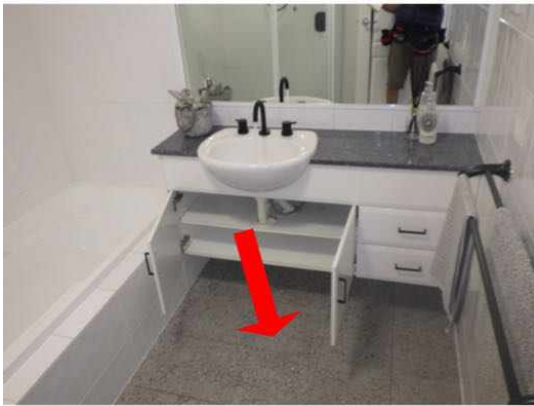
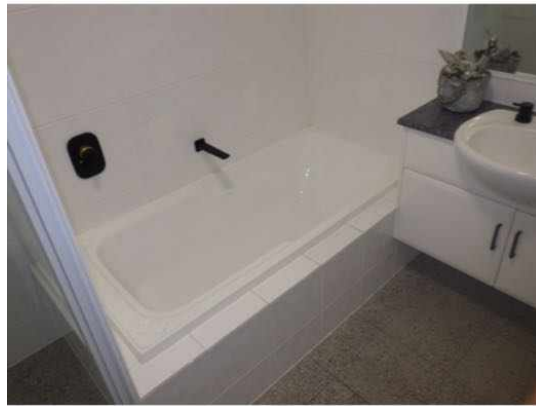
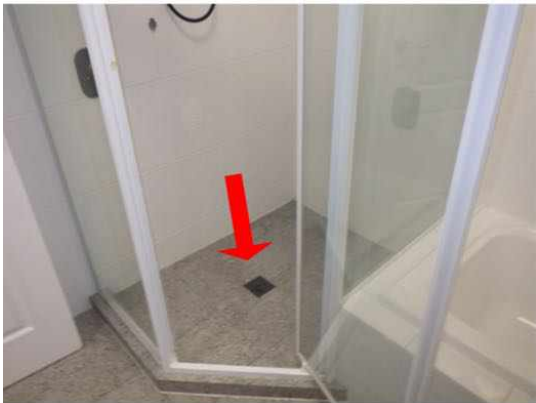
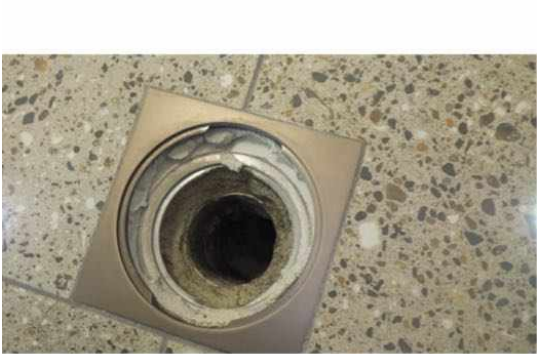
Information: At the time of inspection it was suspected new floor tiles have been laid directly over existing floor tiles in the bathroom and bathroom shower cubicle areas. Although no drummy or deteriorated tiles were observed, tiling over existing tiles can mask underlying issues such as water damage or mould. If the original waterproofing membrane is compromised, it may lead to future problems or issues.

Regular monitoring of the area is advised and if any visual signs of excessive moisture appear (peeling paint, mould) then consultation with a qualified builder or bathroom specialist would be advised.

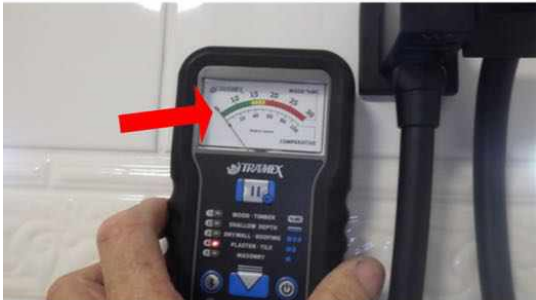
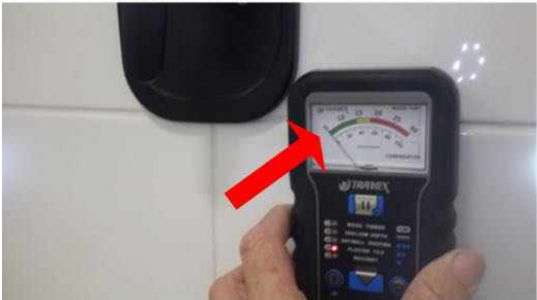
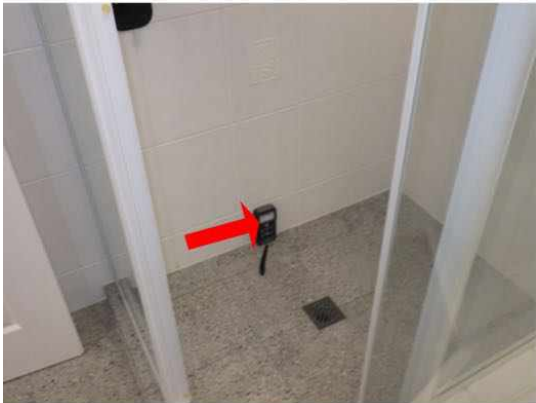
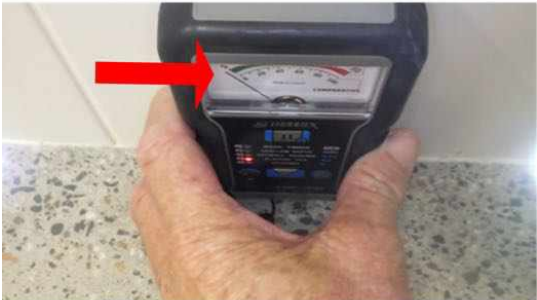
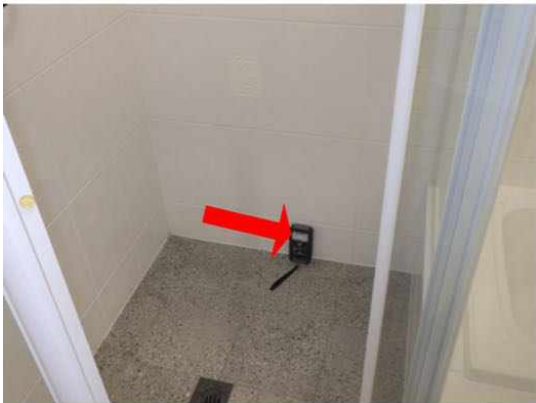
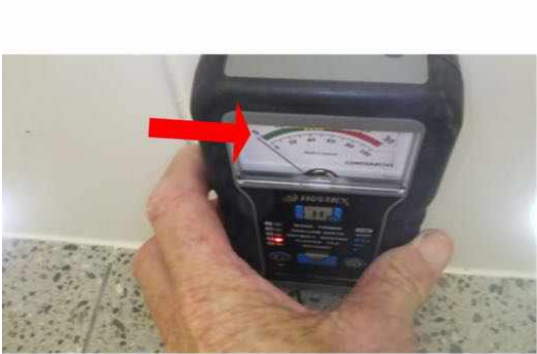
Building: Main Building  
Location: Bathroom > Existing  
Finding: Moisture Level Readings  
Information: At the time of inspection the bathroom shower cubicle areas checked with the Tramex Moisture Meter returned low - normal moisture level readings.

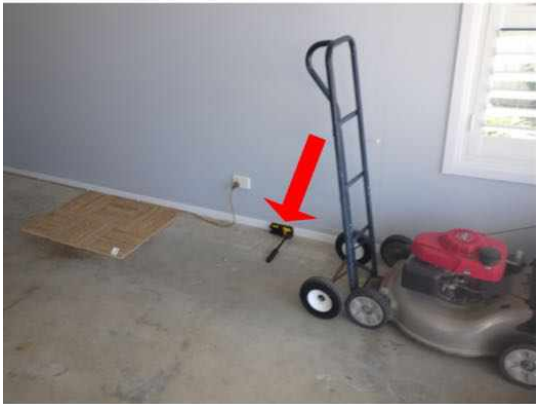
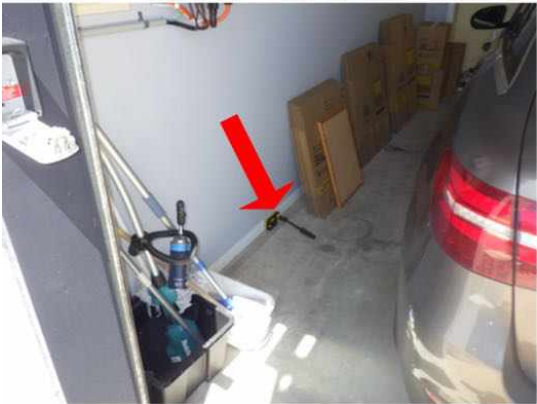
Building: Main Building  
 Location: Internal Areas > Existing  
 Finding: Termitracker  
 Information: The termitracker itracker was positioned randomly to internal wall, timber skirting and window frame areas checking for signs of termite activity.

No activity was recorded at the time of inspection.

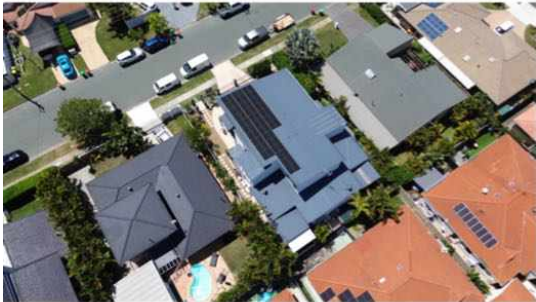
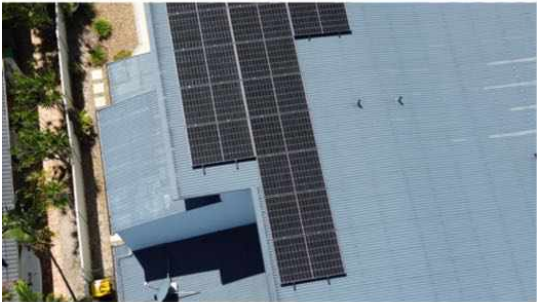
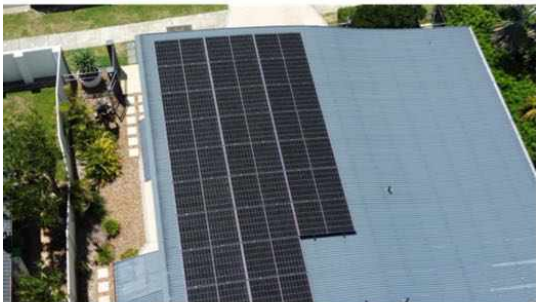
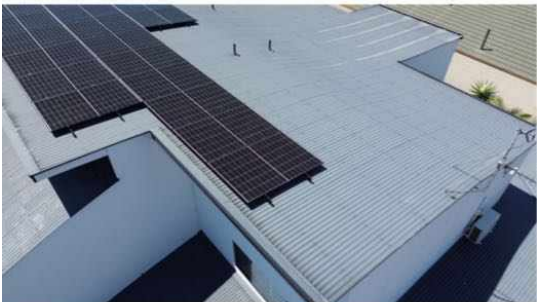
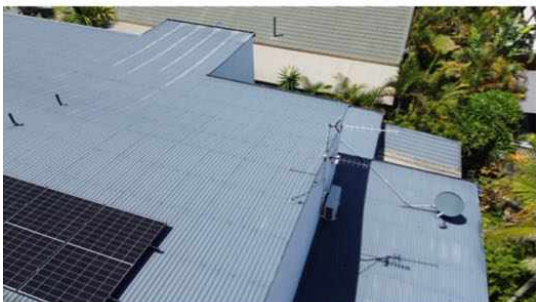
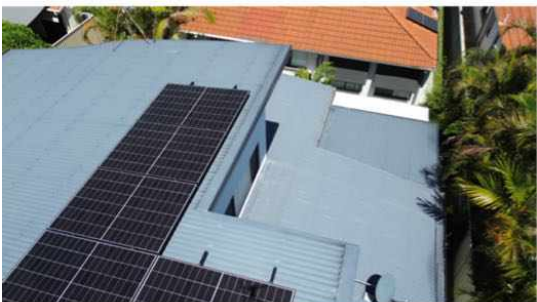
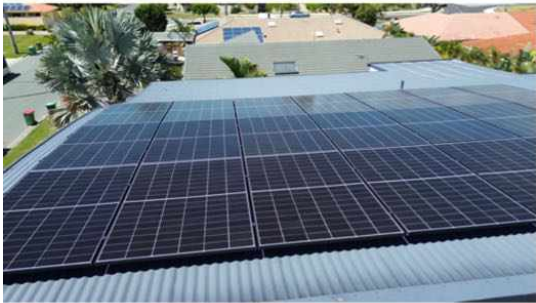
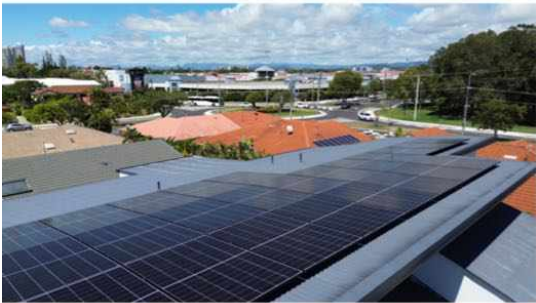
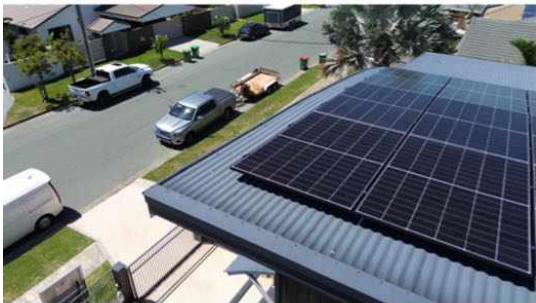
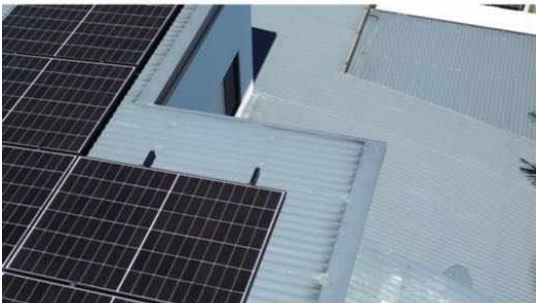
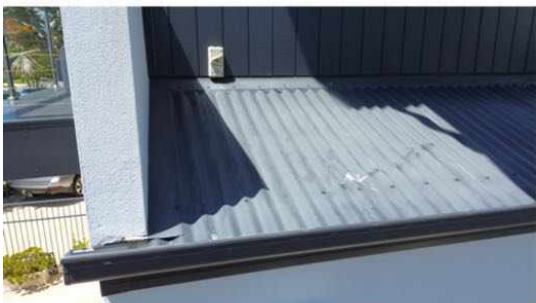
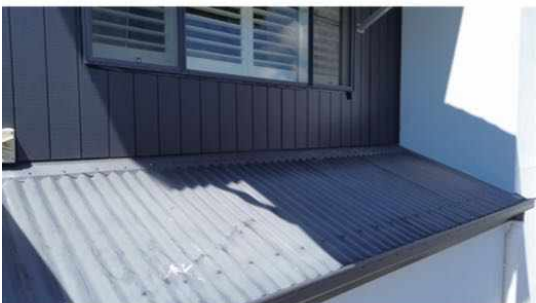
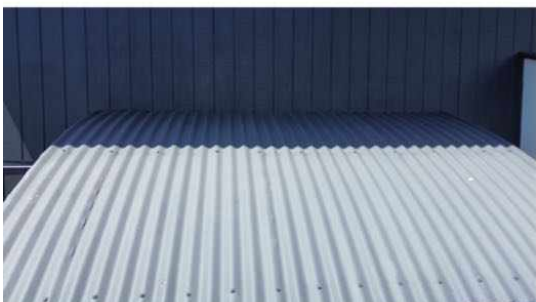
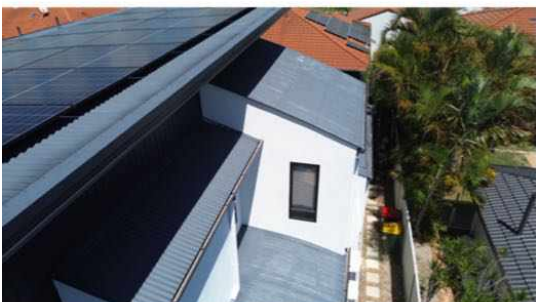
Noted Item

Building: Main Building  
Location: Roof Exterior > Existing  
Finding: Roof Photos  
Information: Roof area photos were taken with the DJI Mini 3 Drone flown over the roof at the time of inspection.
