Building and Timber Pest Inspection Report

Inspection Date: Tue, 24 Feb 2026

Property Address: 3/612 Prune St, Lavington NSW 2641,
Australia

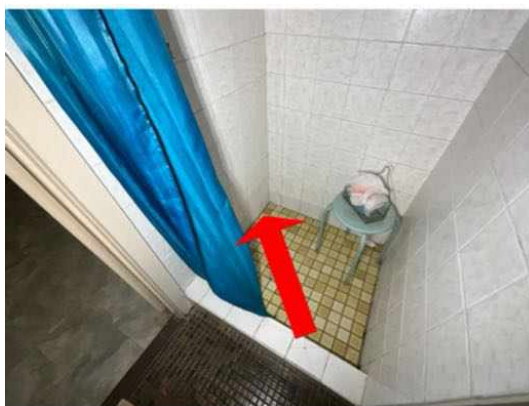
Building: Building 1
Location: Kitchen, shower
Finding: Wall Tiles- Cracked
Information: Cracked tiles within the household detract from the overall appearance of the affected areas, as well as creating potential for water penetration to adjoining building elements. If left unmanaged, water damage may occur as a result of constant water penetration over a prolonged period of time.

While not considered a matter of urgency, replacement of tiles is advised as a solution. A Tiling Contractor may be appointed to perform these works at client discretion.

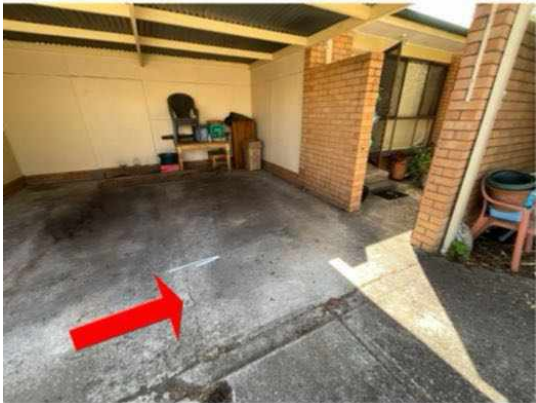
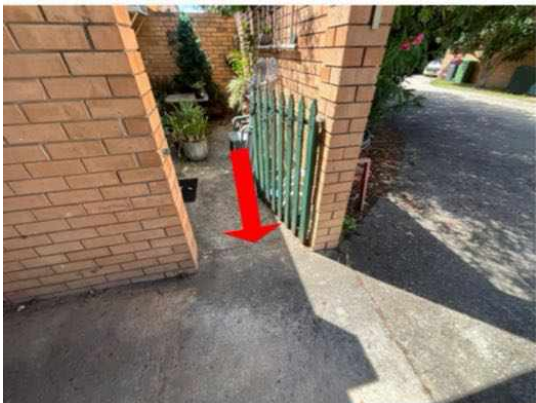
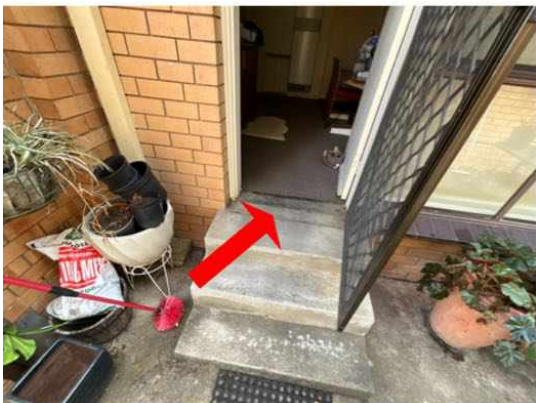
Building:	Building 1
Location:	Yard - Front, carport, entry
Finding:	Cracking - External Concrete Paving Damage Category 2 - Distinct (less than 3mm)
Information:	Distinct cracks were identified in external concrete paving. Distinct cracks are generally found in older concrete paving, and may also present as a trip hazard as consequence of an uneven or curved surface.

General age and expected deterioration of the paved areas is a common cause of this type of cracking. However, expansion and contraction of the slab may also have occurred due to environmental factors. Such factors include variable moisture and weather conditions, the presence of trees and their roots having a settling or lifting affect on the soil, or the effect of load bearing, e.g. heavy vehicles over a sustained period of time.

Cracking to this degree may also be due to poor original installation of the concrete. Factors such as poor compaction of the sub surface and/or inadequate reinforcing of the slab may create cracking and other secondary defects.

Repairs are likely to be required to prevent further cracking and to reduce hazards associated with cracking, such as tripping. Monitoring of all cracking should be conducted frequently. Always contact a building inspector should cracks widen, lengthen, or become more numerous.

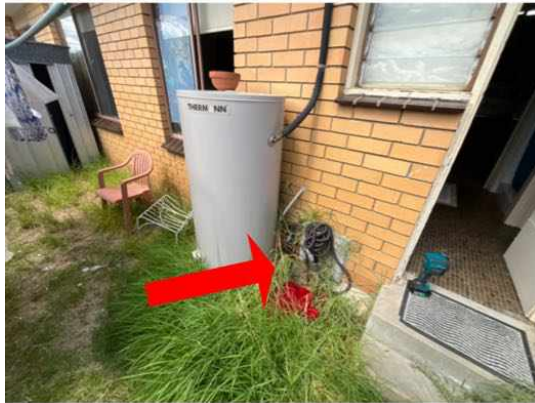
These damp conditions can lead to secondary defects such as rot, rust or corrosion of associated building elements, the formation of fungal decay, or even the creation of potential slip hazards. When coupled with poor site drainage, pooling of water may also attract termite activity to this area.

It is highly recommended that a licensed plumber be appointed to connect the HWS overflow in order to prevent such an environment from being created. These minor works should be carried out as soon as possible.

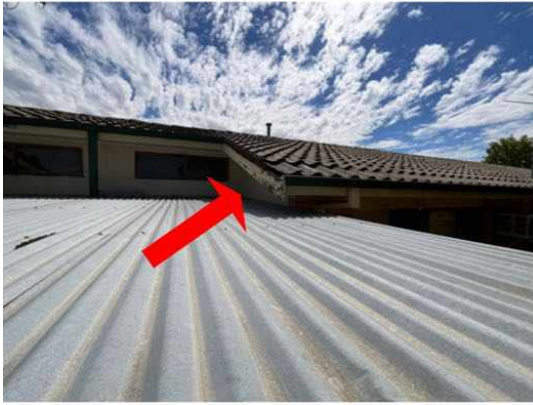
Building:	Building 1
Location:	Eaves
Finding:	Timber - exposed to weather
Information:	External timbers that are frequently exposed to harsh weather conditions require adequate protection in order to maintain their condition. Where timbers have not been painted or treated adequately, general deterioration is likely to occur at an accelerated rate.

If left unattended, replacement of these timbers is likely to be necessary in the short-term future. Adequate treatment of these timbers is required as soon as possible by a painting contractor or general handyman.

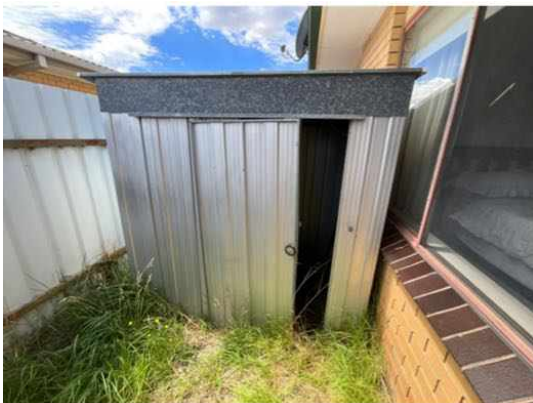
Building:	Building 1
Location:	Shed
Finding:	Untreated or non-durable timbers in a hazardous environment
Information:	To reduce the risk of timber pest attack it is essential that timber used in a hazardous environment (e.g. in direct contact with the ground or frequently exposed to damp conditions) is of sufficient durability and/or is adequately preservative treated.

Untreated timbers in direct contact with the ground are likely to develop severe wood rot and/or fungal decay if left unattended creating attraction for subterranean termites to infest the timbers from surrounding areas.

If untreated or non-durable timbers are found to be in a hazardous environment it is highly advised that replacement of these building elements be performed as soon as possible to aid the protection of the property against termite / timber pest attack.

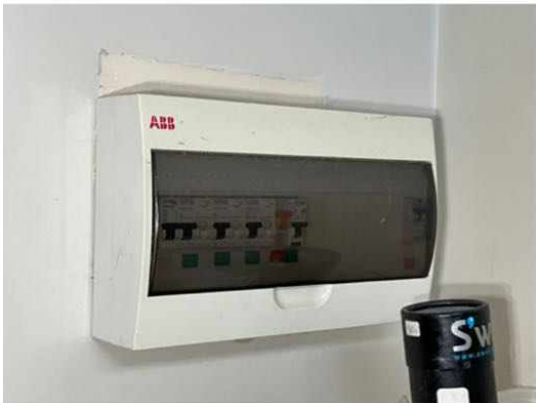
A durable notice should be placed in the switchboard unit to indicate current termite barriers. At the time of inspection, it appeared as though no termite management system has been installed, with no evidence to suggest preventative works taking place.

The client may consider gaining further advice from a pest controller as to the costs and procedures involved with this application. It is recommended that obtaining such advice be a short-term priority.
