Building Inspection Report

Inspection Date: Mon, 30 Mar 2026

Property Address: 607 Heather Grove, Clyde North VIC 3978,
Australia

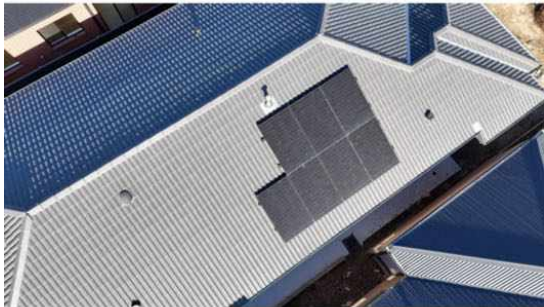
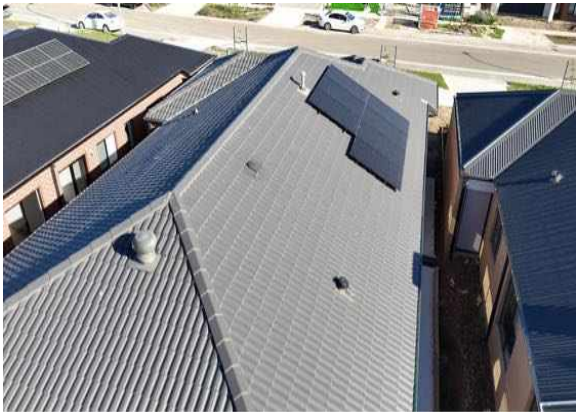
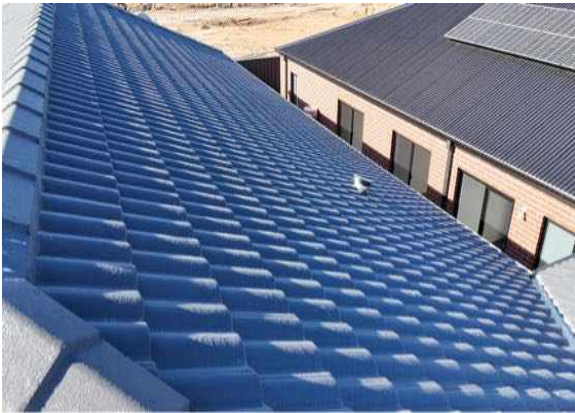
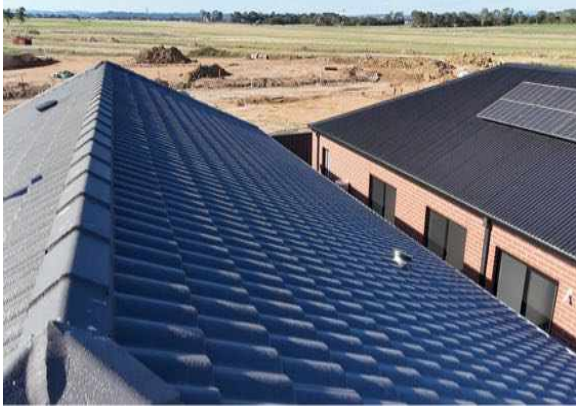
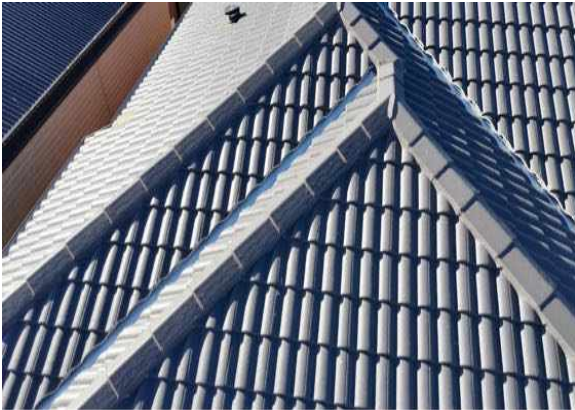
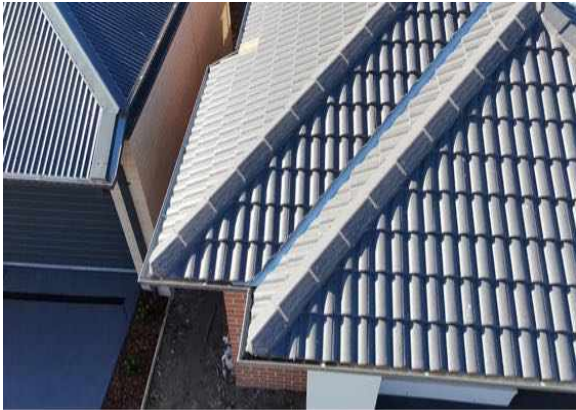
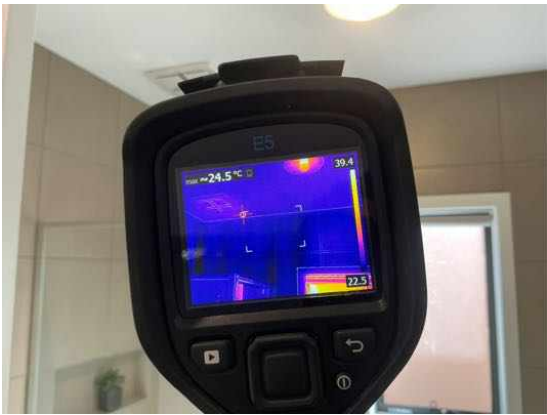
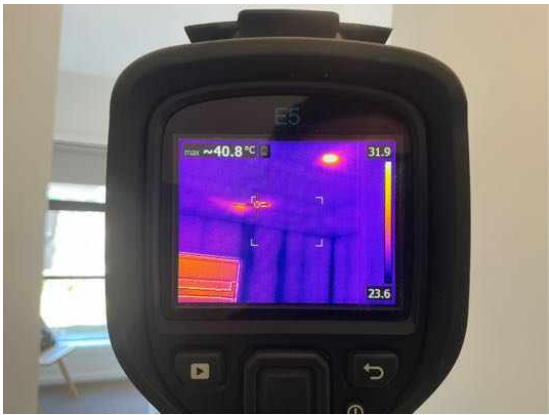
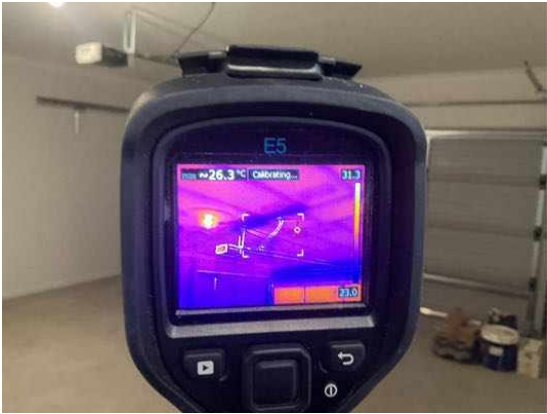
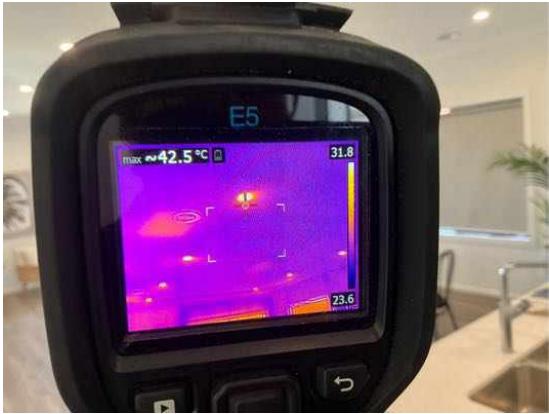
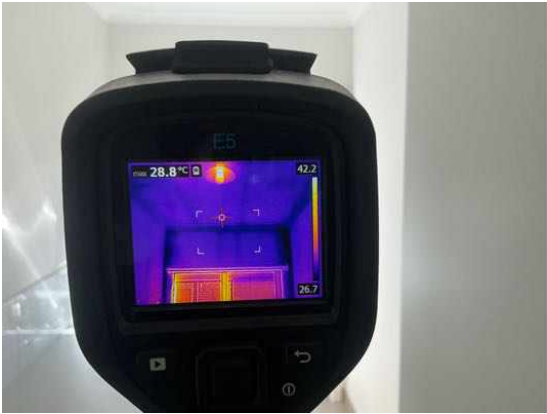
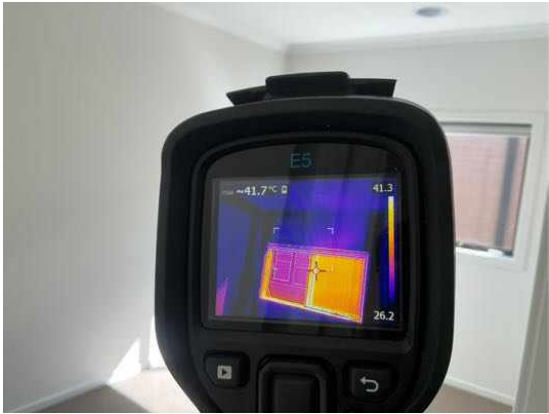
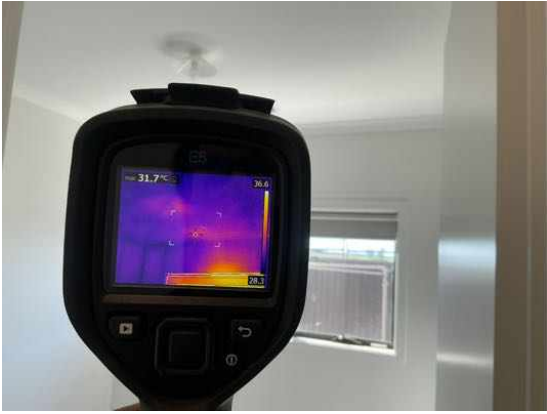
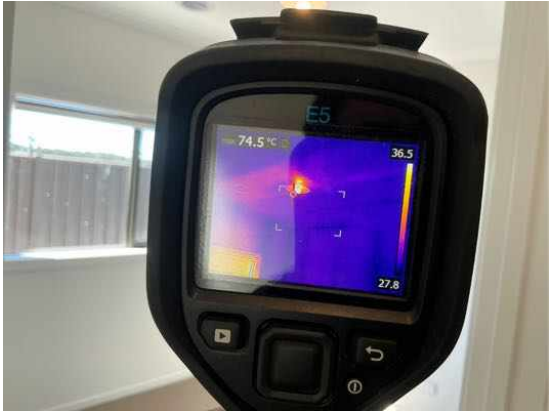
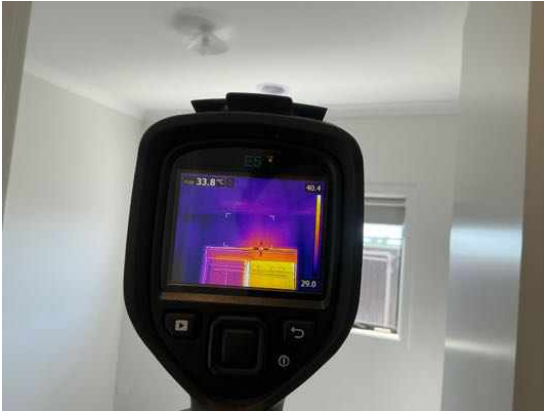
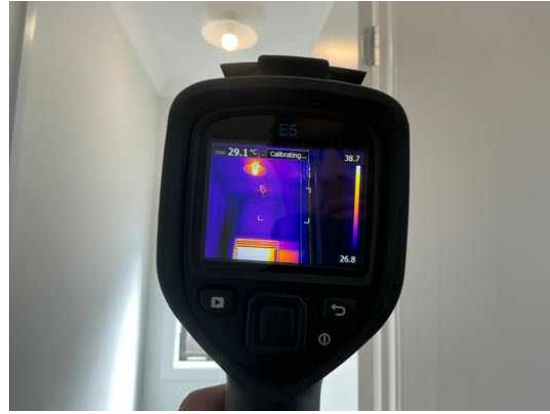
Building: Main Building
Location: All Areas
Finding: Additional Photos
Information: Additional photos are provided for your general reference
