# Building and Timber Pest Inspection Report

Inspection Date: Fri, 30 Jan 2026

Property Address: 3 Clyde Ct, West Wodonga VIC 3690,  
Australia

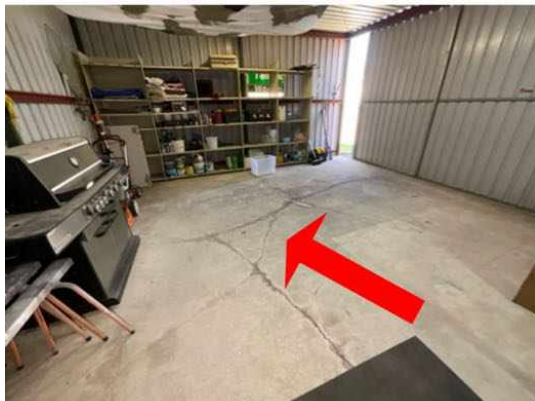
Cracking to this degree may also be due to poor original installation of the concrete. Factors such as poor compaction of the sub surface and/or inadequate reinforcing of the slab may create cracking and other secondary defects. Gaps in the concrete paving may also have a more significant structural cause, such as subsidence of soils.

Where gaps in the concrete paving are adjacent to structural elements of the building, the advice of a Structural Engineer is advisable before undertaking repairs. Significant repair and likely replacement of the concrete paving is probable.
