Building and Timber Pest Inspection Report

Inspection Date: Thu, 8 Jan 2026

Property Address: 11 Sonia Ct, West Wodonga VIC 3690,
Australia

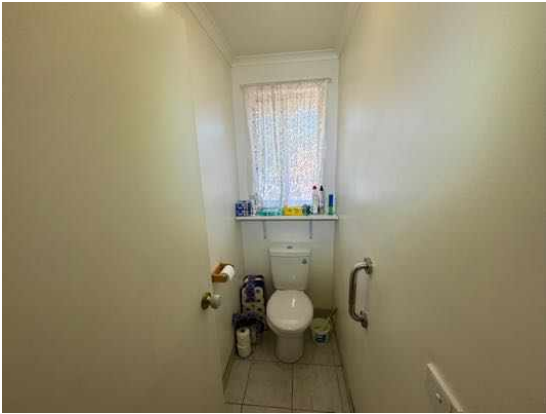
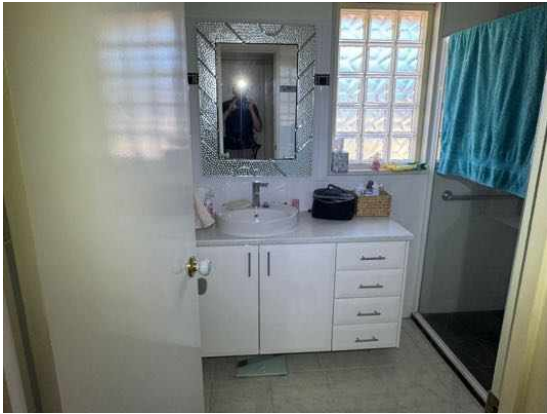
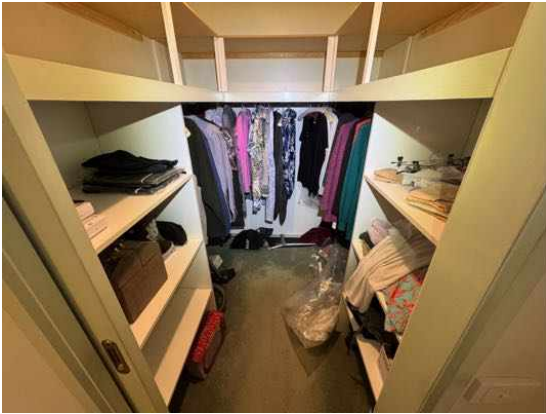
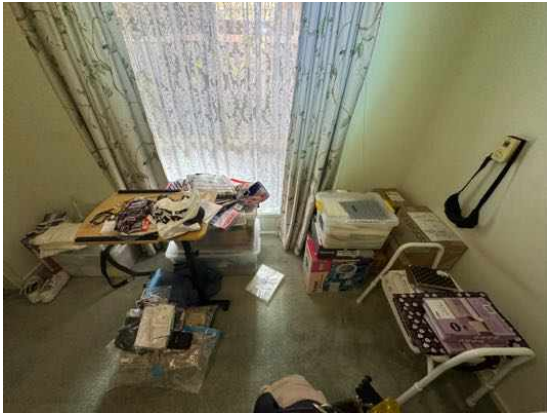
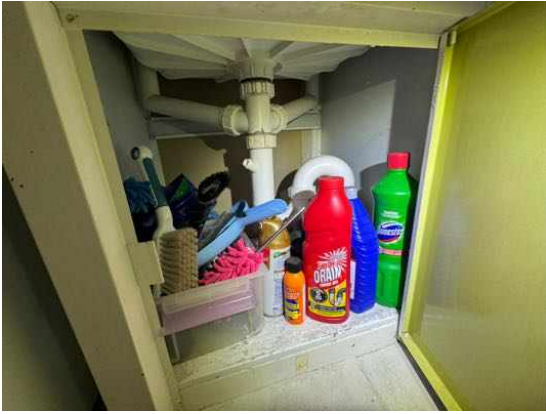
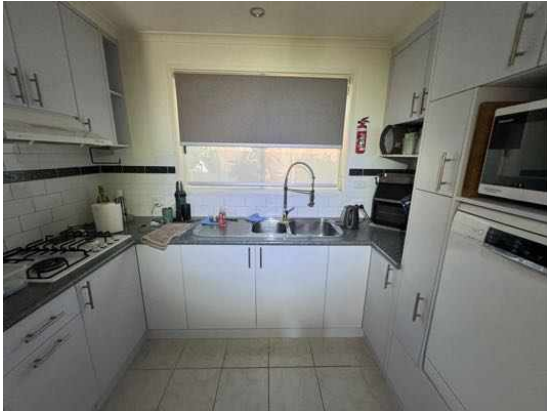
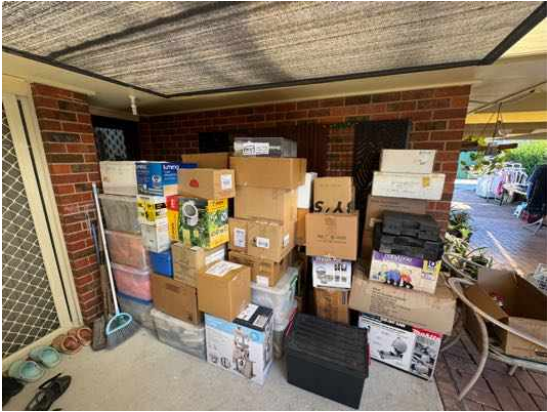
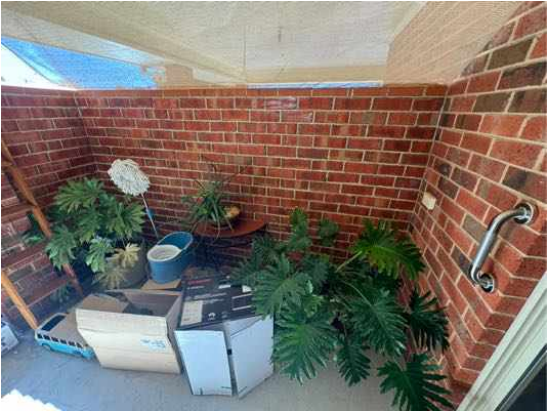
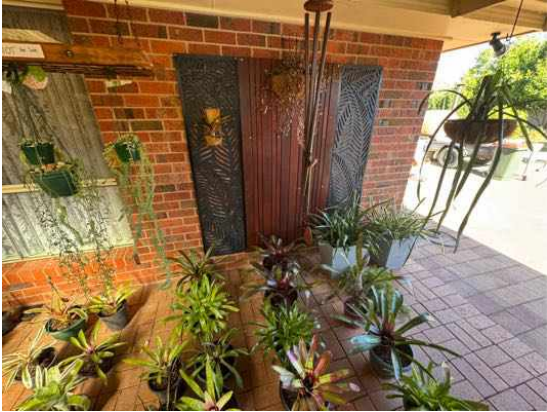
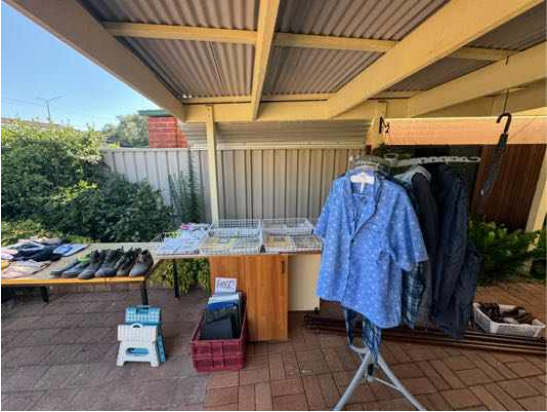
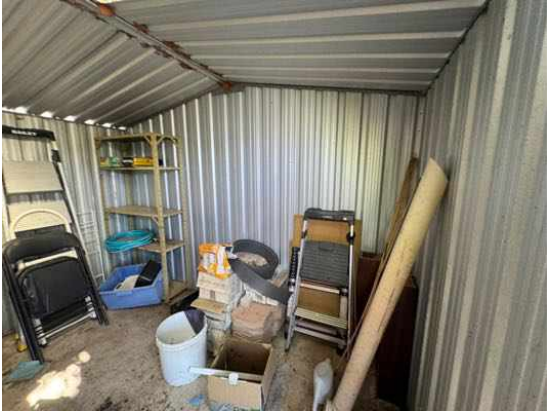
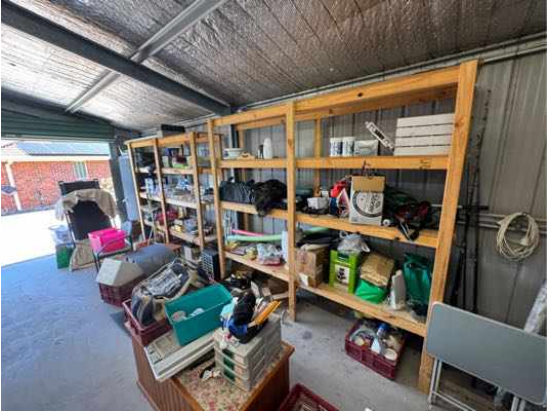
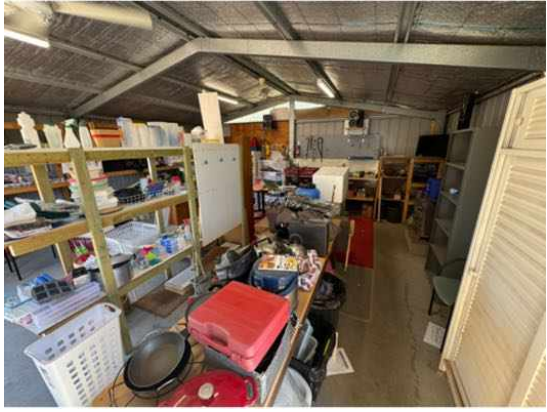
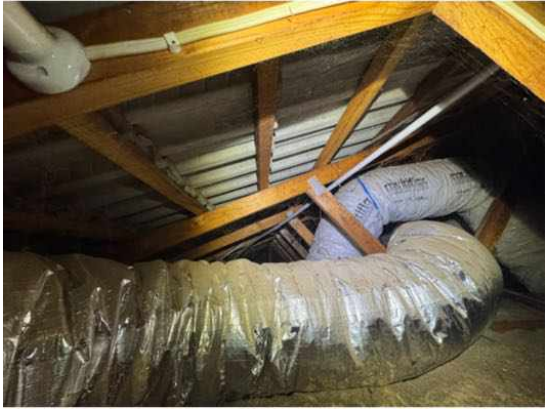
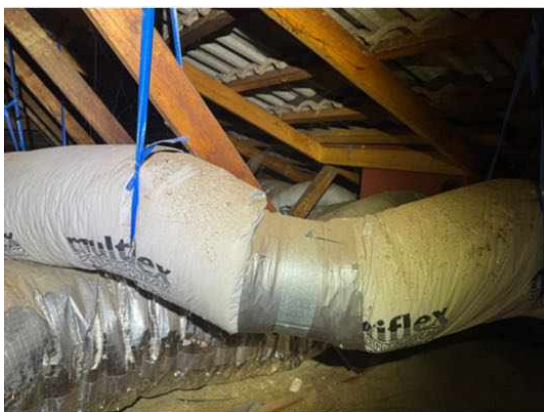
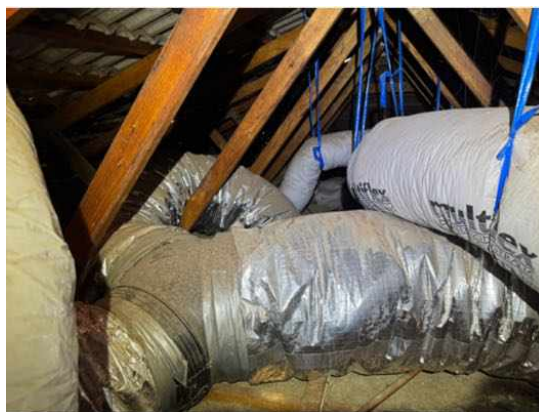
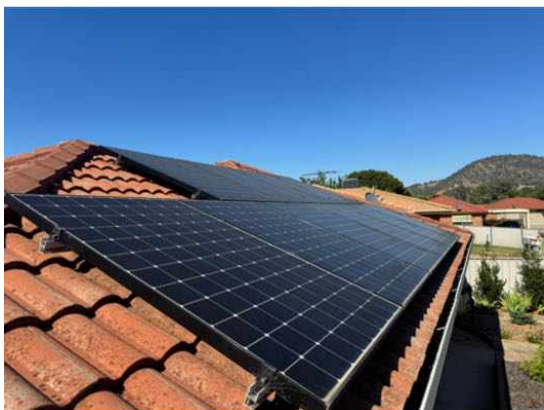
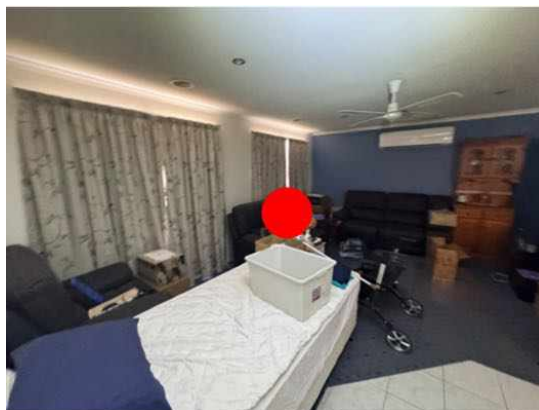
Building: Main Building
Location: All Areas
Finding: Additional Photos - Obstructions and Limitations
Information: These photographs are an indication of the obstructions and limitations which impeded full inspection of the property at the time of inspection. These obstructions can hide an array of defects and should be removed to allow full inspection to be carried out. A re-inspection is recommended once the areas are made accessible.
