# Building and Timber Pest Inspection Report

Inspection Date: Thu, 29 Jan 2026

Property Address: 3 Quail Pl, Modbury Heights SA 5092,  
Australia

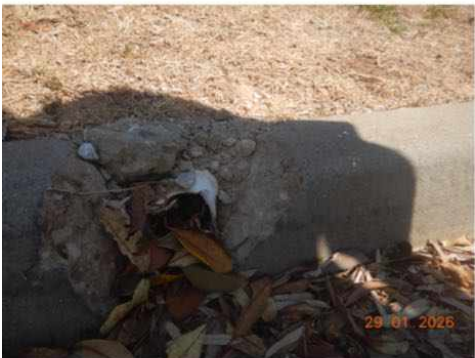
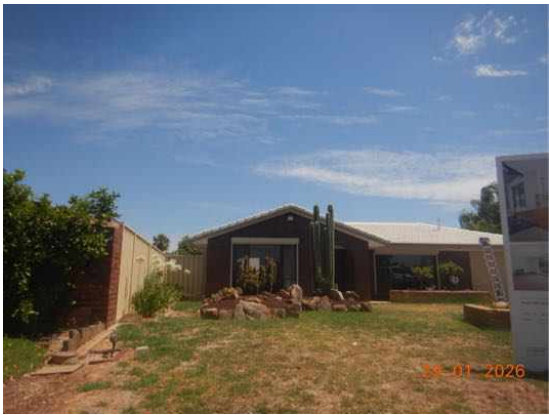
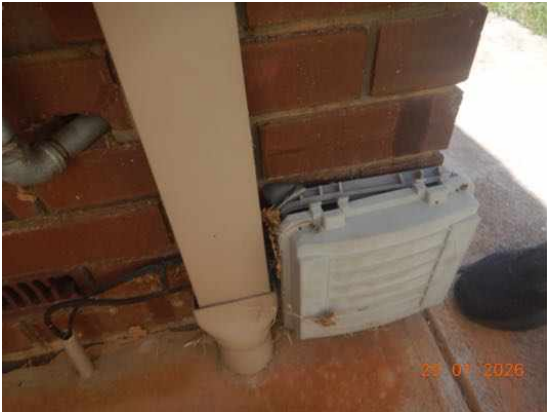
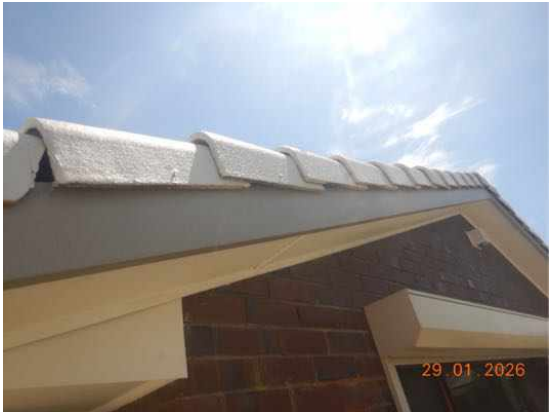
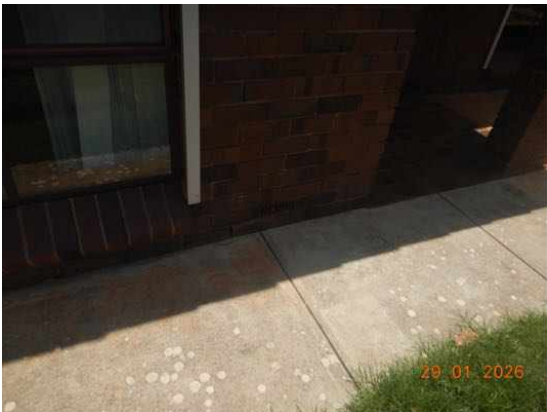
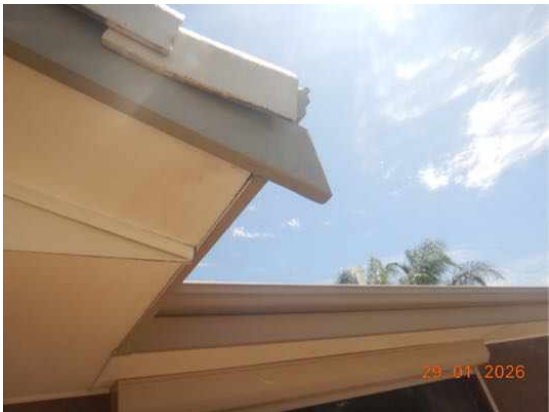
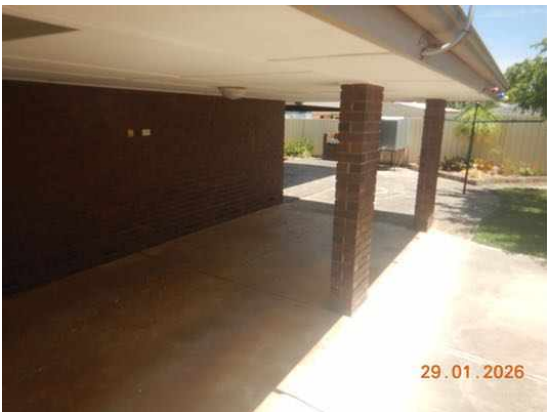
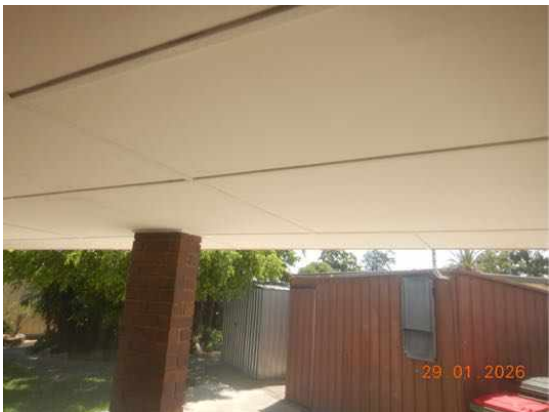
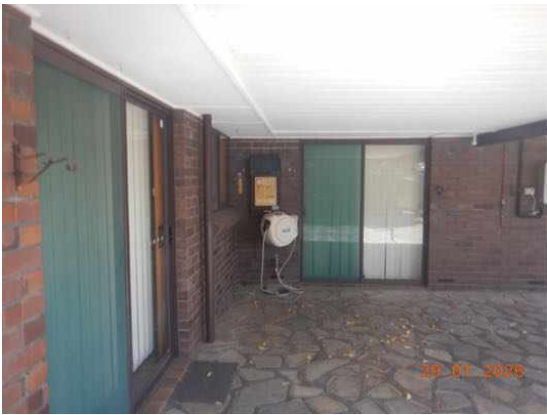
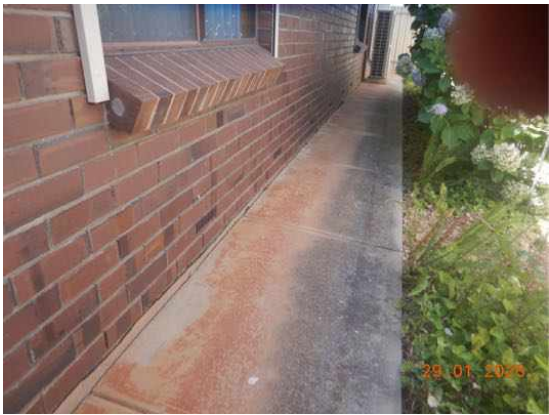
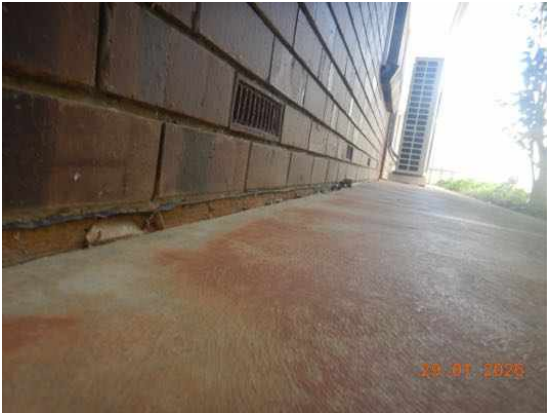
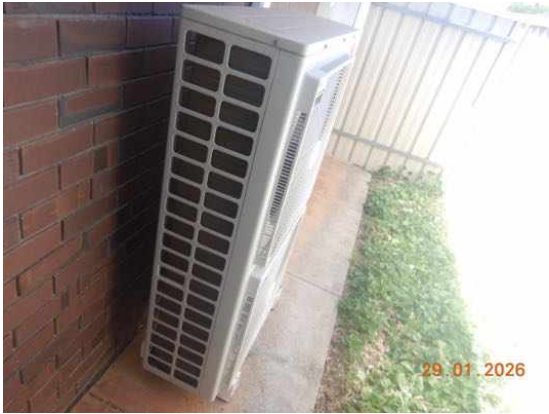
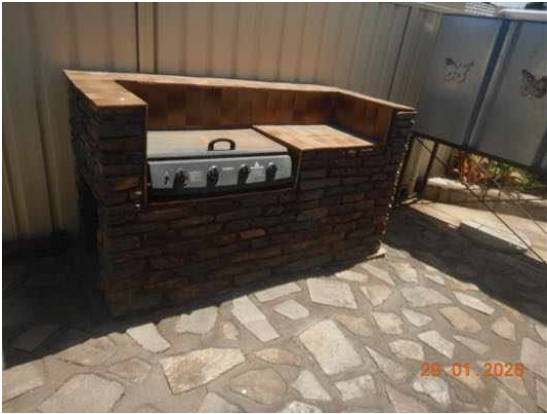
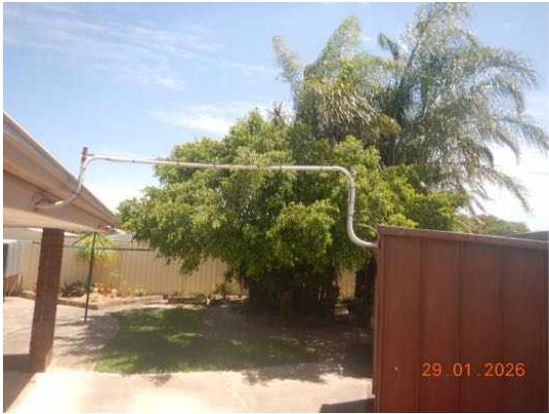
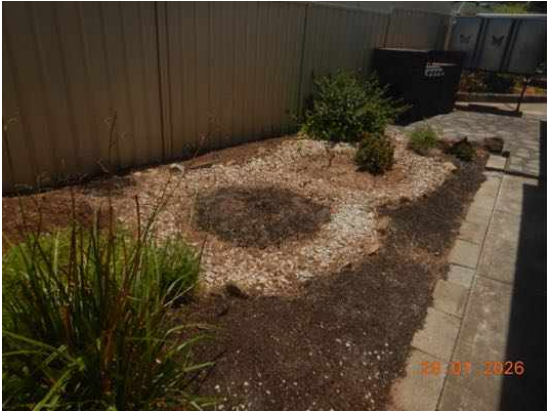
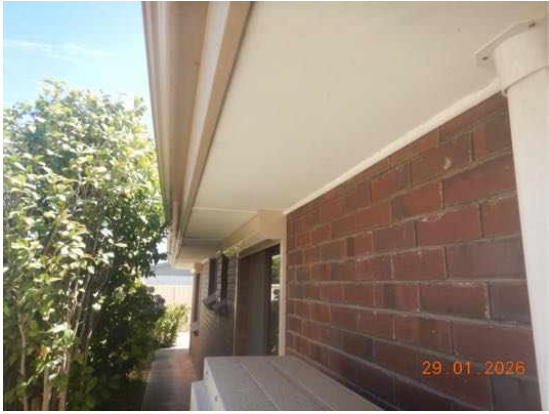
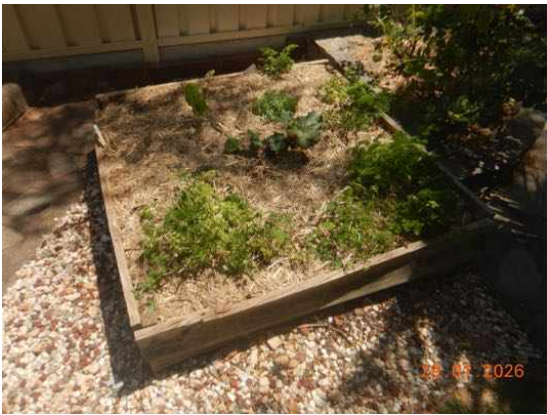
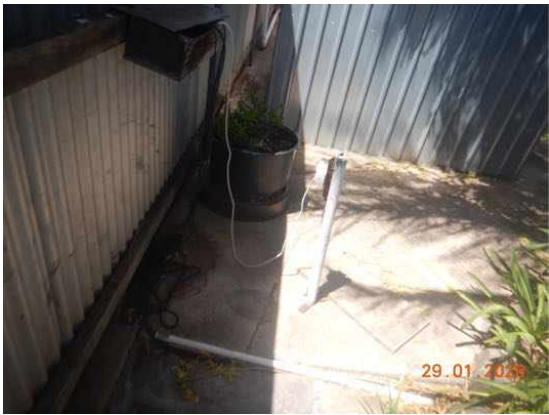
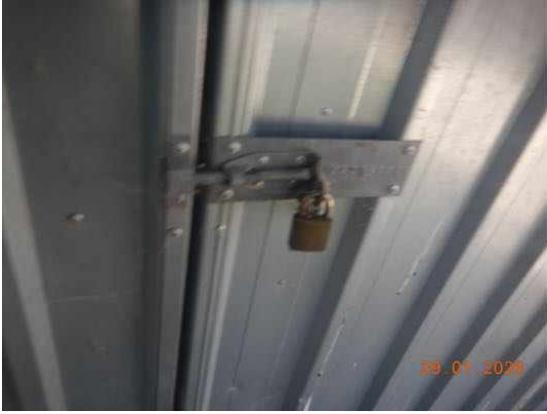
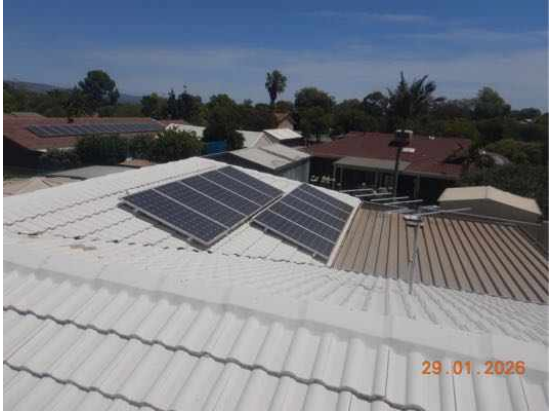
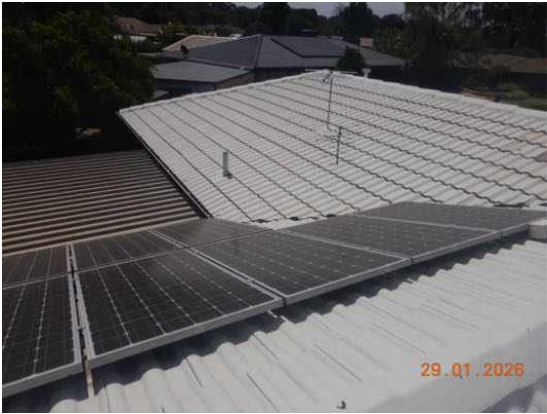
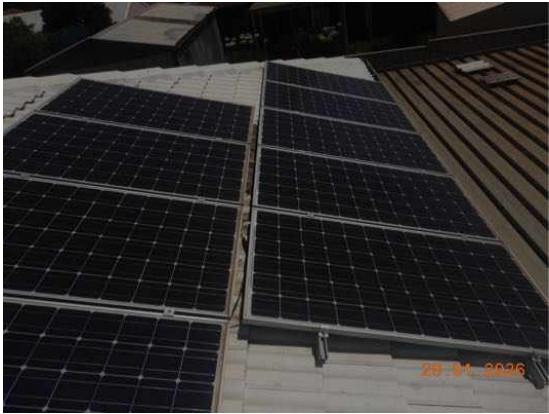
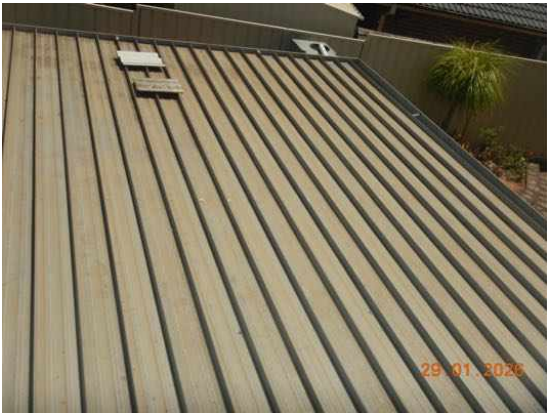
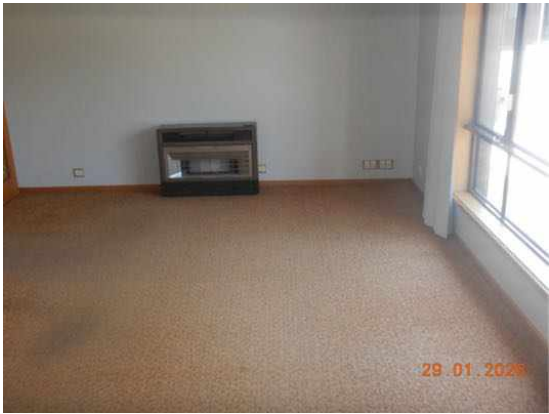
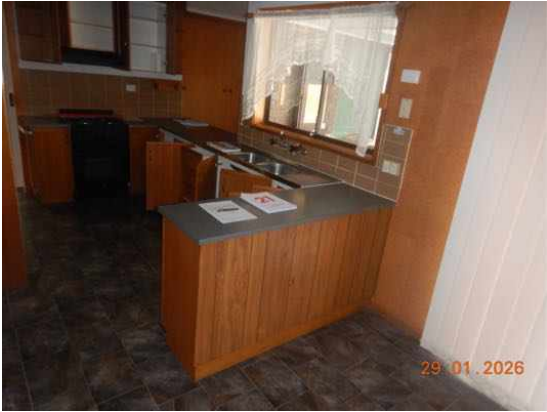
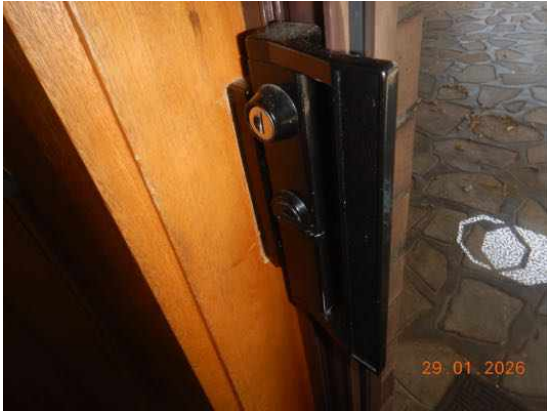
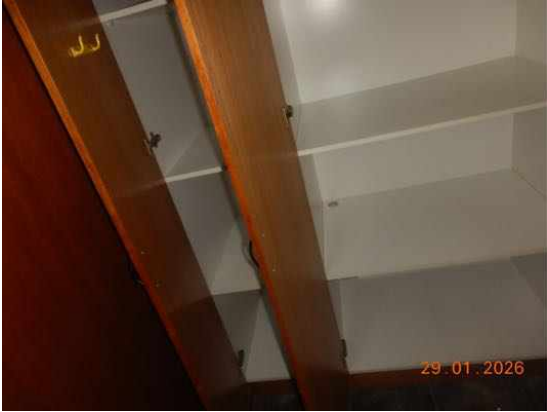
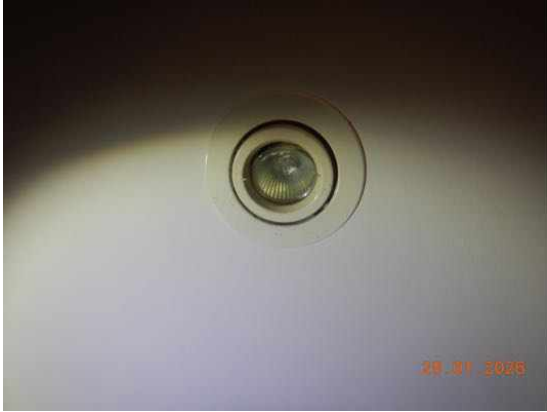
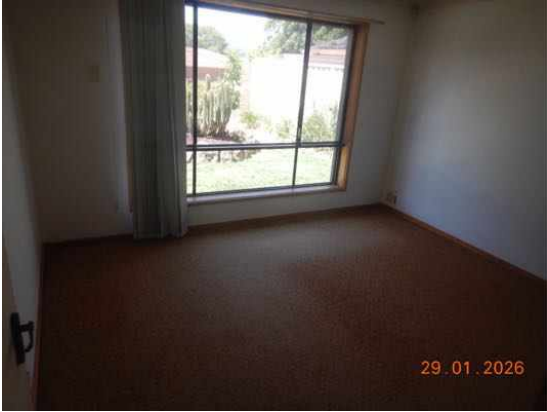
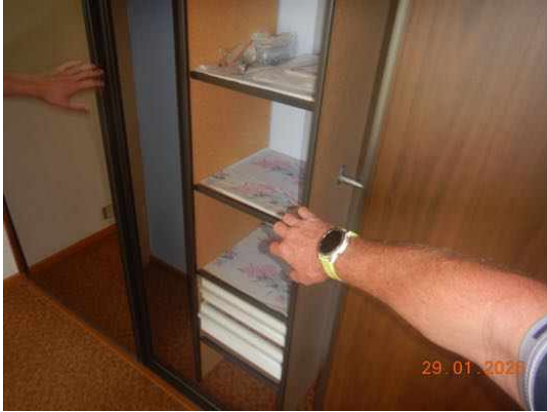
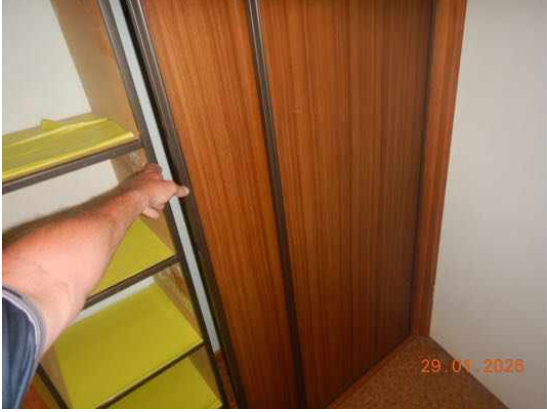
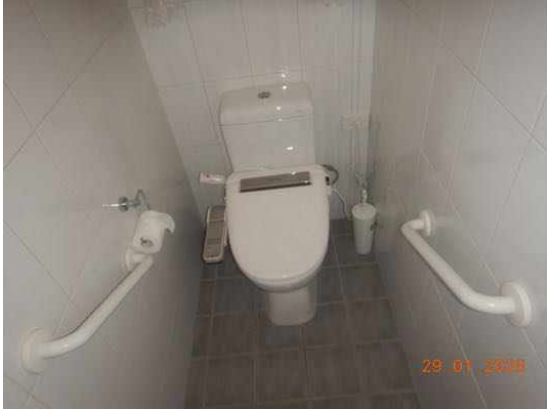
Building:	Building 1
Location:	All Areas
Finding:	Additional Photos - Obstructions and Limitations
Information:	These photographs are an indication of the obstructions and limitations which impeded full inspection of the property at the time of inspection. These obstructions can hide an array of defects and should be removed to allow full inspection to be carried out. A re-inspection is recommended once the areas are made accessible.
