Building and Timber Pest Inspection Report

Inspection Date: Thu, 5 Feb 2026

Property Address: 43 St Pauls Way, Blacktown NSW 2148,
Australia

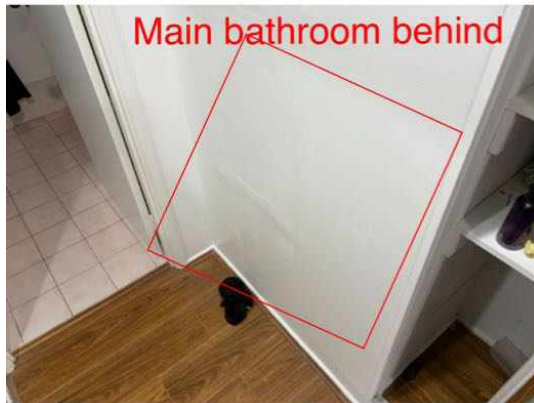
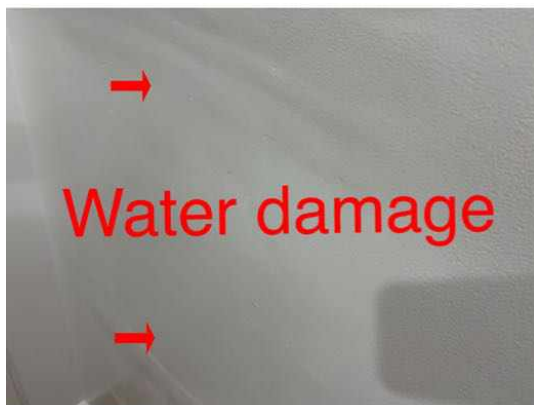
Building:	Main Building
Location:	Master
Finding:	Waterproofing damage - Suspected
Information:	Excessive moisture was detected in these areas at the time of inspection. Internal water leaks can be detrimental to surrounding building elements. The potential cause in this area is damage to the waterproofing membrane inside the shower recess.

Attracting termites, corrosion, mould, decay and water damage are potential outcomes where a minor water leak is left unattended. More serious defects may also result, such as electrical hazards, or water damage to structural building elements.

In extreme cases, structural damage may develop due to a prolonged water leak. It is highly advised that this issue be addressed immediately by a bathroom specialist as a matter of relative urgency.

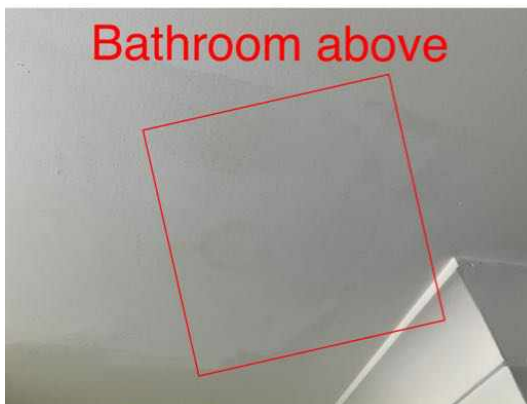
Finding 3.01

Building:	Main Building
Location:	Kitchen
Finding:	Water staining
Information:	Water staining was evident in this area at the time of inspection. Water staining indicates that surfaces have been exposed to excessive moisture over time. The minerals and other elements in the water lead to staining, which may graduate to corrosion and deterioration if left unmanaged.

While mostly an appearance defect, water staining can be indicative of more serious defects, which may be currently concealed by other building elements.

Where water staining is active, a licensed plumber must be consulted to identify the cause of the staining and to provide advice on any reparation works that may be required. Replacement of any broken or damaged structures is advised.

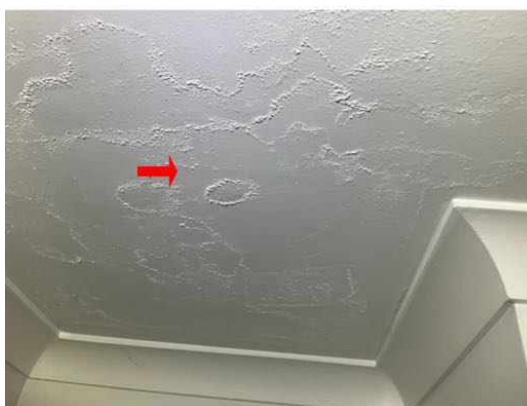
Finding 3.02

Building:	Main Building
Location:	Bathroom
Finding:	Ceiling - Water damaged
Information:	Water damage to the ceiling lining is generally an indication of excessive moisture being present in the roof void, usually via a leak to the roof covering. However since no damage was identified to the surface above in the roofvoid, it is suspected that lack of air ventilation and hence the excess moisture from regular shower use is the underlying reason.

It is highly recommended though that a roofing plumber should be appointed as soon as possible to ensure no water leaks are affecting the roof covering.

Then, consultation with relevant tradespeople, including plasterers and painters, is advised. Rectification works may include replacement of ceiling lining or minor repainting, depending on the extent of the damage.

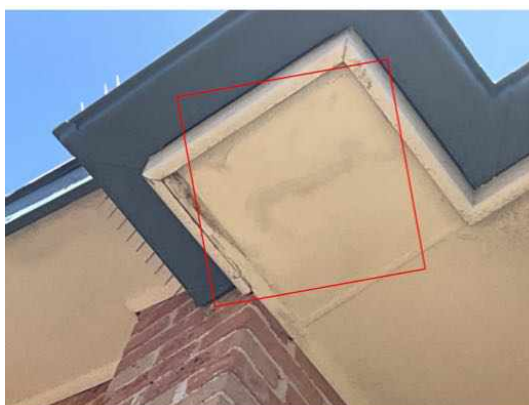
Finding 3.03

Building:	Main Building
Location:	Front right corner
Finding:	Eaves/Roof plumping -- water damages
Information:	Water damage is generally an indication of excessive moisture being present, usually via a leak. It is suspected that gutter blockages causing stormwater to backflow into the eaves causing water damages. This is additionally conducive to termite activity due to the damp conditions.

Where water damage is evident, the primary requirement is to identify and rectify the source of the leak. Gutters must be kept clear of any blockages moving forward. A roofing plumber should be appointed for further assessment if the problem persists.

Once the leak is repaired, consultation with relevant tradespeople, including carpenters, plasterers and painters, is advised.

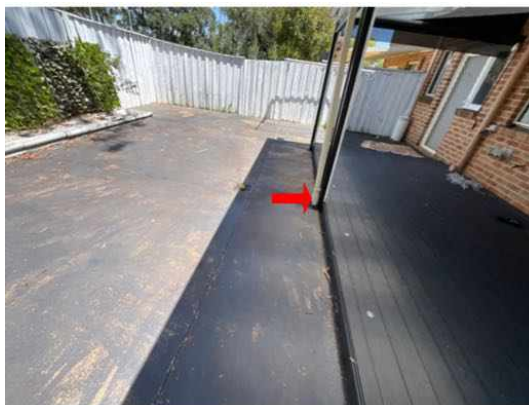
Finding 3.04

Building:	Main Building
Location:	Multiple areas
Finding:	Stormwater drain - Not connected
Information:	The roof plumbing is not adequately connected to stormwater drainage on the site.

Where roof plumbing doesn't drain adequately, the area at the base perimeter can become excessively damp, potentially creating an environment that is susceptible to rust and corrosion of surrounding building elements, as well as attracting termites and other pests.

It is highly recommended that a plumber be appointed to further inspect the area and to install adequate drainage equipment where necessary.

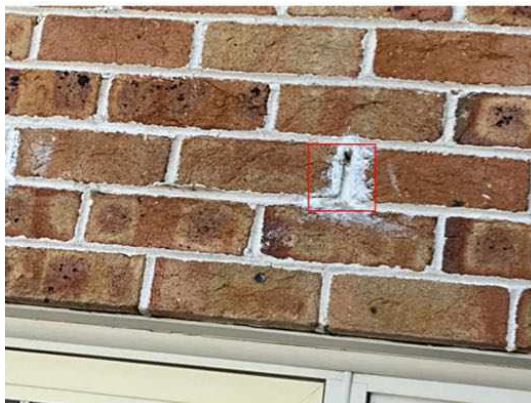
Finding 3.05

Building:	Main Building
Location:	Exterior walls - rear
Finding:	Blockage of weepholes
Information:	Weep holes in the exterior brickwork of the property are designed to allow condensation that may build up between the brickwork and subsequent timber framework to drain from within the wall hence preventing any deterioration of the timber building elements.

Build-up of moisture is likely to occur if weep holes are covered.

It is highly recommended that weep holes are left exposed in all areas throughout the external property. A general handyman must be appointed to ensure all weepholes are fully exposed.

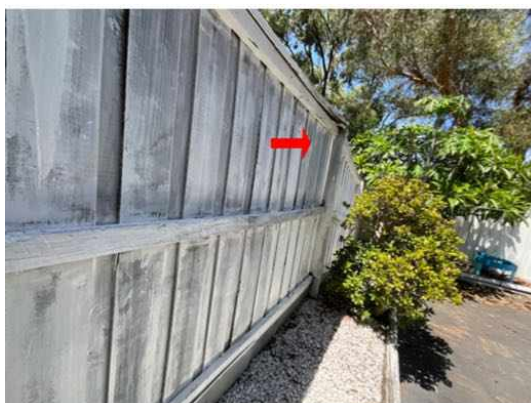
Finding 3.06

Finding: Fencing - Deteriorated

Information: It was noted at the time of inspection that sections of the fencing in this area has deteriorated. Typically fencing deteriorates due to age and or wear, rot and or rust which is generally expected for a structure of this age, due to prolonged exposure to weather conditions. Sometimes inadequate installation or maintenance can be to blame.

If left unattended, it is likely that further damage will occur. It is suspected that repair of several elements of the fencing may be required however replacement may be a consideration of the client also.

A licensed fencing contractor should be appointed to provide further advice and perform rectification works as necessary.

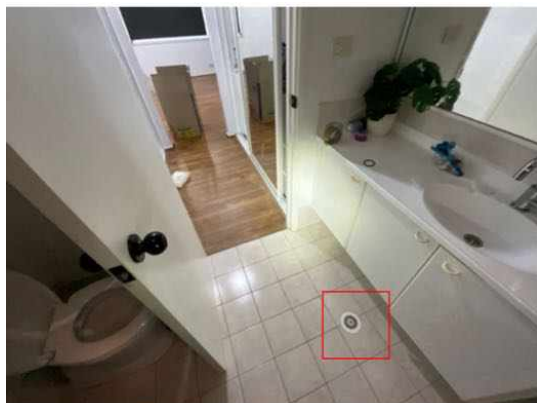
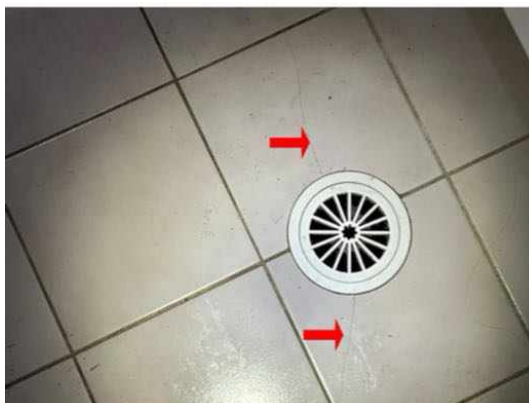
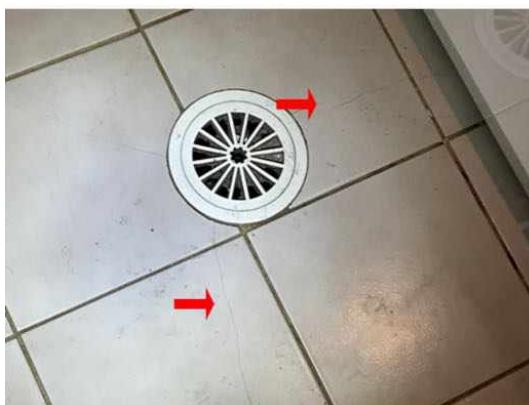
Finding 3.09

Building:	Main Building
Location:	Ensuite, bathroom
Finding:	Wet area tiles - Cracked or damaged
Information:	Cracking was evident to the tiling in this area at the time of inspection. While the cracking appears to be minor, this area is frequently exposed to water, allowing potential for water penetration into adjoining sections of walls or flooring.

If left unmanaged, water penetration to these areas may lead to subsequent water damage, which is likely necessitate repair work to affected building elements.

A bathroom specialist should be appointed to determine the integrity of the bathroom waterproofing membrane. If the membrane was found to be intact then relatively minor works to replace the cracked tiles should be carried out to ensure no further damage occurs. The re-application of silicone and grouting throughout remaining tile work is also advised, to further protect the area against water penetration.

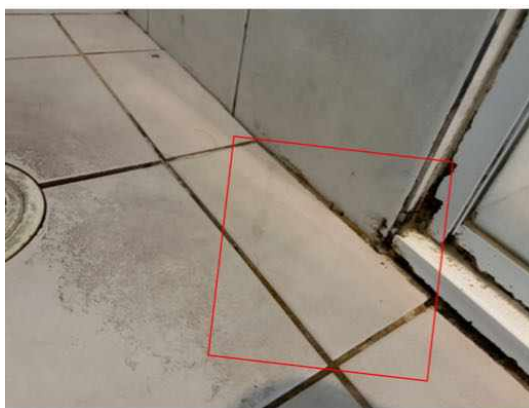
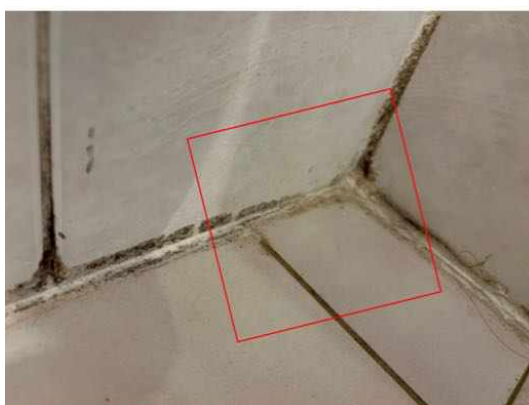
Finding 3.10

Building:	Main Building
Location:	All Wet Areas
Finding:	Sealant and grouting - Missing or damaged
Information:

It was noted on inspection that sealant or grout is degraded to this area.

Different materials and floor areas move at different rates, generally causing cracking to grout or sealant at this point. A flexible sealant is required to allow for expected expansion and contraction, while keeping the joint water tight and protective of all associated building materials.

Flexible and mould resistant materials should be applied to affected areas to prevent any subsequent water damage that is likely to occur. Regular maintenance and replacement of damage or missing or damaged sealant and grout is highly recommended to the wet areas, as this is a regular wear and tear defect. Sealant and grouting in areas that come into regular contact with water should be maintained for the long term care of your property.

A sealant specialist should be appointed to complete these works as soon as possible.

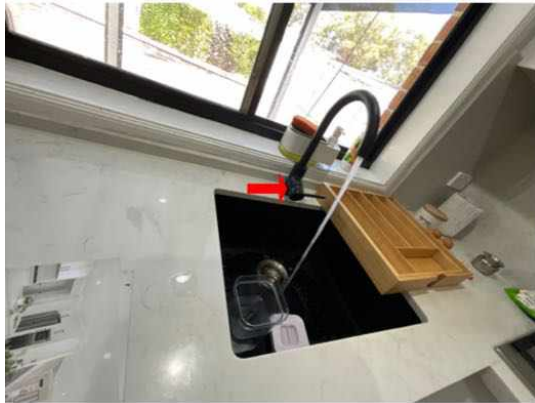
Building:	Main Building
Location:	Kitchen
Finding:	Plumbing fitting or fixture - Loose
Information:	The fitting in this area is loose and requires adjustment to tighten.

If left unmanaged, the fitting may further deteriorate, causing potential for the development of other minor secondary defects.

A licensed plumber should be appointed to perform these rectification works at discretion of the client.

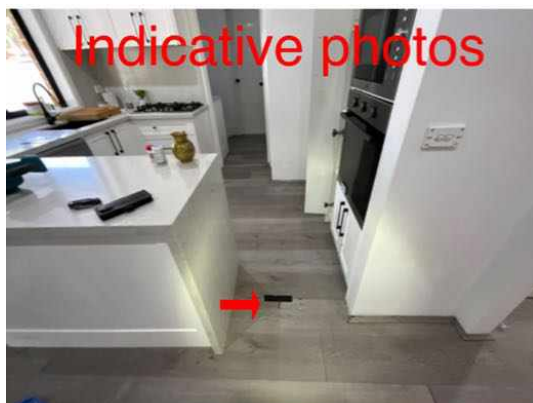
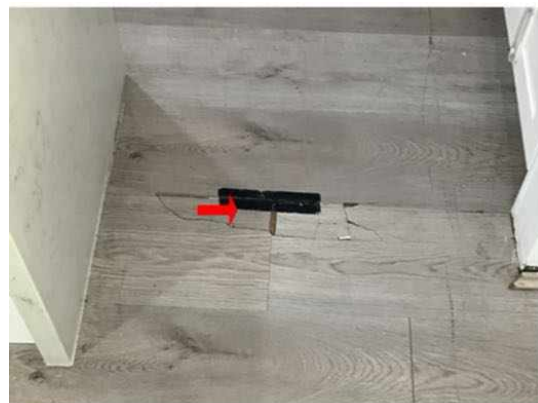
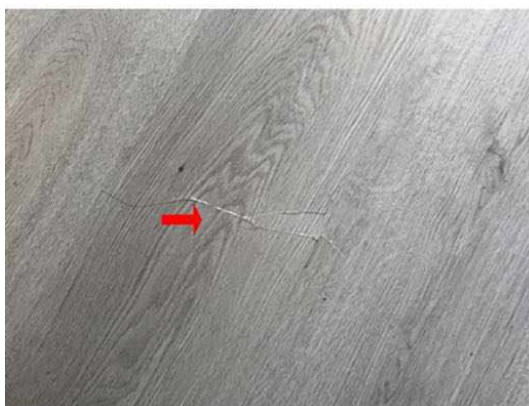
Finding 3.14

Building:	Main Building
Location:	Multiple areas of flooring
Finding:	Building element - Damaged
Information:	Breakage occurs generally when the building materials have either aged and decayed, or as a result of damage (accidental or deliberate).

Repair and/or replacement of broken elements is advised to ensure that additional secondary defects do not arise as a consequence. Such works are necessary, as all building elements play a key role in the operation and function of the overall structure and its performance.

A relevant tradesperson should be appointed to repair or replace the affected building element prior to any subsequent damage being caused.

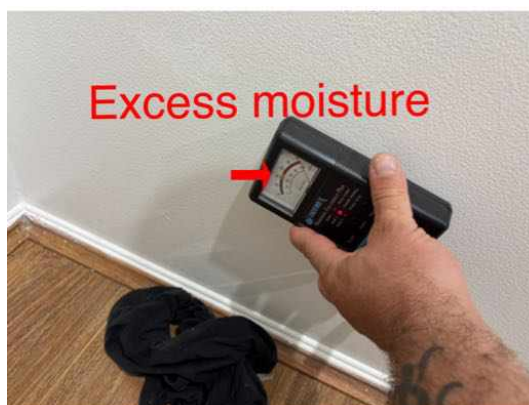
Building:	Main Building
Location:	Master
Finding:	Waterproofing damage - Suspected
Information:	Excessive moisture was detected in these areas at the time of inspection. Internal water leaks can be detrimental to surrounding building elements. The potential cause in this area is damage to the waterproofing membrane inside the shower recess.

Attracting termites, corrosion, mould, decay and water damage are potential outcomes where a minor water leak is left unattended. More serious defects may also result, such as electrical hazards, or water damage to structural building elements.

In extreme cases, structural damage may develop due to a prolonged water leak. It is highly advised that this issue be addressed immediately by a bathroom specialist as a matter of relative urgency.

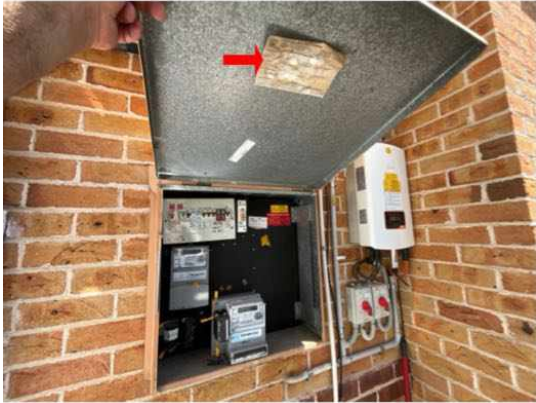
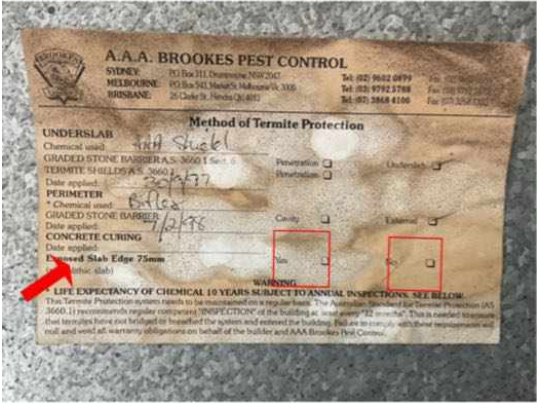
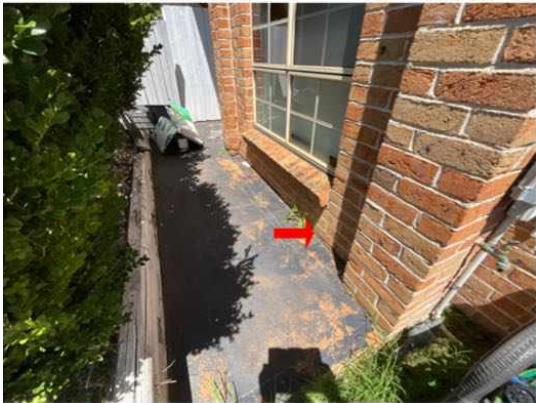
Finding 6.02

Building:	Main Building
Location:	Perimeter
Finding:	Slab Edge - Exposure
Information:	Slab Edge Exposure: Where external concrete slab edges are not exposed there is a high risk of concealed termite entry. In some buildings built since July 1995 the edge of the slab forms part of the termite shield system. In these buildings an inspection zone of at least 75mm should be maintained to permit detection of termite entry. The concrete edge should not be concealed by render, tiles, cladding, flashings, adjoining structures, paving, soil, turf or landscaping etc. Where this is the case you should arrange to have the slab edge exposed for inspection. Concealed termite entry may already be taking place but could not be detected at the time of the inspection. This may have resulted in concealed timber damage. Does the slab edge inspection zone fully comply?

Not able to comment. A very high proportion of termite attacks are over the edge of both Infill and other concrete slabs types. Covering the edge of a concrete slab makes concealed termite entry easy. Infill slab type construction has an even higher risk of concealed termite ingress as the slab edge is concealed due to the construction design and cannot be exposed. The type of slab may only be determined by assessment of the construction plans by a qualified person e.g. Builder, Architect. Construction Plans may be obtainable by your local Council or Builder. Termite activity and or damage may be present in concealed timbers of the building. We strongly

recommend frequent regular inspections in accordance with AS 3660.2. Where the slab edge is not fully exposed or the slab is an infill slab or the slab type cannot be determined then we strongly recommend inspections every 3 to 6 months in accordance with AS 3660.2 or AS 4349.3.

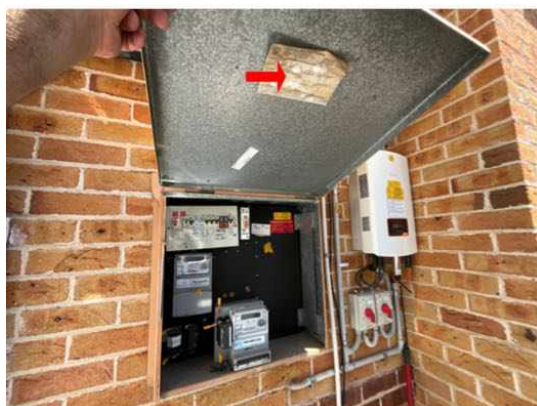
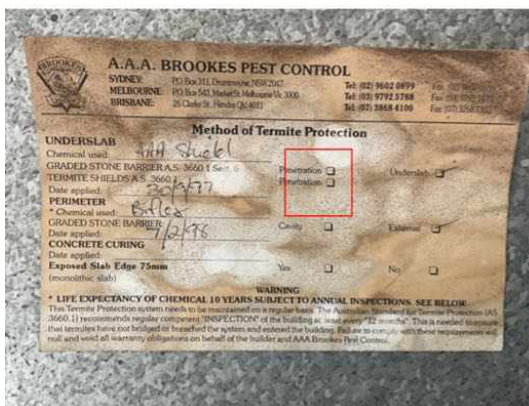
Finding 6.03

- Building: Main Building
- Location: Slab penetrations
- Finding: Service penetrations
- Information: Services into home can allow for concealed termite entry without additional or adequate termite protection.

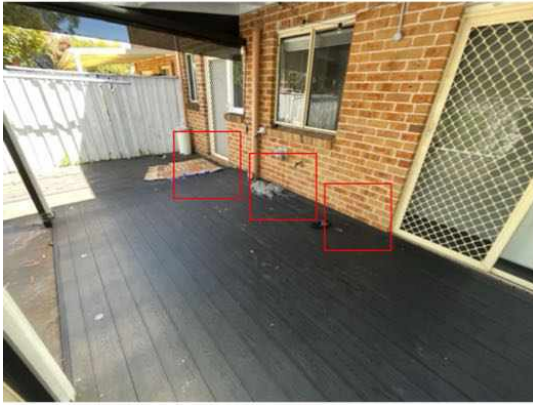
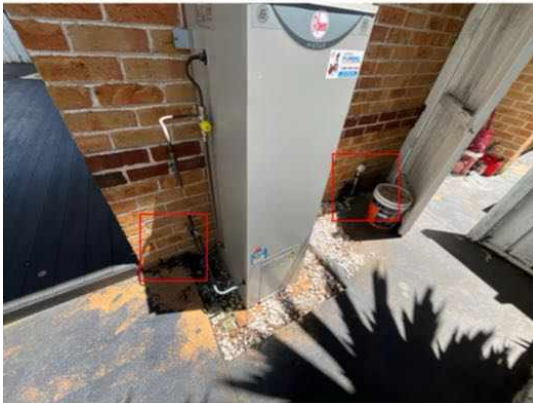
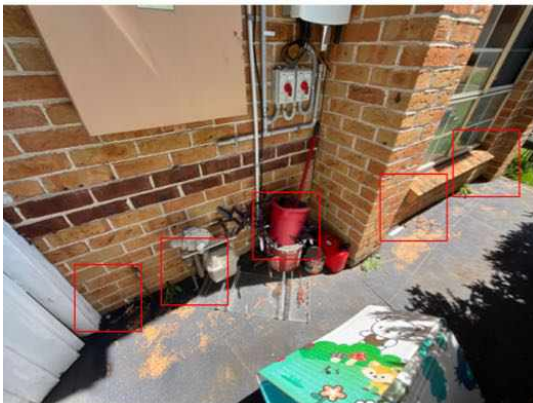
Finding 6.04

Building: Main Building
 Location: Multiple areas
 Finding: Bridging or breaching of termite barriers - weep holes
 Information: Bridging is the spanning of a termite barrier or inspection zone so that subterranean termites are provided with passage over or around that barrier.

Additionally build-up of moisture is likely to occur if weep holes are covered further attracting termite activity to these areas.

It is highly recommended that weep holes are left exposed in all areas throughout the external property. Therefore if any termite activity leading into weep holes becomes easily detectable during frequent pest inspections.

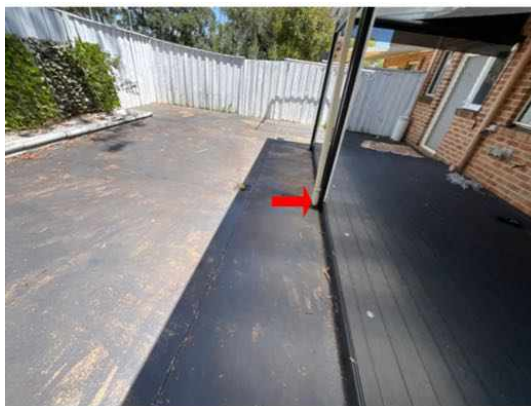
Finding 6.05

Building:	Main Building
Location:	Multiple areas
Finding:	Stormwater drain - Not connected
Information:	The roof plumbing is not adequately connected to stormwater drainage on the site. This disconnection negatively impacts the functional capacity of the roof plumbing.

Where roof plumbing doesn't drain adequately, the area at the base perimeter can become excessively damp, potentially creating an environment that is susceptible to rust and corrosion of surrounding building elements, as well as attracting termites and other pests.

It is highly recommended that a plumber be appointed to further inspect the area and to install adequate drainage equipment where necessary.

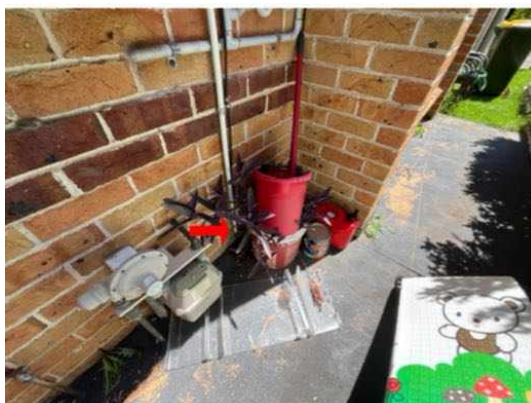
Finding 6.06

Building:	Main Building
Location:	Yard - Side
Finding:	Overflow - Not plumbed for drainage
Information:	The overflow is not plumbed or connected to suitable drainage, which can result in the surrounding area becoming excessively damp.

These damp conditions can lead to secondary defects such as rot, rust or corrosion of associated building elements, the formation of fungal decay, or even the creation of potential slip hazards. When coupled with poor site drainage, pooling of water may also attract termite activity to this area.

It is highly recommended that a licensed plumber be appointed to install adequate drainage to the overflow. These works will ensure that the area remains dry and free of any secondary defects.

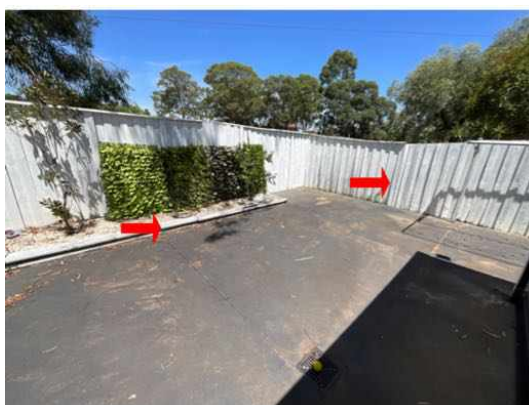
Finding 6.07

Building:	Main Building
Location:	Fencing & Landscaping
Finding:	Building materials in direct ground contact - conducive to termites
Information:	Where timber elements are in direct contact with the ground and consequently moisture or dampness they become conducive to termite activity. Whether timber is used as a building element part of a fencing structure or stored as an unused item they can provide an environment that is attractive to termite infestation.

When met with excessive moisture timber begins to decay and develop wood rot. Any timbers that are in direct contact with external grounds especially if left untreated or non-durable also provide ingress for subterranean termites into that particular element.

The removal of any such materials that may be conducive to termite activity should be removed as soon as possible to minimise the risk of termite attack.

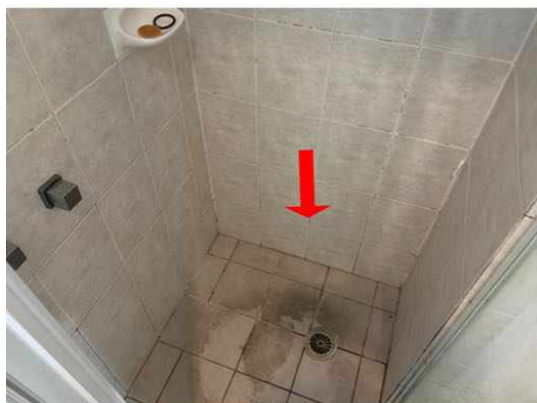
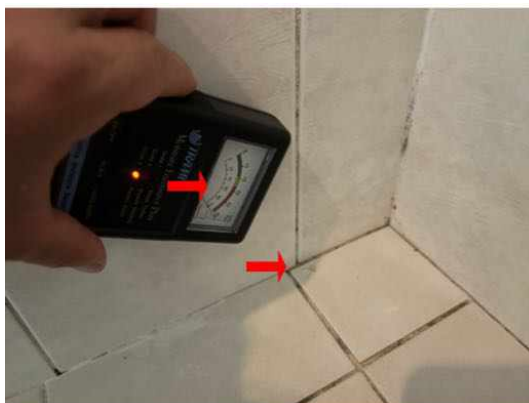
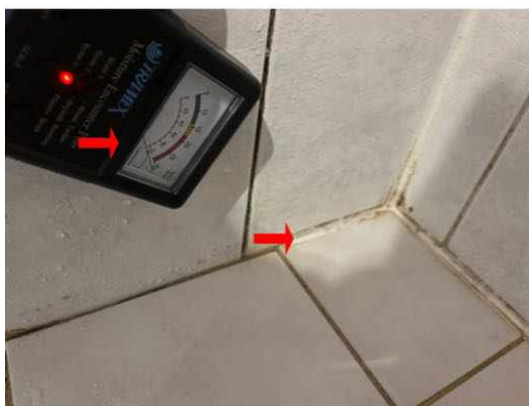
Building: Main Building
 Location: Bathroom, ensuite
 Finding: Shower damp - Sealant and grout
 Information: Damp is evident to the lower 400mm of wall to the shower alcove. This defect is quite common, and is suspected to have been caused by moisture permeating or leaching through the grouting and sealant in this area, which shows evidence of deterioration. Leaking pipes within the wall is also a possible cause however this seems unlikely in

this instance as there is no moisture build up around the taps or transferring to the other side of the wall. There appears to be no sealant around the tap spindles which may be a small contributing factor.

Unmanaged damp in the shower recess is likely to facilitate the formation and development of mould and fungi growth, decaying associated building materials and compromising their structural integrity of associated elements. It is important to address damp conditions, as the World Health Organisation notes that excess moisture leads - on almost all indoor materials - to growth of microbes such as moulds, fungi and bacteria, which subsequently emit spores and other matter into the indoor air. Exposure to these contaminants is associated with a wide range of respiratory and other health-related problems. Damp conditions also create a conducive environment for termite infestation.

Consultation with a bathroom sealant specialist is advised immediately to identify the cause of damp and to perform remedial works as required.

Always ensure that sealant and grout is in good condition to prevent any moisture issues occurring in the future.

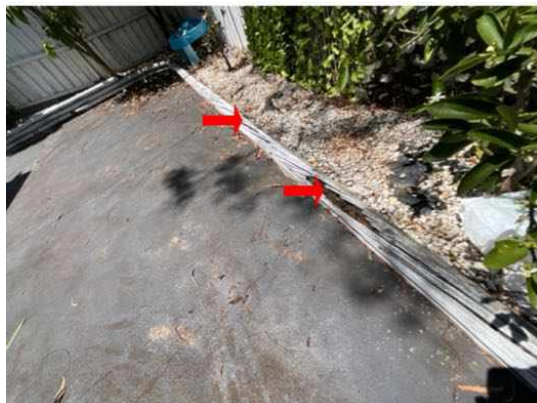
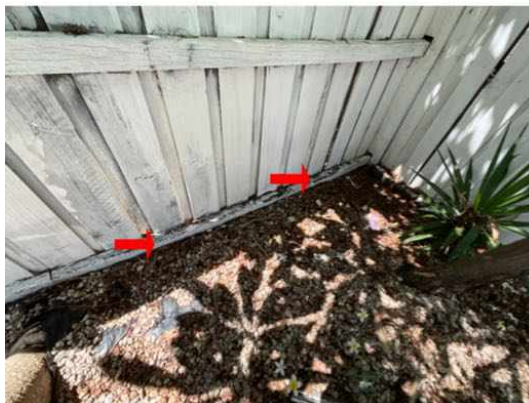
Finding 7.01

Finding: Wood rot/decay

Early intervention and regular maintenance, particularly of exterior timbers, will prolong the useful life of these building elements. Prior to any works being performed, the cause of the moisture that has created the visible wood rot should be identified and addressed in a suitable manner. Replacement of affected timbers may then be a necessary step in protecting surrounding building elements from such deterioration.

A licensed plumber may be appointed to assess the cause of excessive moisture and to provide advice on any remedial works as required. A licensed carpenter may also be required to replace affected building materials.

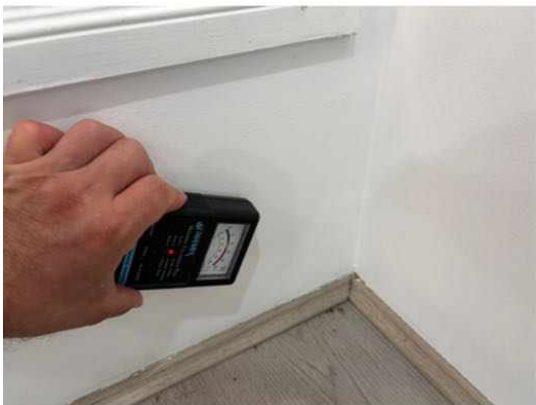
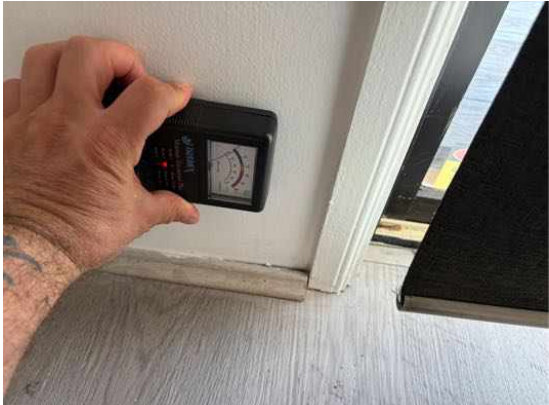
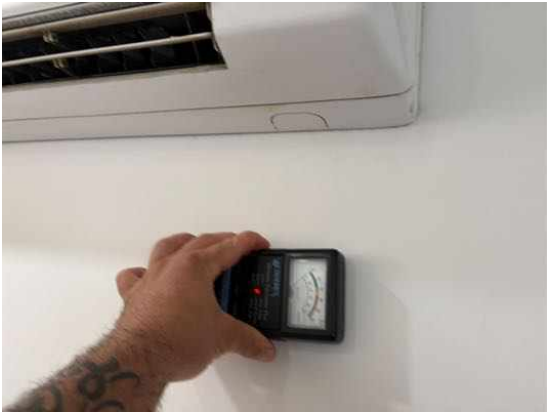
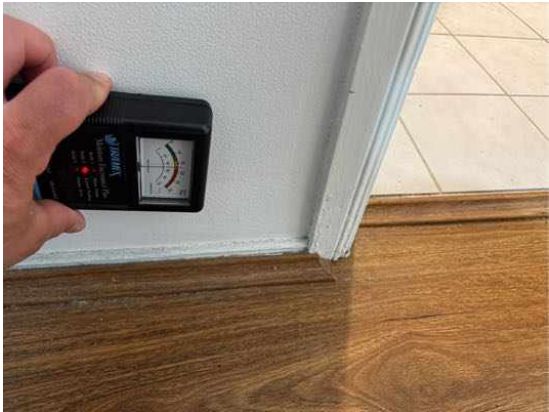
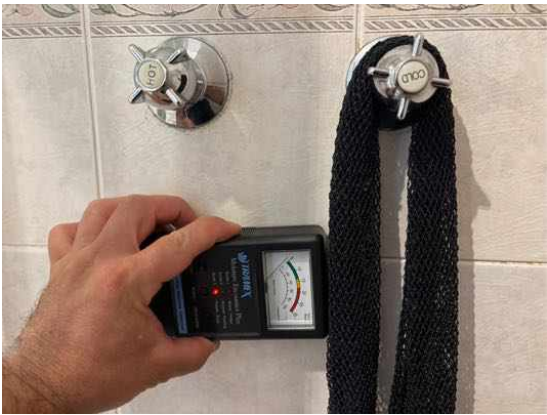
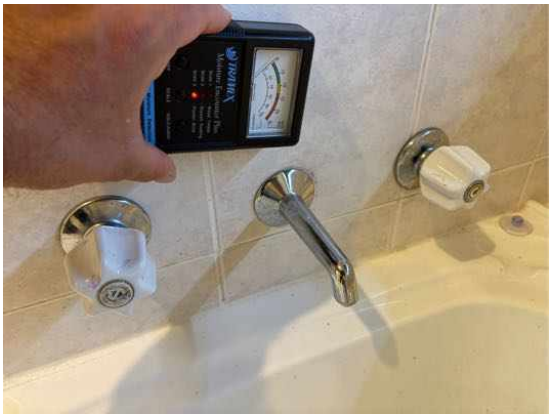
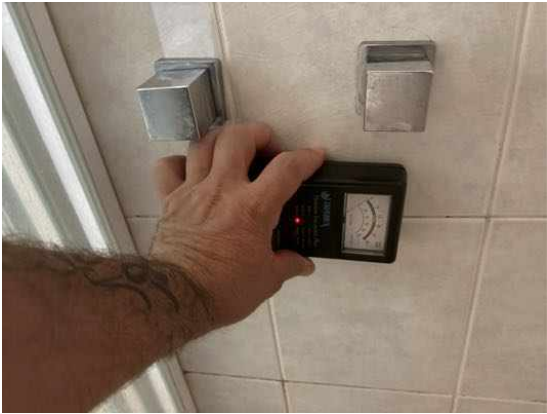
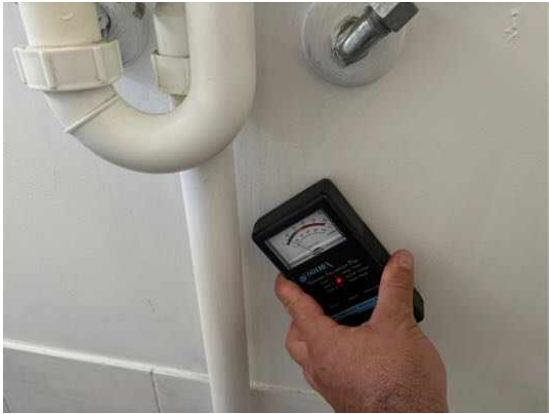
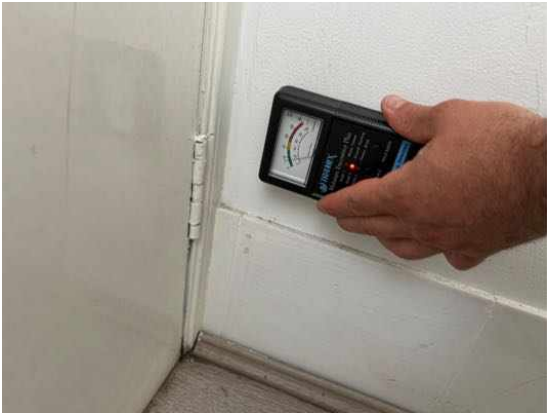
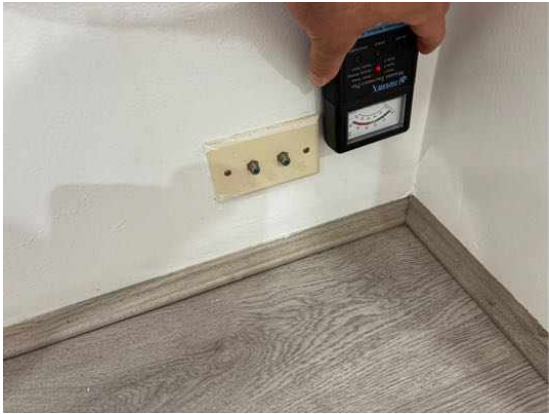
Building: Main Building
Location: All Areas
Finding: Moisture metre
Information: During the inspection the property was checked for moisture using a moisture metre.

This is for information only.

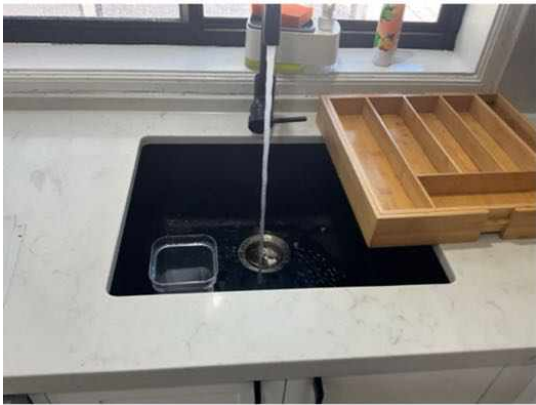
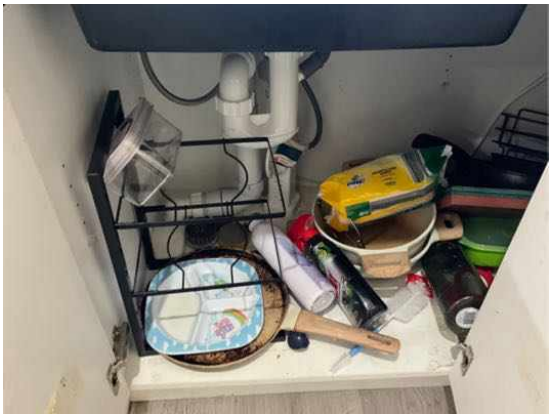
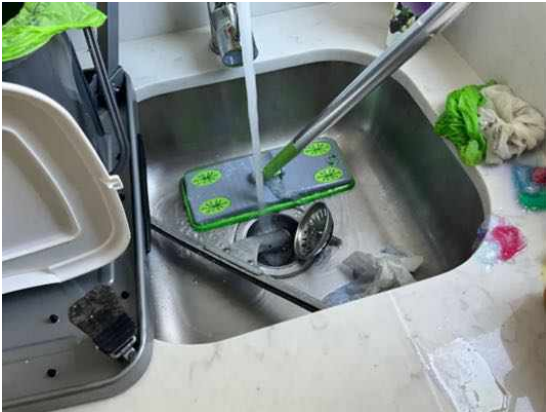
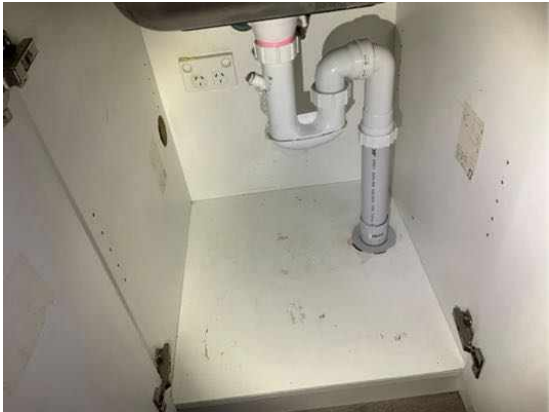
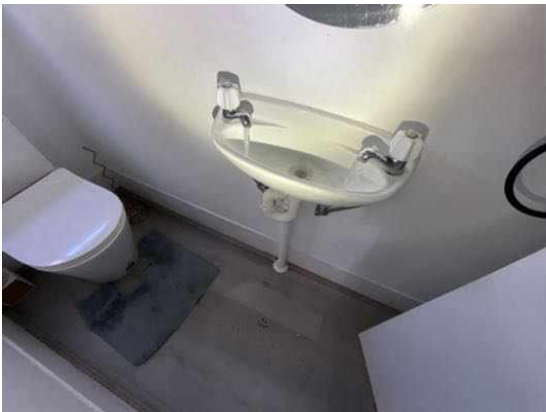
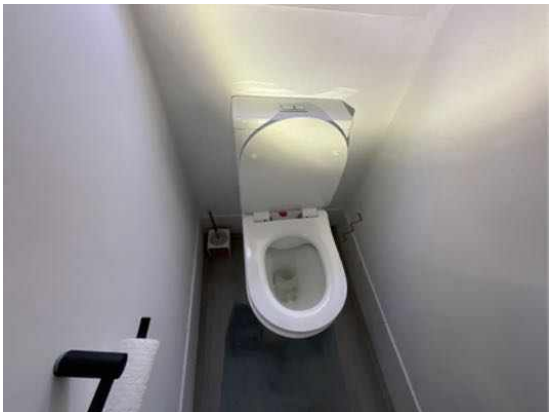
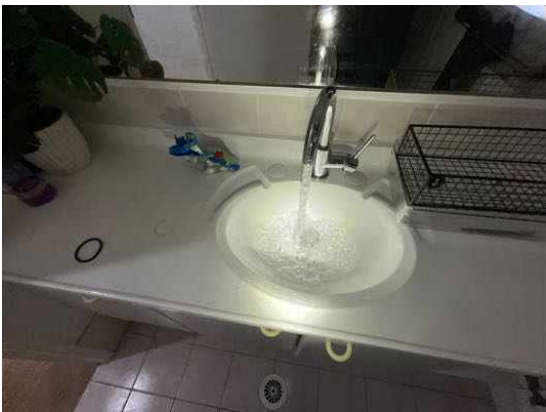
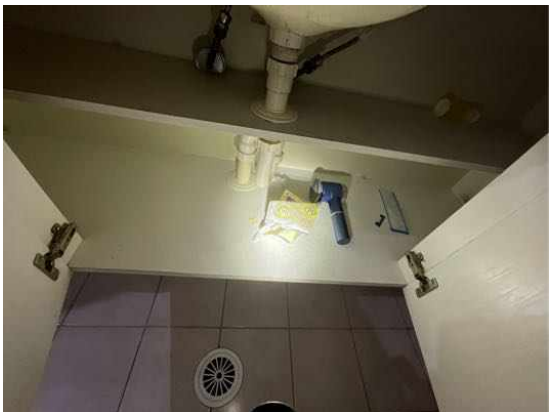
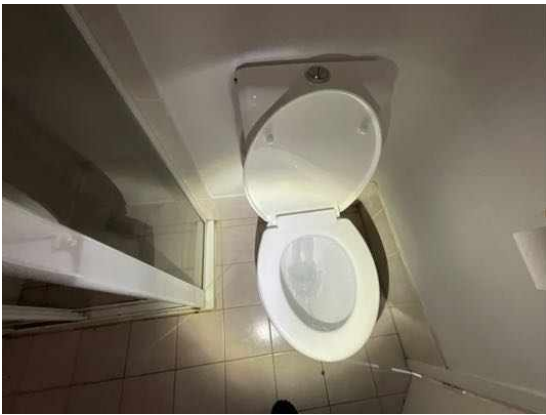
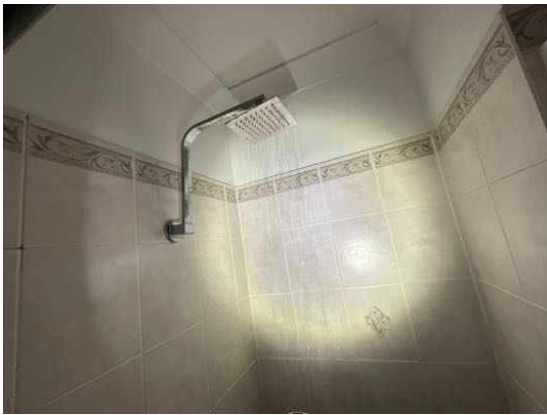
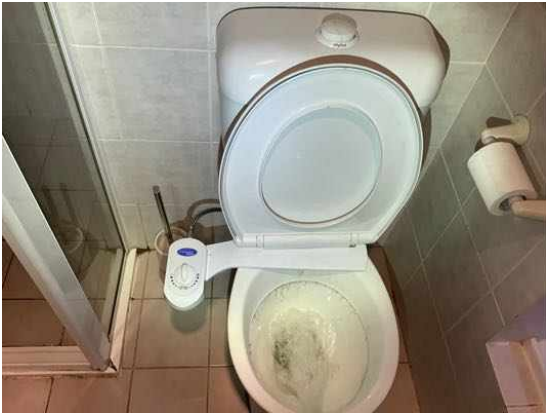
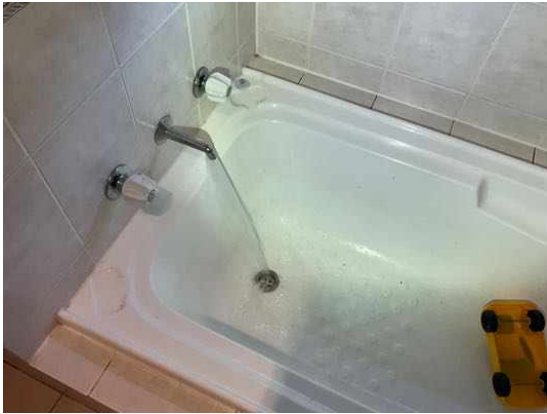
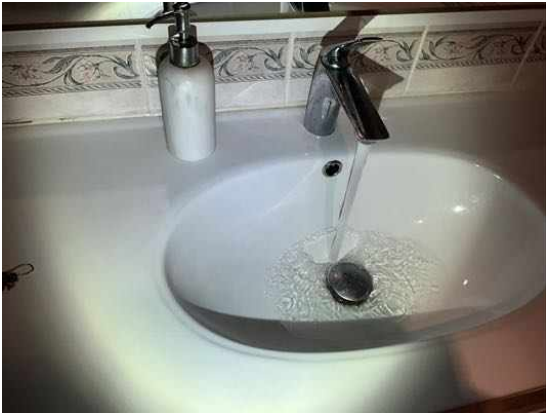
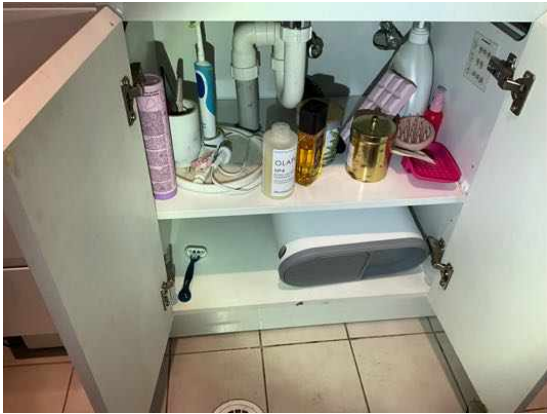
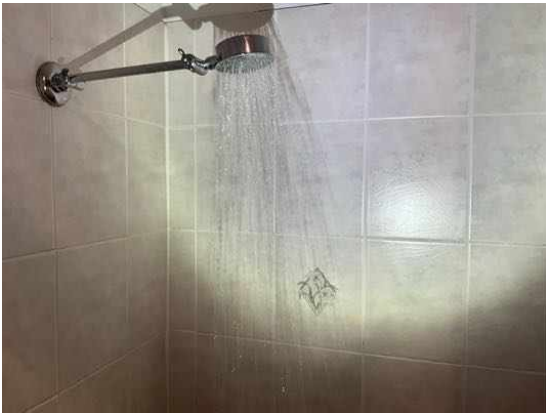
Building: Main Building
Location: All Wet Areas
Finding: Additional Photos
Information:

Additional photos are provided for your general reference.

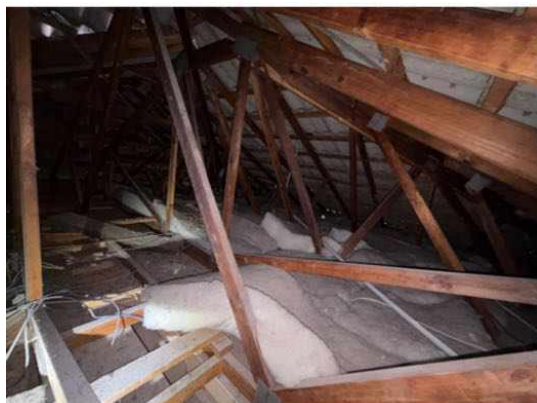
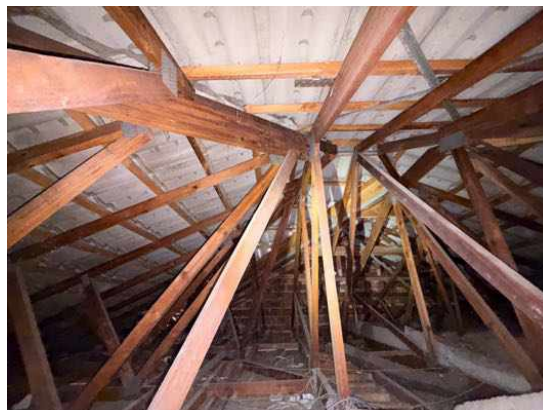
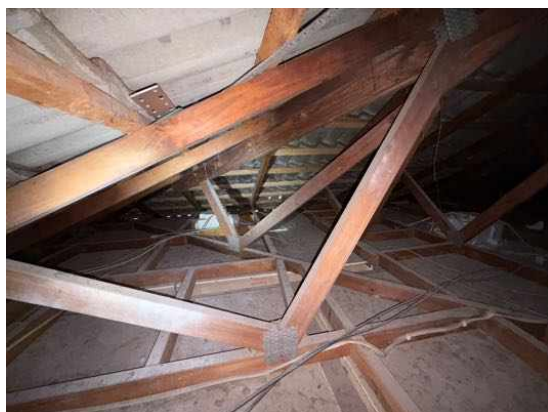
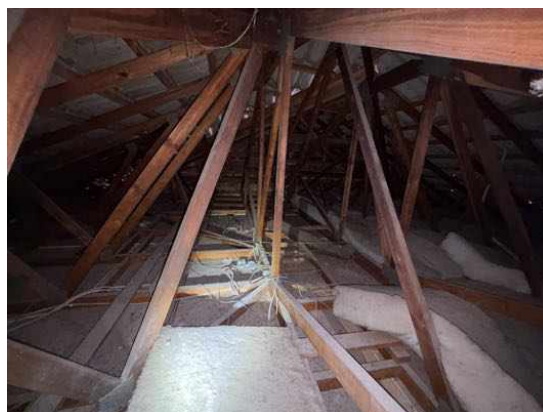
Building: Main Building
 Location: Roof Void
 Finding: Additional Photos
 Information:

Additional photos are provided for your general reference.

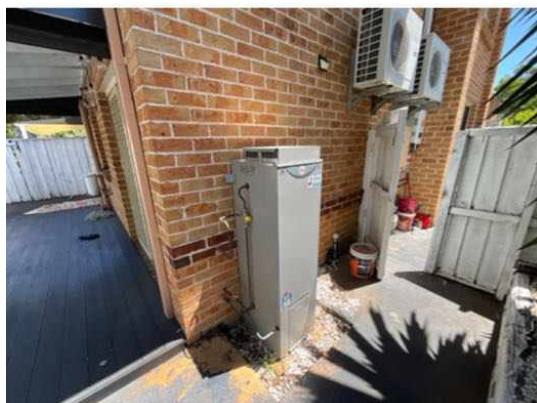
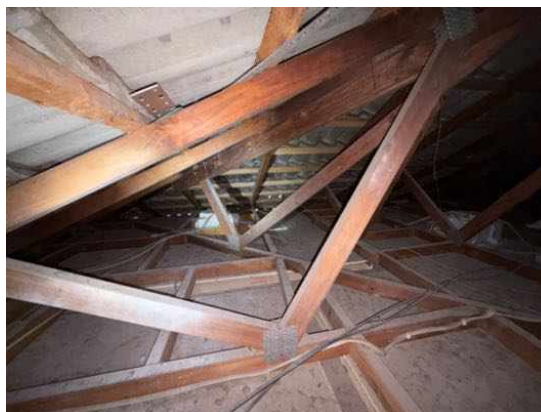
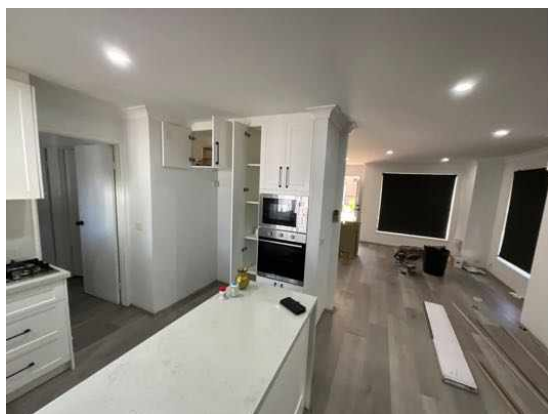
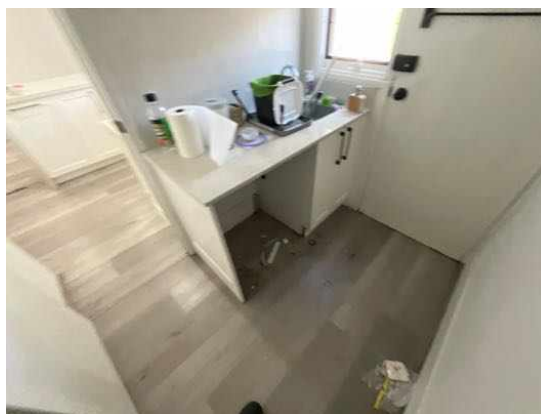
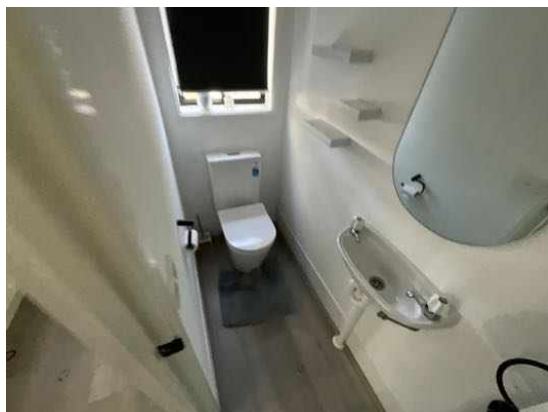
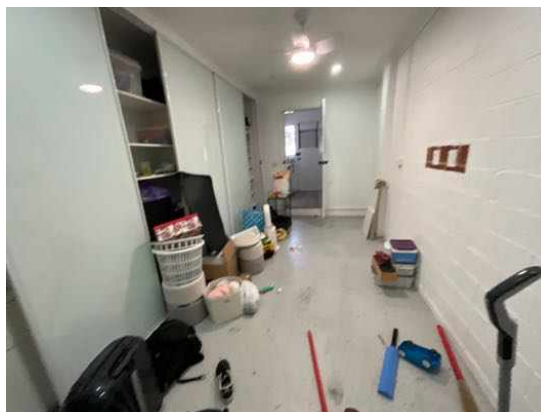
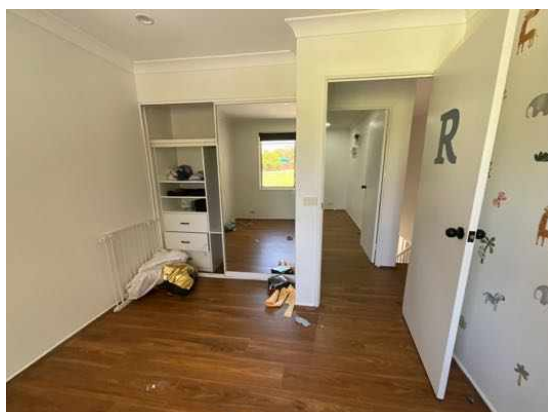
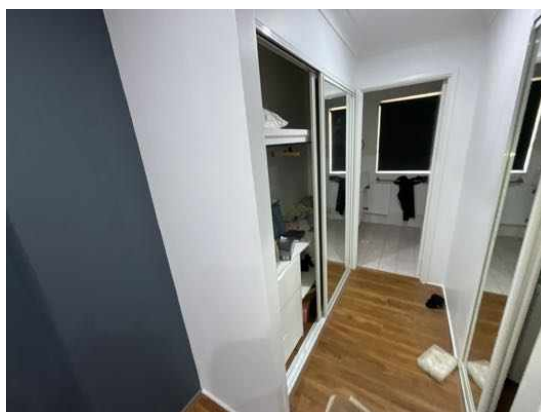
Building:	Main Building
Location:	All Areas
Finding:	Additional Photos - Obstructions and Limitations
Information:	These photographs are an indication of the obstructions and limitations which impeded full inspection of the property at the time of inspection. These obstructions can hide an array of defects and should be removed to allow full inspection to be carried out. A re-inspection is recommended once the areas are made accessible.

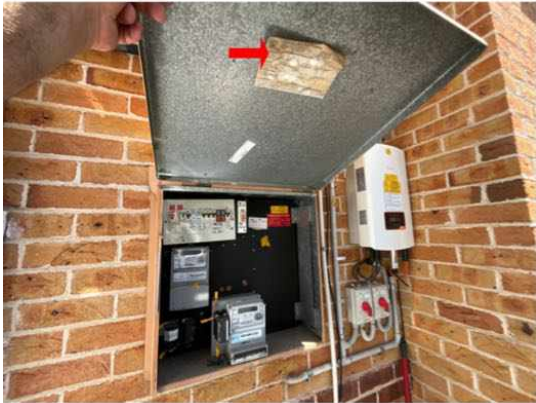
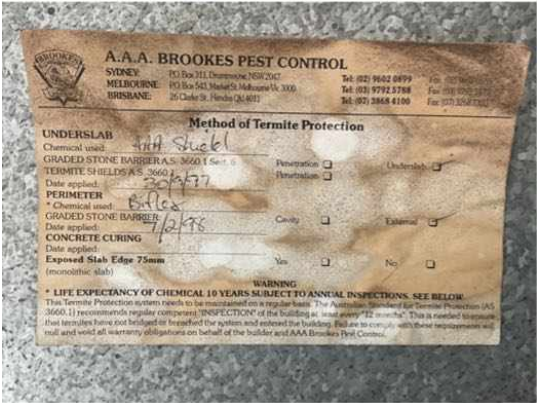
Where a Termite Management System has been identified you should refer to the type of barrier date of installation warranty conditions and any documentation provided by a builder or past owner. Consult the company who installed the barrier to confirm whether the system is still under warranty.

Most chemical termite management systems expire and require replenishment and all physical systems are primarily designed to prevent concealed entry.
