## Building Inspection Report

Inspection Date: Wed, 11 Mar 2026

Property Address: 26 James St, Plympton SA 5038, Australia

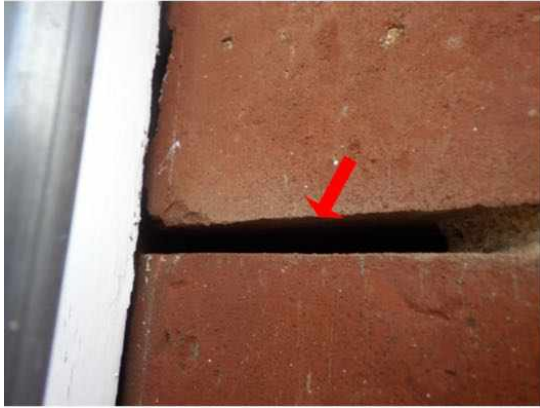
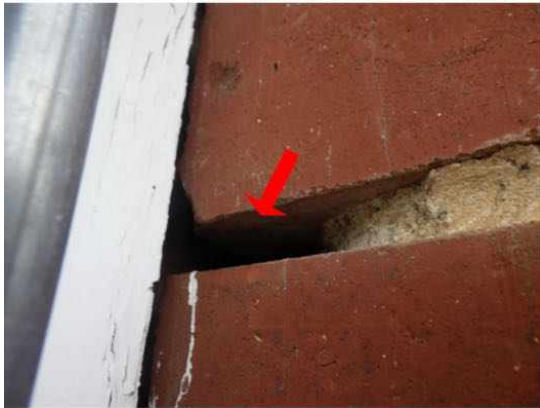
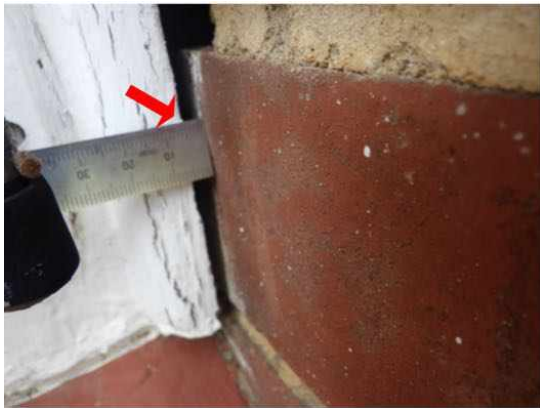
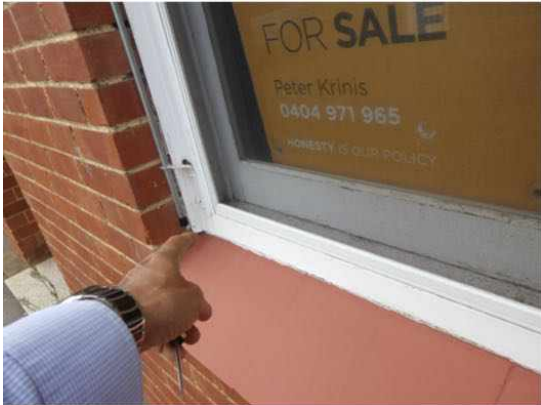
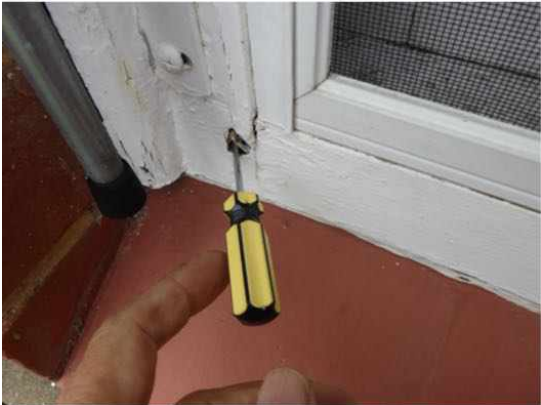
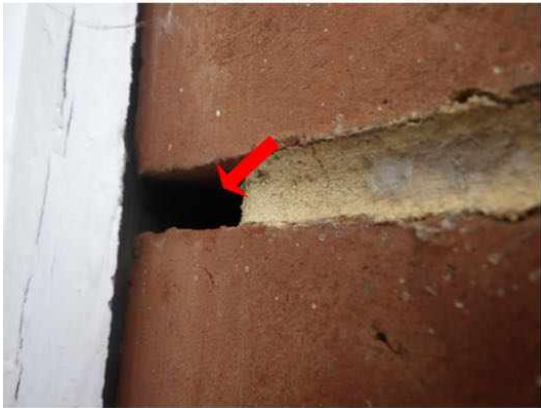
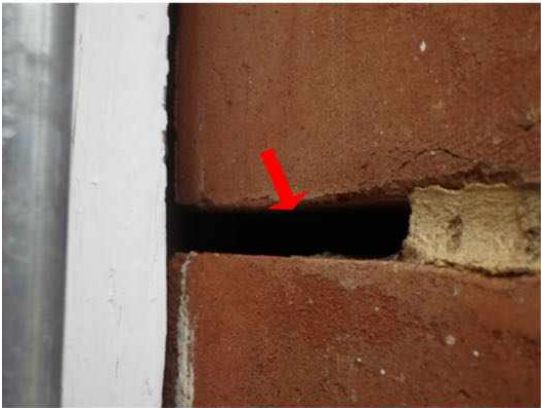
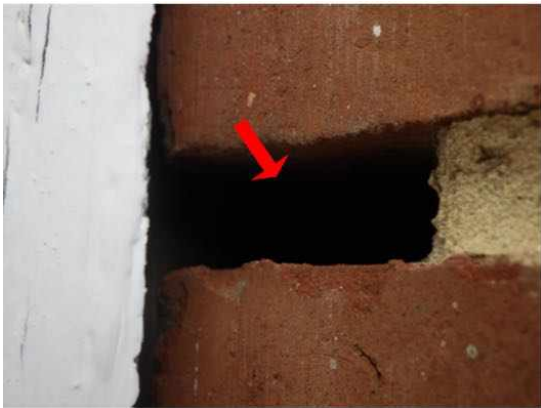
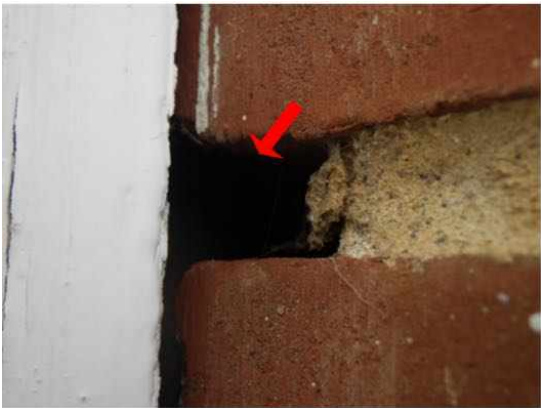
#### Defects 2.01

Building: Building 1  
Location: All External Areas  
Finding: External Walls & Window Frame Assembly - Significant Gaps Observed / Bricks Mortar Deterioration  
Information: At the time of inspection, it was noted that significant gaps are present between the external wall cladding and window frame assembly / building elements at various locations around the property. These gaps indicate poor detailing, movement, deterioration of materials, or inadequate installation and sealing.

Apart from that at the time of inspection it was also noticed evidence of mortar deterioration to few sections of bricks in this area.

Such conditions may arise due to age-related degradation, environmental exposure, or physical damage. If left unrectified, these gaps may allow water and air ingress, potentially leading to secondary defects, including moisture damage, deterioration of adjacent building elements, and reduced thermal and weatherproof performance.

Repair and/or replacement of the affected components is recommended to reinstate the integrity and performance of the building envelope. All building elements play an essential role in the operation and overall performance of the structure, and defects of this nature may adversely impact durability and habitability.

It is advised that a suitably qualified and licensed tradesperson be engaged to assess and rectify the affected areas to prevent further deterioration or consequential damage.

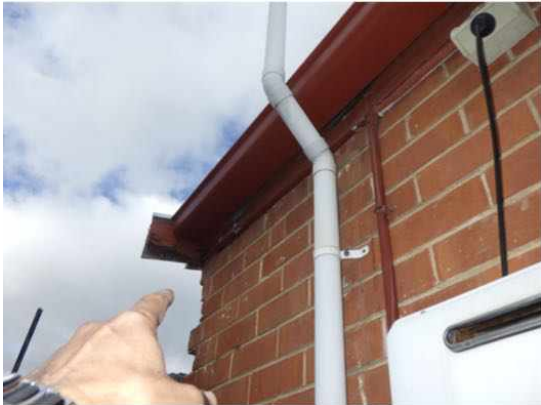
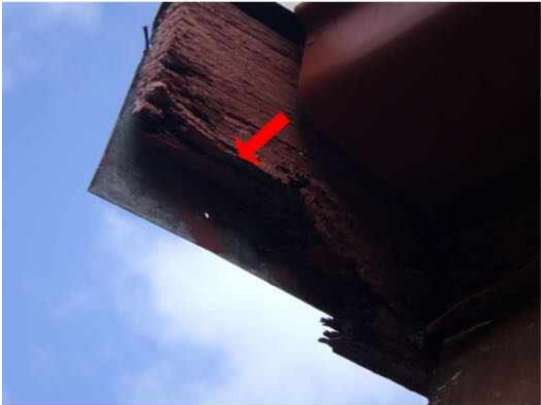
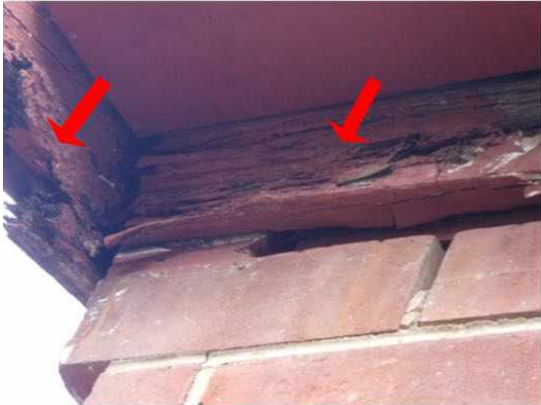
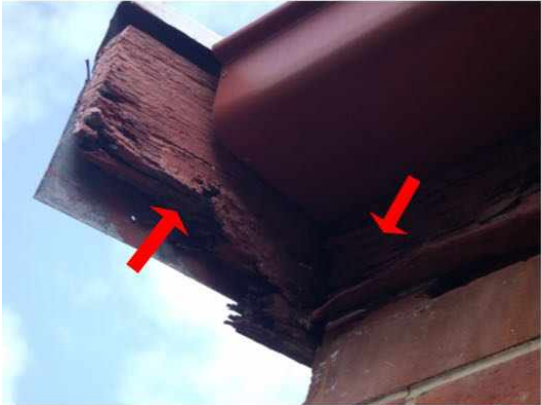
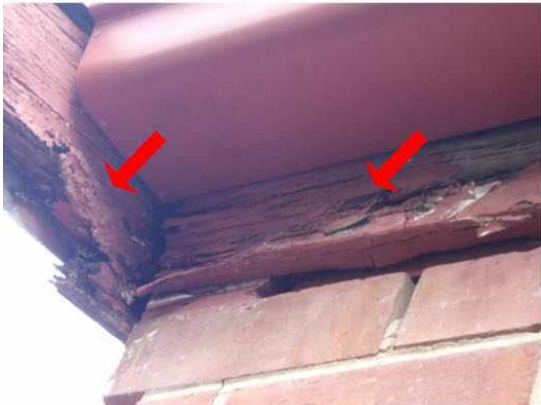
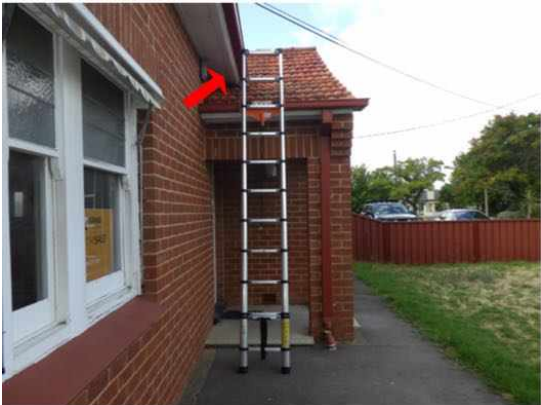
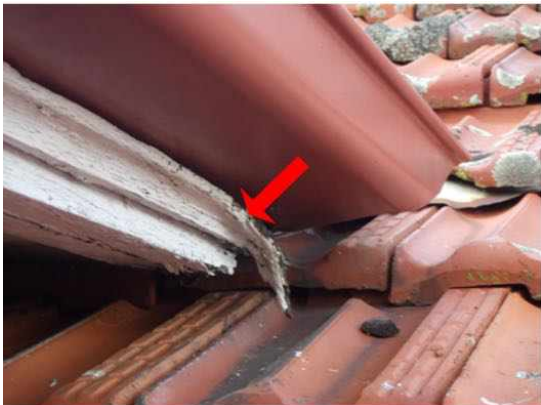
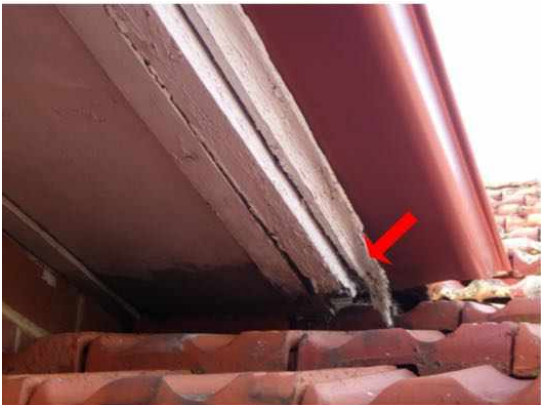
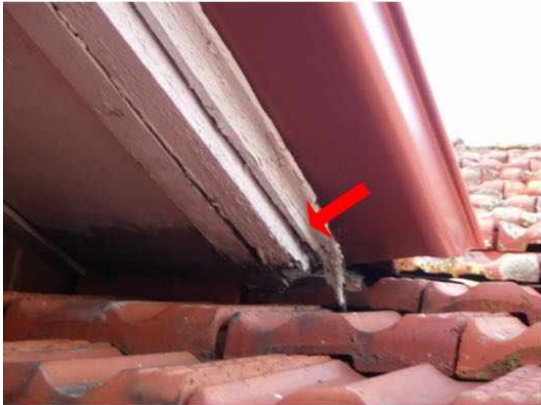
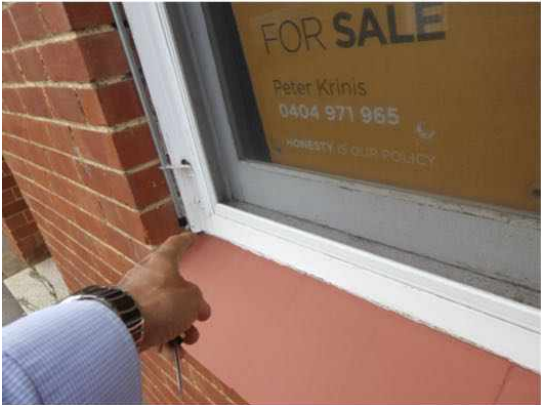
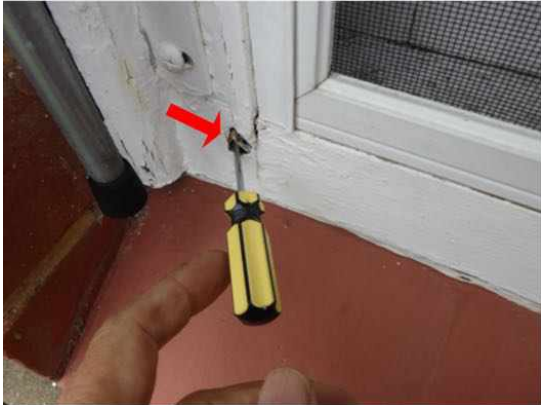
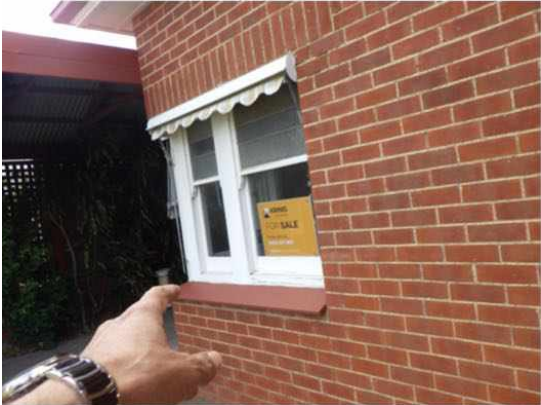
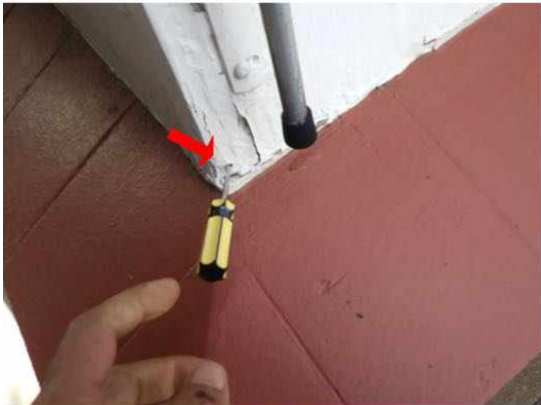
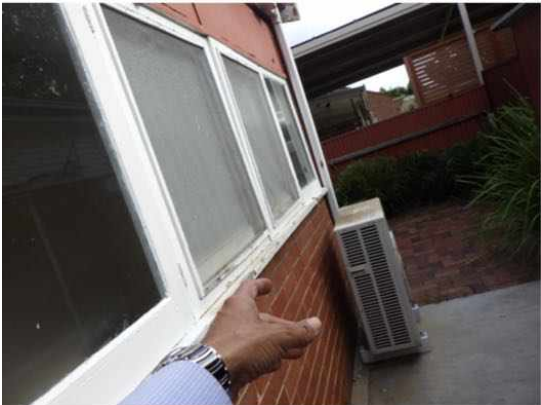
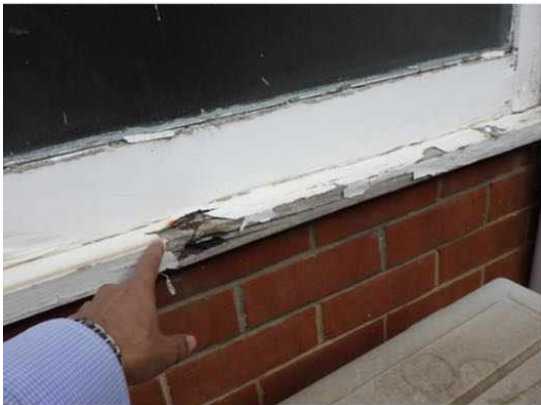
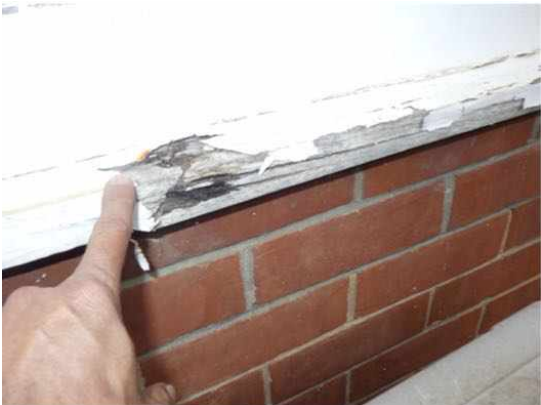
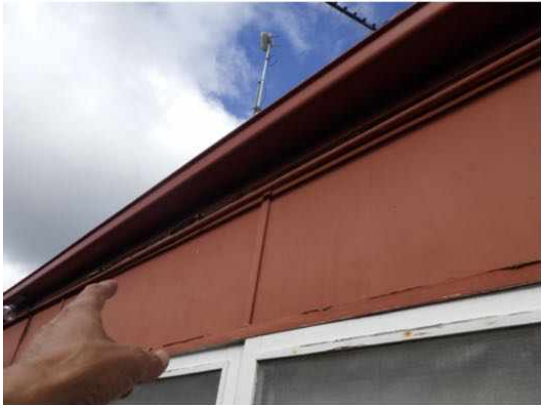
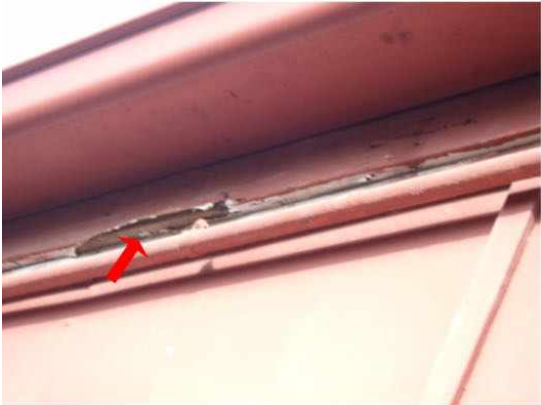
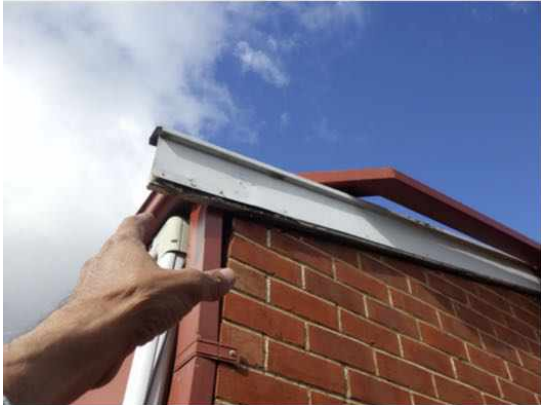
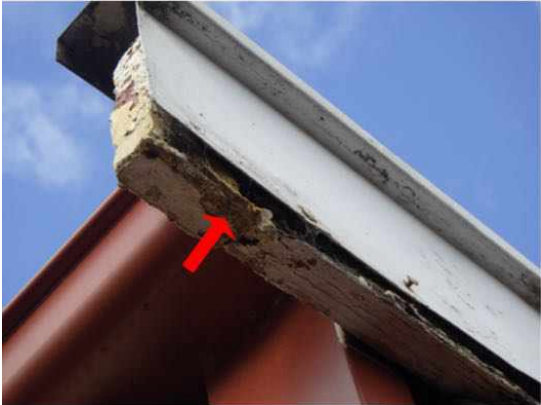
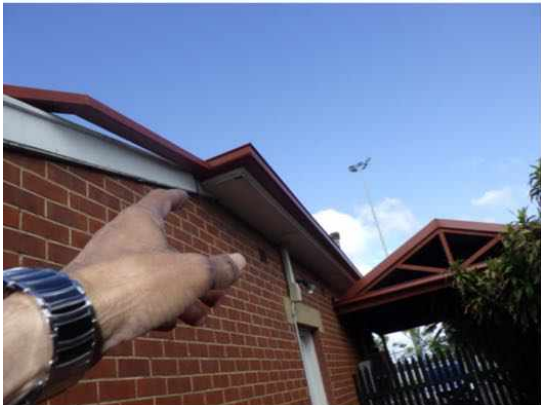
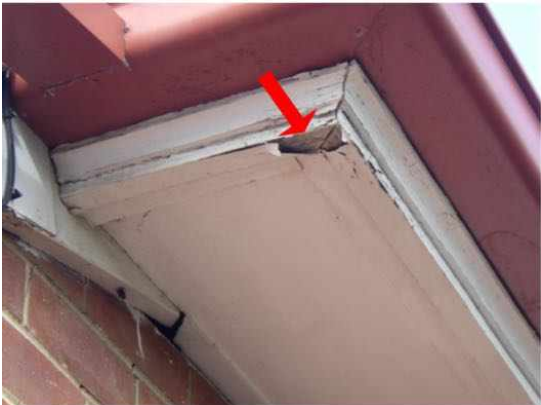
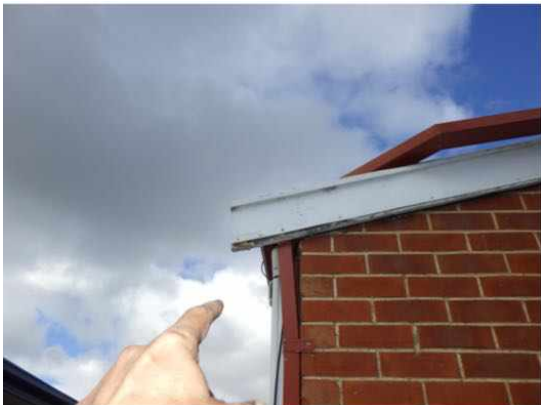
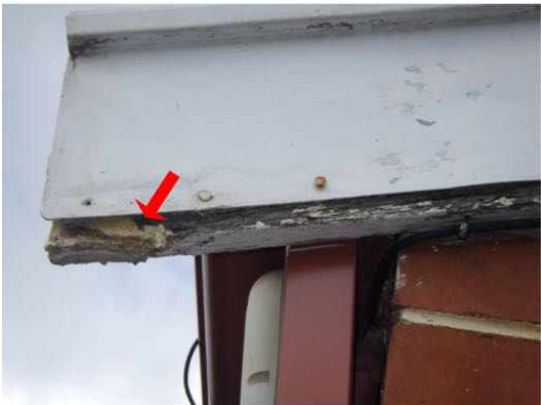
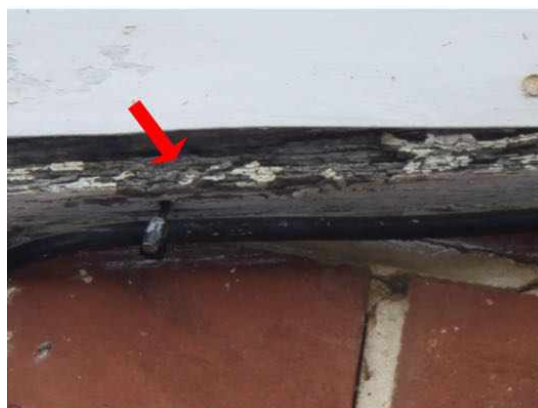
## Defects 2.02

Building:	Building 1
Location:	All External Areas
Finding:	Wood rot
Information:	This building element shows evidence of wood rot. Wood rot, also known as Fungal Decay, occurs when timbers and other cellulose building materials are exposed to damp conditions on an ongoing basis. This could be the result of exposure to weathering over a prolonged period of time, or the attraction of excessive moisture from other abutting building materials. Contributing factors also include poor air ventilation in the area.

Wood rot is often associated with general damp problems and is evidenced by a 'musty' smell or mould and mildew occurring on surfaces. If left unmanaged, damp conditions can lead to further health problems and the decay of timbers will continue.

Early intervention and regular maintenance, particularly of exterior timbers, will prolong the useful life of these building elements. Prior to any works being performed, the cause of the moisture that has created the visible wood rot should be identified and addressed in a suitable manner. Replacement of affected timbers may then be a necessary step in protecting surrounding building elements from such deterioration.

A qualified plumber may be appointed to assess the cause of excessive moisture and to provide advice on any remedial works as required. A qualified carpenter or registered builder may also be required to replace affected building materials.

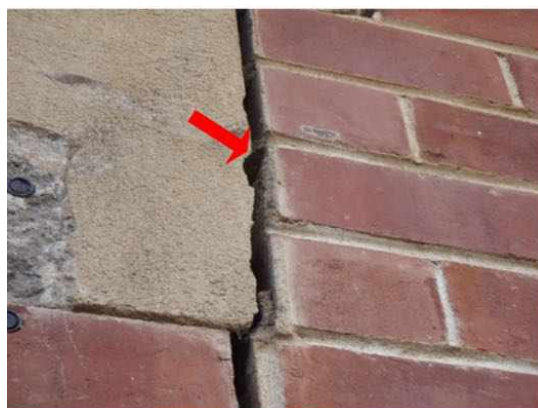
### Defects 2.03

Building: Building 1  
 Location: All External Areas  
 Finding: Brickwork cracking major and minor/ Sections of Bricks Damaged  
 Information: At the time of inspection major and minor cracking were identified to the some sections of exterior brickwork around the property. Cracks of this type are likely to have been caused by minor expected movement of building elements, but may also have a structural cause that is more significant.

Apart from that at the time of inspection it was also noticed evidence of bricks damaged in this external walls rear area / Sections of Bricks Damaged

A crack of this size may be repaired by extensive filling. Additionally, further remedial works to associated building elements, such as eave sheeting or external door frames, is likely to be required.

A qualified bricklayer should be contacted immediately to estimate and perform repair and restoration works. Consultation with a structural engineer may be required where structural instability is found to be the underlying cause of the cracking.

Always contact a building inspector should cracks widen, lengthen, or become more numerous.

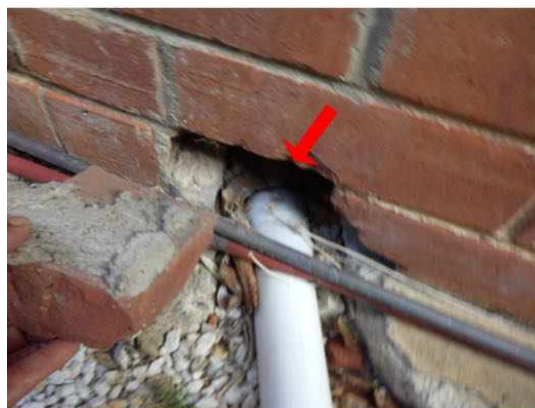
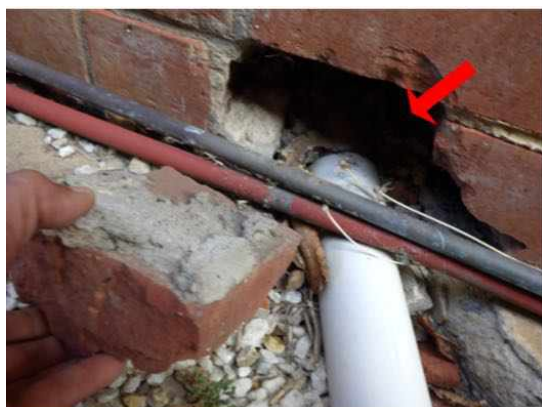
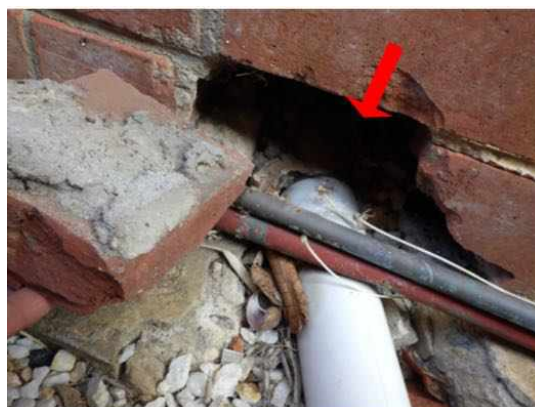
## Defects 2.04

Building:	Building 1
Location:	All External Areas
Finding:	External walls - Holes at lower base
Information:	At the time of inspection significant holes were identified around pipe penetrations in this wall section at lower base. It is suspected that the installation of this pipework was completed to a substandard level of workmanship or is incomplete.

Gaps and holes around pipework makes the area susceptible to insect and vermin ingress, as well as allowing water penetration to the cavity wall. As such, associated building elements are likely to deteriorate at an accelerated rate, and major implications are expected if holes around the pipework are left unmanaged.

All excessive holes, gaps or cracks should be adequately filled by a suitable sealant or trimmings as soon as possible to prevent any further damage. Such works may be conducted by a general handyperson or licensed plumber.

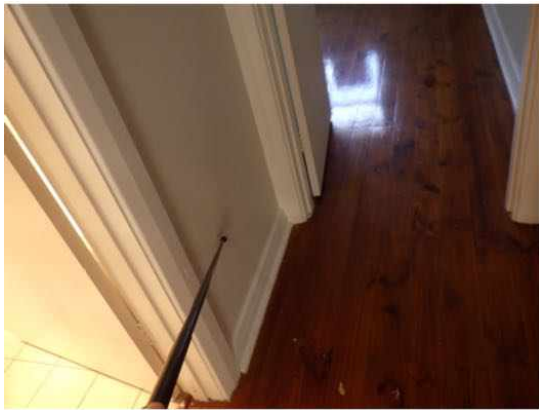
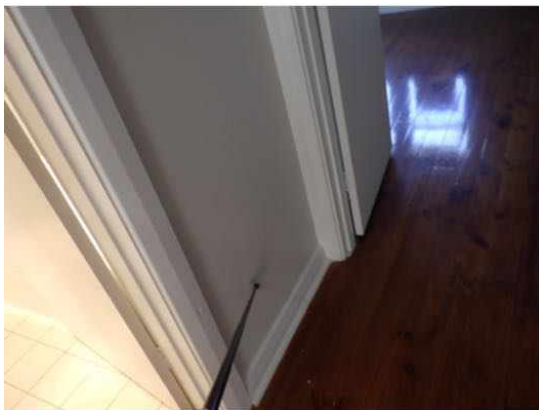
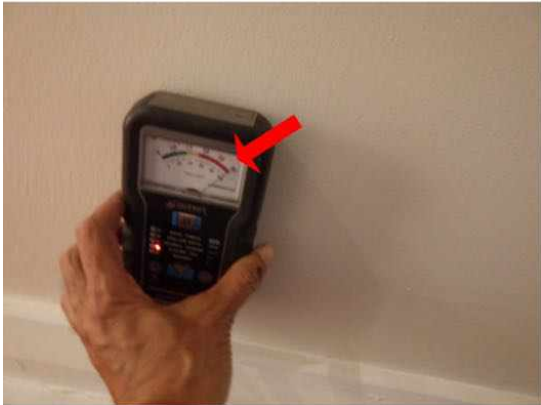
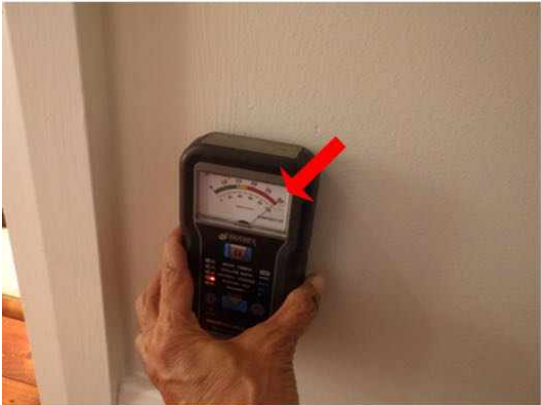
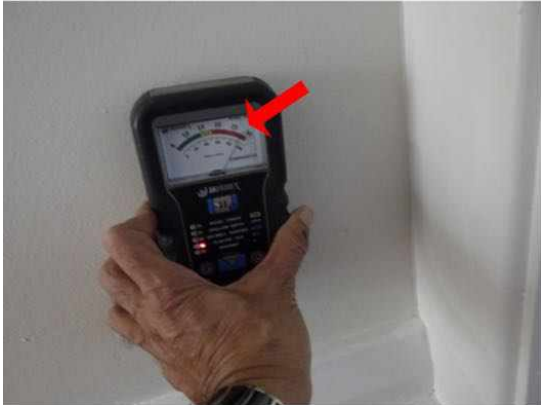
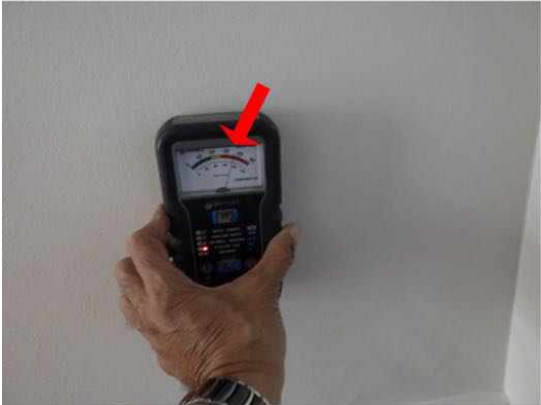
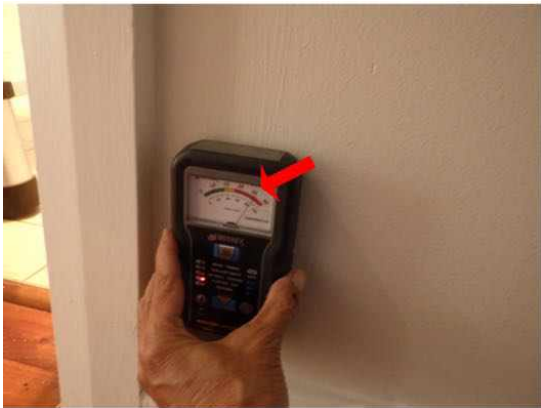
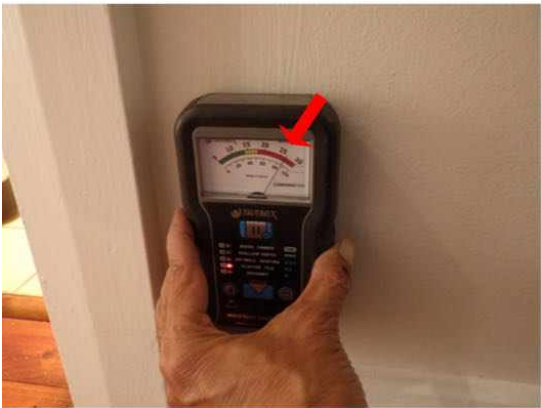
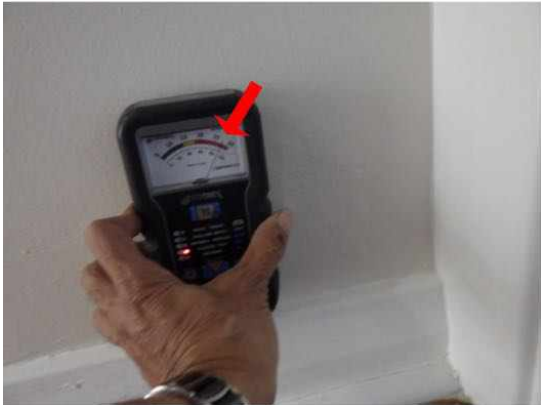
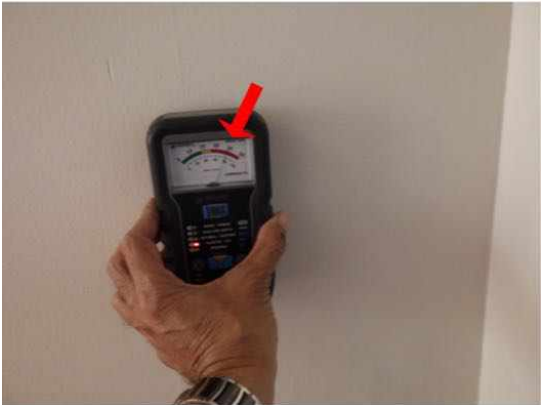
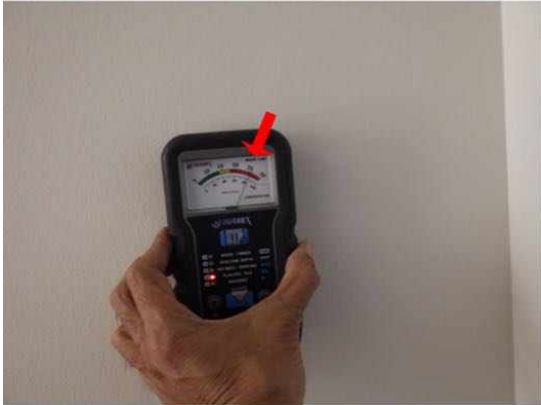
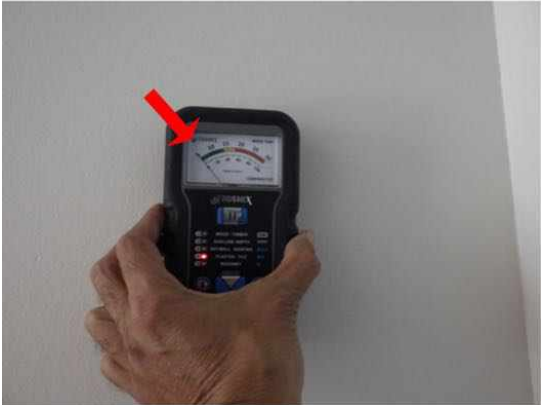
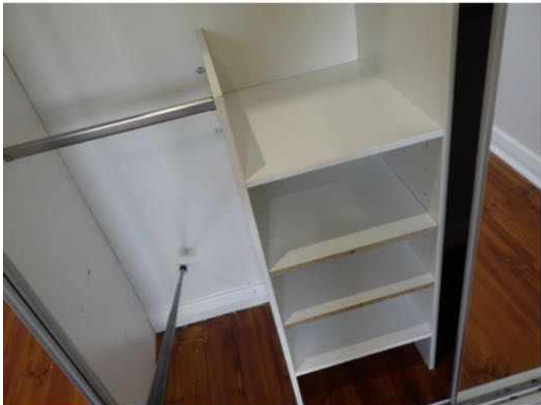
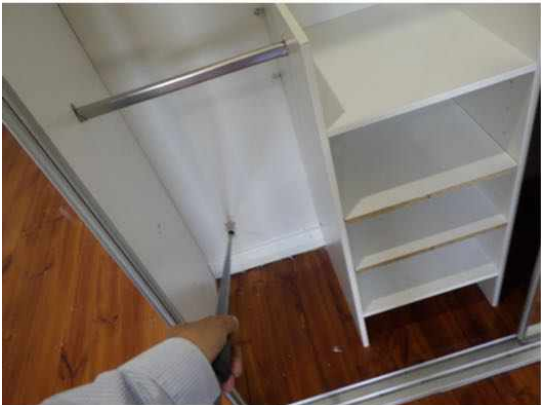
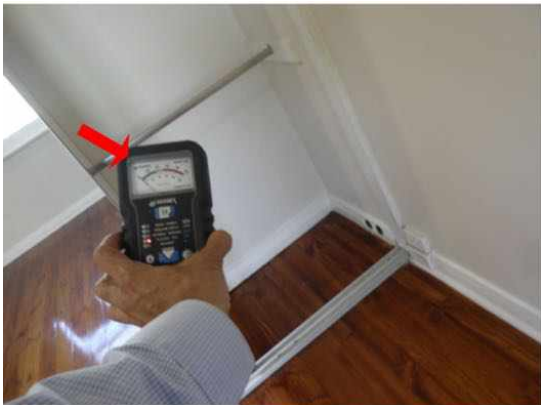
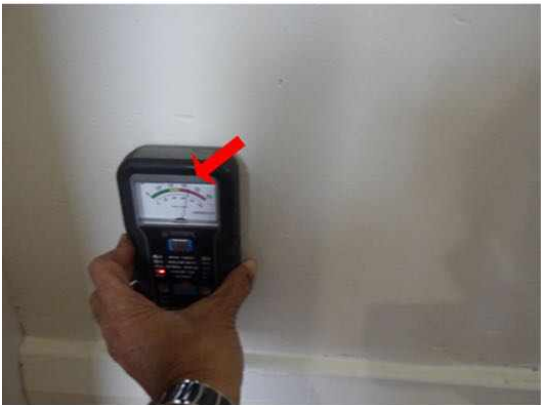
## Defects 2.05

Building:	Building 1
Location:	All Internal Areas
Finding:	Internal walls - Damp adjacent to bathroom
Information:	At the time of inspection it was noticed that high moisture readings were noted in these internal walls adjacent to bathroom.

Apart from that at the time of inspection it was noticed that no high moisture readings were noted in this bathroom - shower alcove and bathtub area.

The first step in addressing damp is to diagnose the cause. The identified cause should be addressed first prior to repairing the appearance and other defects which have resulted from the rising damp. If the original cause is not resolved, further cases of damp are likely to ensue, resulting in secondary defects.

Consultation with a qualified plumber is advised immediately to identify the cause of damp and perform remedial works as required. Where excessive mould growth is present, further inspection by a specialist environmental health inspector should also be considered.

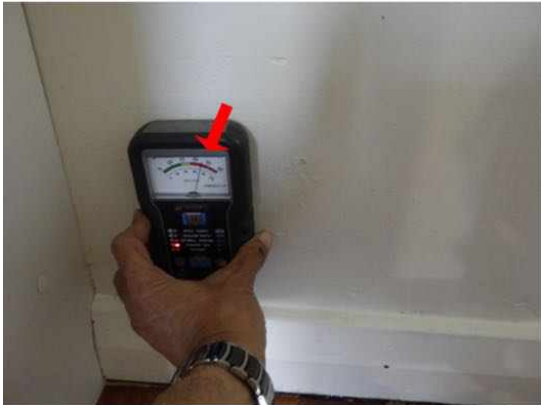
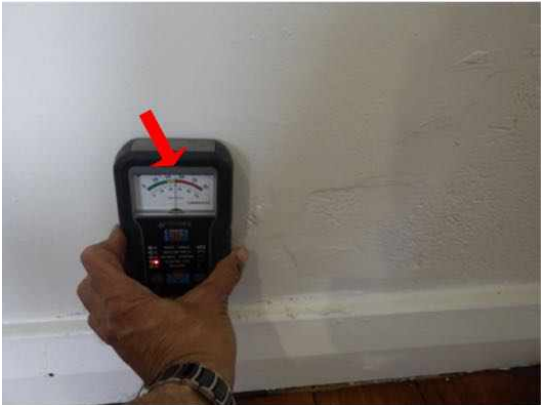
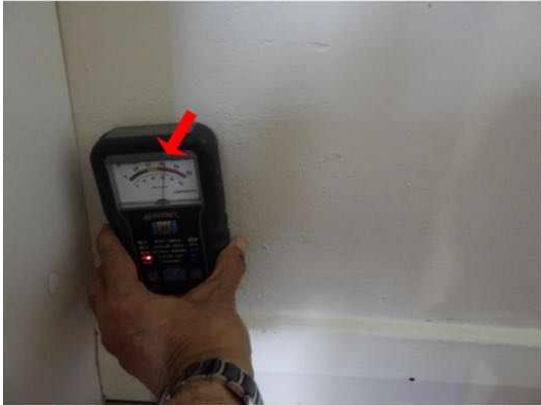
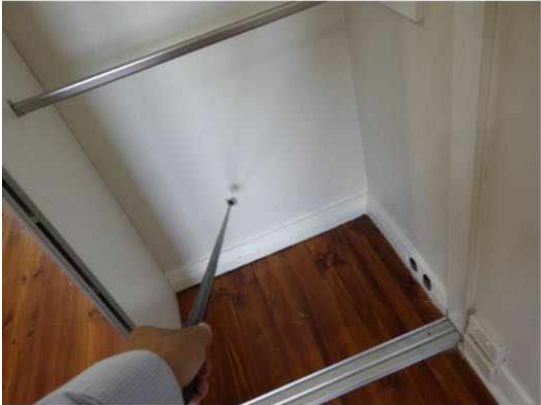
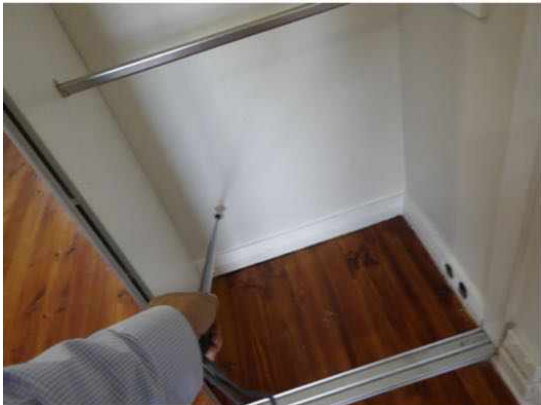
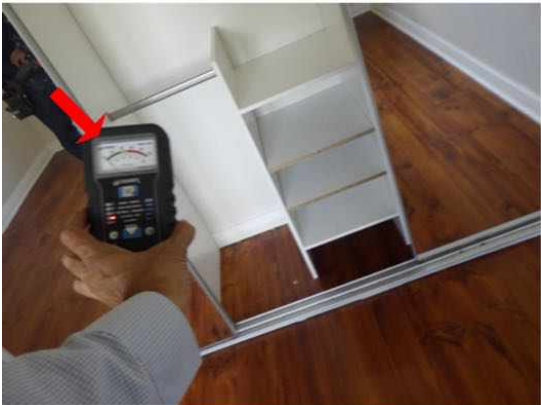
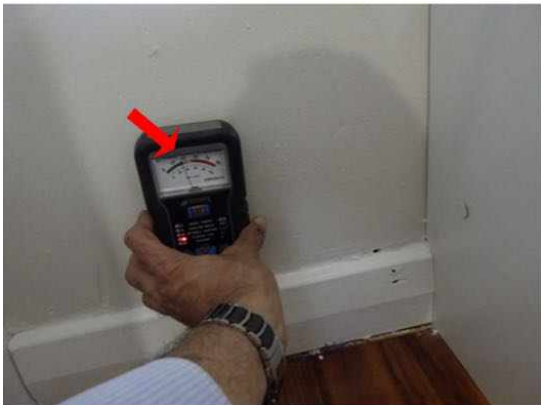
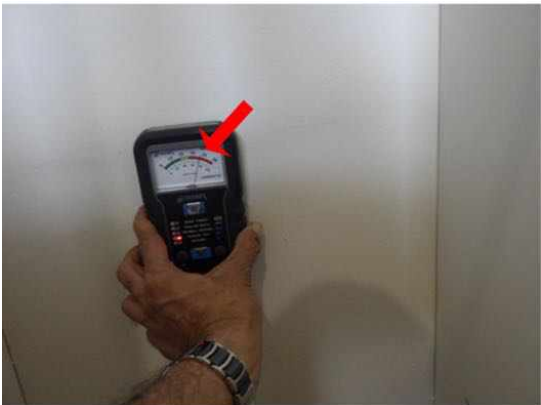
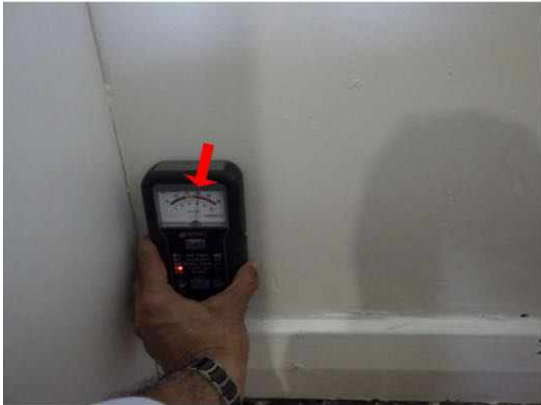
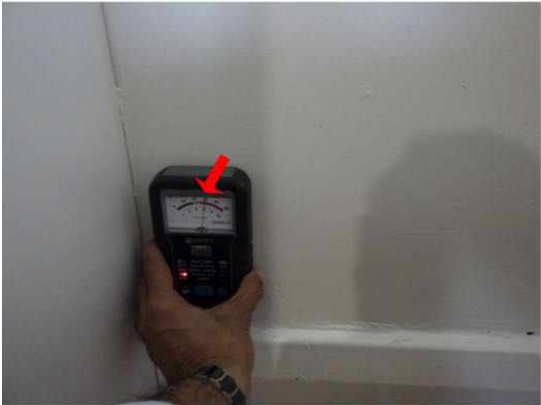
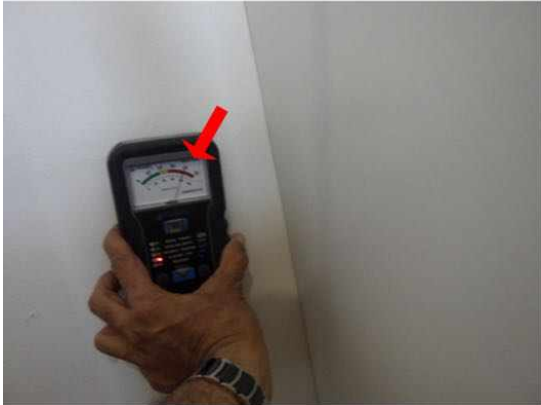
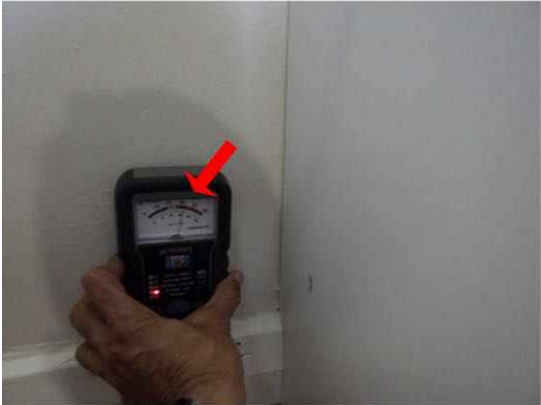
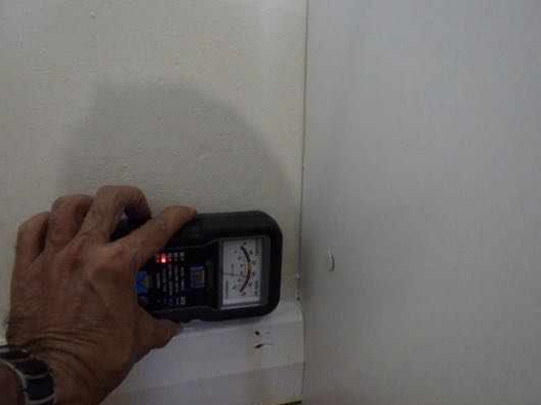
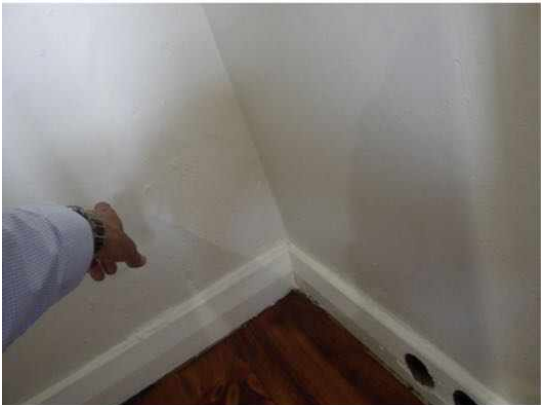
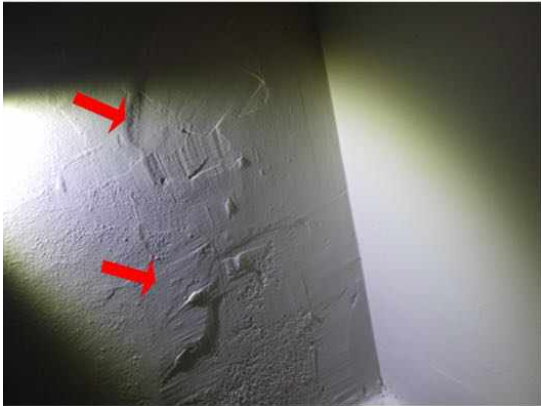
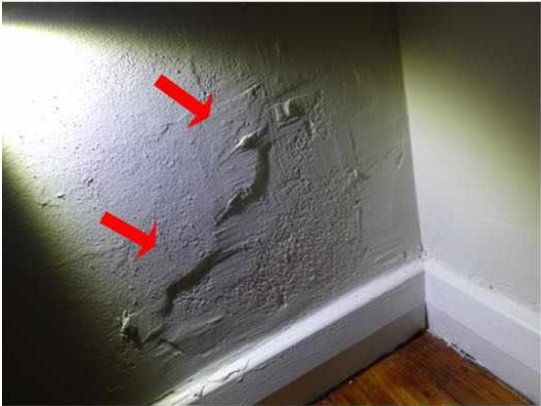
Damp (or structural damp) refers to the presence of unwanted moisture in the structure of a building, either as the result of intrusion from outside, or condensation from within the structure. Generally, structural damp is caused by rain penetration, rising damp, and leaks from plumbing pipes.

Unmanaged damp facilitates the formation and development of mould, fungi growth and wood rot, decaying associated building materials and compromising their structural integrity. Damage to finishes is also likely to occur, including lifting, bubbling,

peeling and staining of paint, plaster and wallpaper.

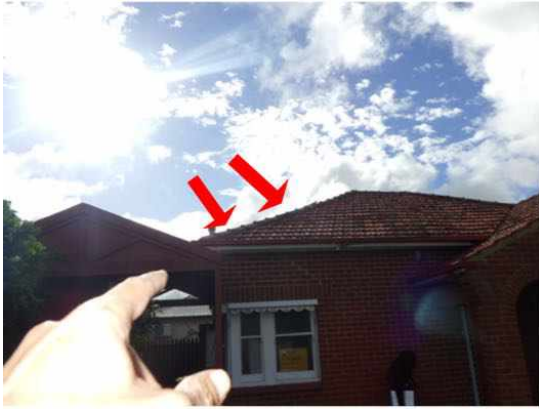
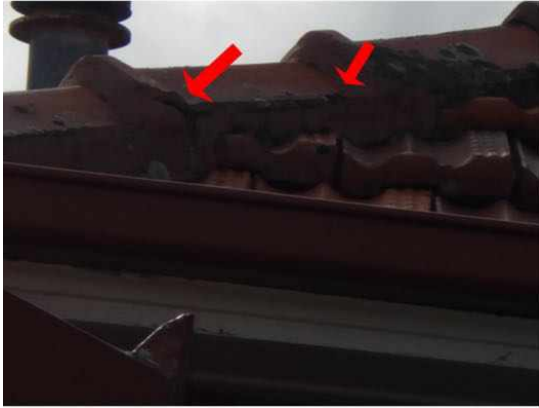
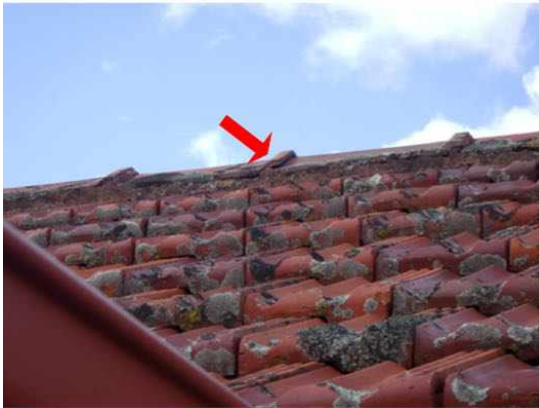
### Defects 3.01

Building:	Building 1
Location:	All External Areas
Finding:	Mortar - Deterioration
Information:	At the time of inspection it was noticed that evidence of mortar deterioration to few roof tiles around the property.

Mortar, or 'bedding', is the material which fills joints and intersections between tiles and other building elements on the exterior roof covering, such as gable ends, hip capping and valleys. Upon inspection of the exterior roof, it was noted that sections of the mortar show varying levels of deterioration.

Mortar generally deteriorates as a result of frequent exposure to weather conditions over a prolonged period of time. Mortar that is deteriorating may allow water ingress into the roof void, putting associated building elements and roofing structures at risk of water damage. Deteriorated mortar also detracts from the functionality of roof tiles and other roofing elements, potentially decreasing weather tightness and roof drainage.

Mortar deterioration can be attended to by a handyperson where areas of deterioration are localised and easily accessible. Otherwise, consultation with a roofing contractor is advised where greater works are required.

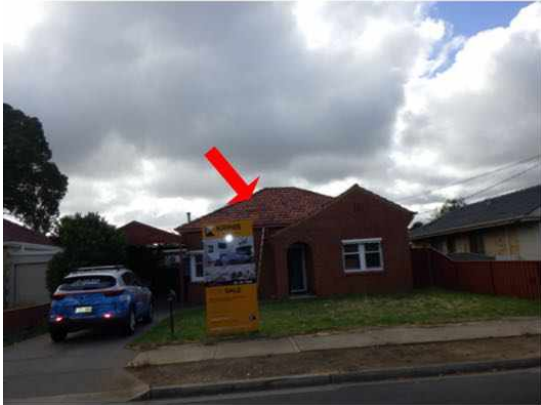
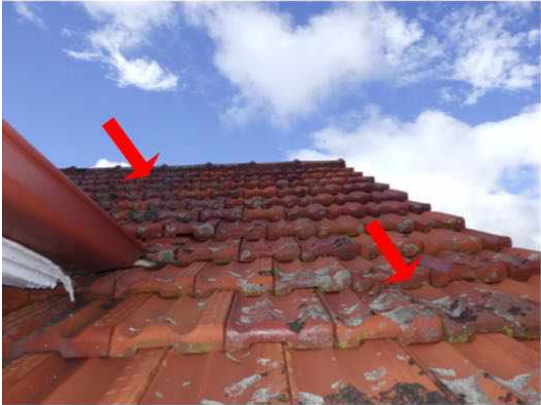
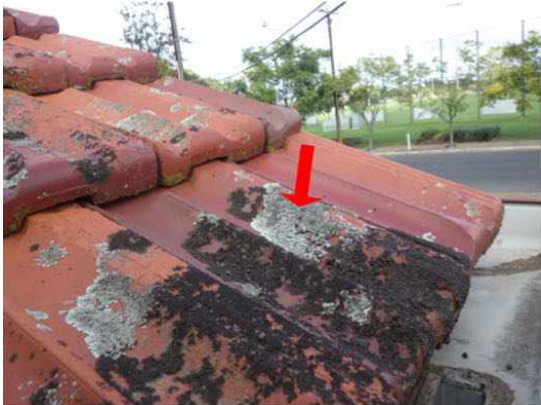
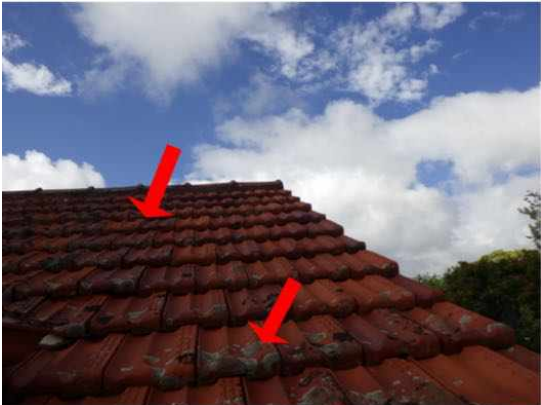
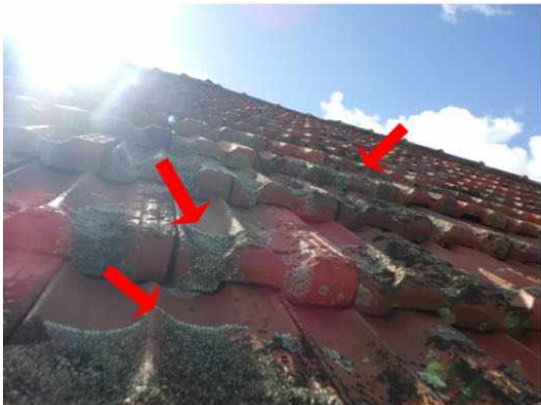
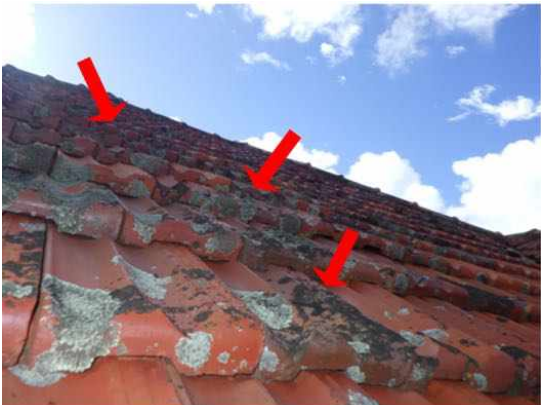
### Defects 3.02

Building:	Building 1
Location:	All External Areas
Finding:	Roof tiles - Weathered
Information:	Upon inspection of the exterior roofing, the majority of roof tiles were considered to be in a fair condition. While weathering of the tiles is consistent with the age of the property, maintenance works are required.

Isolated areas of mortar have come loose in the valleys and minor cracking is also present. Re-pointing and re-sealing the may be considered as an interim solution by the client to help preserve and extend the life span of the tiles.

Where left unmanaged, deteriorating roof tiles are likely to lead to a number of secondary defects, including minor water leaks and weather exposure to internal roofing structures.

Consultation with a roofing contractor is highly advised to gain advice on cost of remedial works that may be required in the short to medium term. Remedial works are likely to increase the longevity of the exterior roofing structure.

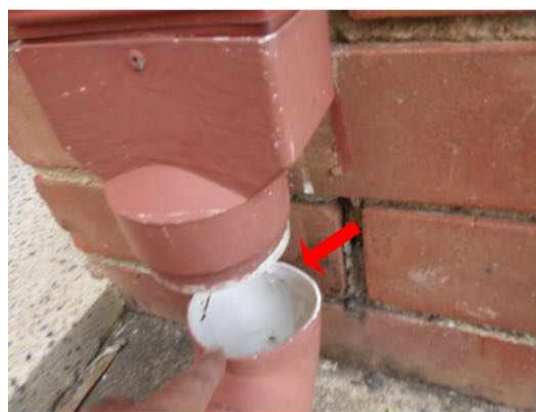
**Defects 3.03**

Building: Building 1  
Location: All External Areas

Finding: Site drainage - Inadequate  
 Information: The site drainage in this entry area was found to be inadequate at the time of inspection, creating potential for subsequent water damage to associated building elements.

It is important that water does not lie against the base of walls; surrounding paths and ground levels should be sloped to drain water away from walls. Downpipes should not discharge stormwater onto lower walls or plinths. Stormwater should be carried away by large, regularly cleaned drains. Ground levels may need to be lowered to expose a buried DPC.

Where site drainage is inadequate, installation of an Agricultural (Aggie) Drain may be required. A qualified plumber should be appointed to further inspect the property and perform any remedial works as necessary. Water damage and secondary defects are likely to occur if left unmanaged.

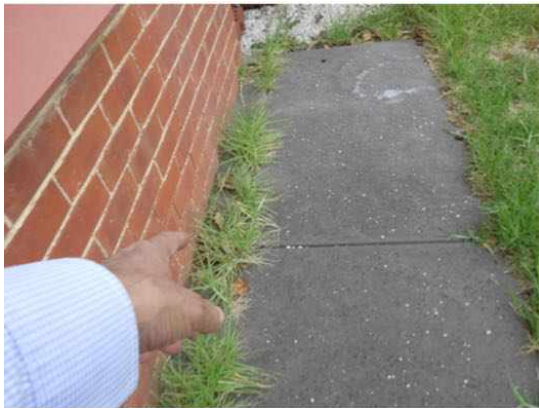
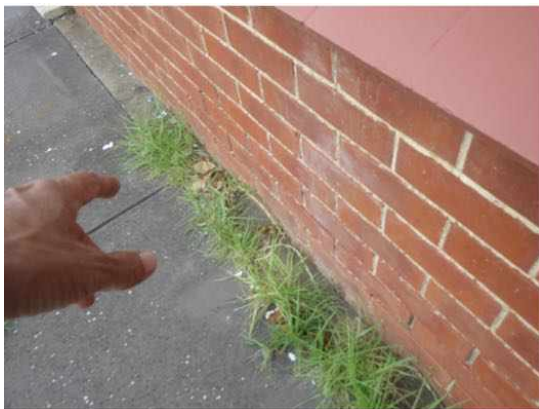
### Defects 3.04

Building: Building 1  
 Location: All External Areas  
 Finding: Bridging - Vegetation  
 Information: Where vegetation obstructs inspection of building elements, also known as bridging as it provides a bridging point for the access of termites, full inspection can not be

achieved. Consequently moisture or dampness may be present and the areas becomes conducive to termite activity. Plants against or very close to buildings provide cover, shade and can provide an environment that is attractive to termite infestation.

The removal and replanting of species that do not provide "cover" or cutting back of existing vegetation will assist greatly in preventing Bridging from occurring.

The removal of any such materials that may be conducive to termite activity should be carried out as soon as possible and arrange re inspection to minimize the risk of termite attack.

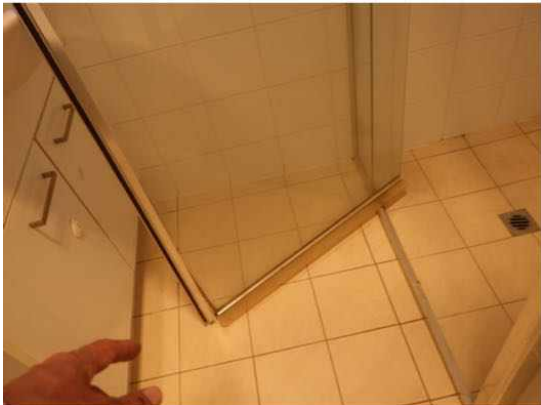
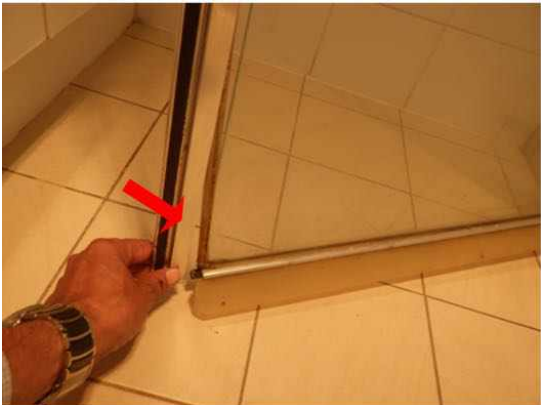
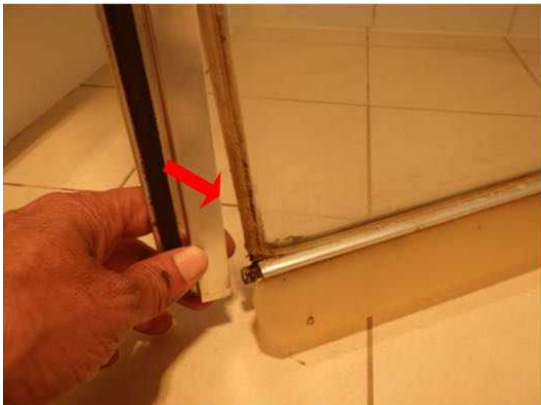
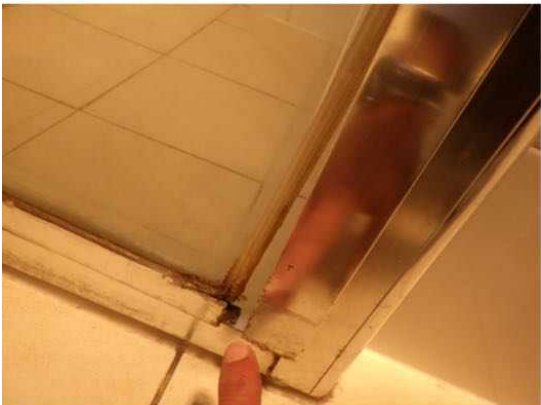
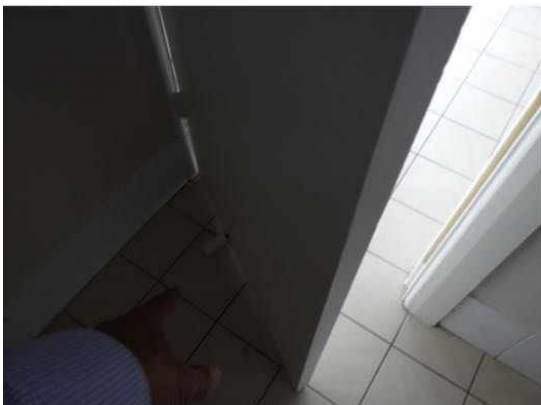
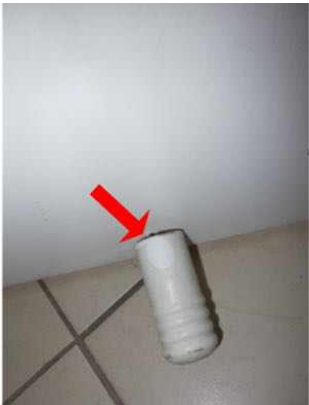
### Defects 3.05

Building:	Building 1
Location:	All Areas
Finding:	Building element - Damaged/ Loose from its original fixing
Information:	At the time of inspection it was noticed evidence of building elements damaged/ loose from its original fixing around the property.

Breakage occurs generally when the building materials have either aged and decayed, or as a result of damage (accidental or deliberate).

Repair and/or replacement of broken elements is advised to ensure that additional

secondary defects do not arise as a consequence. Such works are necessary, as all building elements play a key role in the operation and function of the overall structure and its performance.

A relevant tradesperson should be appointed to repair or replace the affected building element prior to any subsequent damage being caused.
