## Building Inspection Report

Inspection Date: Wed, 11 Mar 2026

Property Address: 26 James St, Plympton SA 5038, Australia

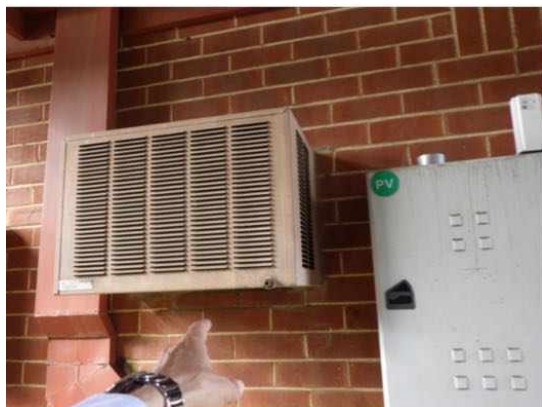
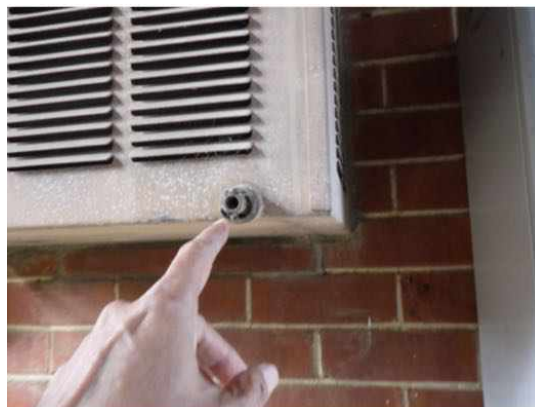
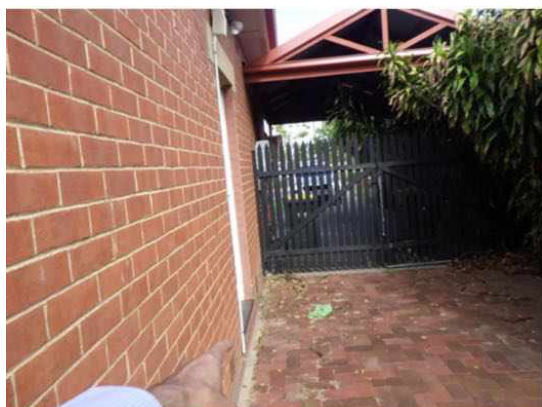
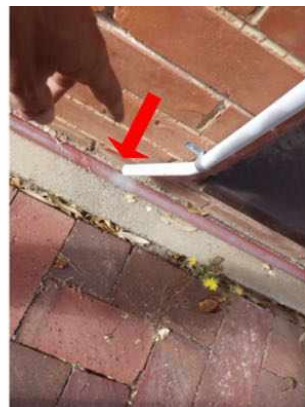
**Defects 3.06**

Building: Building 1  
Location: All External Areas  
Finding: Air conditioner - Disconnected overflow

Information: The Air Conditioner (A/C) overflow was found to be disconnected from storm water drainage and is creating excessive moisture in the surrounding area.

Such leaking creates an environment which is conducive to an array of defects, including water damage to associated building elements and the attraction of termite or timber pest infestation.

It is highly recommended that a licensed plumber be appointed to connect the A/C overflow in order to prevent such an environment from being created. These minor works should be carried out as soon as possible.

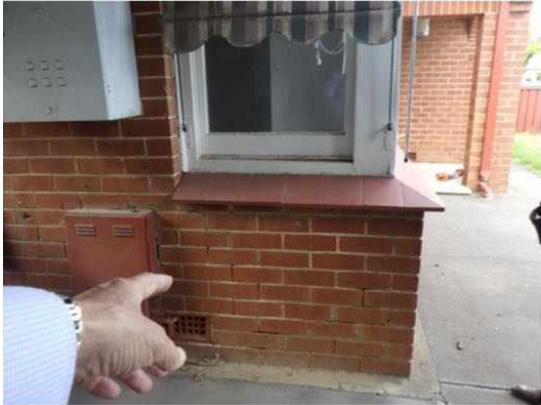
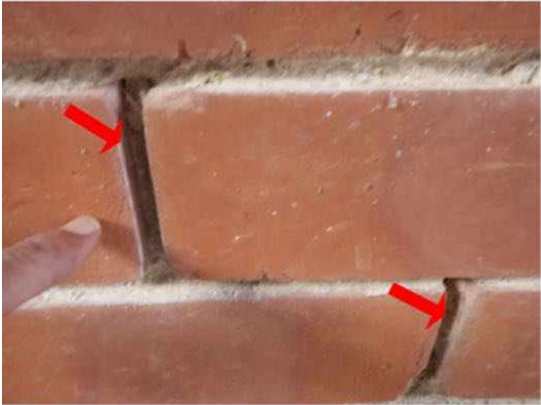
### Defects 3.07

Finding: Brickwork - Deteriorated mortar

Information: Mortar, or 'bedding', is the material which fills joins and intersections between bricks in masonry walls and structures. Sections of mortar in this brickwork were identified as having deteriorated, which is generally expected for a property of this age and condition.

Mortar may deteriorate as a result of age of building materials, minor movement of bricks, or frequent exposure to weathering. Mortar should be replaced to ensure that

bricks remain in their intended location and to prevent gaps, which would allow water or moisture ingress and secondary damage as a result.

Mortar deterioration can be addressed by a bricklayer where areas of deterioration are localised and easily accessible. Alternatively, appointment of a registered builder is advised, to repoint large areas of decaying mortar. Where secondary structural defects have become evident, consultation with a structural engineer may be required.

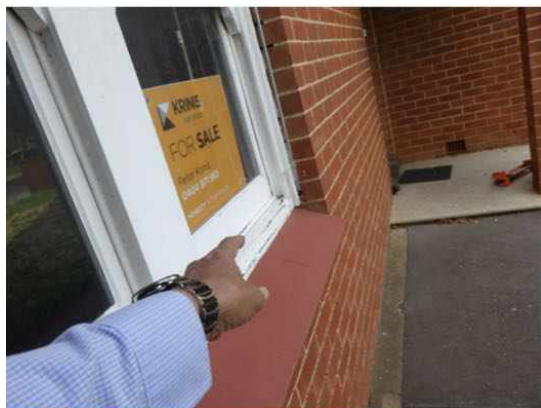
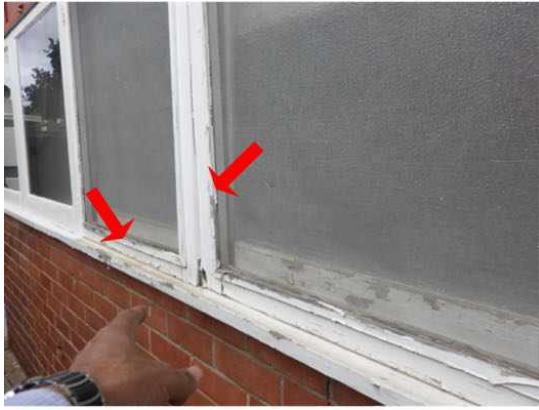
**Defects 3.08**

Finding: External painting deteriorated  
Information: Much of the external paintwork including but not limited to windows, fascias, guttering, veranda and other external fitments have been neglected and require attention to prepare and re-paint.

Whilst incomplete or missing paint finish is generally an appearance defect, it can also lead to the development of secondary building defects over time. Incomplete areas of paint finish expose the area to moisture, potentially accelerating the deterioration of underlying building materials.

Degraded paint finishes should be sanded back, filled, leveled and painted, as applicable. Where inadequate or missing paint protection has led to the deterioration of the associated building element, repair and/or replacement of this building element may be required.

A painting contractor should be appointed as soon as possible to perform necessary works to aid the appearance of the affected area and to ensure the area is protected against further deterioration. Alternatively, the homeowner following manufacturer instructions may perform these works.

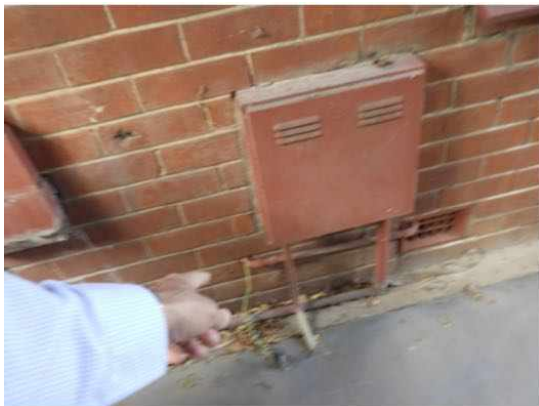
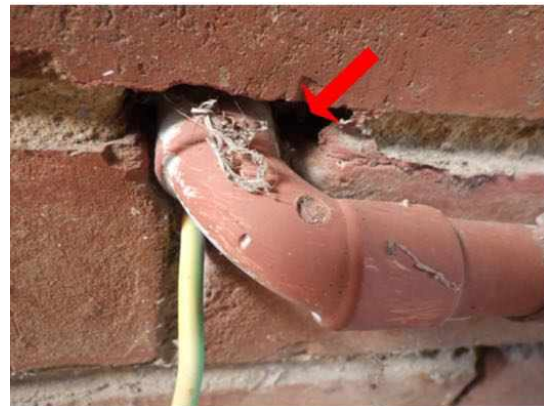
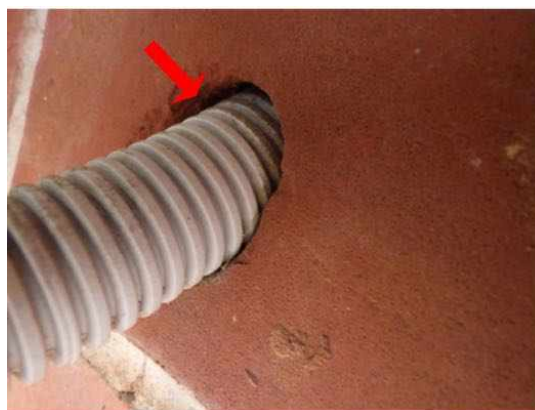
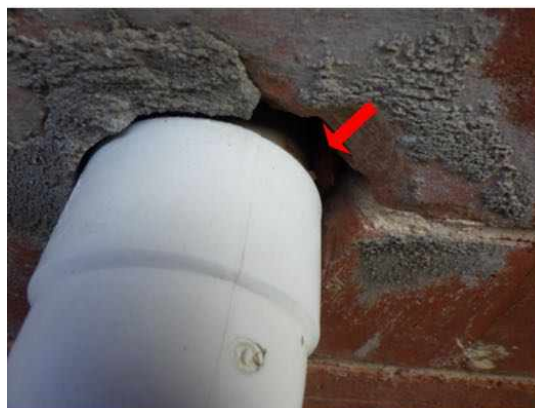
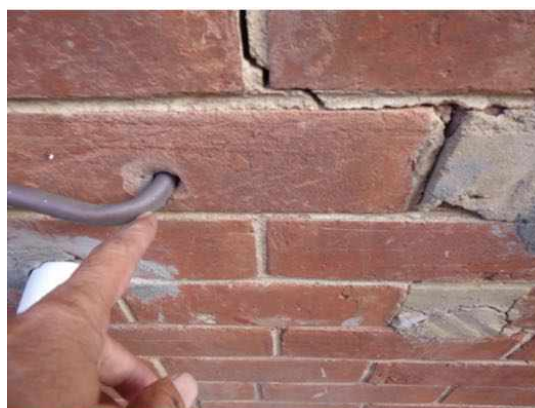
### Defects 3.09

Building:	Building 1
Location:	All External Areas
Finding:	External walls - Holes
Information:	Significant holes were identified around pipe penetrations in this wall section. It is suspected that the installation of this pipework was completed to a substandard level of workmanship or is incomplete.

Gaps and holes around pipework makes the area susceptible to insect and vermin ingress, as well as allowing water penetration to the cavity wall. As such, associated building elements are likely to deteriorate at an accelerated rate, and major implications are expected if holes around the pipework are left unmanaged.

All excessive holes, gaps or cracks should be adequately filled by a suitable sealant or trimmings as soon as possible to prevent any further damage. Such works may be conducted by a general handyperson or licensed plumber.

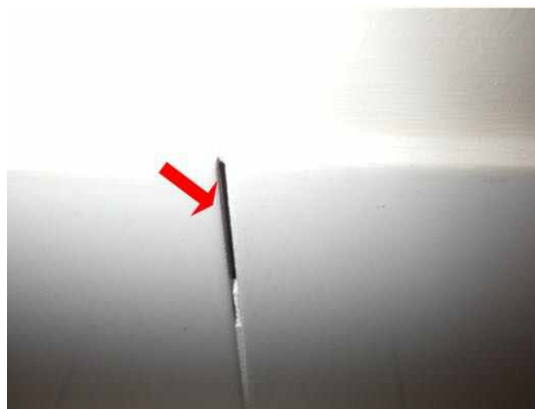
### Defects 3.10

Building:	Building 1
Location:	All Internal Areas
Finding:	Grout - Missing/ Deteriorated
Information:	Grout is missing/ deteriorated in this toilet area. Grout is used to protect gaps and crevices in building materials to ensure that they are water-tight and prevent water penetration to the associated structures.

Where grout is missing, a tiling contractor should be appointed immediately to apply grout and re-apply any silicone where necessary. Failure to do so is likely to lead to water damage to the surrounding area.

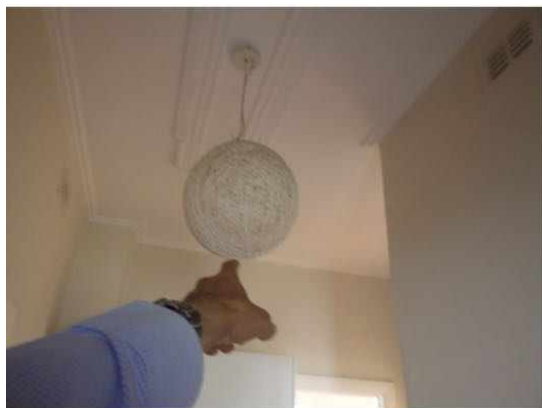
### Defects 3.11

Building:	Building 1
Location:	All Internal Areas
Finding:	Few Globes - Not operating
Information:	At the time of inspection it was noticed that few globes were not operational around the property. Non-operational items should be addressed to ensure that the full function of the building structure is available. Where some building elements are not operating as intended, it is possible that secondary building defects could arise due to their non-operation.

Repair and/or replacement of the faulty building element is recommended. It is highly recommended that the relevant tradesperson be engaged to perform any necessary works.

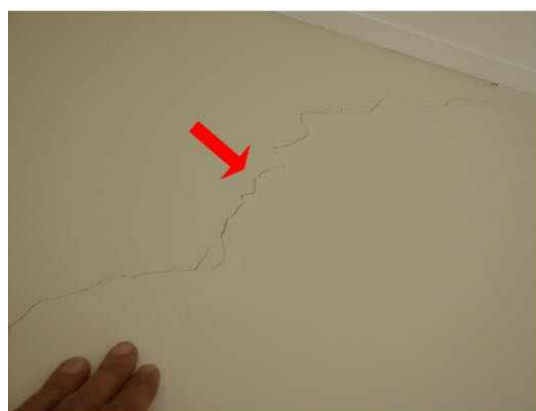
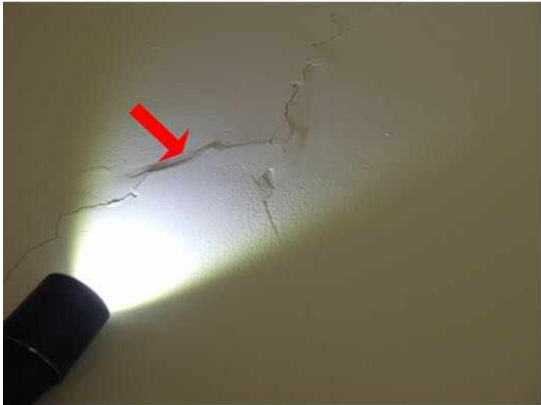
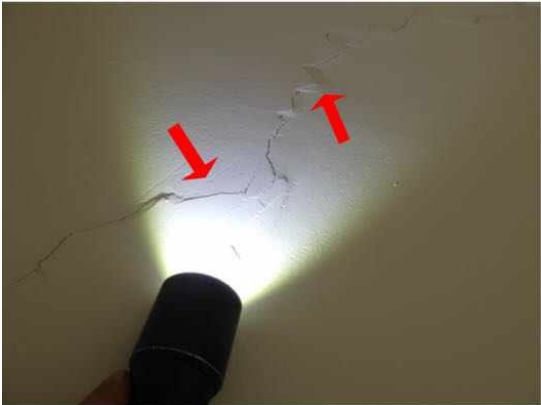
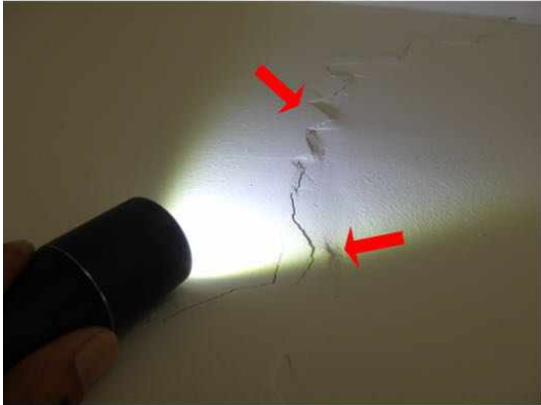
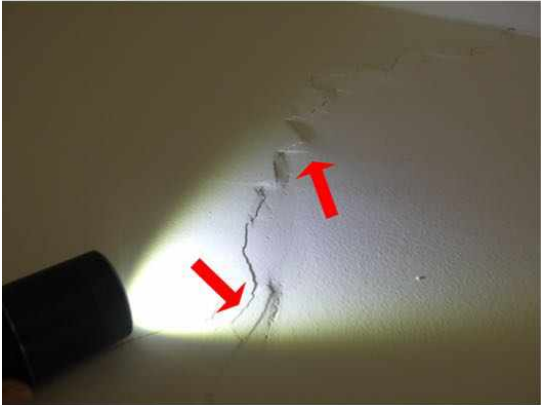
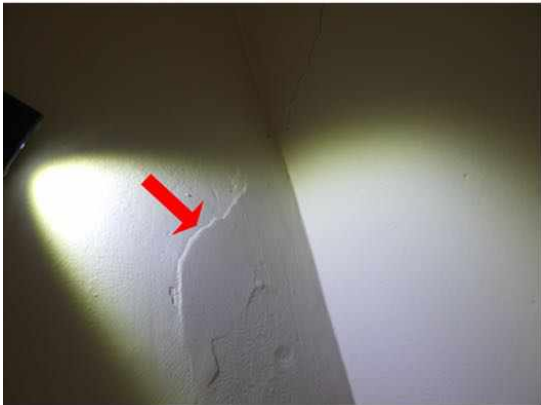
### Defects 3.12

Building:	Building 1
Location:	All Internal Areas
Finding:	Plaster - Drummy
Information:	Sections of plaster sheeting in this living, dining and kitchen area appear to be drummy. The term `drummy` is used to describe plaster which, whilst solid, has become detached from its original fixing.

The most common causes of plaster failure are physical damage and moisture damage. Moisture causes plaster to swell and shrink as the humidity of the air changes, or as a consequence of leaks, which can be enough to create drumminess or cracking.

Drummy plaster generally needs chemical re-adhesion or to be screwed back to the substrate, with minor consequent patching and painting required.

Ensure that the general environment is free of moisture and humidity to aid in the prevention of drummy plaster and plaster damage. Appointment of a qualified plasterer is advised in order to complete remedial works as necessary.

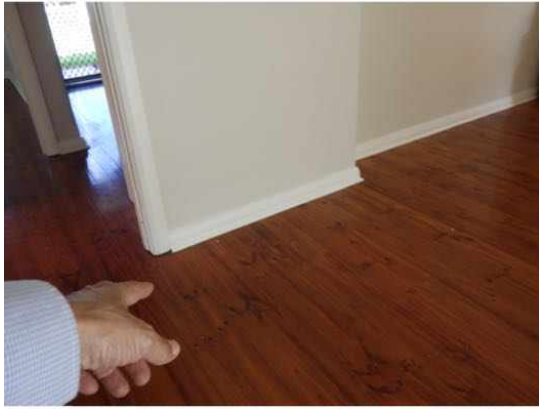
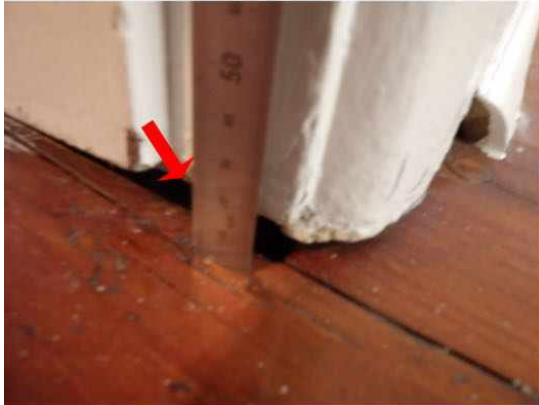
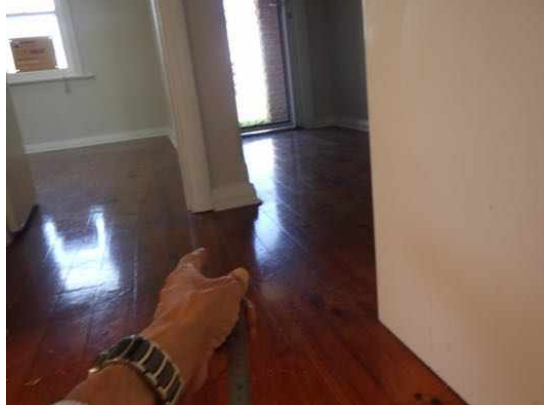
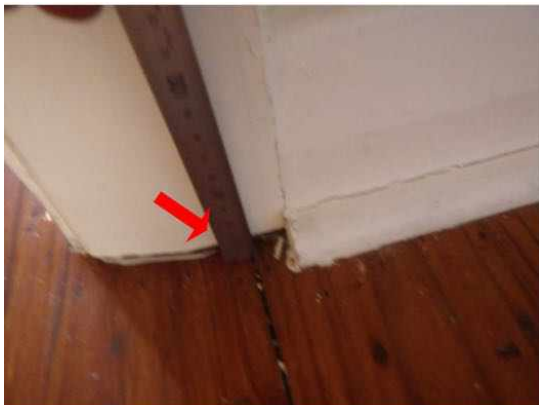
### Defects 3.13

Building:	Building 1
Location:	All Internal Areas
Finding:	Timber flooring - Gaps to edges
Information:	Considerable gaps were noticeable around door jambs and edges of flooring. These gaps serve the purpose of allowing the flooring material to expand and contract, which is expected due to moisture levels and humidity.

While purposeful, these gaps make the adjoining building elements prone to water penetration, creating potential for the development of secondary damage.

While beading is used in most places to cover this gap around smaller corners, it is recommended that these gaps be filled with a coloured caulking compound. Such works should be performed by a qualified carpenter or general handyman, and should be completed at the discretion of the client.

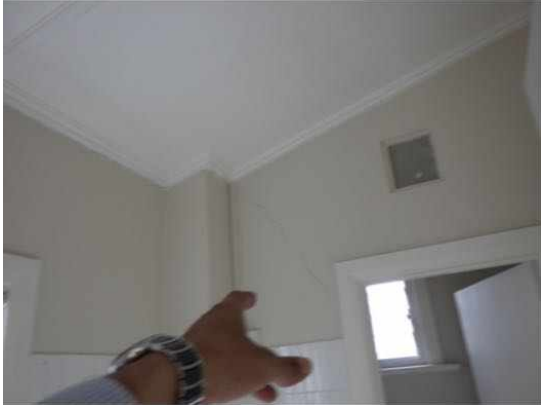
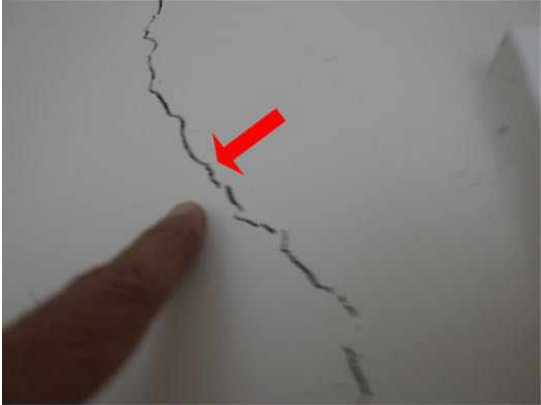
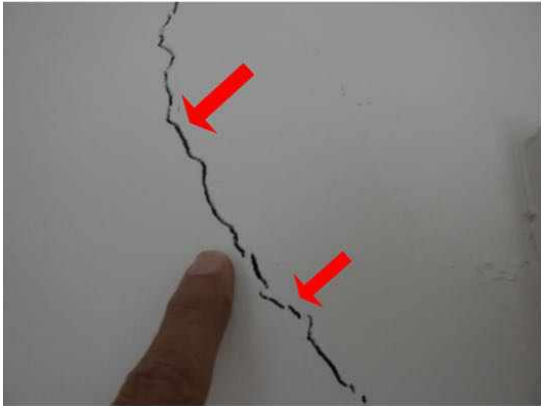
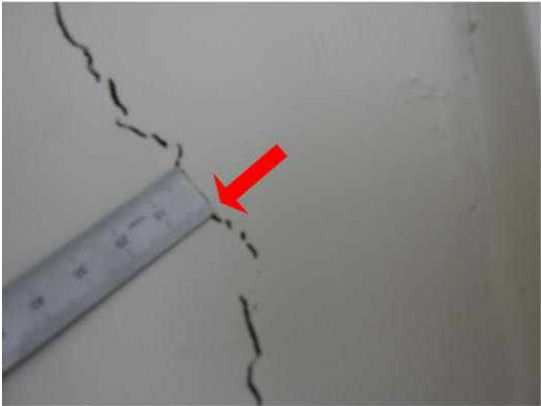
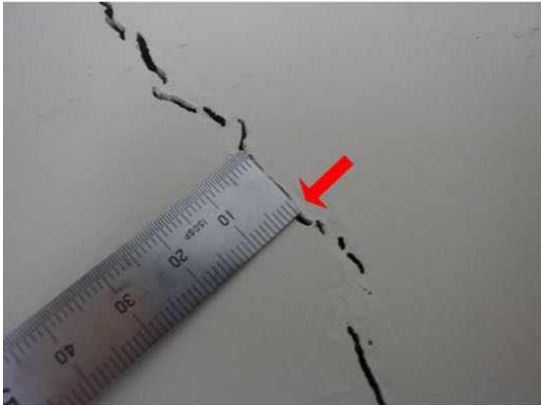
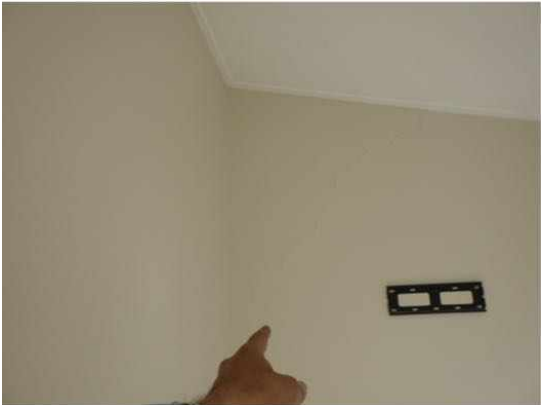
### Defects 3.14

Building:	Building 1
Location:	All Internal Areas
Finding:	Cracks to internal render - Category 2
Information:	It has been observed that cracking to internal rendered surfaces has occurred. The degree of damage falls within Category 2, described as noticeable cracks which are easily filled. Cracking of this size are generally less than 5mm in width.

Category 2 damage is required to be monitored for a period of 12 months. After the monitoring period, a crack rated at Category 2 or above is considered a defect requiring rectification.

Always contact your building inspector should cracks widen, lengthen, or become more numerous.

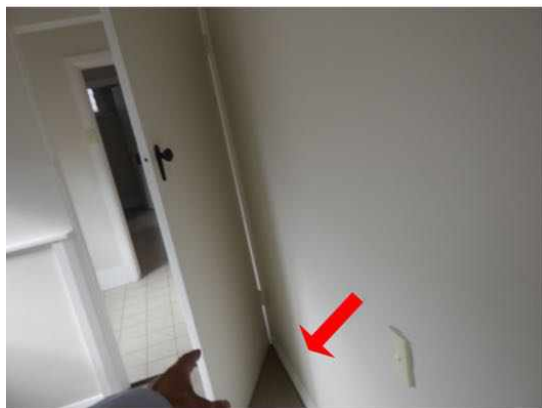
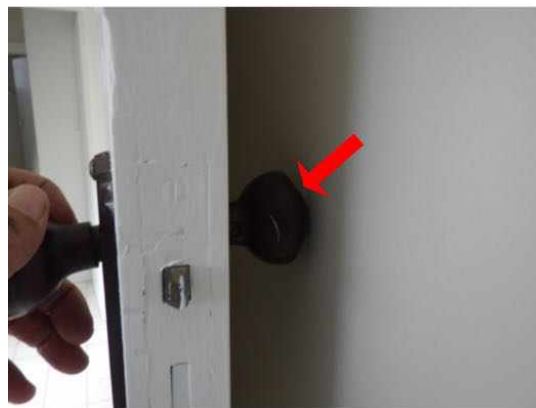
### Defects 3.15

Building:	Building 1
Location:	All Internal Areas
Finding:	Door stop - Missing
Information:	The door stop is missing or is inadequate to stop the door handle from damaging the wall. Although some building elements may seem irrelevant or unnecessary, all building elements play a key role in the operation and function of the overall structure and its performance.

Re-installation or replacement of the door stop is advised as soon as possible to prevent any subsequent damage to the door or associated structures. A general handyman may be appointed to perform these works at client discretion.

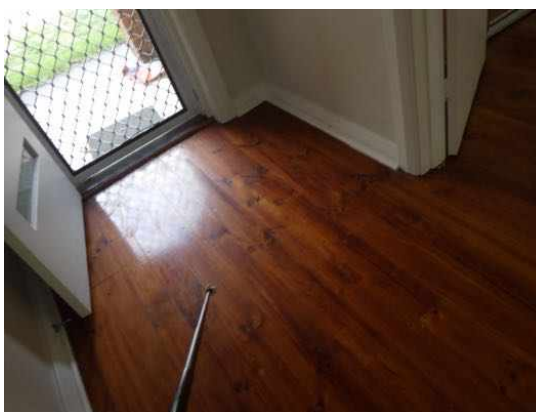
### Defects 3.16

Building:	Building 1
Location:	All Internal Areas
Finding:	Floors - bouncy
Information:	The internal flooring in this area was identified as being bouncy at the time of inspection. A bouncy floor surface generally presents as a discernible change in level as they are walked across, in noisy or creaking flooring, or in consequent movement of surrounding furniture and fixtures.

Bouncy floors generally indicate that the floorboards or the subfloor structures are coming loose from the joists that they are installed on. Bouncy flooring may also be the result of gaps between flooring and stumps or joist structures, which require packing.

The client is advised to seek quotations for required repairs from a Registered Builder specialising in re-stumping. The potential resolution may range from packing gaps in subfloor structures through to replacement of subfloors stumps and refixing of flooring.

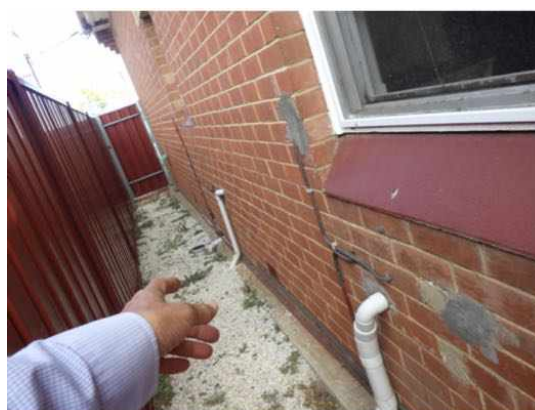
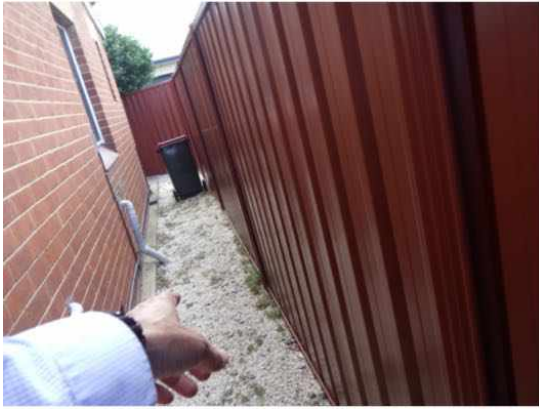
### Defects 3.17

Building:	Building 1
Location:	All External Areas
Finding:	External Paving – Missing Sections / Not Installed
Information:	At the time of inspection, it was observed that several sections of external paving were missing or not installed around the perimeter of the property. This condition has resulted in exposure of the concrete slab edge, thereby compromising the intended protection to the slab and adjoining building elements.

Exposed slab edges may increase the risk of moisture penetration, deterioration of structural and non-structural elements, termite or pest ingress, and ongoing maintenance issues. This condition is considered a defect and a maintenance concern that requires attention.

It is recommended that a suitably qualified and licensed contractor be engaged to install the missing external paving sections and reinstate adequate protection to the slab edge. All works should be carried out in accordance with relevant Australian Standards, the National Construction Code (NCC), and accepted building practices.

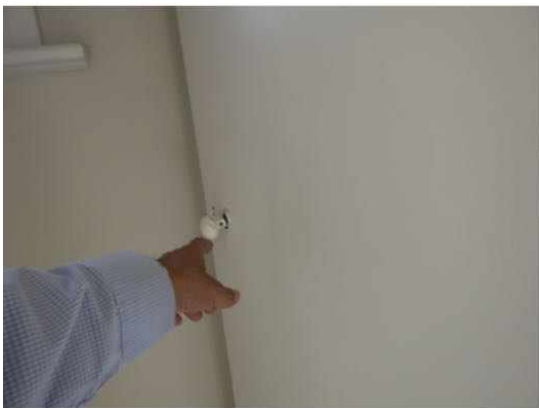
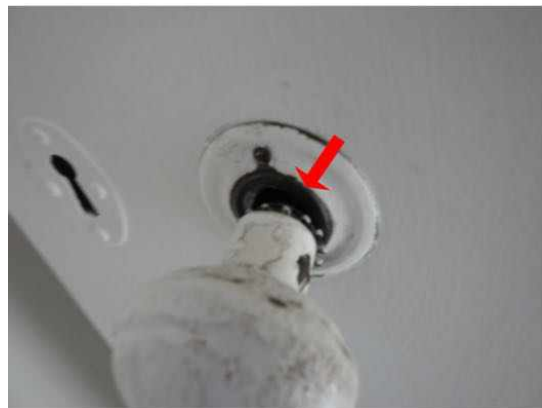
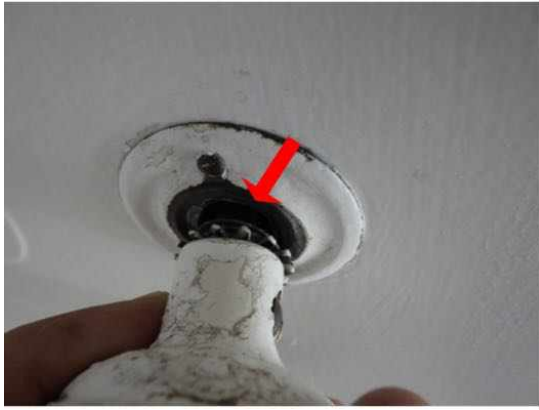
### Defects 3.18

Building:	Building 1
Location:	All Areas
Finding:	Door - Broken handle/ Loose from its original fixing
Information:	The door handle in this toilet area was found to be broken / loose from its original fixing at the time of inspection. Breakage occurs generally when the building materials have aged and decayed, but may be indicative of impact damage (accidental or deliberate).

Repair and/or replacement of the broken door handle is advised to improve the operational state of the associated door.

A qualified carpenter or general handyman should be appointed to repair/replace the door handle at the client's discretion.

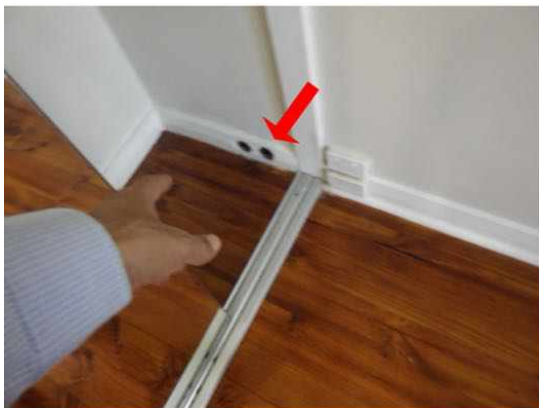
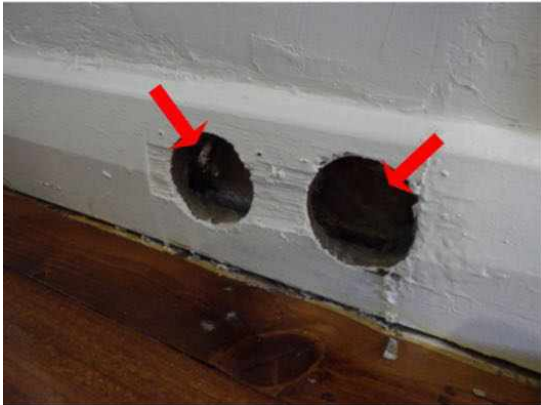
### Defects 3.19

Building:	Building 1
Location:	All Internal Areas
Finding:	Surface - Holes
Information:	Holes in surfaces are generally indicative of impact damage, whether accidental or deliberate, or a failing of the surface material.

Where holes are apparent in the surface of a building material, the surface is no longer sealed against water penetration or further impact damage, which may lead to additional damage to the surrounding surface.

Repair or replacement of the affected building element is recommended as soon as possible to ensure that any secondary defects are minimised. A qualified carpenter or general handyperson should be appointed to perform these works.

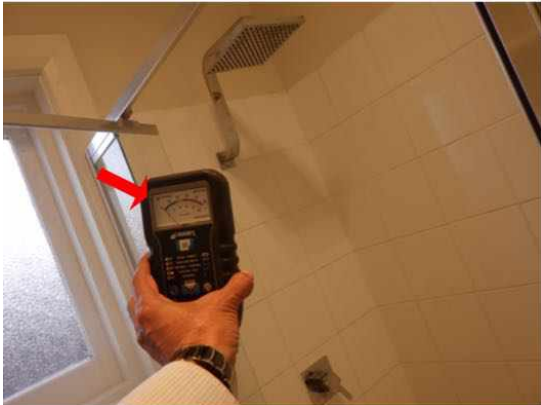
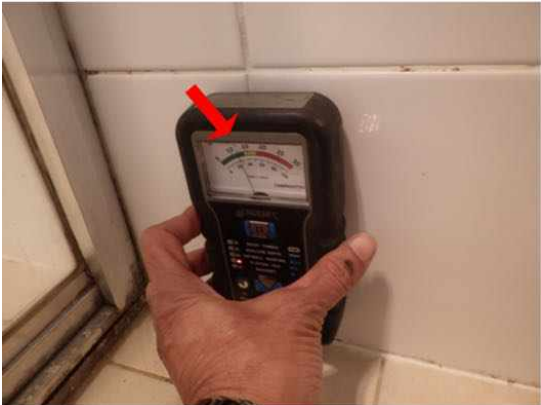
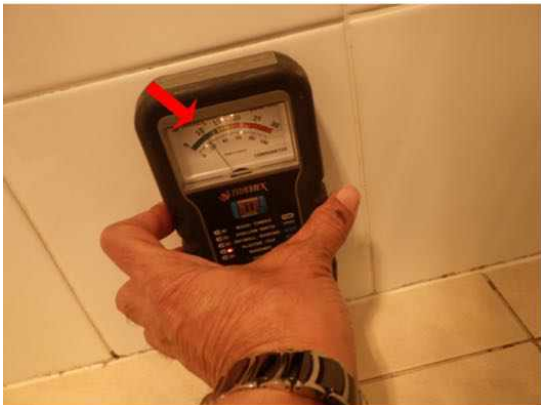
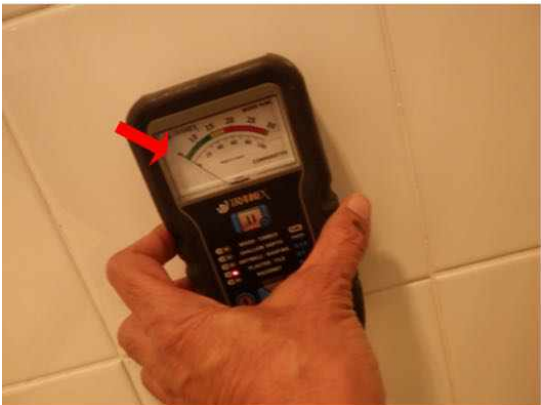
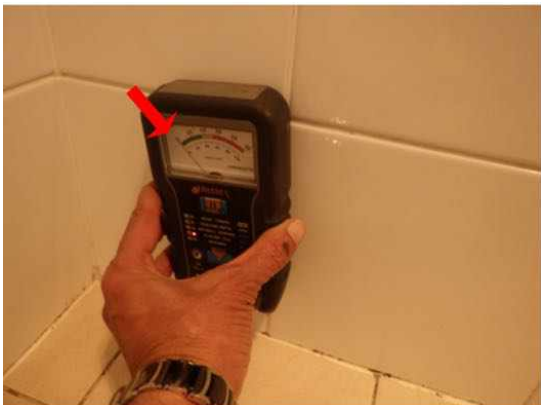
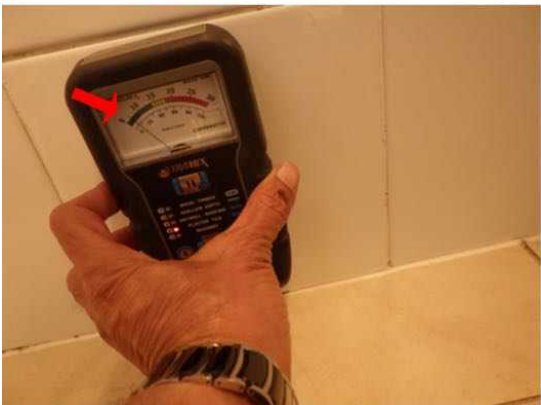
#### Noted Item

Apart from that at the time of inspection it was also that no high moisture readings were noted in this bathtub area.

Damp (or structural damp) refers to the presence of unwanted moisture in the structure of a building, either as the result of intrusion from outside, or condensation from within the structure. In the shower area, internal water leaks or other sources of excessive moisture are generally the cause of damp.

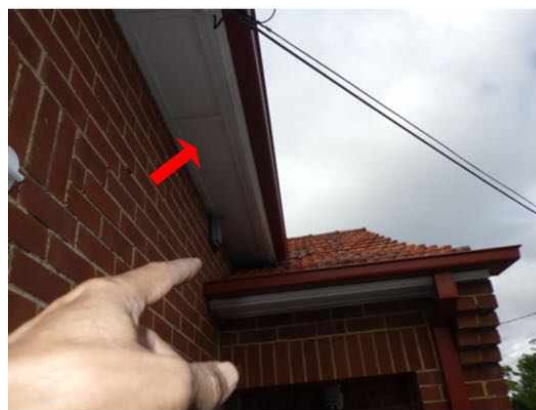
Noted Item

Building:	Building 1
Location:	All External Areas
Finding:	Asbestos - Suspected ACM Identified on Site
Information:	Reporting on Asbestos is outside the Scope of this Report. This suspected defect is highlighted as a caution only. We suspect, based on our experience in the building industry, that there is a higher risk of the identified building element containing asbestos.

As Asbestos Reporting is outside the scope of this report, we advise that you consider a separate Asbestos Inspection and Condition Audit, which can include the taking of samples for definitive confirmation of the presence of Asbestos.

In the interim, the client is advised to act with caution, especially when considering any damage to building materials general wear and tear renovations extensions demolition and general maintenance activities due to the suspected presence of Asbestos.
