## Building Inspection Report

Inspection Date: Wed, 11 Mar 2026

Property Address: 26 James St, Plympton SA 5038, Australia

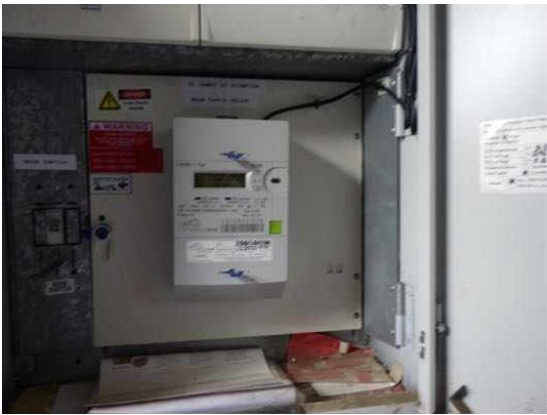
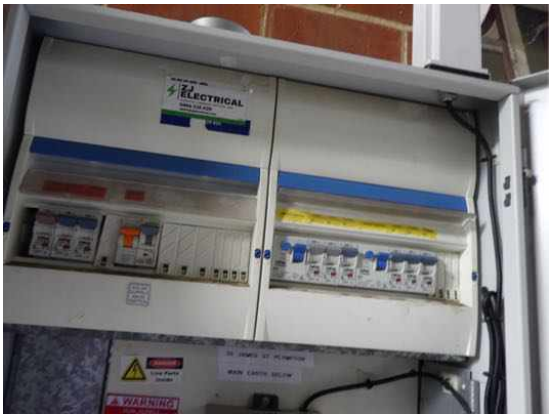
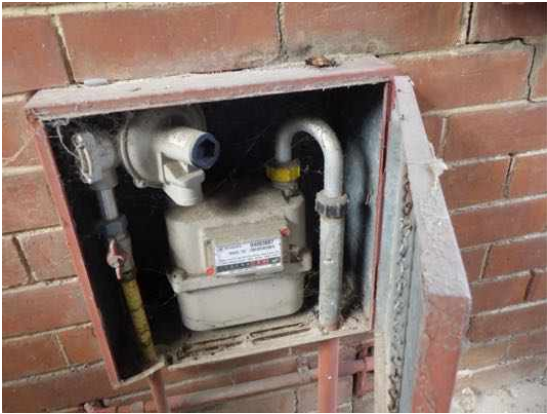
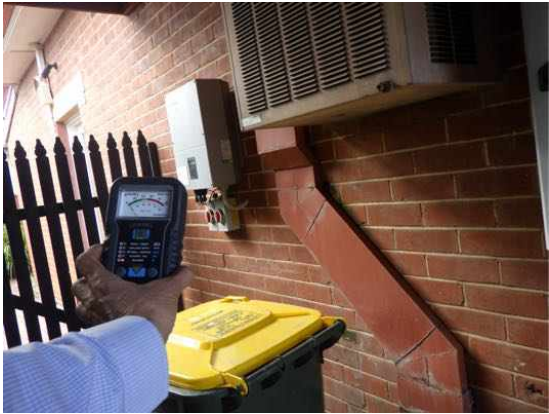
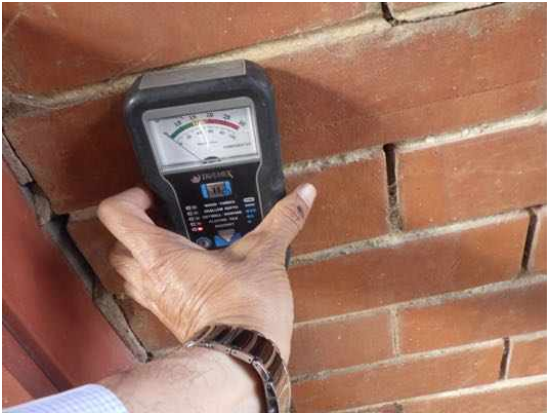
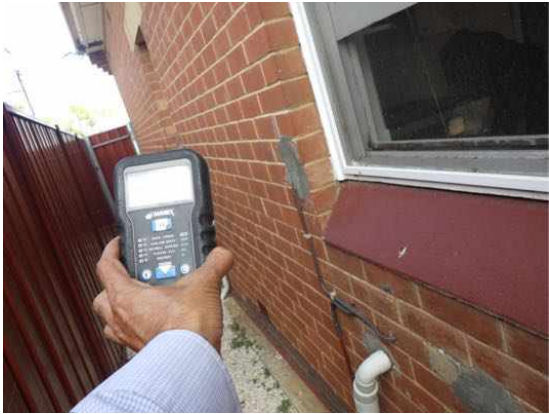
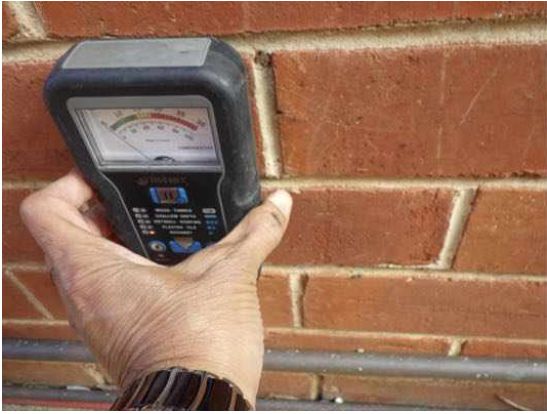
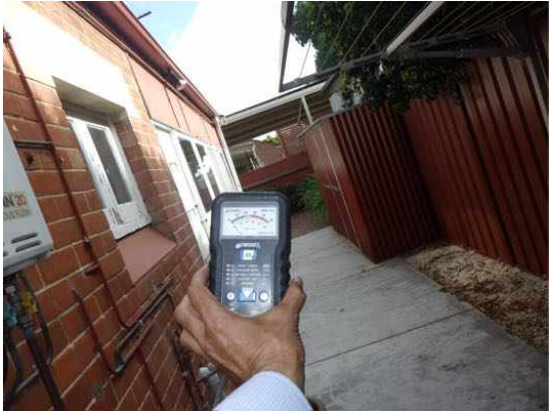
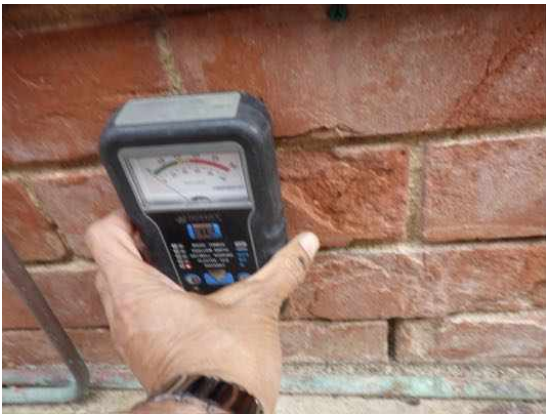
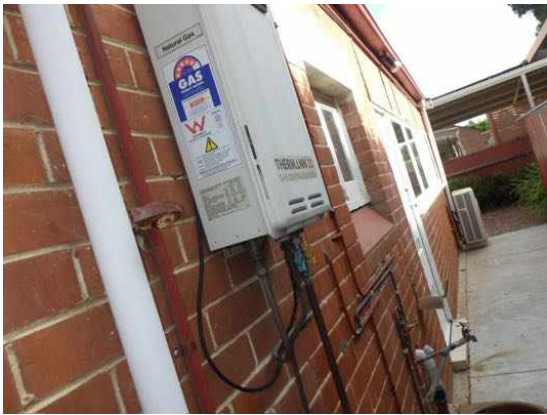
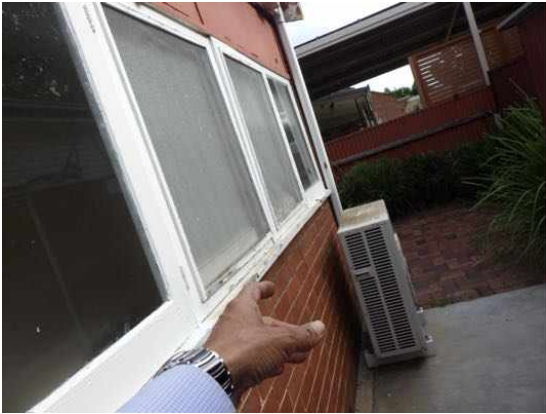
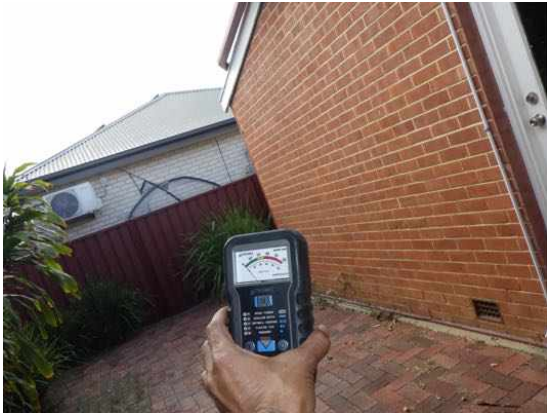
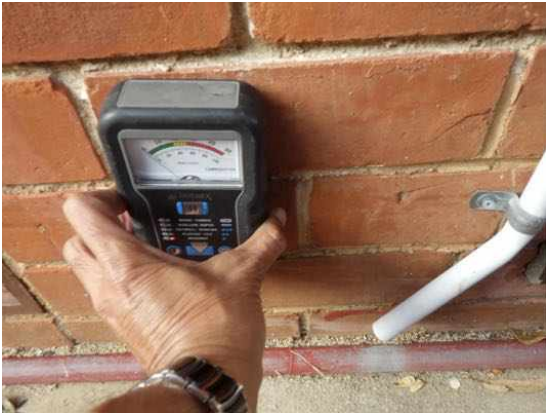
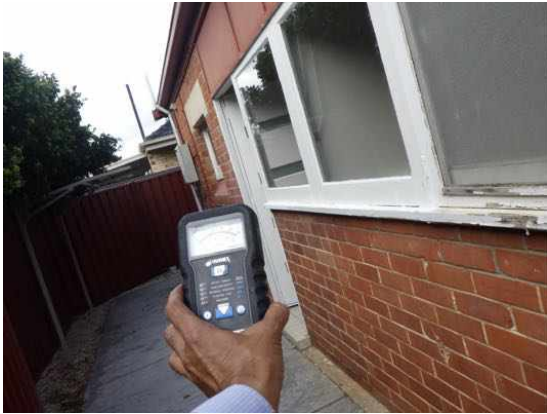
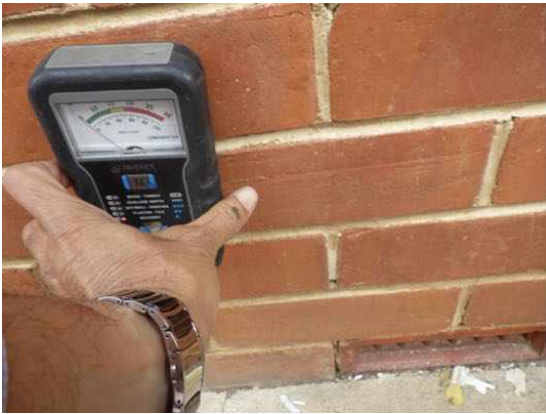
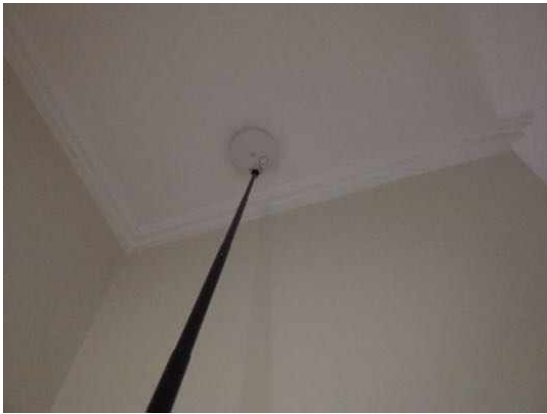
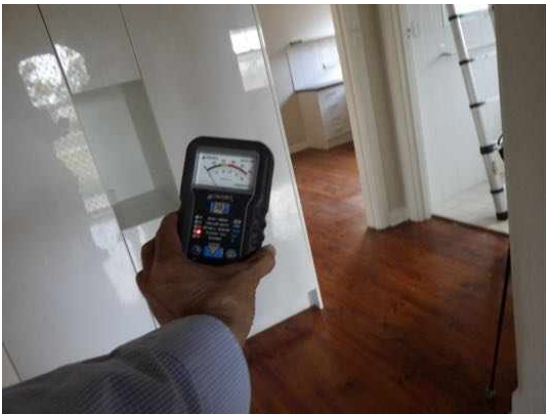
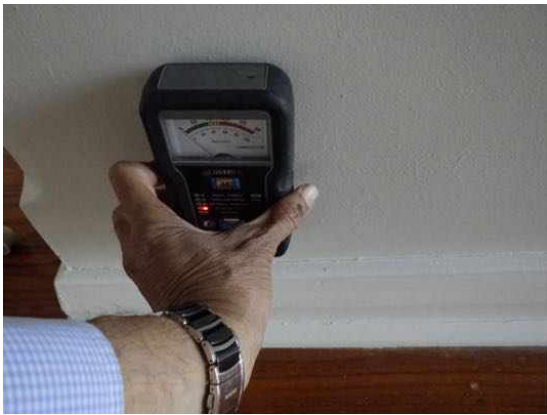
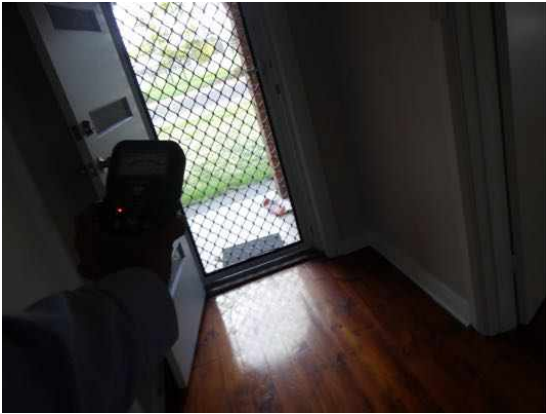
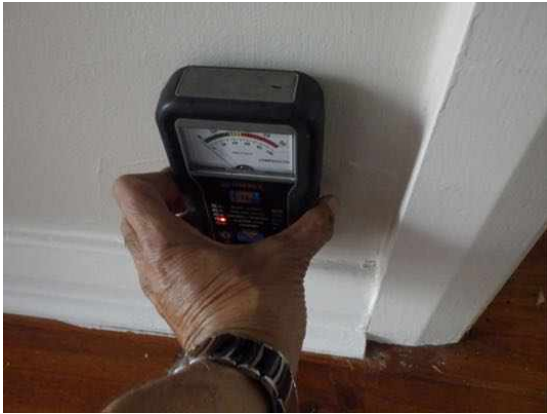
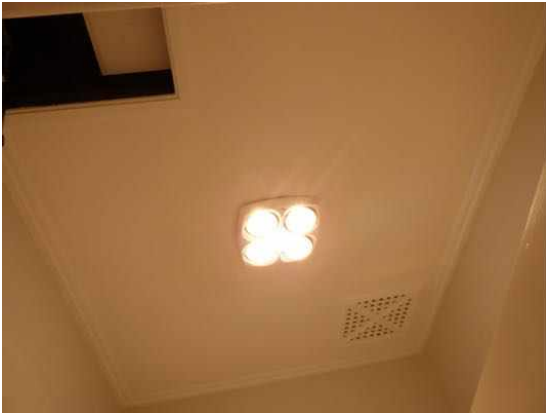
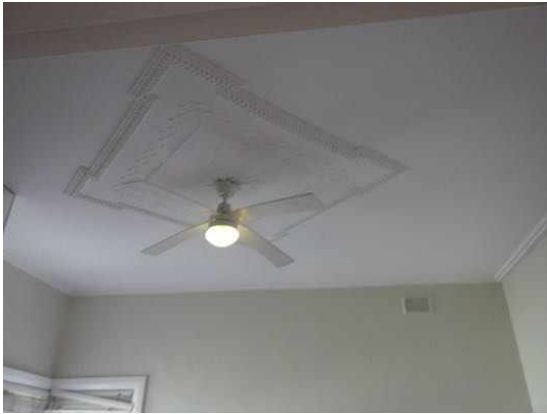
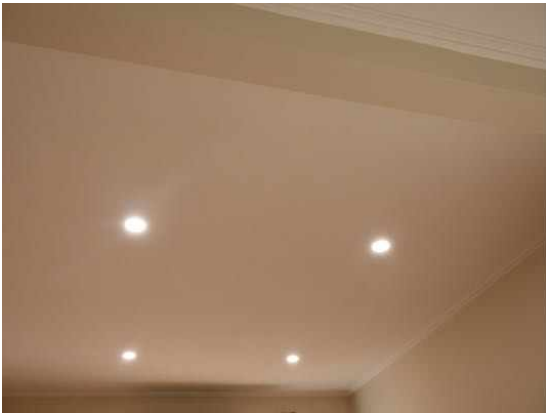
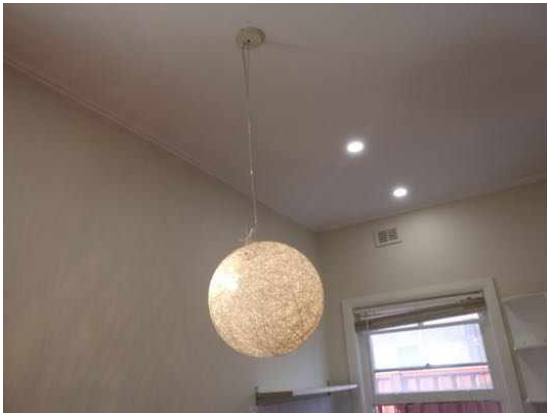
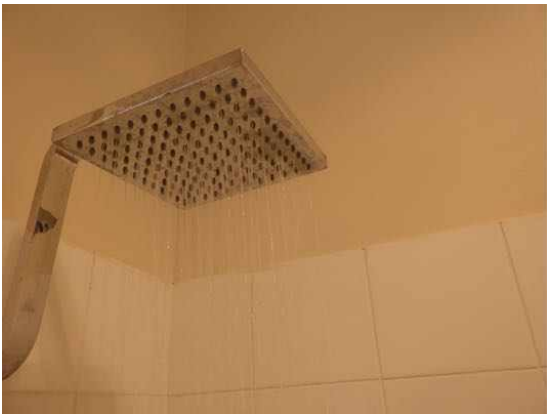
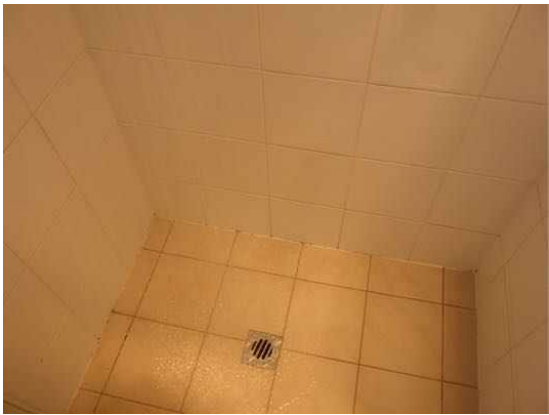
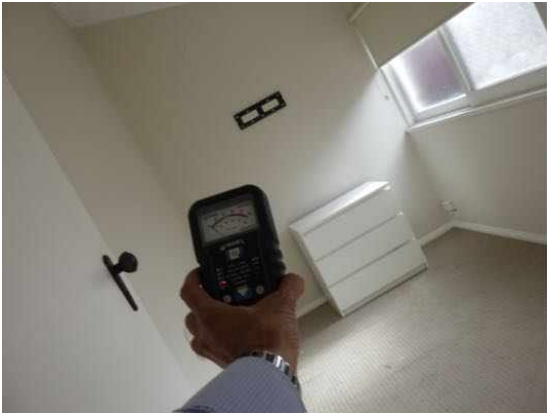
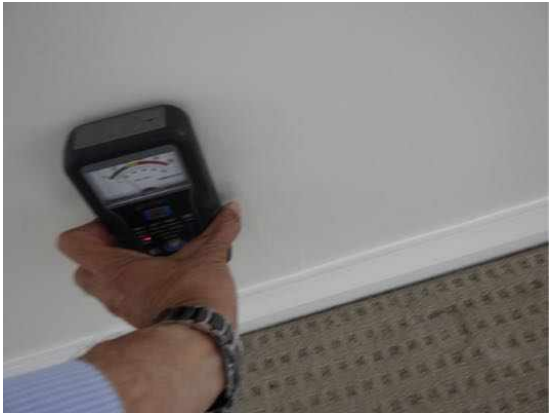
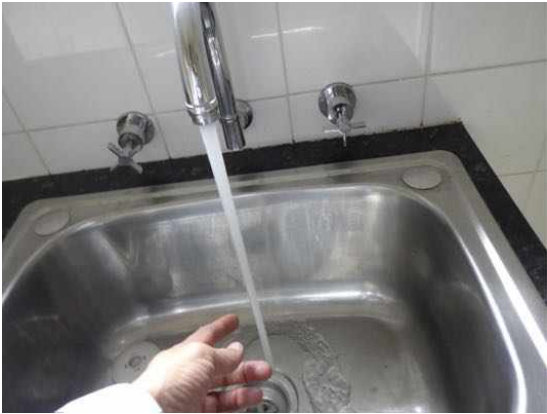
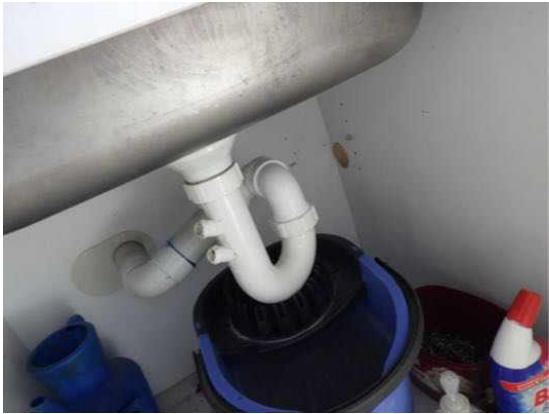
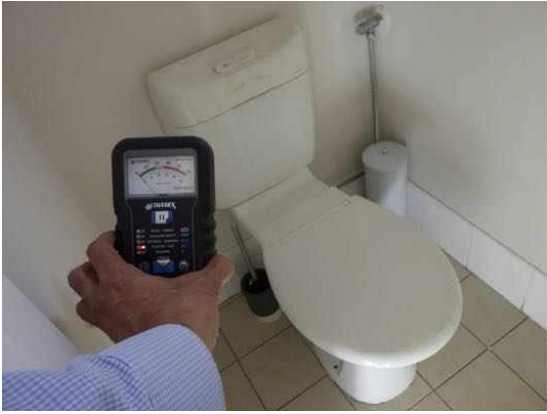
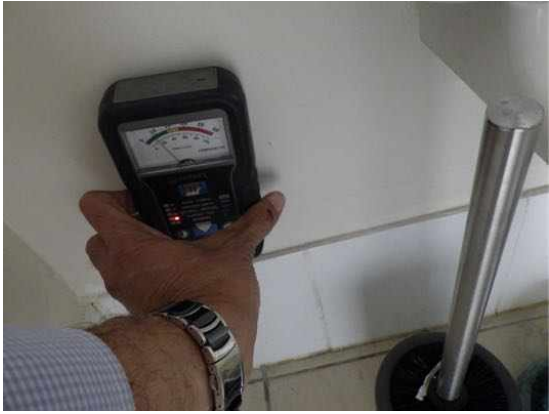
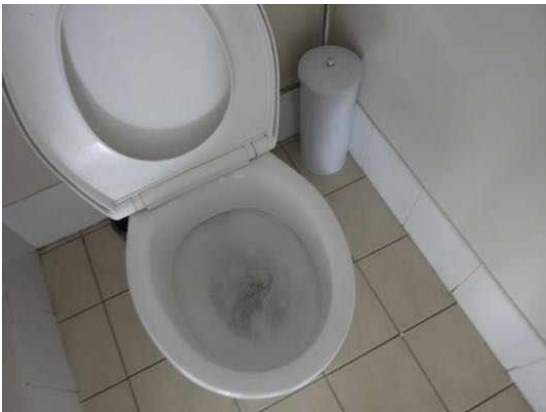
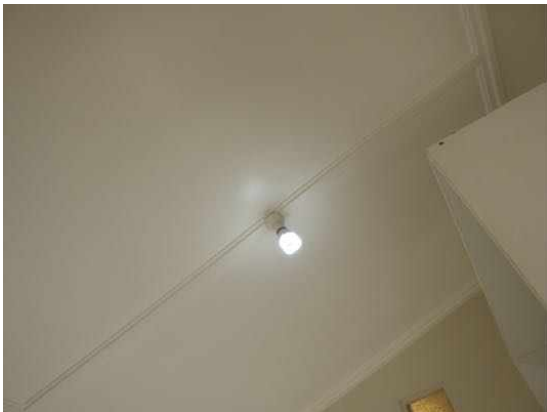
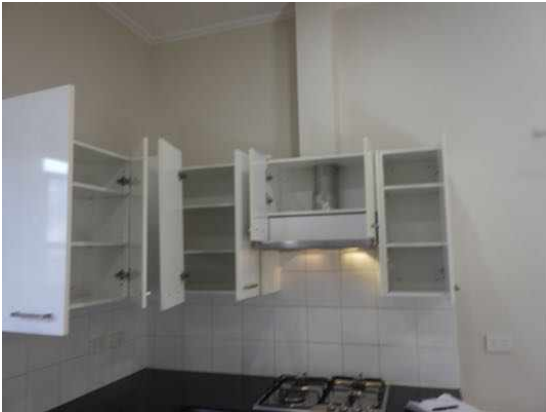
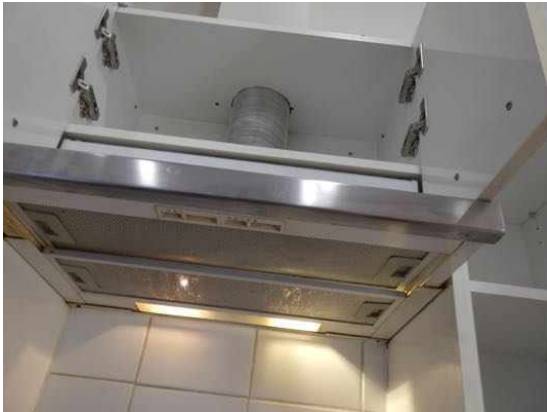
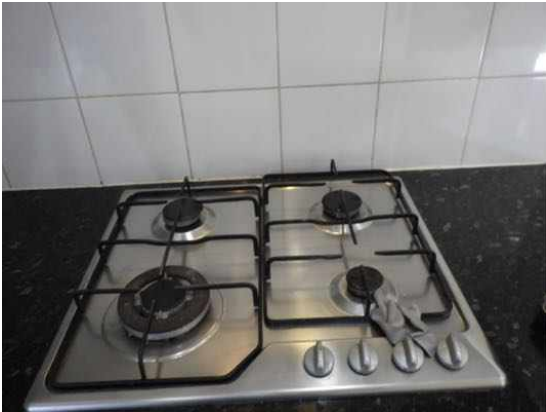
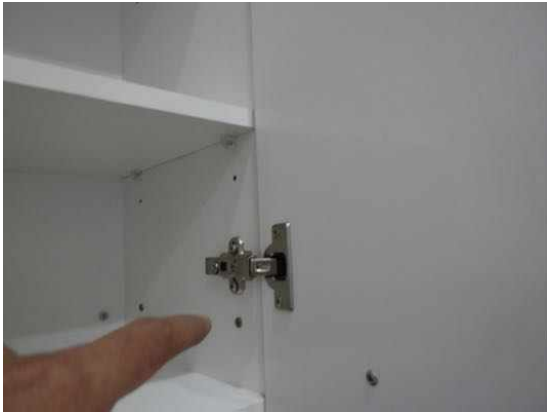
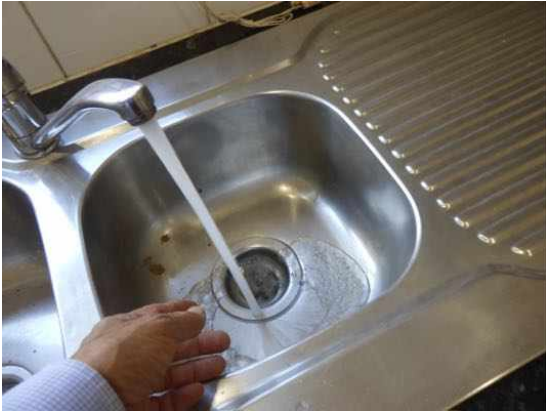
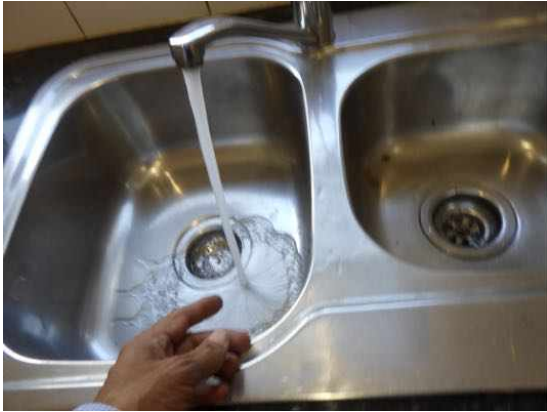
Building: Building 1  
Location: All Areas  
Finding: Additional Photos  
Information: Additional photos are provided for your general reference

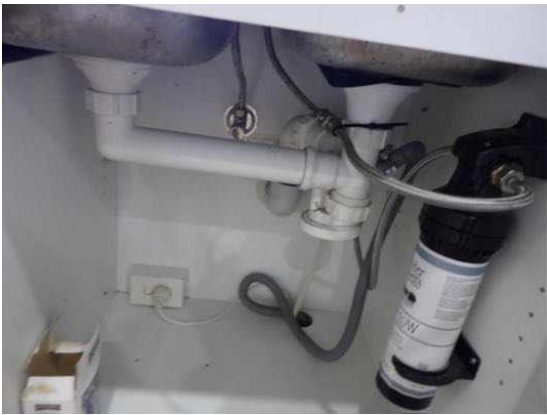
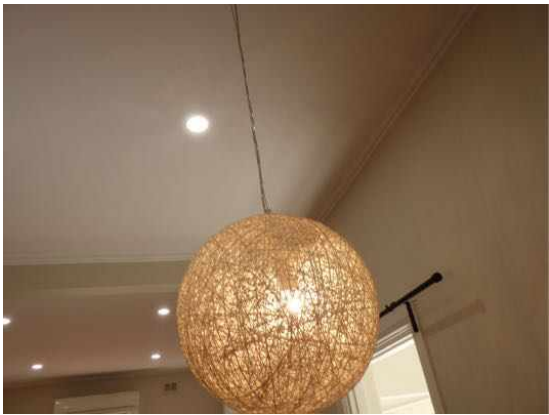
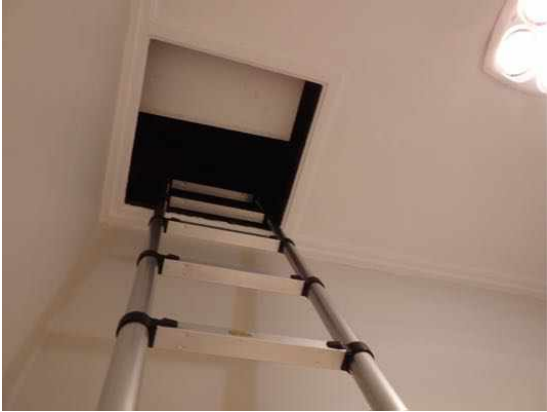
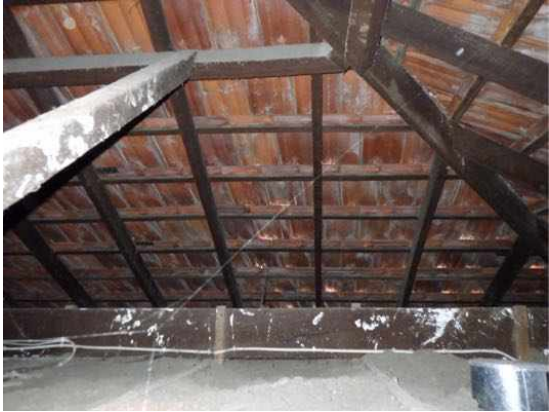
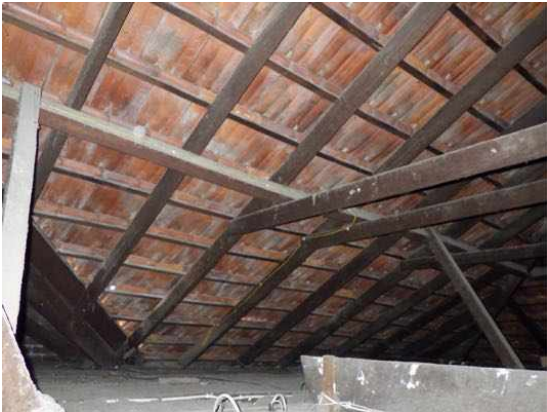
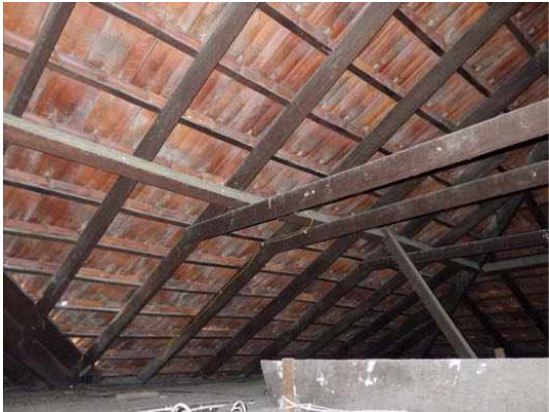
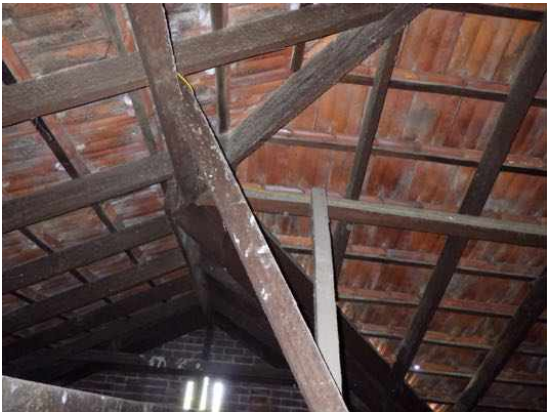
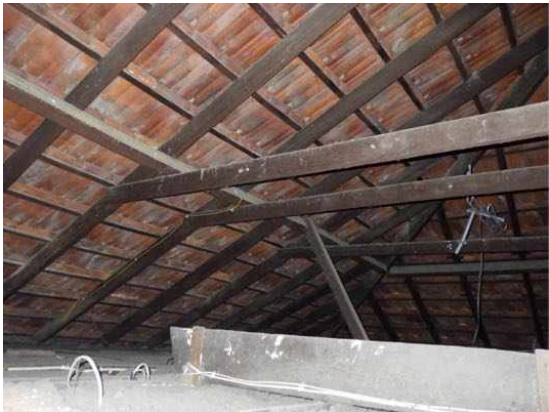
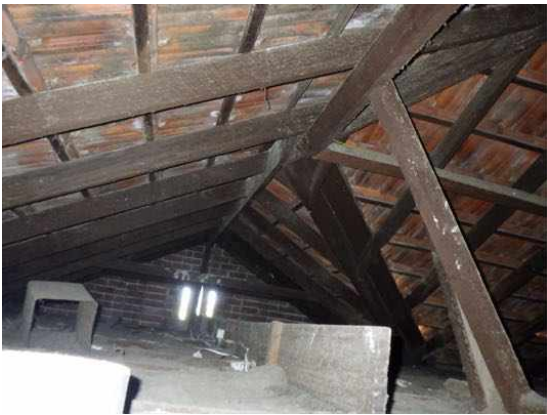
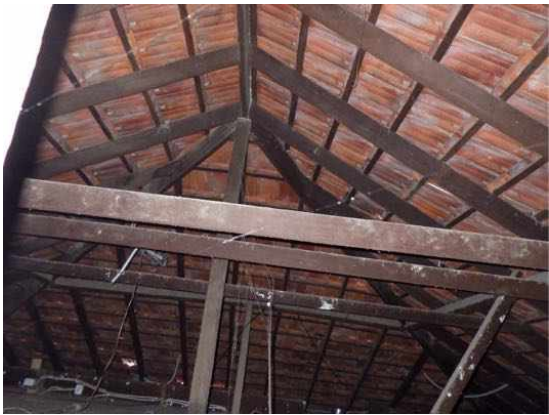
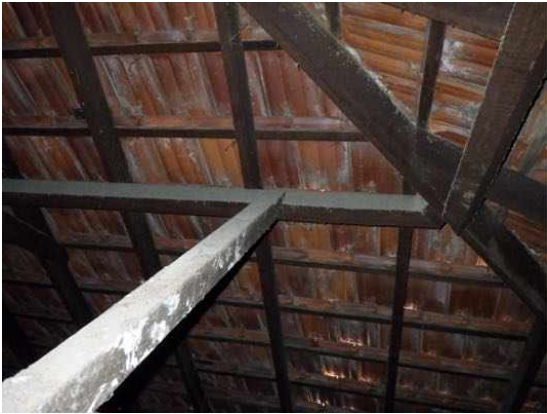
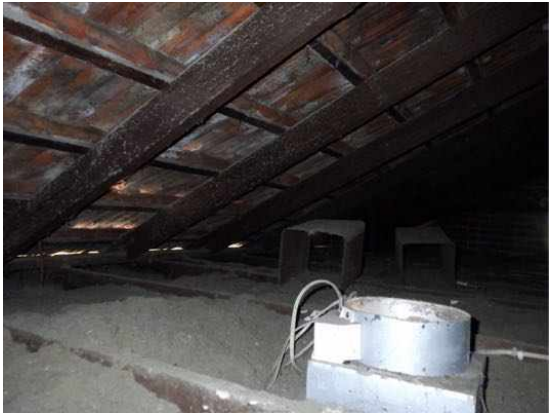
Building:	Building 1
Location:	All Areas
Finding:	Additional Photos - Obstructions and Limitations
Information:	These photographs are an indication of the obstructions and limitations which impeded full inspection of the property at the time of inspection. These obstructions can hide an array of defects and should be removed to allow full inspection to be carried out. A re-inspection is recommended once the areas are made accessible.
