Building and Timber Pest Inspection Report

Inspection Date: Thu, 19 Mar 2026

Property Address: 5/436 Malabar Rd, Maroubra NSW 2035,
Australia

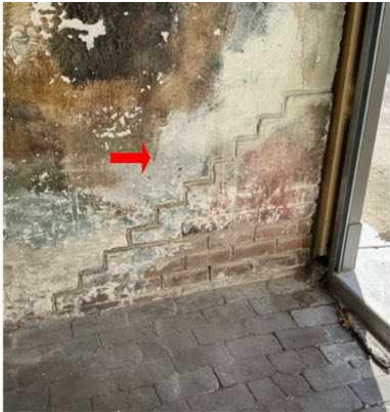
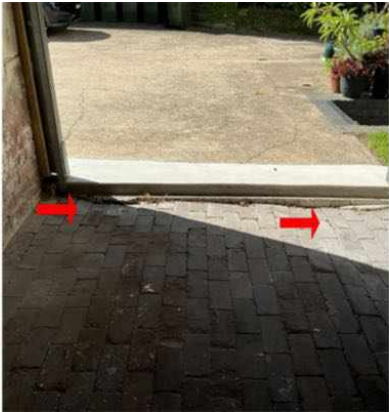
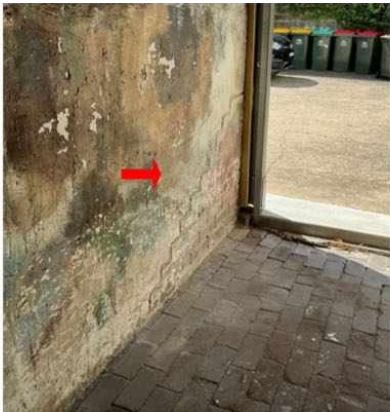
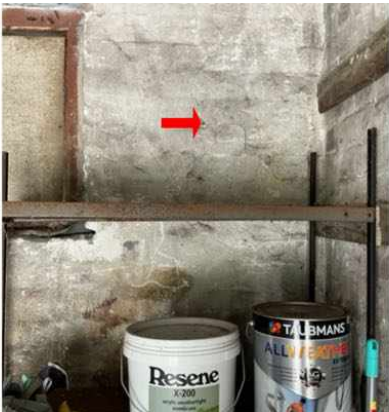
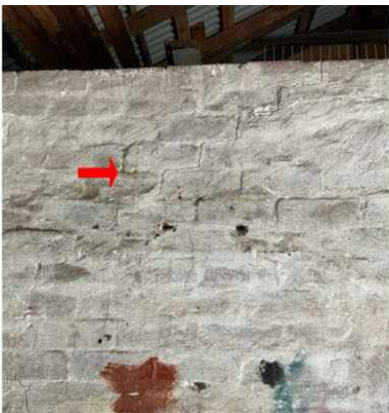
Building:	Main Building
Location:	Garage
Finding:	Brickwork - Step cracking - Strata - Requires further investigation
Information:	External garage brickwork displayed stepped cracking and uneven floor with associated moisture-related deterioration and surface breakdown. The cracking pattern suggests movement within the masonry, potentially related to footing

settlement and/or prolonged moisture ingress. This condition is beyond normal cosmetic deterioration and may lead to further cracking, moisture penetration, and localised structural degradation if left unaddressed. Further assessment and repair by a suitably qualified structural engineer and remedial masonry/waterproofing contractor is recommended.

As the affected wall appears to form part of the external garage structure within a strata complex, responsibility for investigation and repair may rest with the Owners Corporation, subject to confirmation against the strata plan and by-laws.

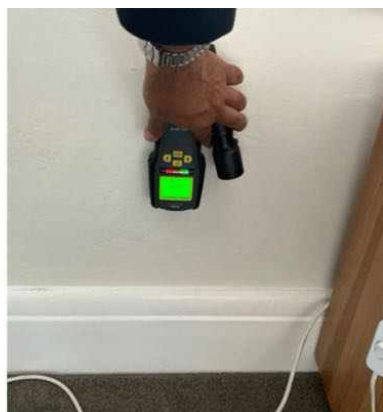
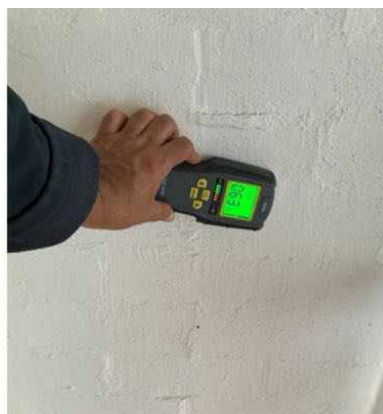
Finding 3.01

Building:	Main Building
Location:	All Internal Areas- External parameter wall
Finding:	Damp (Elevated moisture related deterioration (Paint bubbling) also present to some areas
Information:	Damp (or structural damp) refers to the presence of unwanted moisture in the structure of a building, either as the result of intrusion from outside, or condensation from within the structure. Generally, structural damp is caused by rain penetration, rising damp, and leaks from plumbing pipes.

Unmanaged damp facilitates the formation and development of mould, fungi growth and wood rot, decaying associated building materials and compromising their structural integrity. Damage to finishes is also likely to occur, including lifting, bubbling, peeling and staining of paint, plaster and wallpaper.

The first step in addressing damp is to diagnose the cause. The identified cause should be addressed first prior to repairing the appearance and other defects which have resulted from the rising damp. If the original cause is not resolved, further cases of damp are likely to ensue, resulting in secondary defects.

Consultation with a qualified plumber is advised immediately to identify the cause of damp and perform remedial works as required. Where excessive mould growth is present, further inspection by a specialist environmental health inspector should also be considered.

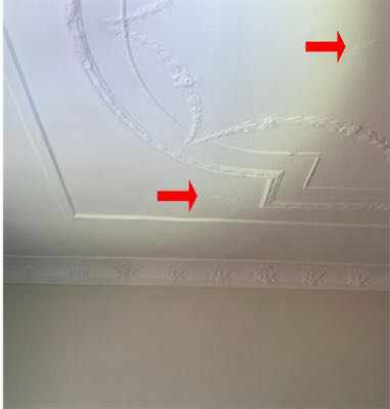
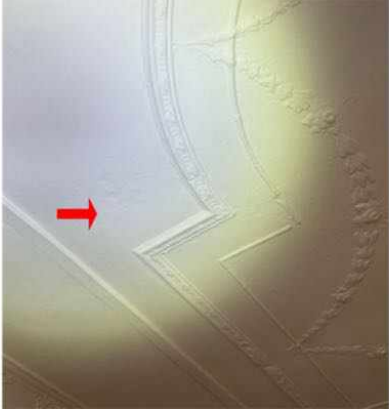
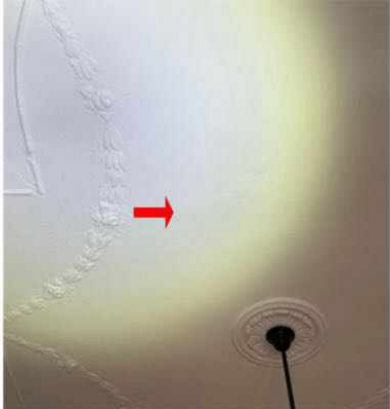
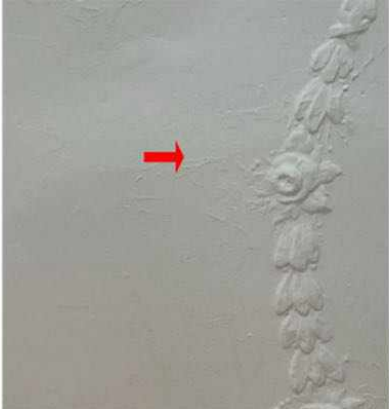
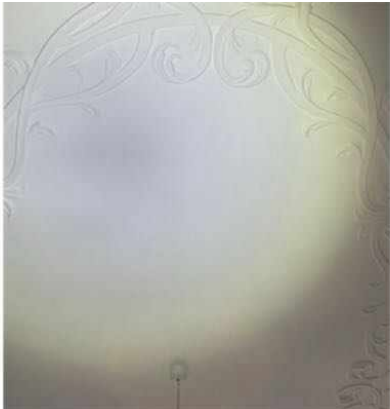
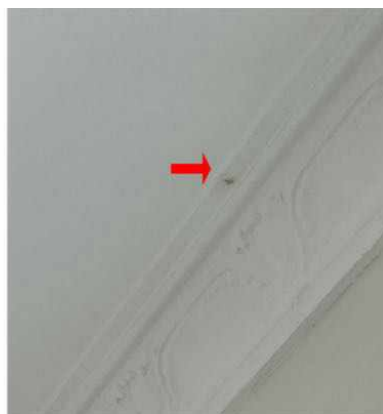
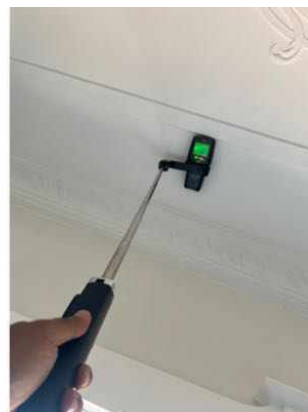
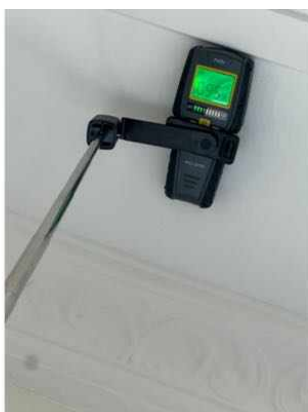
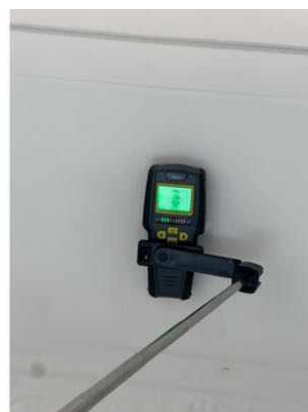
Finding 3.02

Building:	Main Building
Location:	All Internal Areas - Ceiling
Finding:	Painted surface - Bubbling/Elevated moisture and moisture related deterioration to some areas - Requires further investigation (Possible waterproofing)
Information:	Sections of paint in this area was found to have bubbled and deteriorated. Paint bubbling is generally an indication of excessive moisture in the area, that is currently hidden by the painted surface. The ceiling also exhibited elevated moisture in multiple locations. The exact cause of moisture ingress couldn't be confirmed during a visual inspection however waterproofing risk could not be ruled out.

The presence of excessive moisture can have major implications on associated

building elements if left unattended. The ceiling remains serviceable however, the damage cannot be determined due to the paint obstructing any further inspection of the damage.

It is highly advised that the affected paint be cleaned to allow a further, more invasive inspection by a licensed plumber. Failure to act on this defect may necessitate major works in the future.

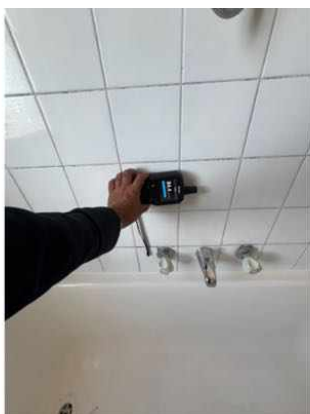
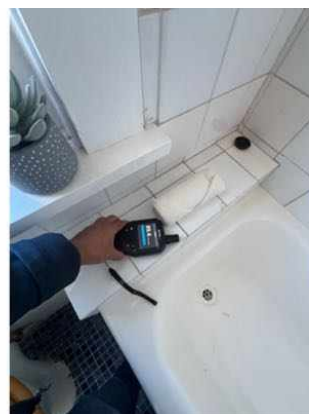
Finding 3.03

Building:	Main Building
Location:	Bathroom
Finding:	Elevated Moisture Bathroom & Back of shower (Possible waterproofing, requires further investigation)
Information:	Elevated moisture levels were detected to tiled surfaces in bathroom/shower areas. This may be due to porous or missing grout, cracked tiles or recent use, however the possibility of waterproofing membrane failure or plumbing leaks cannot be excluded. Persistent moisture ingress can lead to concealed damage, including timber rot and mould growth. Further investigation by a licensed plumber and/or waterproofing contractor is recommended as soon as possible. The back of shower area also

showed elevated moisture but no visible deterioration was evident at the time of inspection.

Failure to investigate further could result in significant works and costs in the future.

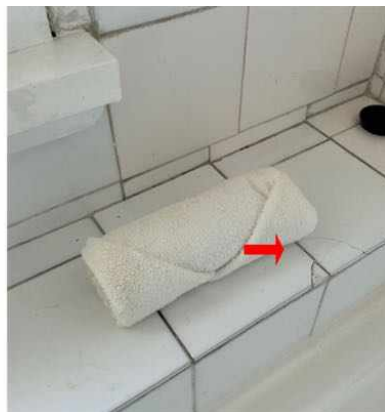
Finding 3.04

Building:	Main Building
Location:	All Internal Areas - Kitchen, Bathroom
Finding:	Tiles - Cracked or damaged
Information:	Cracking was evident to the tiling in this area at the time of inspection. While the cracking appears to be minor, this area is frequently exposed to water, allowing

If left unmanaged, water penetration to these areas may lead to subsequent water damage, which is likely necessitate repair work to affected building elements.

A tiling contractor should be appointed to ensure that no further water damage occurs. The re-application of silicone and grouting throughout remaining tile work is also advised, to further protect the area against water penetration.

Where water penetration has led to water damage, appointment of a relevant tradesperson may be required to repair damaged building elements.

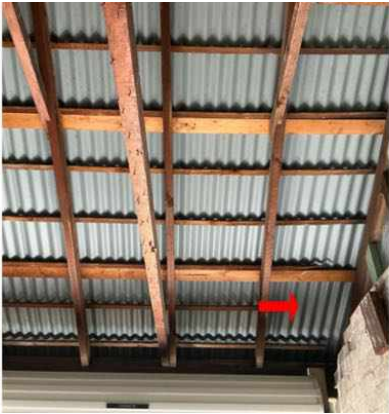
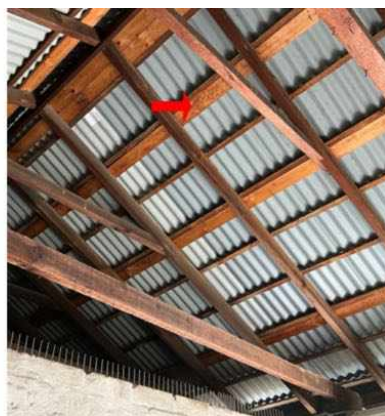
Finding 3.06

Building: Main Building
Location: Garage
Finding: Timber Delignification
Information: A section of roof framing timber was found to be deteriorated. The condition is consistent with delignification, a chemical breakdown of lignin caused by prolonged exposure to heat and moisture in the roof void. The affected timber should be assessed by a qualified carpenter for potential reinforcement or replacement. A further invasive inspection by a strata appointed licensed timber pest technician is also recommended.

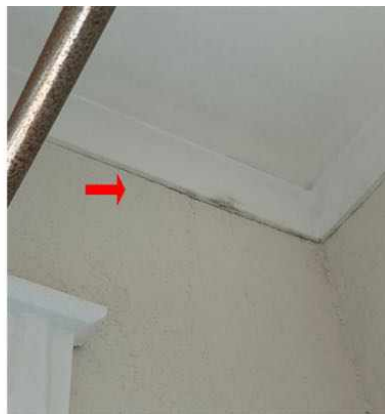
Finding 3.07

Finding: Water staining

Information: Water staining was evident in this area at the time of inspection. Water staining indicates that surfaces have been exposed to excessive moisture over time. The minerals and other elements in the water lead to staining, which may graduate to corrosion and deterioration if left unmanaged.

While mostly an appearance defect, water staining can be indicative of more serious defects, which may be currently concealed by other building elements.

Where water staining is active, a licensed plumber must be consulted to identify the cause of the staining and to provide advice on any reparation works that may be required. Replacement of any broken or damaged structures is advised.

Conversely, where water staining is old and inactive, affected building materials may be repaired or replaced at client discretion. A qualified carpenter or registered builder may be appointed to perform these works.

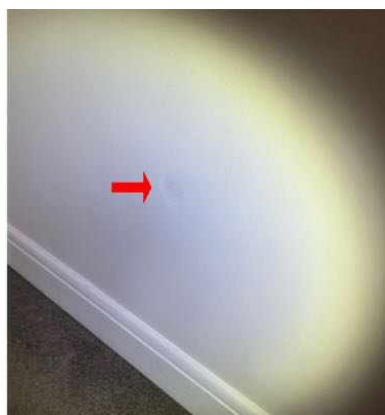
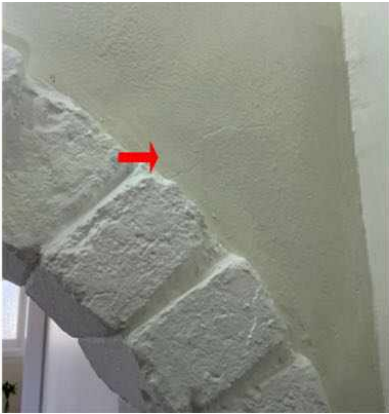
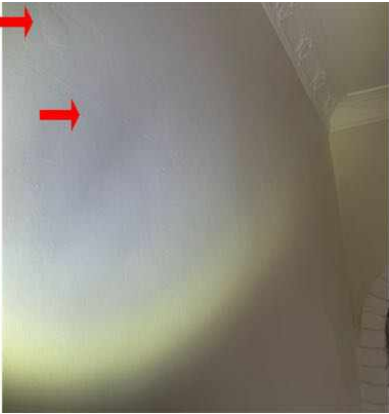
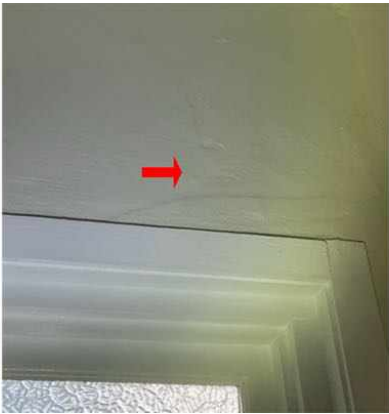
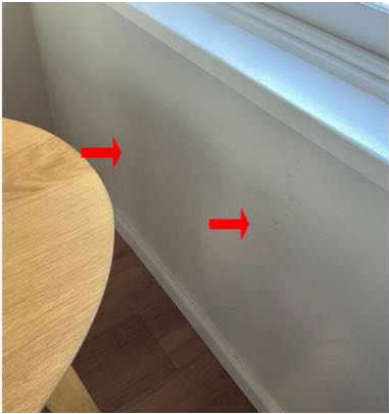
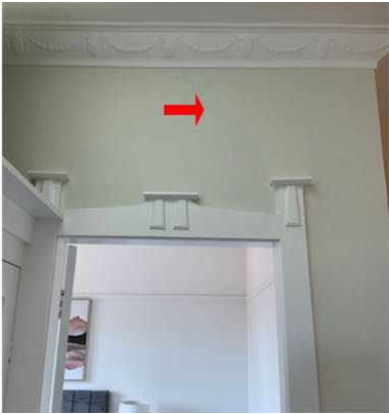
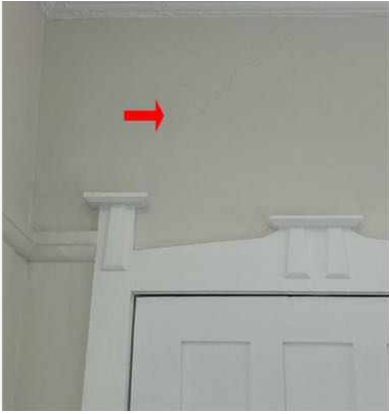
Finding 3.08

Building:	Main Building
Location:	All Internal Areas
Finding:	Paint finish and hairline cracking to some areas
Information:	The paint finish in this area was identified as being incomplete at the time of inspection including some hairline minor cracking.

Whilst incomplete or missing paint and minor cracking and imperfections in finish is generally an appearance defect, it can also lead to the development of secondary building defects over time. Incomplete areas of paint finish expose the area to moisture, potentially accelerating the deterioration of underlying building materials.

Incomplete paint finishes should be sanded back, filled, leveled and painted, as applicable. Where inadequate or missing paint protection has led to the deterioration of the associated building element, repair and/or replacement of this building element may be required.

A painting contractor should be appointed as soon as possible to perform necessary works to aid the appearance of the affected area and to ensure the area is protected against further deterioration. Alternatively, the homeowner following manufacturer instructions may perform these works.

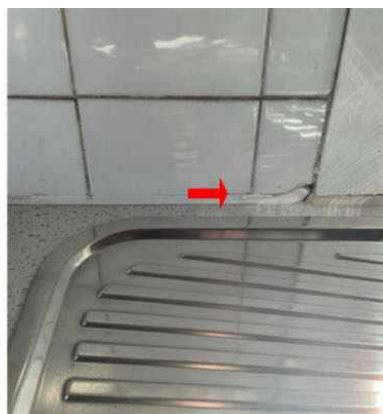
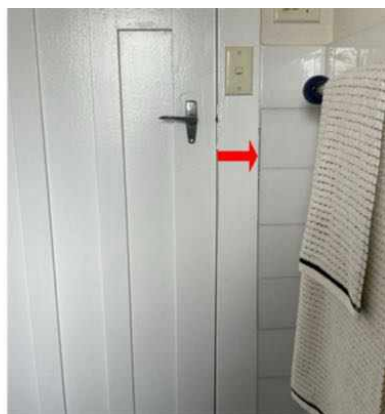
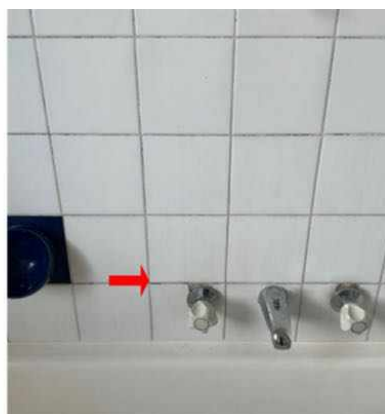
Finding 3.09

Building: Main Building
Location: All Internal Areas - Bathroom , Kitchen
Finding: Sealant and grouting - Missing or degraded to some areas
Information: It was noted on inspection that sealant or grout is degraded. There is also evidence of poor workmanship and excessive use of sealant. Silicone should never be used as a first line of defence against waterproofing. Further inspection by a licensed waterproofing contractor is highly recommended

Different materials and floor areas move at different rates, generally causing cracking to grout or sealant at this point. A flexible sealant is required to allow for expected expansion and contraction, while keeping the joint water tight and protective of all associated building materials.

There appears to be excessive mould to the sealant and grout which will likely require scraping out and replacement.

Flexible and mould resistant materials should be applied to affected areas to prevent any subsequent water damage that is likely to occur. Regular maintenance and replacement of damage or missing or damaged sealant and grout is highly recommended to the wet areas, as this is a regular wear and tear defect. Sealant and grouting in areas that come into regular contact with water should be maintained for the long term care of your property.

A sealant specialist or tiling contractor should be appointed to complete these works as soon as possible

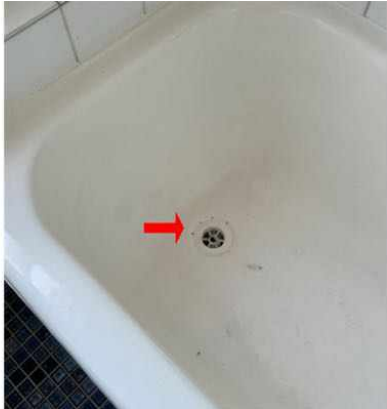
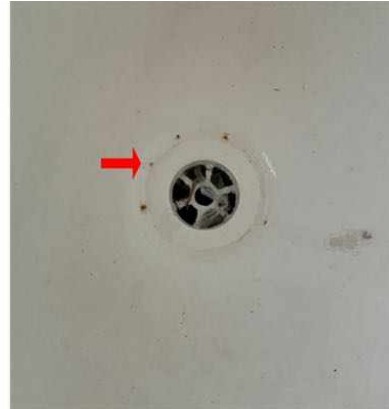
Finding 3.10

Building:	Main Building
Location:	Bathroom
Finding:	Building element - Rusted or corroded - Bathtub minor rust staining
Information:	This building element shows evidence of rusting and corrosion, which is likely to have developed as a result of excessive exposure to moisture and or inadequate coatings.

As surface rust provides no protection to the underlying iron, the deteriorating condition is likely to worsen if not addressed in the short-term future.

Rusting and corrosion should be managed by ideally removing or limiting the affected surface from exposure to moisture. A registered builder may be appointed to replace any building elements that have been severely affected by rust or water damage.

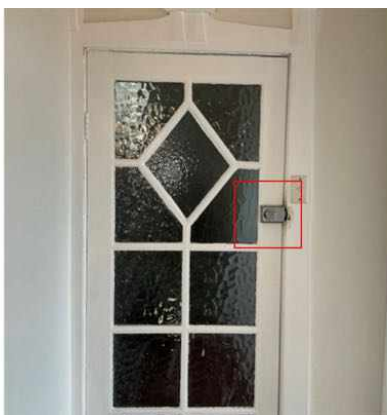
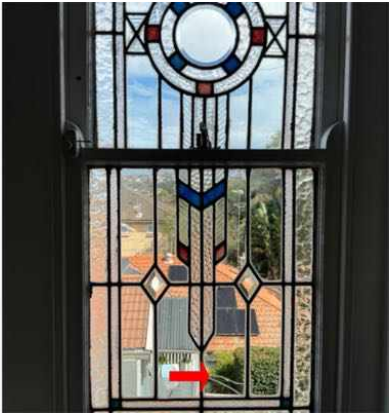
Finding 3.11

Building:	Main Building
Location:	All Internal Areas
Finding:	Building element - Damaged - excess silicone use front door , window glass cracked lounge
Information:	Breakage occurs generally when the building materials have either aged and decayed, or as a result of damage (accidental or deliberate).

Repair and/or replacement of broken elements is advised to ensure that additional secondary defects do not arise as a consequence. Such works are necessary, as all building elements play a key role in the operation and function of the overall structure and its performance.

A relevant tradesperson should be appointed to repair or replace the affected building element prior to any subsequent damage being caused.

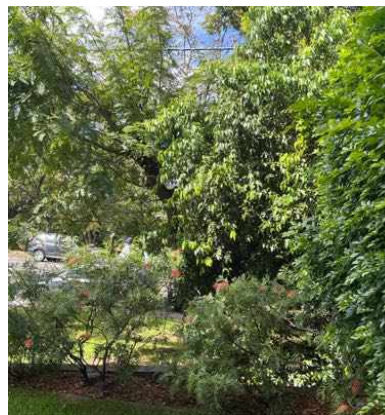
Finding 6.01

Building: Main Building
Location: All External Areas
Finding: Trees within 50m
Information: Trees within 50m of the property can be conducive to termite activity. It is recommended an invasive inspection of all trees within 50m to the property be carried out by a qualified pest control expert.

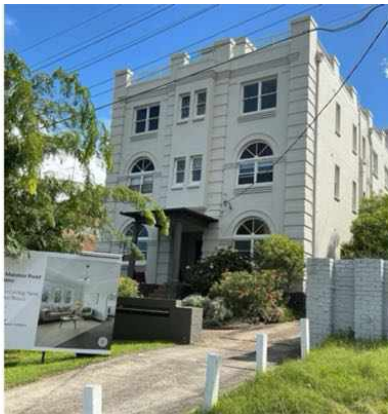
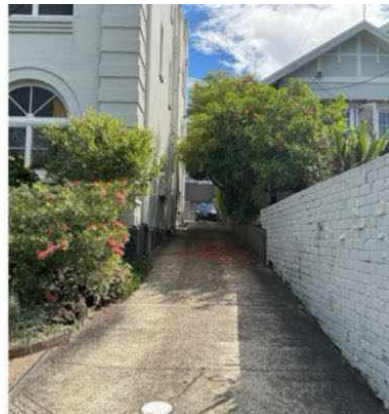
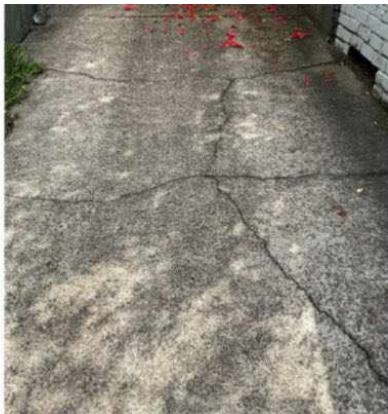
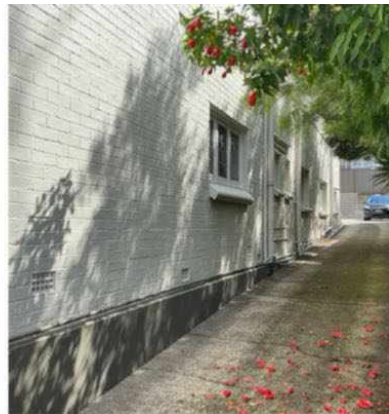
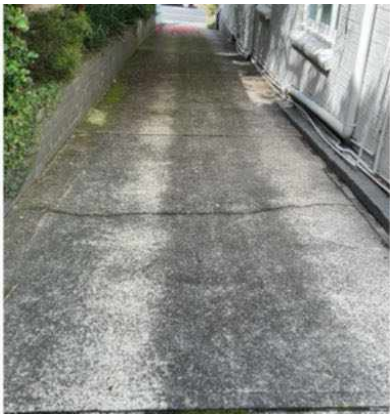
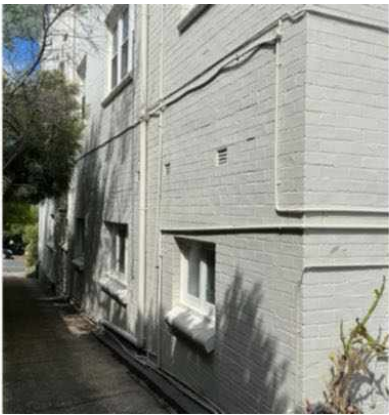
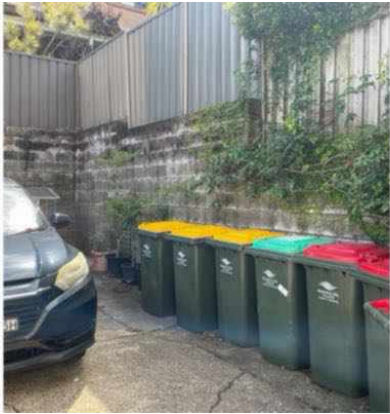
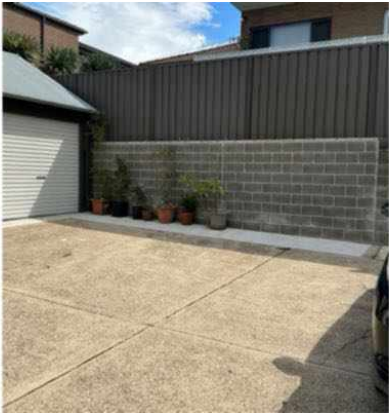
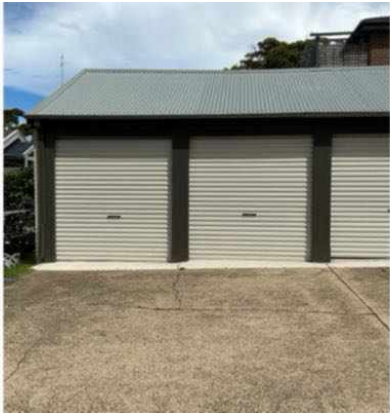
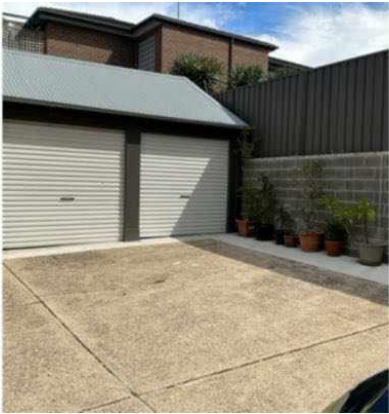
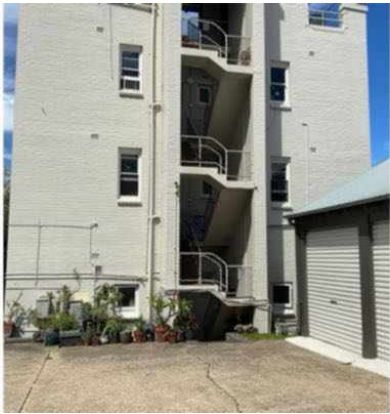
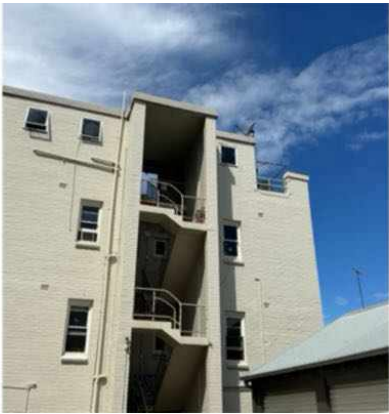
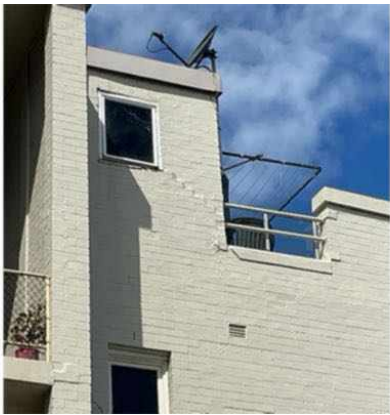
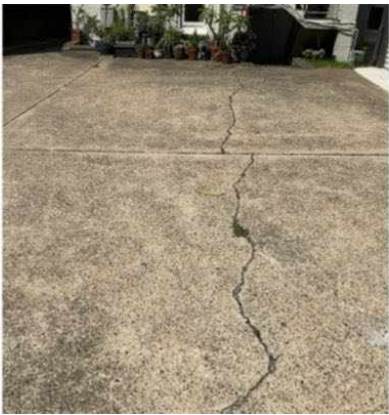
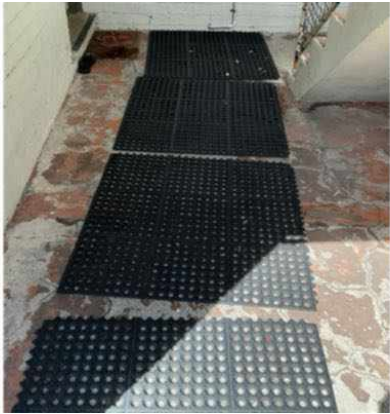
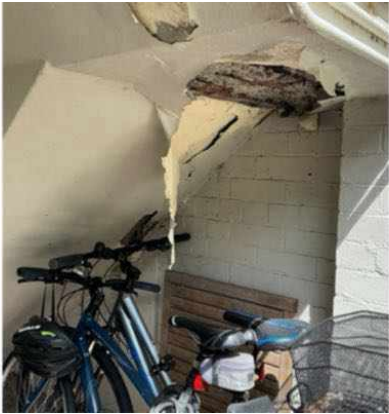
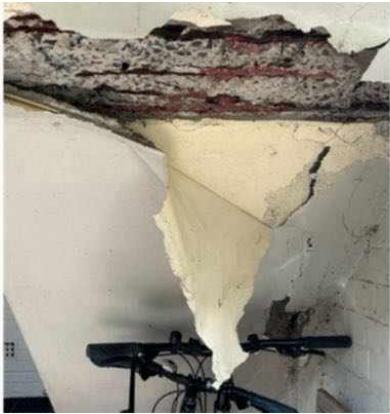
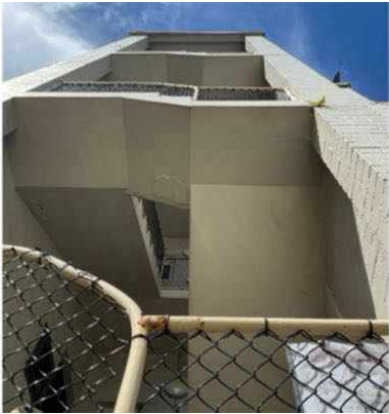
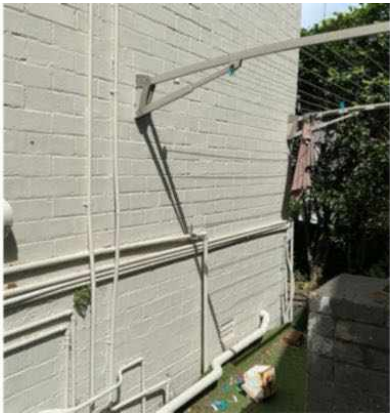
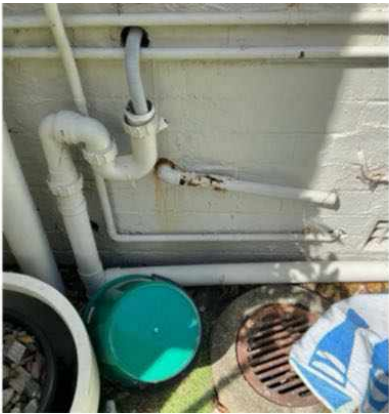
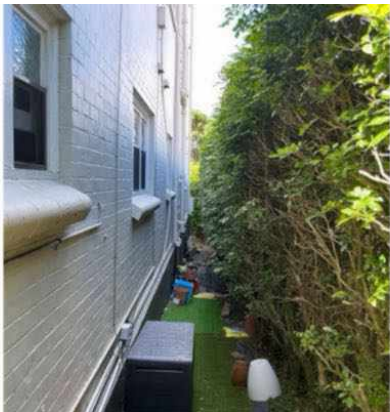
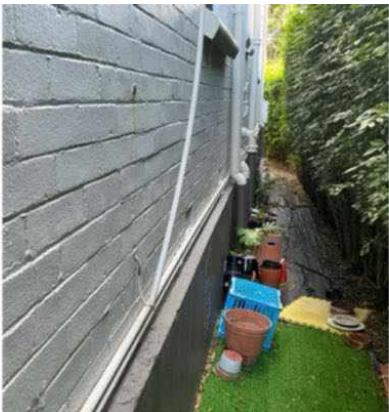
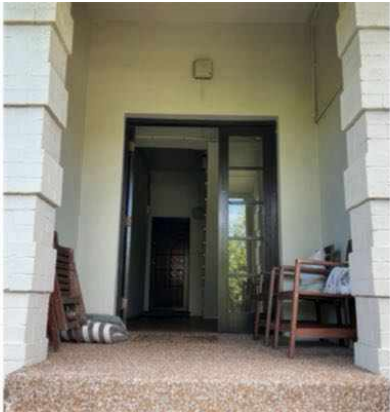
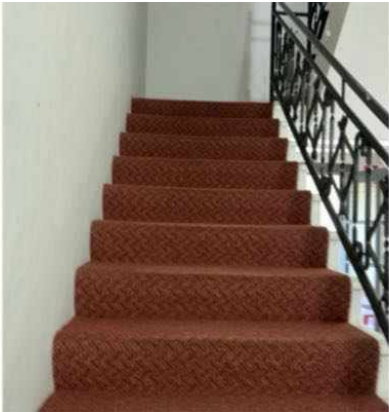
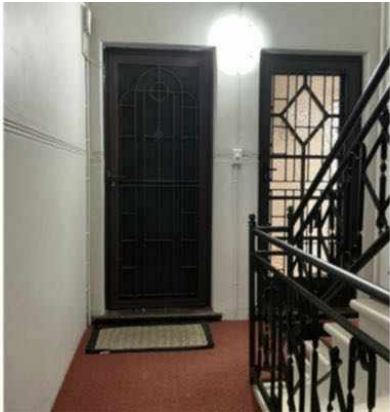
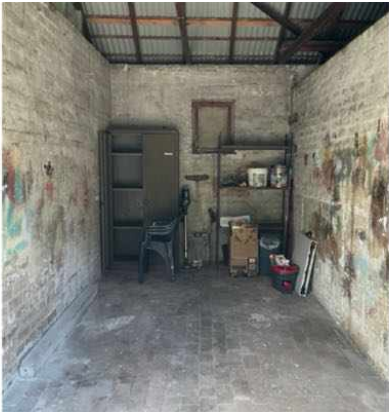
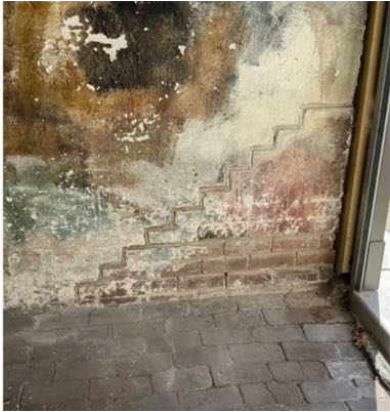
Building: Main Building
Location: All External Areas
Finding: Additional Photos - Obstructions and Limitations
Information: These photographs are an indication of the obstructions and limitations which impeded full inspection of the property at the time of inspection. These obstructions can hide an array of defects and should be removed to allow full inspection to be carried out. A re-inspection is recommended once the areas are made accessible.

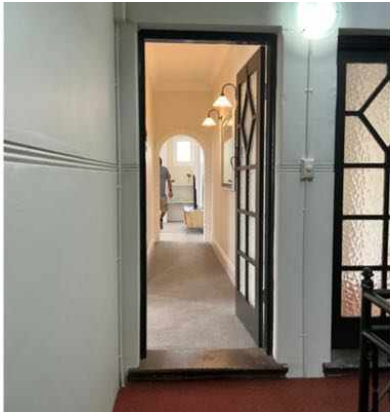
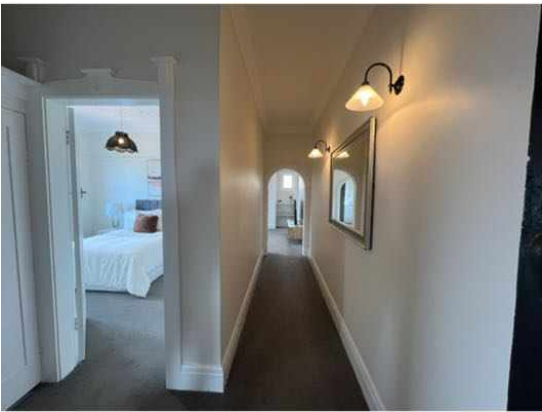
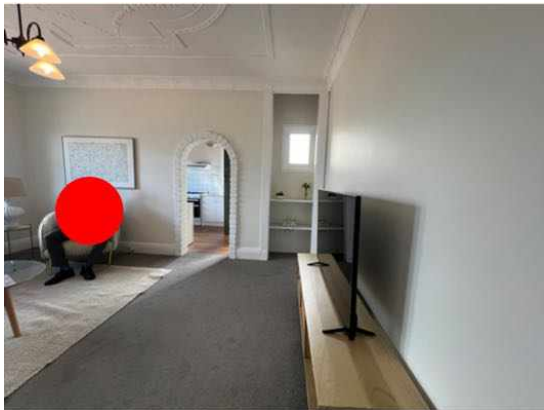
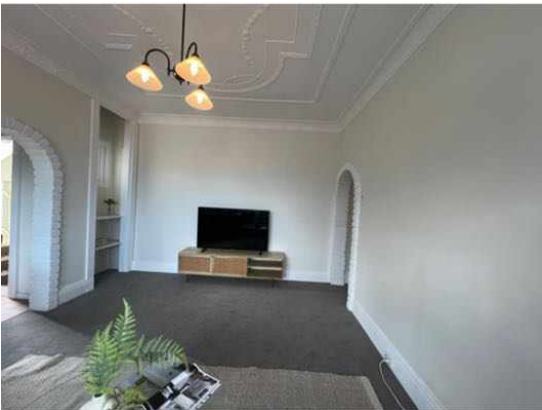
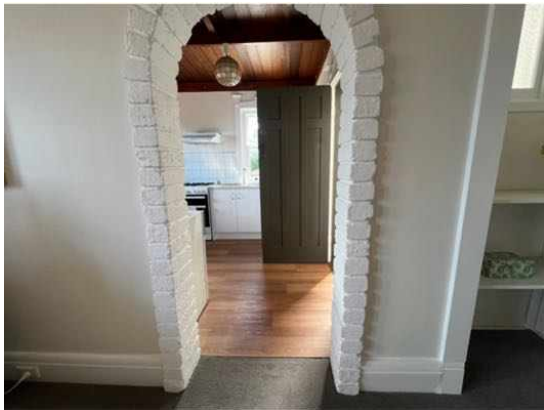
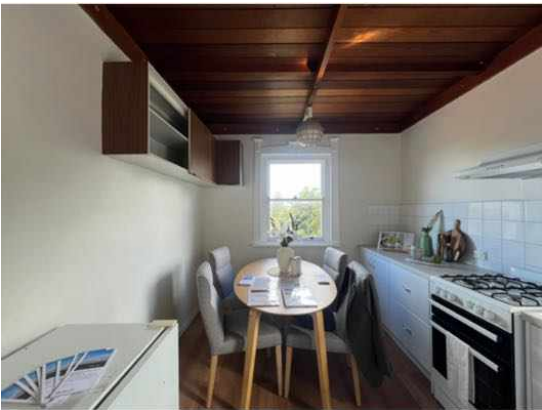
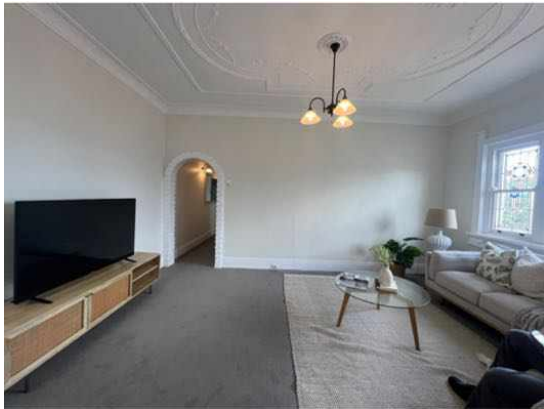
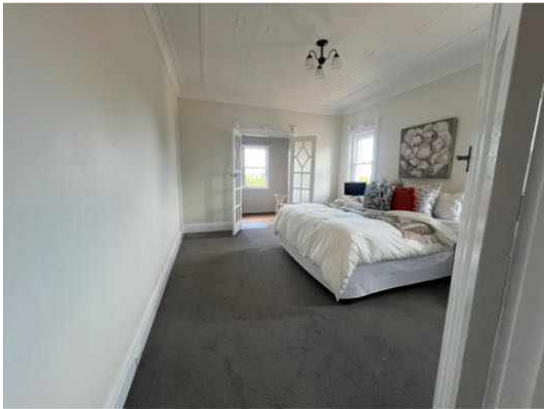
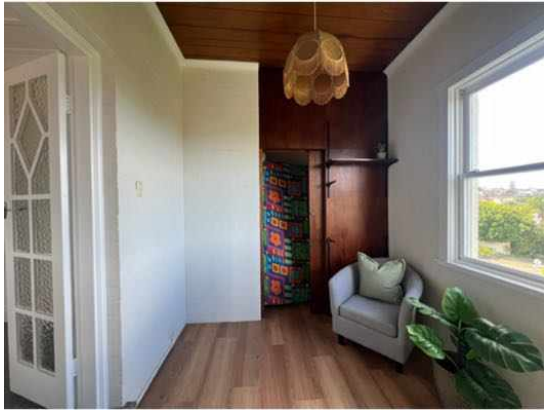
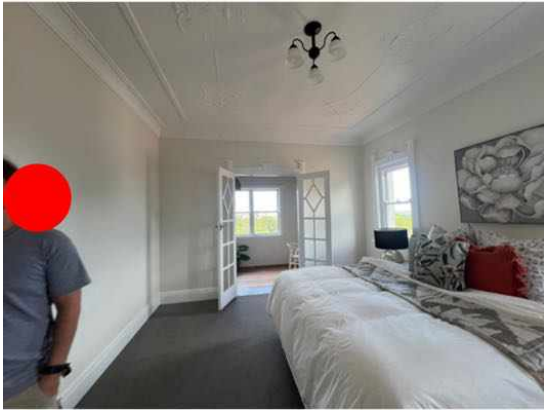
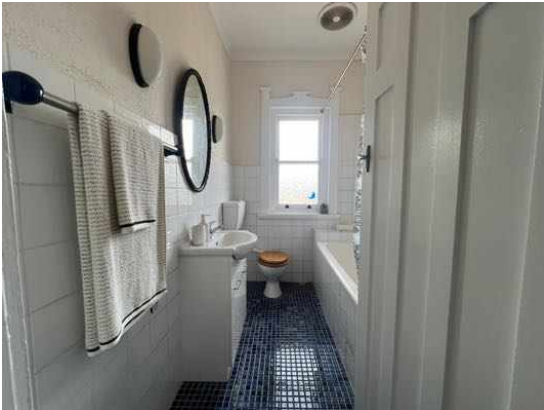
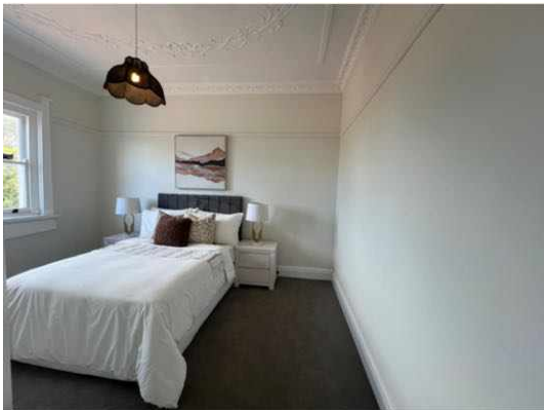
Building: Main Building
Location: All Internal Areas
Finding: Additional Photos - Obstructions and Limitations
Information: These photographs are an indication of the obstructions and limitations which impeded full inspection of the property at the time of inspection. These obstructions can hide an array of defects and should be removed to allow full inspection to be carried out. A re-inspection is recommended once the areas are made accessible.
