## Building Inspection Report

Inspection Date: Thu, 9 Apr 2026

Property Address: 6 Elijah St, Morphett Vale SA 5162,  
Australia

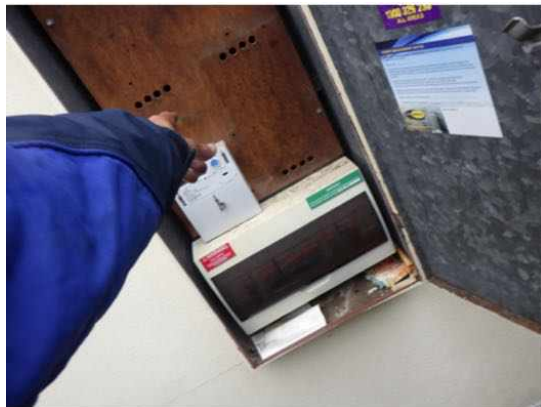
#### Defects 1.01

| Finding: | Electrical Backing Board - Broken/ Loose from its original fixing |
| Information: | The electrical backing board in this area was found to be broken/ loose from its original fixing at the time of inspection. Breakage occurs generally when the building materials have aged and decayed, but may also be indicative of impact damage to the building element (accidental or deliberate). |

Left unmanaged, the fitting is unlikely to cause further damage to surrounding building elements. However, the broken fitting does expose electrical works, and may create a safety hazard if there is potential contact with persons in the area.

Repair and/or replacement of the broken fitting is advised. A Licensed electrician should be appointed to repair/replace the fitting immediately.

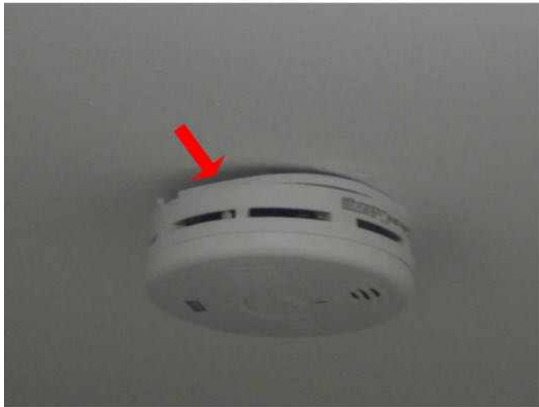
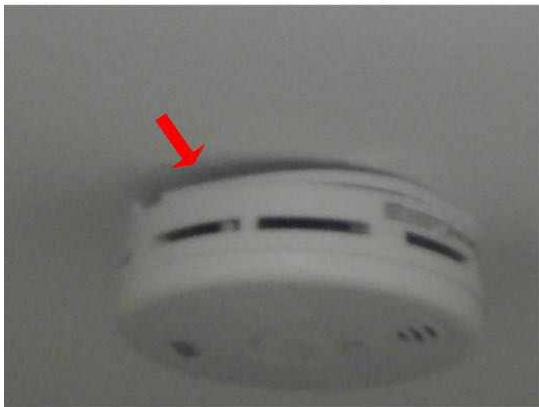
## Defects 1.02

| Finding: | Smoke Detectors and Alarms - Loose from its original fixing |
| Information: | At the time of inspection it was noticed that Smoke Detectors and Alarms - Loose from its original fixing and creating a potential safety hazards for the persons coming in contact in this area. |

Please note that this defect is highlighted as a caution only. We suspect, based on our experience in the building industry, that the absence of smoke detectors, or their poor condition, should be addressed as a matter of urgency to improve occupant safety.

Always ensure sufficient working and suitable smoke detectors are installed prior to occupying any building. Additionally, it is advised that all smoke detectors be tested by the homeowner on a monthly basis.

Please refer to AS3786 and state based legislation, which may also apply.

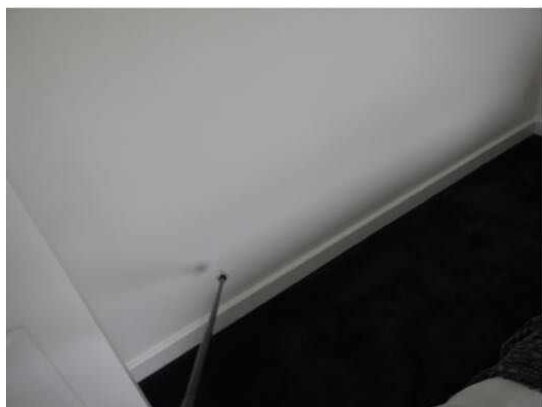
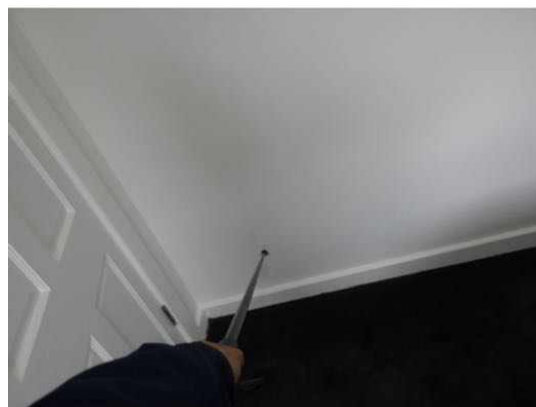
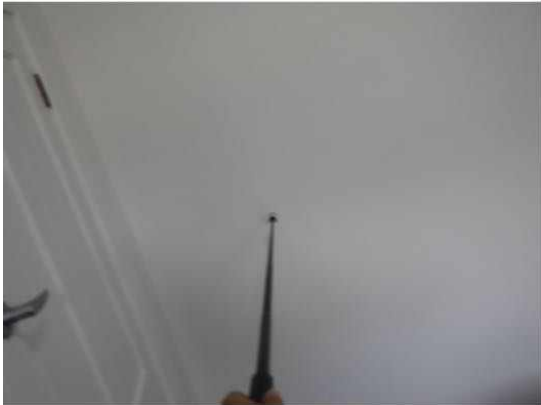
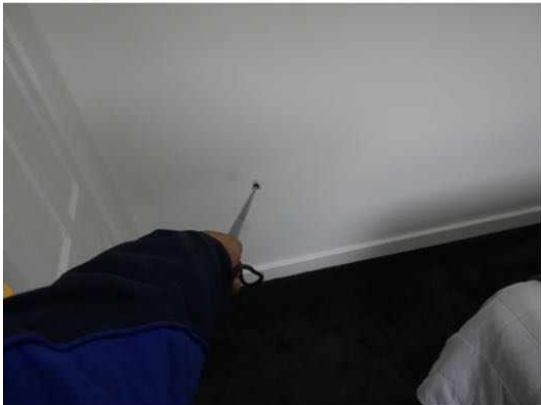
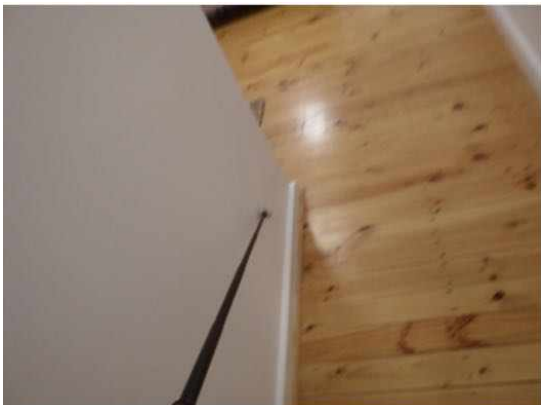
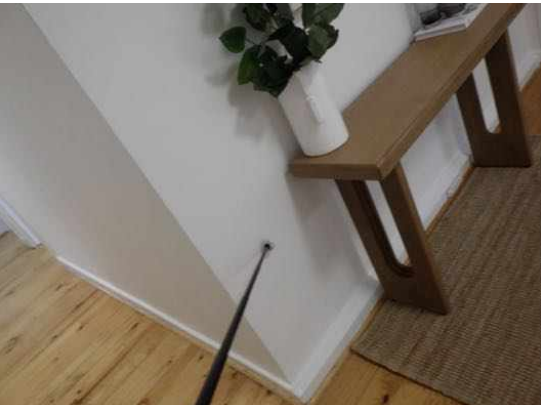
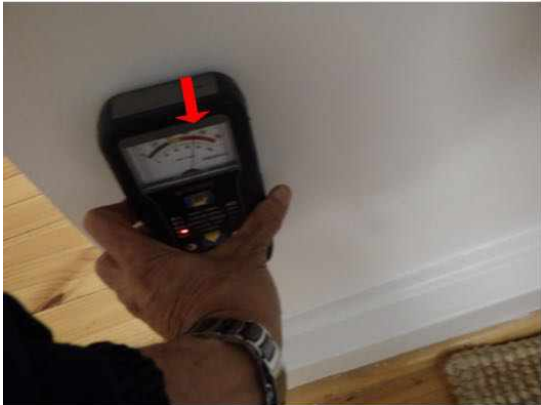
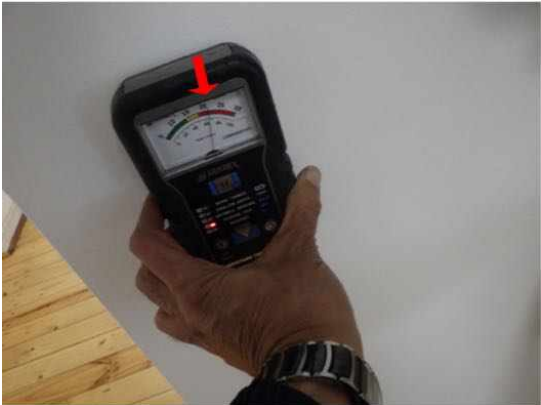
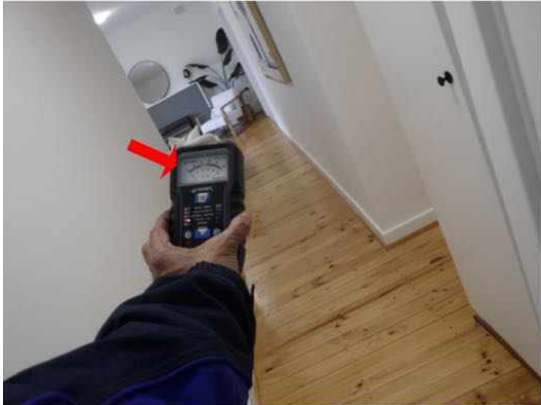
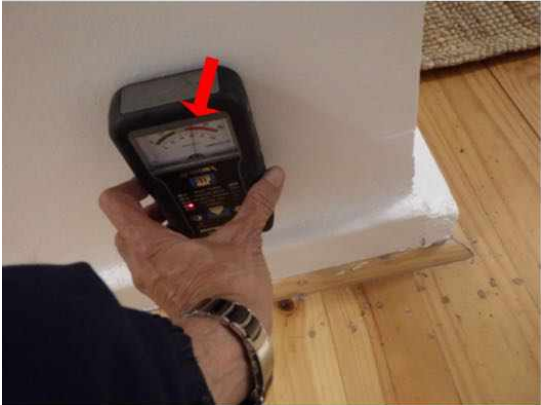
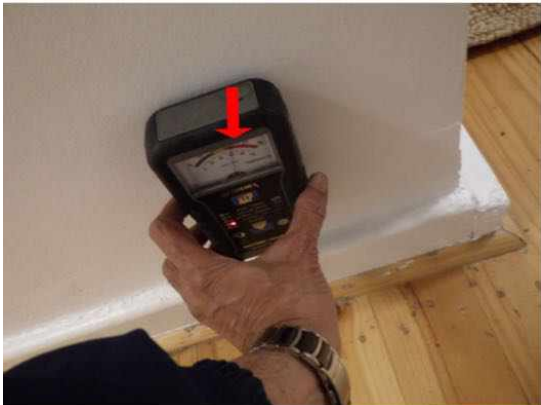
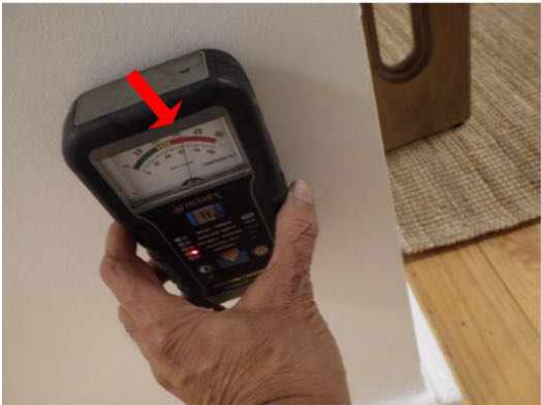
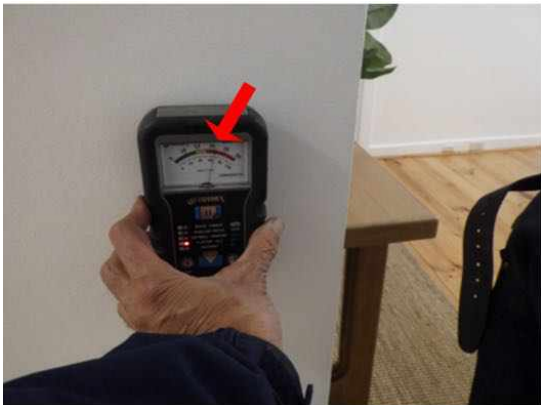
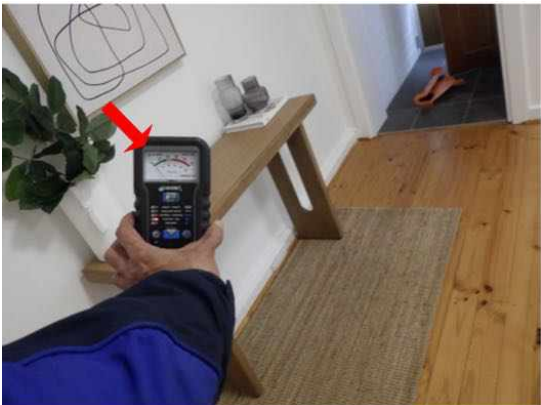
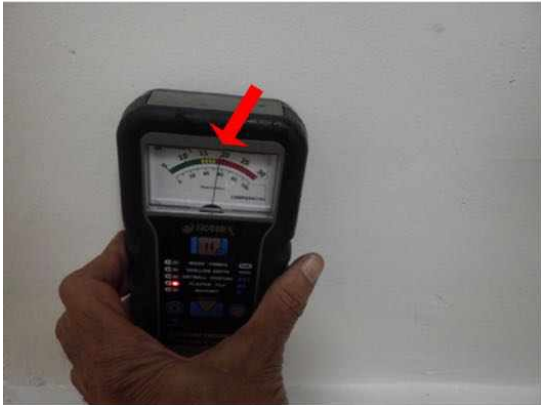
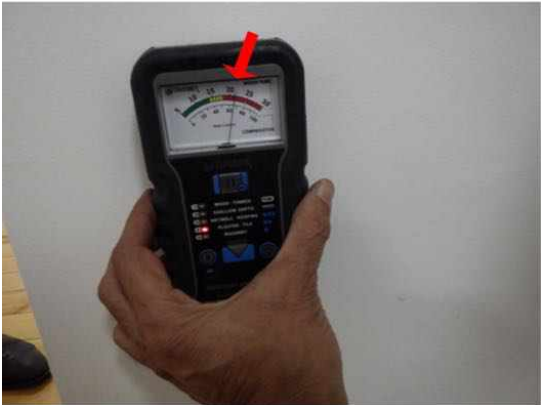
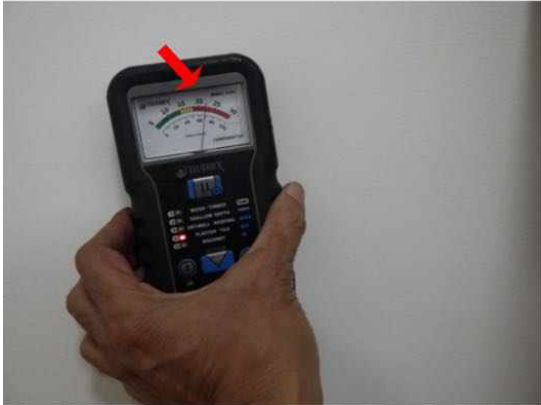
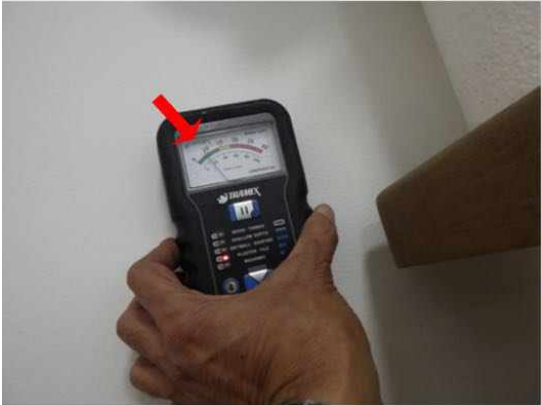
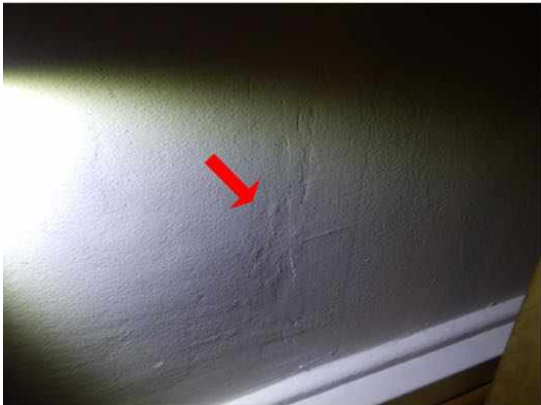
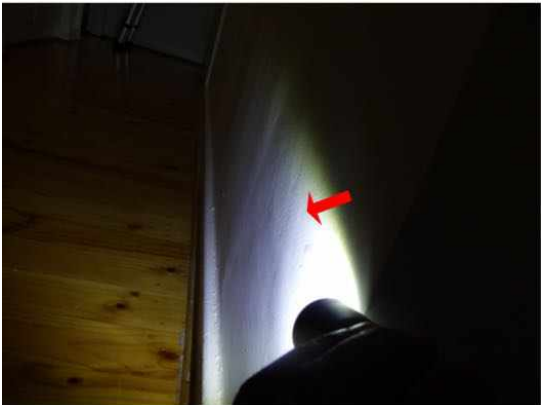
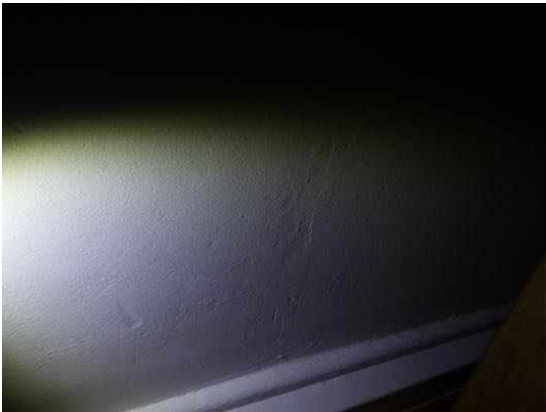
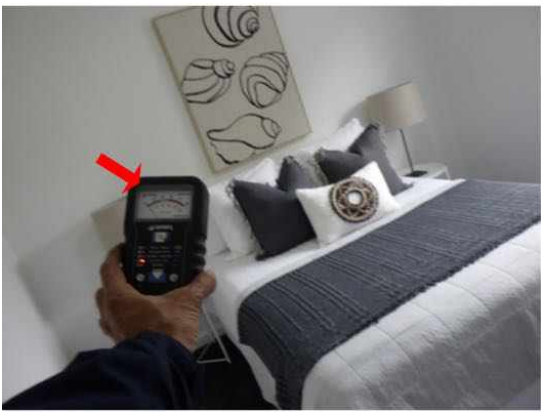
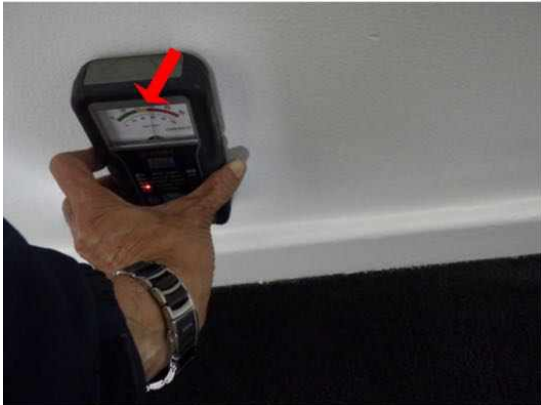
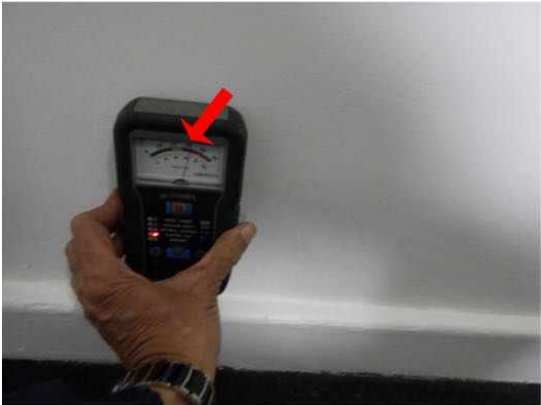
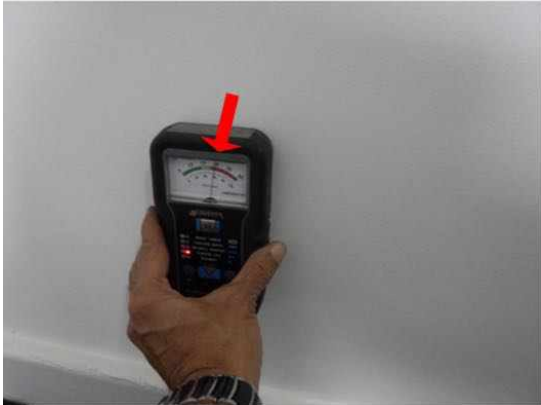
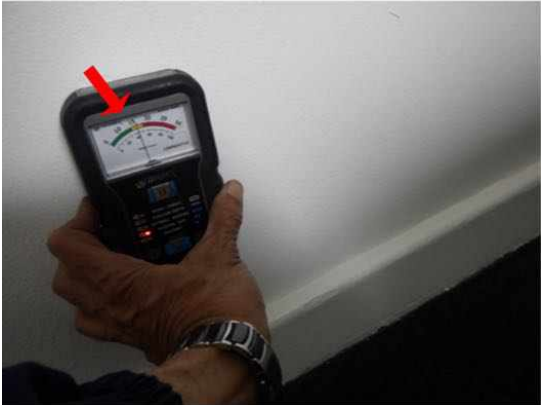
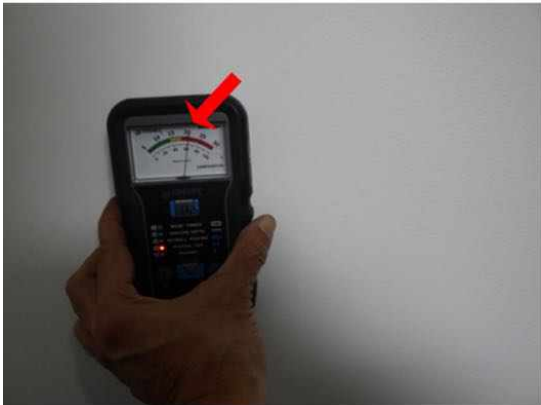
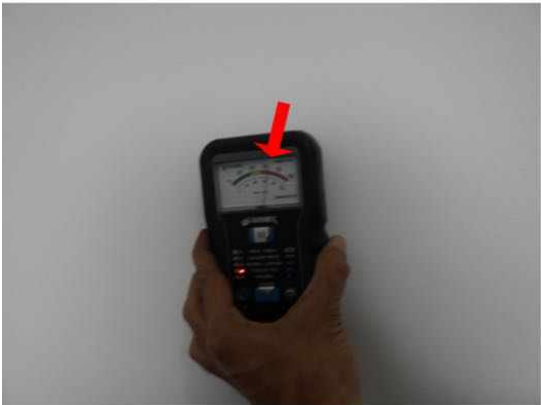
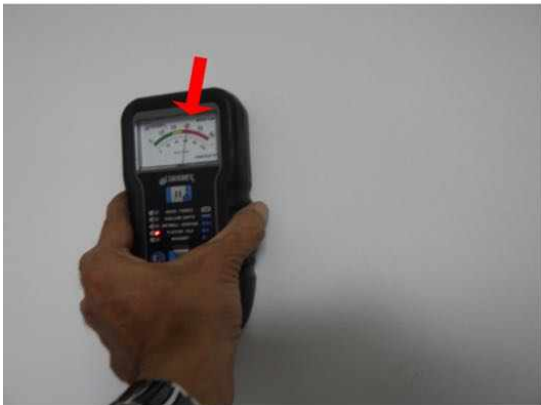
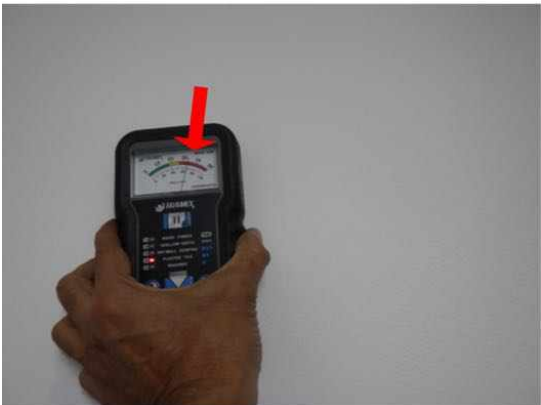
### Defects 2.01

Building: Building 1  
Location: All Internal Areas  
Finding: Internal walls - Damp  
Information: At the time of inspection it was noticed that high moisture reading to few sections of internal walls around the property.

Damp (or structural damp) refers to the presence of unwanted moisture in the

structure of a building, either as the result of intrusion from outside, or condensation from within the structure. Generally, structural damp is caused by rain penetration, rising damp, and leaks from plumbing pipes.

Unmanaged damp facilitates the formation and development of mould, fungi growth and wood rot, decaying associated building materials and compromising their structural integrity. Damage to finishes is also likely to occur, including lifting, bubbling, peeling and staining of paint, plaster and wallpaper.

The first step in addressing damp is to diagnose the cause. The identified cause should be addressed first prior to repairing the appearance and other defects which have resulted from the rising damp. If the original cause is not resolved, further cases of damp are likely to ensue, resulting in secondary defects.

Consultation with a qualified plumber is advised immediately to identify the cause of damp and perform remedial works as required. Where excessive mould growth is present, further inspection by a specialist environmental health inspector should also be considered.

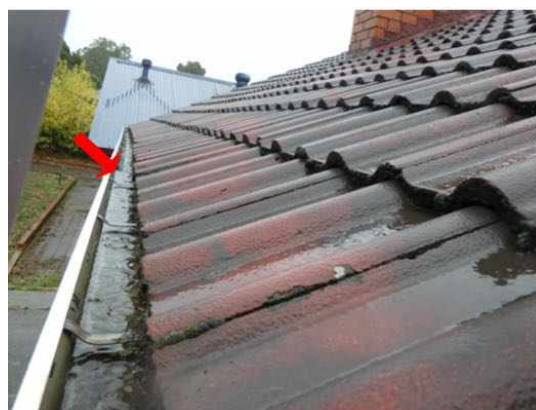
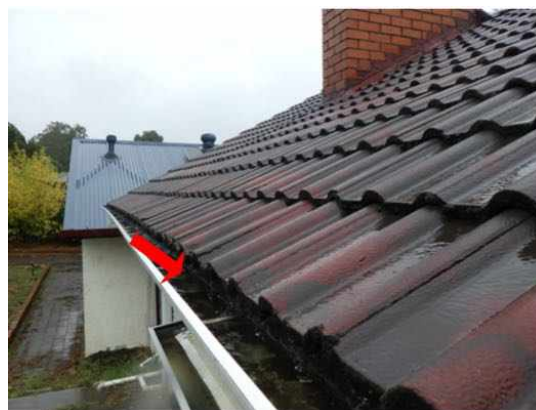
### Defects 3.01

Blocked gutters are likely to lead to high levels of moisture in the affected areas. Such moisture will not only cause rust and decay of the associated building materials, but can also provide conditions that are conducive to termite and timber pest activity. Blockages in gutters should therefore be removed immediately to ensure dry conditions are maintained.

Consult a Licensed Plumber for further specific advice on remedial works that may be required. In the interim, it is highly advised that blocked gutters be removed by the homeowner or a general handyperson as a matter of urgency.

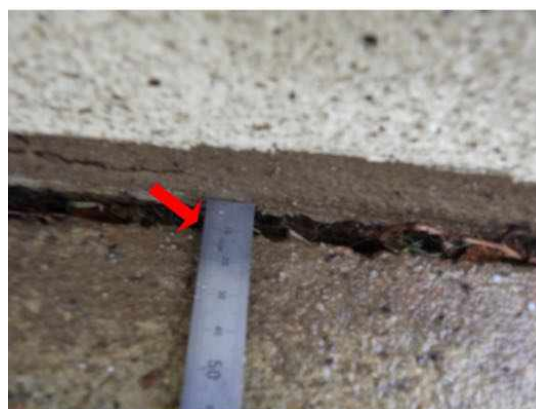
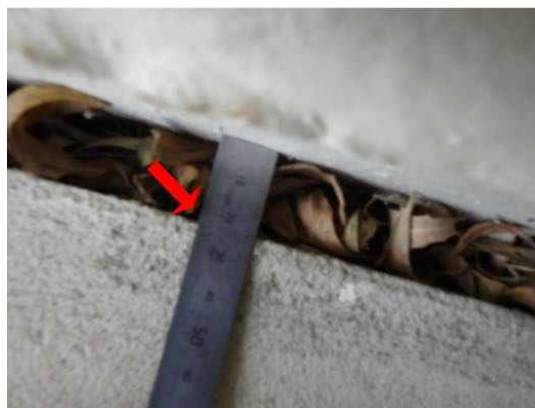
## Defects 3.02

| Information: | Gaps in the external concrete paving were identified at the time of inspection. Gaps in the slab are significant and are likely to lead to the development of secondary defects if left unmanaged, such as the creation of a trip hazard and water entry points. |

With reactive clay soils, it is extremely important to ensure that all stormwater flows including roof and ground flows, contained and continually maintained. High moisture also creates an environment that is conducive to termite attack.

A licensed Plumber should be appointed immediately to ensure that the stormwater pipework is intact and adequate, and all gaps to concrete, driveways and paths should be sealed by a licensed builder or a general handy person to keep moisture from entering.

A licensed concretor may be required to replace pavements that are beyond repair.

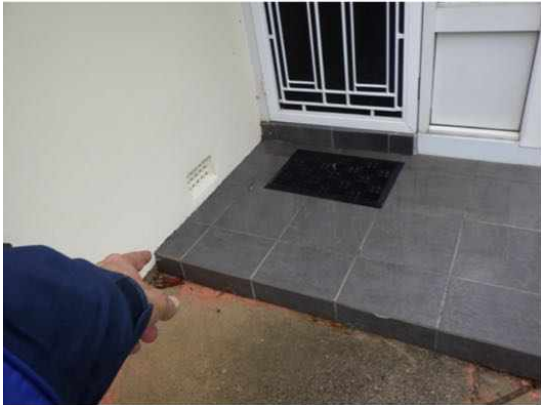
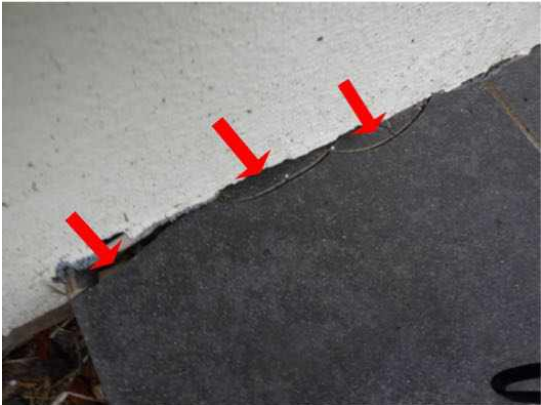
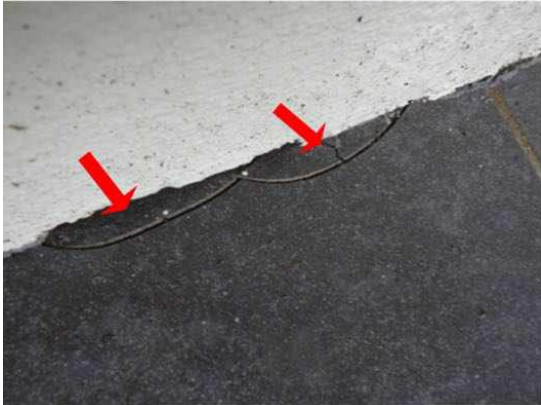
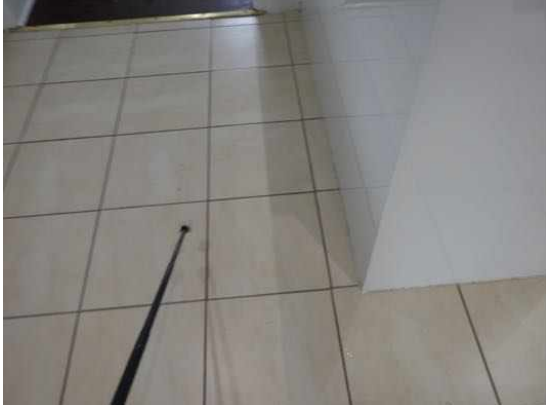
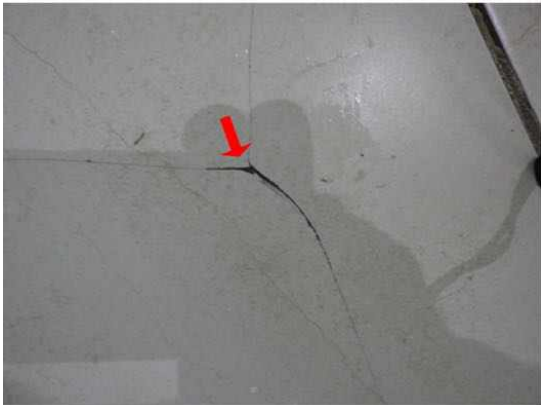
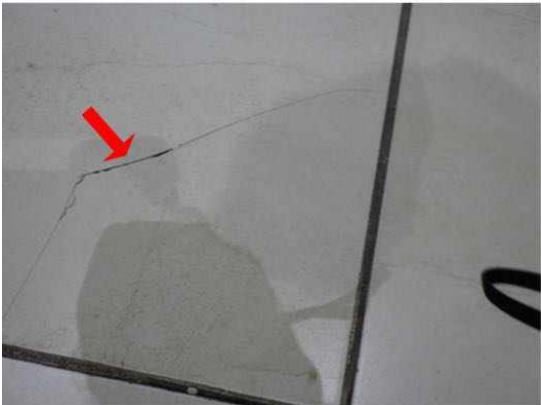
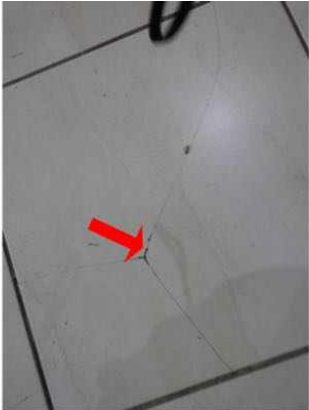
### Defects 3.03

| Finding: | Tiles - Cracked or damaged |
| Information: | Cracking was evident to the tiling in this entry & kitchen area at the time of inspection. While the cracking appears to be minor, this area is frequently exposed to water, allowing potential for water penetration into adjoining sections of walls or flooring. |

If left unmanaged, water penetration to these areas may lead to subsequent water damage, which is likely necessitate repair work to affected building elements.

A tiling contractor should be appointed to ensure that no further water damage occurs. The re-application of silicone and grouting throughout remaining tile work is also advised, to further protect the area against water penetration.

Where water penetration has led to water damage, appointment of a relevant tradesperson may be required to repair damaged building elements.

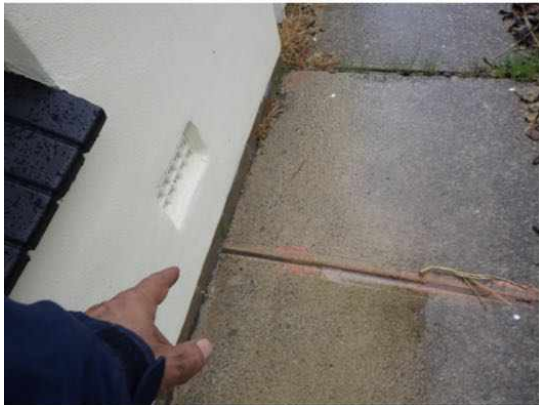
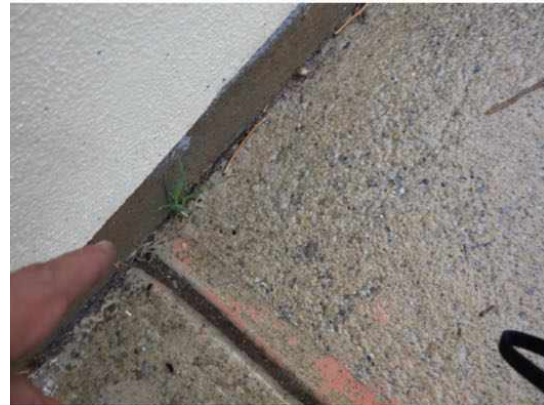
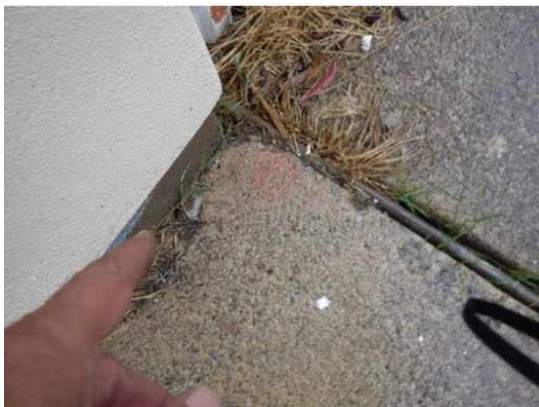
Defects 3.04

Building: Building 1  
 Location: All External Areas  
 Finding: Bridging - Vegetation  
 Information: Where vegetation obstructs inspection of building elements, also known as bridging as it provides a bridging point for the access of termites, full inspection can not be achieved. Consequently moisture or dampness may be present and the areas becomes conducive to termite activity. Plants against or very close to buildings provide cover, shade and can provide an environment that is attractive to termite infestation.

The removal and replanting of species that do not provide "cover" or cutting back of existing vegetation will assist greatly in preventing Bridging from occurring.

The removal of any such materials that may be conducive to termite activity should be carried out as soon as possible and arrange re inspection to minimize the risk of termite attack.

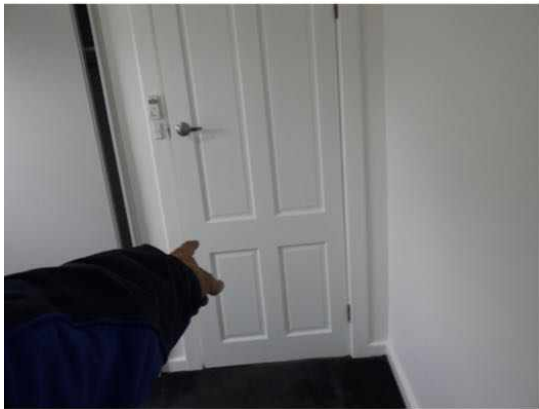
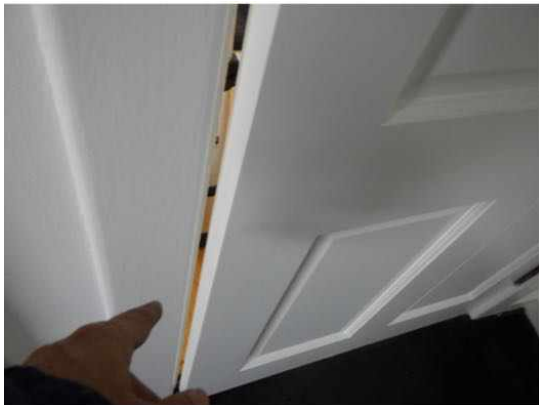
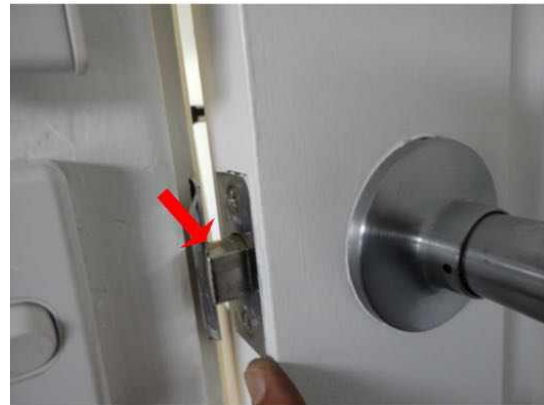
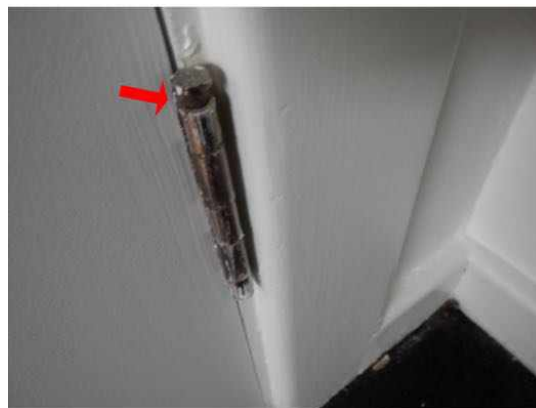
### Defects 3.05

Building: Building 1  
 Location: All Internal Areas  
 Finding: Door - Binding/jamming  
 Information: Binding and/or jamming of this bedroom door is evident during standard operation.

This defect inhibits the functionality of the affected door as well as creating potential for secondary defects to associated building elements, such as damage to the floor covering.

A door that binds to flooring or to the associated door frame may have several causes, ranging from minor defects, such as poor installation of the door or deteriorated hinges, through to major structural issues, such as damage to subfloor structures.

Where door binding/jamming appears to indicate major structural issues, a registered builder specialising in re-stumping should be appointed to provide an estimate on the cost of rectification.

For minor causes, a qualified carpenter or general handyman should be appointed to perform minor rectification works at client discretion.

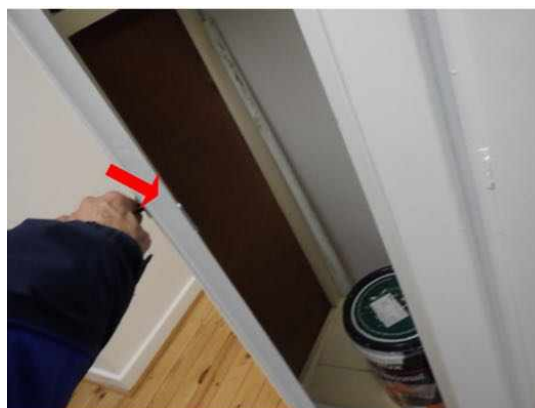
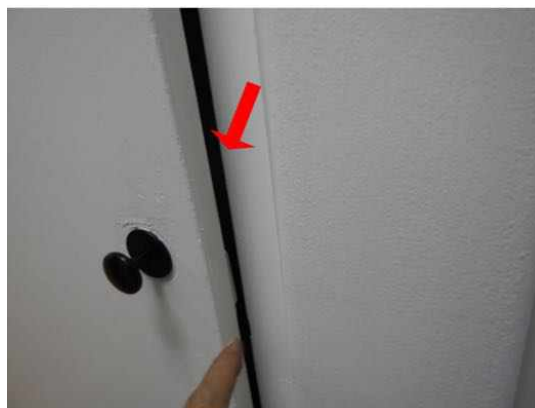
### Defects 3.06

| Information: | It was noted that the cabinet door in this area was not latching during operation at the time of inspection. Whilst detracting from the functionality of this building element, this minor defect may also be a security risk, and may therefore have serious implications if left unattended. |

It is suspected that this defect has occurred due to minor issues with the associated hinges. Such damage is identified as general wear and tear, which is expected for building elements of this age.

A qualified carpenter or general handyperson may be appointed to perform rectification works as necessary, at client discretion. If left unattended, further functional impairment is likely to occur.

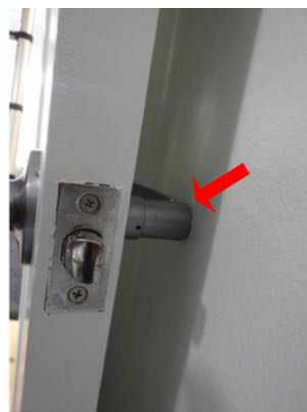
### Defects 3.07

| Finding: | Door stop - Missing |
| Information: | The door stop is missing or is inadequate to stop the door handle from damaging the wall. Although some building elements may seem irrelevant or unnecessary, all building elements play a key role in the operation and function of the overall structure and its performance. |

Re-installation or replacement of the door stop is advised as soon as possible to prevent any subsequent damage to the door or associated structures. A general handyman may be appointed to perform these works at client discretion.

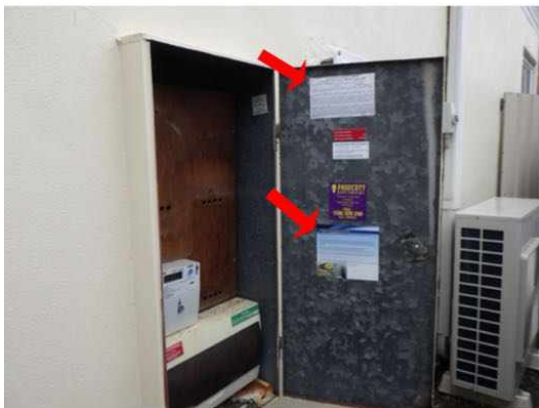
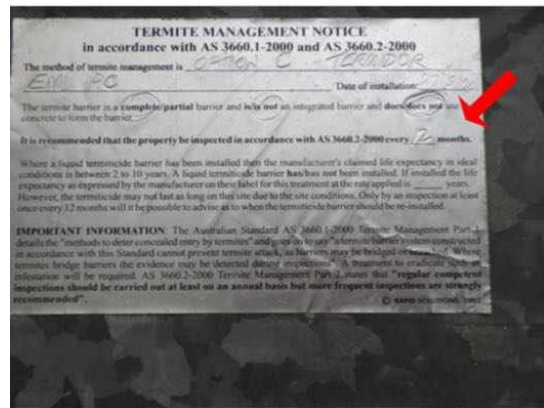
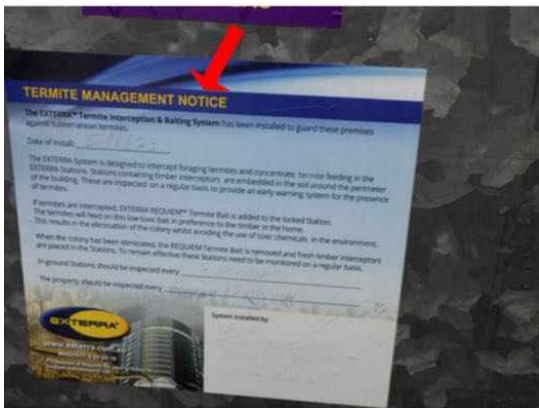
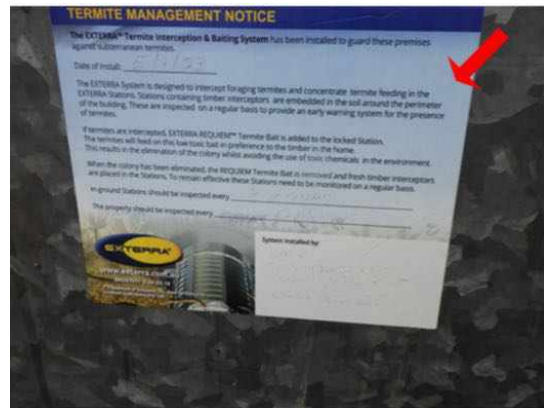
#### Noted Item

Where a Termite Management System has been identified you should refer to the type of barrier date of installation warranty conditions and any documentation provided by a builder or past owner. Consult the company who installed the barrier to confirm whether the system is still under warranty.

Most chemical termite management systems expire and require replenishment and all physical systems are primarily designed to prevent concealed entry.

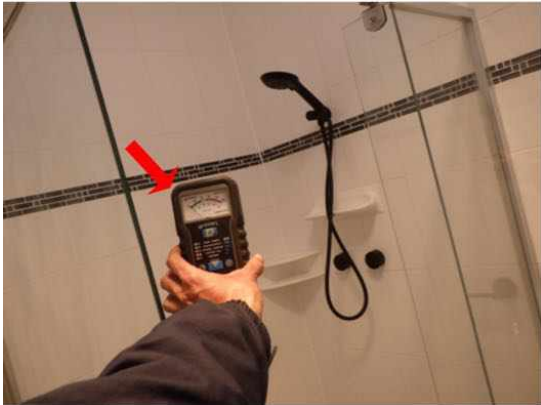
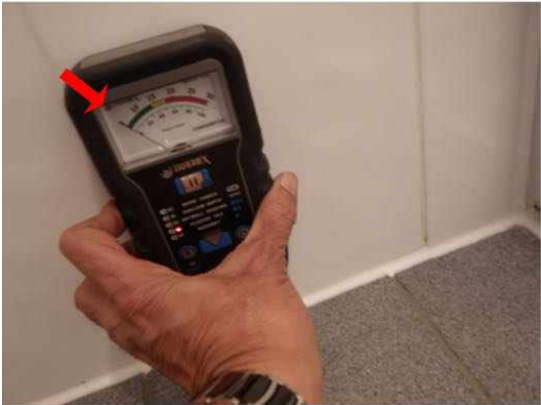
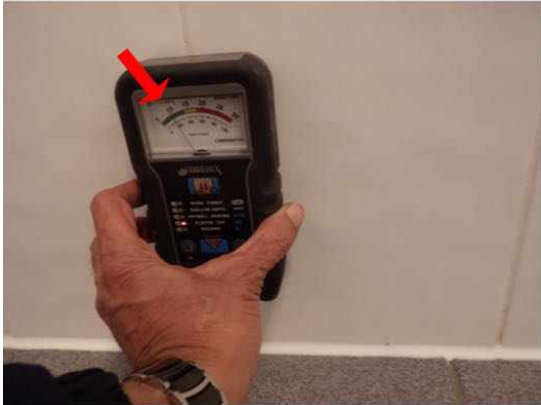
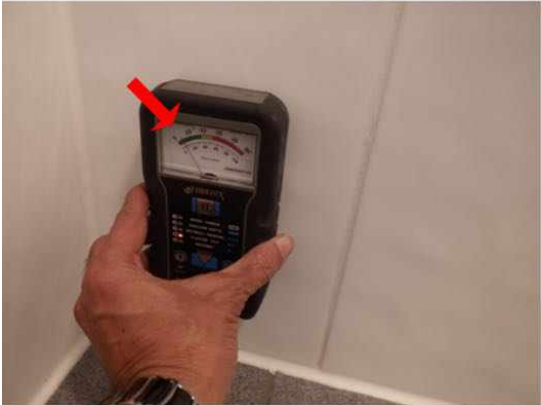
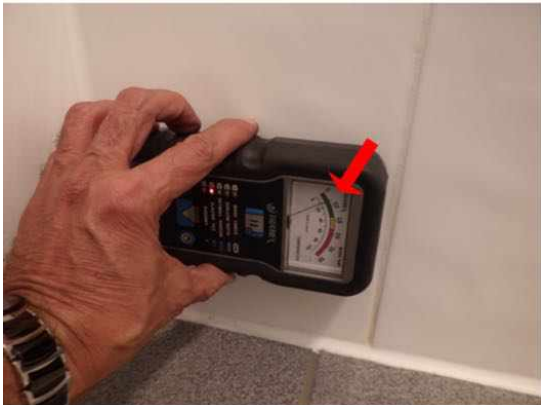
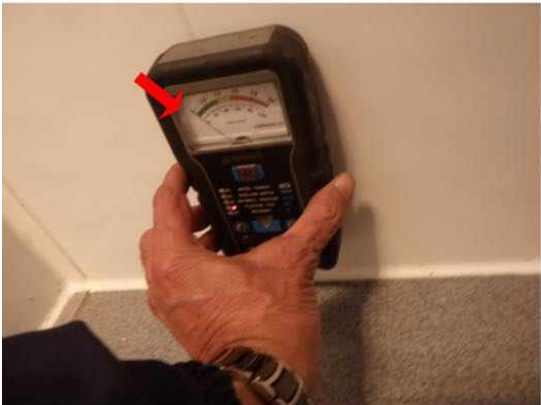
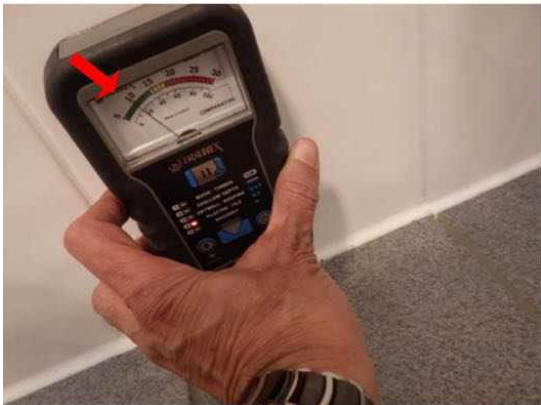
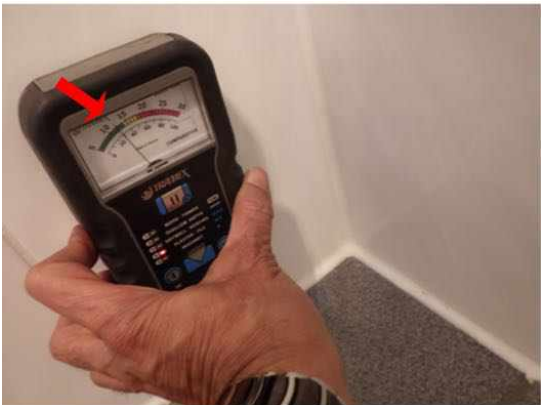
Building: Building 1  
 Location: Bathroom  
 Finding: Shower Alcove - No Damp  
 Information: At the time of inspection it was noticed that damp is not evident to the shower alcove.

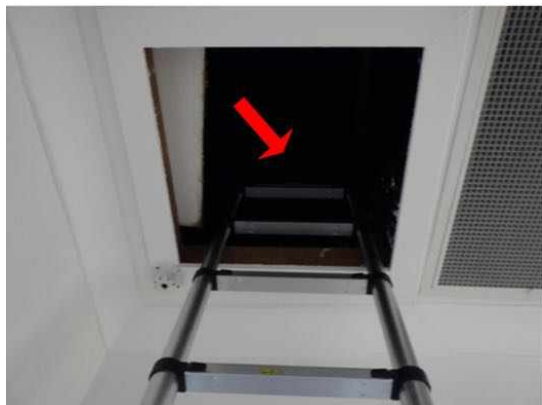
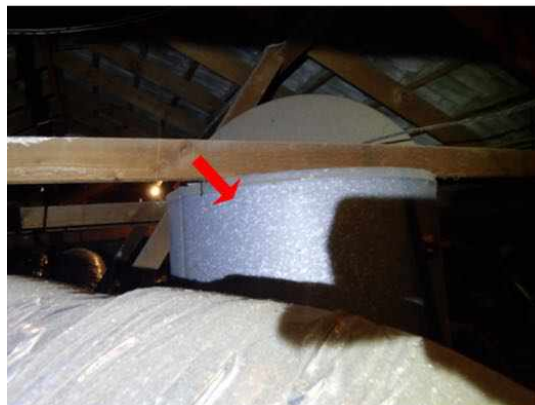
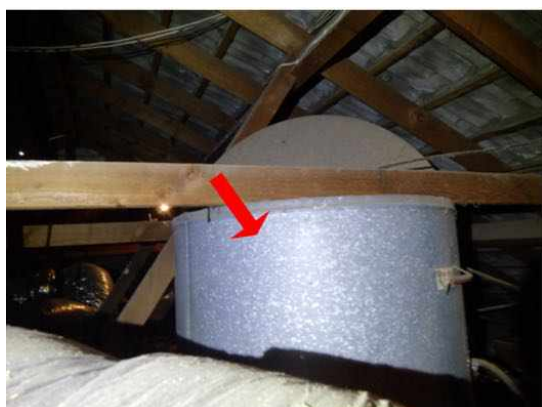
Building: Building 1  
Location: All Areas  
Finding: Additional Photos - Obstructions and Limitations  
Information: These photographs are an indication of the obstructions and limitations which impeded full inspection of the property at the time of inspection. These obstructions can hide an array of defects and should be removed to allow full inspection to be carried out. A re-inspection is recommended once the areas are made accessible.
