## Building Inspection Report

Inspection Date: Thu, 9 Apr 2026

Property Address: 6 Elijah St, Morphett Vale SA 5162,  
Australia

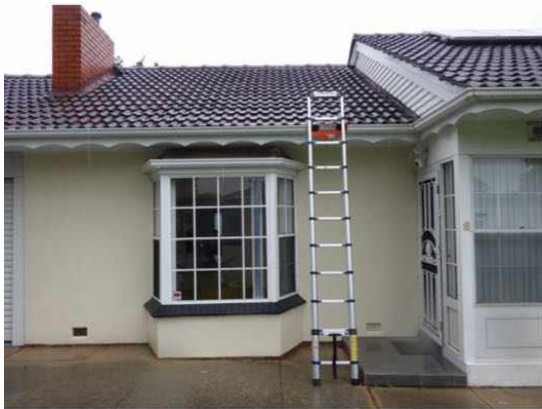
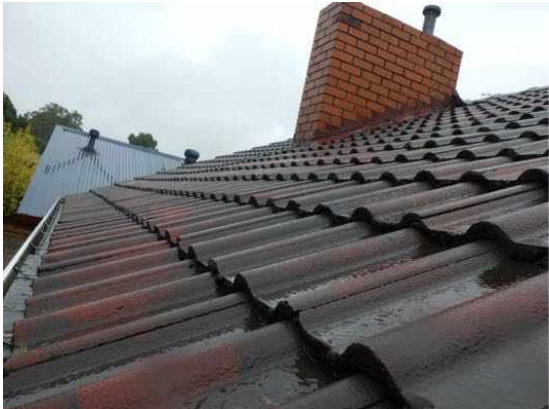
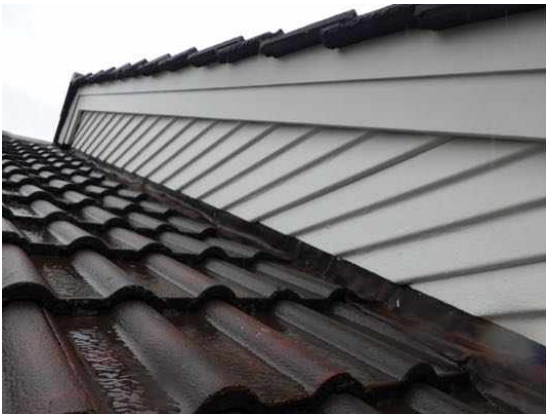
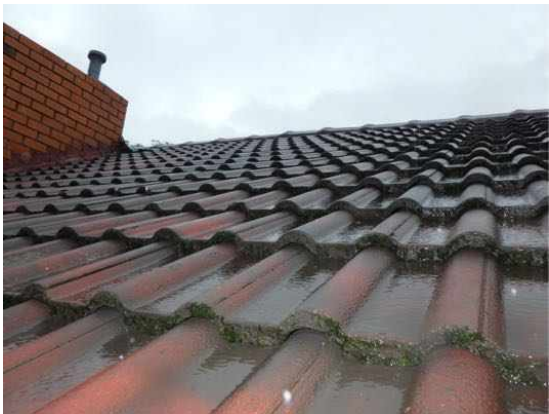
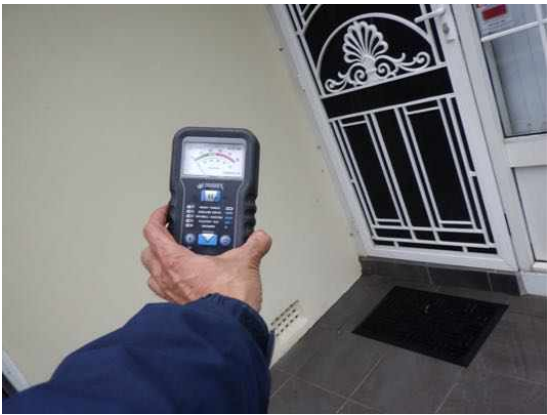
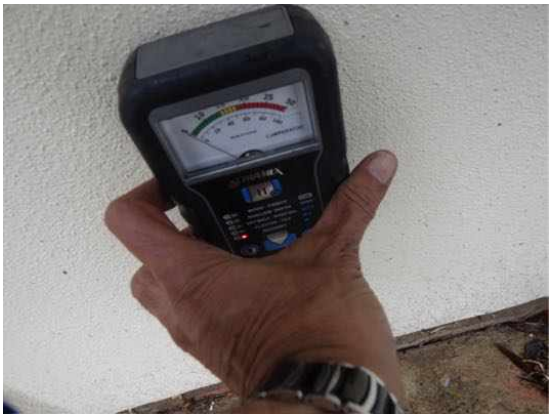
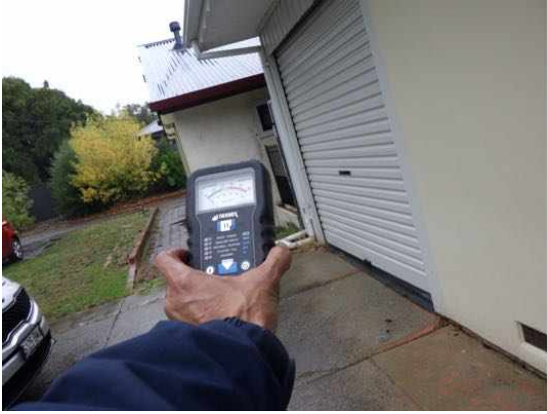
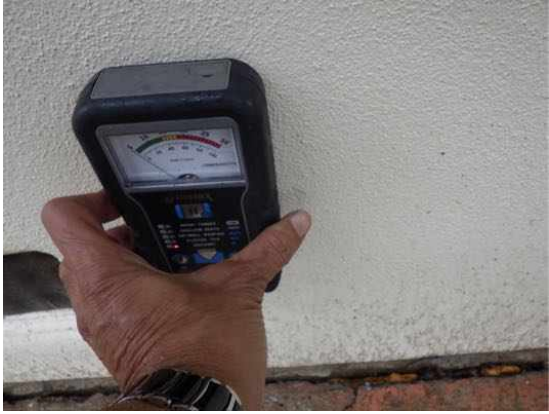
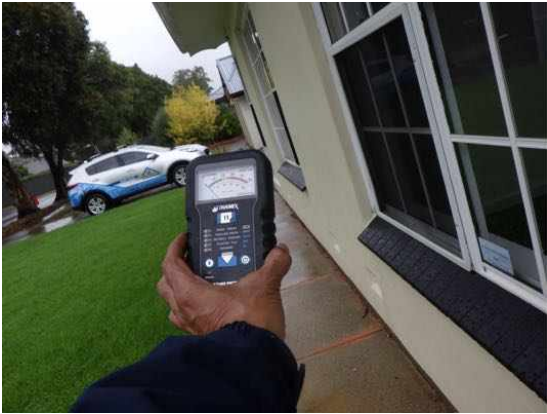
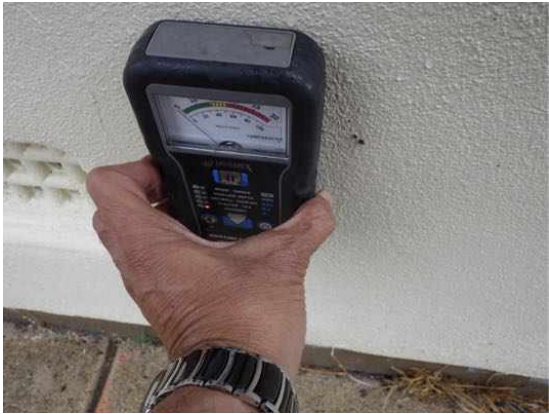
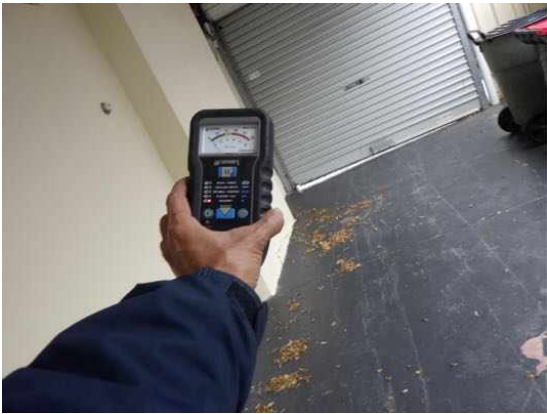
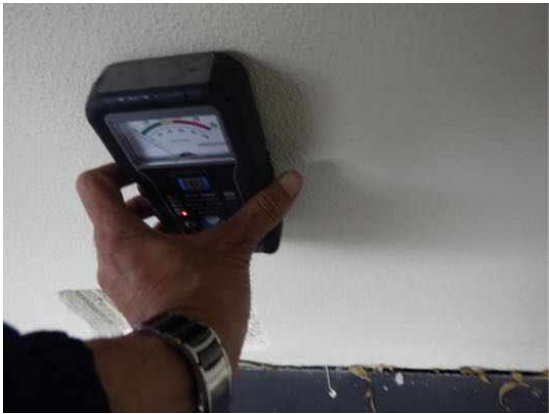
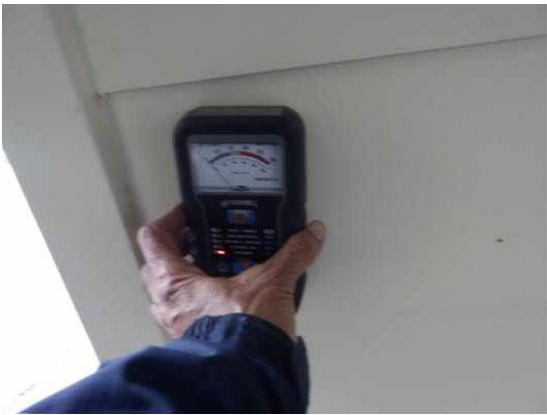
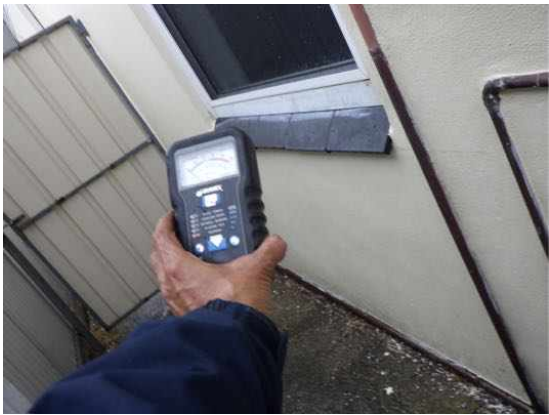
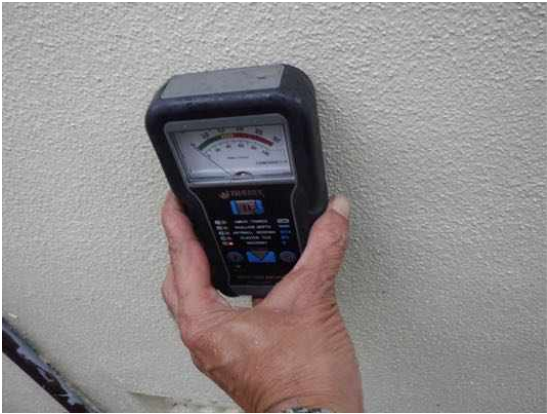
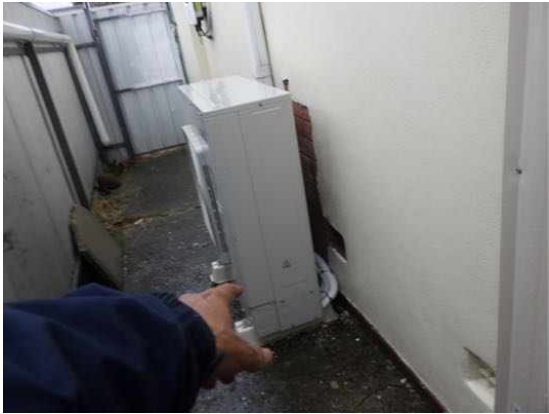
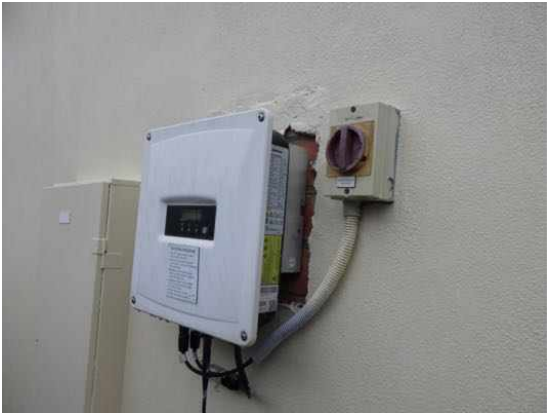
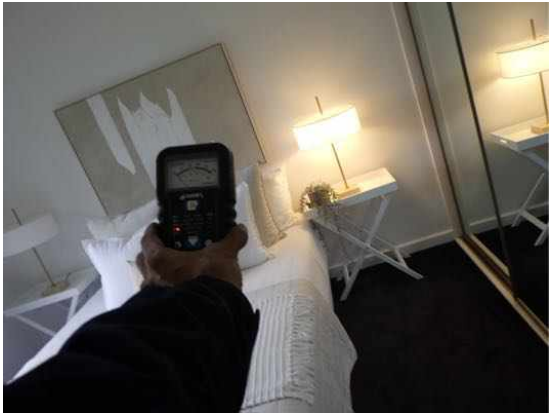
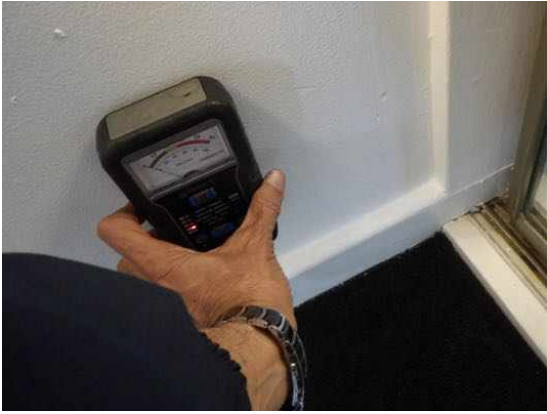
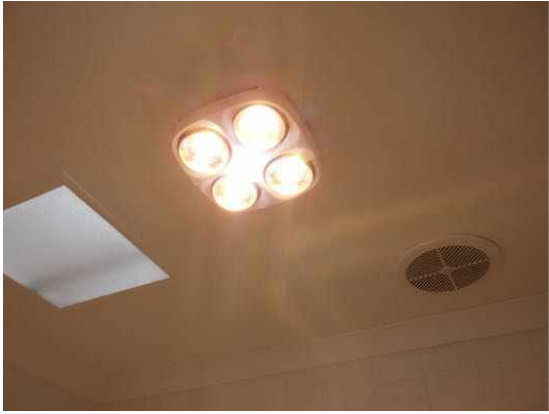
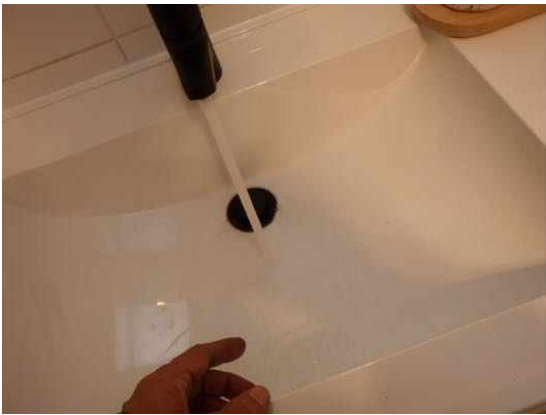
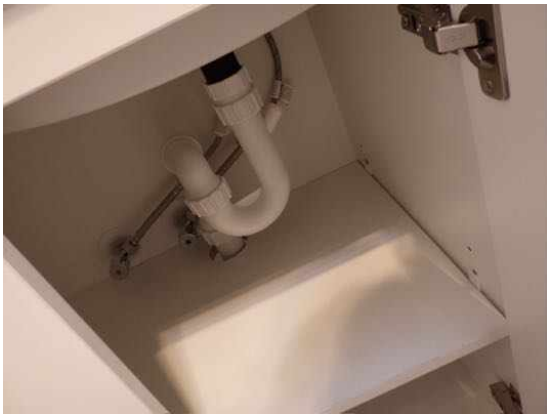
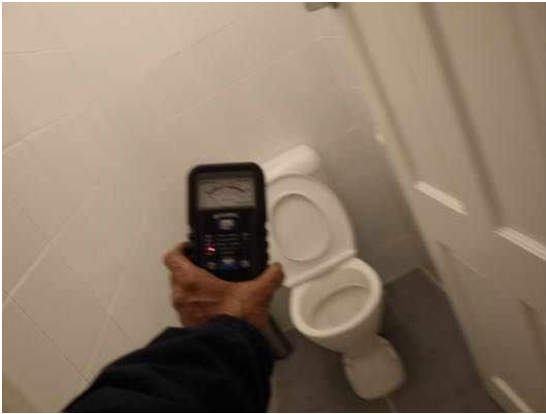
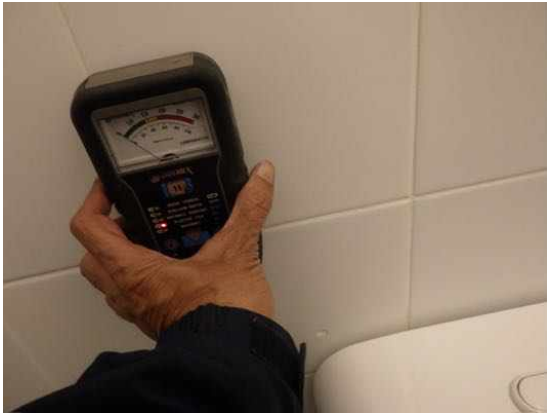
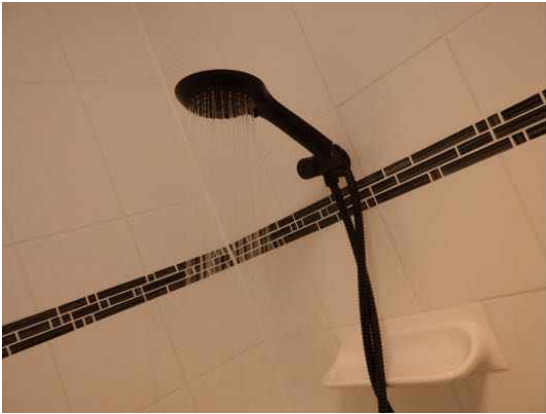
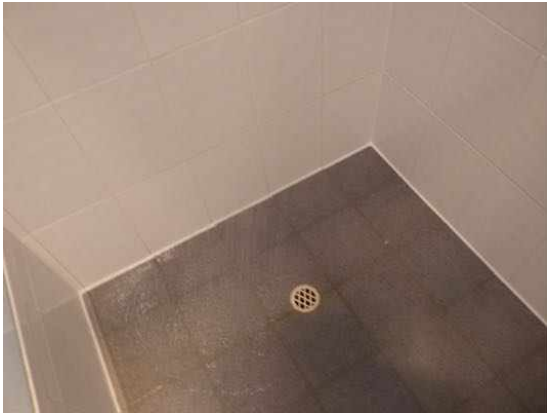
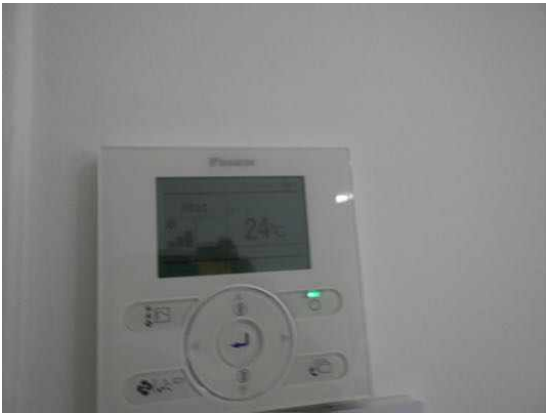
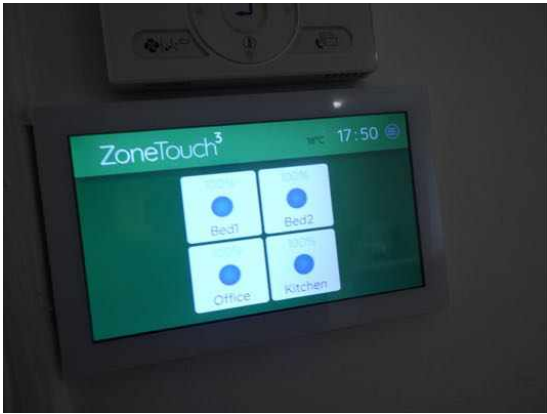
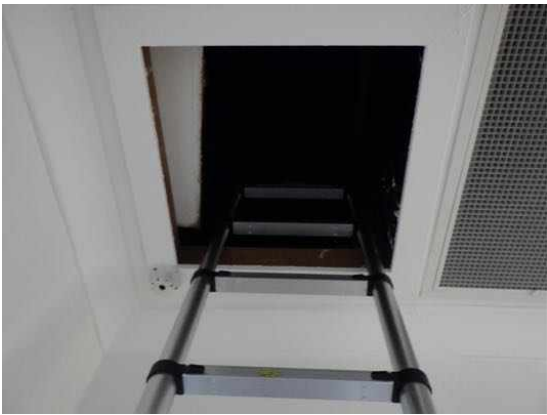
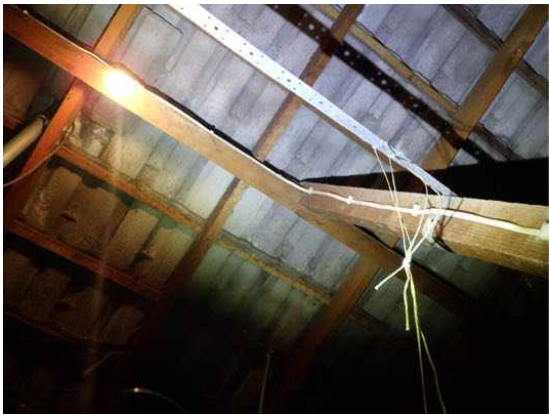
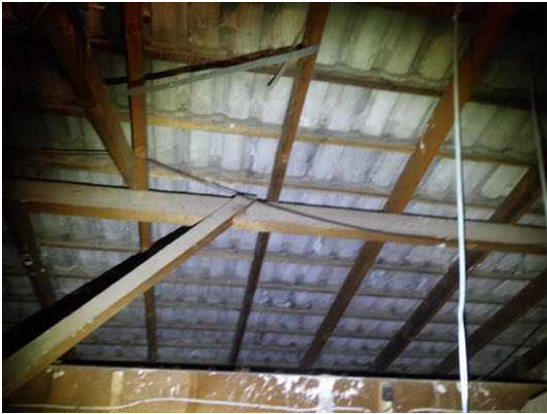
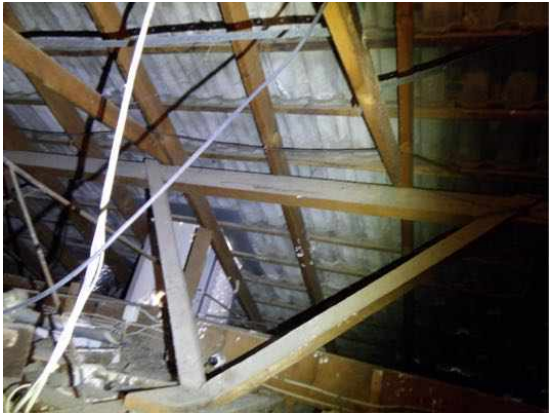
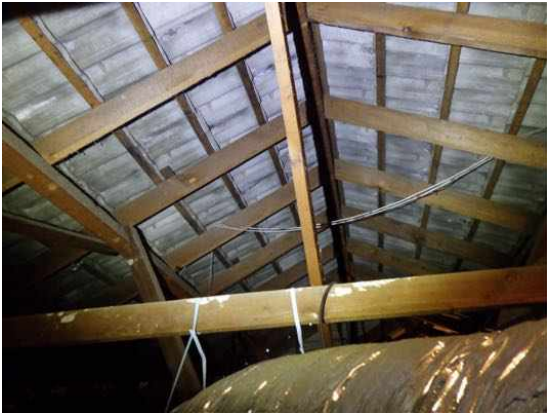
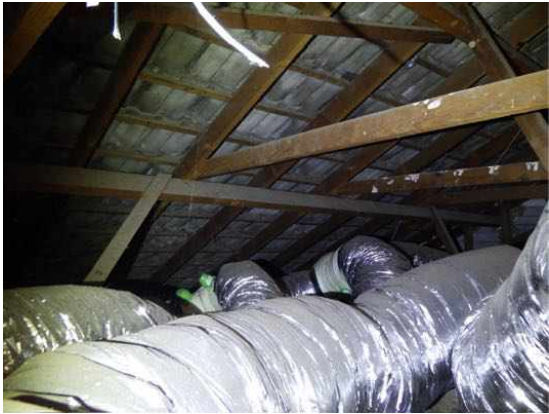
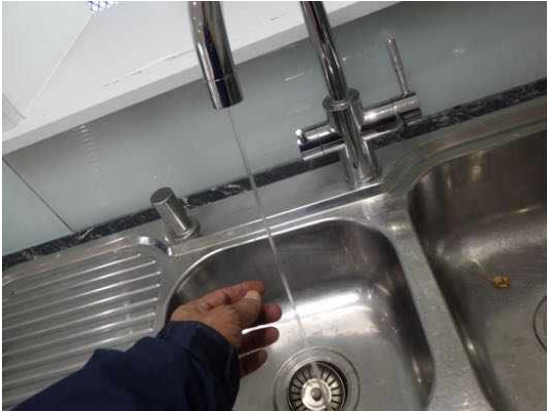
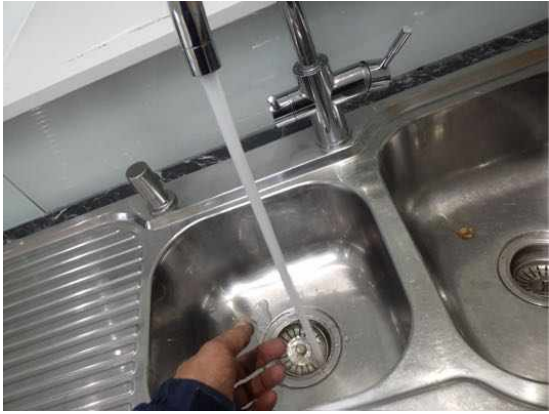
Building: Building 1  
Location: All Areas  
Finding: Additional Photos  
Information: Additional photos are provided for your general reference

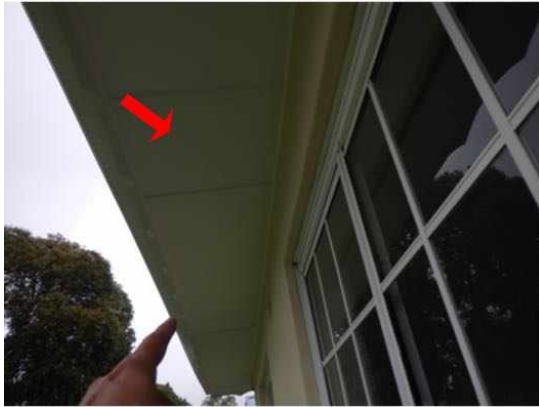
Building: Building 1  
Location: All External Areas  
Finding: Asbestos - Suspected ACM Identified on Site  
Information: Reporting on Asbestos is outside the Scope of this Report. This suspected defect is highlighted as a caution only. We suspect, based on our experience in the building industry, that there is a higher risk of the identified building element containing asbestos.

As Asbestos Reporting is outside the scope of this report, we advise that you consider a separate Asbestos Inspection and Condition Audit, which can include the taking of samples for definitive confirmation of the presence of Asbestos.

In the interim, the client is advised to act with caution, especially when considering any damage to building materials general wear and tear renovations extensions demolition and general maintenance activities due to the suspected presence of Asbestos.
