Building and Timber Pest Inspection Report

Inspection Date: Thu, 8 Jan 2026

Property Address: 33 Paynters Pocket Ave, Palmwoods QLD
4555, Australia

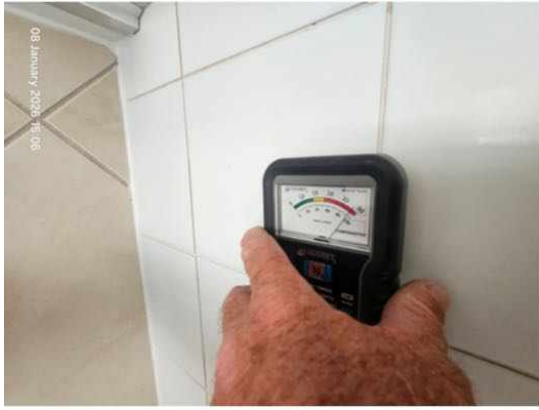
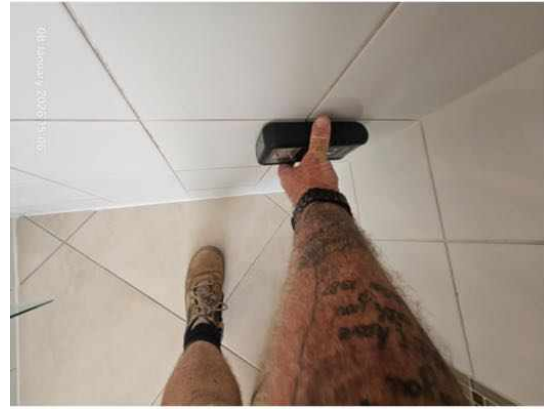
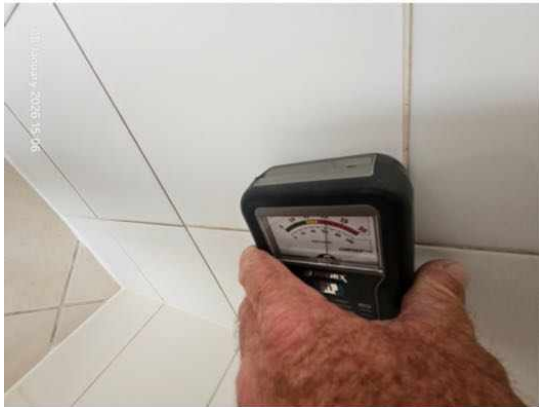
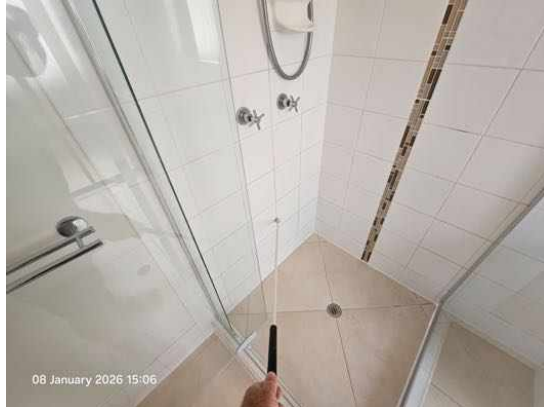
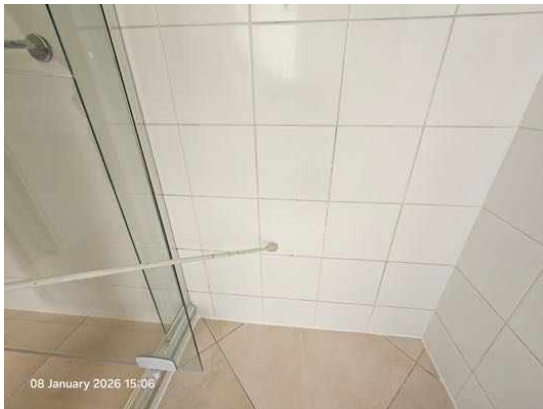
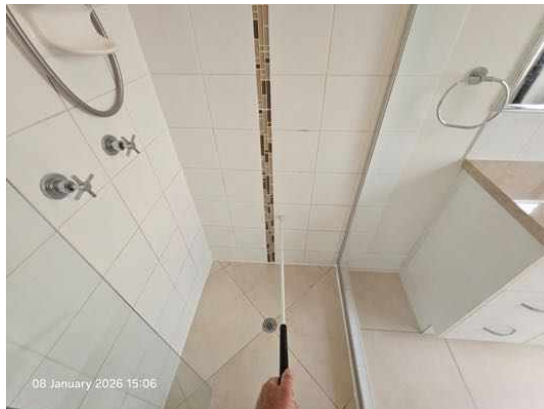
Elevated moisture can attract timber pests and vermin, and produce conditions that promote timber pest attack, fungal growth and wood decay.

It is recommended that the moisture levels in these areas be monitored over time and the grout and silicone could be renewed to possibly eliminate any further moisture penetration.

A licensed tiler and / or sealant specialist could be engaged to renew these elements.

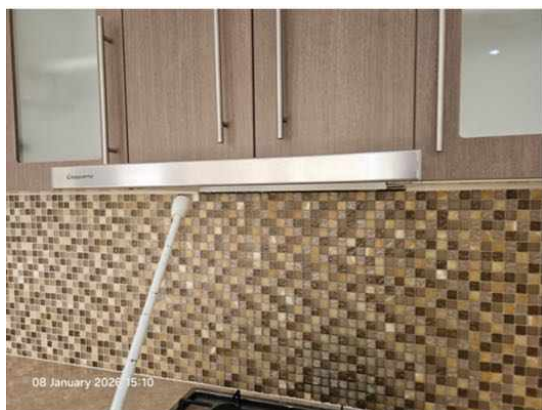
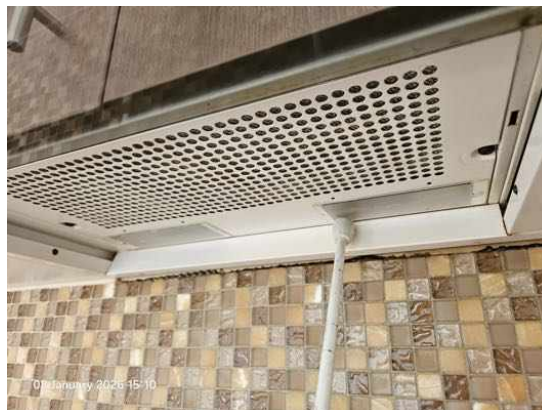
Finding 3.04

Building: Main Building
Location: Kitchen
Finding: Range hood lights
Information: On the day of inspection, the range hood lights were not working.

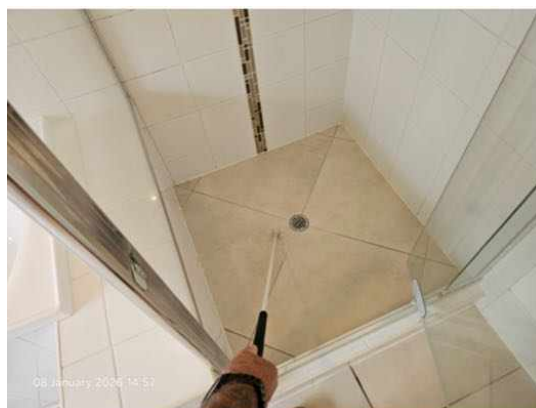
Tiled areas may swell and shrink with changes in air humidity if the area has sustained moisture damage. Any exposure to moisture is capable of causing tiled areas to become drummy and/or cracked over a prolonged period of time. Drummy tiled areas generally require removal and replacement of affected tiles.

Specialist trades are available for these types of services. A licensed builder may be required to undertake works if damage is extensive or if secondary building defects have resulted. Otherwise, it is advised that a tiling contractor or a tile adhesive injection service may be appointed to perform works as necessary.

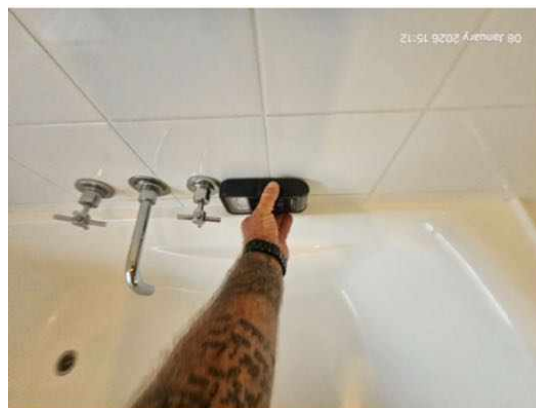
Finding 3.07

Building:	Main Building
Location:	Bathroom
Finding:	No moisture detected in bathroom
Information:	On the day of inspection the shower in the bathroom was measured for moisture using a "Tramex" moisture meter. During this inspection no moisture was detected in these areas and the tiled / sheeted surfaces appear to be in good order.

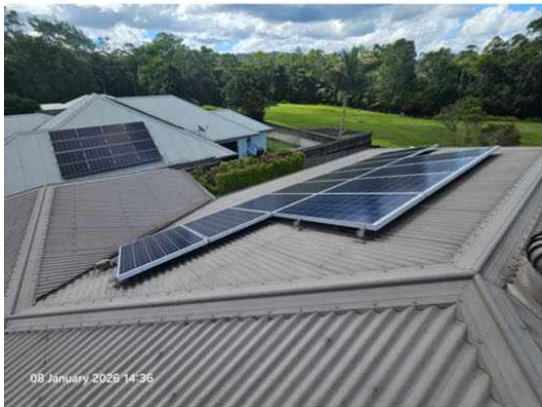
Noted Item

Building: Main Building
Location: All Areas
Finding: Additional Photos for client reference
Information: Additional photos are provided for your general reference.

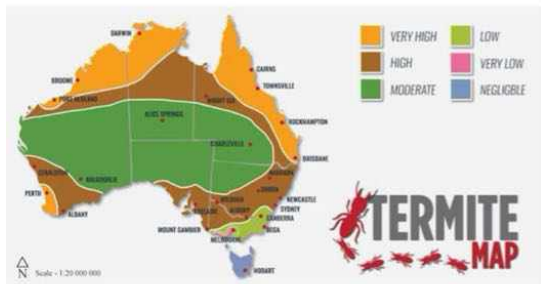
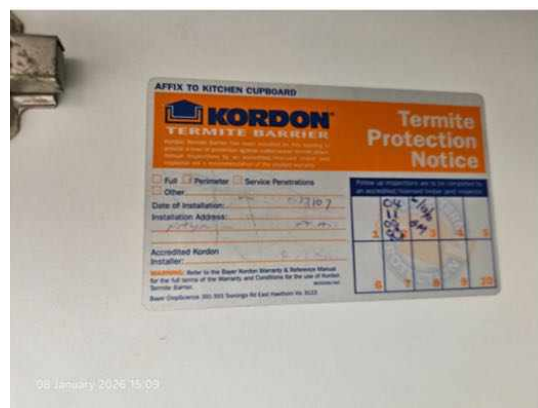
Review the attached map for Australia's termite zones and their risk profile.

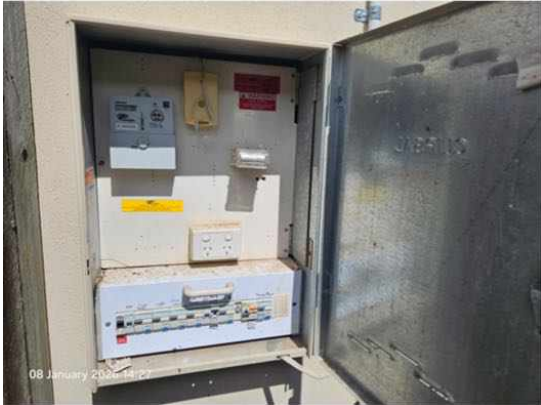
The following items were noted as - Evidence of a previous termite management program

The building employs a physical barrier system to the perimeter and slab penetrations. In order for a barrier system to be effective, the property must have regular inspections at intervals of not greater than 12 months. Depending on the risk profile attributed to the property, these inspections may be recommended at lesser time periods.

Where a Termite Management System has been identified you should refer to the type of barrier, date of installation, warranty conditions and any documentation provided by a builder or past owner. Consult the company who installed the barrier to confirm whether the system is still under warranty.
