# Building and Timber Pest Inspection Report

Inspection Date: Tue, 31 Mar 2026

Property Address: 14 Selwyn Ave, Cambridge Gardens NSW  
2747, Australia

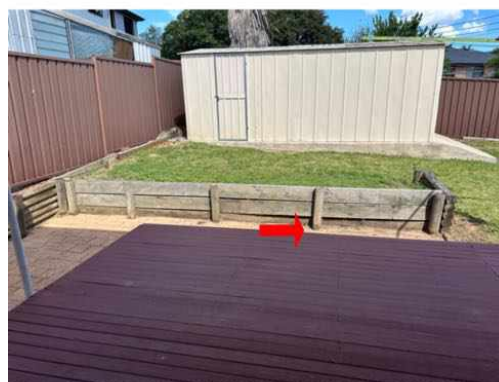
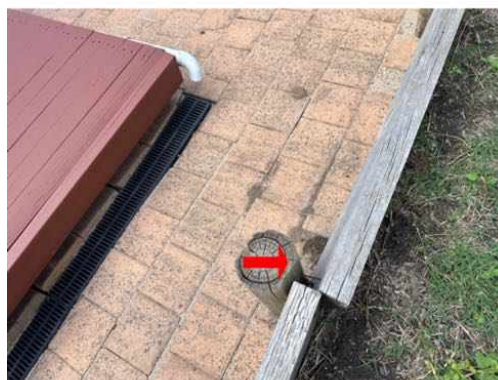
Building: Yard  
Location: Yard - Back > Rear Left  
Finding: Retaining wall - Defective  
Information: The retaining wall in this area was found to be defective at the time of inspection. Generally, defective retaining walls are caused by poor original design or material use. However, deteriorated retaining walls may also be a result of substandard construction, poor site drainage or unmanaged stormwater flows.

If left unmanaged, the retaining wall may become a safety hazard if it continues to destabilise. Where retaining walls further rot and decay, an environment is created that is conducive to termite and pest infestation.

Significant repair and replacement should be expected. Where retaining walls are considered structural walls, a structural engineer / surveyor should be consulted regarding required remedial works. Otherwise, a landscaper or retaining wall installer may be appointed to repair or replace the wall, at the discretion of the client.

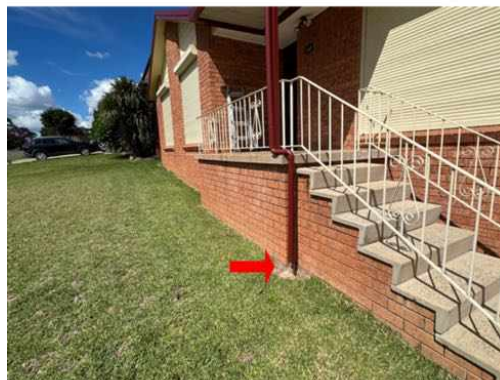
### Finding 3.02

Building:	Main Building
Location:	Front Elevation > Centre
Finding:	Roof plumbing - Missing
Information:	Some sections of the roof are not adequately drained via gutters and downpipes. Gutters and downpipes that are not installed adequately are likely to result in excessively damp conditions against the exterior surfaces and around the base perimeter of the building.

Excessive moisture creates an environment which accelerates the deterioration of building elements in the area, as well as being conducive to termite and pest infestation. Such an environment is likely to necessitate repair and/or replacement of building elements, which are prone to sustaining wood rot, rust or corrosion.

A roofing plumber should be appointed as soon as possible to install relevant roof plumbing materials. Depending on the extent of the damage, repair and/or replacement of damaged building elements may be required.

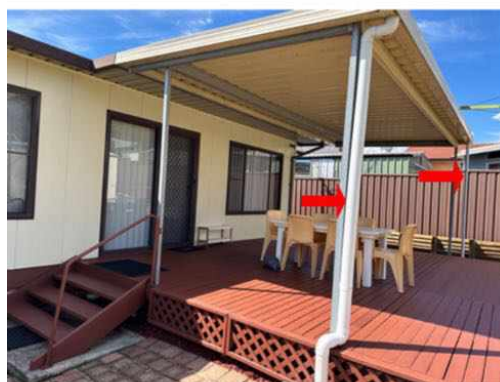
### Finding 3.03

Building:	Main Building
Location:	Deck > Rear Left
Finding:	Roof plumbing - Missing
Information:	Some sections of the roof are not adequately drained via gutters and downpipes. Gutters and downpipes that are not installed adequately are likely to result in excessively damp conditions against the exterior surfaces and around the base perimeter of the building.

Excessive moisture creates an environment which accelerates the deterioration of building elements in the area, as well as being conducive to termite and pest infestation. Such an environment is likely to necessitate repair and/or replacement of building elements, which are prone to sustaining wood rot, rust or corrosion.

A roofing plumber should be appointed as soon as possible to install relevant roof plumbing materials. Depending on the extent of the damage, repair and/or replacement of damaged building elements may be required.

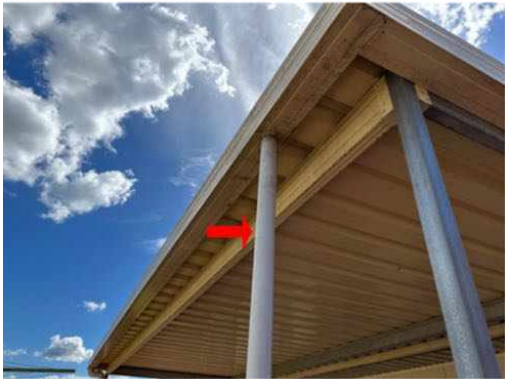
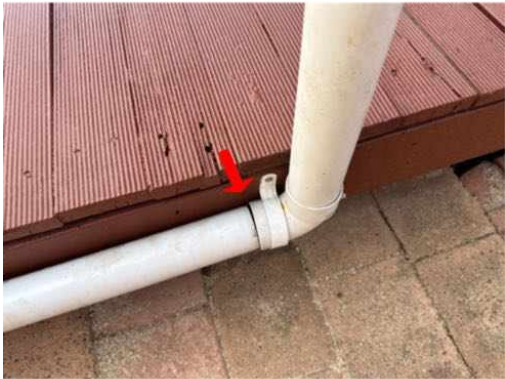
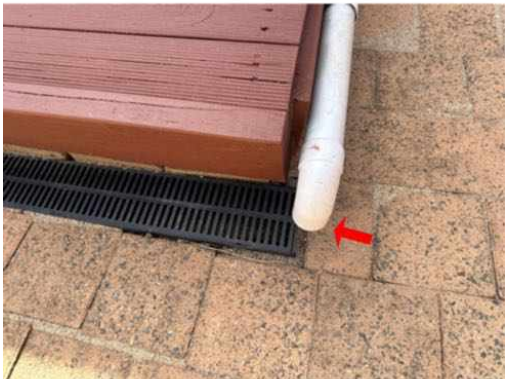
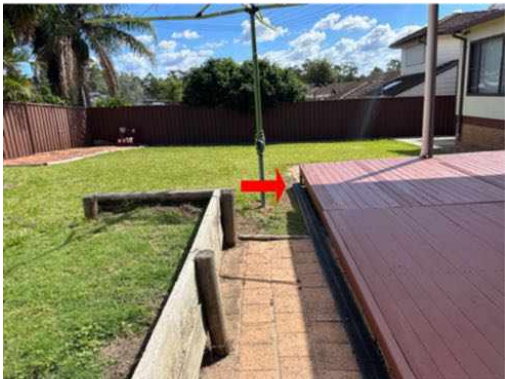
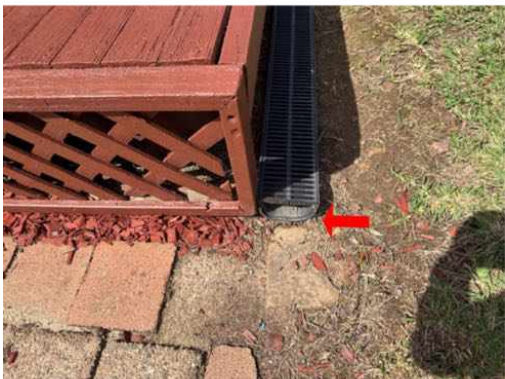
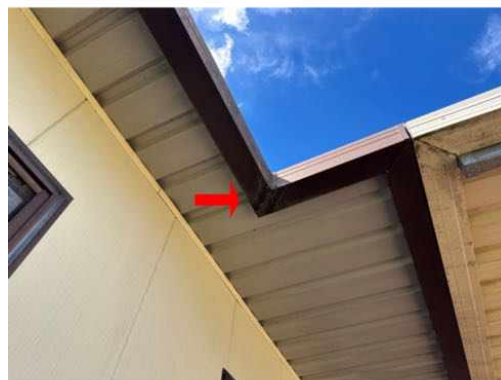
**Finding 3.04**

Building: Main Building  
 Location: Roof Exterior > Centre,Rear  
 Finding: Roof plumbing - leaking.  
 Information: Some sections of the roof are not adequately drained via gutters and downpipes. Gutters and downpipes that are not installed adequately are likely to result in excessively damp conditions against the exterior surfaces and around the base perimeter of the building.

Excessive moisture creates an environment which accelerates the deterioration of building elements in the area, as well as being conducive to termite and pest infestation. Such an environment is likely to necessitate repair and/or replacement of

building elements, which are prone to sustaining wood rot, rust or corrosion.

A roofing plumber should be appointed as soon as possible to install relevant roof plumbing materials. Depending on the extent of the damage, repair and/or replacement of damaged building elements may be required.

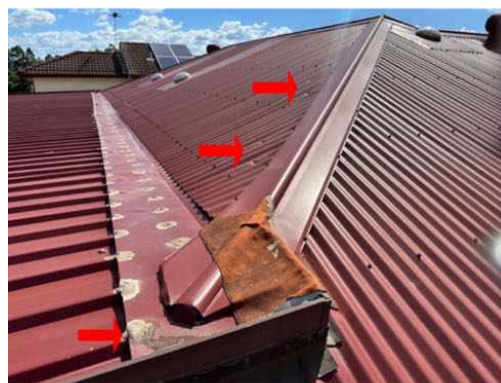
### Finding 3.05

Building:	Main Building
Location:	Roof Exterior > Centre,Rear
Finding:	Roof sheets - Excessive silicone work
Information:	The silicone repair work performed to the roofing colorbond appears to have been completed to an unsatisfactory standard. Excess silicone was evident in many sections of the colorbond area providing a blemish on the appearance as well as detracting from the drainage of the area.

It was also noted that some of the sheets have been creased or dented, this may over time provide areas for the Colorbond to develop areas of rust. The sheets may be replaced by a roofing contractor at the client discretion.

While weather-tight the excess silicone should be removed in order to increase roof drainage and to prevent accelerated deterioration of the roof sheets. A roofing contractor may be appointed to perform these works at client discretion.

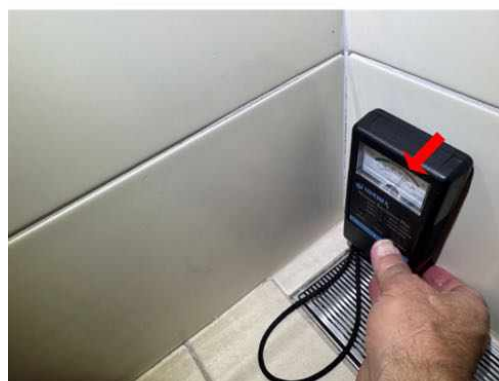
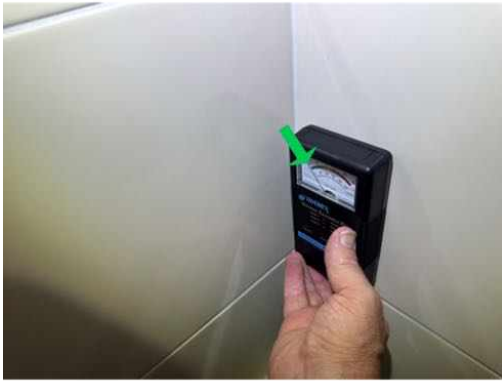
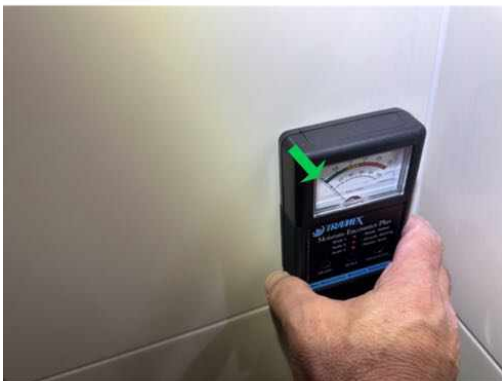
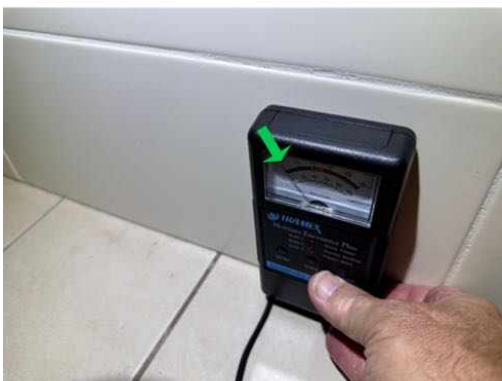
### Finding 3.06

Building: Main Building  
Location: Bathroom > Centre Left  
Finding: Moisture meter: used in Shower area.  
Information: A moisture meter was used during the inspection and isolated spots of excessive moisture was detected to accessible walls inside the property at the time of inspection.

It was noted on inspection that sealant or grout is in fair condition to most of the tiled shower alcove.

Different materials and floor areas move at different rates, generally causing cracking to grout or sealant at this point. A flexible sealant is required to allow for expected expansion and contraction, while keeping the joint water tight and protective of all associated building materials.

Flexible and mould resistant materials should be applied to affected areas to prevent any subsequent water damage that is likely to occur. Regular maintenance and replacement of damage or missing or damaged sealant and grout is highly recommended to the wet areas, as this is a regular wear and tear defect. Sealant and grouting in areas that come into regular contact with water should be maintained for the long term care of your property.

Monitoring the area is advised and if any visual signs of excessive moisture appear (peeling paint, mould) then consultation with a qualified plumber or bathroom specialist would be advised to identify the cause of damp and to perform remedial works as required.

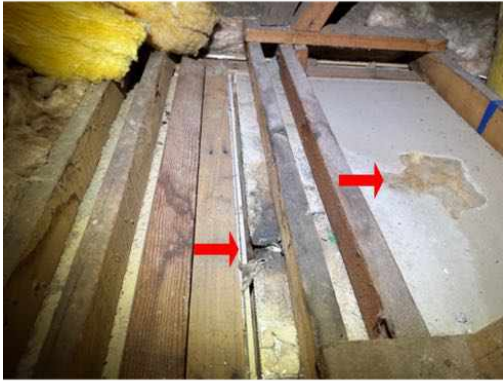
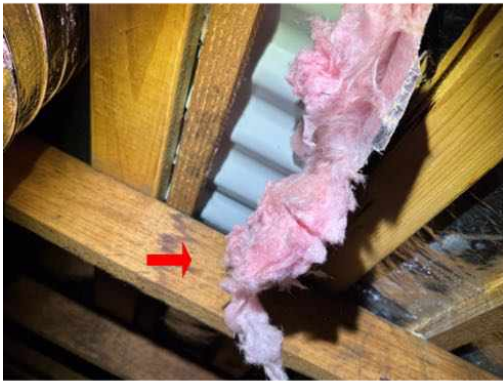
### Finding 3.07

Building: Main Building  
 Location: Roof Void > Centre  
 Finding: Water leak - Inactive  
 Information: Water leaks generally occur when a particular area of the property is not weather- or water-tight. While the damage in this area appears to be from an old inactive water leak, possibly from the original tiled roof that has been replaced with Colorbond, the area should be monitored frequently for the recurrence of any dampness.

Repair and / or replacement of previously affected building elements is at client discretion. Consider a further invasive inspection: removal of obstructions around the damaged area may reveal further damage which has been concealed. A more

significant or major defect may be identified at this time.

Where recurrence of an active water leak is identified, a qualified plumber should be appointed immediately to rectify the leak and advise on any further preventative works as necessary.

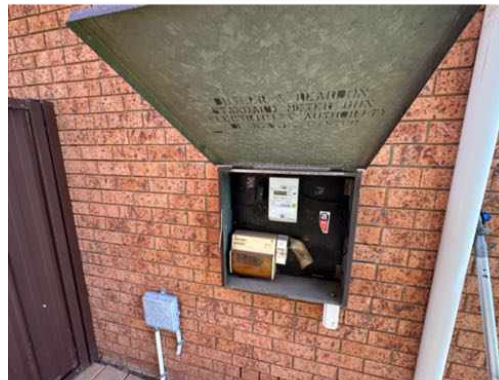
Building:	Main Building
Location:	Electrical circuit box > Front Left
Finding:	Termite Management System - no evidence of a chemical installation
Information:	The application of a post-construction chemical termite barrier is highly recommended for all properties, particularly if live termite activity has been found on the site previously. Such barriers are highly effective in preventing termite attack on any timber building elements throughout the property.

A durable notice should be placed in the switchboard unit to indicate current termite barriers. At the time of inspection, it appeared as though no termite management system has been installed, with no evidence to suggest preventative works taking place.

The client may consider gaining further advice from a pest controller as to the costs and procedures involved with this application. It is recommended that obtaining such advice be a short-term priority.

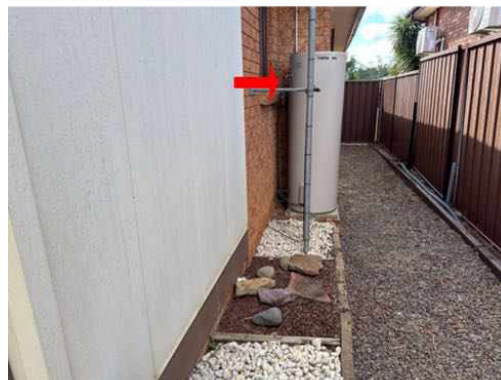
### Finding 6.02

Building:	Main Building
Location:	Exterior walls - left side > Rear Left
Finding:	HWS Overflow - Not Connected
Information:	The Hot Water System (HWS) overflow was found to be disconnected from storm water drainage and is creating excessive moisture in the surrounding area.

These damp conditions can lead to secondary defects such as rot, rust or corrosion of associated building elements, the formation of fungal decay, or even the creation of potential slip hazards. When coupled with poor site drainage, pooling of water may

also attract termite activity to this area.

It is highly recommended that a licensed plumber be appointed to connect the HWS overflow in order to prevent such an environment from being created. These minor works should be carried out as soon as possible.

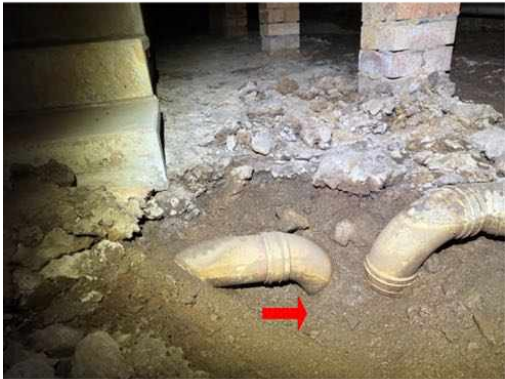
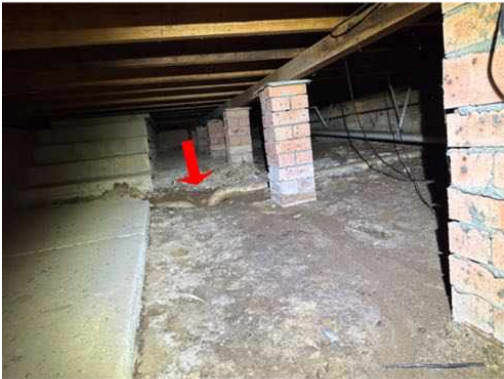
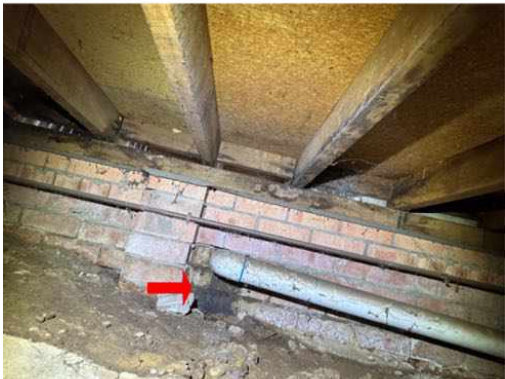
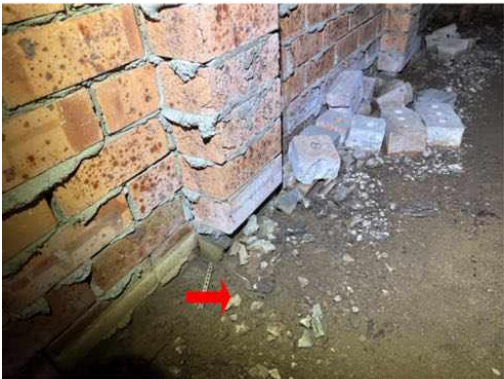
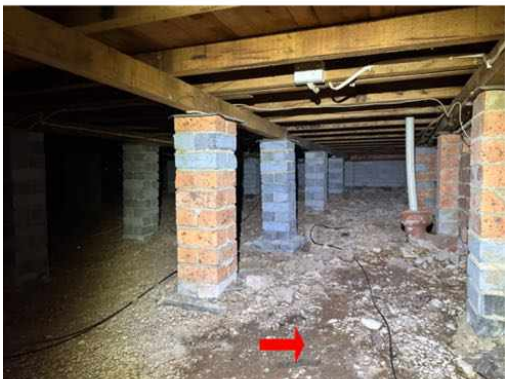
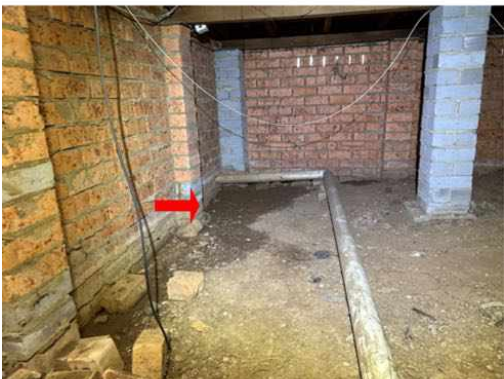
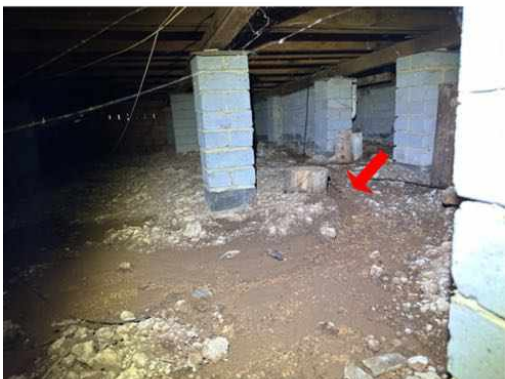
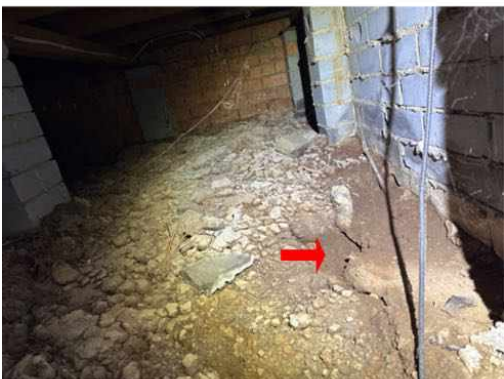
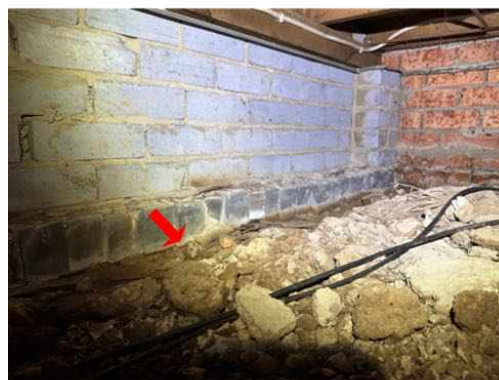
### Finding 6.03

Building:	Main Building
Location:	Subfloor > All Areas
Finding:	Subfloor: Damp.
Information:	At the time of inspection there appeared to be sections of the subfloor area with excessive moisture which can lead to secondary defect of other building materials. A well drained sub floor can aid in preventing secondary damage such as wood rot and pest activity, as well as preventing the development of mould and mildew (which can lead to respiratory safety hazards for occupants). This should be investigated as soon as possible by a plumber for leaking pipes or to improve site drainage.

Ventilation can be restricted by a variety of minor defects, including obstructions in the subfloor space, a lack of vents or a low clearance.

The initial step in improving ventilation is to ensure that the subfloor area is free of any debris or stored items. Where ventilation is still inadequate, it is advised to ensure that all vents are clear of blockages, and additional vents may be installed.

The client may also consider mechanical ventilation (powered fans) to improve subfloor airflow. Remedial works should be conducted as a matter of urgency to protect against the development of potentially harmful subfloor conditions.

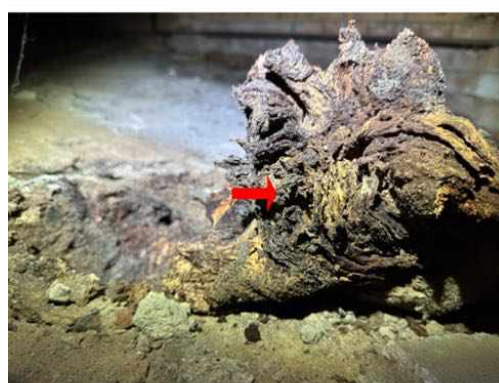
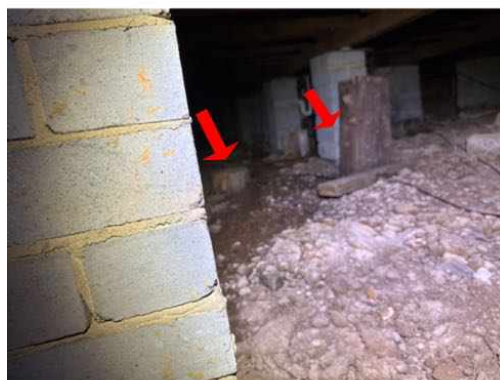
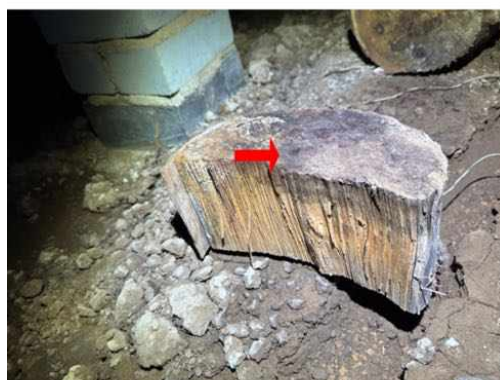
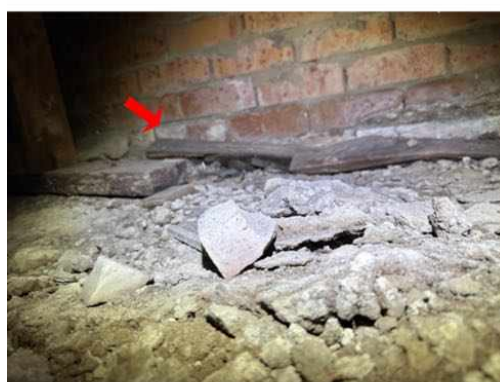
### Finding 6.04

Information: An array of debris was found in the subfloor area at the time of inspection. Debris in this area restricts subfloor ventilation and creates potential for concealed pest entry. Stored timbers and other materials may also make the area susceptible to termite activity and wood rot.

Debris in the subfloor should be removed as soon as possible. Depending on the location and amount of debris and stored items, the homeowner may elect to undertake this task. Alternatively there are a large number of rubbish removal subcontractors that could undertake these works.

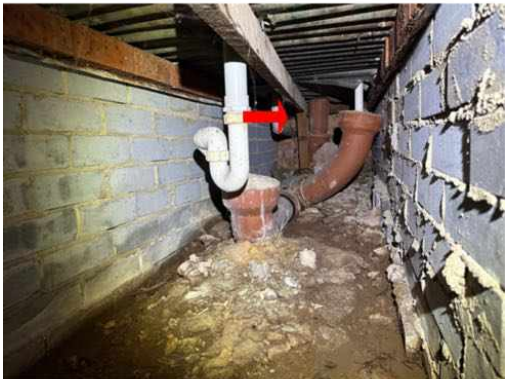
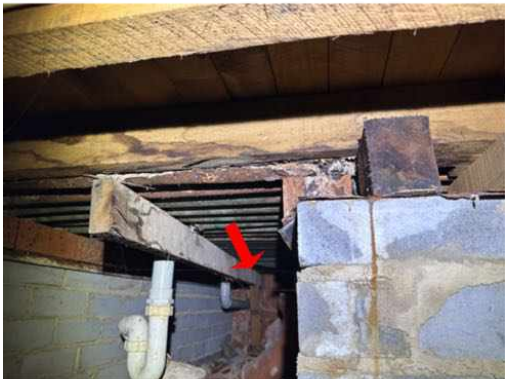
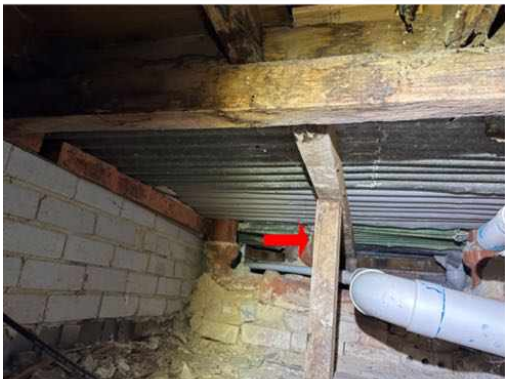
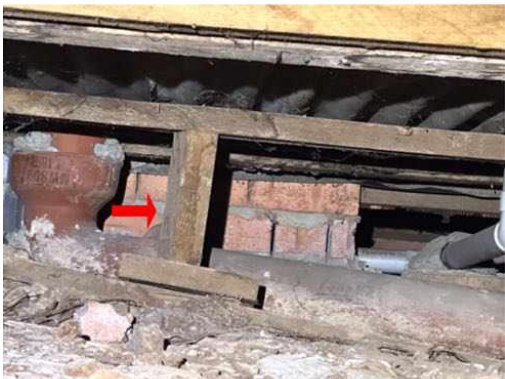
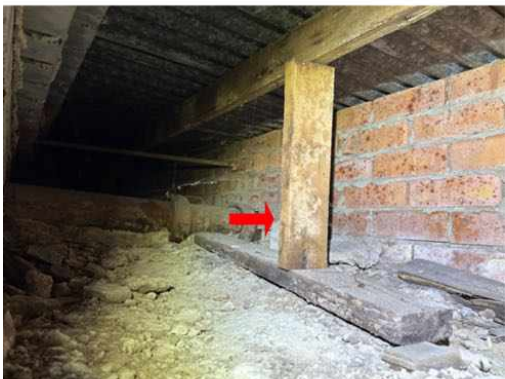
### Finding 6.05

Building:	Main Building
Location:	Subfloor > All Areas
Finding:	Formwork timber: Left in situ
Information:	Formwork timber appears to have been left on site and in situ after concrete construction. Formwork timber is used to support and shape the concrete while pouring during the construction process. Leaving formwork timbers in the subfloor space or around the exterior of the property increases the risk of termite activity being present. As they are likely to come into contact with weather conditions or excessive moisture wood rot is likely to develop on timbers that are not treated. It is highly recommended that any formwork timbers be immediately removed from areas in

which they may attract any termite/timber pest attack. Minimisation of risk/prevention of termite attack is far more adequate than dealing with the presence of termite activity.

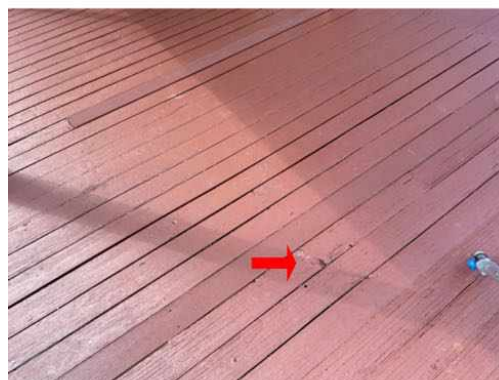
**Finding 7.01**

Building: Main Building  
Location: Deck > Rear Left  
Finding: Fungal decay - present (localised)

In this case although the affected timber element is in a decaying state the extent of any visible damage appears to be localised to a specific area and is yet to spread to other parts of the building element or affect adjoining structures. It is highly recommended that the deck to be inspected by a licensed contractor or engineer to determine the structural load capacity of the affected timber and the need for replacement or repair of any timber deemed necessary.

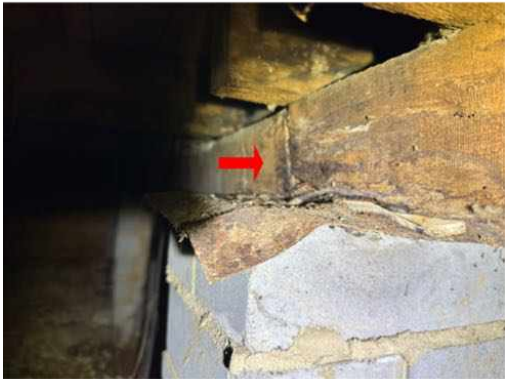
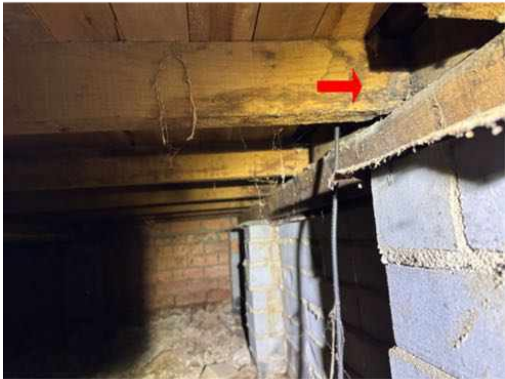
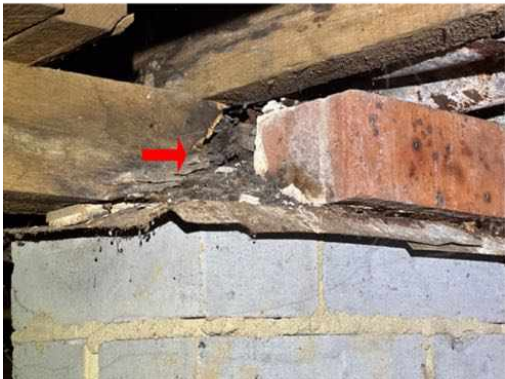
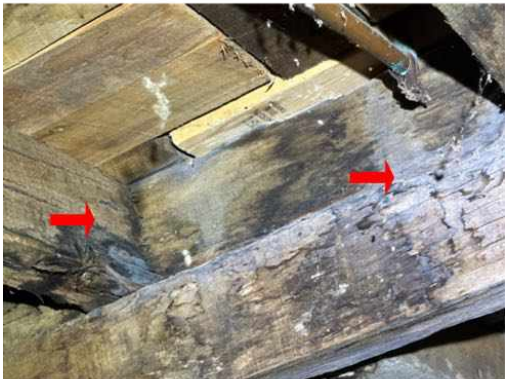
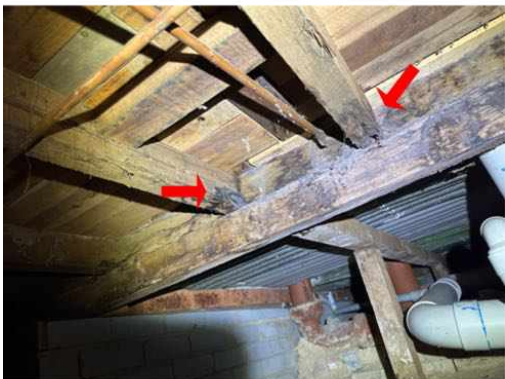
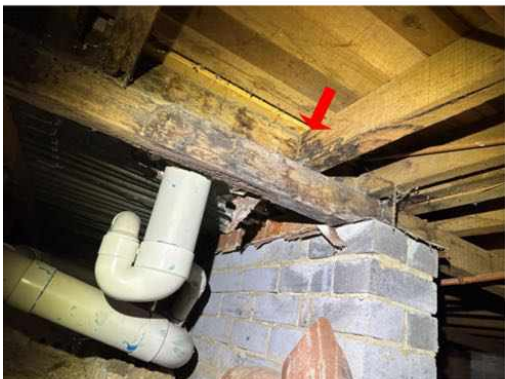
Building:	Main Building
Location:	Subfloor > Centre
Finding:	Fungal decay - present (shower areas)
Information:	Fungal decay also known as wood decay or wood rot generally refers to the deterioration of timber elements when in contact with excessive levels of moisture for a prolonged period of time.

The development of fungal decay is accelerated by temperatures in the range of 5degreeC to 40degreeC as well as the presence of oxygen. Generally fungal decay develops on timber elements that are exposed to excessive amounts of moisture, such as leaks from showers.

In this case although the affected timber element is in a decaying state the extent of any visible damage appears to be localised to the specific area of the master ensuite and bathroom. The fungal decay is therefore most likely a result of the bathroom and ensuite shower recess leaking. It appears that the shower recess on both ensuite and main bathroom have undergone renovations and it is unclear if the water leak is still active as the property is currently vacant and the showers not in use. It is highly recommended that the area to be monitored when in prolonged use. If the leaking shower recess is active it should be addressed by a licensed tiller, waterproofing specialist as soon as possible before the damage becomes extensive to the floor structure.

Wood rot or fungal decay was found in the subfloor adjacent to the ensuite and main bathroom shower recess at the time of inspection. Wood rot is conducive to termite activity, all susceptible timbers (where applicable) should be removed and where applicable replaced with non-susceptible timber as soon as possible.

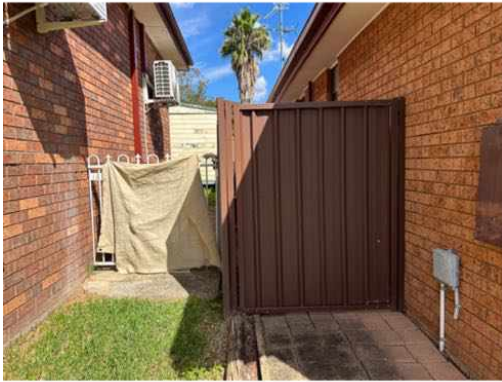
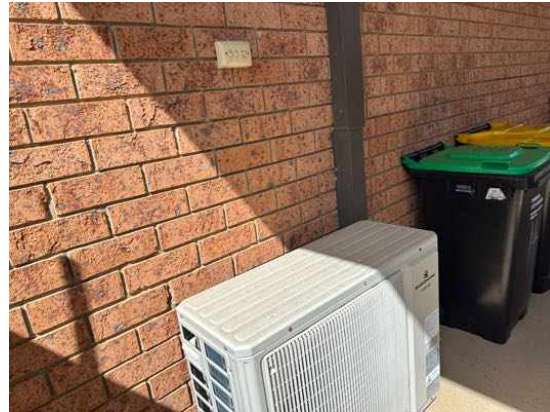
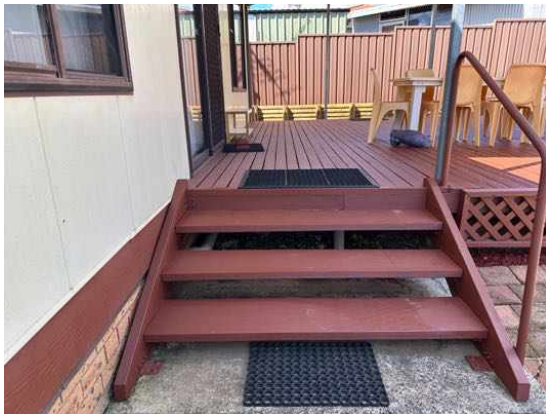
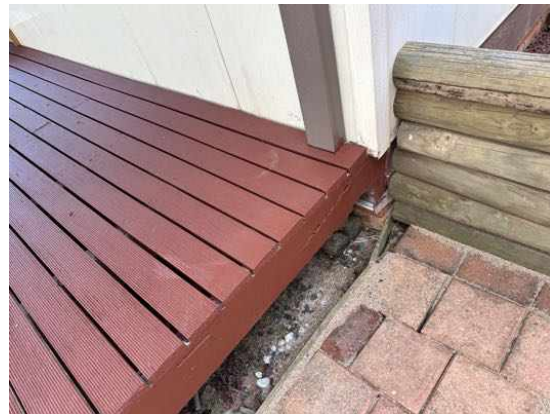
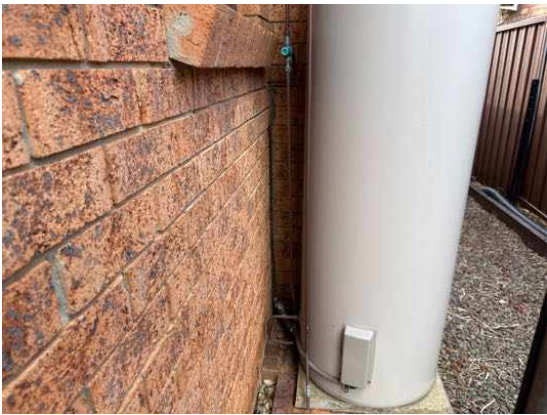
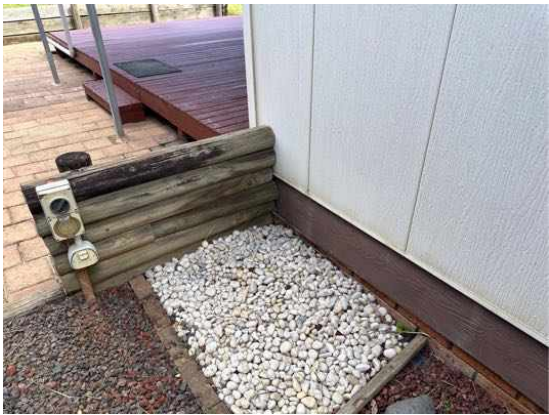
Building: Main Building  
Location: All Areas > All Areas  
Finding: Additional Photos - Obstructions and Limitations  
Information: These photographs are an indication of the obstructions and limitations which impeded full inspection of the property at the time of inspection. These obstructions can hide an array of defects and should be removed to allow full inspection to be carried out. A re-inspection is recommended once the areas are made accessible.

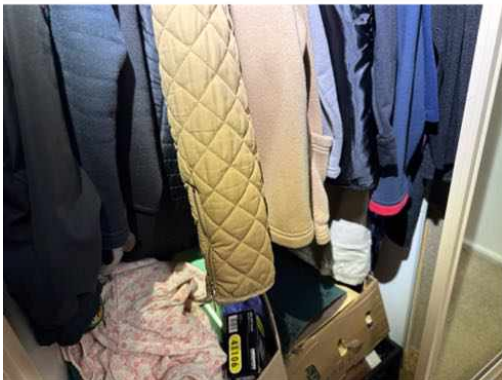
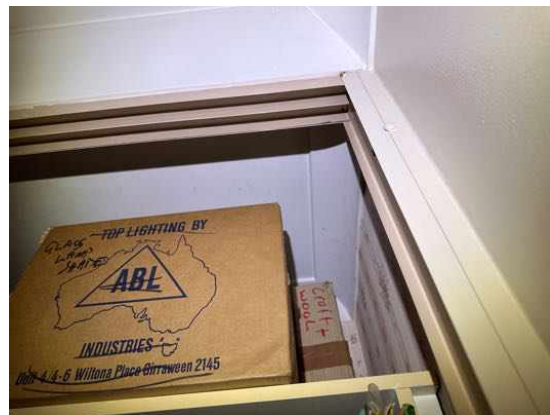
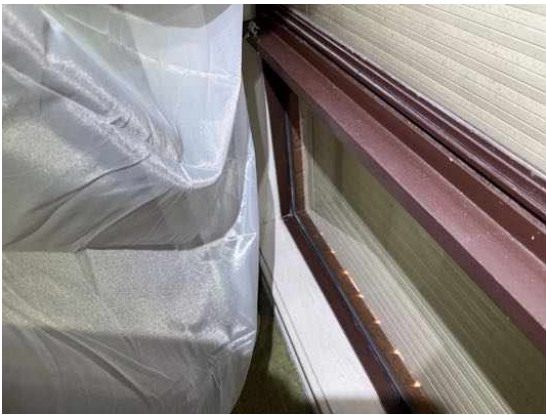
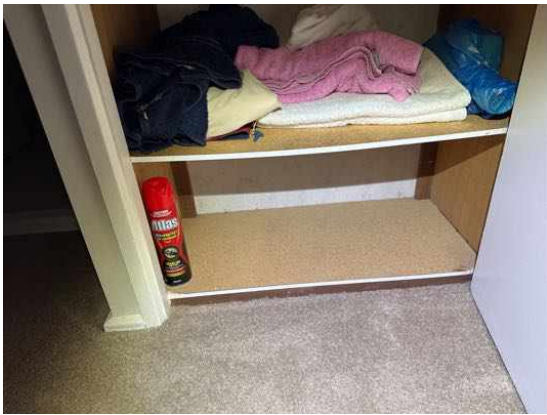
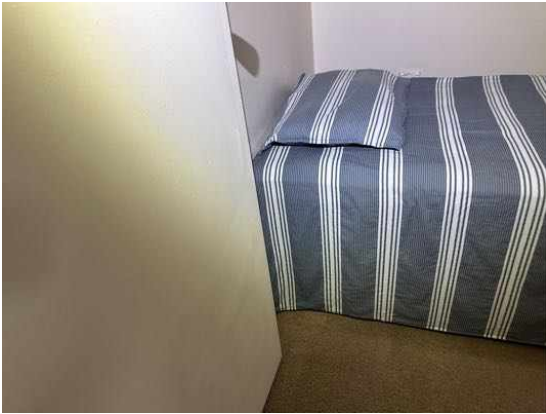
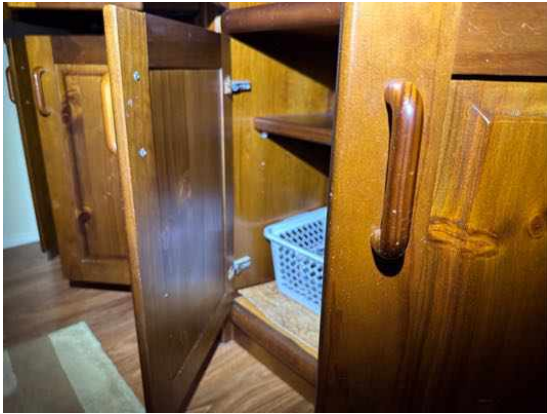
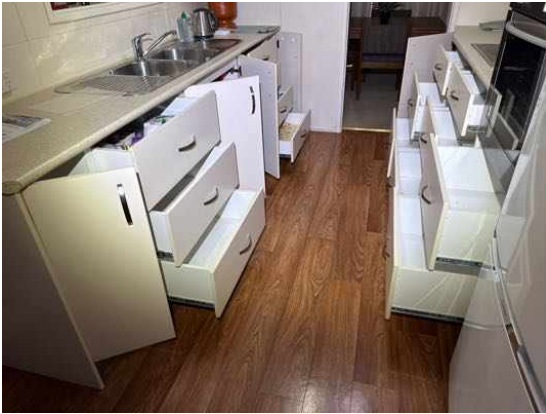
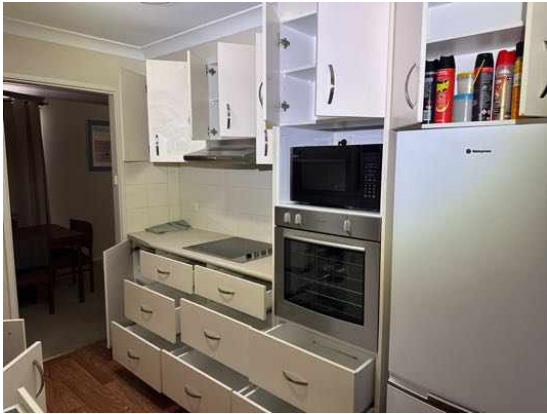
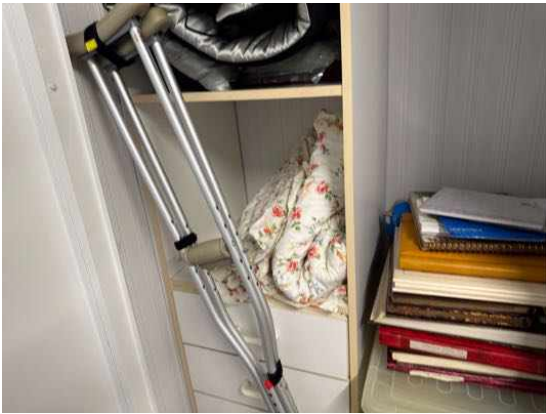
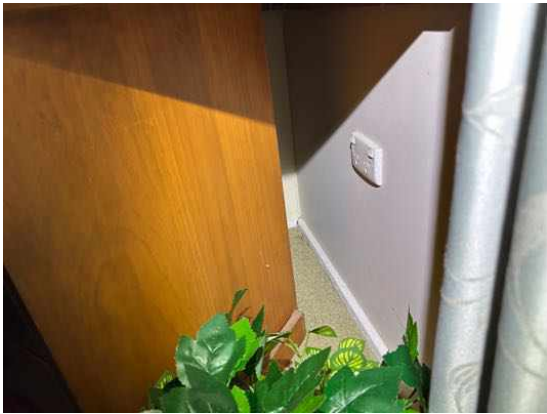
Building:	Main Building
Location:	All Areas > All Areas
Finding:	Additional Photos - Obstructions and Limitations
Information:	These photographs are an indication of the obstructions and limitations which impeded full inspection of the property at the time of inspection. These obstructions can hide an array of defects and should be removed to allow full inspection to be carried out. A re-inspection is recommended once the areas are made accessible.

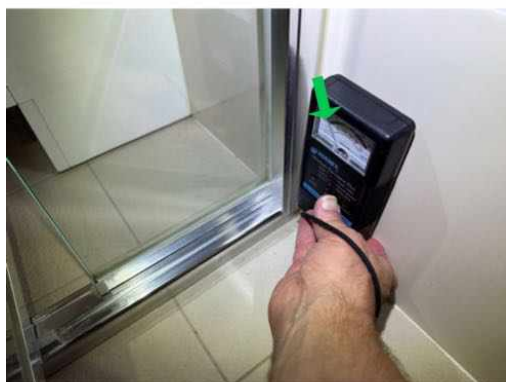
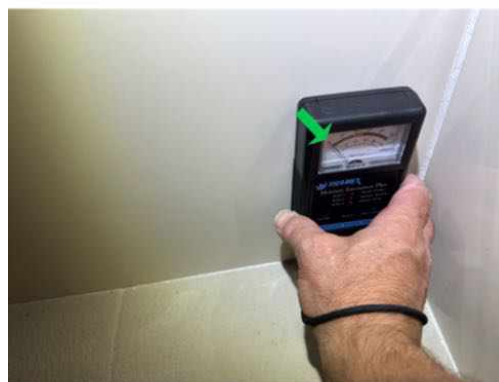
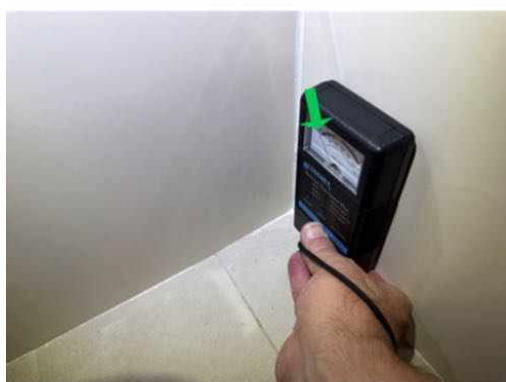
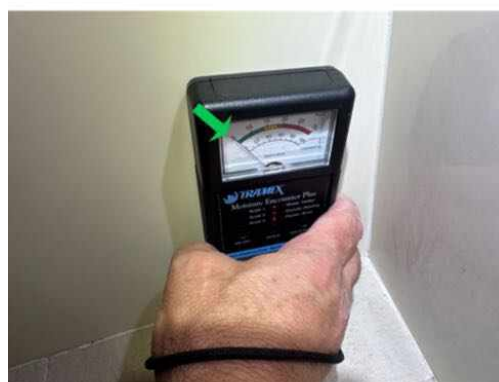
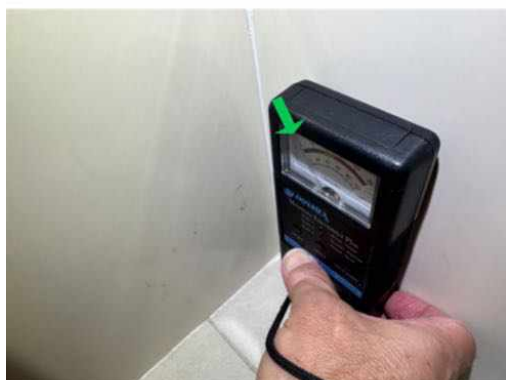
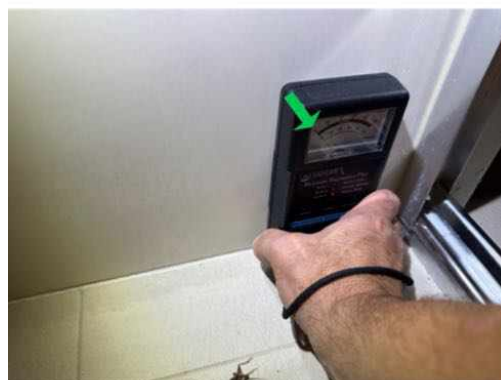
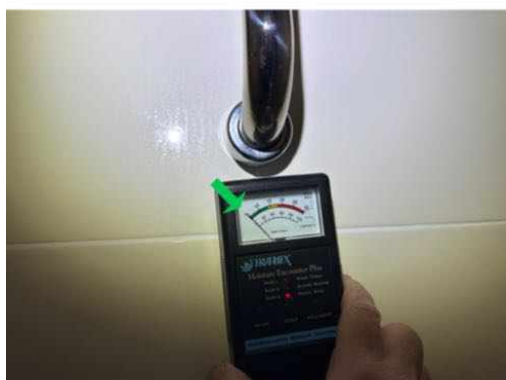
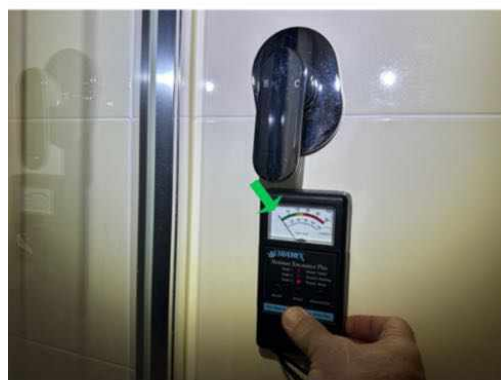
Building: Main Building  
Location: Ensuite - Master > Centre Left  
Finding: Moisture Meter used: No Moisture Detected.  
Information: Moisture meter was used during the inspection and no excessive moisture was detected to accessible walls inside the shower recess at the time of inspection.

The grout and tiles in this area appear to be in good condition at the time of inspection

Monitoring the area is advised and if any visual signs of excessive moisture appear (peeling paint, mould) then consultation with a qualified plumber or bathroom specialist would be advised to identify the cause of damp and to perform remedial works as required.

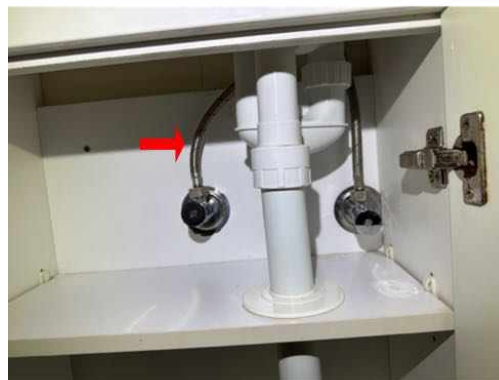
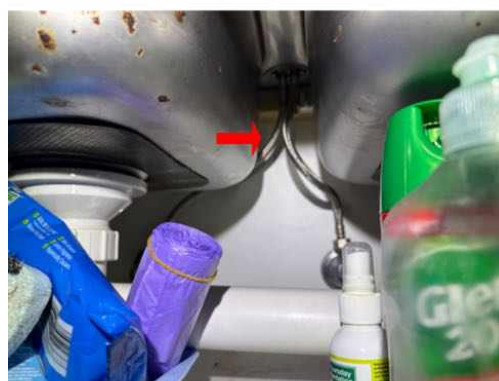
Building: Main Building  
 Location: All Areas > All Areas  
 Finding: Pipe: Flexible Braided pipes.  
 Information: Braided Stainless Steel Flexi connector hose are popular in modern home fit outs because they can be bent into shape. They started to be installed in the early two thousands and their use is now extremely widespread in contemporary construction and renovations.

Flexible braided hoses accounted for more than one in five water damage claims lodged by Australian households according to research released by general insurer IAG.

It is recommended that the Flexi pipes to be replaced at the owners discretion to avoid an “escape water incident” which may lead to water damage to other building elements in the home.

This work can be undertaken by a licensed plumber, general handy person at the owners discretion.

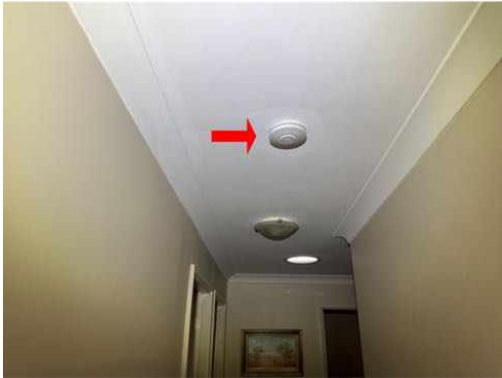
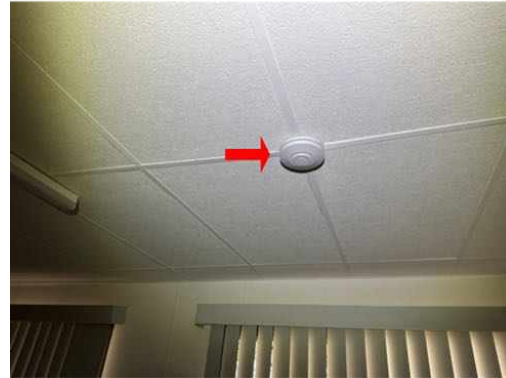
### Noted Item

Please note that this defect is highlighted as a caution only. We suspect, based on our experience in the building industry, that the absence of smoke detectors, or their poor condition, should be addressed as a matter of urgency to improve occupant safety.

Always ensure sufficient working and suitable smoke detectors are installed prior to occupying any building. Additionally, it is advised that all smoke detectors be tested by the homeowner on a monthly basis.

Please refer to AS3786 and state based legislation, which may also apply.

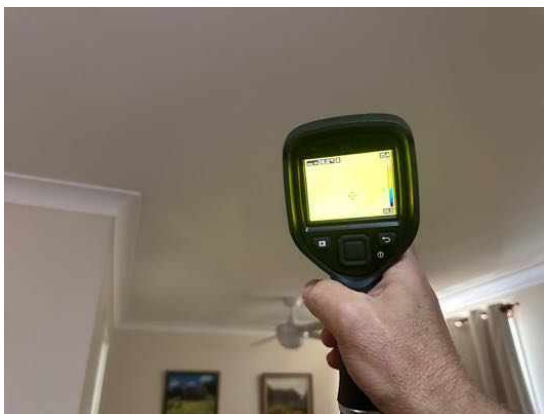
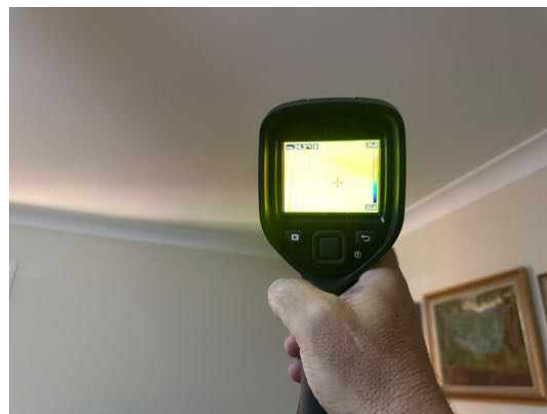
### Noted Item

Building: Main Building  
 Location: All Areas > All Areas  
 Finding: Thermal imaging: No excessive moisture presentation.  
 Information: At the time of inspection there appeared to be no excessive moisture presentation in this area.

NOTE: If the Property has been vacant for a period of time or wet areas not used, moisture levels or leaks may not be detectable at the time of the inspection because often only frequent use of water pipes (showers, taps etc) result in a leak being identifiable. We advise further testing on pipes and water susceptible areas (such as the bathroom and laundry) after more frequent use has occurred.

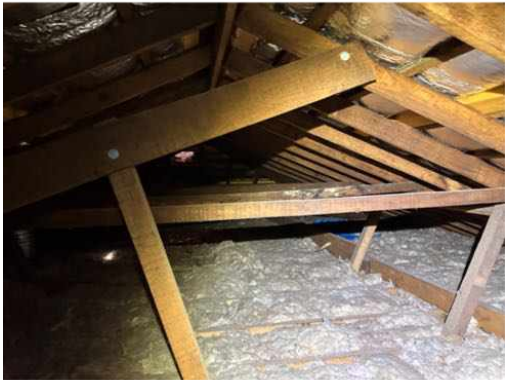
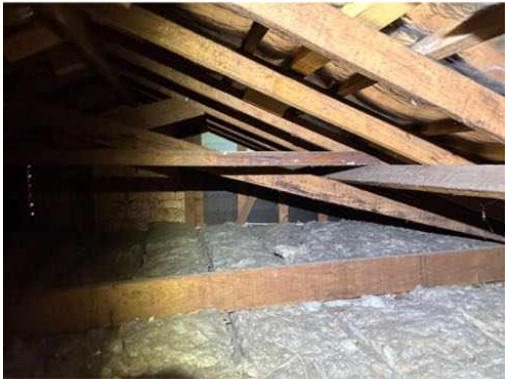
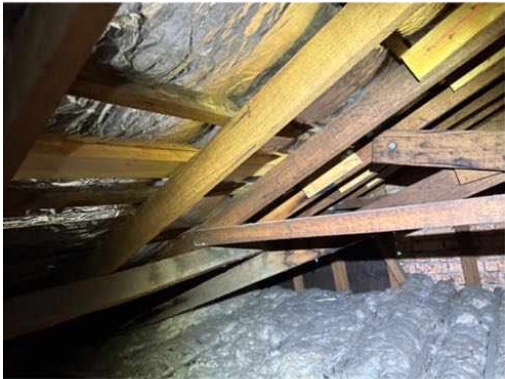
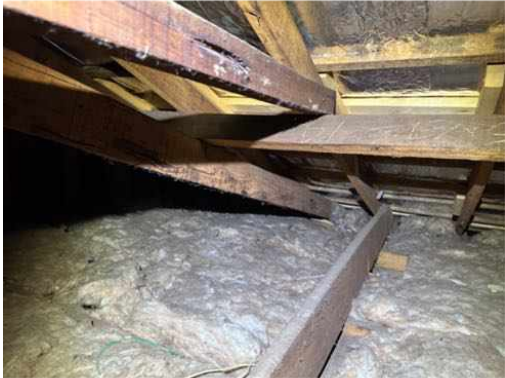
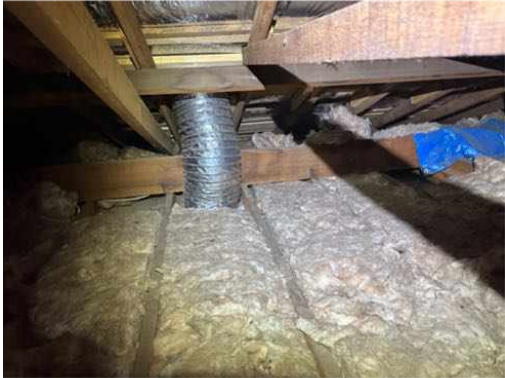
Noted Item

Building: Main Building  
Location: All Areas > All Areas  
Finding: Roof void: limited access.  
Information: Limited access to the roof void was present due to facts including but not limited to access hatch size or placement, insulation, areas of low pitched roof, for this reason inspection to the roof void was minimal and a range of defect's from minor to major may not be visible at the time of inspection.
