Building and Timber Pest Inspection Report

Inspection Date: Fri, 6 Feb 2026

Property Address: 802/187 Kent Street, Sydney NSW 2000

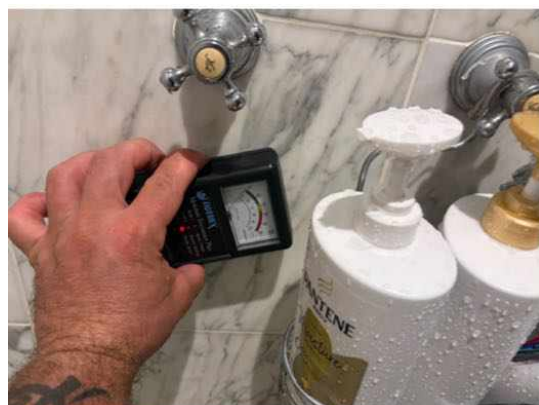
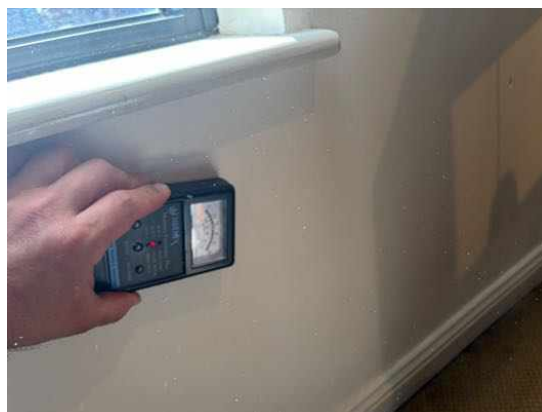
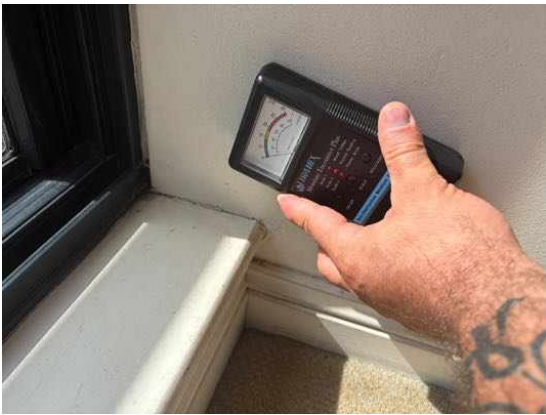
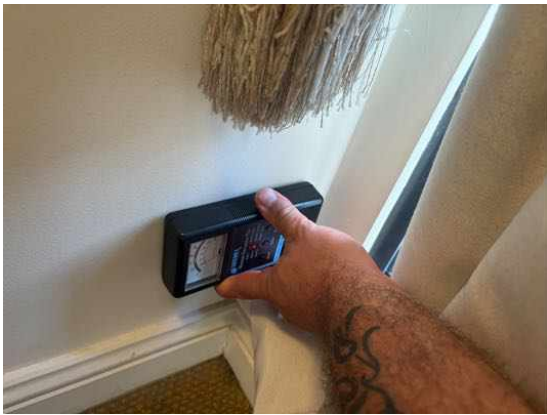
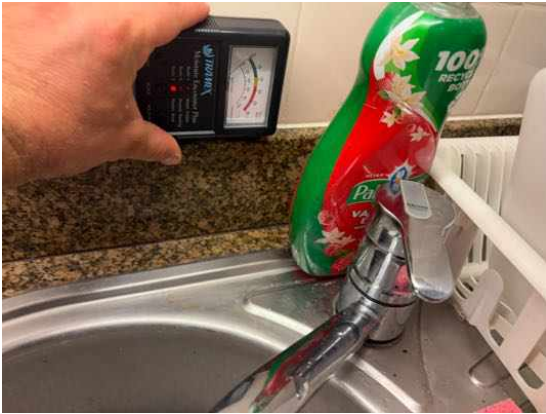
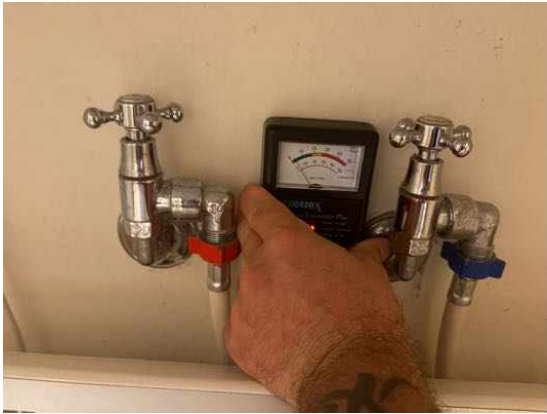
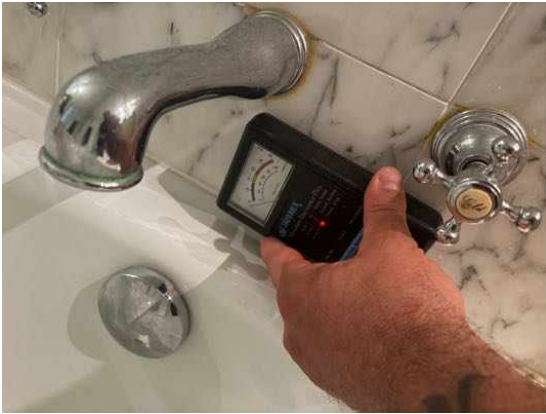
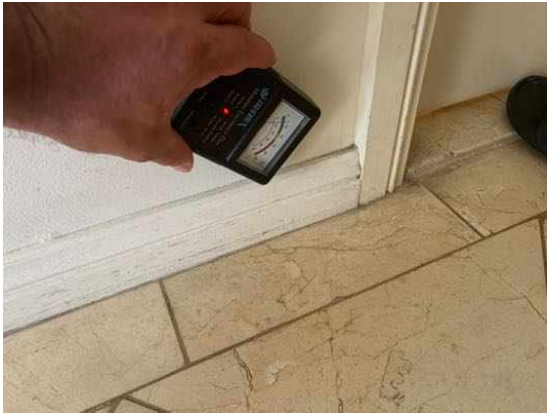
Building: Main Building
 Location: All Areas
 Finding: Moisture metre
 Information: During the inspection the property was checked for moisture using a moisture metre.

This is for information only.

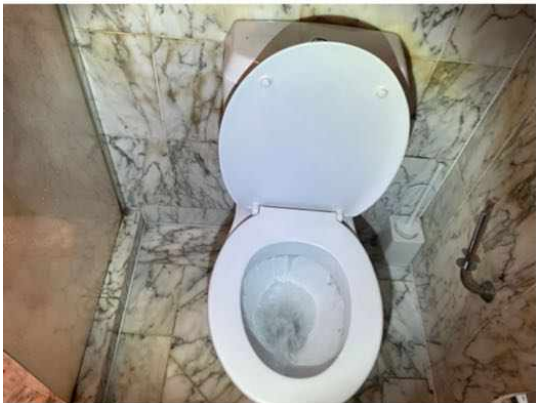
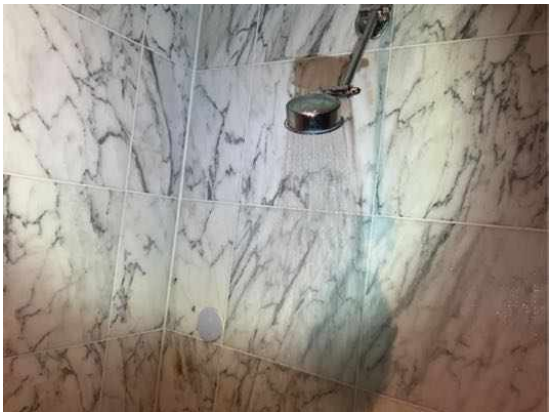
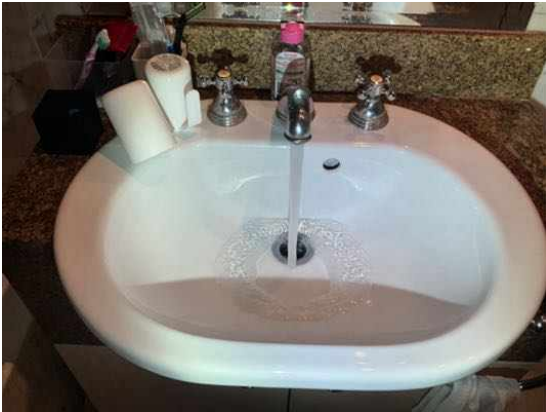
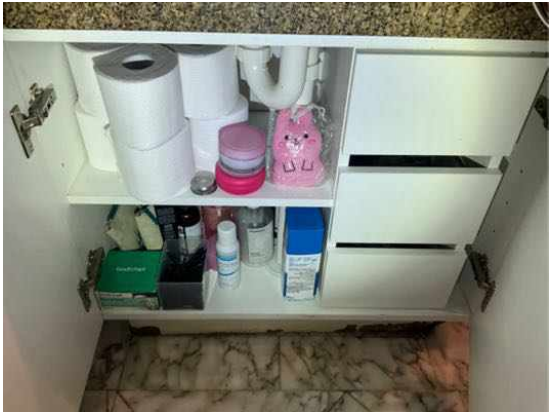
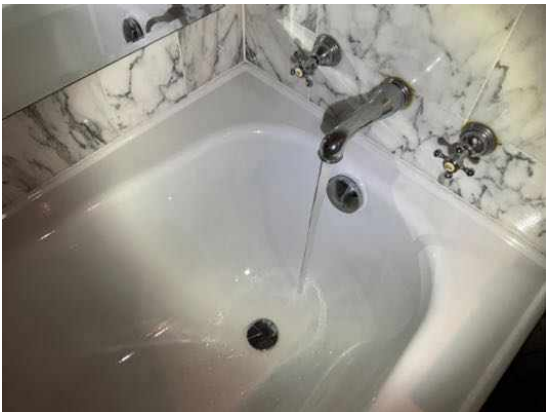
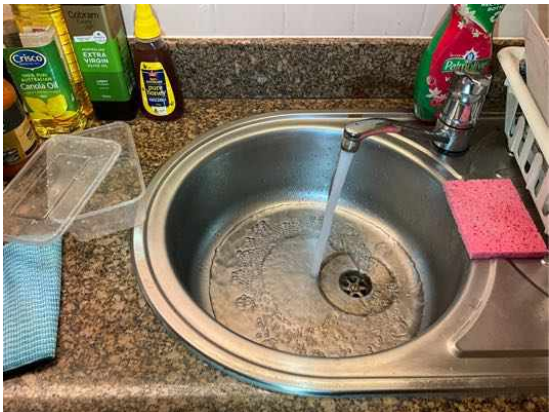
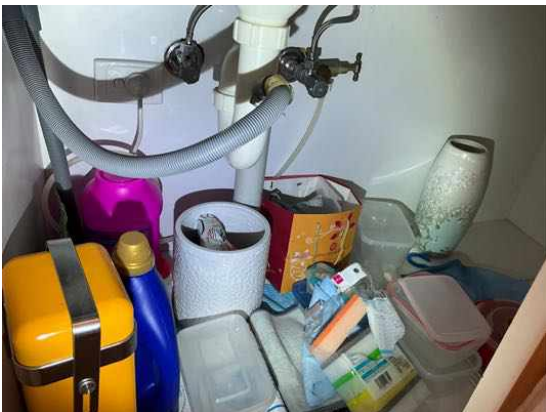
Building: Main Building
Location: All Wet Areas
Finding: Additional Photos
Information:

Additional photos are provided for your general reference.

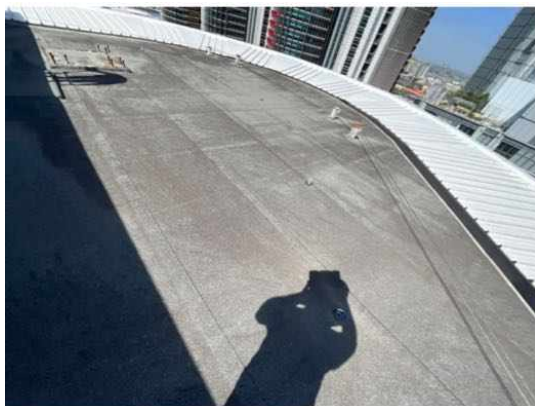
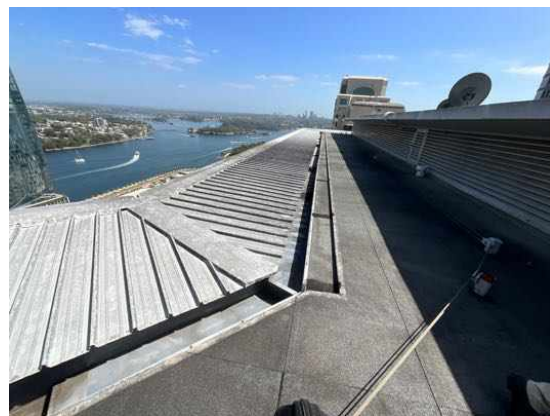
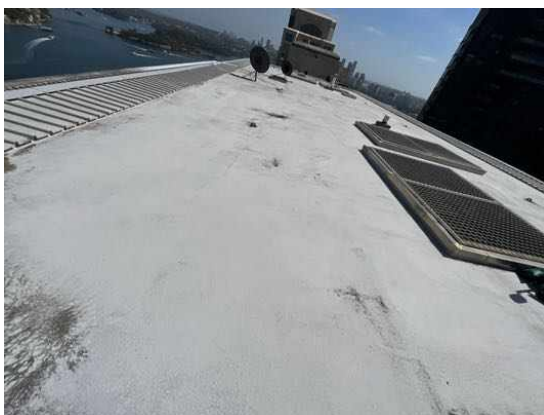
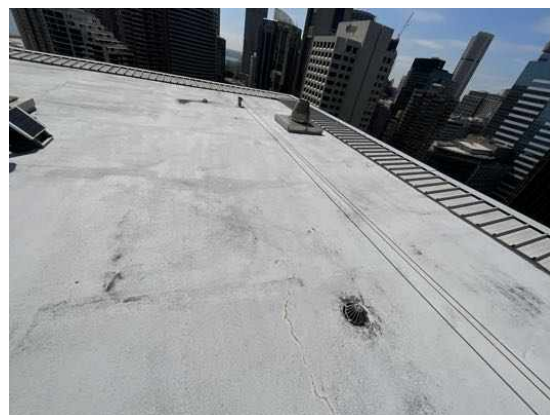
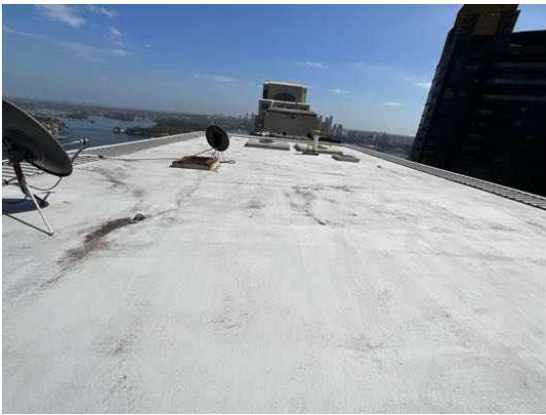
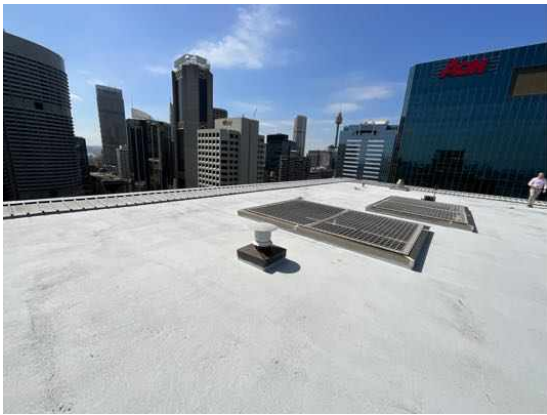
Building: Main Building
 Location: Rooftop
 Finding: Additional Photos- ceiling cavity
 Information: Additional photos are provided for your general reference. Arrows may have been included to highlight areas of importance. Please discuss these photos with your building consultant for clarification.

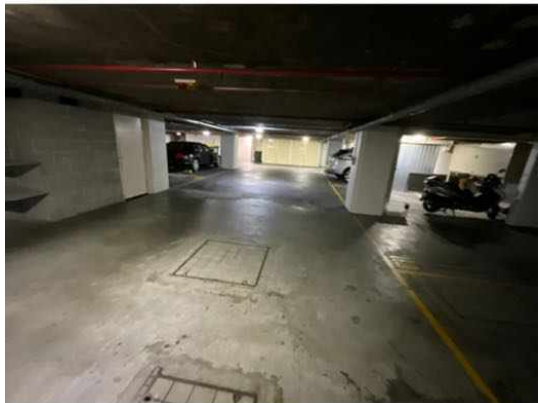
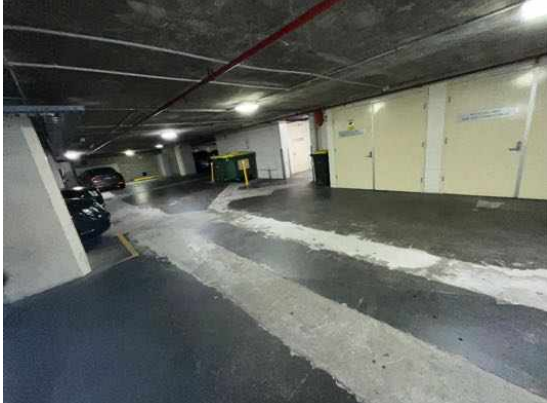
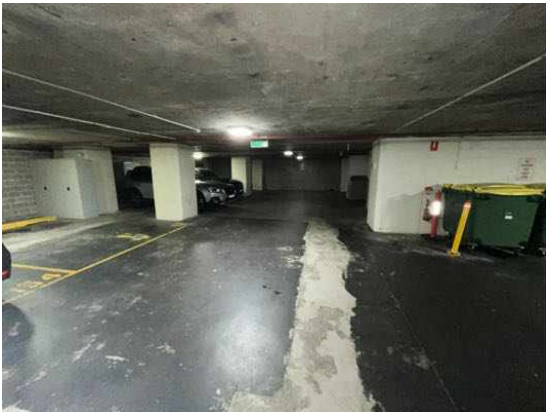
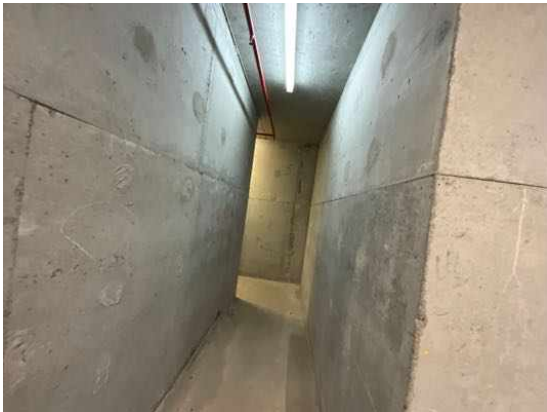
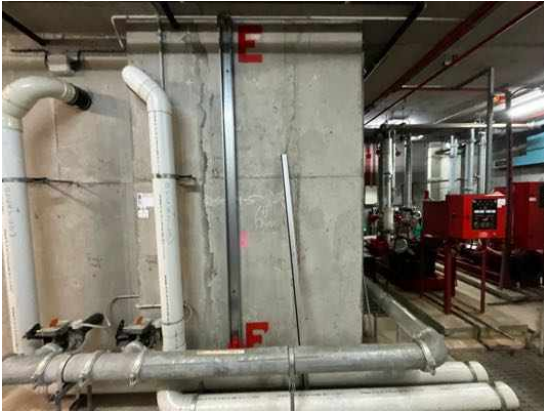
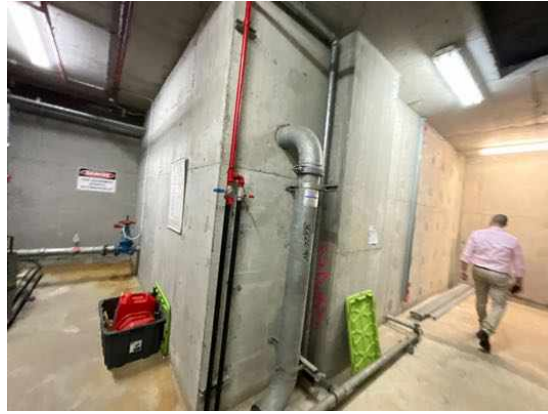
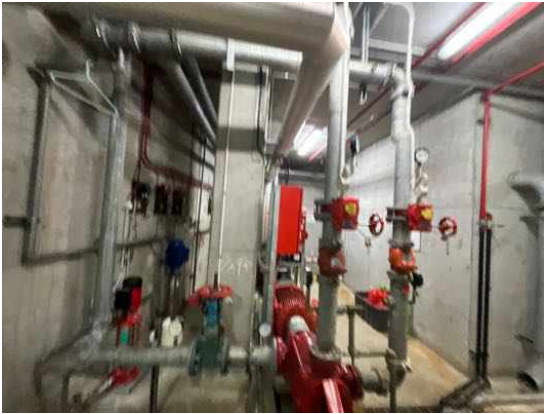
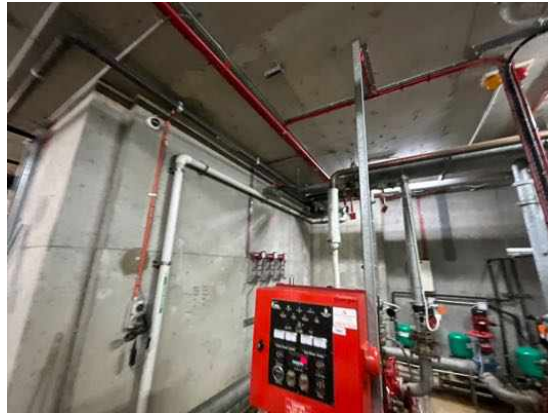
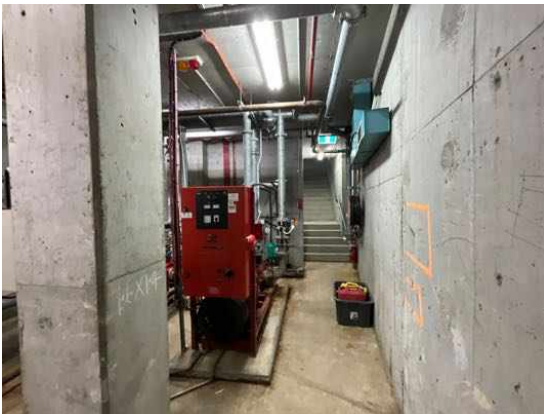
Building: Main Building
Location: Garage
Finding: Additional Photos- Garage
Information: Additional photos are provided for your general reference. Arrows may have been included to highlight areas of importance. Please discuss these photos with your building consultant for clarification.

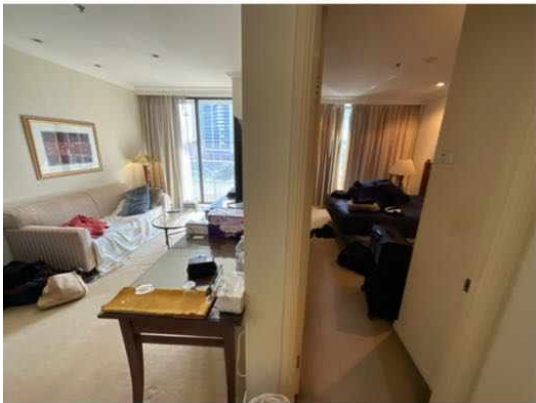
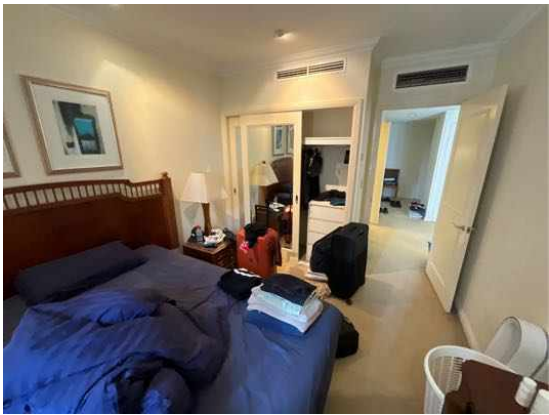
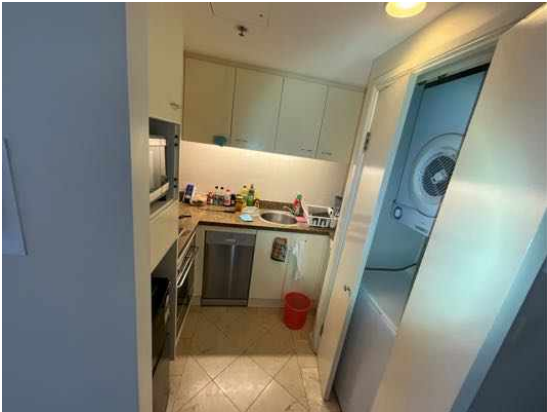
Building: Main Building
 Location: All Areas
 Finding: Additional Photos - Obstructions and Limitations
 Information:

These photographs are an indication of the obstructions and limitations which impeded full inspection of the property at the time of inspection. These obstructions can hide an array of defects and should be removed to allow full inspection to be carried out. A re-inspection is recommended once the areas are made accessible.
