Building Inspection Report

Inspection Date: Tue, 13 Jan 2026

Property Address: 1/2 Waterloo Pl, Richmond VIC 3121,
Australia

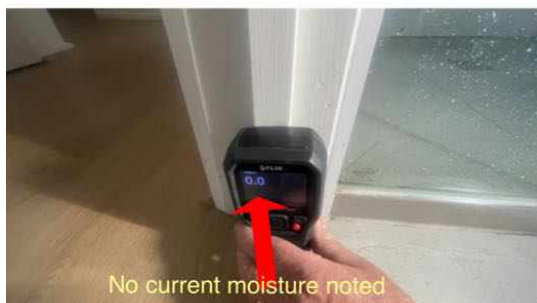
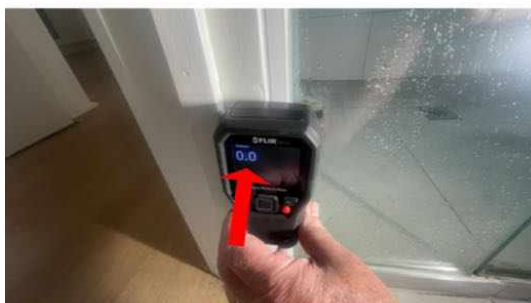
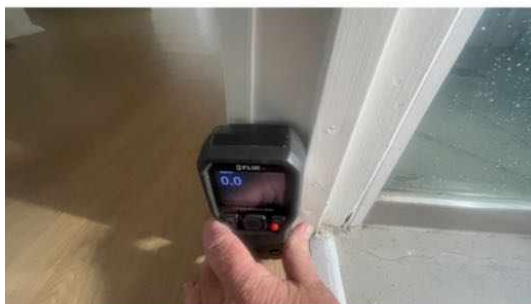
Defects 3.06

Finding: Moisture damage to the door frame in this bathroom.

Information: Evidence of moisture damage was identified to the door frame in this bathroom.

The first step to repair this defect is to re-dash seal around the shower screen . Once this has been completed, a licensed carpenter or competent handyman may be

engaged to inspect the moisture damaged areas and repair or replace any items where necessary.

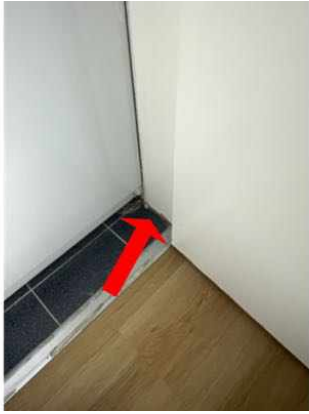
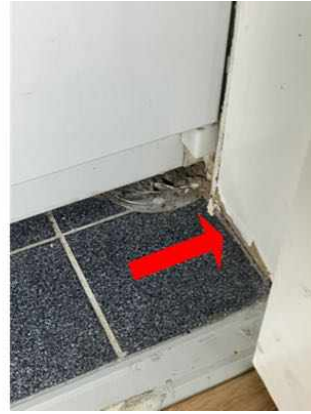
Defects 3.09

At the time of inspection no current moisture was noted when checked with a moisture meter. As a result , no further damage is likely in this area.

A licenced carpenter or competent handyman should be engaged to inspect the moisture damaged areas and repair or replace any items where necessary at the discretion of the homeowner.

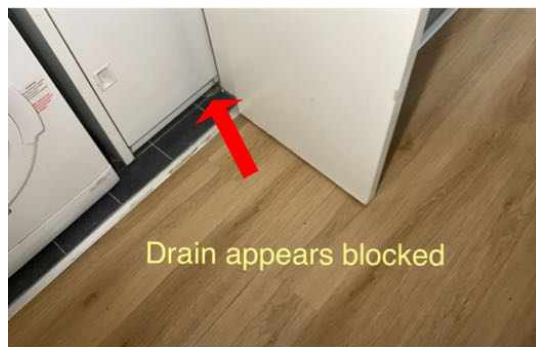
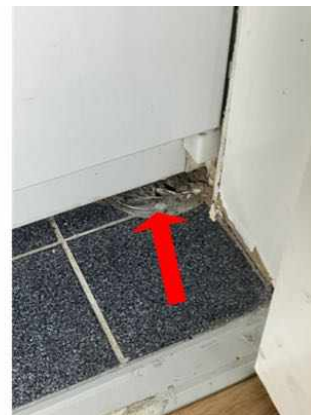
Finding: Additional Photos - for your information

Information: Additional photos are provided for your general reference.

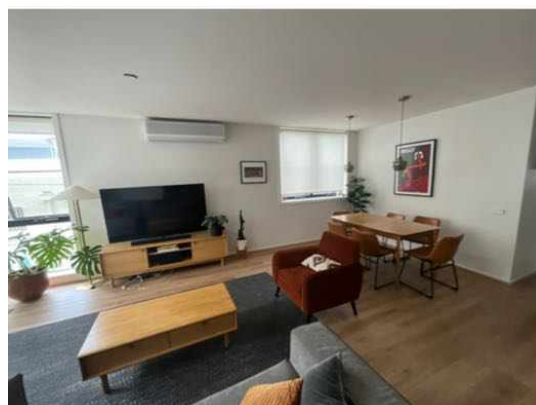
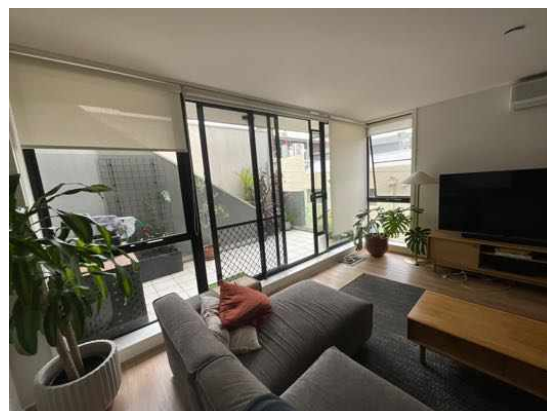
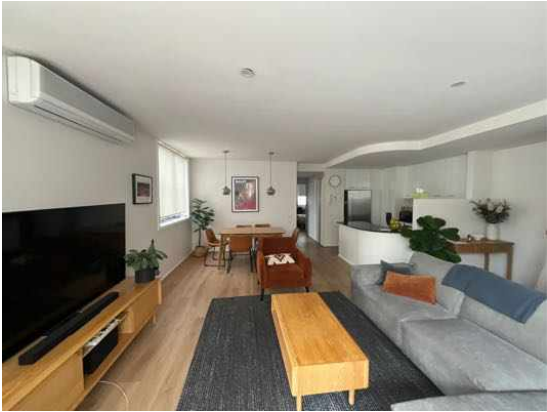
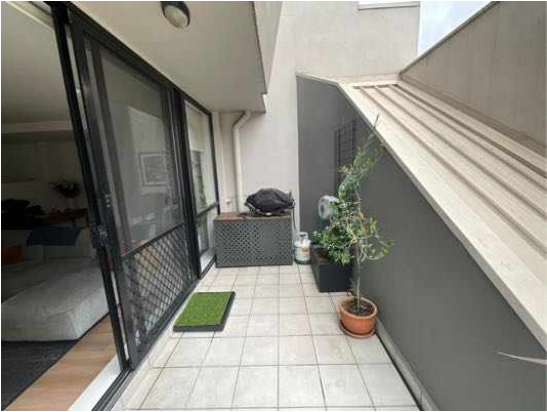
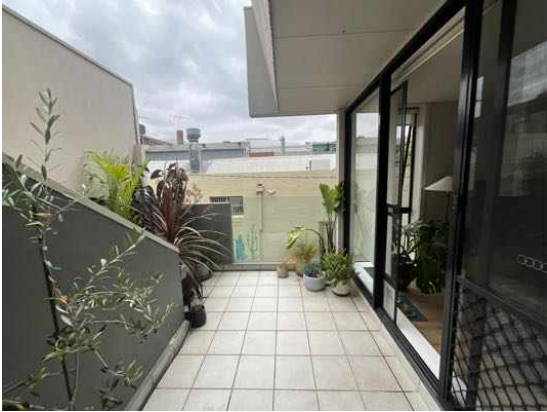
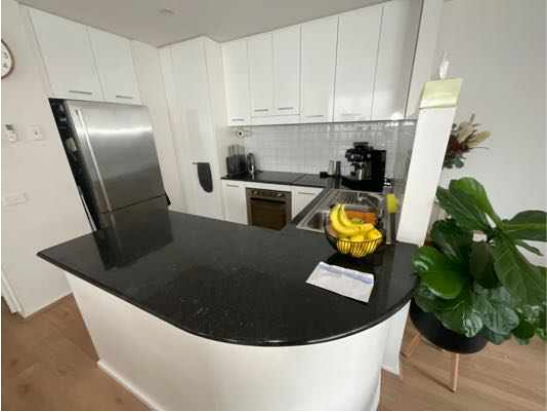
Noted Item

Finding: Additional Photos - Obstructions and Limitations

Information: These photographs are an indication of the obstructions and limitations which impeded full inspection of the property at the time of inspection. These obstructions can hide an array of defects and should be removed to allow full inspection to be carried out. A re-inspection is recommended once the areas are made accessible.
