Building and Timber Pest Inspection Report

Inspection Date: Tue, 24 Mar 2026

Property Address: 138 Donald Dr, Curra QLD 4570, Australia

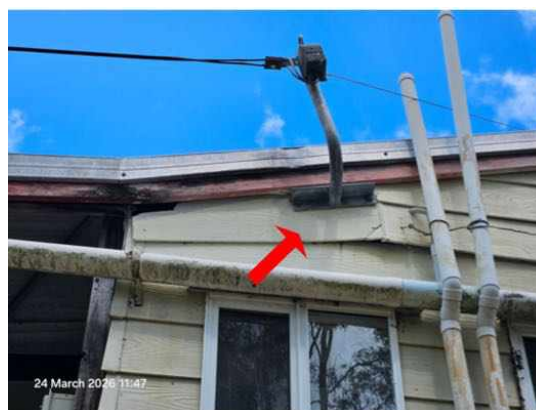
Building: Main Building
 Location: As shown
 Finding: Overhead electrical connection - bracket loose
 Information: During the inspection of the building exterior, it was noted that the steel post / bracket securing the overhead electrical connection appears to be unstable. It will require an assessment by a licensed electrician and a licensed builder. This has the potential to become an electrical safety hazard.

It is advisable to consult an electrician for a best practice solution.

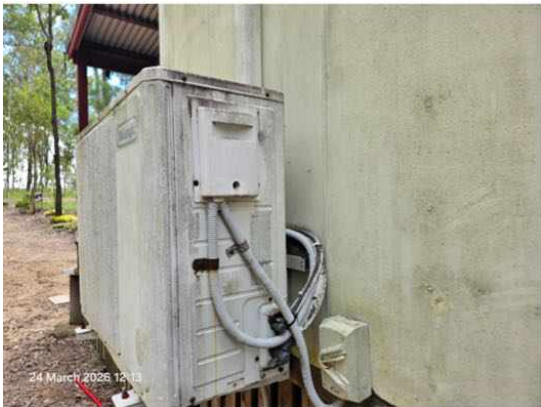
Finding 2.02

Building: Main Building
 Location: Right side
 Finding: Air conditioner - electrical issue, service recommended
 Information: During the inspection, the appliances are turned on to observe functionality. Appliances are not tested for serviceability, this is out of scope for this type of inspection. When the unit was turned on at the wall isolator switch, it tripped the safety switch. A licensed air conditioner technician and a licensed electrician should be engaged to assess the electrical service.

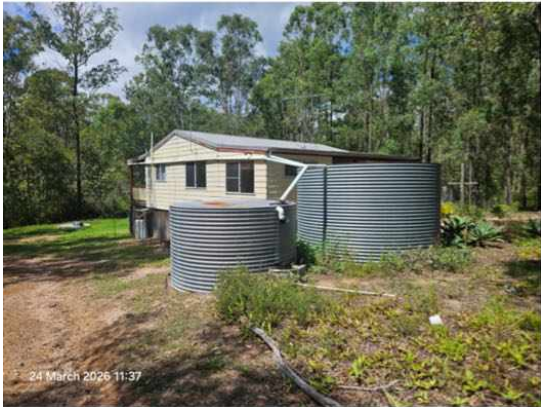
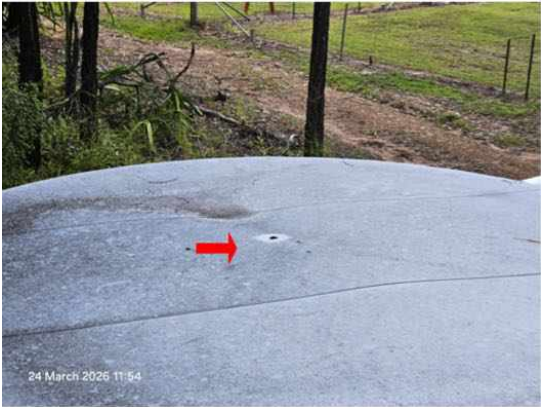
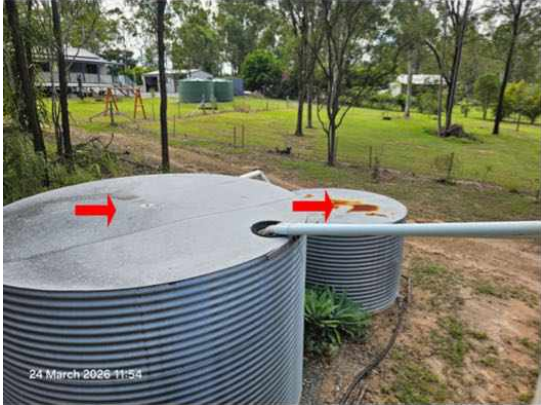
Finding 3.01

Building: Yard
Location: As shown
Finding: Rust - rain water tank
Information: The top surface of the smaller rain water tank is rusted and the larger tank has a hole in the centre of the lid. Maintenance / repair works will be required to prevent rust and debris from settling into the interior of the tank.

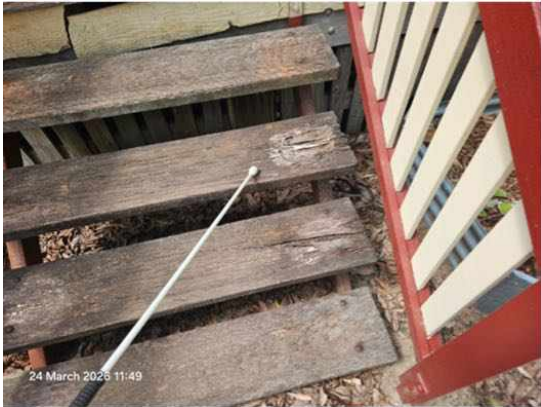
Building:	Main Building
Location:	Deck
Finding:	Decking and steps - deteriorating
Information:	During the inspection it was noted that many of the decking boards and some of the step treads are showing signs of deterioration and early stage wood rot. This will happen over time to timber building elements continually exposed to weather and the elements.

These photos are indicative only and are not an exhaustive depiction of the complete situation.

Over time at the clients discretion, the boards could be replaced as required. This could be done by the client, a licensed carpenter or a general handyman.

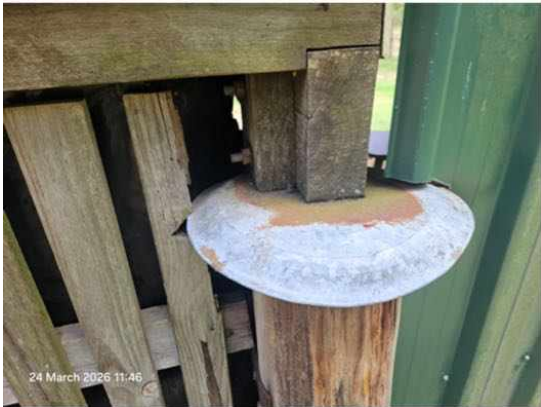
Finding 3.04

Building: Main Building
 Location: All External Areas
 Finding: Ant caps, timber pest barrier
 Information: On the day of inspection it was observed that the ant caps to the timber stumps of the sub floor are rusted. These components are an integral part of the timber pest management system and should be maintained in good order.

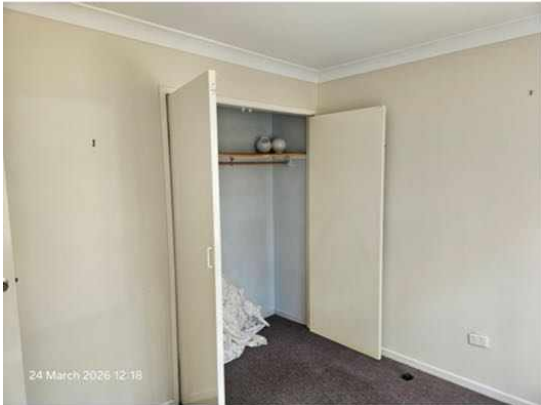
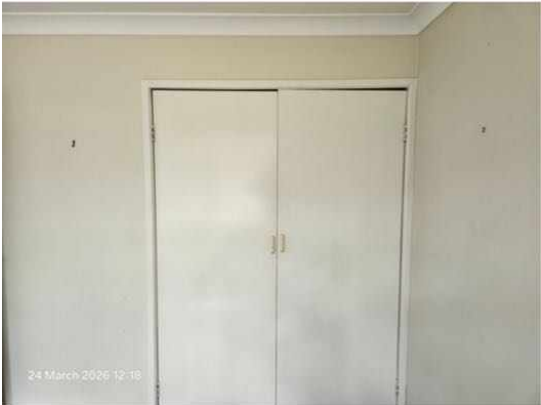
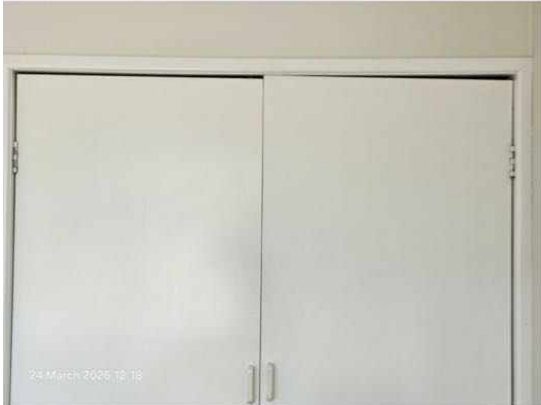
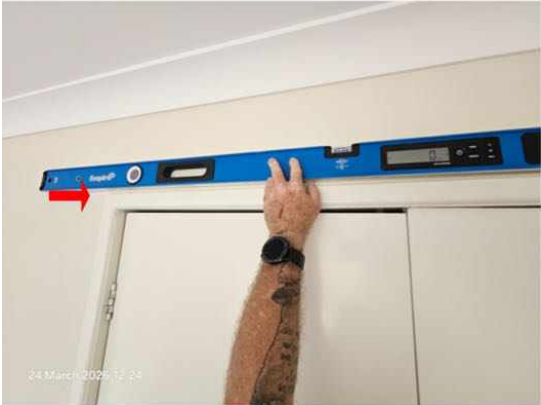
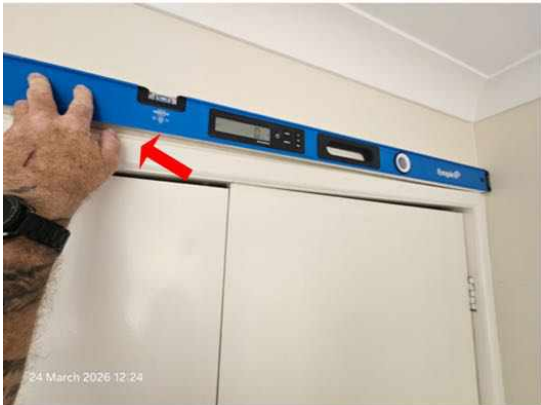
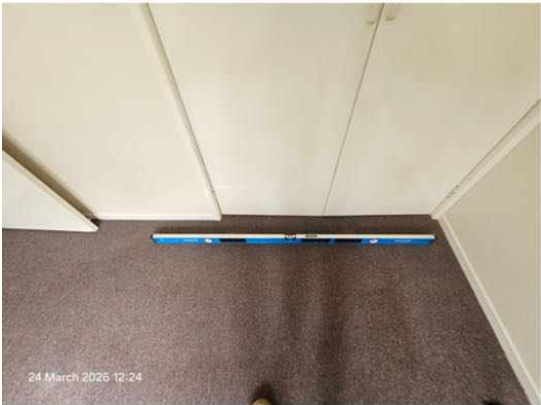
The internal flooring in bedroom 2 is out of level. This is shown in the unevenness of the wardrobe doors and when the level is used, it shows the floor and the wardrobe architrave are out of level by 6mm in a metre toward the hallway. Uneven flooring is likely to indicate minor defects such as expected movement of the foundations of the property, but may also indicate subsidence of the associated subfloor stumps.

It should be noted, this is an information statement of an observation only, in buildings of significant age subfloor can be expected and floor levels can be less than true.

It is advised that the flooring be closely monitored to identify any further movement. Where flooring remains relatively unchanged for an extended period of time (i.e. several months), it is likely that this defect has been caused by expected movement of the foundations of the property.

If no further movement is experienced, a licensed builder could be engaged to Re level the sub floor. It is not considered as anything other than minor at this time.

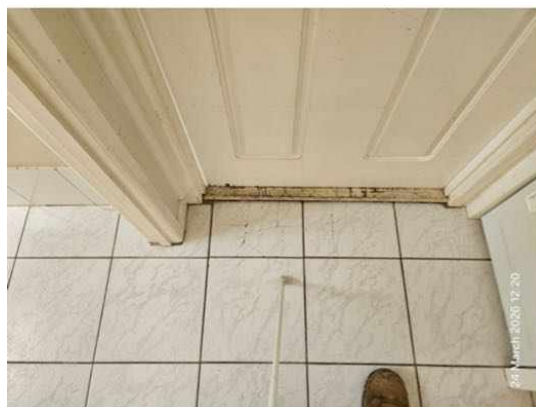
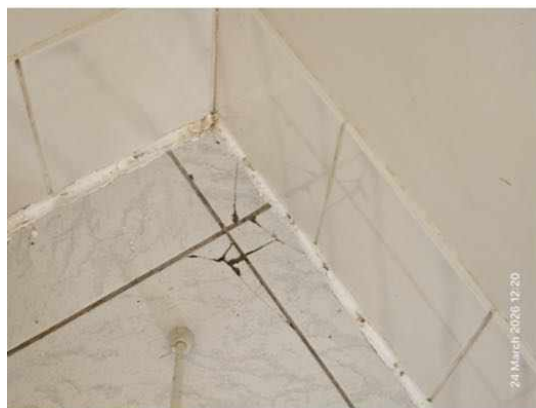
Finding 3.07

Building: Main Building
 Location: Laundry
 Finding: Cracked ceramic tiles
 Information: Cracking in the ceramic tiles of the laundry was evident in this area at the time of inspection.

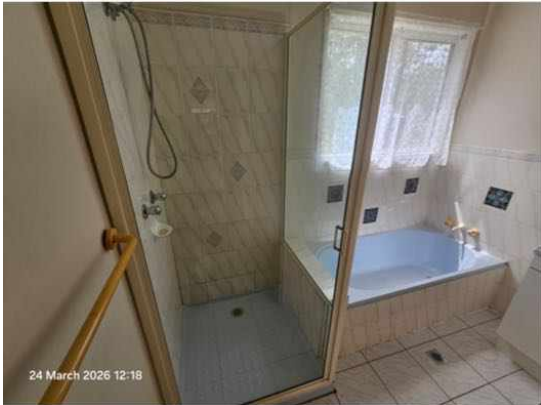
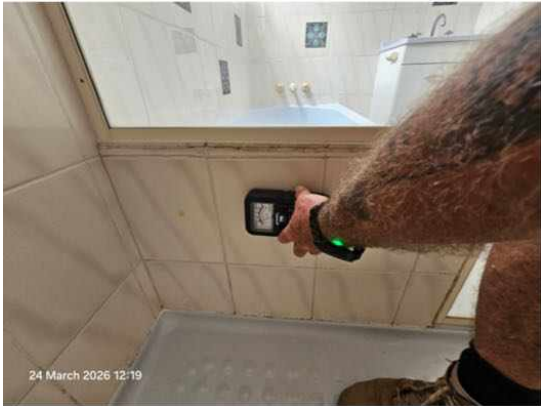
Finding 3.08

Building: Main Building
 Location: Bathroom
 Finding: No moisture detected in bathroom / ensuite
 Information: On the day of inspection the shower in the bathroom was measured for moisture using a "Tramex" moisture meter. During this inspection no moisture was detected in these areas and the tiled / sheeted surfaces appear to be in fair to good order.

The sealants require renewal and at the tap connections, the silicone is deteriorated and a cracked tile was noted above the cold tap.

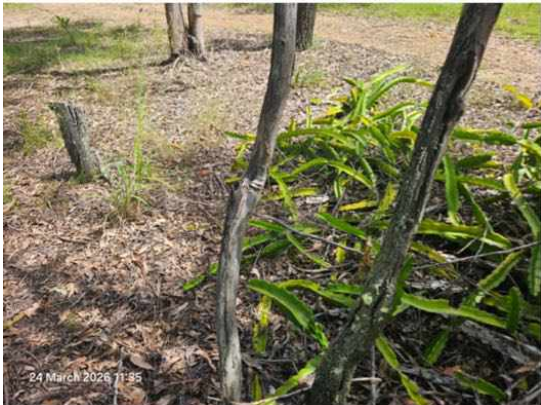
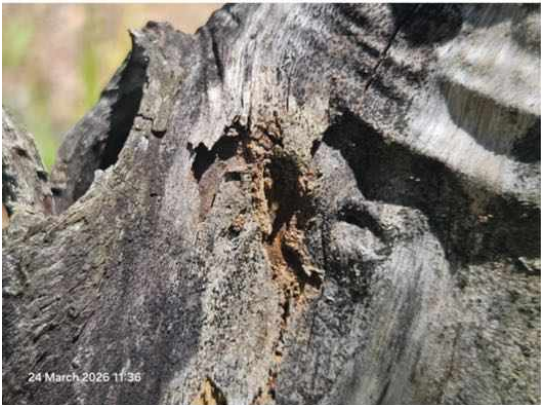
Finding 4.01

Building: Yard
Location: As shown
Finding: Termite damage - active presence
Information: During the inspection of the yard termite activity was observed. As shown in the photographs, active termites are seen in the tree stump.

It is highly recommended that a pest controller be engaged to carry out the required program to eliminate this activity.

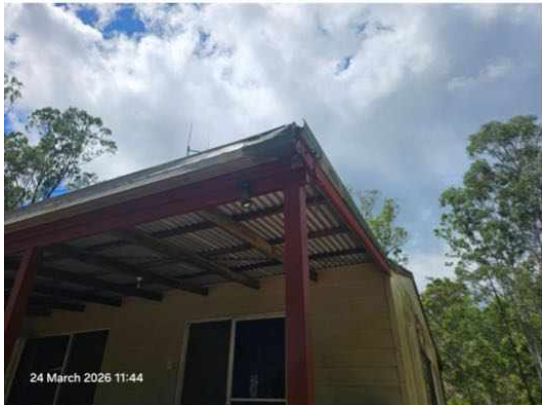
Building:	Main Building
Location:	Fascia's
Finding:	Wood rot / fungal decay
Information:	The timber components show evidence of wood rot beginning in various sections of the timber.

Wood rot, also known as Fungal Decay, occurs when timbers and other cellulose building materials are exposed to damp conditions on an ongoing basis. This could be the result of exposure to weathering over a prolonged period of time, or the attraction of excessive moisture from other abutting building materials.

Early intervention and regular maintenance, particularly of exterior timbers, will prolong the useful life of these building elements. Prior to any works being performed, the cause of the moisture that has created the visible wood rot should be identified and addressed in a suitable manner. Replacement of affected timbers may then be a necessary step in protecting surrounding building elements from such deterioration.

A licensed carpenter or licensed builder should be consulted to advise on a solution for the affected building materials.

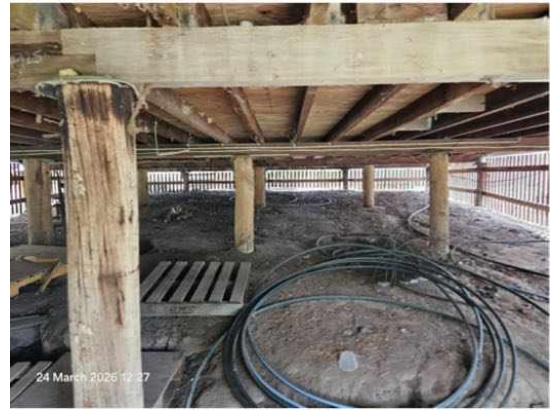
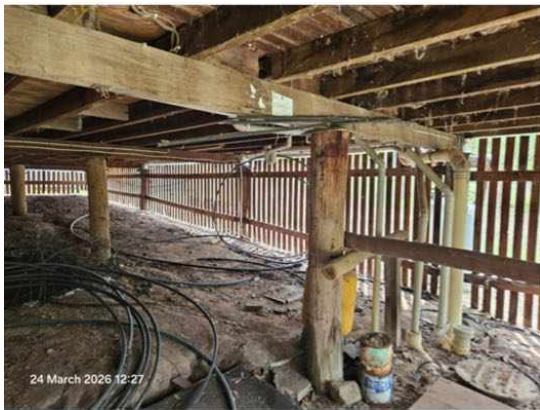
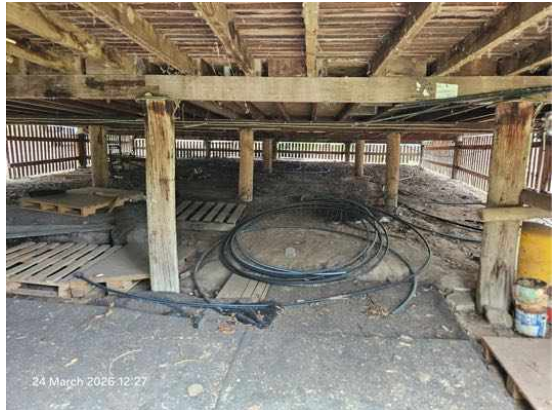
The following items were noted as - Evidence of a previous termite management program

Where a Termite Management System has been identified you should refer to the type of barrier, date of installation, warranty conditions and any documentation provided by a builder or past owner. Consult the company who installed the barrier to confirm whether the system is still under warranty.

In order for a barrier system to be effective, the property must have regular inspections at intervals of not greater than 12 months. Depending on the risk profile attributed to the property, these inspections may be recommended at lesser time periods.
