Building and Timber Pest Inspection Report

Inspection Date: Mon, 16 Mar 2026

Property Address: 17 Bandicoot Dr, Woodcroft NSW 2767,
Australia

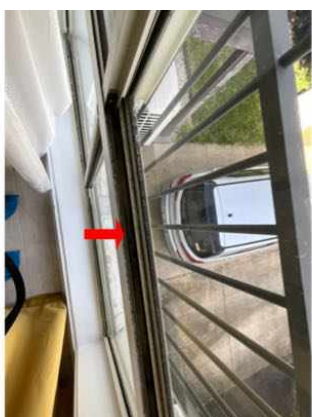
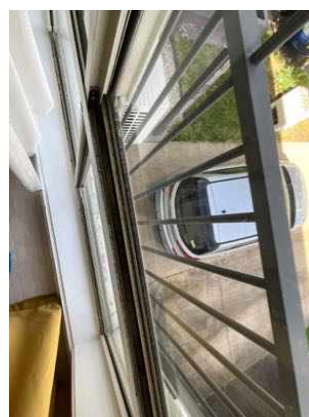
Finding 1.01

Building:	Main Building
Location:	All Areas
Finding:	Window child lock missing
Information:	The window in question lacks a child lock mechanism, which poses a potential safety risk to young occupants in the premises. As per Australian Standards windows accessible to children should be equipped with appropriate child safety locks to prevent accidental opening, reducing the risk of falls and ensuring compliance with safety regulations.

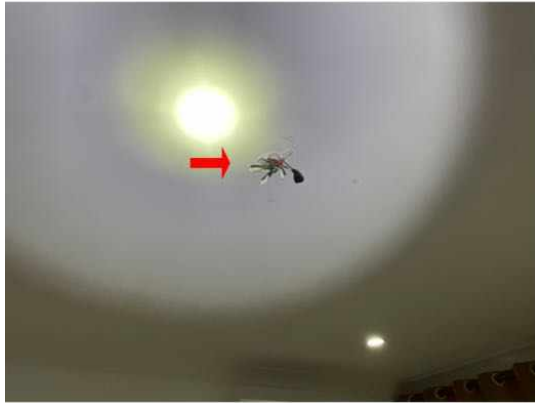
Finding 1.02

Building:	Main Building
Location:	Bedroom - Master
Finding:	Poor workmanship
Information:	The structure exhibits signs of poor workmanship, evident in various aspects of construction and finishing.

Risk: Poor workmanship poses a range of risks, including compromised structural integrity, potential safety hazards, and a decreased lifespan of the structure. It may also lead to aesthetic and functional issues.

Resolution: A qualified contractor or construction professional should be consulted to assess and address the poor workmanship. They can implement corrective measures to ensure structural soundness, safety, and overall quality of the construction.

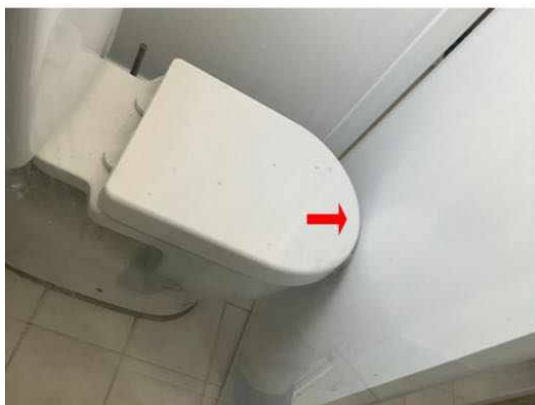
Finding 1.03

Information: A safety hazard was identified in the bathroom of the property. The issue pertains to the door, which, when fully opened, makes contact with the adjacent toilet. This situation poses an immediate risk to the safety and well-being of occupants due to the potential for accidents and injuries.

Collision between the door and the toilet can cause injury to individuals using the bathroom.

The repeated contact between the door and the toilet can also result in damage to both fixtures, leading to costly repairs or replacements.

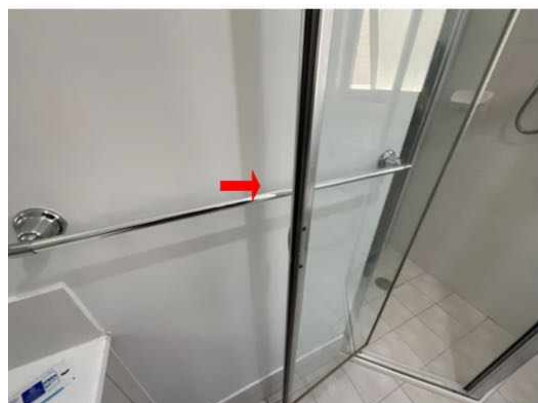
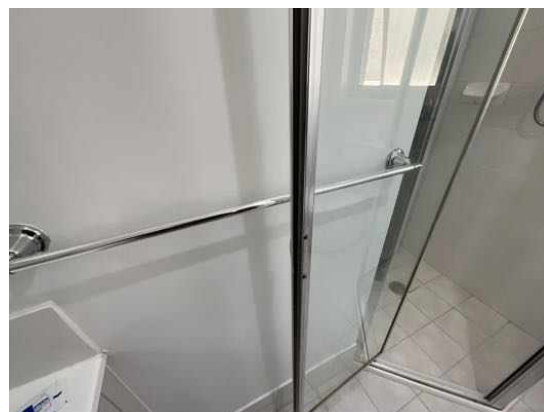
Finding 1.04

Building: Main Building
 Location: Ensuite
 Finding: shower screen door hitting fixed towel rail/bar
 Information: The shower screen door was found to make contact with the fixed towel rail/bar upon opening. This indicates poor placement or alignment of fittings.

This condition is considered a potential safety hazard. Ongoing impact may lead to loosening of fittings or damage to the shower glass, which carries a risk of glass breakage and injury to occupants.

It is recommended that a licensed glazier or bathroom renovator further evaluate and rectify this issue. Adjustment of the shower screen door alignment or relocation of the towel rail is required to prevent contact and ensure safe operation.

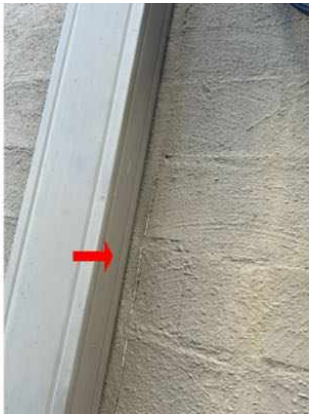
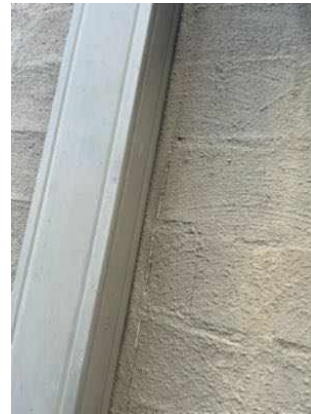
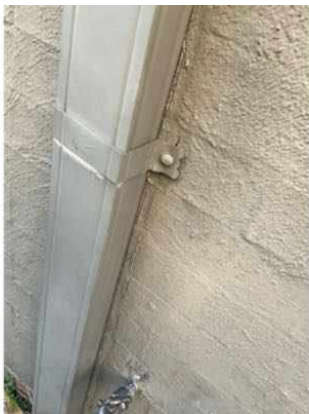
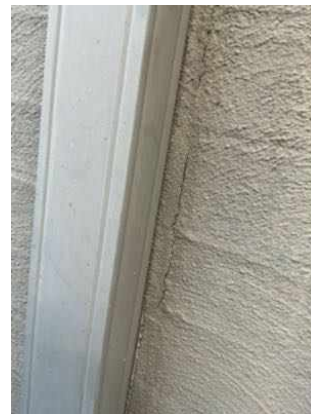
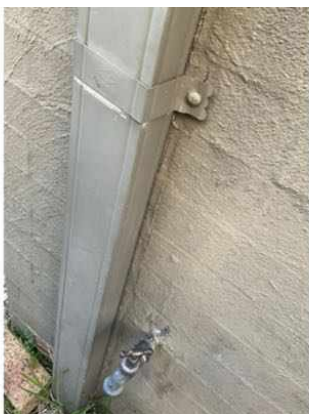
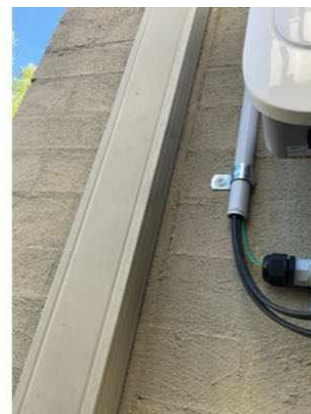
Building: Main Building
 Location: All Areas
 Finding: Brickwork - Cracking [Fine]
 Information: Although fine cracks are quite noticeable, they are often only considered to be an appearance defect and usually do not indicate any structural damage. Generally, the

cause of a fine crack is indicative of a separation between brickwork and mortar throughout the structure, but single bricks may also show cracks of this nature.

Cracking of this nature can generally be repaired with minor filling and should be conducted by a qualified bricklayer.

Always contact a building inspector should cracks widen lengthen or become more numerous.

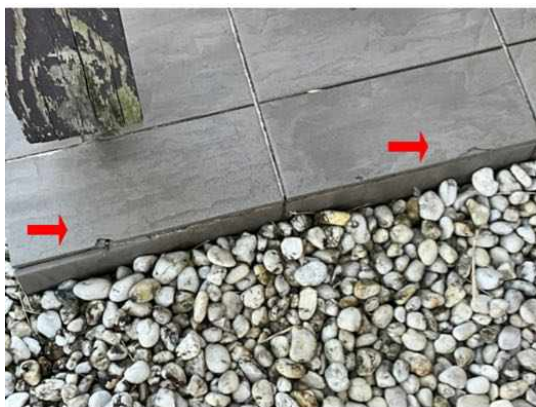
Finding 3.02

Building: Main Building
 Location: Front porch
 Finding: Tile - Floor Tile Damaged
 Information: A floor tile is visibly damaged, showing a chipped/broken section on the surface.

The damaged tile presents a trip hazard, may lead to cuts if stepped on barefoot, and can allow moisture ingress into the substrate, which may cause further deterioration or loosening of adjacent tiles. It also affects the overall appearance of the floor.

A licensed tiler should be engaged to remove the damaged tile and install a matching replacement. If spare tiles are unavailable, additional remedial work may be required to blend the repair with surrounding finishes.

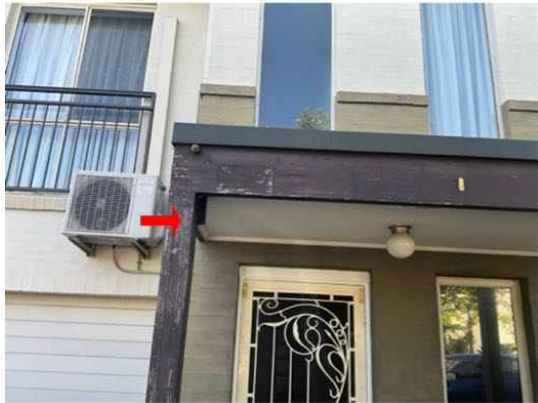
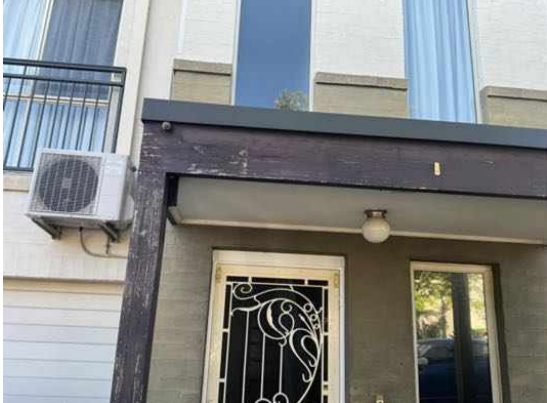
Finding 3.03

Building: Main Building
 Location: Front porch
 Finding: Timber - exposed to weather

External timbers that are frequently exposed to harsh weather conditions require adequate protection in order to maintain their condition. Where timbers have not been painted or treated adequately, general deterioration is likely to occur at an accelerated rate.

If left unattended, replacement of these timbers is likely to be necessary in the short-term future. Adequate treatment of these timbers is required as soon as possible by a painting contractor or general handyman.

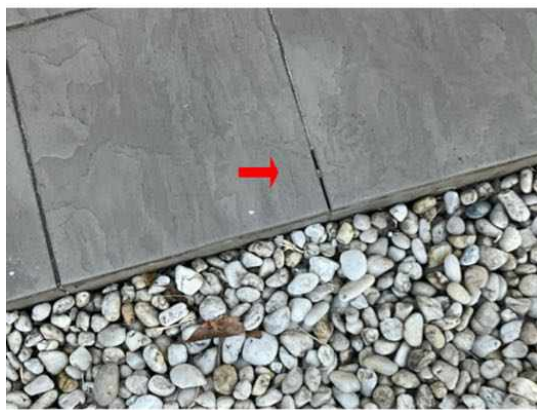
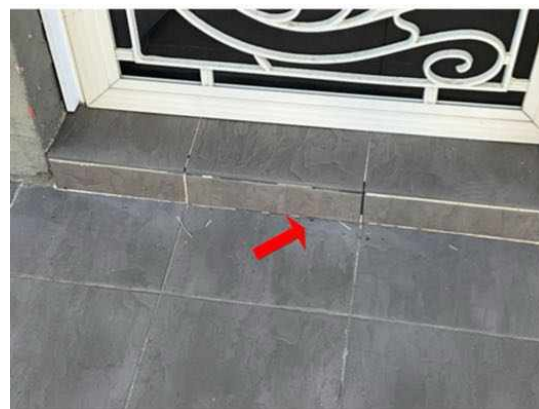
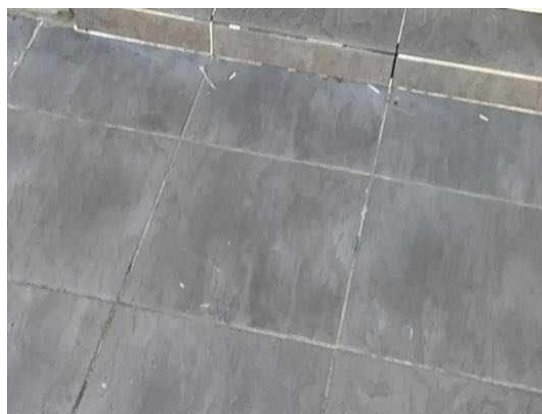
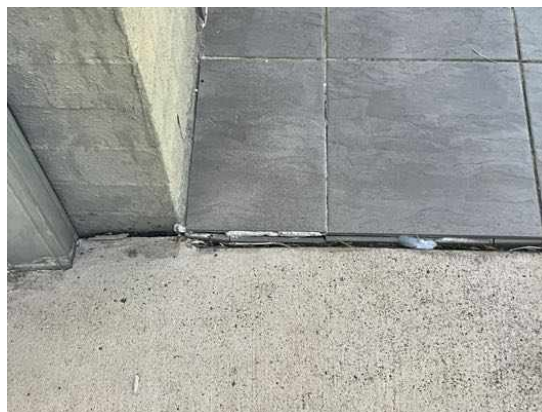
Finding 3.04

Location: Front porch
Finding: Grouting - Missing or damaged
Information: It was noted on inspection that sealant or grout is Missing or damaged. A flexible sealant is required to allow for expected expansion and contraction, while keeping the joint water tight and protective of all associated building materials.

Flexible and mould resistant materials should be applied to affected areas to prevent any subsequent water damage that is likely to occur. Regular maintenance and replacement of damage or missing or damaged sealant and grout is highly recommended , as this is a regular wear and tear defect.

A sealant specialist or tiling contractor should be appointed to complete these works as soon as possible

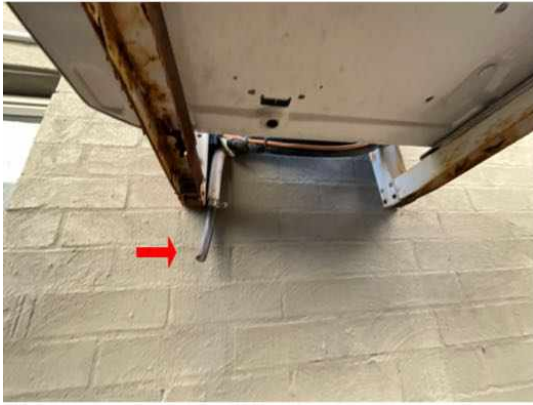
Building:	Main Building
Location:	Exterior walls - right side
Finding:	Air conditioner - Disconnected overflow
Information:	The Air Conditioner (A/C) overflow was found to be disconnected from storm water drainage and is creating excessive moisture in the surrounding area.

Such leaking creates an environment which is conducive to an array of defects, including water damage to associated building elements and the attraction of termite or timber pest infestation.

It is highly recommended that a licensed plumber be appointed to connect the A/C overflow in order to prevent such an environment from being created. These minor works should be carried out as soon as possible.

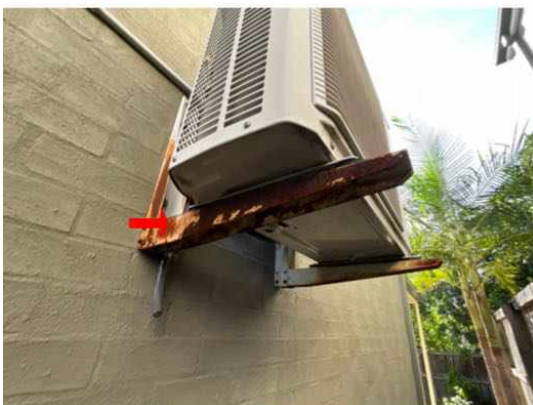
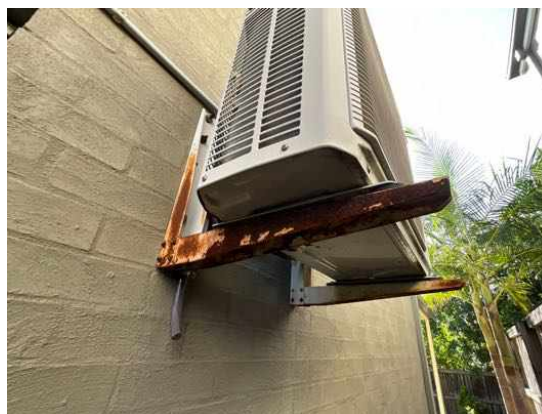
Finding 3.07

Building:	Main Building
Location:	Exterior walls - right side
Finding:	Building element - Rusted or corroded
Information:	This building element shows evidence of rusting and corrosion, which is likely to have developed as a result of excessive exposure to moisture and or inadequate coatings.

As surface rust provides no protection to the underlying iron, the deteriorating condition is likely to worsen if not addressed in the short-term future.

Where possible, the use of galvanized (treated) metals or aluminium coated metals aid in rust prevention, as does regular general maintenance. Rust formation can be controlled with coatings, such as paint, that isolate the iron from the environment.

Rusting and corrosion should be managed by ideally removing or limiting the affected surface from exposure to moisture. A registered builder may be appointed to replace any building elements that have been severely affected by rust or water damage.

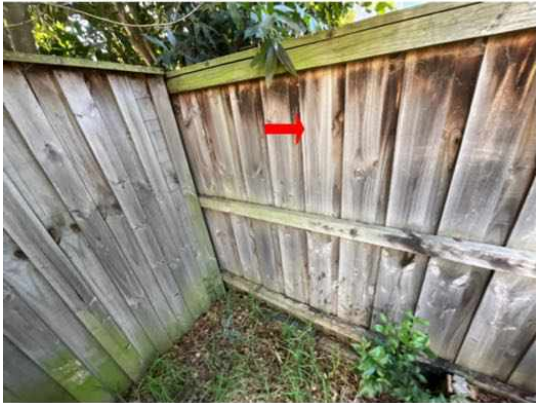
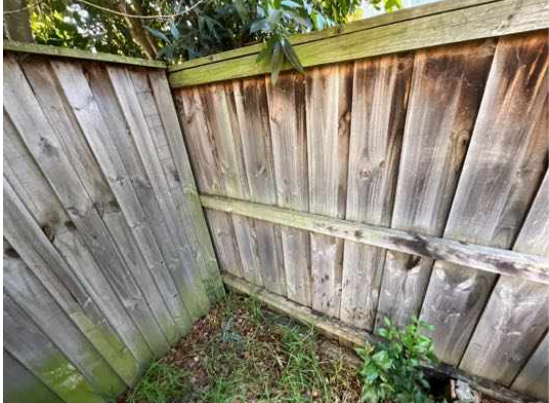
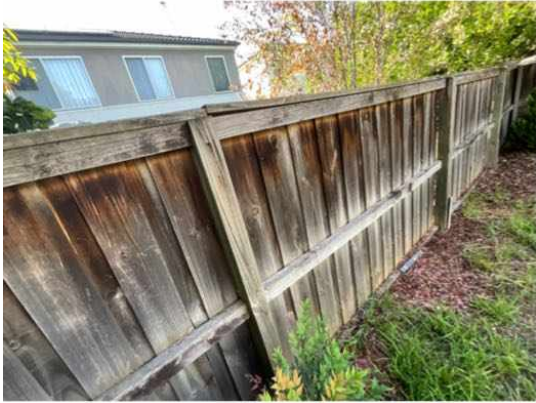
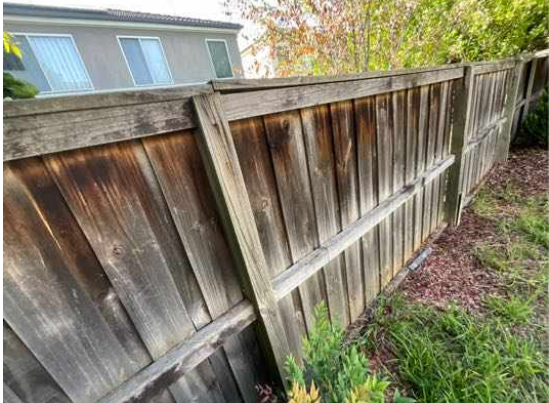
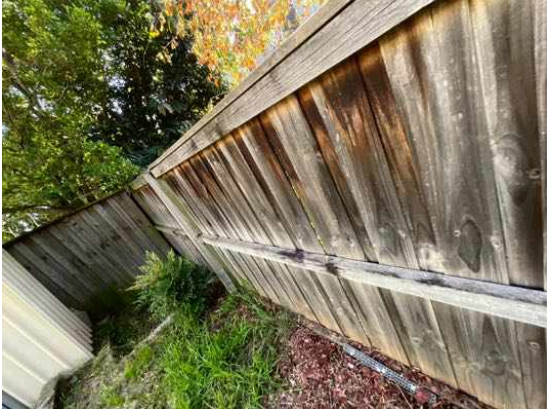
Finding 3.08

Building:	Main Building
Location:	All Areas
Finding:	Deteriorated fence
Information:	The fence along the property boundary has deteriorated significantly, showing signs of rot, rust, and structural weakness. Several sections are leaning or have become detached, compromising the integrity of the fence and its ability to perform its intended function.

The deteriorated fence poses multiple risks:

1. **Safety Hazard:** The unstable fence may collapse, posing a risk of injury to residents, visitors, and passersby.
2. **Security Concern:** The compromised fence may allow unauthorized access to the property, increasing the risk of theft, vandalism, or trespassing.
3. **Property Damage:** Falling sections of the fence could damage nearby structures, plants, or other property features.

- **Licensed Fencing Contractor:** A professional fencing contractor should be hired to assess the extent of the damage and either repair or replace the deteriorated sections.
- **Handyman Services:** For minor repairs, a qualified handyman could be engaged to reinforce or repair specific sections of the fence.
- **Landscaper (if the fence is part of a larger garden feature):** If the fence is integrated into the landscape design, a landscaper with experience in fencing could be involved in the repair or replacement process.

It's important to ensure that whoever is hired is experienced and qualified to ensure the fence is restored to a safe and functional condition, compliant with local regulations.

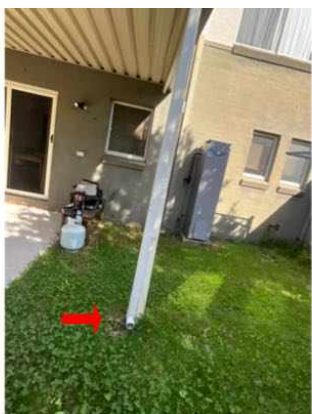
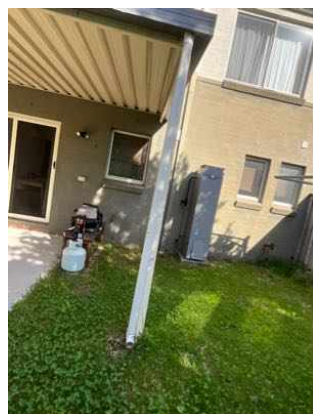
Finding 3.09

Building:	Main Building
Location:	Pergola
Finding:	Disconnected downpipe
Information:	A notable defect with a disconnected downpipe, compromising the efficient drainage of rainwater from the roof. This disconnectivity poses an increased risk of water accumulation, potentially leading to foundation erosion, water damage to the property, and a conducive environment for mold growth.”

1. Foundation Erosion: Accumulated water around the foundation due to the disconnected downpipe can lead to soil erosion, jeopardizing the stability of the property’s foundation.
2. Water Damage: Uncontrolled water runoff can result in water penetrating the building envelope, causing interior water damage to walls, ceilings, and other structural components.
3. Mold Growth: The presence of excess moisture provides an ideal environment for mold growth, posing health risks and necessitating costly remediation.

Engage a qualified and licensed roofing or gutter specialist to address the disconnected downpipe. This professional will reconnect the downpipe to ensure proper water drainage, mitigating the associated risks and preserving the integrity of the property.

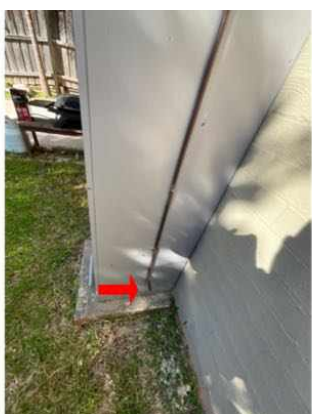
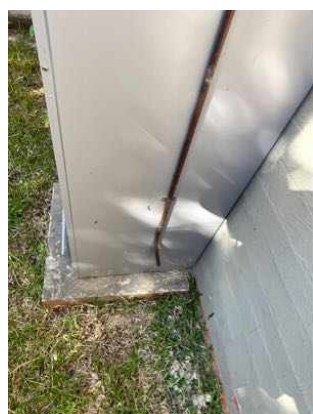
Finding 3.10

Building: Main Building
 Location: Exterior walls - rear
 Finding: HWS Overflow - Not Connected
 Information: The Hot Water System (HWS) overflow was found to be disconnected from storm water drainage and is creating excessive moisture in the surrounding area.

These damp conditions can lead to secondary defects such as rot, rust or corrosion of associated building elements, the formation of fungal decay, or even the creation of potential slip hazards. When coupled with poor site drainage, pooling of water may also attract termite activity to this area.

It is highly recommended that a licensed plumber be appointed to connect the HWS overflow in order to prevent such an environment from being created. These minor works should be carried out as soon as possible.

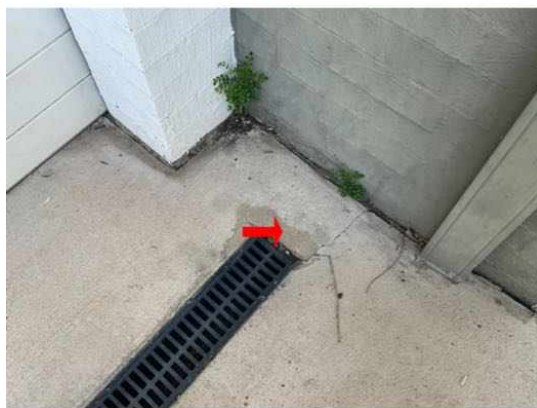
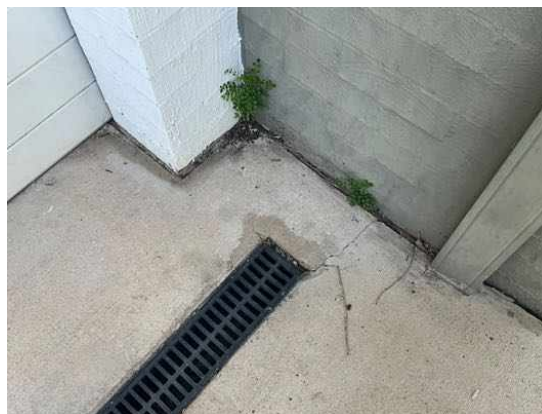
Finding 3.11

Building: Main Building
 Location: Driveway
 Finding: Crack in concrete slab - Category 0
 Information: A crack coded as Category 0 was identified in the slab. A Category 0 crack is

described as a hairline crack, representing insignificant movement of slab from level.

The approximate width of the crack to be considered Category 0 is 0.3mm, or change in offset of less than 8mm when a 3m straight edge is placed over the defect.

No rectification is required at this time. However, all cracking should be monitored over a 12 month period to identify any further damage in the area.

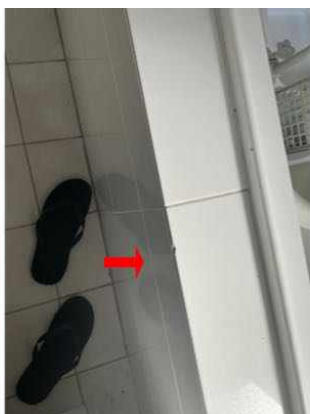
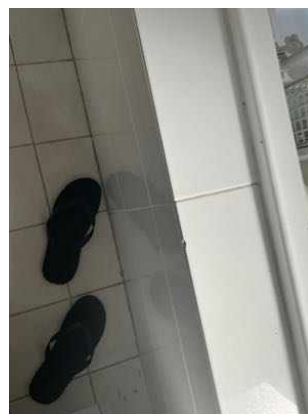
- Injury Risk: The sharp edge of the chipped tile can cause cuts if someone accidentally steps on or touches it.
- Water Damage Risk: If the chipped area becomes larger, water may seep through, potentially damaging the subfloor or causing mold growth.

- Tiler or Handyman: A professional tiler or a handyman should be contacted to replace the chipped tile or, if feasible, repair it to prevent further damage or injury.

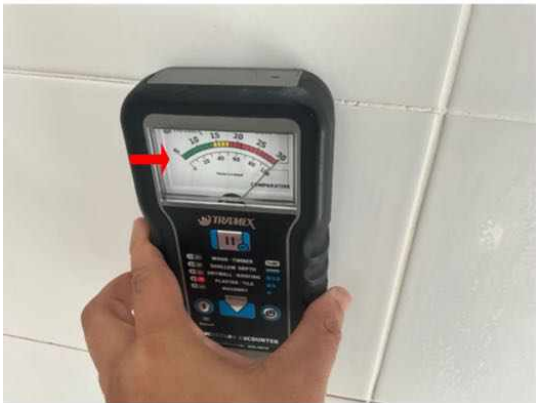
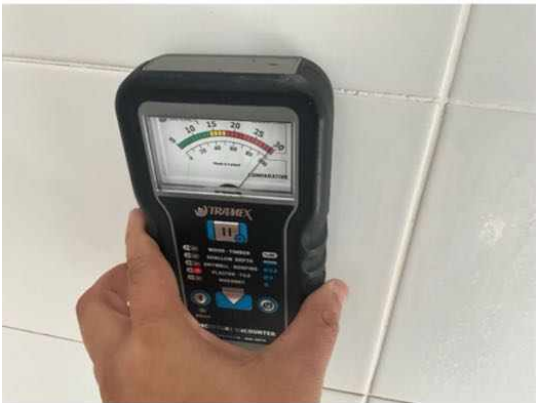
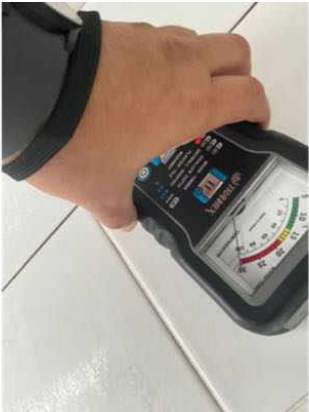
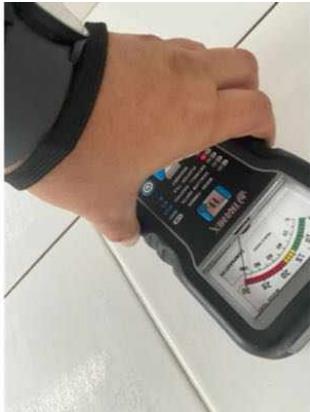
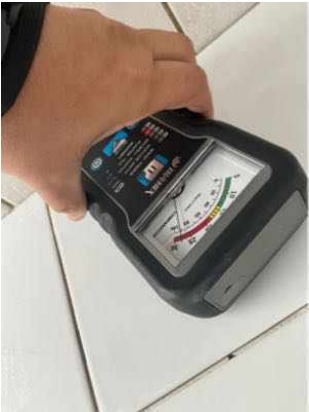
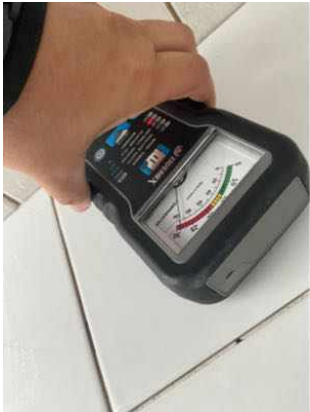
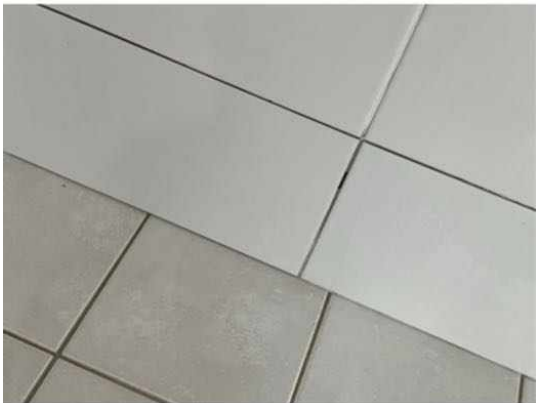
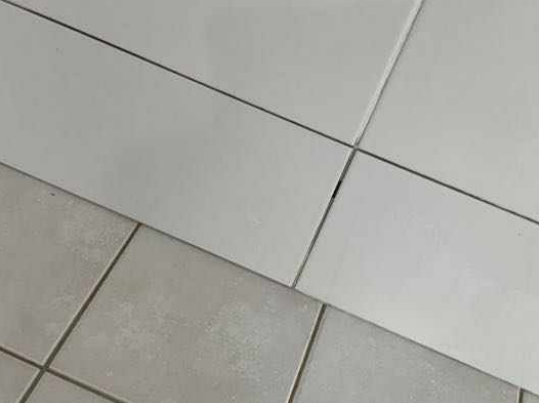
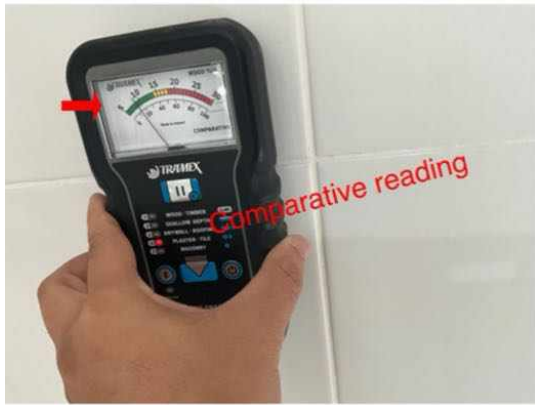
Building:	Main Building
Location:	Bathroom
Finding:	Shower - Damp
Information:	Damp is evident to the lower 300mm of wall to the shower alcove. This defect is quite common, and is suspected to have been caused by moisture permeating through the grouting in this area, which shows evidence of deterioration. Leaking pipes within the adjoining wall is also a possible cause.

Damp (or structural damp) refers to the presence of unwanted moisture in the structure of a building, either as the result of intrusion from outside, or condensation from within the structure. In the shower area, internal water leaks or other sources of excessive moisture are generally the cause of damp.

Unmanaged damp in the shower recess is likely to facilitate the formation and development of mould and fungi growth, decaying associated building materials and compromising their structural integrity. It is important to address damp conditions, as the World Health Organisation notes that excess moisture leads - on almost all indoor materials - to growth of microbes such as moulds, fungi and bacteria, which subsequently emit spores and other matter into the indoor air. Exposure to these contaminants is associated with a wide range of respiratory and other health-related problems.

Consultation with a qualified plumber or bathroom specialist is advised immediately to identify the cause of damp and to perform remedial works as required. Where excessive mould growth is present, further inspection by a specialist environmental health inspector should also be considered.

Always ensure that sealant and grout is in good condition to prevent any moisture issues occurring in the future.

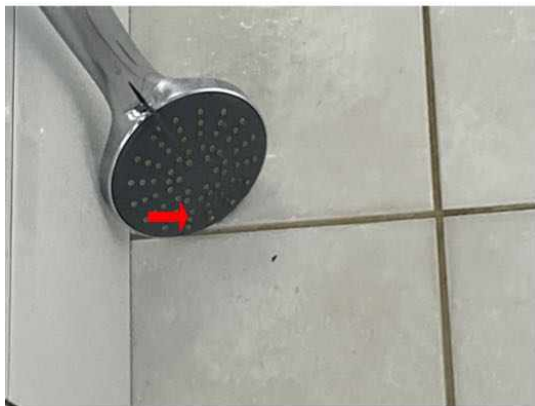
Finding 3.15

Building: Main Building
 Location: Bathroom
 Finding: Leaking plumbing fitting
 Information: Leaking plumbing fitting identified, posing the risk of water damage and increased water bills.

Potential structural damage, mold growth, and wastage of water resources.

Engage a licensed plumber to inspect and repair the leaking plumbing fitting, ensuring a proper seal and preventing any further water-related issues.

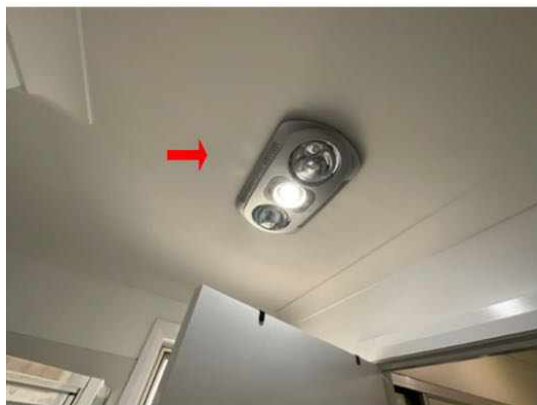
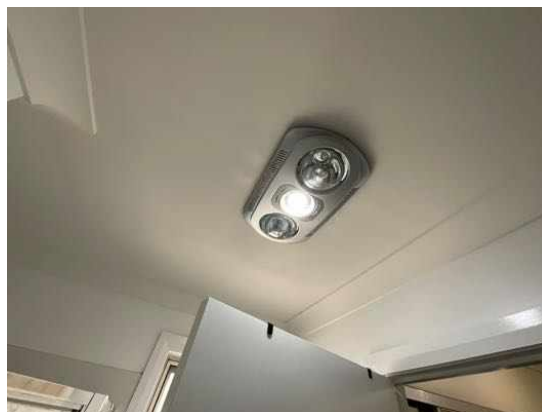
Finding 3.16

Building: Main Building
 Location: Ensuite
 Finding: Exhaust fan - Not operating
 Information: The exhaust fan in this area appears to be damaged or blocked and is not operating as intended. If left unmanaged, a lack of general maintenance is likely to lead to the development of more significant defects, such as water damage to surrounding building materials from inadequate ventilation. If left unattended for a prolonged period of time, poor ventilation in this area may also be conducive to the development of

Where no secondary damage has developed, the Homeowner may undertake minor cleaning of the area and consider replacement of the exhaust fan. Alternatively, consultation with a Licensed Electrician is required to check for any secondary or concealed damage and consider repair or replacement.

Please be advised that a cabinet maker or qualified carpenter may also be required if water damage has occurred and that an additional specialist mould inspection may be required if severe mould has resulted.

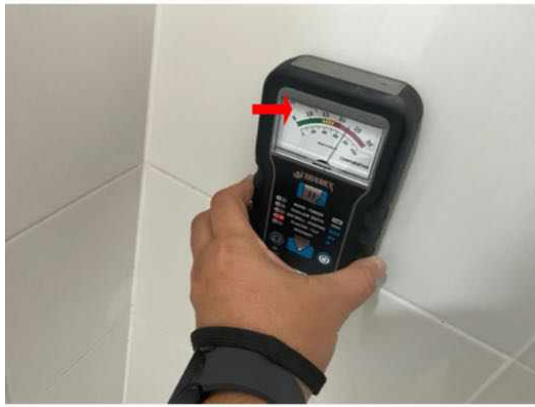
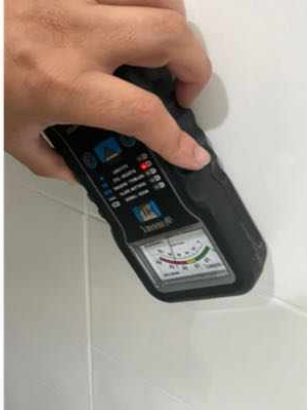
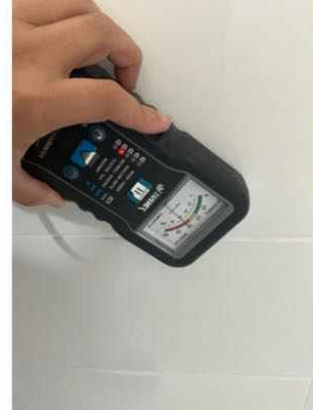
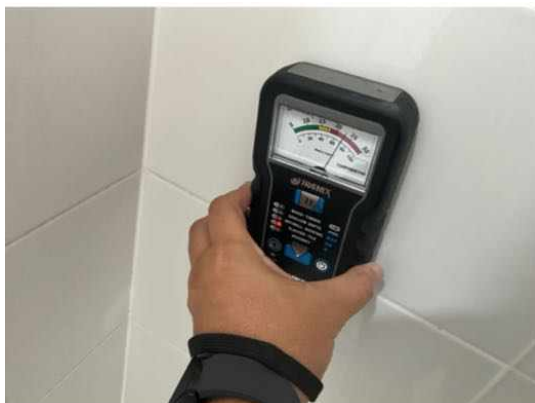
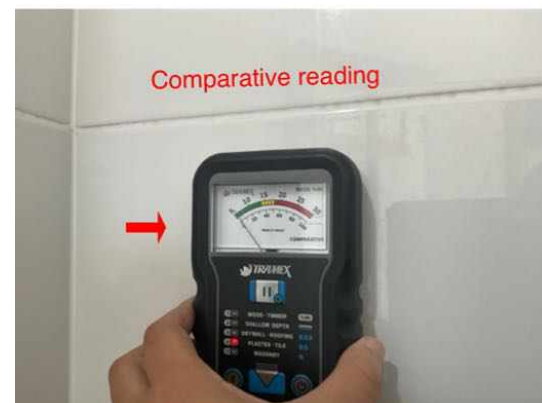
Finding 3.17

Building:	Main Building
Location:	Ensuite
Finding:	Evidence of excessive moisture was present at the time of inspection
Information:	Excessive moisture is present behind the bathroom tiles, indicating a potential water leakage issue within the wall.

The prolonged presence of moisture can lead to mold growth, deteriorate the structure, and create an environment conducive to health hazards. Additionally, it may compromise the adhesive holding the tiles, leading to their detachment.

A licensed plumber or a qualified contractor specializing in water damage remediation should investigate the source of the moisture, fix any leaks, and address the damage. Additionally, replacing affected tiles and ensuring proper waterproofing are crucial to preventing future issues.

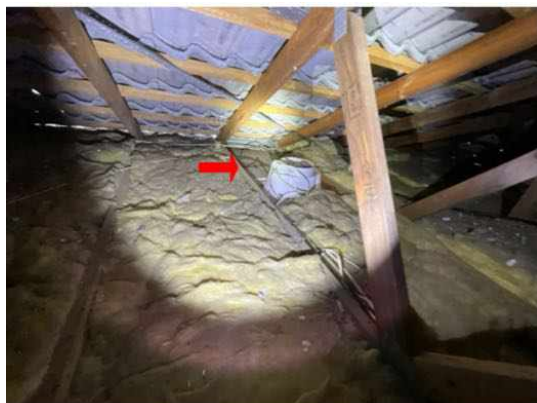
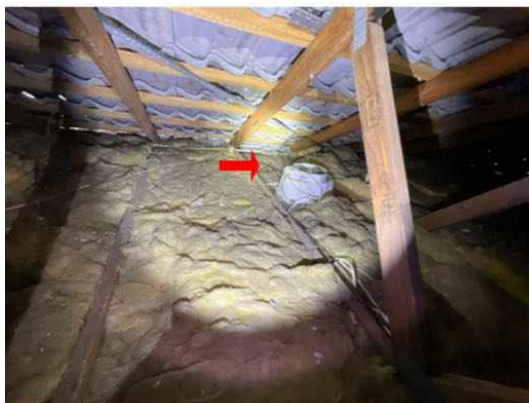
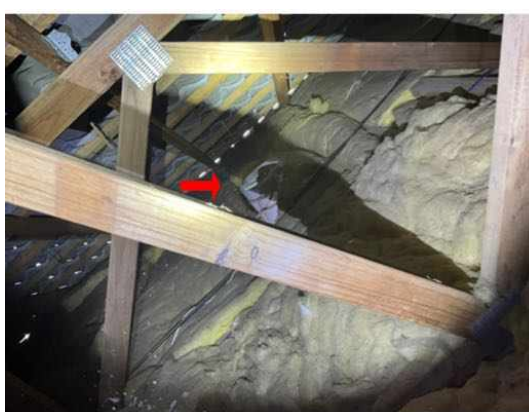
Finding 3.18

Information: The exhaust fan located within the roof void is not appropriately ducted to the external atmosphere and is currently discharging moist air directly into the roof space. This is considered a defect under AS 4349.1, as it does not meet the minimum standard of residential building performance expected under normal residential building practices.

This condition may lead to excessive condensation within the roof void, increasing the

risk of mould growth, deterioration of insulation, timber decay, and overall reduced durability of building elements. It may also result in poor indoor air quality, potentially affecting occupant health.

It is recommended that the exhaust fan be modified by a licensed HVAC contractor or qualified builder, ensuring it is properly ducted to discharge externally in accordance with manufacturer specifications, the National Construction Code (NCC), and applicable Australian Standards.

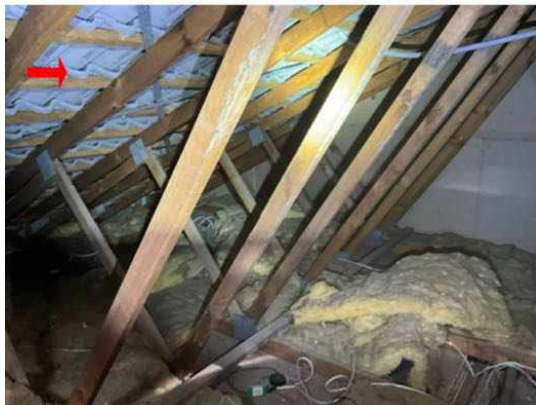
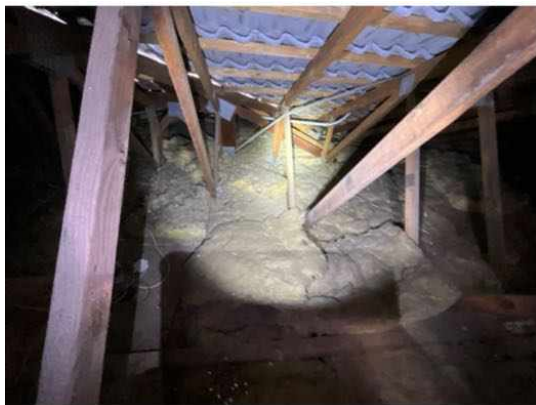
Finding 3.19

Building:	Main Building
Location:	Roof Void
Finding:	Sarking - Missing
Information:	Sarking is missing under the roof sheeting. Sarking acts as an insulator that helps with noise reduction and protects against water penetration. Sarking plays a key role in the operation and function of the overall roofing structure and its performance.

Although not a requirement at the time of construction, replacement of any missing building element is advisable (although this can be quite expensive to do after the time of construction). Where sarking is missing, regular inspections of the roof tiles for cracking and potential moisture penetration is required.

Sarking may be retrospectively fitted by a registered builder at the discretion of the client.

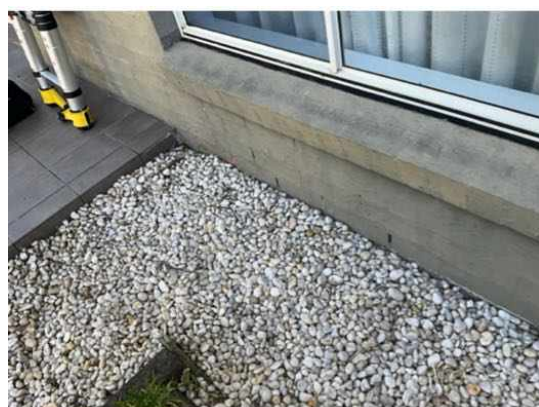
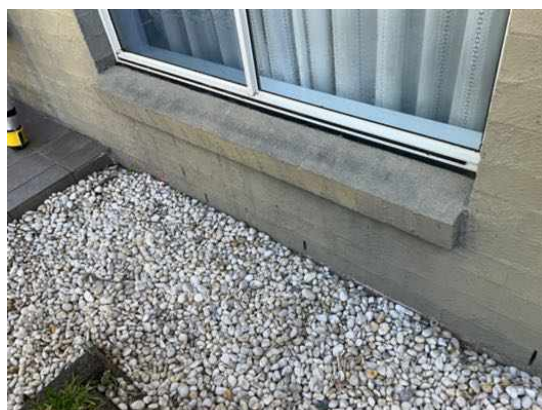
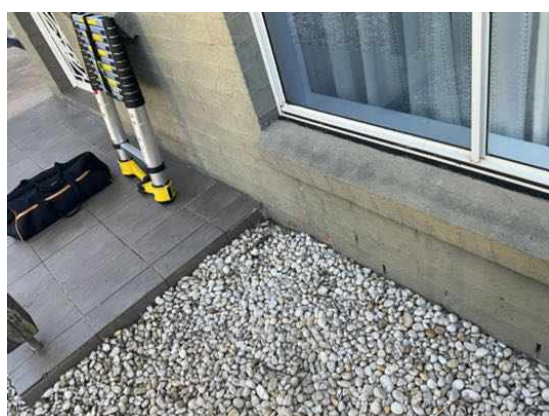
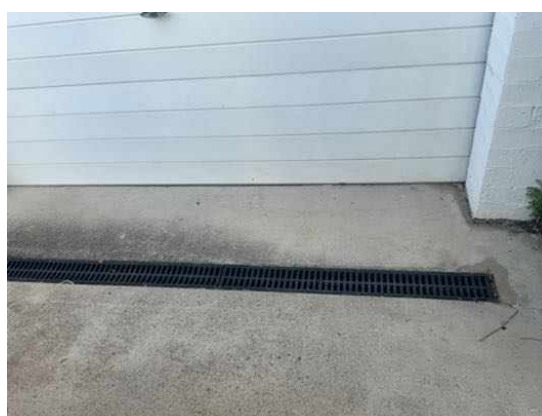
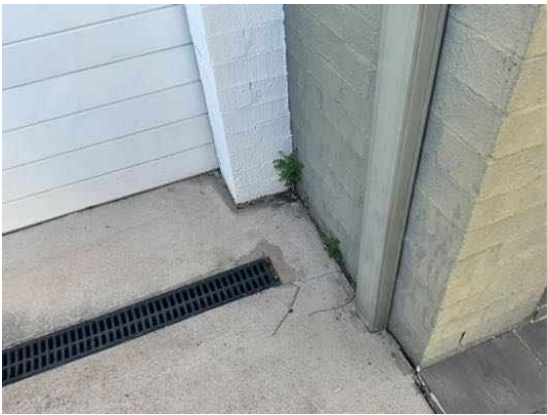
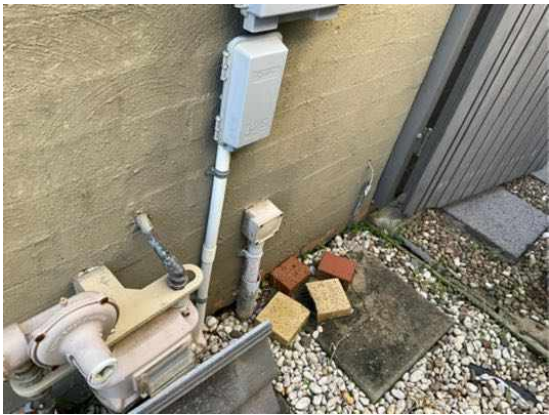
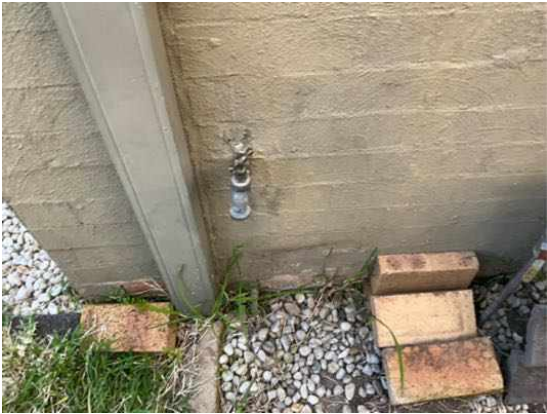
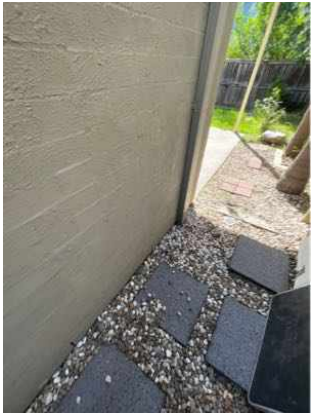
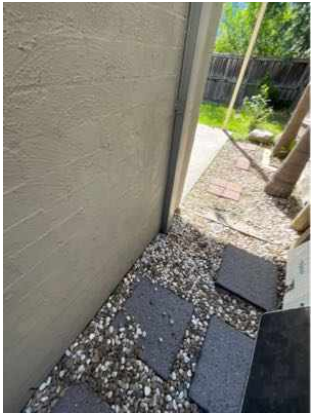
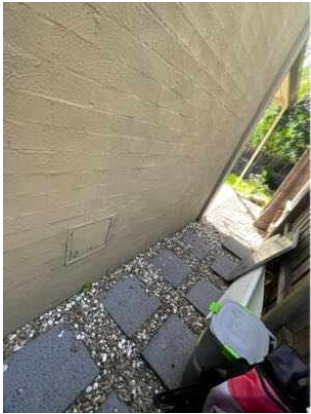
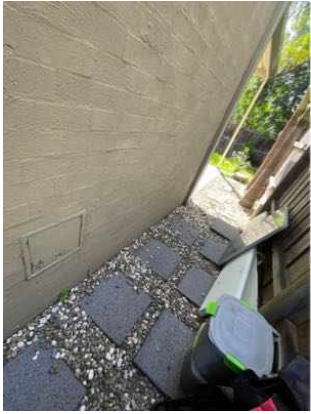
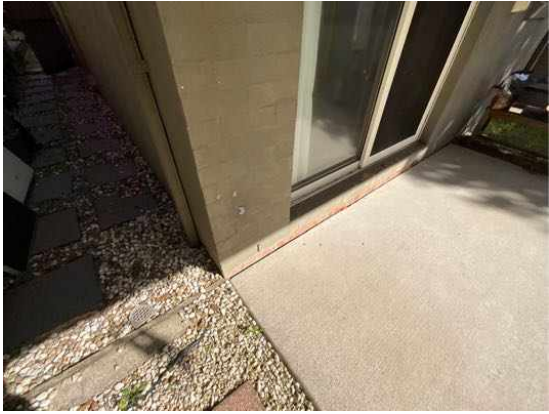
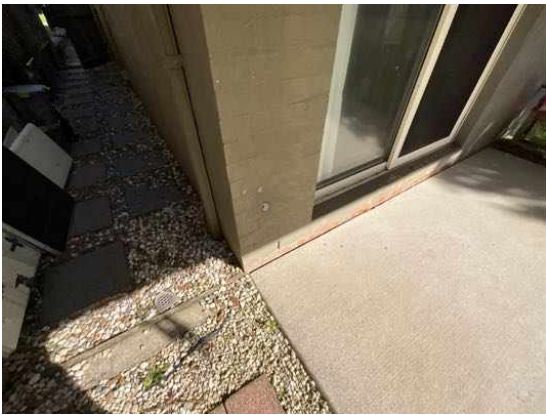
If the slab edge is not properly exposed there is a high risk of termite attack. Sometimes, in order to determine the type of slab, a suitably qualified person such as an architect or builder may be required to consult the construction plans.

Where the slab edge cannot be properly inspected, it is highly recommended that termite or timber pest inspections be carried out every 6-12 months to aid protection of the property against infestation.

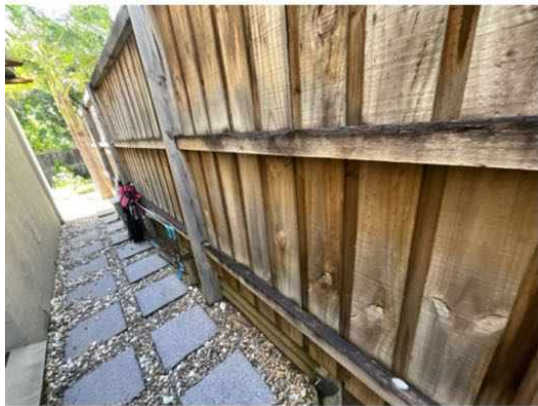
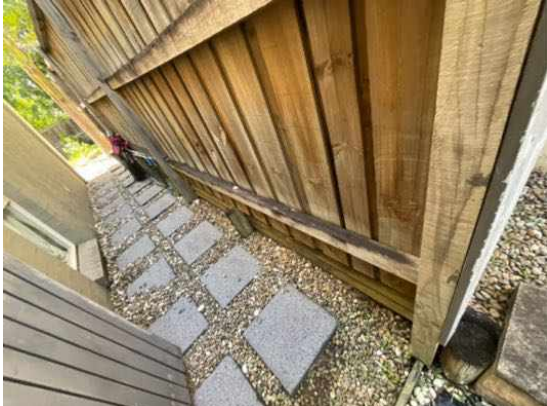
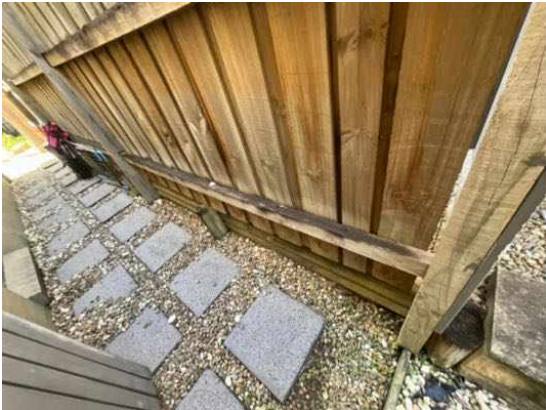
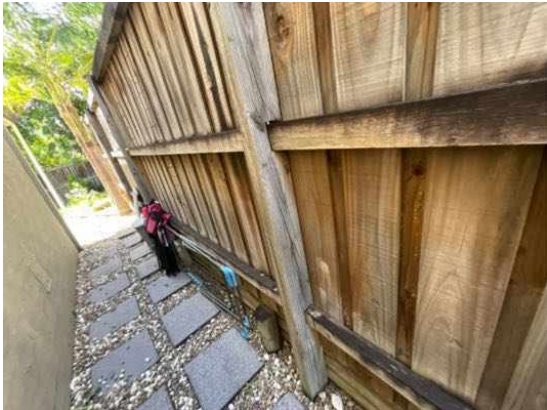
Finding 6.02

Building: Main Building
Location: All Areas
Finding: Timber on ground / conducive conditions to termite damage
Information: Timber on the ground is indeed conducive to termite damage. Termites are known to thrive in moist environments, and wood in contact with soil or moisture is more susceptible to infestation.

To prevent this, it's important to keep timber elevated and away from direct ground contact. Regular inspections and proper termite control measures are also essential to protect your wooden structures from termite damage.

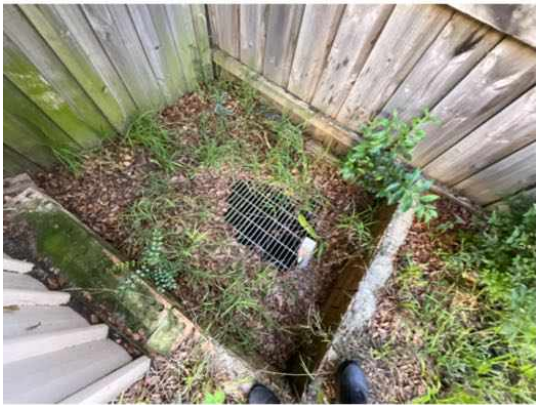
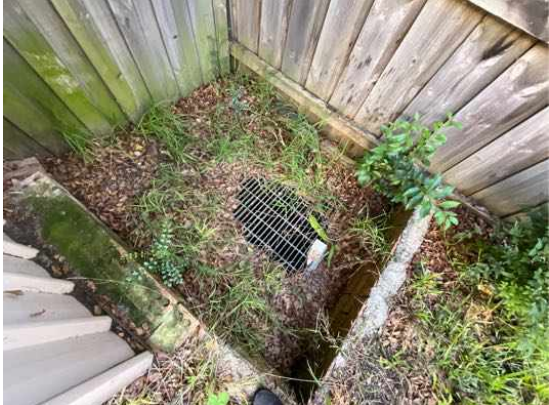
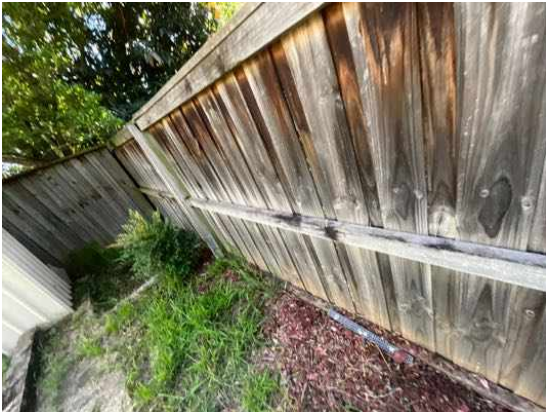
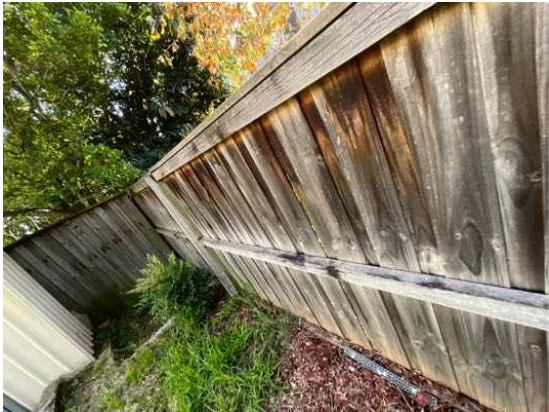
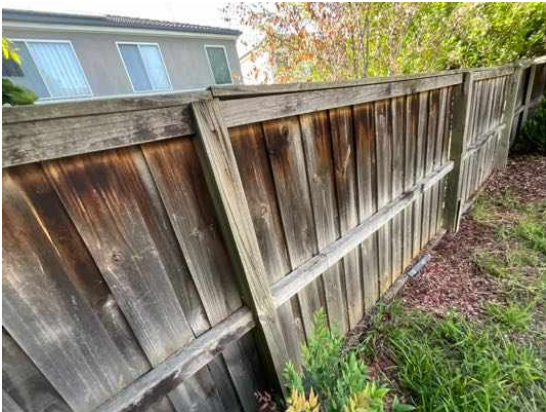
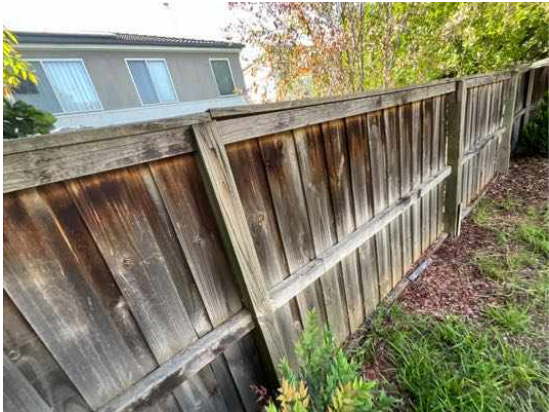
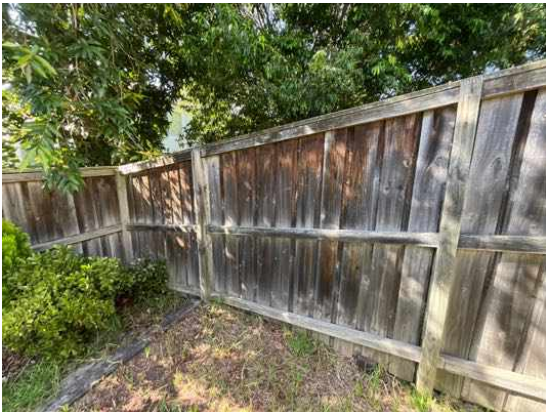
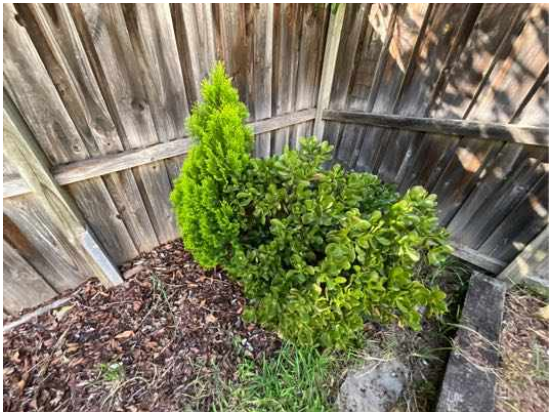
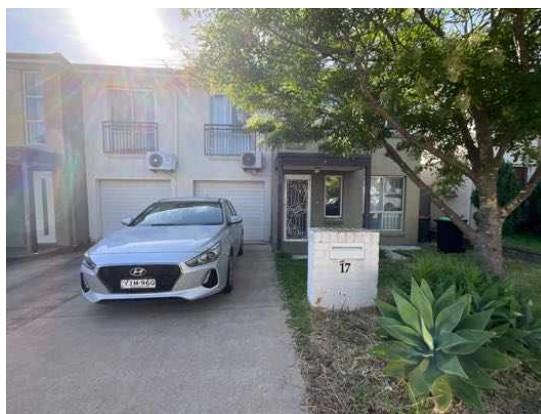
Finding 6.03

Building:	Main Building
Location:	All Areas
Finding:	vegetation around a property can increase the risk of termite infestation
Information:	The presence of vegetation around a property can increase the risk of termite infestation, as it provides a conducive environment for them. To address this, consider maintaining a clear space between the vegetation and your home. If you suspect a termite issue, it's advisable to consult with a licensed pest control professional for inspection and treatment.

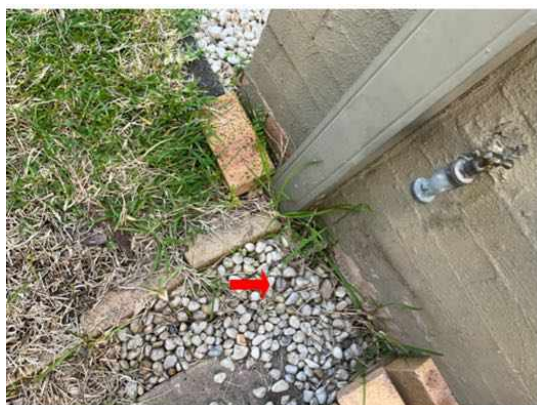
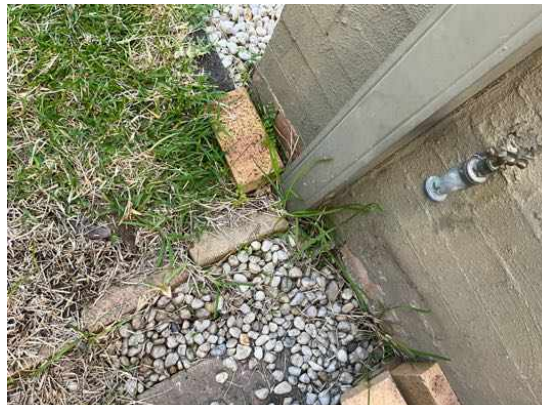
Finding 6.04

Building:	Main Building
Location:	All Areas
Finding:	No Drain under tap
Information:	There is no drain installed under the tap, leading to water accumulation and creating conducive conditions for timber pests. This defect needs immediate attention to prevent potential damage and pest infestation.

1. Water Accumulation: Without proper drainage, water can accumulate around the base of the tap, leading to persistent dampness in the surrounding area.
2. Timber Pest Infestation: The damp environment created by standing water is highly conducive to timber pests, such as termites and wood borers, which thrive in moist conditions and can cause significant damage to wooden structures.
3. Structural Damage: Prolonged exposure to moisture can lead to wood rot and deterioration of structural timber, compromising the integrity of the building.
4. Health Hazards: Persistent dampness can also promote mold and mildew growth, posing health risks to occupants.
5. Aesthetic Damage: Water stains and damage to finishes and materials around the tap area can detract from the appearance of the building and lead to costly repairs.

A licensed plumber or a qualified building contractor can address this defect by:

3. Repair and Prevention: Inspecting and repairing any existing water damage and implementing measures to prevent future water accumulation and pest infestations.

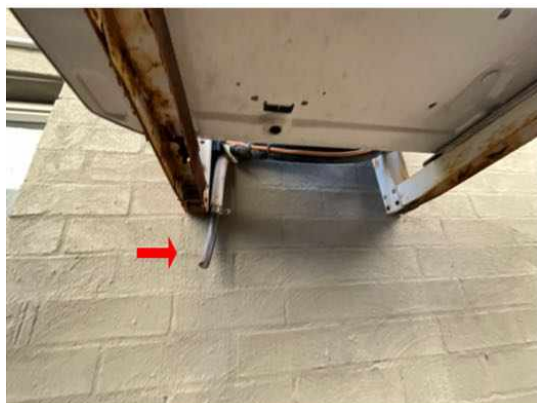
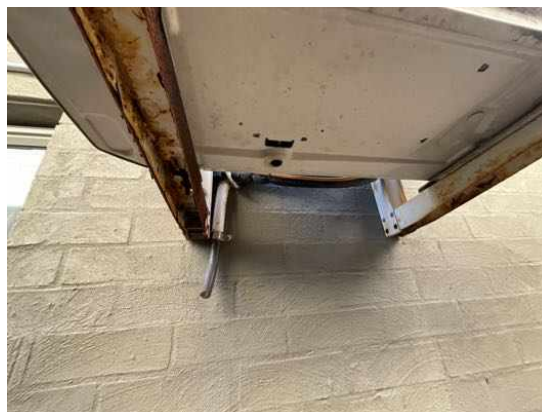
Finding 6.05

Building: Main Building
 Location: Exterior walls - right side
 Finding: Aircon - Excessive moisture conducive condition near Air-conditioner
 Information: Excessive moisture near an air conditioner can indeed create conducive conditions for termites. Termites are attracted to damp and decaying wood, which can be found in areas with high moisture levels. To fix this issue:

1. Fix Leaks: Check for any leaks or condensation around your air conditioning unit. Repair any damaged pipes, drains, or insulation

2. Proper Drainage: Ensure that your air conditioner has proper drainage. Make sure the condensate drain line is clear and directed

5. Please consult a HVAC Technician: HVAC (Heating, Ventilation, and Air Conditioning) technicians are trained to diagnose and
