Building and Timber Pest Inspection Report

Inspection Date: Mon, 16 Mar 2026

Property Address: 17 Bandicoot Dr, Woodcroft NSW 2767,
Australia

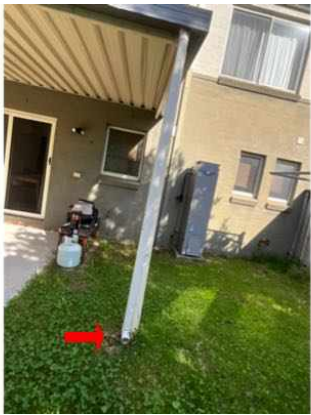
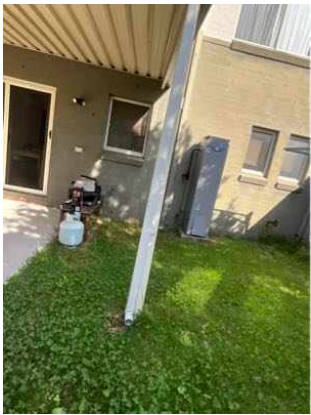
Finding 6.06

Building:	Main Building
Location:	Pergola
Finding:	Downpipes not connected- Conducive conditions for timber pest
Information:	Unconnected downpipes can indeed pose a risk for attracting termites, as they provide a source of moisture near a building's foundation. Termites are attracted to moisture and wood, so it's important to address this issue to prevent potential infestations. Connecting downpipes to the stormwater system or ensuring proper drainage away from the building can help mitigate this a licensed plumber is the most qualified professional to handle plumbing-related tasks, including connecting downpipes to the stormwater system. They have the necessary expertise and tools to ensure proper installation.

Please remember that proper installation is essential to ensure effective drainage and prevent future issues, so it's often best to hire a qualified professional, especially for complex or extensive downpipe installations.

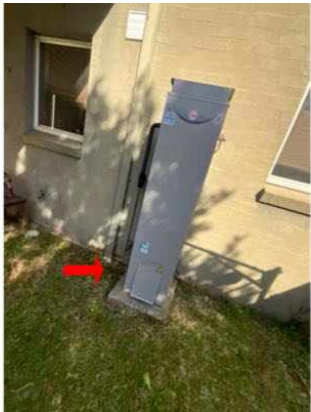
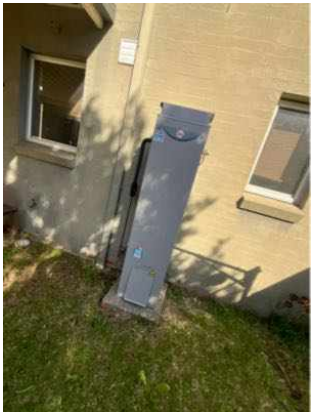
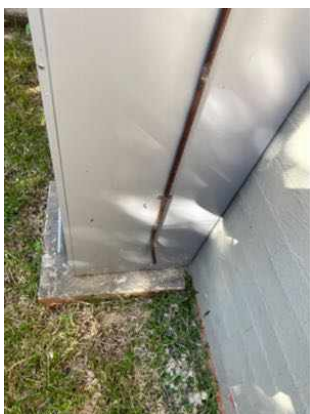
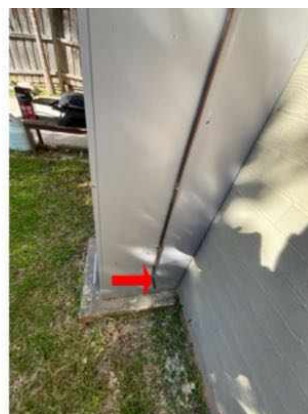
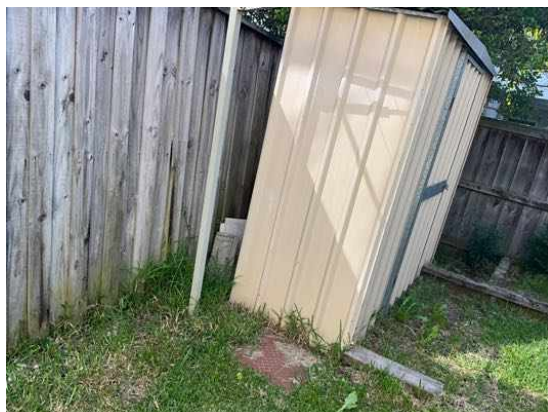
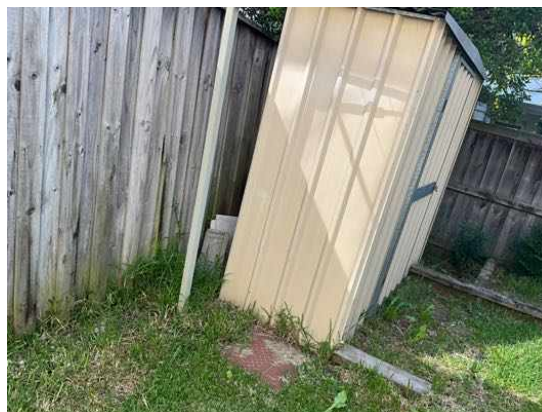
Finding 6.07

Building: Main Building
Location: All Areas
Finding: Bridging or Obstruction Conducive environment for Termites
Information: Bridging of termite barriers occurs when termites bridge (usually by building a mud tunnel) a termite barrier or inspection inspection zone or where termites have a passage, allowing them to bridge the barrier.

Where bridging has occurred full inspection is prevented and termites may enter a property in a concealed or undetected manner.

Recommended moving obstructions away from the external walls for further and future inspections.

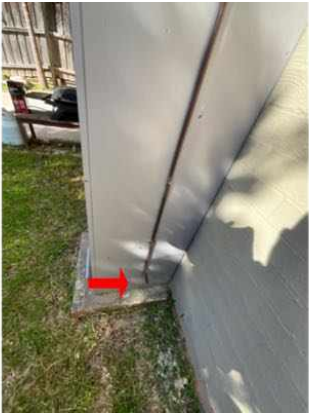
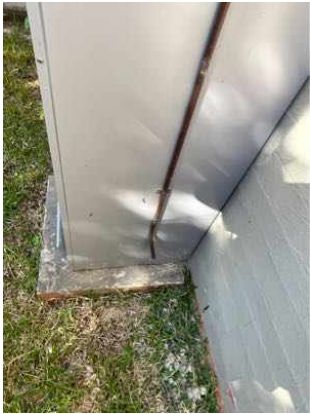
Finding 6.08

Building:	Main Building
Location:	Exterior walls - rear
Finding:	HWS not connected - conducive conditions for timber pest attacks
Information:	The hot water system (HWS) is not connected, leaving exposed pipes and creating conducive conditions for timber pest attacks.

Risk of Timber Pest Attack: The risk of timber pest attack is heightened when the hot water system is not connected. Exposed pipes provide easy access points for timber pests like termites and ants to infiltrate the building structure. These pests are attracted to moisture, and the absence of flowing water through the system can lead to moisture buildup, creating an ideal environment for pests to thrive and cause damage to timber components within the building.

A licensed plumber or qualified plumbing technician should be engaged to reconnect the hot water system. They will assess the existing plumbing infrastructure, determine the appropriate connection points, and ensure proper installation and functionality of the HWS. Additionally, they may inspect for any signs of timber pest activity and recommend preventive measures, such as installing physical barriers or implementing moisture control measures, to deter pest infestations and protect the building from damage. Regular maintenance and inspections by homeowners or property managers are also essential to detect and address potential issues before they escalate.

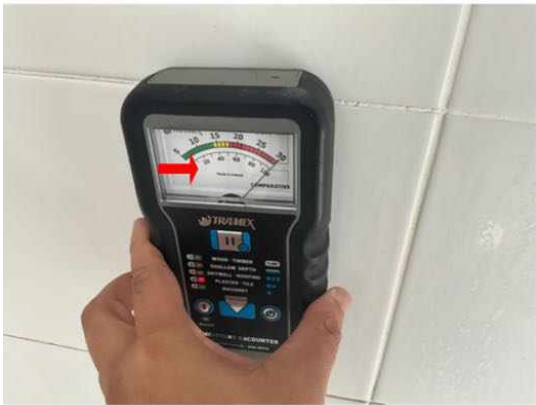
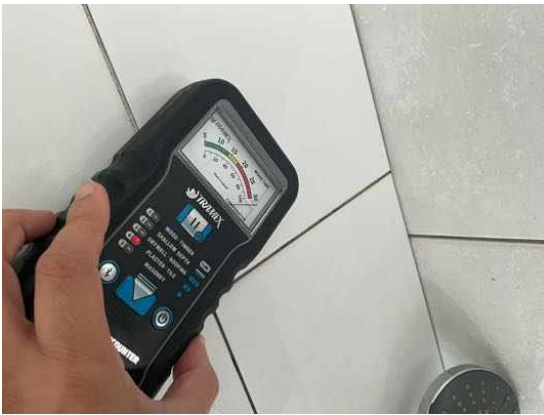
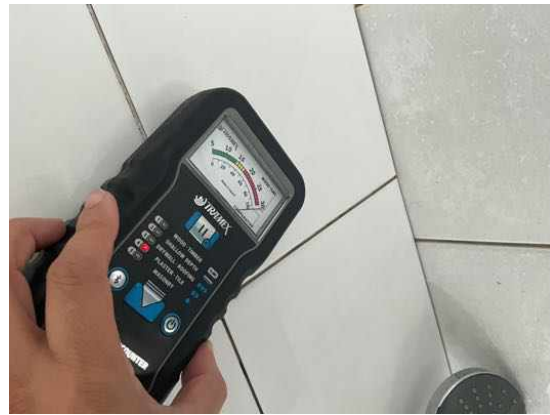
Finding 6.09

Building: Main Building
Location: Bathroom
Finding: Evidence of excessive moisture was present at the time of inspection
Information: Excessive moisture is present behind the bathroom tiles, indicating a potential water leakage issue within the wall.

The prolonged presence of moisture can lead to mold growth, deteriorate the structure, and create an environment conducive to health hazards. Additionally, it may compromise the adhesive holding the tiles, leading to their detachment.

A licensed plumber or a qualified contractor specializing in water damage remediation should investigate the source of the moisture, fix any leaks, and address the damage. Additionally, replacing affected tiles and ensuring proper waterproofing are crucial to preventing future issues.

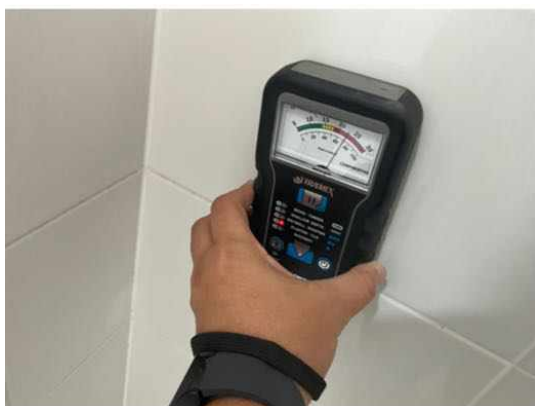
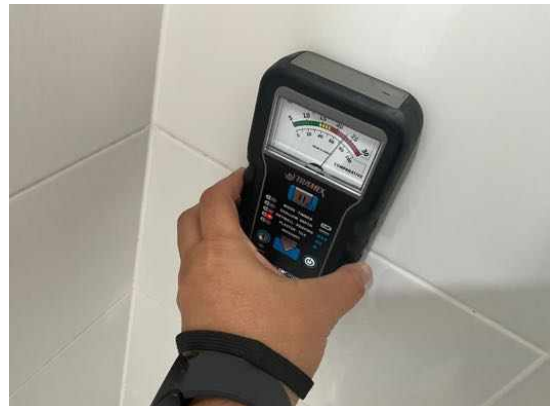
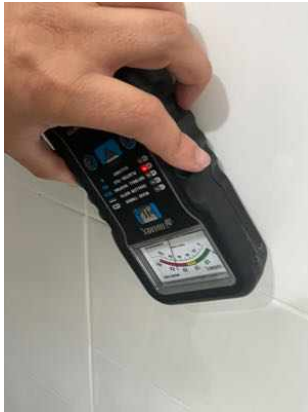
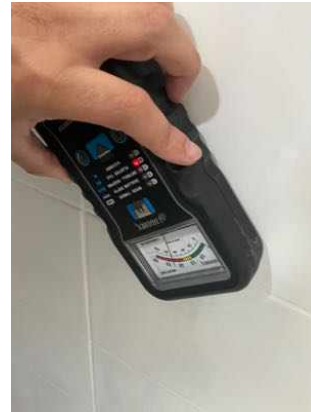
Finding 6.10

Building:	Main Building
Location:	Ensuite
Finding:	Excessive moisture - Conducive to Timber pest
Information:	Excessive moisture can attract termites and produce conditions that promote fungal growth and wood decay.

Excessive moisture is generally caused by deteriorated inadequate or missing roof drainage leaking plumbing pipes or fixtures poorly plumbed HWS overflows or condenser units and poor site drainage.

Prior to any remedial works being performed a qualified plumber should be appointed to further inspect the property and to identify the cause of the excessive moisture. Works to remove affected building elements may then be necessary and should be performed by an appropriate tradesperson.

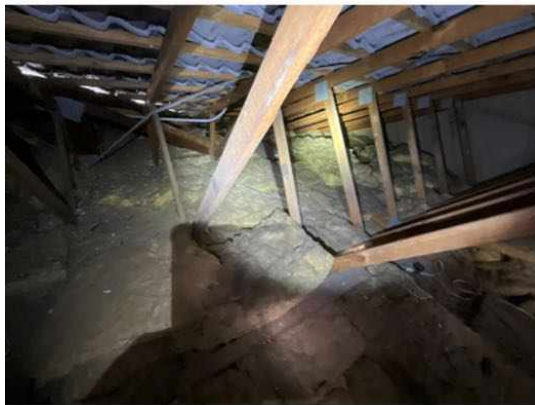
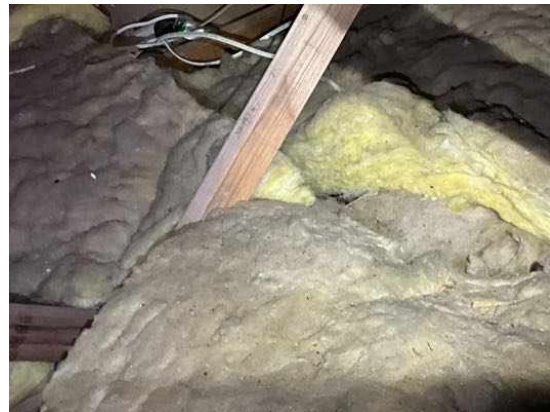
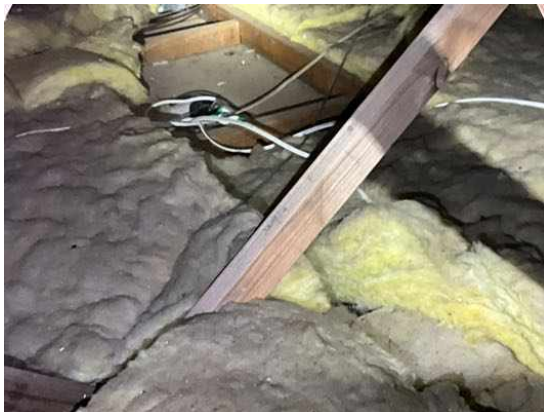
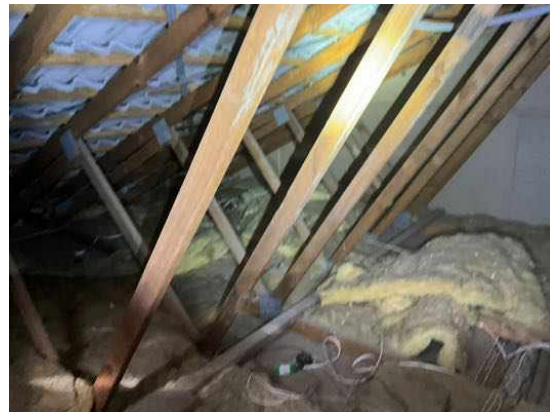
Noted Item

Building: Main Building
Location: All Areas
Finding: Additional Photos - Obstructions and Limitations
Information: These photographs are an indication of the obstructions and limitations which impeded full inspection of the property at the time of inspection. These obstructions can hide an array of defects and should be removed to allow full inspection to be carried out. A re-inspection is recommended once the areas are made accessible.

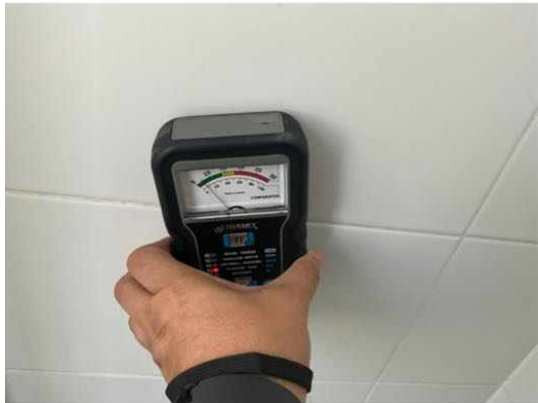
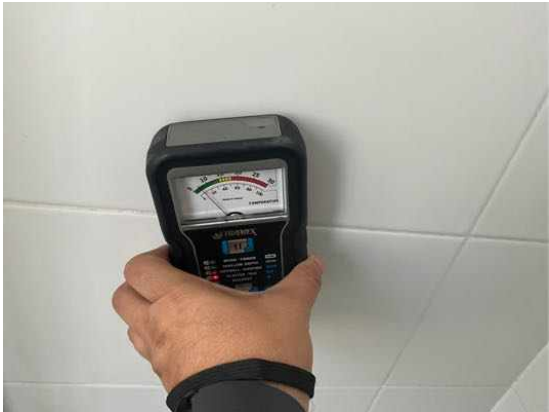
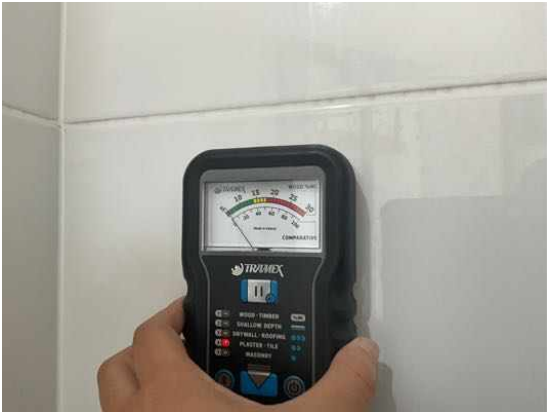
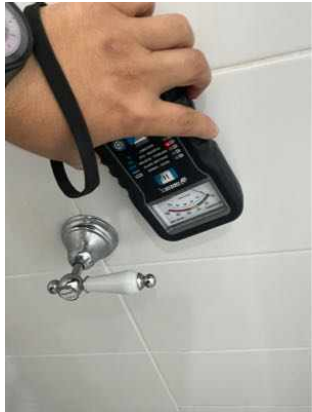
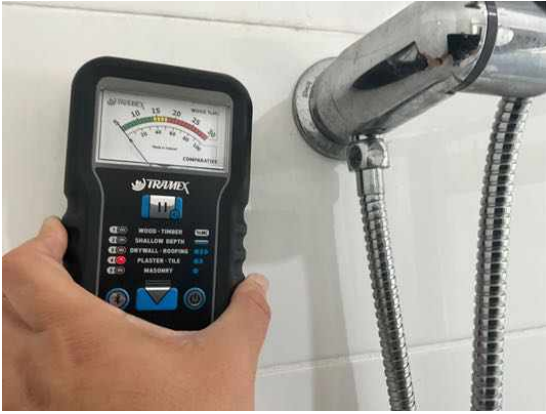
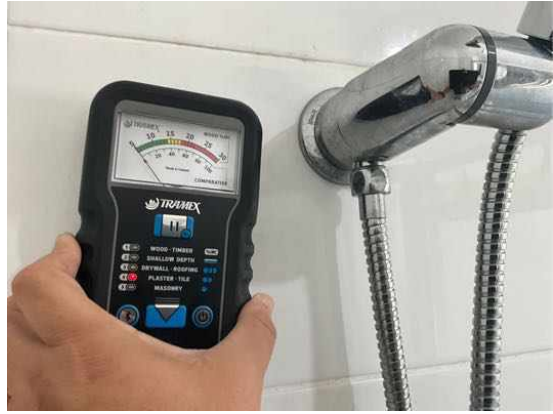
Building: Main Building
Location: All Areas
Finding: Additional Photos
Information: Additional photos are provided for your general reference

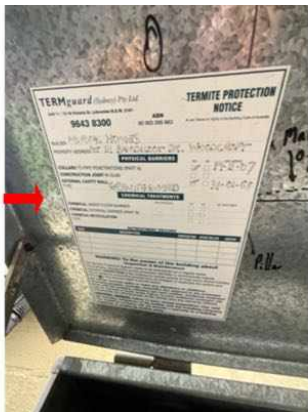
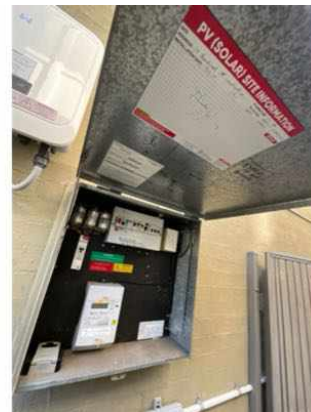
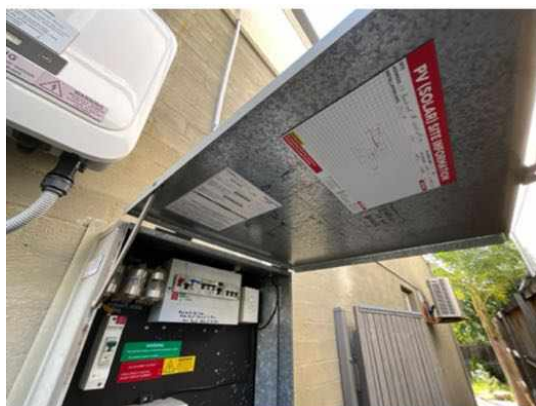
Building:	Main Building
Location:	Exterior walls - right side
Finding:	Evidence of Termite Management System - Durable notice / Legible Sticker - seek further information
Information:	The application of a pre & post-construction chemical termite barrier is highly recommended for all properties. Such barriers are highly effective in preventing termite attack on any timber building elements throughout the property.

A durable notice placed in the switchboard unit to indicate termite barriers at the time of inspection.

Client must seek further information from the vendor or real estate agent if the conditions of termite management systems were maintained as per the label or seek advise from licensed pest controller.
