Building Inspection Report

Inspection Date: Mon, 30 Mar 2026

Property Address: 2 Paxton Link, Pakenham VIC 3810,
Australia

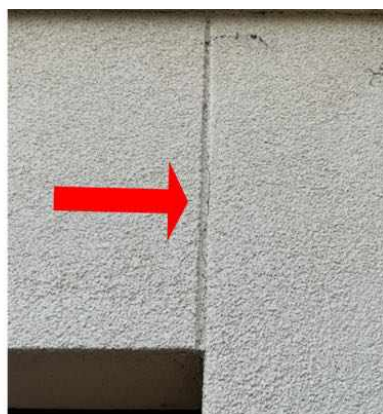
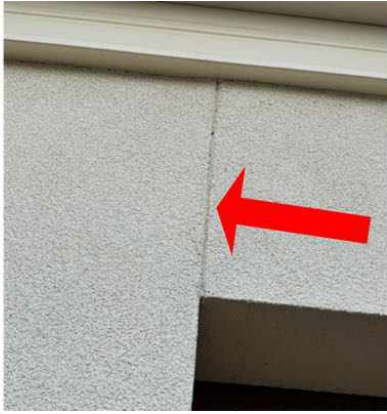
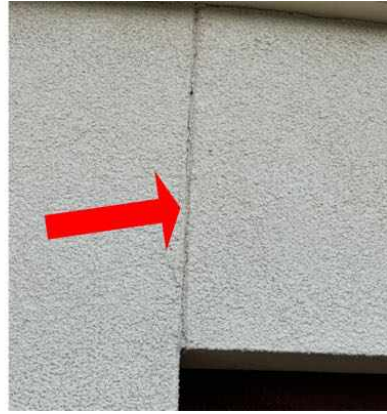
Defects 3.01

When these joints are covered by rigid finishes such as render, the ability of the structure to move freely is reduced. This can lead to cracking in the render or adjacent building elements over time, and may also contribute to moisture ingress if movement causes gaps or fractures in the render.

It is recommended that the rendered-over section be carefully removed to expose the expansion joint, and the joint reinstated with an appropriate flexible sealant or control joint system to ensure it continues to function as intended.

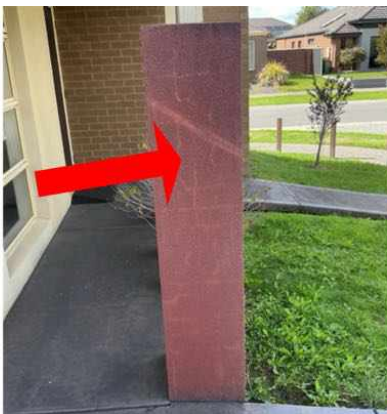
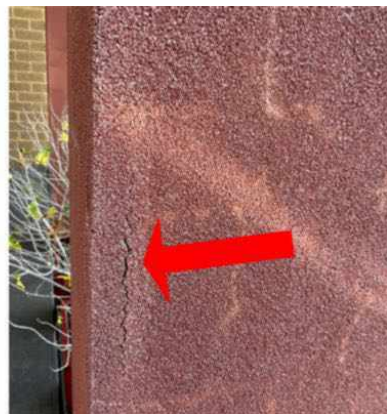
Defects 3.02

Building: Main Building
 Location: Front Elevation
 Finding: Cracking to External Render – Front Elevation Post
 Information:

Cracks were observed to the external render of the post at the front elevation of the property.

This condition may allow moisture ingress into the substrate and can lead to further deterioration of the render and underlying materials if not addressed in a timely manner.

It is recommended that a qualified renderer be engaged to repair the cracks, including appropriate patching and, where required, reapplication of render layers to ensure a durable and weather-resistant finish.

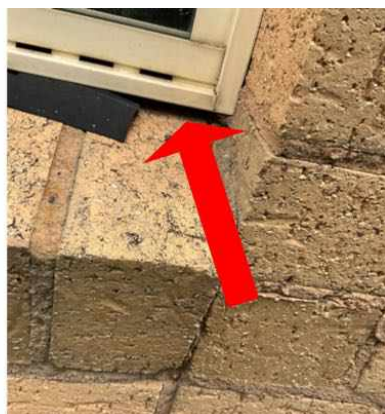
Defects 3.03

Building: Main Building
 Location: All External Areas
 Finding: Window seals - deteriorated
 Information: The window seals have deteriorated and are in a generally poor condition. Due to frequent exposure to weather conditions and subsequent moisture, deterioration of

window seals is expected in a property of this condition and age.

Where window seals have deteriorated, the window is no longer weather-tight; rain penetration and subsequent water damage is therefore likely to ensue. Insulation of the area against external weather conditions will also be compromised.

It is recommended that all deteriorated window seals be replaced by a general handyman or sealant expert to prevent any further damage and to restore the window to a fully functional level.

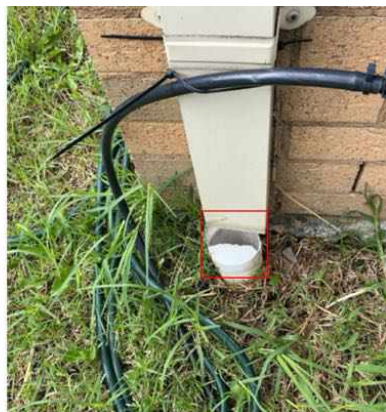
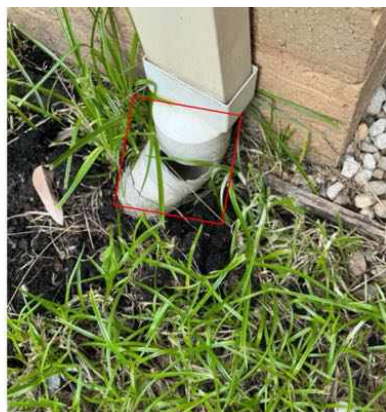
Defects 3.04

Building:	Main Building
Location:	All External Areas
Finding:	Broken Downpipe Connections
Information:

Two downpipes were observed to be broken at their connections to the stormwater system at the time of inspection.

This condition can result in uncontrolled discharge of rainwater at the base of the structure, leading to excessive moisture accumulation, increased risk of termite activity, and potential deterioration of footings and surrounding building elements.

It is recommended that a licensed plumber be engaged as a matter of urgency to repair or replace the damaged downpipe connections and ensure proper discharge of stormwater away from the structure.

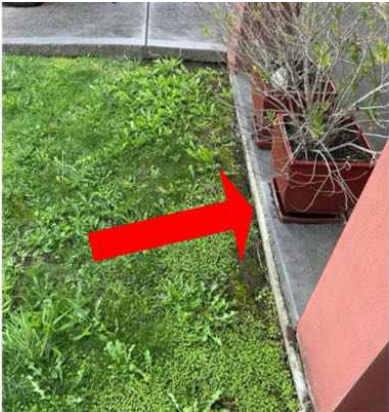
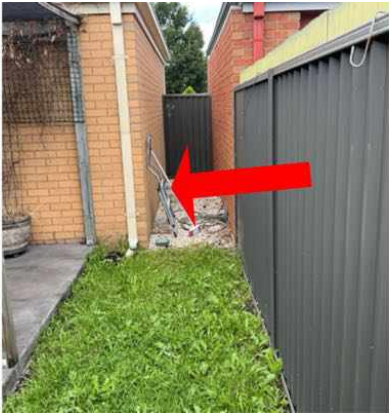
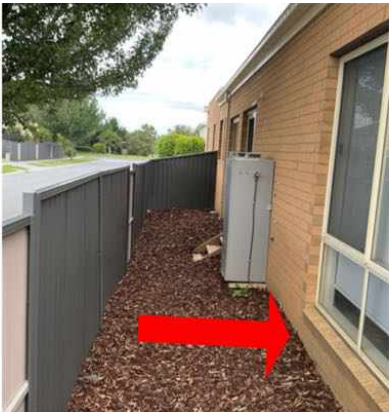
Defects 3.07

Building: Main Building
Location: All External Areas
Finding: Site drainage - Inadequate
Information:

The site drainage in all yards was found to be inadequate at the time of inspection, creating potential for subsequent water damage to associated building elements.

It is important that water does not lie against the base of walls; surrounding paths and ground levels should be sloped to drain water away from walls. Downpipes should not discharge stormwater onto lower walls or plinths. Stormwater should be carried away by large, regularly cleaned drains. Ground levels may need to be lowered to expose a buried DPC.

Where site drainage is inadequate, installation of an Agricultural (Aggie) Drain may be required. A qualified plumber should be appointed to further inspect the property and perform any remedial works as necessary. Water damage and secondary defects are likely to occur if left unmanaged.

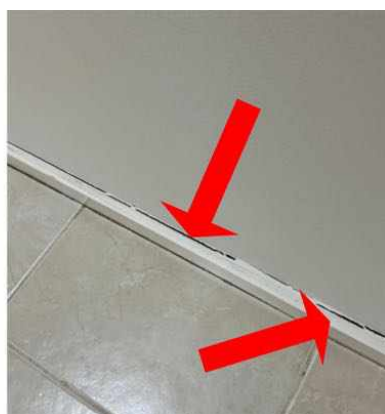
Defects 3.08

Building:	Main Building
Location:	Hallway
Finding:	Gaps and Separation to Skirting Boards – Hallway
Information:	The skirting boards in the hallway were observed to be splitting and forming small gaps at the time of inspection.

This condition is commonly associated with minor building movement and material shrinkage, which can result in loosening of fixings and visible separation over time.

It is recommended that a qualified carpenter re-secure the affected skirting boards, apply a suitable flexible sealant to fill the gaps, and carry out repainting as required to restore a neat and durable finish.

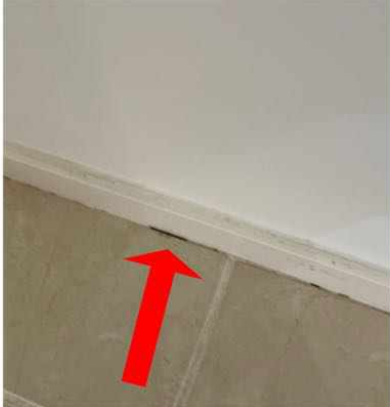
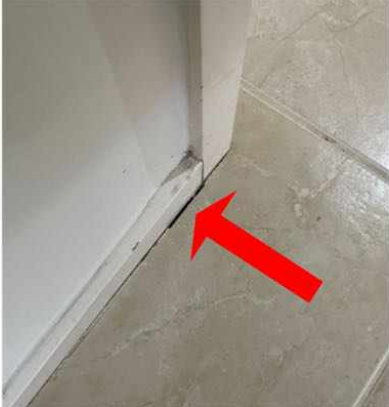
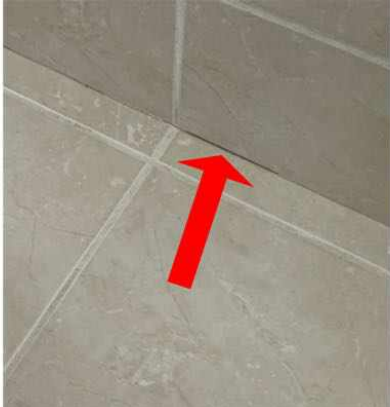
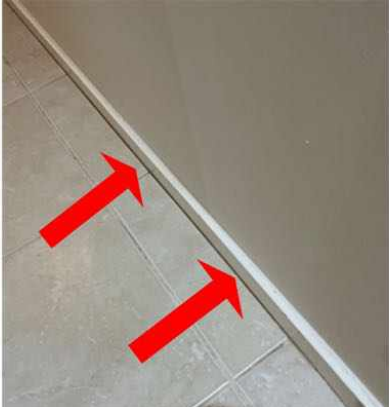
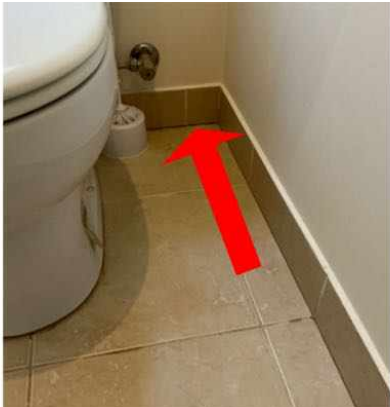
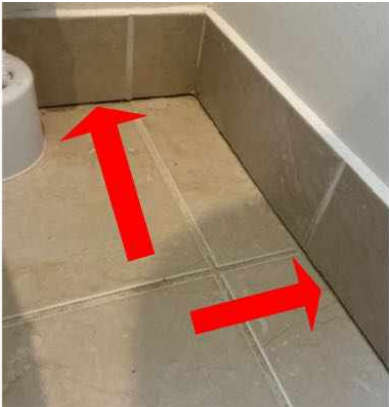
Defects 3.09

Building:	Main Building
Location:	All Internal Areas
Finding:	Gaps Between Floor Tiles and Adjacent Surfaces
Information:	Gaps were observed between the edges of the floor tiles and adjoining surfaces such as skirting boards and wall tiles. These gaps vary in width and appear to lack appropriate finishing materials such as sealant. The presence of such gaps may

indicate poor workmanship or a failure to allow for proper movement joints during installation.

It is recommended that a qualified tiler or apply flexible sealant to the gaps at client discretion

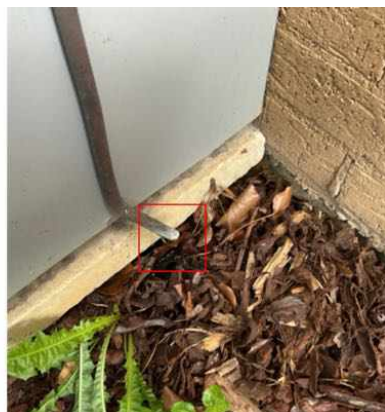
Defects 3.10

Building: Main Building
Location: Yard - Side
Finding: HWS Overflow - Not Connected
Information: The Hot Water System (HWS) overflow was found to be disconnected from storm

water drainage and is creating excessive moisture in the surrounding area.

These damp conditions can lead to secondary defects such as rot, rust or corrosion of associated building elements, the formation of fungal decay, or even the creation of potential slip hazards. When coupled with poor site drainage, pooling of water may also attract termite activity to this area.

It is highly recommended that a licensed plumber be appointed to connect the HWS overflow in order to prevent such an environment from being created. These minor works should be carried out as soon as possible.

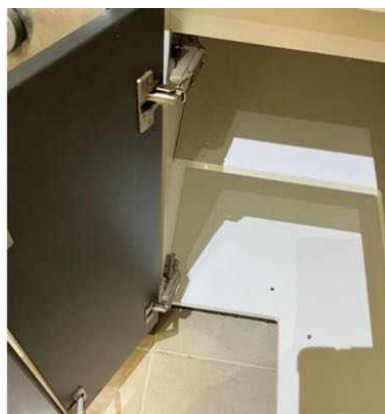
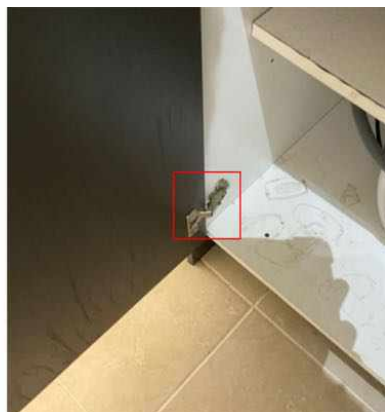
Defects 3.11

Building:	Main Building
Location:	Kitchen
Finding:	Loose and Unstable Kitchen cupboard Hinges
Information:	Upon visual inspection, it was observed that the kitchen cupboards exhibited signs of instability and looseness. The hinge was found to be improperly tightened, resulting in a wobbly and shaky doors. This condition may hinder the smooth operation of the drawer and could potentially lead to further wear or damage over time.

It is recommended that a handyman or qualified cabinet maker be engaged to assess and secure the hinge properly to restore full functionality and ensure the longevity of the cupboards .

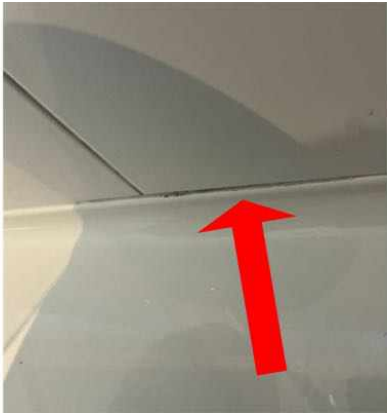
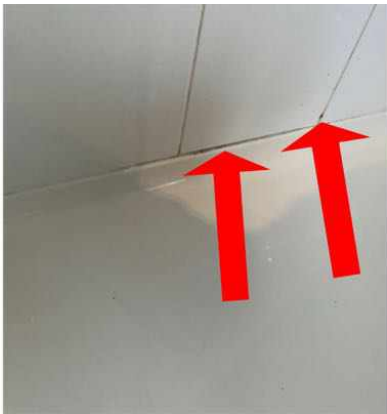
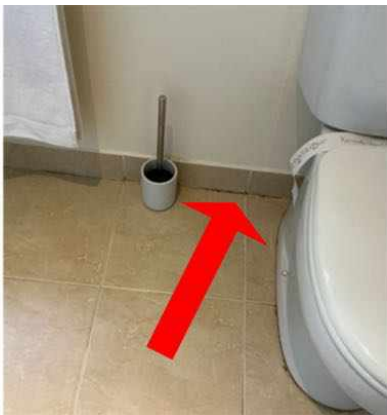
Defects 3.12

Building:	Main Building
Location:	Ensuite - Master
Finding:	Sealant and grouting - Minor deterioration
Information:	It was noted on inspection that sealant or grout is degraded to the tiled shower alcove and other areas of the bathroom.

Different materials and floor areas move at different rates, generally causing cracking to grout or sealant at this point. A flexible sealant is required to allow for expected expansion and contraction, while keeping the joint water tight and protective of all associated building materials.

Minor signs of mould were also observed in the bathroom.

Flexible and mould resistant materials should be applied to affected areas to prevent any subsequent water damage that is likely to occur. Regular maintenance and replacement of damage or missing or damaged sealant and grout is highly recommended to the wet areas, as this is a regular wear and tear defect. Sealant and grouting in areas that come into regular contact with water should be maintained for the long term care of your property.

A sealant specialist or tiling contractor should be appointed to complete these works as soon as possible

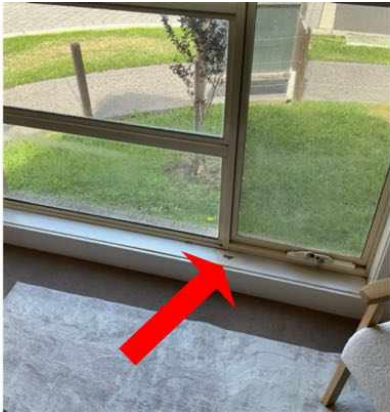
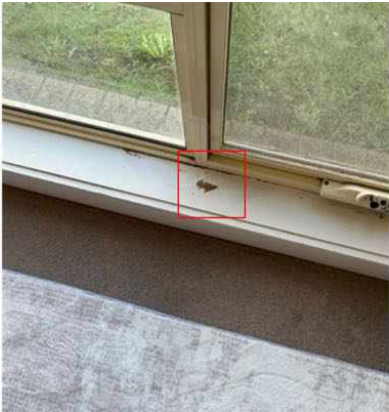
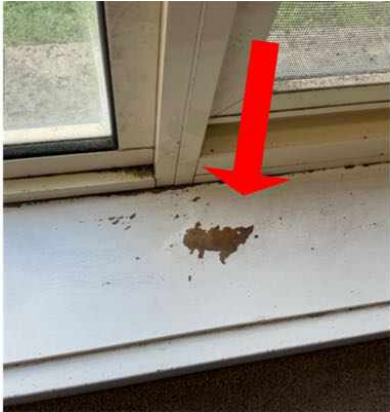
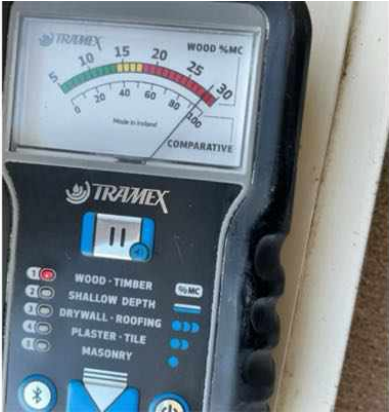
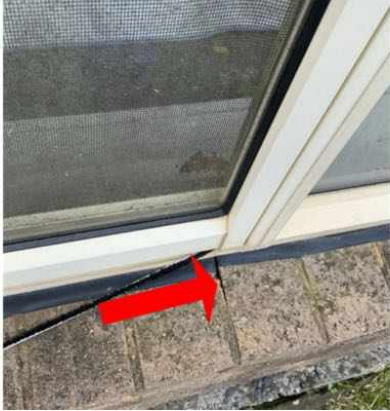
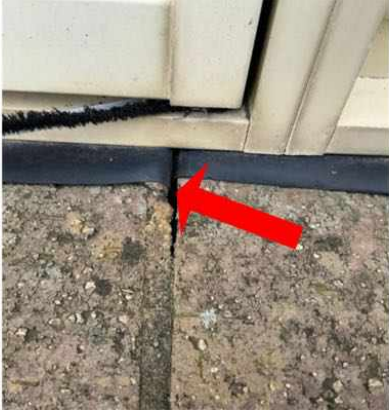
Defects 3.13

Building:	Main Building
Location:	Bedroom - Master
Finding:	Water Ingress and Moisture Damage – Master Bedroom Window - urgent rectification require
Information:	The window in the master bedroom shows signs of water damage to the windowsill, with elevated moisture readings recorded at the time of inspection. This condition is consistent with water ingress, likely due to gaps, failed sealant, or inadequate sealing around the window frame.

Ongoing moisture ingress can lead to deterioration of the window frame and surrounding building elements, as well as potential mould growth if not addressed promptly. The elevated moisture levels indicate that the issue may still be active or recurring.

It is recommended that a registered builder be engaged to carry out a detailed assessment of the window assembly, identify the source of water ingress, and undertake necessary rectification works. This should include resealing the window perimeter and ensuring the assembly is fully watertight to prevent further moisture penetration.

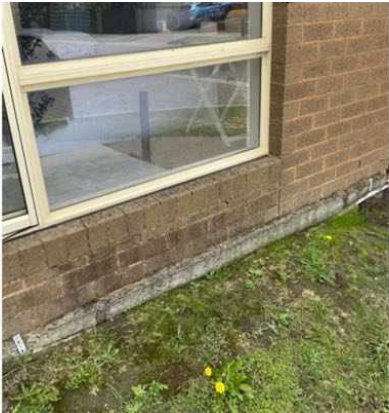
Defects 3.14

Building: Main Building
 Location: Exterior walls - front
 Finding: Water Runoff Staining to External Wall Below Window
 Information:

Significant water staining and evidence of prolonged runoff were observed to the external brickwork at the front elevation below the master bedroom window, indicating repeated exposure to rainwater in this area.

This condition suggests inadequate protection from direct rainfall and/or poor water shedding around the window assembly, which may lead to ongoing saturation of the wall, increased risk of moisture ingress into the building envelope, and potential deterioration of materials over time.

It is recommended that a registered builder assess this area and implement appropriate measures to control water exposure, which may include installation of a suitable awning or weather protection above the window, ensuring the window and surrounding penetrations are fully sealed and watertight, and cleaning of the affected brickwork. Rectification should be carried out promptly to prevent further moisture-related issues.

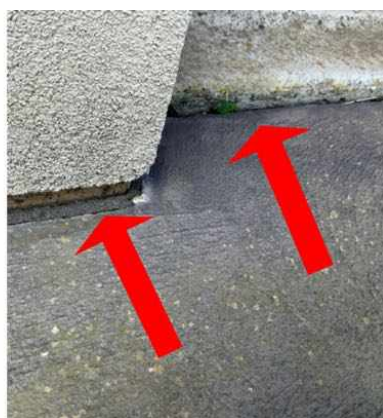
Defects 3.15

Building:	Main Building
Location:	Driveway
Finding:	Minor Subsidence to Driveway
Information:	The driveway was observed to have minor subsidence, with sections having dropped by a few millimetres at the time of inspection.

This condition may be associated with ground movement or inadequate subgrade support and, if progressive, could lead to further settlement, surface cracking, and drainage issues.

It is recommended that a qualified concreter be consulted to assess rectification options. The area should also be monitored over time to determine whether any ongoing movement is occurring.

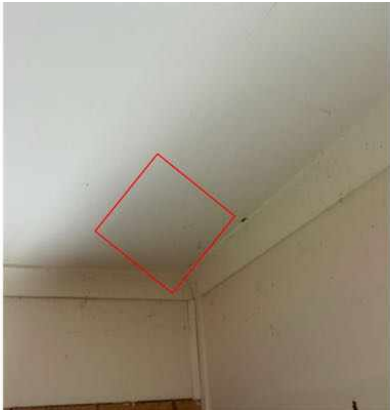
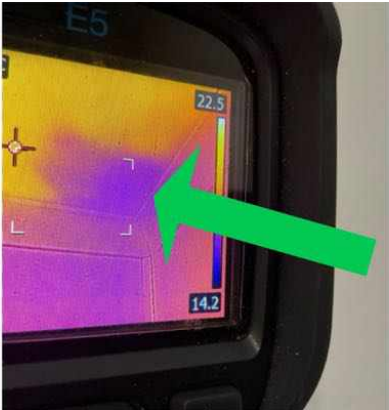
Defects 3.17

Building: Main Building
Location: Garage
Finding: Active Water Leaks to Garage Ceiling - urgent rectification required
Information: Two active leaks were identified in the garage ceiling at the time of inspection, with visible signs of water ingress and mould. Excessive moisture readings were recorded, and thermal imaging confirmed the presence of active water leaks in the affected areas.

This condition indicates ongoing moisture intrusion, which may lead to deterioration of ceiling materials, potential mould growth, and damage to surrounding structural elements if not addressed promptly.

It is recommended that a licensed plumber be engaged immediately, as a matter of urgency, to investigate the source of the leaks and carry out necessary repairs to prevent further water ingress and associated damage.

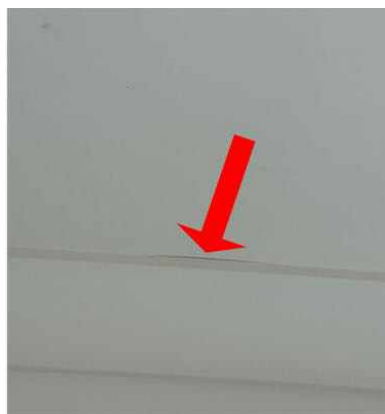
Defects 3.18

A minor sag was observed to the cornice in the living room at the time of inspection.

This condition may indicate inadequate fixing, minor movement, or deterioration of the adhesive or substrate, and may worsen over time if not addressed.

It is recommended that a qualified plasterer inspect the affected cornice, re-secure or reinstate it as required, and ensure a firm and uniform finish.

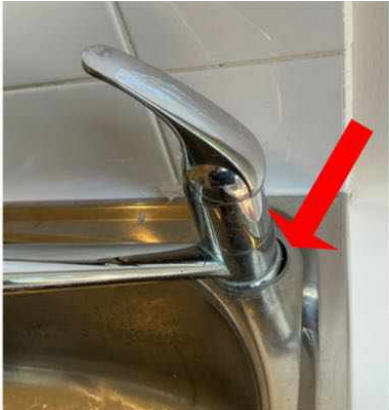
Defects 3.21

Building: Main Building
 Location: Laundry
 Finding: Tap - Loose
 Information: The tap in laundry room area has deteriorated with age, and is consequently loose. This tap being loose creates potential for water leaks and subsequent water damage to the surrounding area.

Where taps or spouts are loose, a qualified plumber should be appointed to re-fix the plumbing fitting.

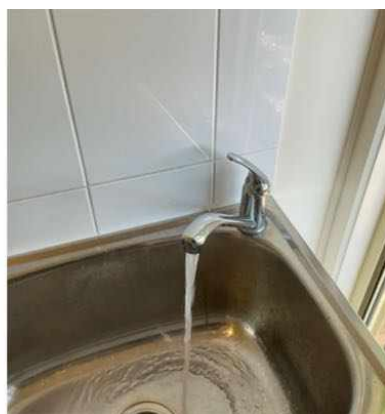
Defects 3.22

Building:	Main Building
Location:	Laundry
Finding:	Tap - Leaking
Information:	The tap in the laundry sink was found to be leaking at the time of inspection. This is a common defect that is consistent with general ageing of the building element. However, it may be indicative of substandard plumbing workmanship if the tap is relatively new.

While this defect only seems minor, if left unmanaged, it is likely to result in the development of rust, water damage and/or extensive water usage.

It is advised that a licensed plumber be appointed to perform remedial works on the affected tap. Such works should be performed prior to the development of secondary defects to ensure adequate functionality of all associated building elements.
