# Building and Timber Pest Inspection Report

Inspection Date: Wed, 14 Jan 2026

Property Address: 4/114 Rooty Hill Rd N, Rooty Hill NSW  
2766, Australia

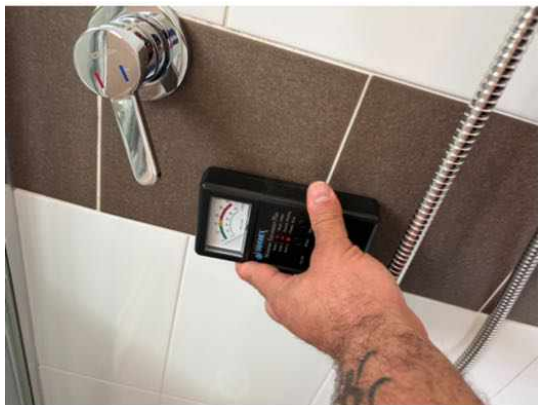
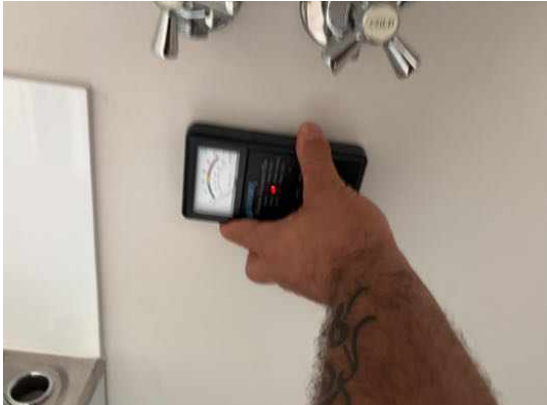
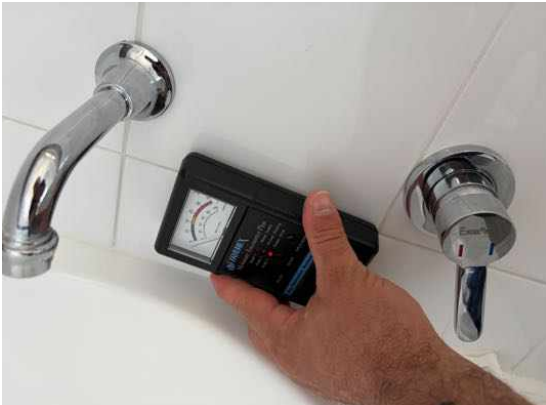
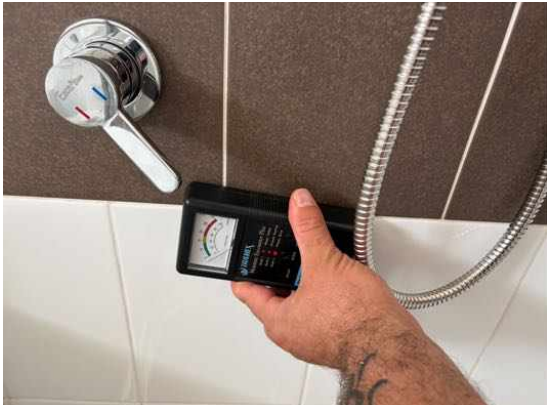
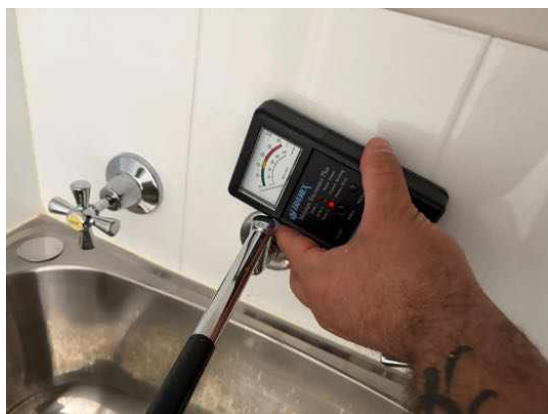
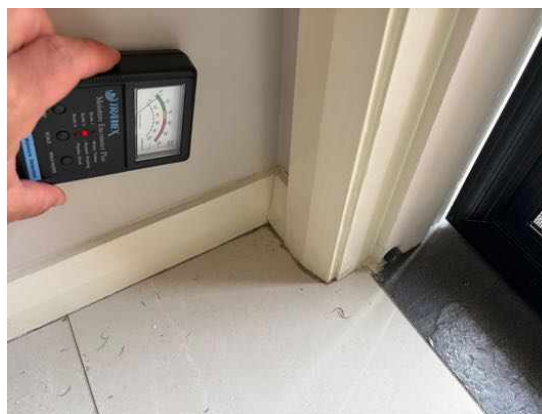
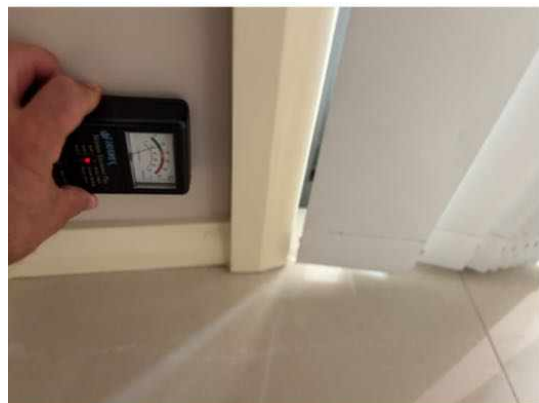
Building: Main Building  
Location: All Areas  
Finding: Moisture metre  
Information: During the inspection the property was checked for moisture using a moisture metre.

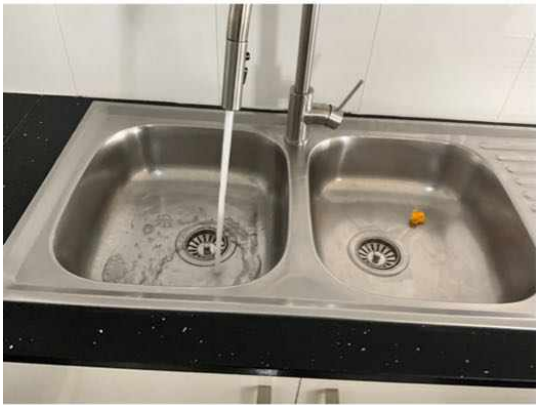
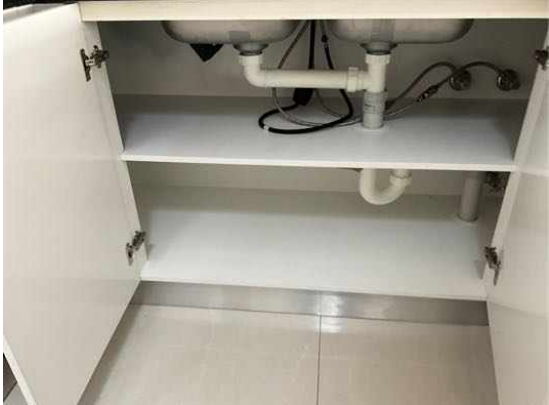
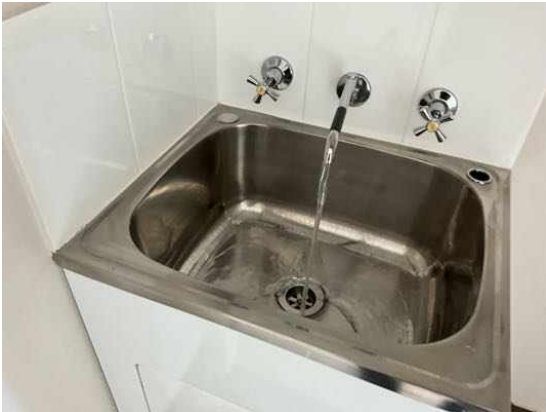
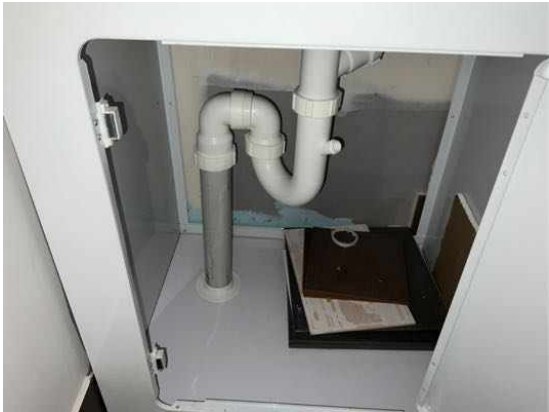
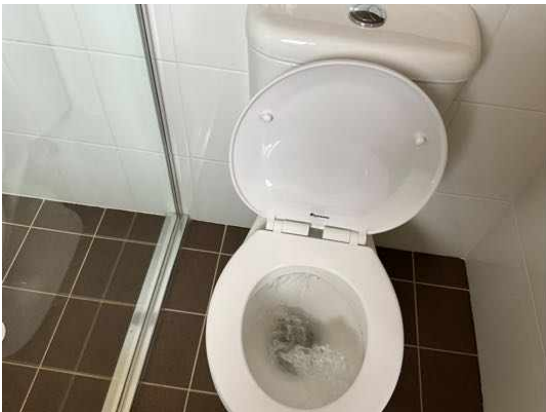
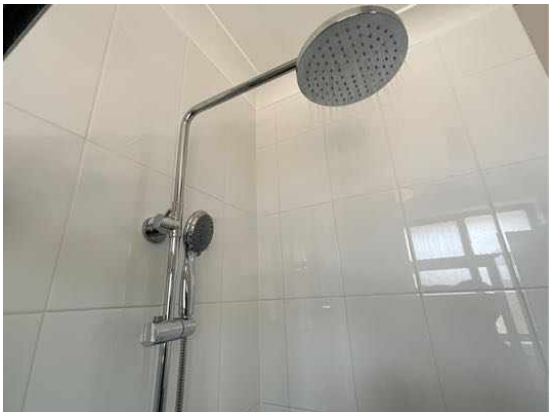
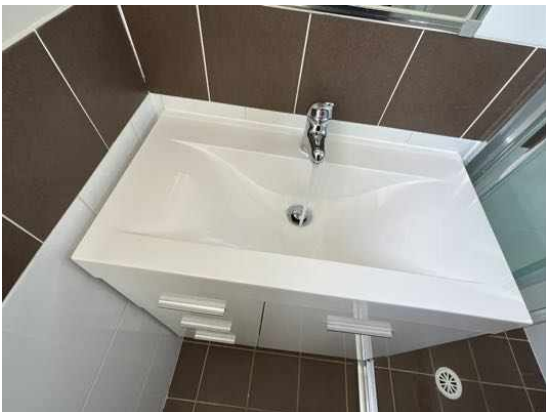
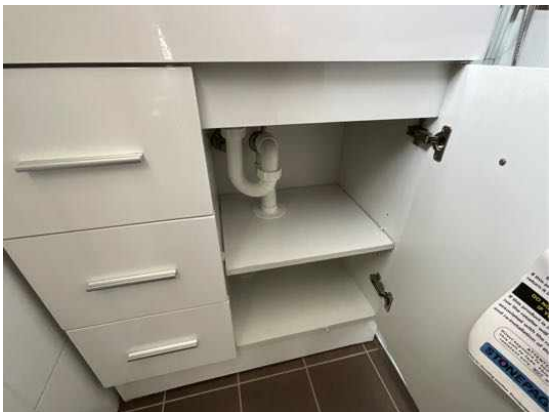
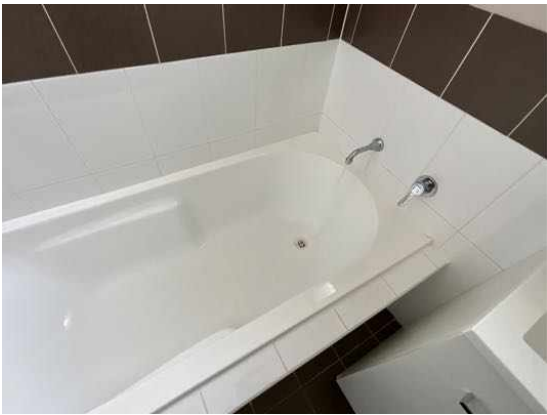
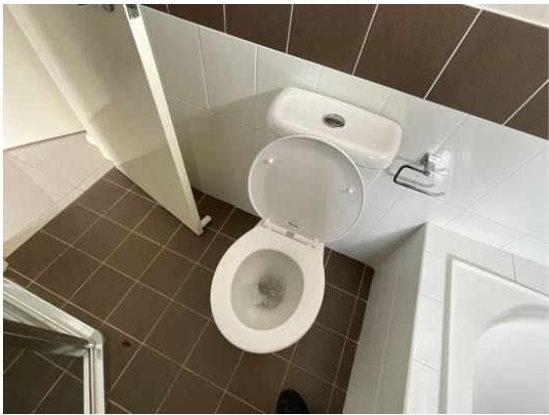
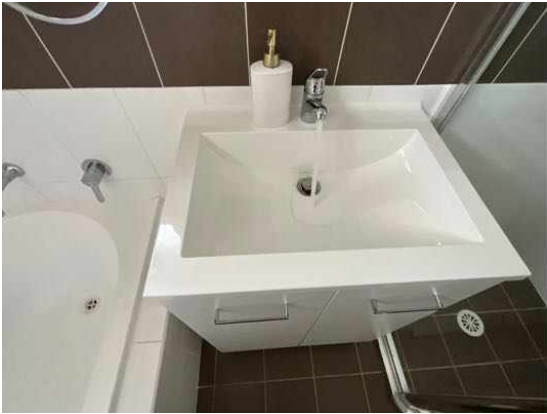
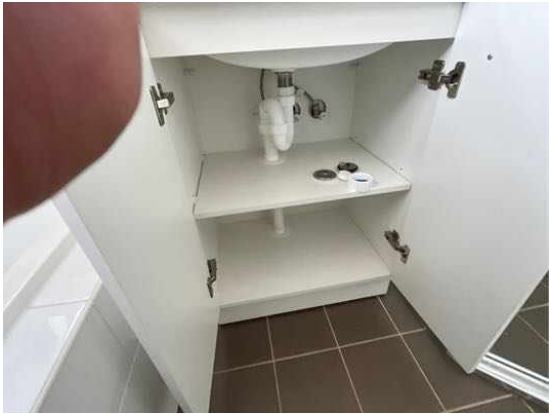
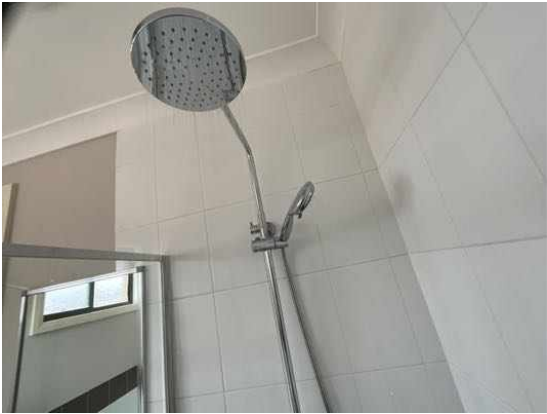
Building: Main Building  
 Location: All Wet Areas  
 Finding: Waterproofing  
 Information:

All taps, mixers and toilets were tested for operation, except for those obstructed. The waterproofing to the shower recess was assessed by checking the walls in and around the shower recess for varying moisture content. There were no significant variations across the tested areas. No sign of recent water damage was evident upon a visual inspection of the surrounding walls, where the visual nature of the inspection was possible.

Consequently, there is no conclusive evidence of any current shower recess leakage other than those which may have already been mentioned earlier in this report. It is reasonable to assume the shower waterproofing is sound. Note that if the shower is not used, or has not been used for some time, moisture readings would not vary significantly and this can lead to erroneous results. It is not possible under the visual inspection criteria (under which a prepurchase inspection is carried out) to categorically determine if there are leaks. If a more accurate assessment is required, a special purpose inspection should be requested. Alternatively, the assumption should be made that the shower may leak.
