Building and Timber Pest Inspection Report

Inspection Date: Mon, 23 Mar 2026

Property Address: 77 Strickland Road East Bendigo

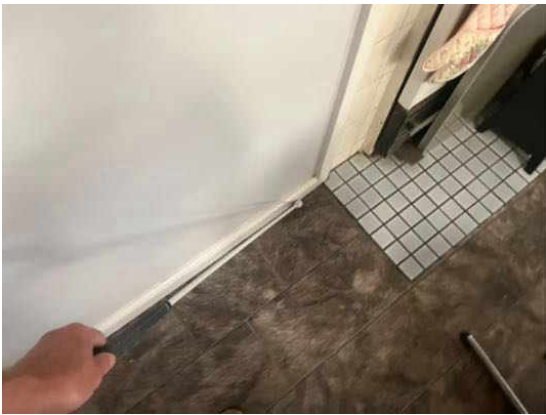
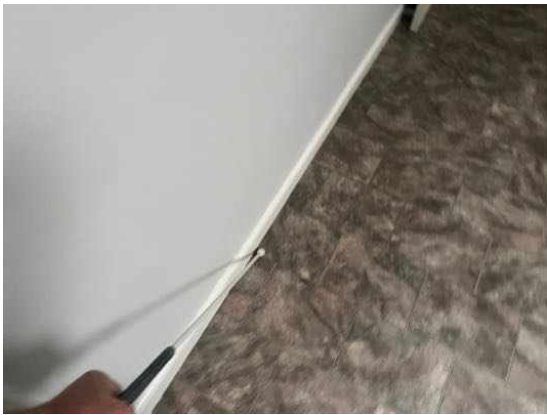
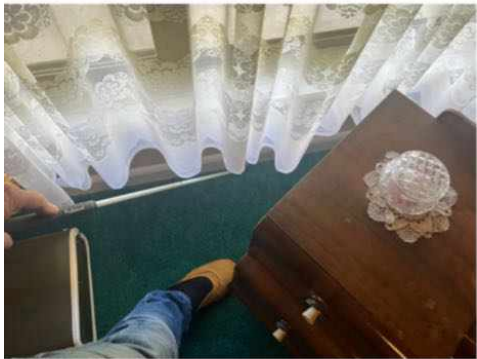
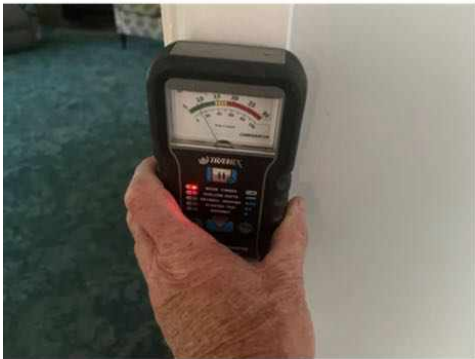
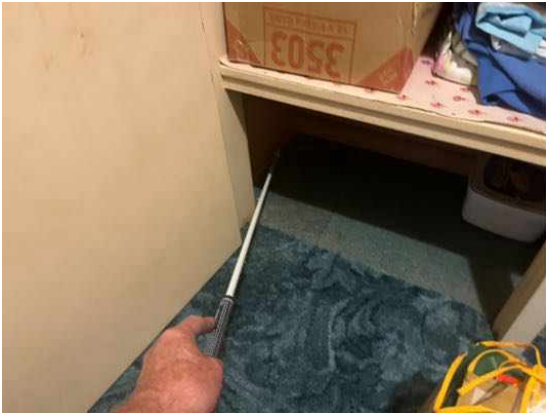
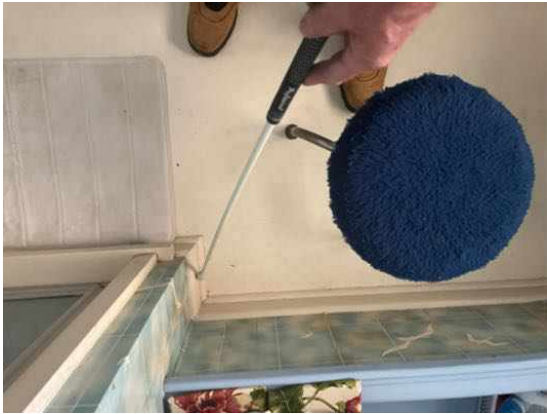
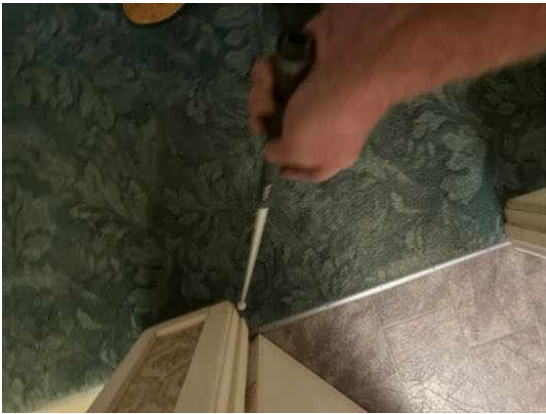
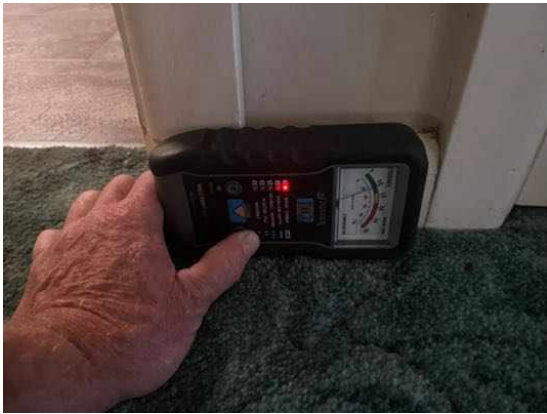
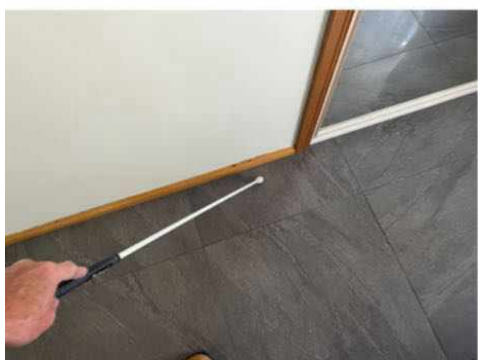
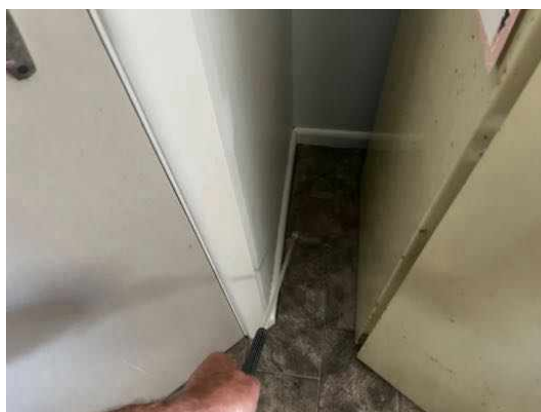
Finding 6.02

Building:	Main Building
Location:	All Areas
Finding:	Termite Management System - no evidence of a chemical installation
Information:	The application of a post-construction chemical termite barrier is highly recommended for all properties, particularly if live termite activity has been found on the site previously. Such barriers are highly effective in preventing termite attack on any timber building elements throughout the property.

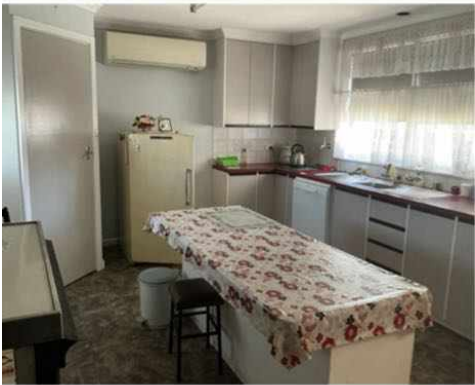
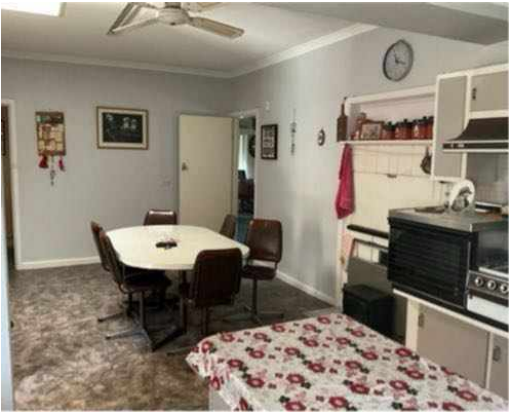
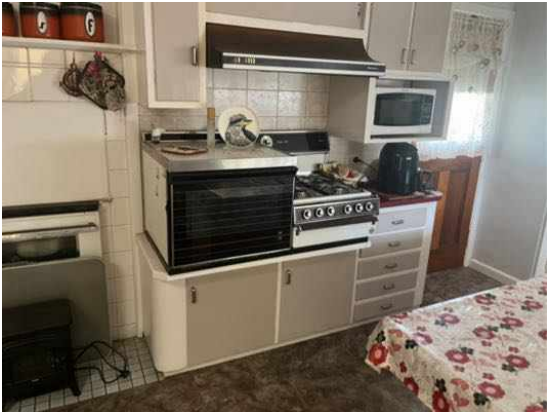
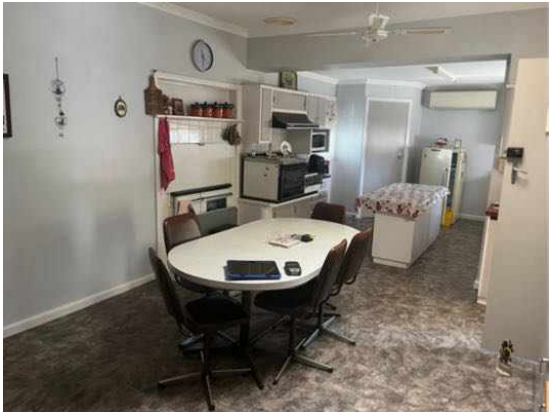
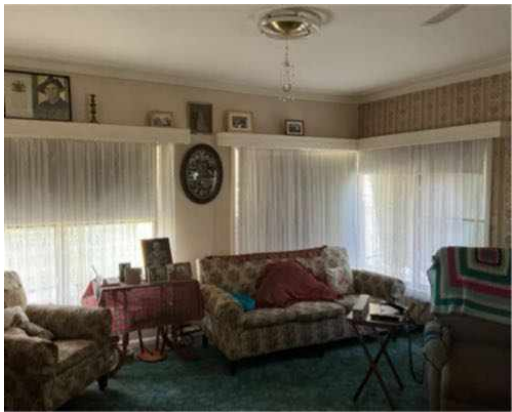
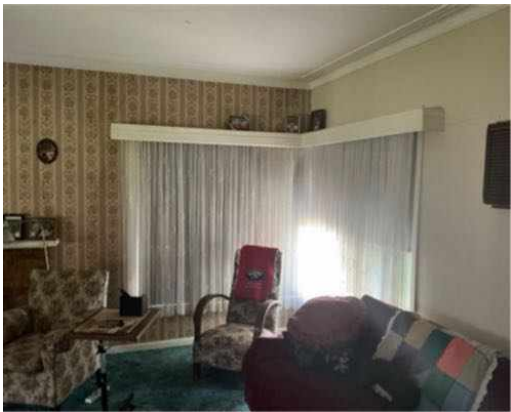
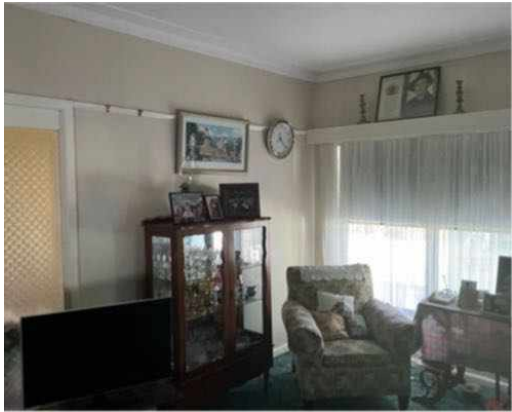
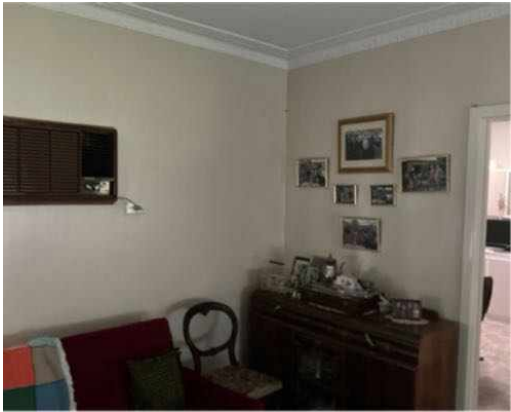
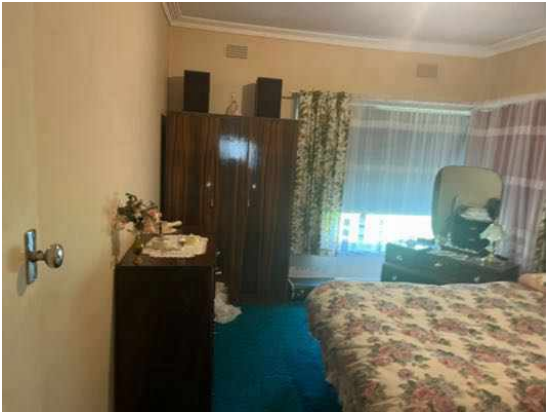
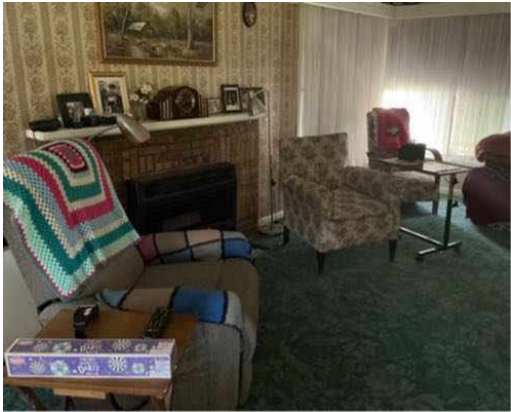
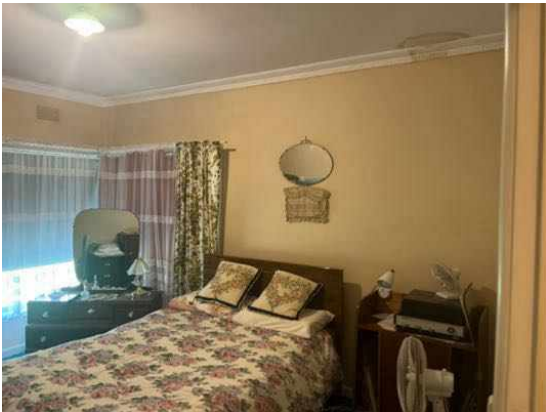
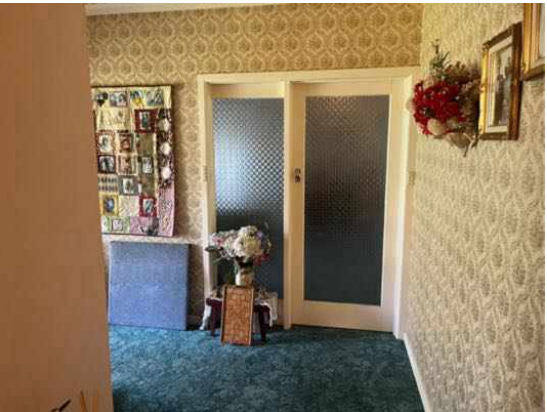
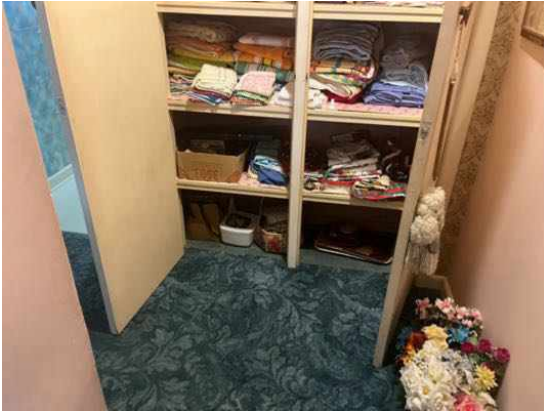
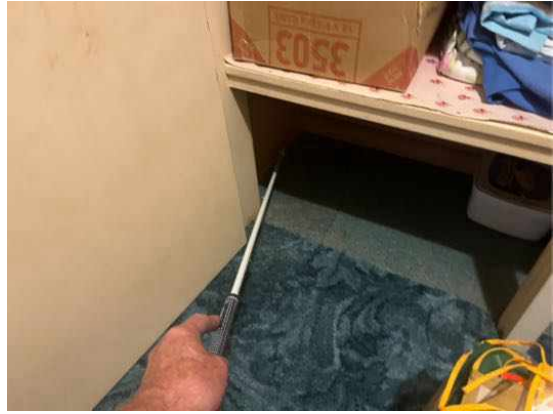
Building: Main Building
Location: All Areas
Finding: Additional Photos
Information: Additional photos are provided for your general reference

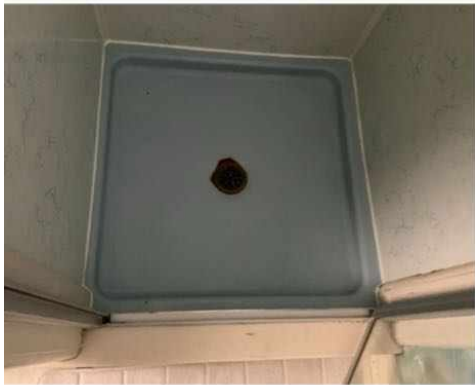
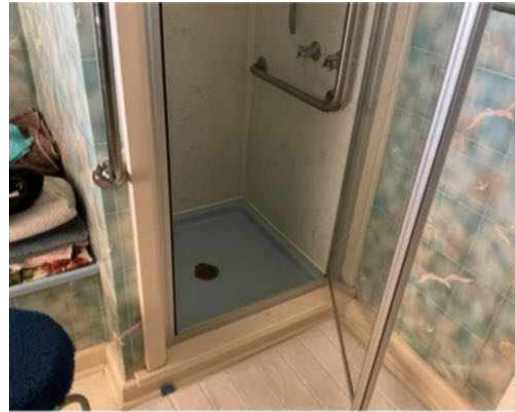
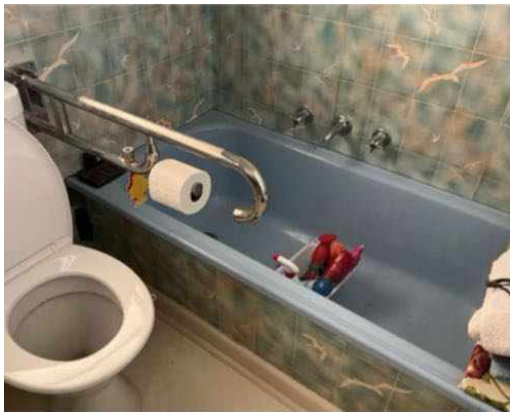
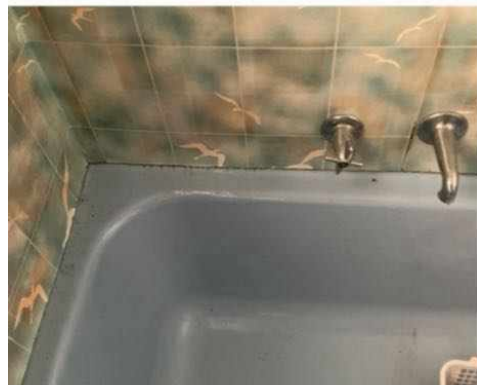
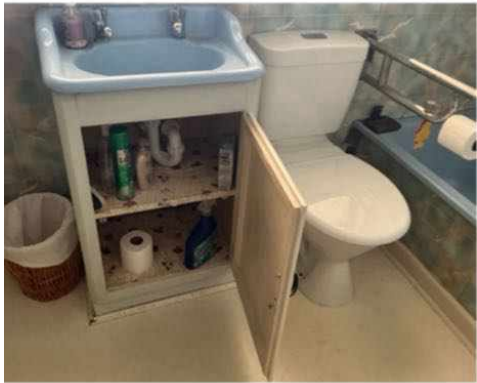
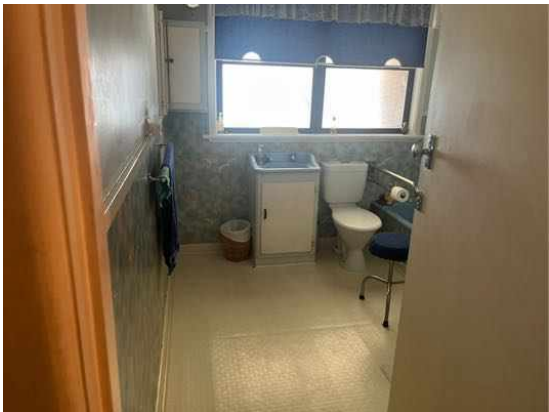
Building: Main Building
Location: Bathroom
Finding: Additional Photos
Information: Additional photos are provided for your general reference
