# Building and Timber Pest Inspection Report

Inspection Date: Sat, 28 Mar 2026

Property Address: 23 Matson Cres, Miranda NSW 2228,  
Australia

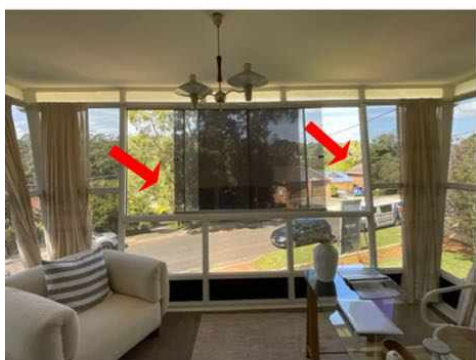
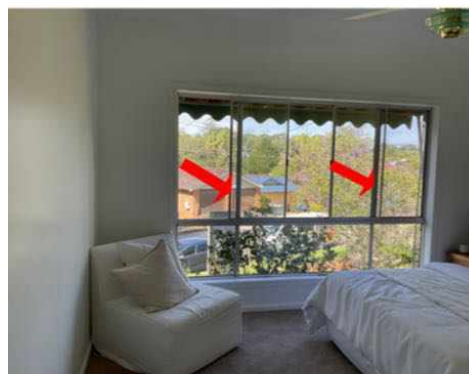
Building:	Building 1
Location:	Exterior walls - front
Finding:	Window opening restrictors missing.
Information:	The Building Code of Australia rules require all openable windows (where the internal floor is more than 2m above the ground outside) in residential rooms to be fitted with a suitable screen or restrictor. Windows located 1.7m above the floor level do not require protection.

Window restrictors are required where people who are vulnerable to the risk of falling have access to windows. This means all windows above ground level which do not have another fall prevention safety measure in place, such as a balcony or balustrade should have a restrictor.

These need to be added urgently for the safety of all persons.

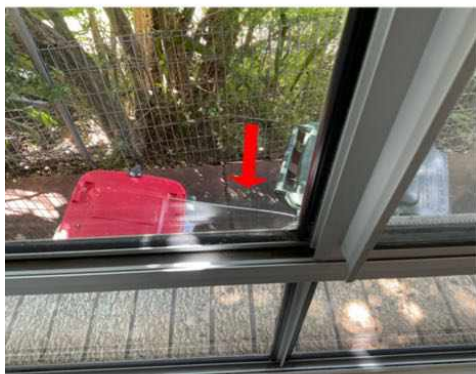
#### Finding 1.02

Building: Building 1  
Location: Sunroom  
Finding: Windows - Cracked  
Information:

Cracks were identified in the windows in this sunroom and lounge areas. Cracking in windows is generally the result of impact damage, and is likely to develop further when left unmanaged. The likelihood of this windowpanes further cracking and shattering is increased exponentially, providing a safety hazard in the area. The cracked windows also impairs the weather tightness of the building, creating potential for minor water leaks.

A qualified glazier is required to repair the window as soon as possible. Depending on the extent of the cracking, replacement of the window may be required.

Due to the unusual angles in the front sunroom windows - leaning outward, the glass, trim and putty holding these windows into their frames should be closely checked every year. Any area of even very minor wood rot need to be repaired immediately.

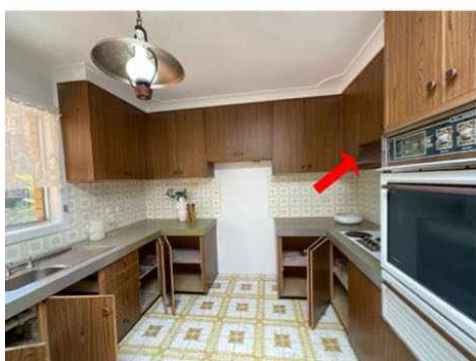
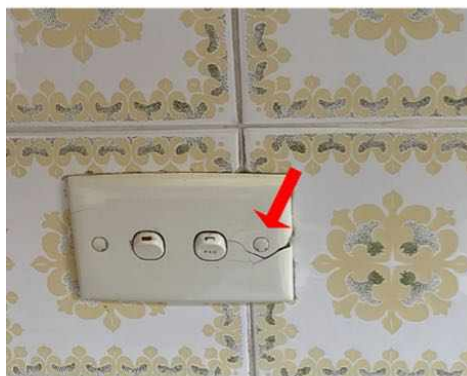
### Finding 1.03

Building:	Building 1
Location:	Kitchen wall power point
Finding:	Rangehood switch damaged
Information:	The rangehood light switch has cracked requiring immediate replacement for the safety of all users.

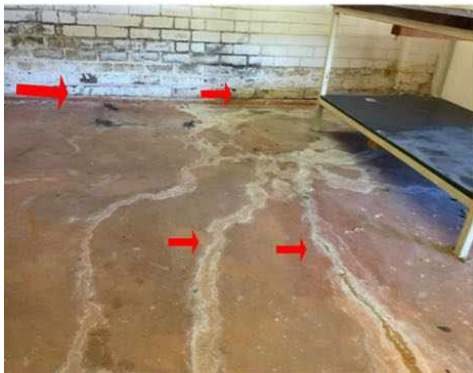
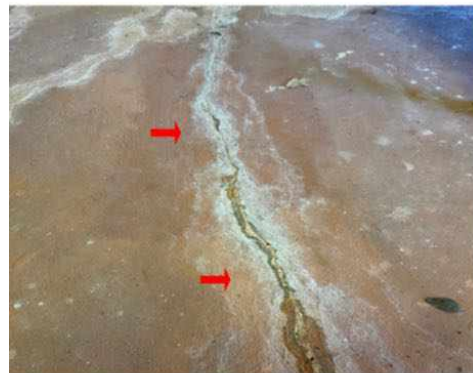
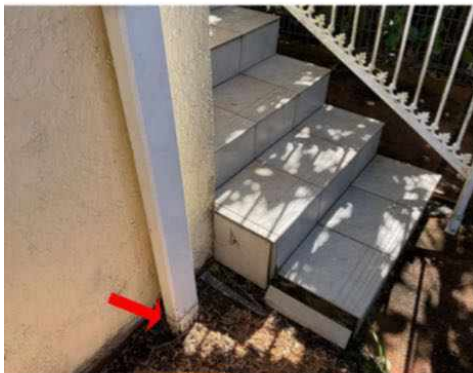
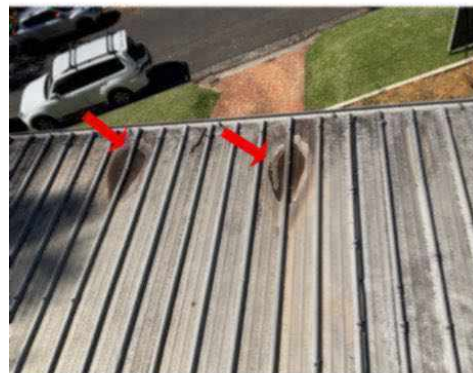
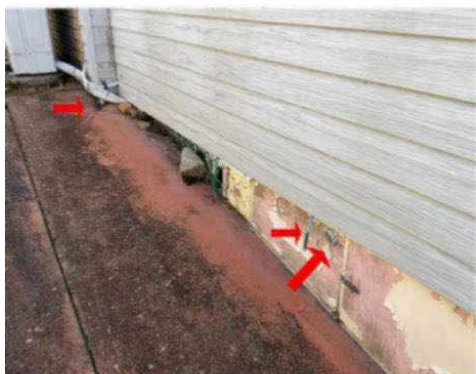
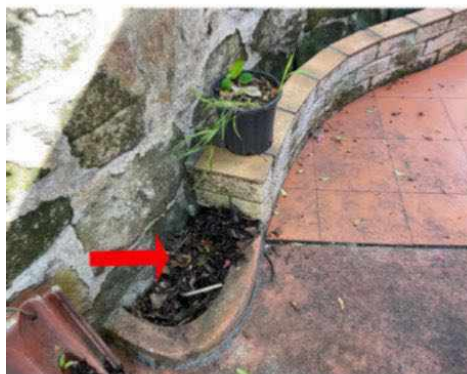
### Finding 2.01

Building:	Building 1
Location:	Walls and front roof.
Finding:	Site drainage - Inadequate
Information:	The site drainage to the property was found to be inadequate at the time of inspection, creating subsequent water damage to subfloor and garage areas.

It appears in high rain events, water enters the rear subfloor and some moisture is coming up through the garage slab, evidenced by the water staining and rising damp found.

This moisture is suspected to be the cause of movement in the house walls and some subfloor walls leading to very uneven floors. This is also thought to be the cause of the garage slab concrete cracking however a structure engineer is required to assess these areas to determine what is causing the uneven floors and cracking.

Other minor drainage defects include the following -

Some gutters and downpipes have rusted. Some water pools on the front flat roof. The air conditioner, some floor wastes and hot water system overflows all run against the left house walls. Many rainwater drains and gutters are blocked from a lack of maintenance.

It is important that water does not lie against the base of walls; surrounding paths and ground levels should be sloped to drain water away from walls. Downpipes should not discharge stormwater onto lower walls or plinths. Stormwater should be carried away by large, regularly cleaned drains. Ground levels may need to be lowered to expose a buried DPC.

Where site drainage is inadequate, installation of an Agricultural (Aggie) Drain may be required. A qualified plumber should be appointed to further inspect the property and perform any remedial works as necessary. Secondary defects are likely to occur if left unmanaged.

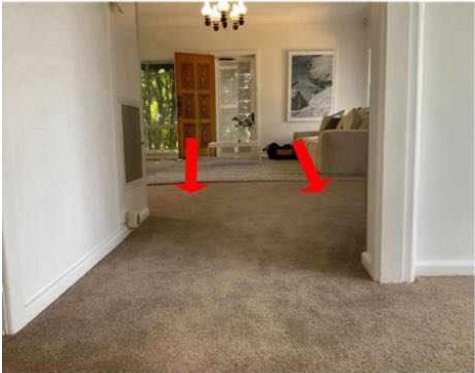
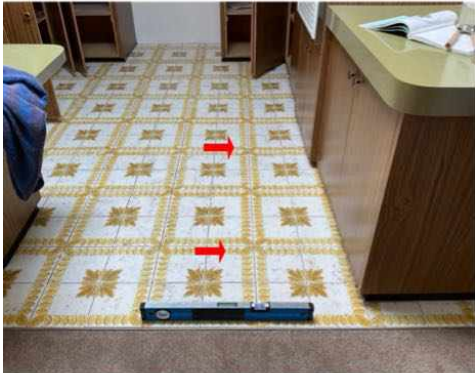
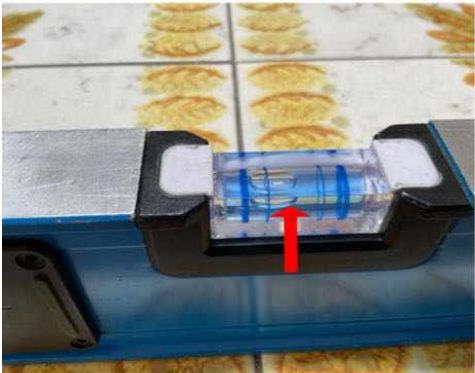
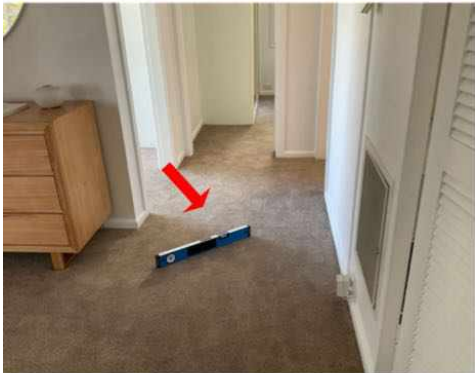
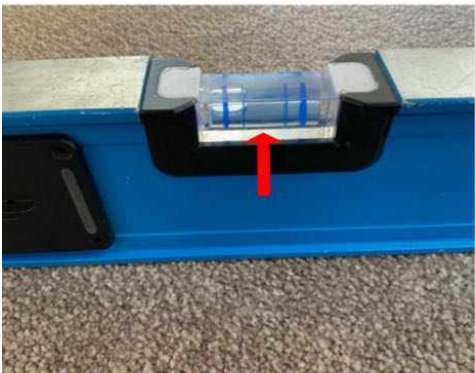
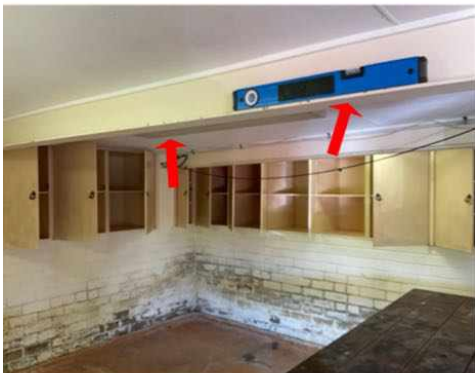
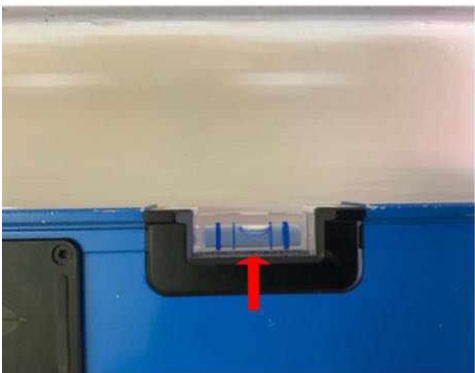
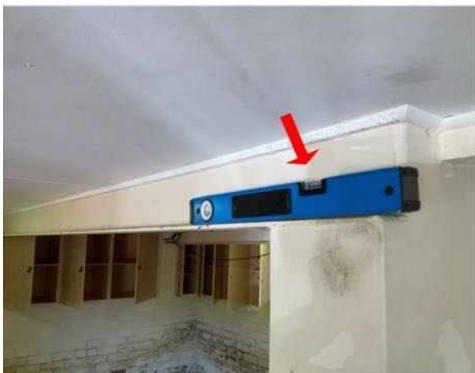
### Finding 3.01

Building:	Building 1
Location:	Most areas
Finding:	Flooring - Uneven
Information:	The internal flooring in many areas is out of level and uneven. Uneven flooring is likely to indicate minor defects such as expected movement of the foundations of the property, but may also indicate subsidence of the associated subfloor stumps.

It is advised that the flooring be closely monitored to identify any further movement. Where flooring remains relatively unchanged for an extended period of time (i.e. several months), it is likely that this defect has been caused by expected movement of the foundations of the property.

However, where flooring is uneven further, potentially invasive inspection of the subfloor structures and stumps in this area is required. In this case, works to repair are likely to be required, and would be carried out by a registered builder specialising in re-stumping.

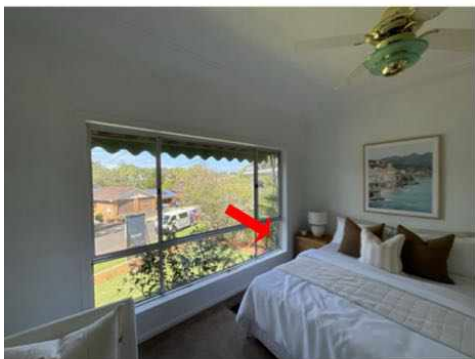
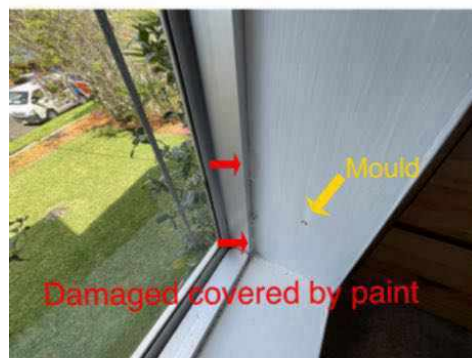
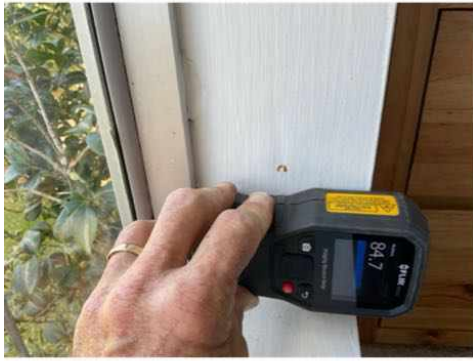
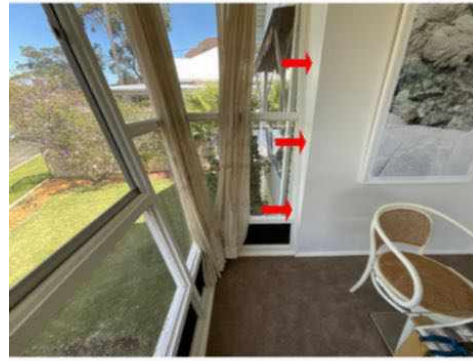
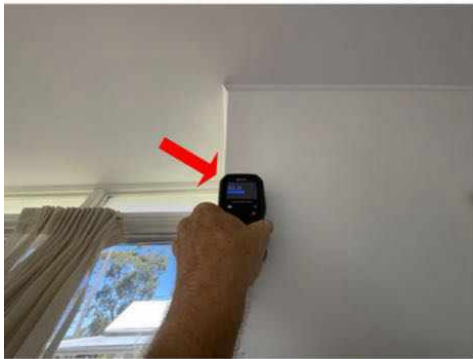
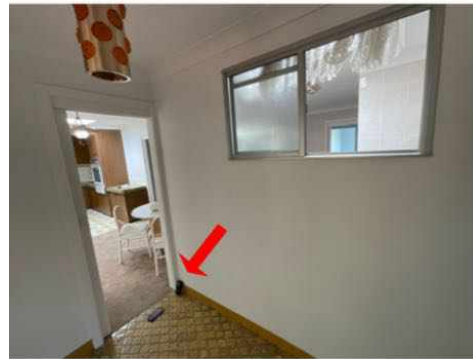
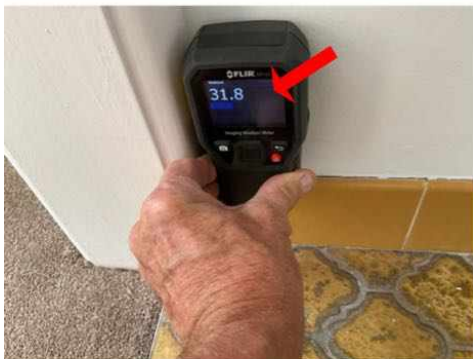
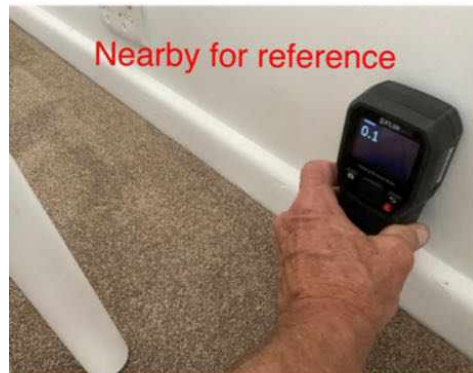
### Finding 3.02

Building:	Building 1
Location:	Bedroom - Master
Finding:	Evidence of excessive moisture was present at the time of inspection
Information:	Excessive moisture can attract termites and produce conditions that promote termite attack, fungal growth and wood decay.

High readings in the master bedroom window frame of 61 (top of window) and 84.7(bottom of window) and 31.8 (behind shower rear wall) were found.

Excessive moisture is generally caused by deteriorated, inadequate or missing roof drainage, leaking plumbing pipes or fixtures, poorly plumbed HWS overflows or condenser units and poor site drainage. It is highly recommended that all plumbing and drainage fixtures and fittings be maintained regularly in order to prevent excessive moisture being present in the internal property.

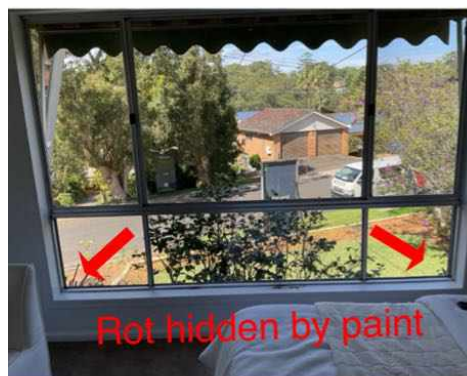
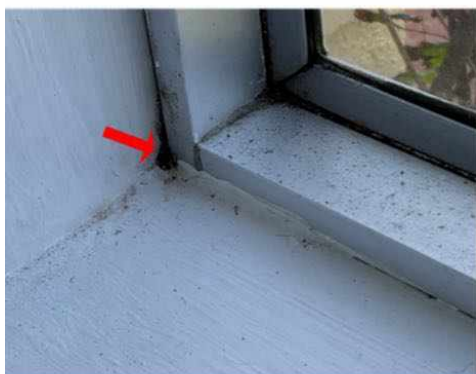
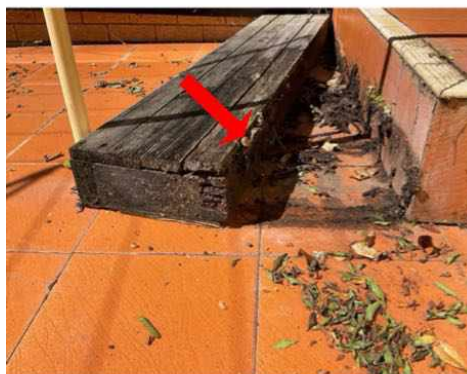
### Finding 3.03

Building: Building 1  
 Location: Pictured areas  
 Finding: Wood rot  
 Information:

The building shows evidence of wood rot. Wood rot, also known as Fungal Decay, occurs when timbers and other cellulose building materials are exposed to damp conditions on an ongoing basis. This could be the result of exposure to weathering over a prolonged period of time, or the attraction of excessive moisture from other abutting building materials.

cause of the moisture that has created the visible wood rot should be identified and addressed in a suitable manner. Replacement of affected timbers may then be a necessary step in protecting surrounding building elements from such deterioration.

A qualified carpenter or registered builder may also be required to replace affected building materials.

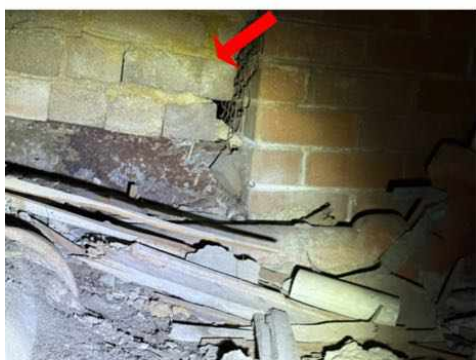
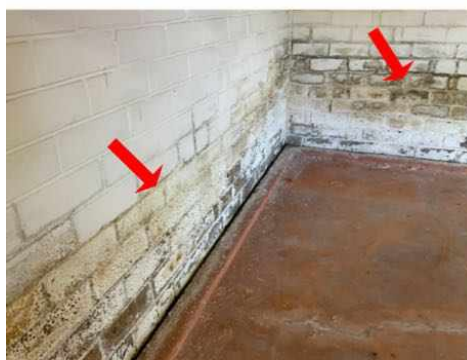
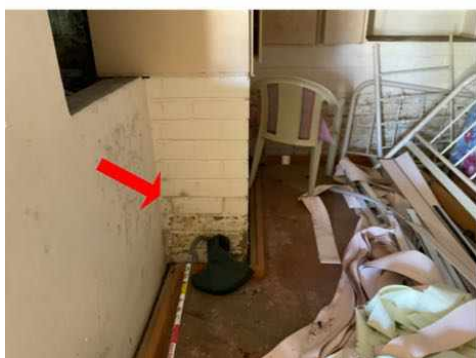
### Finding 3.04

Building:	Building 1
Location:	Subfloor
Finding:	Damp - Rising
Information:	Rising damp was found in many subfloor and garage area. This describes the upward movement of water in low sections of building elements (e.g. walls) by capillary action - the movement of water through porous materials such as bricks, sandstone or mortar.

Rising damp is generally managed by the installation of a damp proof course during construction. A Damp Proof Course (DPC) is an impermeable barrier at the base of the wall above ground level. However, many 19th Century buildings have no damp course installed, or the materials have failed. The DPC may have been omitted as a consequence of poor workmanship, or it may have been bridged where materials built up against the side of the house allow moisture ingress above the DPC level.

The first step in addressing rising damp is to diagnose the cause. The identified cause should be addressed first before addressing the appearance and other defects which have resulted from the rising damp. If the original cause is not resolved, further cases of damp are likely to ensue, resulting in secondary defects.

Consultation with a qualified plumber is advised immediately to identify the cause of the damp and perform remedial works as required.

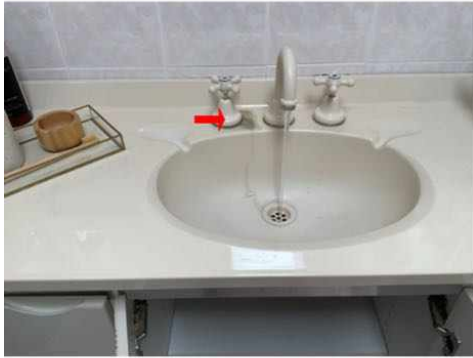
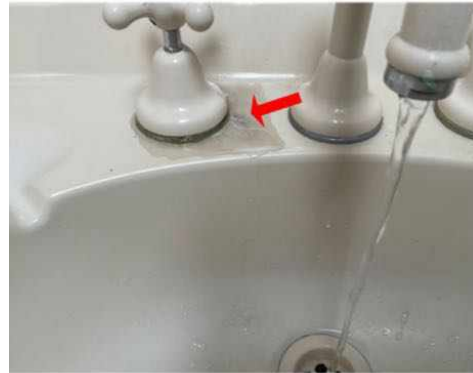
### Finding 3.05

Building:	Building 1
Location:	Bathroom
Finding:	Tap - Leaking and no pressure in the vanity
Information:	The tap in this vanity area was found to be leaking with poor flow at the time of inspection. This is a common defect that is consistent with general ageing of the building element. However, it may be indicative of substandard plumbing workmanship if the tap is relatively new.

While this defect only seems minor, if left unmanaged, it is likely to result in the

development of rust, water damage and/or extensive water usage.

It is advised that a licensed plumber be appointed to perform remedial works on the affected tap. Such works should be performed prior to the development of secondary defects to ensure adequate functionality of all associated building elements.

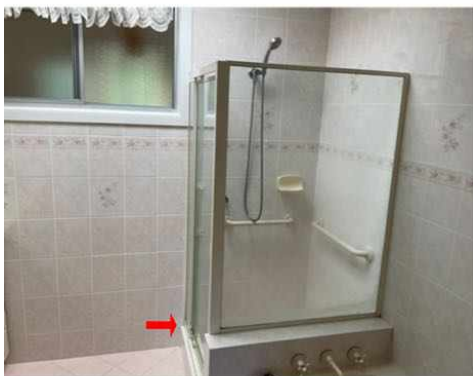
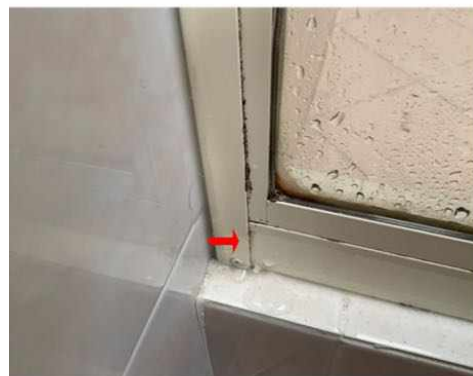
### Finding 3.06

Building:	Building 1
Location:	Bathroom
Finding:	Shower screen - Leaking
Information:	Leaking was evident to the shower screening at the time of inspection. It is suspected that the leaking has occurred as a result missing sealant. Leaking from the shower , where left unattended, is likely to lead to water damage to adjoining flooring and walls. Such damage can lead to water damage and necessitate extensive remedial works being required. Active water leaks may also create an environment that is susceptible to the formation and development of mould.

Appointment of a sealant expert is required to repair or replace this missing sealant. Such works should be performed as soon as possible to ensure that no further damage occurs.

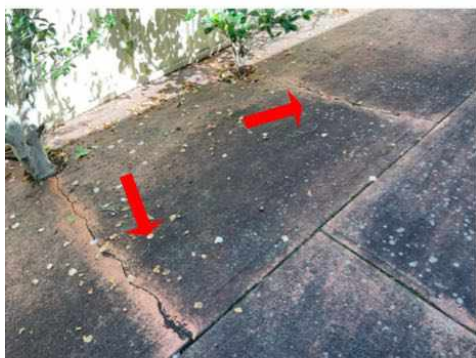
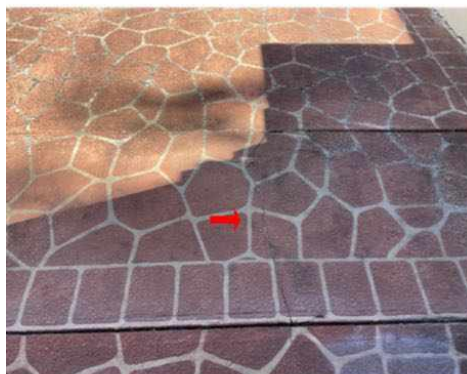
Building:	Building 1
Location:	Yard and garage
Finding:	Crack in concrete slabs - Category 1
Information:	Cracks coded as Category 1 was identified in these pictured slabs. A Category 1 crack is described as a fine but noticeable crack, with the slab at an otherwise reasonable level. To be considered Category 1, the approximate width of the crack is less than 1.0mm, or a less than 10mm change in offset when a 3m straight edge is placed over the defect.

Category 1 cracks should be monitored for a period of 12 months. At the end of the monitoring period, identified cracks that are rated greater than Category 2 are considered defects, and require rectification.

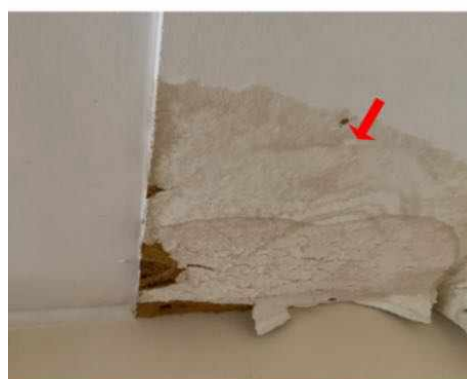
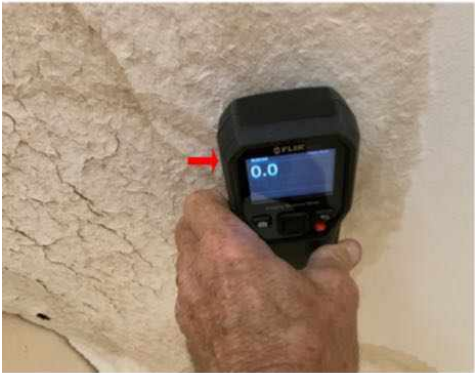
### Finding 3.09

Building:	Building 1
Location:	Garage
Finding:	Ceiling - Water stained
Information:	Water staining to ceiling linings in this area was evident at the time of inspection. Water staining indicates that surfaces have been exposed to excessive moisture over time. The minerals and other elements in the water lead to staining, which may graduate to corrosion and deterioration if left unmanaged.

While mostly an appearance defect, water staining can be indicative of more serious defects, which may be currently concealed by interior ceilings.

Where water staining is active, a licensed plumber must be consulted to identify the cause of the staining and to provide advice on any reparation works that may be required. Replacement of any damaged structures is advised.

Conversely, where water staining is old and inactive (no moisture was found here) the affected building materials may be repaired or replaced at client discretion.

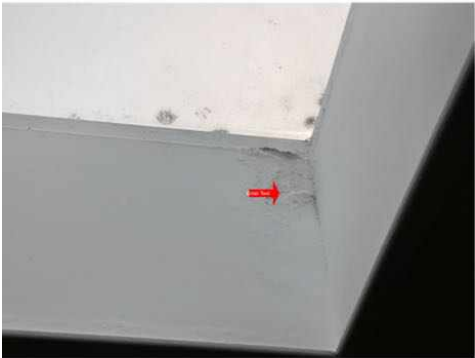
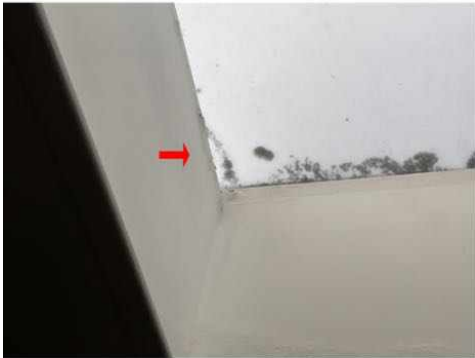
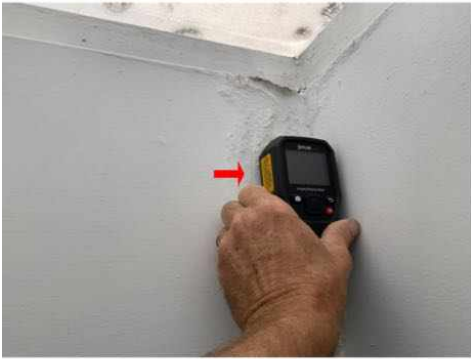
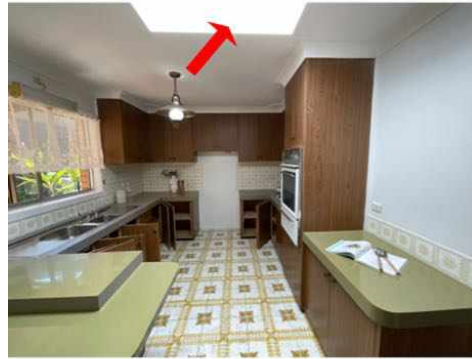
**Finding 3.10**

Building: Building 1  
Location: Kitchen  
Finding: Swollen skylight cladding  
Information: Swollen building elements generally indicate that the building materials have been affected by excessive moisture over a prolonged period of time, and have swollen as a result. The structural integrity of swollen building elements cannot be guaranteed, and further damage is possible if these areas are left unmanaged.

No moisture was found here after 6 tests of this skylight area.

Repair or replacement of swollen building elements should be conducted by a qualified carpenter or cabinet maker.

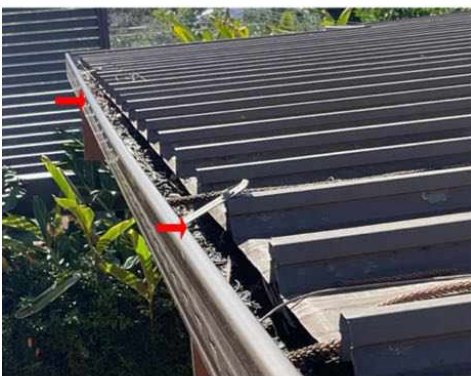
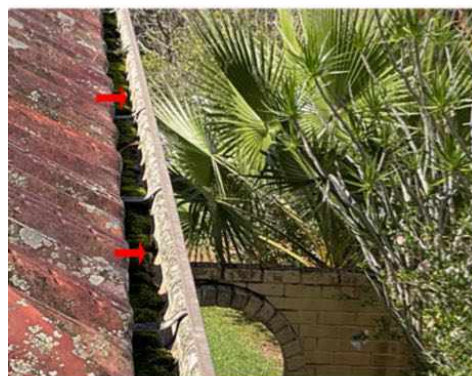
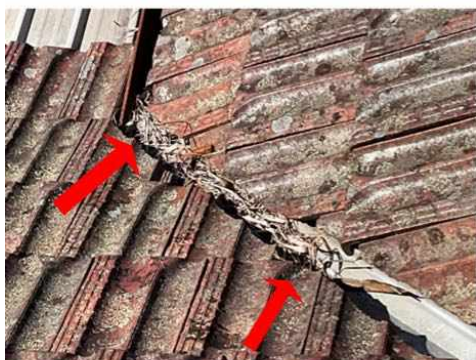
### Finding 3.11

Building:	Building 1
Location:	Roof exterior
Finding:	Gutters - Full and blocked
Information:	The guttering on around the roof was found to be blocked at the time of the inspection. Roof plumbing structures, such as guttering and downpipes, should be free of all debris to prevent blockages. Blockages of the guttering and downpipes will lead to pooling and accumulated water overflows, which is likely to subsequently flood eaves and exterior walls.

Blocked gutters are likely to lead to high levels of moisture in the affected areas which can cause rust and decay of the gutters and downpipes and wood rot to adjoining timber areas. Blockages in gutters should therefore be removed immediately to ensure dry conditions are maintained.

It is highly advised that gutters be cleaned by the homeowner or a general handyperson as a matter of urgency.

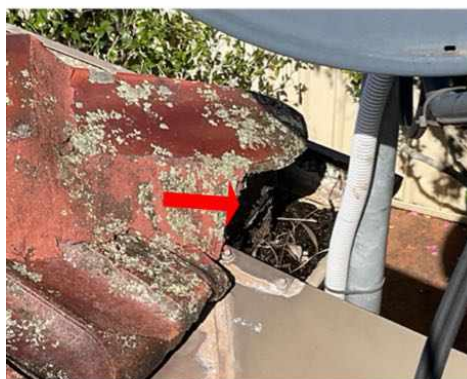
Building:	Building 1
Location:	Roof Exterior
Finding:	Roofing areas - Weathered
Information:	Upon inspection of the exterior roofing, the majority of the roof areas were considered to be in fair condition. All fungi and leaf debris need to be removed for an accurate assessment. While weathering of these pictured areas is consistent with the age of the property, maintenance works are required.

Re-sealing and replacing small areas of gaps, damage or rust the may be considered

as an interim solution by the client to help preserve and extend the life span of these roofing areas. Where left unmanaged, deteriorating roofing materials are likely to lead to a number of secondary defects, including minor water leaks and weather exposure to internal roofing structures.

Consultation with a roofing contractor is highly advised to gain advice on cost of remedial works that may be required in the short to medium term.

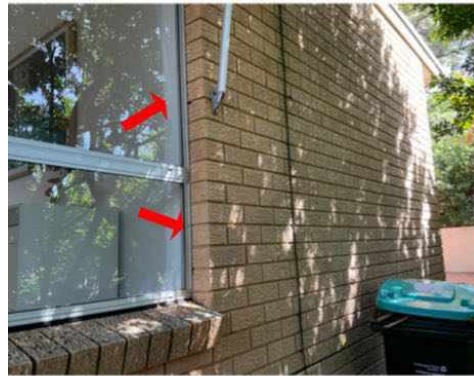
### Finding 3.14

Building:	Building 1
Location:	Pictured Areas
Finding:	Sealant (external) - Missing.
Information:	It was noted on inspection that areas of external sealant was missing to small areas of the external walls.

Flexible sealants should be applied to these affected areas to prevent any subsequent water damage that is likely to occur.

A sealant specialist or skilled handy person should be appointed to complete these works as soon as possible

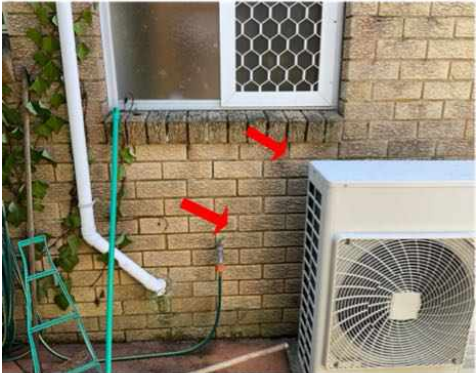
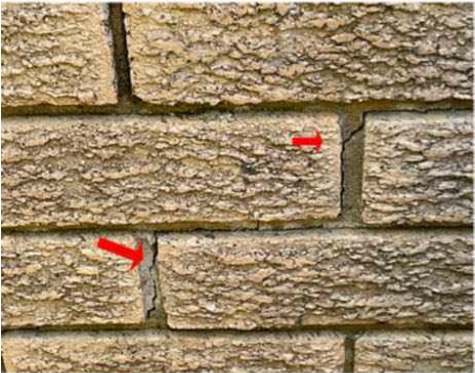
Building:	Building 1
Location:	Exterior wall
Finding:	Step cracking to brickwork (very minor)
Information:	Step cracking was identified to the brickwork in this area at the time of inspection. Step cracking, which is similar to other forms of cracking, has a variety of possible causes. However, the most common is the subsidence of adjacent footings.

Step cracking is a relatively common defect, and is most likely to occur adjacent to windows, doors and other openings. Mortar failure in the gaps between affected bricks indicates the stresses and tensions affecting the wall.

Where step cracking is extensive or severe, the client is advised to consult a structural engineer. Minor step cracking can be used as a warning sign to address factors causing stress to the wall, which can include the effect of surrounding trees, water leaks, soil erosion, or even the presence of reactive soils in the surrounding area.

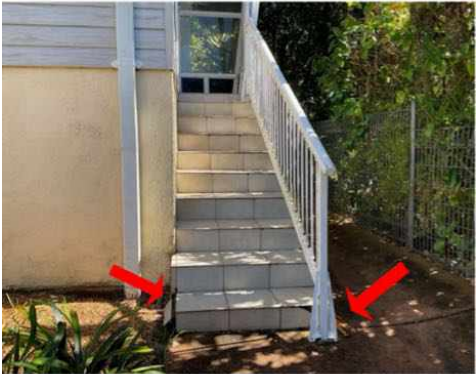
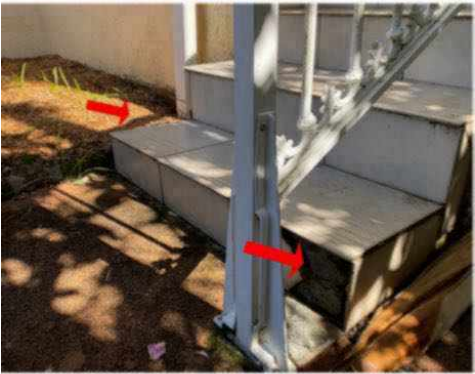
**Finding 3.17**

Building: Building 1  
Location: Stairs, Kitchen, Bathroom  
Finding: Tiles cracked, loose, missing  
Information: Damaged tiles were evident in these pictured areas at the time of inspection. It is suspected that this cracking has occurred as a result of minor settlement or impact damage.

Cracked tiles throughout the household detract from the overall appearance of the affected areas. In wet areas of kitchens and bathrooms, it can lead to water damage of adjoining walls and floors.

Replacement of cracked tiles is recommended as soon as possible. A tiling contractor may be appointed to perform these works. Where cracks become more numerous, contact a licensed building inspector for further investigation.

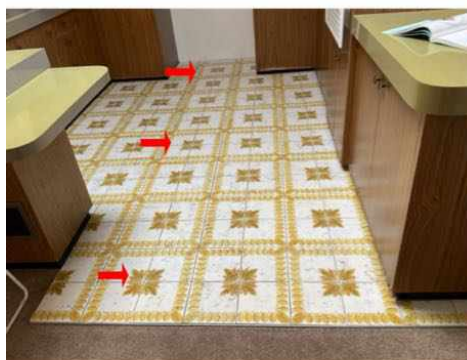
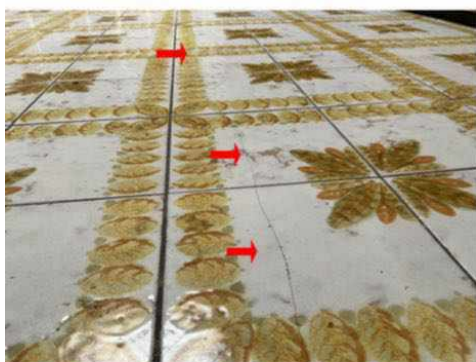
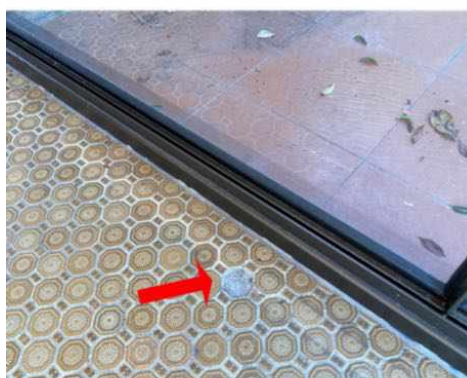
### Finding 3.18

Building:	Building 1
Location:	Kitchen, Bathroom, Laundry
Finding:	Tiles - Drummy
Information:	Drummy tiled areas were identified at the time of inspection. The term 'drummy' refers to tiles that have become detached from their fixing, despite otherwise being in relatively good condition. Such defects are generally caused by physical or moisture damage to the area. Drummy tiled areas may also be a direct result of poor workmanship during the construction process.

Tiled areas may swell and shrink with changes in air humidity if the area has sustained moisture damage. Any exposure to moisture is capable of causing tiled areas to become drummy and/or cracked over a prolonged period of time. Drummy tiled areas generally require removal and replacement of affected tiles, with adequate sealant and grouting.

Specialist trades are available for these types of services. A registered builder may be required to undertake works if damage is extensive or if secondary building defects have resulted. Otherwise, it is advised that a tiling contractor be appointed to perform works as necessary. Immediate action is recommended to ensure that no further damage is sustained in the affected area.

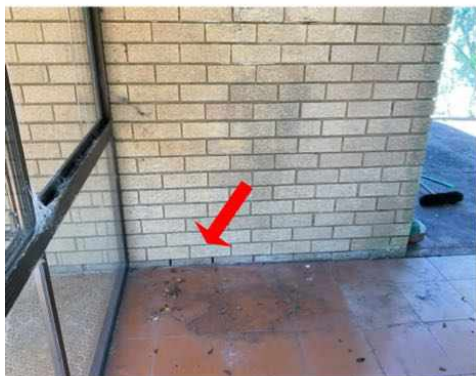
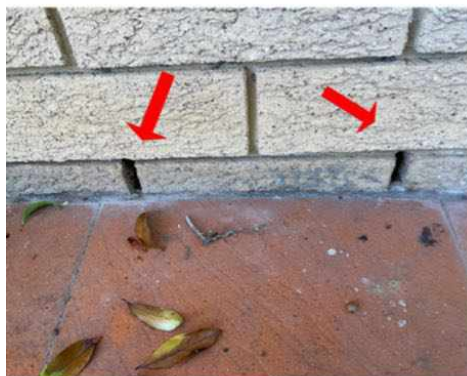
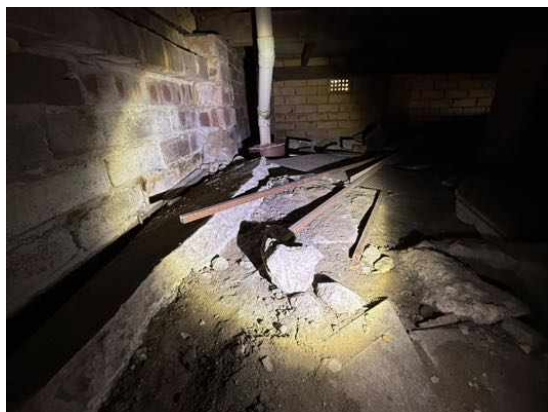
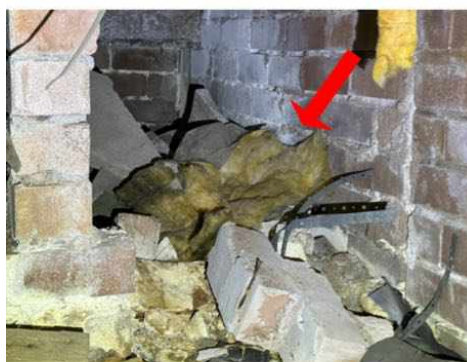
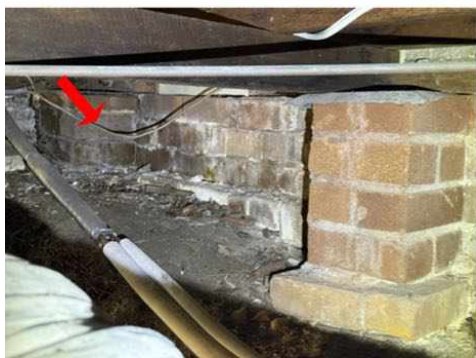
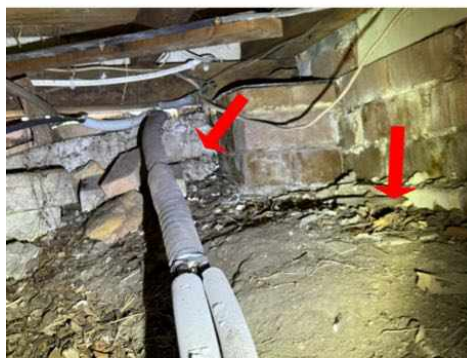
### Finding 3.24

Building:	Building 1
Location:	Rear right verandah corner and rear subfloor
Finding:	Concrete spalling
Information:	This verandah and rear subfloor has suffered minor Concrete Spalling. This is the breakdown of concrete via natural weathering and/or chemical reaction that results in sections of cement chipping off the main body – often resulting in fractured, compromised concrete. Spalling looks like pitted acne scarring and breaks off in flecks which can expose rebar.

A concreting contractor can provide advice on repairs of these damaged concrete areas when convenient.

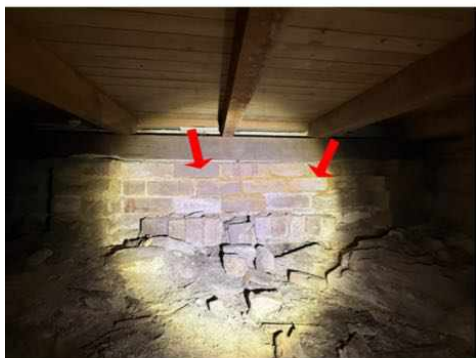
Building:	Building 1
Location:	Subfloor under laundry rear wall
Finding:	Evidence of rear minor termite damage & possible front termite activity
Information:	Despite no live termite or timber pest activity being found, previous termite damage was found to have affected this rear subfloor formwork. This rear damage is considered to be inactive and is minor in nature. Possible termite activity was found in the master bedroom wall where excessive moisture was found and an unknown substance on the window sill. Photos of this material was sent to a timber pest (termite) controller, however it still could not be identified.

Termites require moisture and will access walls where moisture is present which is the case here (see excessive moisture defect). Damage to this wall has been filled and painted over. This may be wood rot or termite activity or both and will only be determined by an invasive inspection by opening up this wall.

It is advised that a timber pest controller undertake an invasive inspection of this wall to rule out live termite and possible previous termite damage.

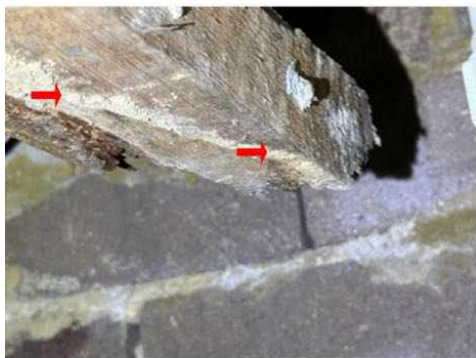
Generally this takes the form of finished ground levels external paving or concrete being retrospectively installed above the damp course level the adjacent internal floor level or weep and ventilation holes.

Where bridging has occurred full inspection is prevented and termites may enter a property in a concealed or undetectable manner.

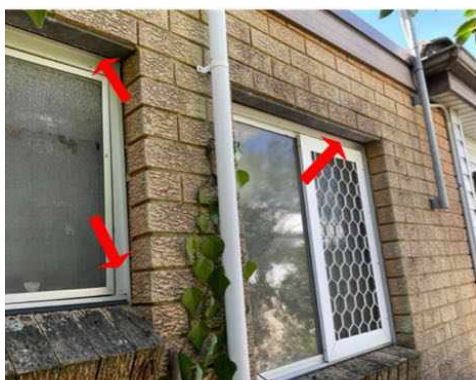
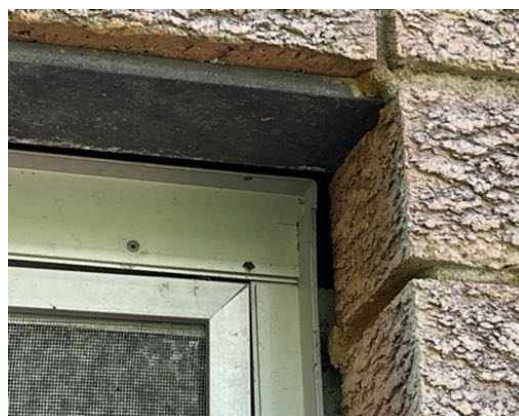
Note - see all photos in Sealant external (missing) in the above building report defects.

A sealant specialist or skilled handy person should be appointed to complete these works as soon as possible.

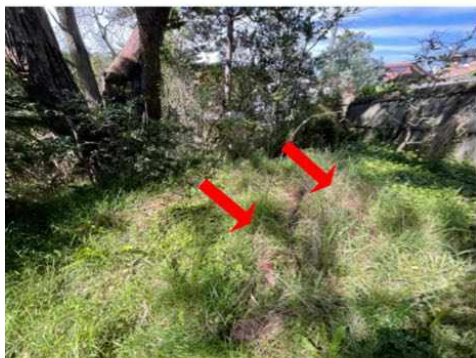
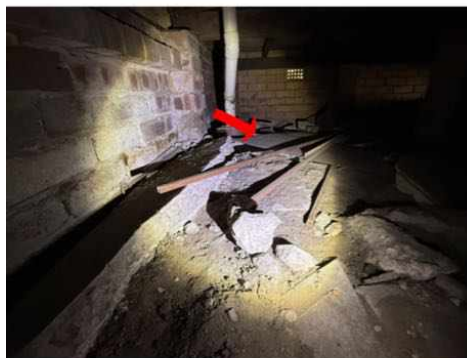
### Finding 6.03

Building: Building 1  
 Location: Yard - Back and subfloor  
 Finding: Timber in contact with the ground  
 Information: Any timbers in direct ground contact provide opportunity for concealed termite entry and are likely to be subject to premature rot and decay as the soil retains moisture or damp conditions against the timbers.

Removal of all waste timber that is in direct contact with ground is highly advised. This timber is promoting mould and wood rot and is very attractive to termites.

Frequent pest inspections are advised to readily identify any termite activity in these areas.

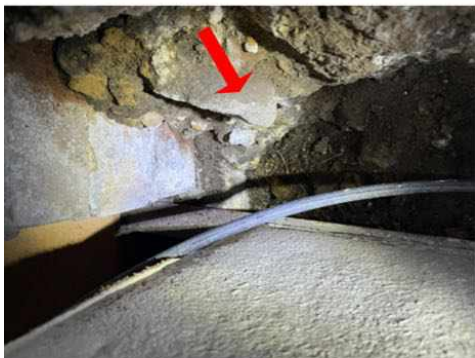
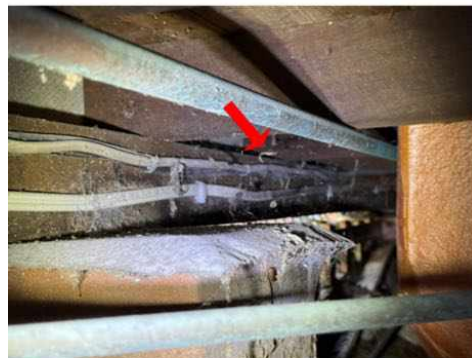
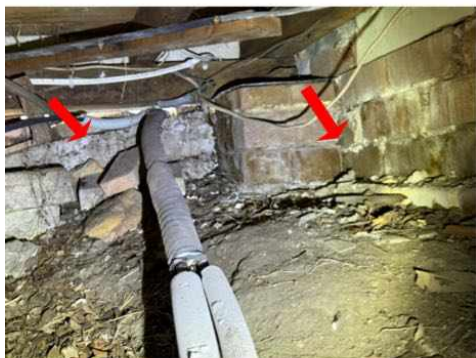
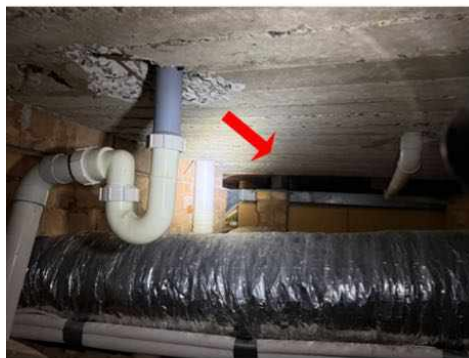
Building:	Building 1
Location:	Subfloor
Finding:	Subfloor ventilation - Inadequate
Information:	Adequate subfloor ventilation aids in preventing excessive moisture wood rot and termite activity by ensuring a dry subfloor environment.

Where ventilation is substandard or blocked, it is usually caused by factors such as failure to install adequate vents during construction or earth and vegetation covering vents. Low subfloor clearance and stored items or debris in the subfloor also restricting airflow.

Subfloor ventilation can be improved in most cases by addressing the causes such as exposing subfloor vents, installing additional vents, installing mechanical ventilation and removing debris from the subfloor.

A registered builder should be appointed as soon as possible to perform these works as necessary.

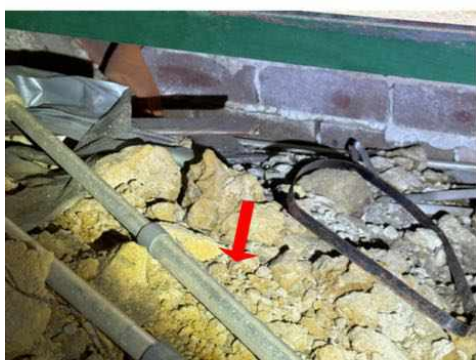
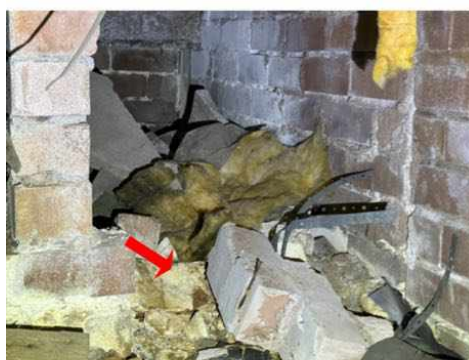
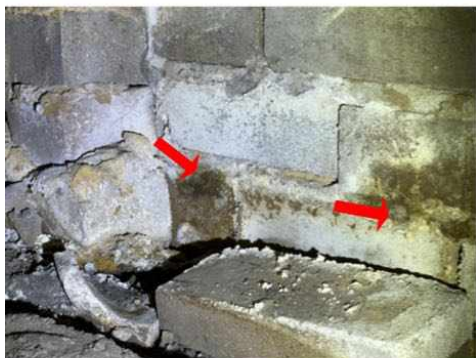
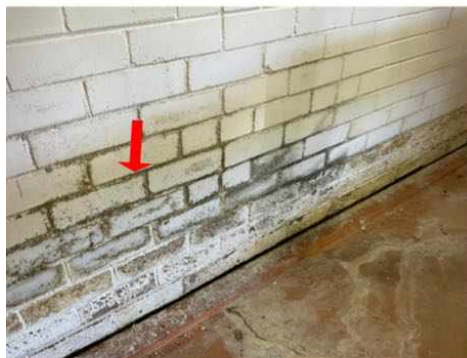
### Finding 6.07

Building:	Building 1
Location:	Subfloor and garage
Finding:	Mould - Present in subfloor
Information:	Where evidence of mould growth was noted, there may be environmental, biological or health issues associated with the report. A specialist inspection by a suitably qualified environmental health inspector is warranted, where mould is extensive or where any queries regarding air quality spores or other related issues apply.

Subfloor mould is generally caused by moisture ingress, lack of external drainage, lack of adequate ventilation and subfloor debris present. These issues need rectification

to stop mould development. Any mould found during the inspection should be cleaned immediately by a cleaning contractor or the homeowner as applicable.

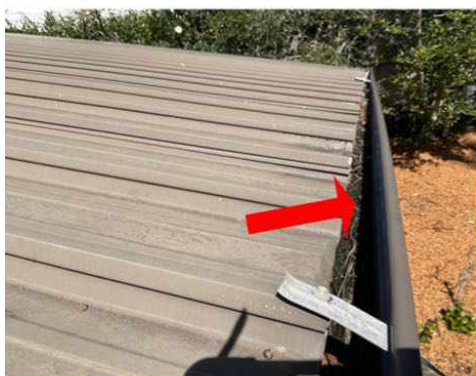
### Finding 6.08

Building:	Building 1
Location:	Roof exterior
Finding:	Gutters - Full and blocked
Information:	The guttering on around the roof was found to be blocked at the time of the inspection. Roof plumbing structures, such as guttering and downpipes, should be free of all debris to prevent blockages. Blockages of the guttering and downpipes will lead to pooling and accumulated water overflows, which is likely to subsequently flood eaves and exterior walls.

Blocked gutters are likely to lead to high levels of moisture in the affected areas. Such moisture will not only cause rust and decay of the associated building materials, but can also provide conditions that are conducive to termite and timber pest activity. Blockages in gutters should therefore be removed immediately to ensure dry conditions are maintained.

It is highly advised that gutters be cleaned by the homeowner or a general handyperson as a matter of urgency.

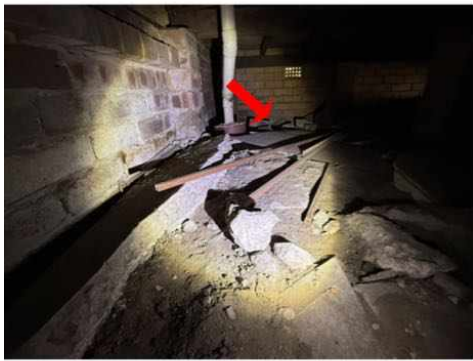
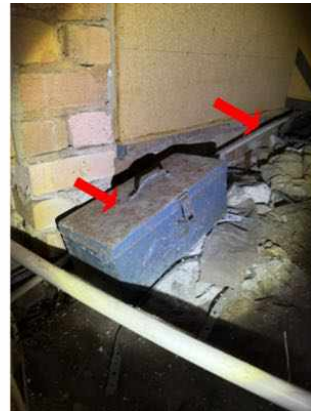
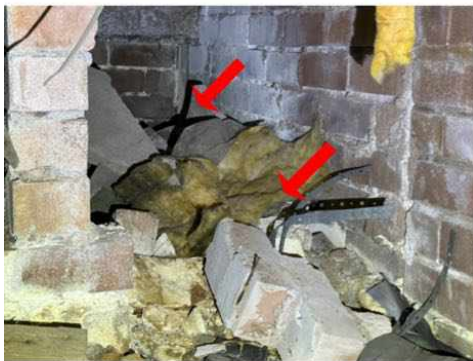
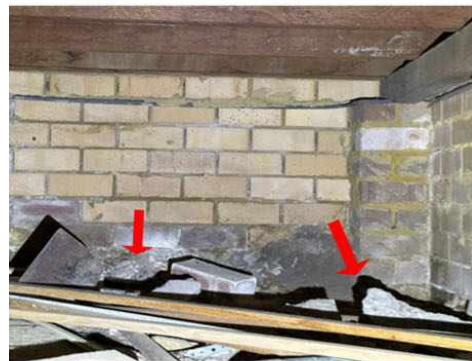
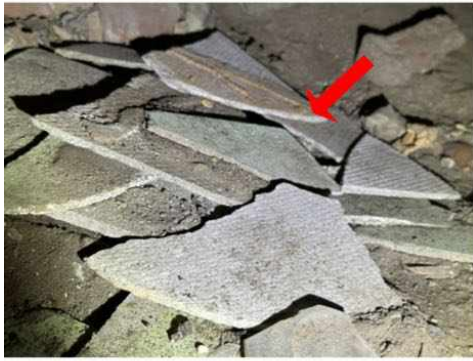
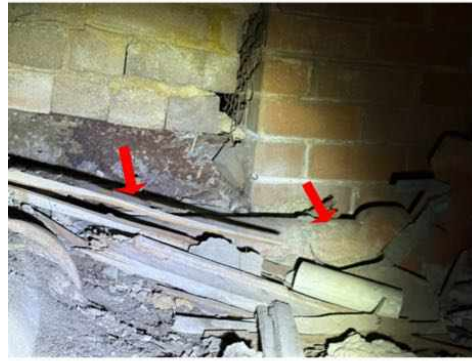
### Finding 6.09

Building:	Building 1
Location:	Subfloor

Information: An array of debris was found in the subfloor area at the time of inspection. Debris in this area restricts subfloor ventilation and creates potential for concealed pest entry. Stored timbers and other materials may also make the area susceptible to termite activity and wood rot.

Debris in the subfloor should be removed as soon as possible. Depending on the location and amount of debris and stored items, the homeowner may elect to undertake this task. Alternatively there are a large number of rubbish removal subcontractors that could undertake these works.

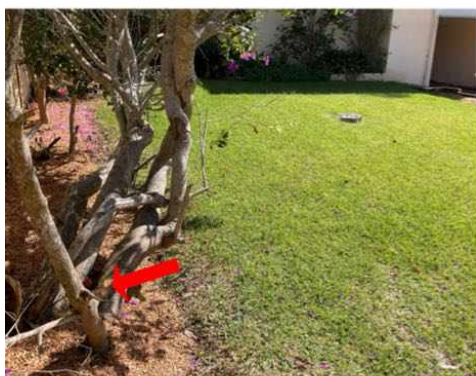
### Finding 8.01

Building:	Building 1
Location:	Some trees
Finding:	Evidence of wood borer activity identified
Information:	Wood borers small beetles that colonise in exposed timber elements are a common timber pest that are regularly mistaken for termites. Although wood borer activity is generally not detrimental to the affected timber they may lead to serious damage and necessitate replacement of certain building elements if left unattended.

As no live wood borer activity was identified treatment is not required at this time. Replacement of affected timbers may be considered by the client for superficial reasons.

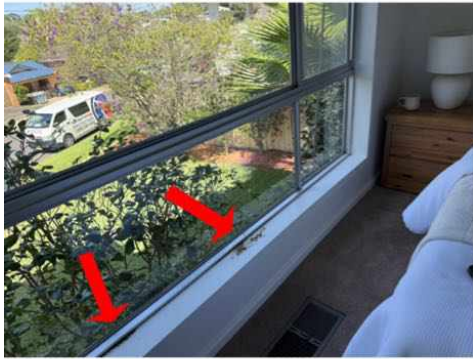
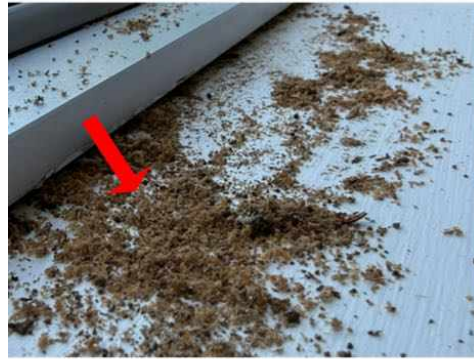
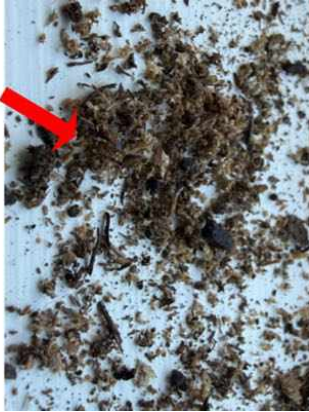
Building: Building 1  
 Location: Master bedroom  
 Finding: Additional Photos of pest material identified  
 Information: Additional photos are provided of this material found on the master bedroom window sill. This material could be from regular ants, termites or another source.

An invasive inspection by opening up this plaster wall is highly recommended to rule out the presence in termites in the area.

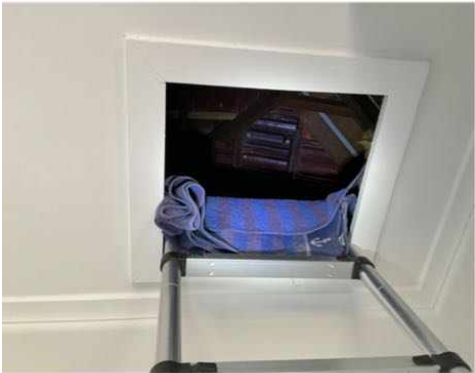
Building:	Building 1
Location:	Roof Void
Finding:	Sarking - Missing
Information:	Sarking is missing under the roof sheeting. Sarking acts as an insulator that helps with noise reduction and protects against water penetration. Sarking plays a key role in the operation and function of the overall roofing structure and its performance.

Although not a requirement at the time of construction, replacement of any missing building element is advisable (although this can be quite expensive to do after the time of construction). Where sarking is missing, regular inspections of the roof tiles for cracking and potential moisture penetration is required.

Sarking may be retrospectively fitted by a registered builder at the discretion of the client.
