# Building and Timber Pest Inspection Report

Inspection Date: Sat, 28 Mar 2026

Property Address: 23 Matson Cres, Miranda NSW 2228,  
Australia

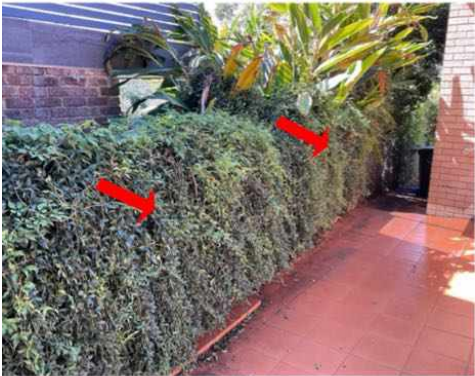
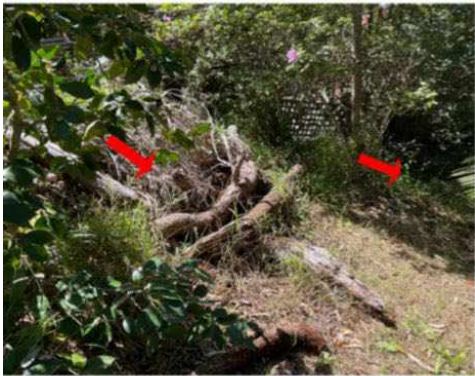
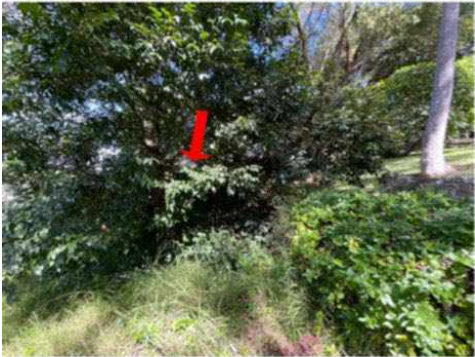
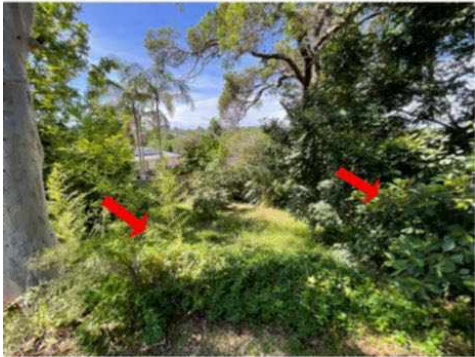
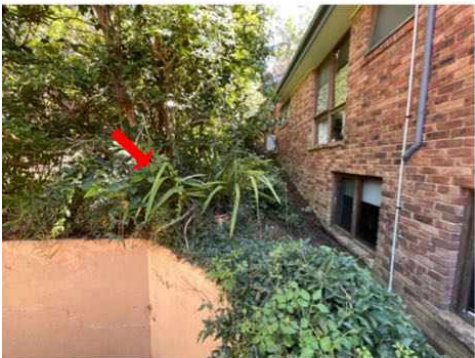
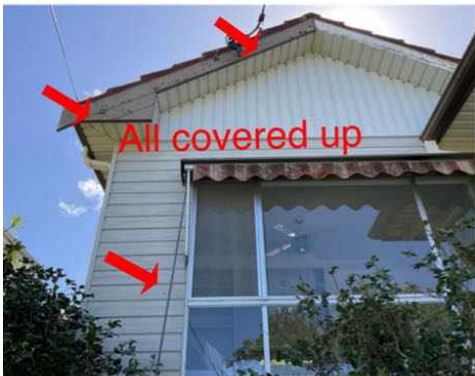
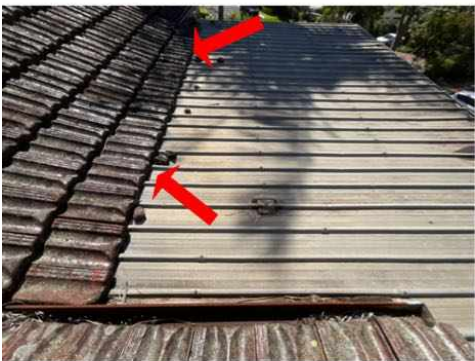
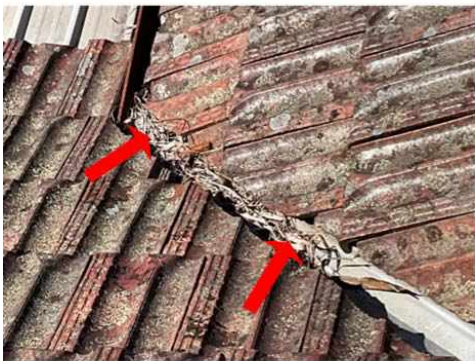
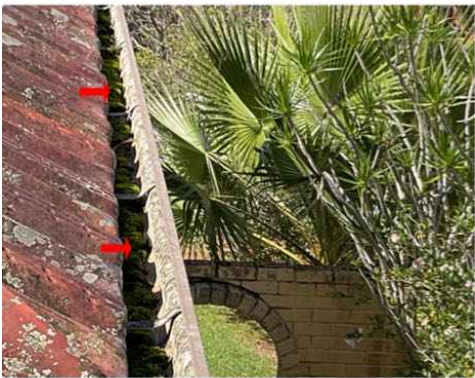
Building: Building 1  
Location: All External Areas  
Finding: Additional Photos - Obstructions and Limitations of EXTERNAL AREAS  
Information: These photographs are an indication of the obstructions and limitations which impeded full inspection of external areas at the time of inspection. These obstructions can hide an array of defects and should be removed to allow full inspection to be carried out. A re-inspection is recommended once the areas are made accessible.

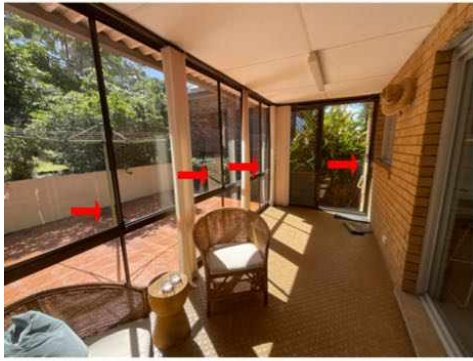
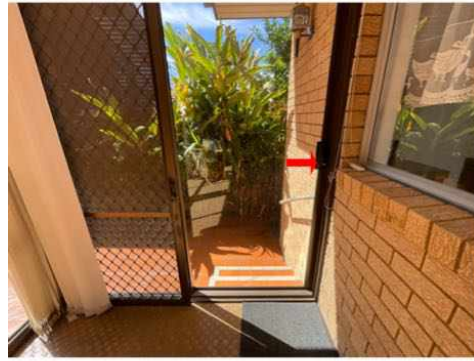
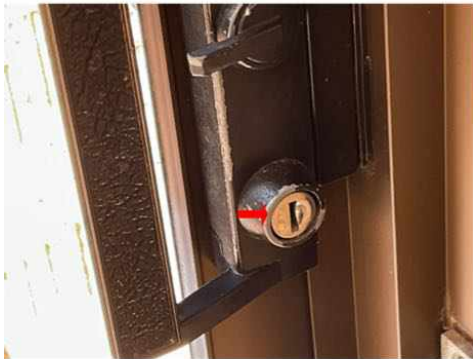
Building: Building 1  
Location: All Internal Areas  
Finding: Additional Photos - Obstructions and Limitations of INTERNAL AREAS  
Information: These photographs are an indication of the obstructions and limitations which impeded full inspection of Internal areas at the time of inspection. These obstructions can hide an array of defects and should be removed to allow full inspection to be carried out. A re-inspection is recommended once the areas are made accessible.

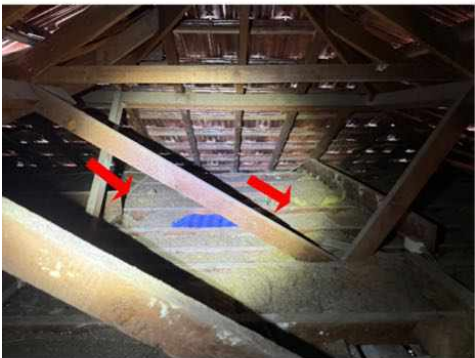
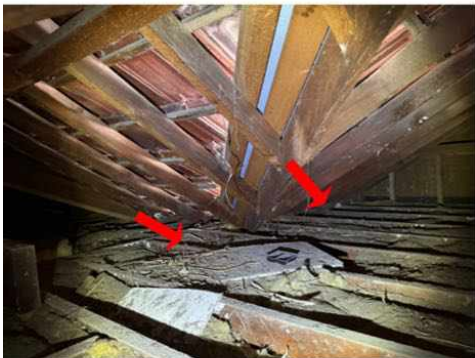
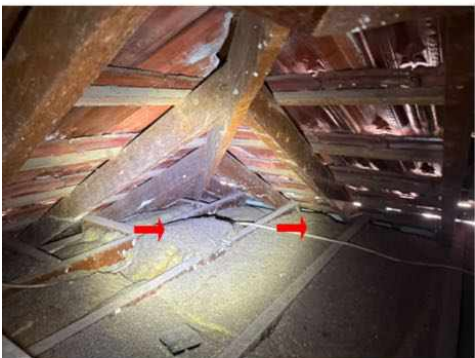
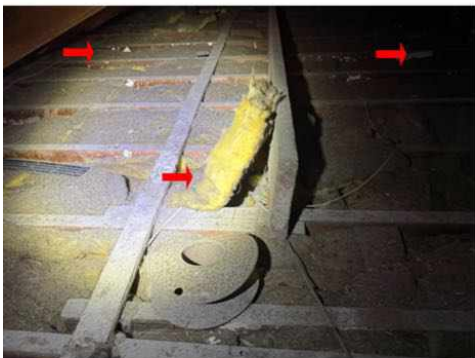
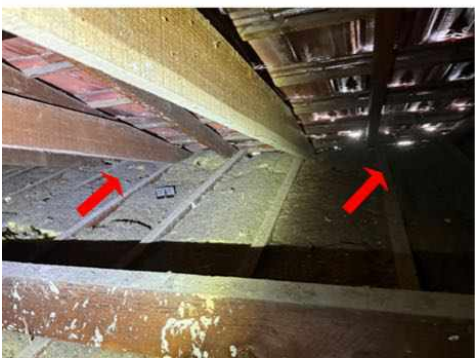
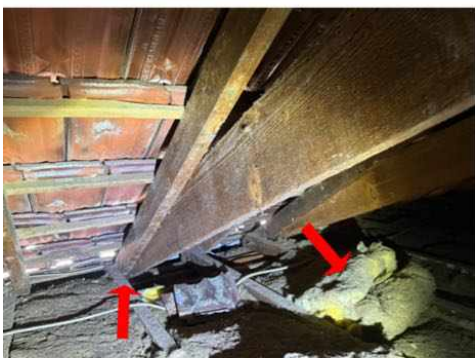
Building:	Building 1
Location:	All Roof cavity areas
Finding:	Additional Photos - Obstructions and Limitations of the ROOF CAVITY
Information:	<p>These photographs are an indication of the obstructions and limitations which impeded full inspection of roof cavity areas at the time of inspection. These obstructions can hide an array of defects and should be removed to allow full inspection to be carried out if applicable. A re-inspection is recommended once the areas are made accessible.</p> <p>The inspection was also limited to areas with an allowable crawl space of 600mm x 600mm, in particular towards the external walls where the roof line diminishes, these areas were not accessible.</p>

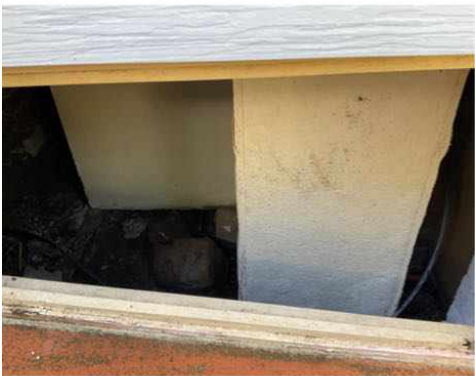
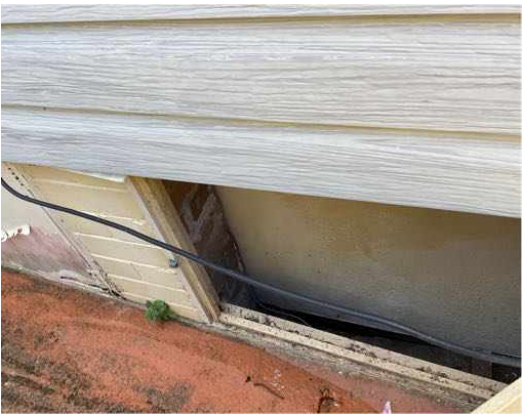
Building: Building 1  
Location: All Subfloor Areas  
Finding: Additional Photos - Obstructions and Limitations of SUBFLOOR AREAS  
Information: These photographs are an indication of the obstructions and limitations which impeded full inspection of subfloor areas at the time of inspection. These obstructions can hide an array of defects and should be removed to allow full inspection to be carried out. A re-inspection is recommended once the areas are made accessible.

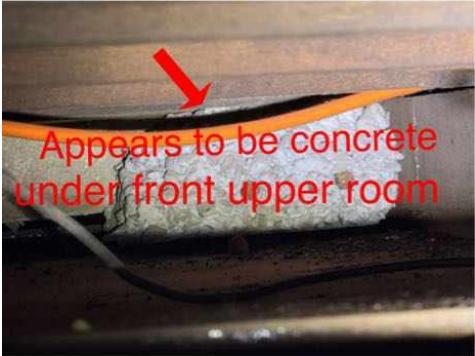
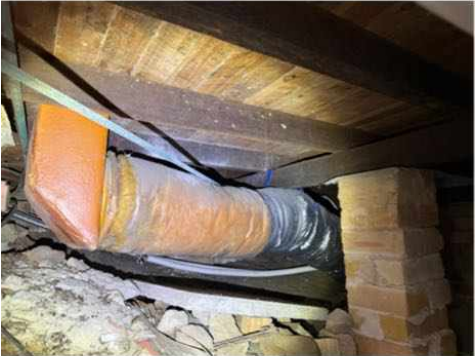
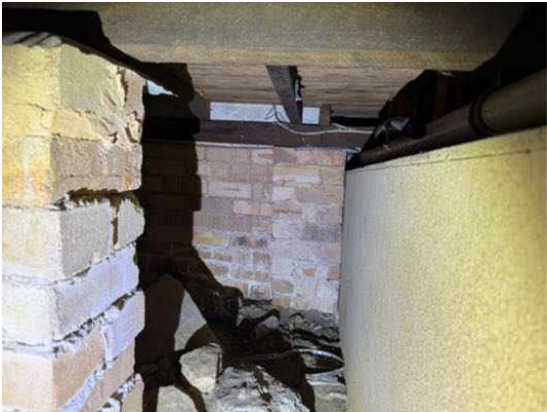
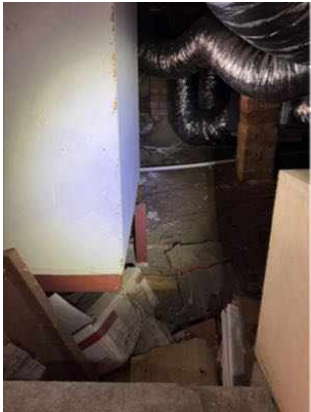
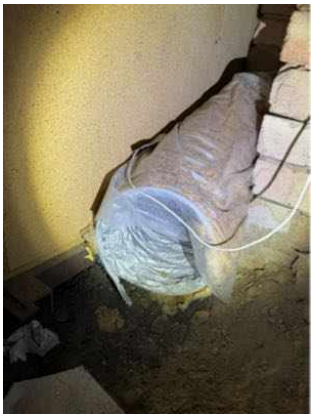
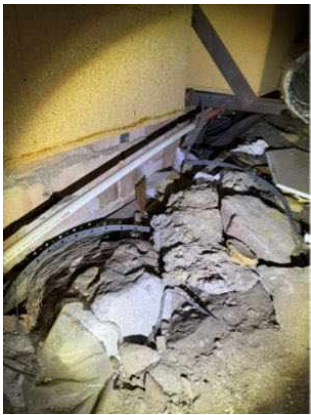
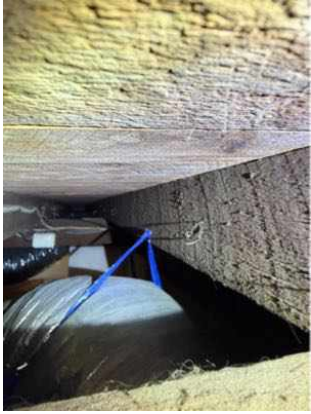
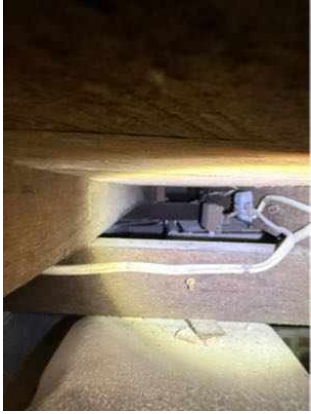
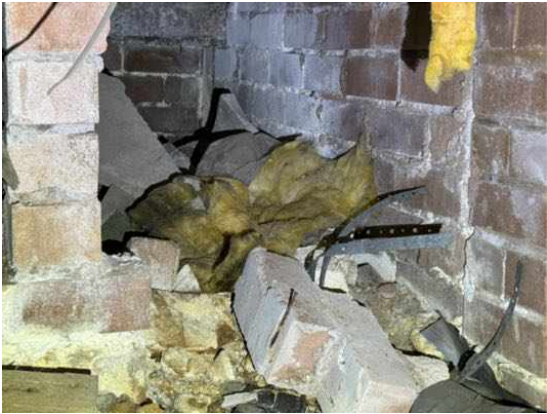
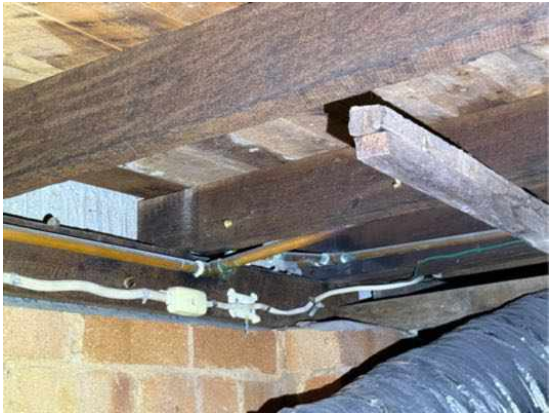
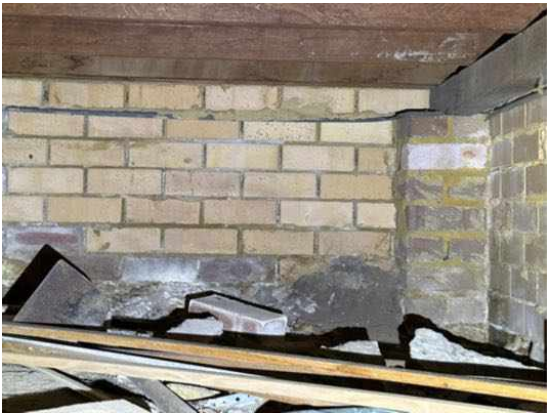
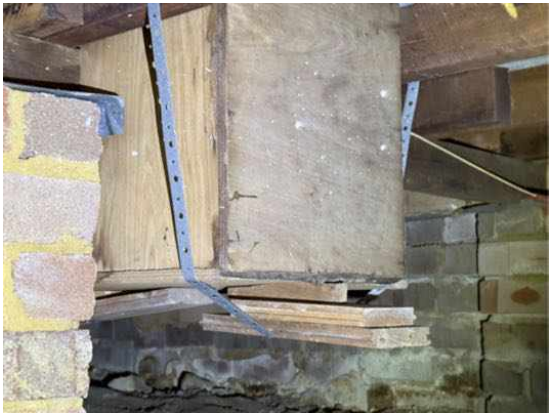
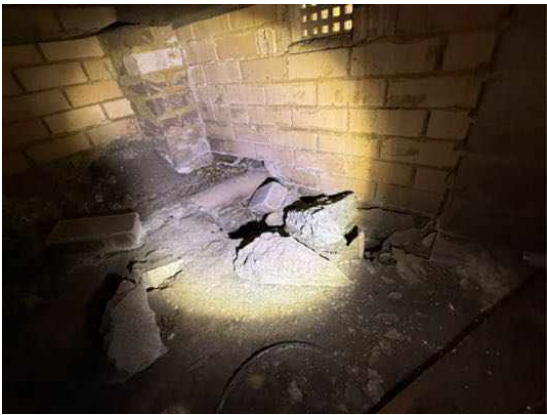
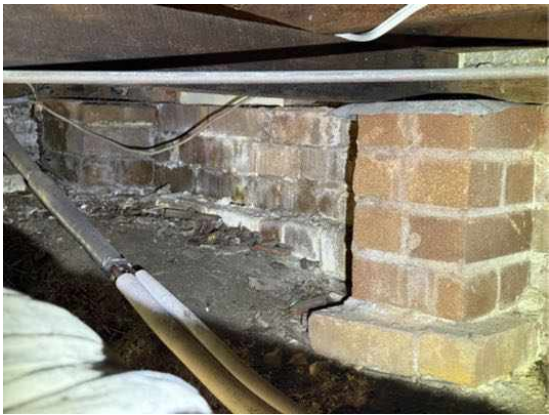
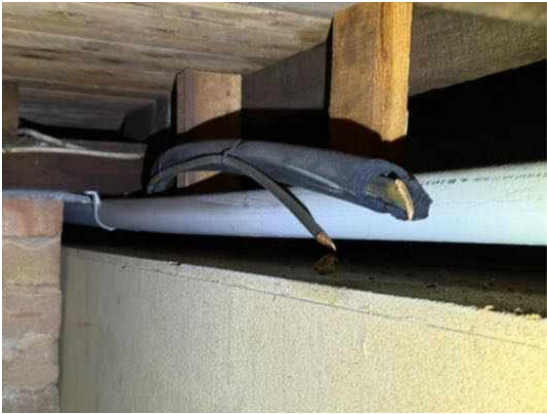
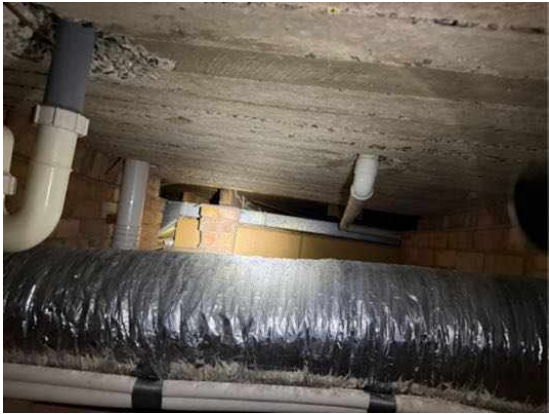
Building: Building 1  
Location: Subfloor  
Finding: Additional Photos  
Information: Additional photos are provided for your general reference

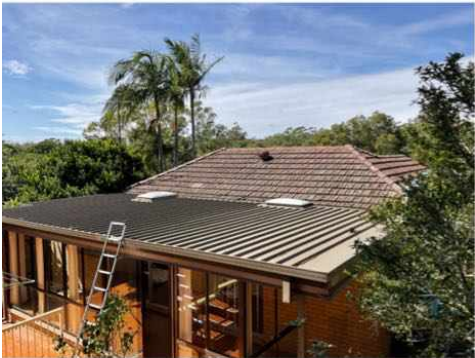
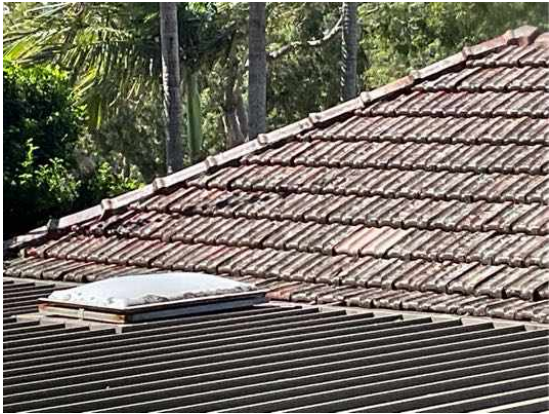
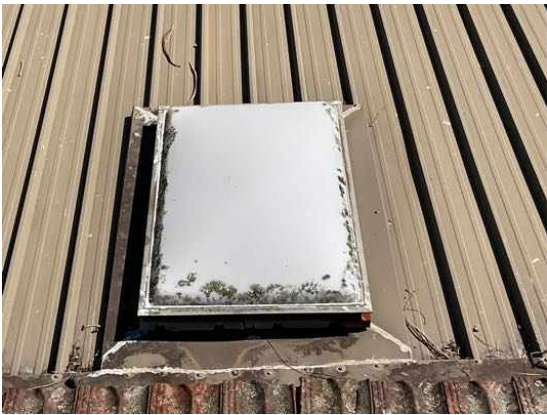
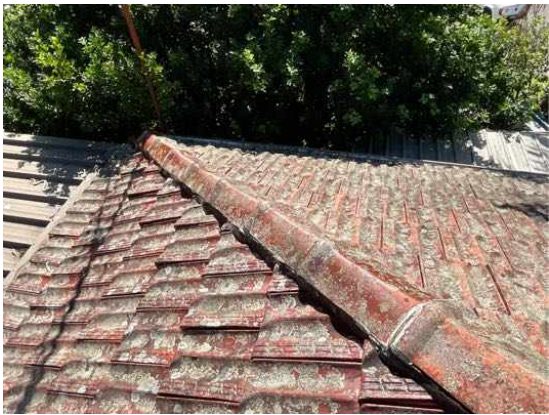
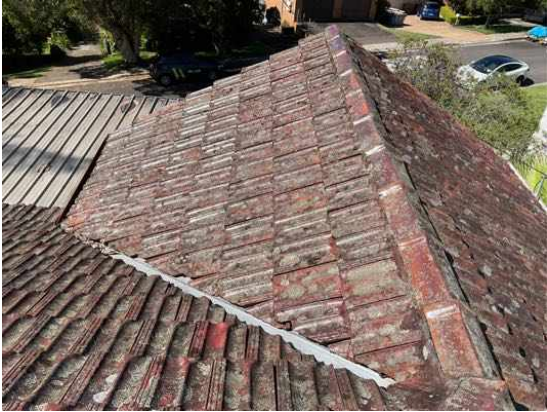
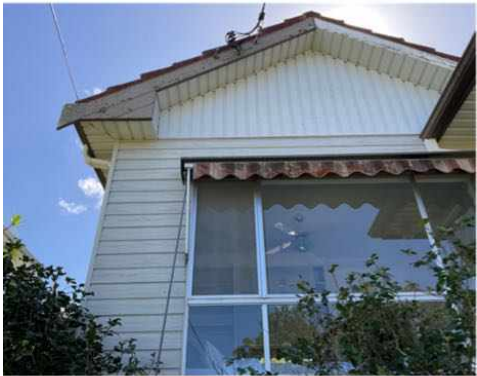
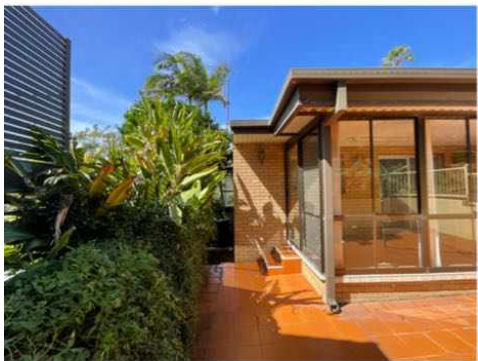
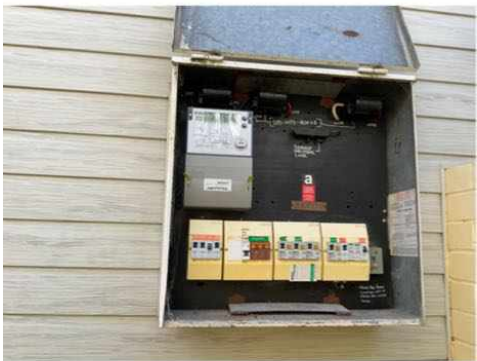
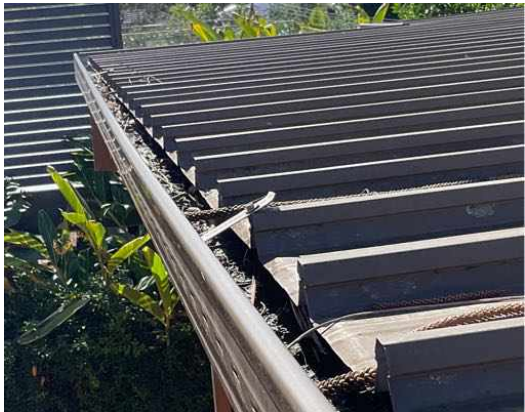
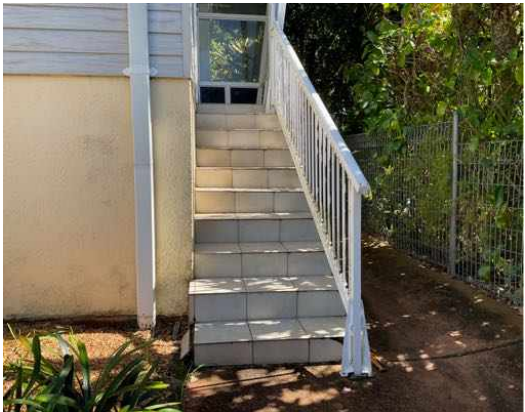
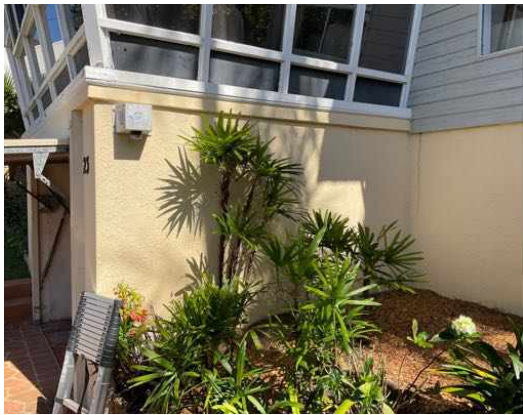
Building: Building 1  
Location: All External Areas  
Finding: Additional Photos  
Information: Additional photos are provided for your general reference

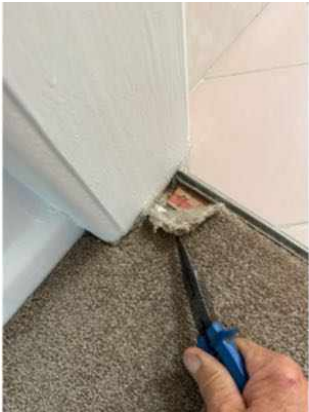
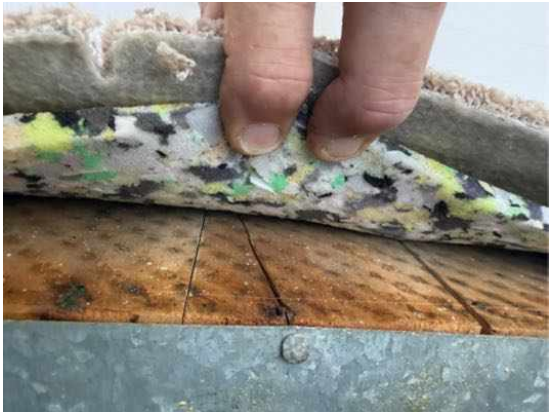
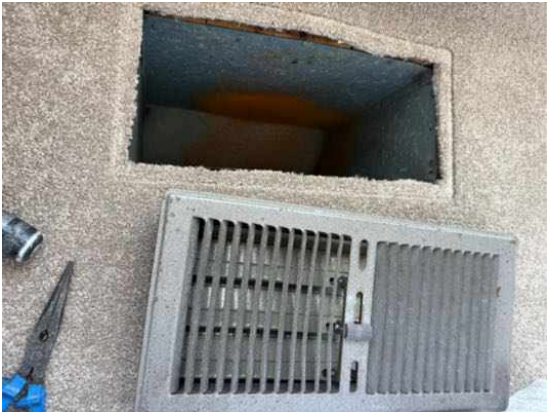
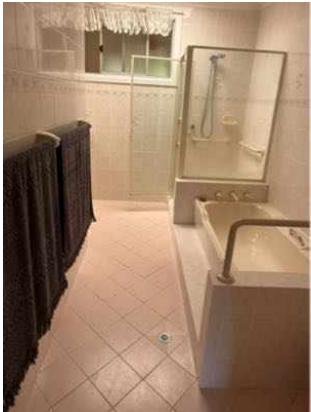
Building: Building 1  
Location: All Internal Areas  
Finding: Additional Photos  
Information: Additional photos are provided for your general reference

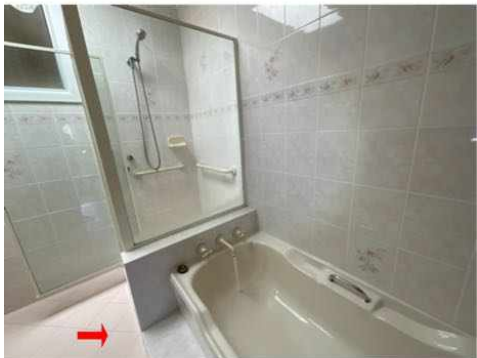
Building: Building 1  
 Location: Bathrooms and laundry  
 Finding: Waterproofing membranes - Information Only  
 Information: Internal Water Proofing Membranes, are crucial in preventing water ingress into the property is important to know that the Membrane System used is to Australian Standards and has been installed correctly.

With older property's where this information is unavailable all wet areas should be monitored. If any leaks, water staining, peeling or bubbling of the paint become evident to any adjacent walls or ceilings below a licensed builder or waterproofing specialist is recommended to investigate further.

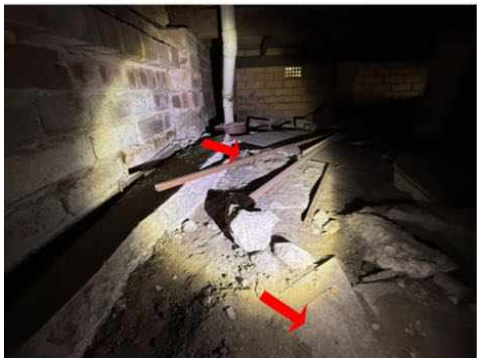
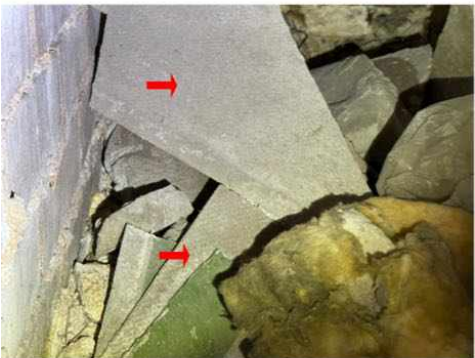
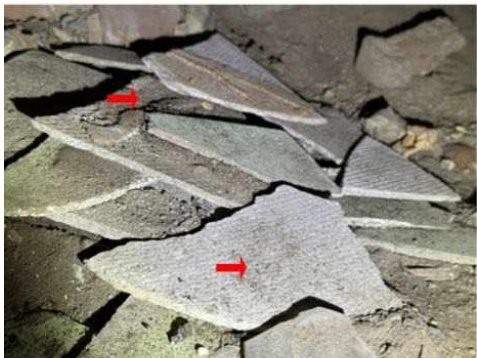
Building: Building 1  
Location: Subfloor  
Finding: Asbestos - Suspected ACM Identified on Site  
Information: Reporting on Asbestos is outside the Scope of this Report. This suspected defect is highlighted as a caution only. We suspect, based on our experience in the building industry, that there is a higher risk of the identified building element containing asbestos.

As Asbestos Reporting is outside the scope of this report, we advise that you consider a separate Asbestos Inspection and Condition Audit, which can include the taking of samples for definitive confirmation of the presence of Asbestos.

In the interim, the client is advised to act with caution, especially when considering any damage to building materials general wear and tear renovations extensions demolition and general maintenance activities due to the suspected presence of Asbestos.

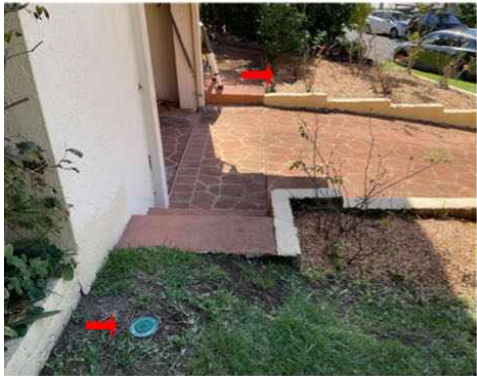
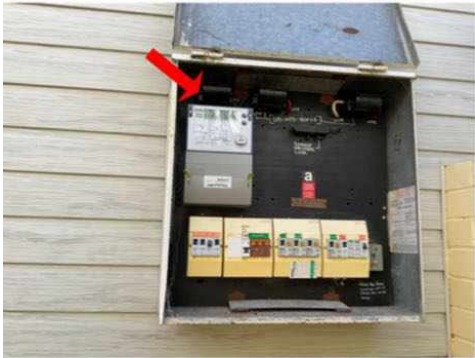
**The following items were noted as - Evidence of a previous termite management program**

Where a Termite Management System has been identified you should refer to the type of barrier date of installation warranty conditions and any documentation provided by a builder or past owner. Consult the company who installed the barrier to confirm whether the system is still under warranty.
