Building and Timber Pest Inspection Report

Inspection Date: Mon, 16 Feb 2026

Property Address: 181 Cox St, South Windsor NSW 2756,
Australia

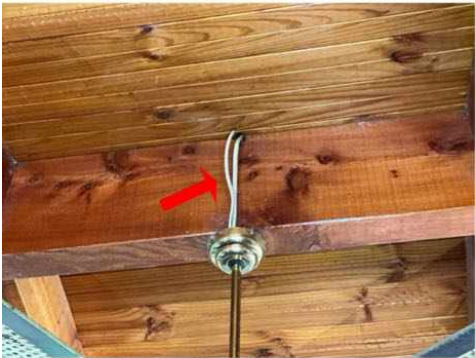
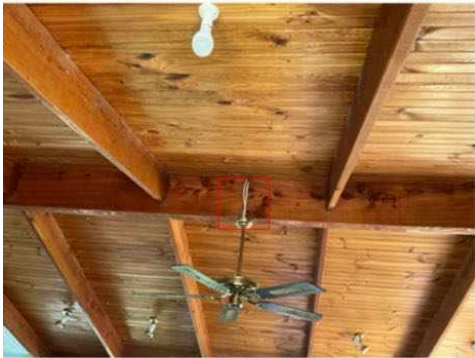
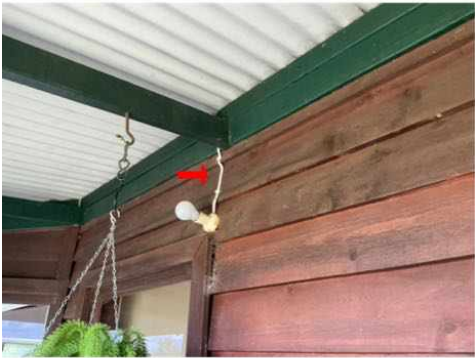
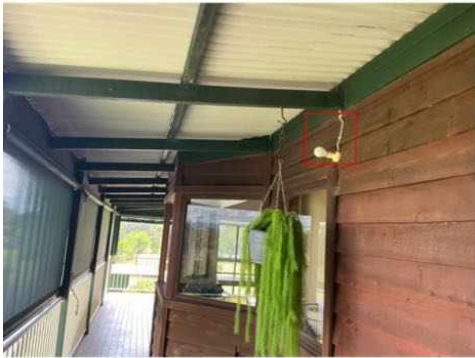
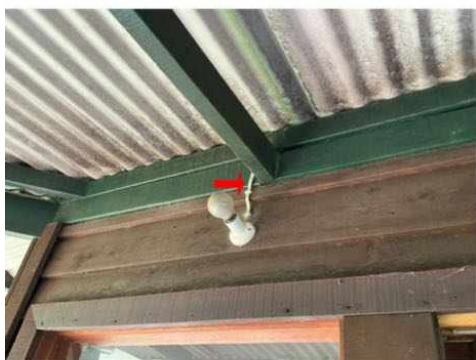
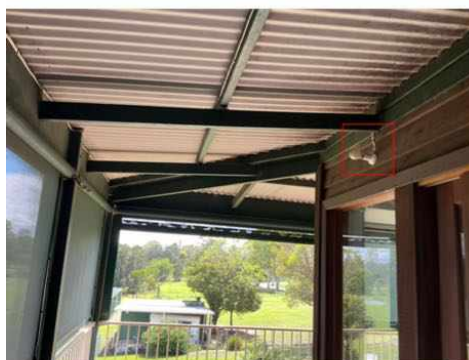
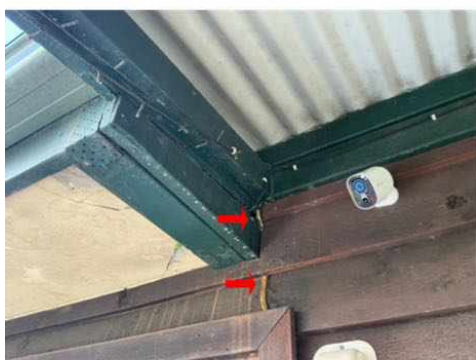
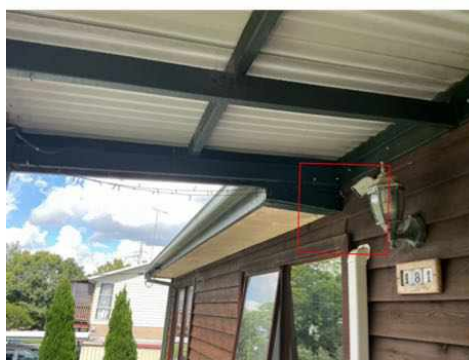
Finding 1.01

Building: Main Building
Location: All Areas, Living Room
Finding: Electrical Wires - Exposed
Information: During the inspection, exposed electrical wires were noted. This condition poses a significant safety hazard, as it increases the risk of electrical shock, short circuits, and potential fire. It is imperative that a qualified electrician addresses this issue immediately by properly insulating the exposed wires and ensuring all electrical connections comply with safety standards. Prompt action will mitigate the risks associated with exposed wiring and maintain the safety and integrity of the property's electrical system.

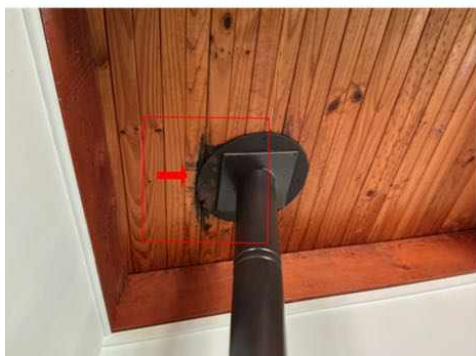
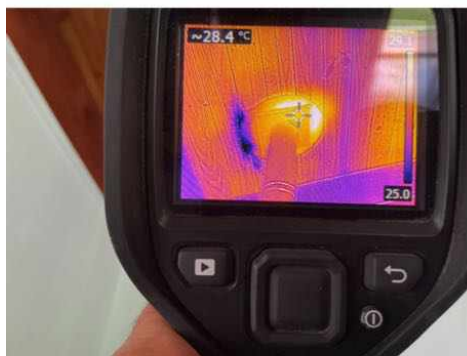
Building:	Main Building
Location:	Living Room
Finding:	Moisture Noted Around Fireplace Flue Penetration
Information:	At the time of inspection, minor moisture staining was observed to the ceiling area surrounding the fireplace flue penetration. Thermal imaging indicated temperature variations consistent with possible moisture presence adjacent to the flue collar, suggesting minor water ingress around the roof penetration point. The staining and moisture appear localised; however, any water entry at roof penetrations can progressively deteriorate surrounding materials if not addressed.

It is recommended that a licensed roofing contractor inspect the roof area around the fireplace flue termination and thoroughly assess the condition of the flashing, sealants and surrounding roof covering. Particular attention should be given to the integrity of the storm collar and flashing system to ensure the penetration is properly sealed and

weather-tight.

The client is advised that rectification should be undertaken as soon as practicable, as prolonged moisture exposure can lead to timber deterioration, ceiling damage and mould growth. Ongoing moisture conditions within concealed areas may also create an environment conducive to termite activity.

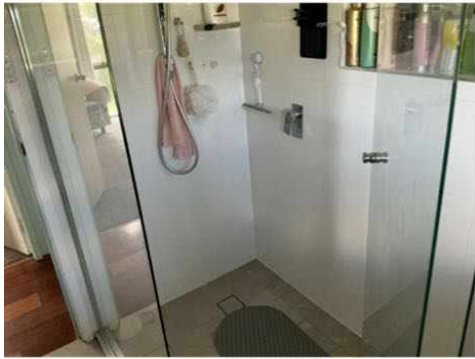
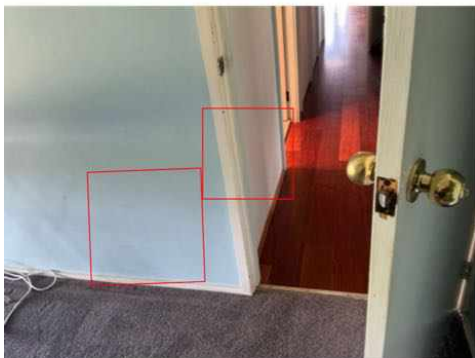
Finding 3.02

Building:	Main Building
Location:	Bedroom
Finding:	Shower Damp - Adjacent Bathroom (Monitoring)
Information:	At the time of inspection, elevated moisture levels were detected on the wall adjacent to the shower area. While no visible water damage or deterioration was noted, the presence of moisture suggests possible seepage or condensation associated with regular shower use.

At this stage, no immediate action is required. However, the area should be monitored over the next 12 months for any signs of deterioration such as staining, bubbling paint, or mould growth. It should be noted that moisture ingress of this nature does not generally resolve without intervention, and at some point remedial works are likely to be required. Should conditions worsen, the client is advised to engage services of a licensed plumber or waterproofing specialist to rectify the issue of moisture before this minor defect turns into major defect.

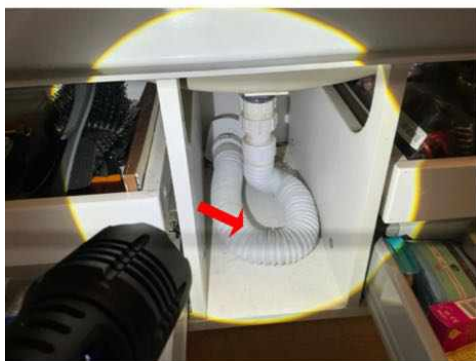
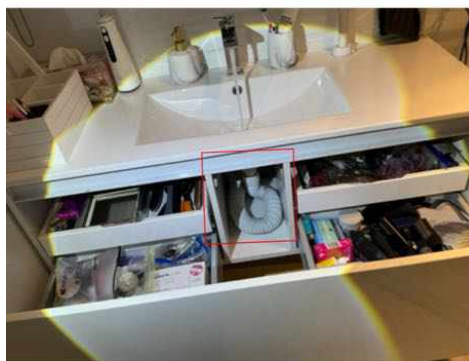
Finding 3.03

Finding: Flexible Pipe - Non Complaint

Information: At the time of inspection, the flexible waste pipe installed beneath the bathroom basin was noted to be non-compliant and not considered a solid, permanent plumbing connection. The setup is also missing a proper S-trap or P-trap, which is required to prevent sewer odours from entering the home and to ensure correct drainage. A solid, rigid pipe with an appropriate trap should be installed in accordance with standard plumbing practices. It is recommended that a licensed plumber be engaged to replace the current flexible pipe and install a compliant trap assembly.

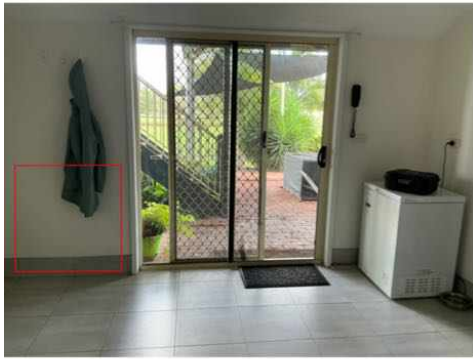
Finding 3.04

Building: Main Building
 Location: Games Room
 Finding: Damp - Rising

Information: At the time of inspection, rising damp was identified within the property. This condition results from the upward movement of moisture through porous building materials, such as bricks, sandstone, or mortar, via capillary action. A damp-proof course (DPC), an impermeable barrier installed at the base of walls above ground level during construction, is typically used to prevent rising damp. However, the absence, deterioration, or bridging of the DPC can compromise its effectiveness, specially in older buildings, leading to moisture ingress. Inadequate site drainage, which allows water to accumulate around the foundation, is a common contributing factor to this issue.

If left unaddressed, rising damp can pose significant health risks due to mould growth and cause extensive damage to building elements, including wall finishes such as paint and plasterwork. The current condition should be monitored over a 12-month period to assess its progression.

It is strongly recommended that the client engage a qualified damp-proofing specialist for remedial actions. Additionally, consulting a qualified plumber or drainage specialist to assess and improve site drainage is advised to mitigate further risks. Monitoring the condition for 12 months is essential to evaluate its status and prevent potential recurrence or further damage.

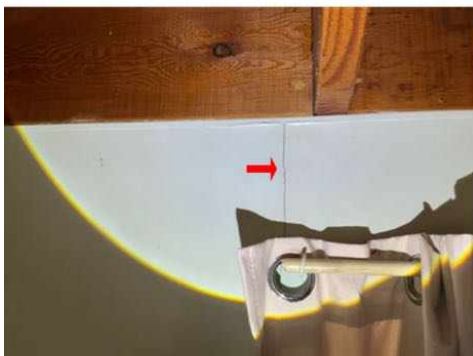
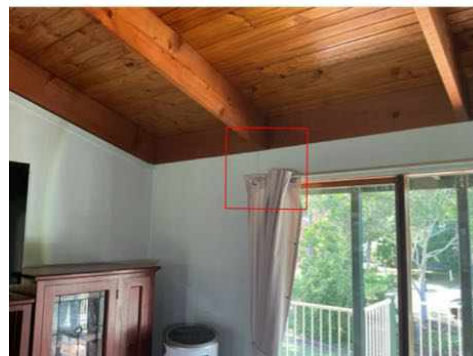
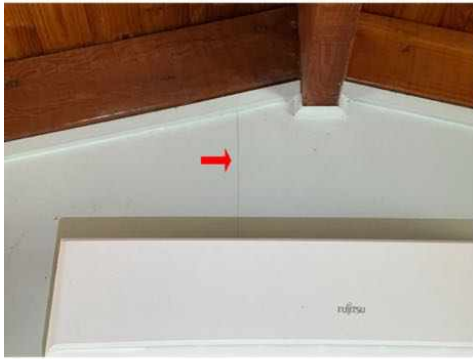
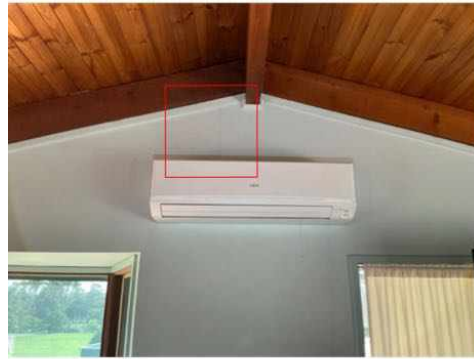
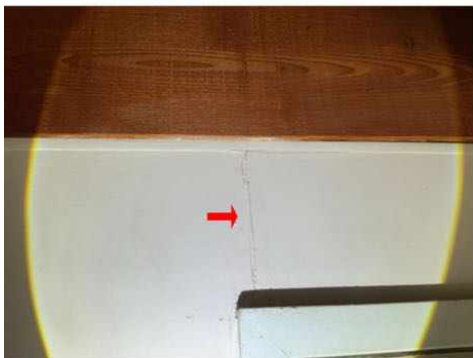
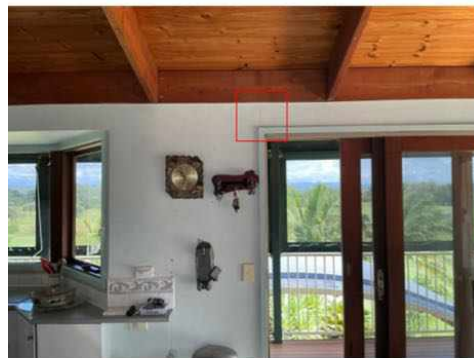
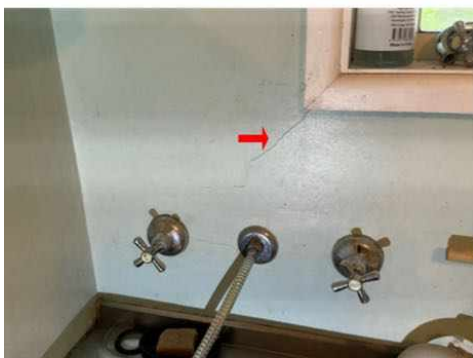
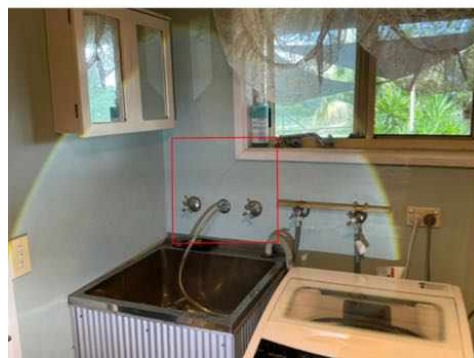
Finding 3.05

Finding: Cracking - Damage Category 1 - Fine (up to 1mm)

Information: Although fine cracks are quite noticeable, they are often only considered to be an appearance defect, and usually do not indicate any structural damage. Generally, the cause of a fine crack is indicative of a separation between building materials and finishes (e.g. paint, plaster, etc.) along joins.

Cracking of this nature can generally be repaired with minor sanding, filling and/or repainting. Such works should be performed by a qualified painter or a general handyman.

Monitoring of all cracking should be conducted frequently. Always contact a building inspector should cracks widen, lengthen, or become more numerous.

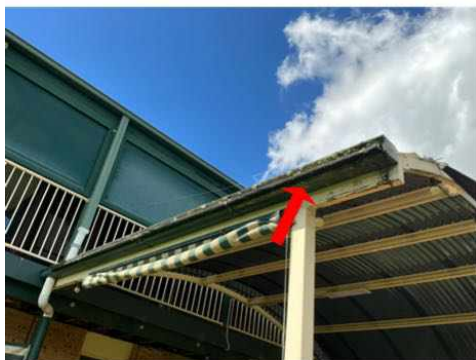
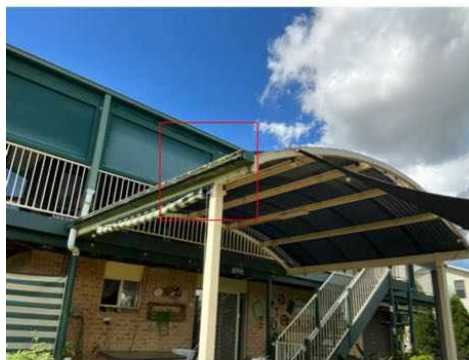
Finding 3.06

Finding: Gutters - Corroded/Rusted

Information: At the time of inspection, sections of the gutters were observed to be corroded/showing visible rust. Corrosion typically occurs due to prolonged exposure to moisture, standing water, or accumulated debris, which prevents proper drainage and allows water to sit in the gutter. Over time, rust can weaken the metal, leading to leaks, holes, and eventual gutter failure if not addressed.

It is recommended that a licensed roof plumber inspect the affected areas and replace the rusted gutter sections to restore proper function.

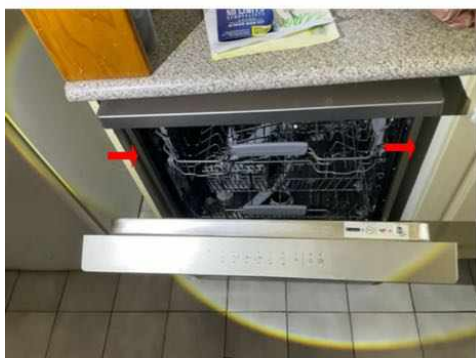
Finding 3.07

Information: At the time of the inspection, it was noted that the dishwasher in this area was not securely installed and appeared to be loose. This improper installation requires prompt attention to ensure the appliance is correctly fitted and stable. If left unmanaged, the condition of the fitting may worsen over time, potentially leading to further deterioration and the development of additional minor defects. These secondary issues could affect both the dishwasher itself and the surrounding cabinetry or flooring.

A loose dishwasher may produce excessive noise and vibration during operation, which can be both disruptive and uncomfortable for occupants. The lack of secure installation may also place strain on the dishwasher's components, potentially reducing the lifespan of the appliance and leading to more significant repairs or maintenance needs in the future.

It is strongly recommended that a qualified plumber be appointed to carry out the necessary rectification work. Ensuring the dishwasher is securely installed will improve its performance, reduce noise and vibration, and prevent further damage to the surrounding area. The client should engage a professional plumber to complete these repairs, ensuring the appliance operates efficiently and safely.

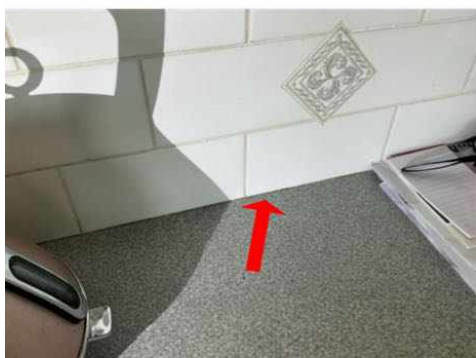
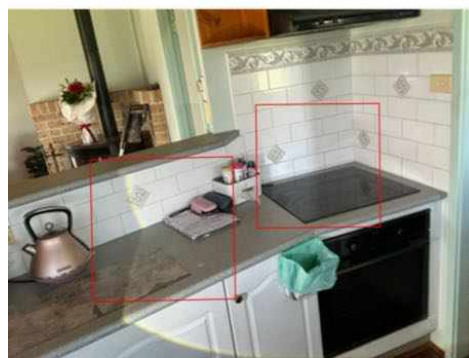
Finding 3.08

Finding: Sealant/Grouting - Missing or Damaged

Information: At the time of inspection, areas of missing and/or deteriorated sealant and grout were noted in this area. This condition can allow water to penetrate behind finishes, which may lead to moisture ingress, deterioration of waterproofing membranes, mould growth, and potential leaks into adjoining areas over time. If left unaddressed, this may result in costly repairs and hidden water damage.

It is recommended that a licensed plumber (or suitably qualified tradesperson experienced in wet area sealing) be engaged to assess the affected areas and reinstate compliant waterproof sealant and grout as required, ensuring all junctions are properly sealed to prevent further water ingress.

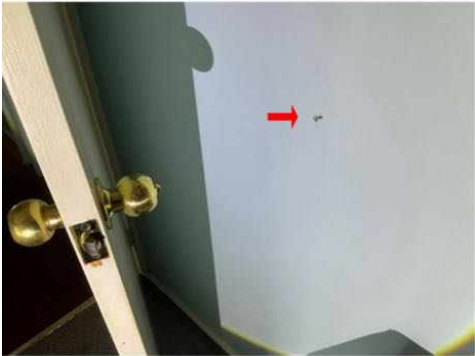
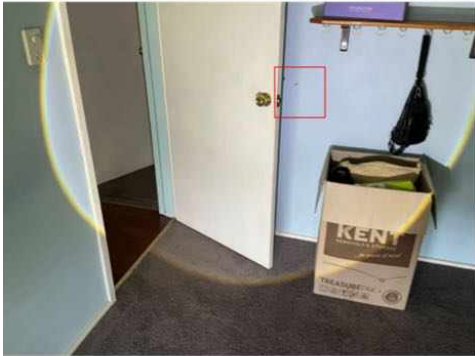
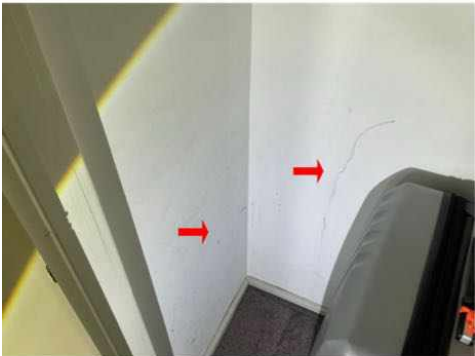
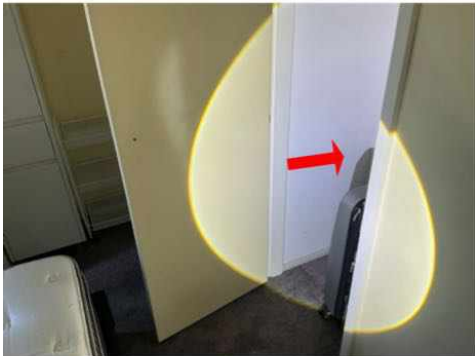
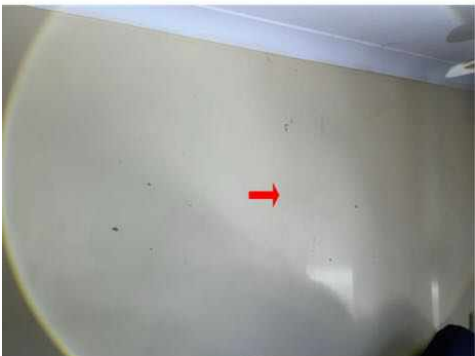
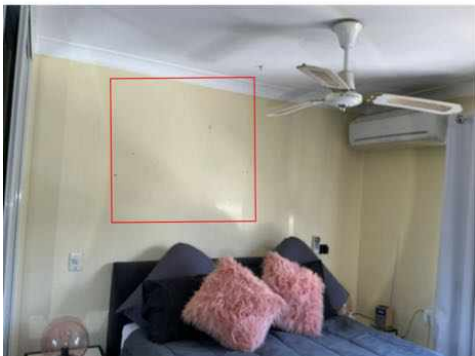
Finding 3.09

Finding: Maintenance and/or Wear and tear on building elements

Information: It was observed at the time of inspection that some building elements and areas around the property require general maintenance and/or exhibit signs of wear and

tear. These typically include minor imperfections such as paint scuff marks, scratches on surfaces, small chips, nails or hooks left in walls from previous picture hanging, and other superficial blemishes.

These are generally considered minor items that are common in established homes. While they may be noticeable on visual inspection, they do not affect the structural integrity or functionality of the property. In most cases, these issues can be easily addressed by a qualified handyman as part of routine maintenance.

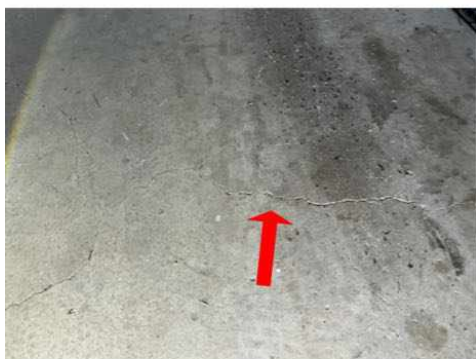
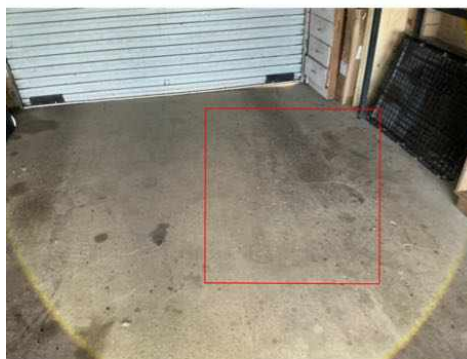
Finding 3.10

Location: Garage
 Finding: Crack in concrete slab - Category 2
 Information: A crack coded as Category 2 was identified in the slab. A Category 2 crack is described as a distinct crack, with the slab being noticeably curved or changed in level.

To be considered Category 2, the approximate width of the crack is less than 2.0mm, or a change in offset of less than 15mm when a 3m straight edge is placed over the defect.

Category 2 cracks to slabs should be monitored for a period of 12 months. At the end of the monitoring period, cracks rated greater than Category 2 are considered defects that require rectification.

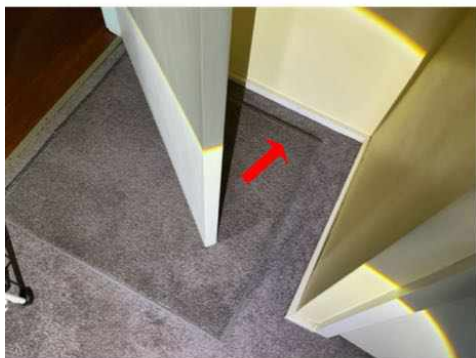
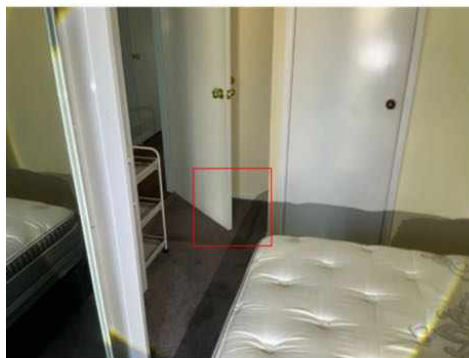
Finding 3.11

Building: Main Building
 Location: Bedroom 2
 Finding: Door Stopper(s) - Missing
 Information: At the time of inspection, it was noted that a door stopper was missing in this area.

The absence of a door stopper can lead to potential damage to the door, wall, or surrounding finishes, as the door may swing open too far and impact the wall or adjacent objects. Over time, this can cause dents, scuffs, or even structural damage to the wall or door. It is recommended that a door stopper be installed to prevent further damage and ensure the protection of both the door and the surrounding area.

The client is advised to engage services of a handyman to install the door stopper.

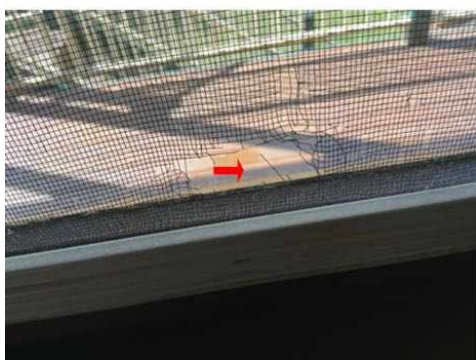
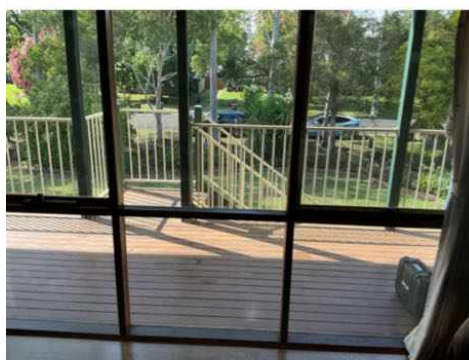
Building:	Main Building
Location:	Living Room
Finding:	Fly Screen Damaged
Information:	It was noted at the time of inspection, the fly screen was damaged.

Window fly screens can sustain damage due to a variety of reasons, including exposure to harsh weather conditions like storms or strong winds, accidental tears or punctures, wear and tear over time, pets scratching or clawing at the screens, poor installation leading to misalignment or weak attachment points, and the use of low-quality materials that may deteriorate faster. Regular maintenance and addressing these factors can help prevent or minimize damage to window fly screens.

A general handyman should be appointed to rectify the issue at owners discretion.

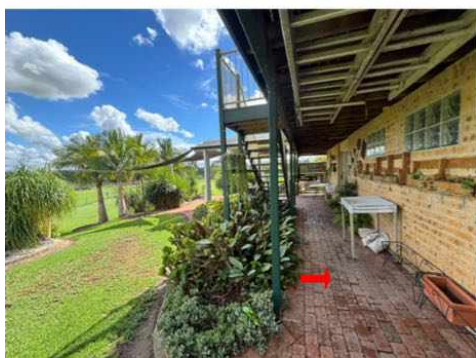
Finding 3.13

Building:	Main Building
Location:	Yard - Back
Finding:	Inadequate Site Drainage - Exterior Areas
Information:	At the time of inspection, inadequate site drainage was observed around the perimeter of the building, which can lead to water pooling and insufficient runoff management.

This condition may result in moisture being absorbed by the foundation or lower walls, potentially leading to rising damp, cracks in brickwork, erosion of the soil around the building, or structural issues over time. Water pooling can also create ideal conditions for mould growth, contribute to the deterioration of exterior materials, and act as conducive conditions for termite activity, as termites are attracted to areas with elevated and persistent moisture levels.

It is recommended that proper site drainage be installed, such as redirecting water flow away from the building or incorporating drainage systems, to prevent further damage and ensure the long-term stability of the structure.

To address the inadequate site drainage, a qualified landscaper or drainage specialist should be engaged to design and install appropriate drainage solutions, such as grading the ground away from the building or installing French drains, surface drains, or downspout extensions. If more complex issues are present, such as damage to the foundation or moisture entering the walls, a structural engineer may need to assess the situation, and a builder may be required for repairs.

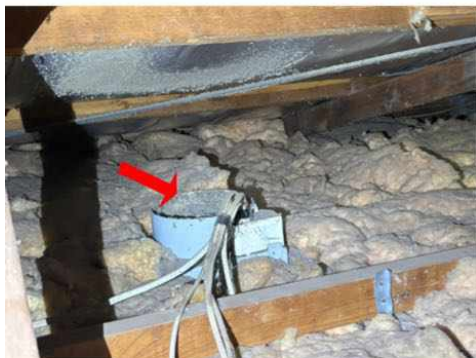
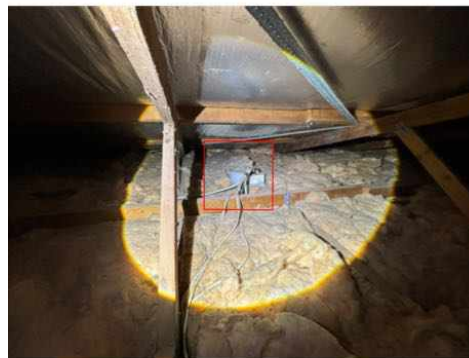
Finding 3.14

Building:	Main Building
Location:	Roof Void
Finding:	Vent - Extracted into Roof Space
Information:	During the inspection, it was noted that the exhaust vent has been improperly terminated into the roof space instead of being ducted to the exterior of the property.

This configuration is a defect as it allows moist air to accumulate within the roof cavity, increasing the risk of condensation, mould growth, and deterioration of insulation or timber framing. Proper ventilation is essential to maintain a healthy indoor environment and protect the structural integrity of the building. It is recommended that the vent be appropriately re-routed to discharge externally in compliance with relevant building standards.

A licensed mechanical ventilation contractor/electrician should be appointed as soon as possible to provide further consultation on the scope of these works and to provide

quotations for any necessary works.

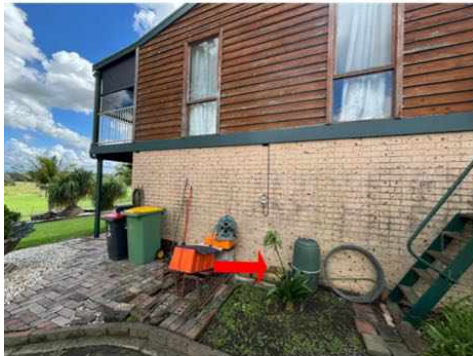
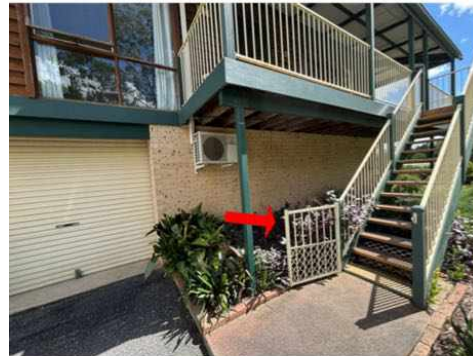
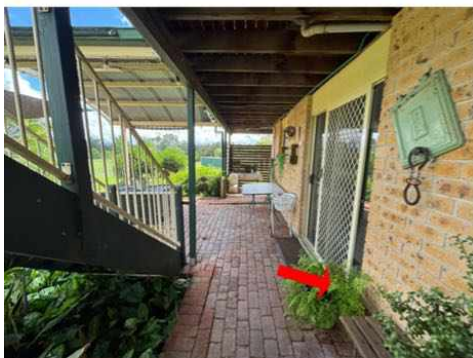
If the slab edge is not properly exposed there is a high risk of termite attack. Sometimes, in order to determine the type of slab, a suitably qualified person such as an architect or builder may be required to consult the construction plans.

Where the slab edge cannot be properly inspected, it is highly recommended that termite or timber pest inspections be carried out every 6-12 months to aid protection of the property against infestation.

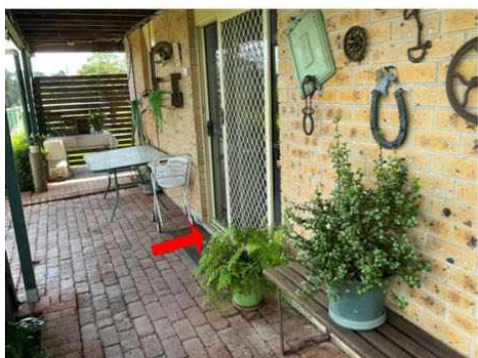
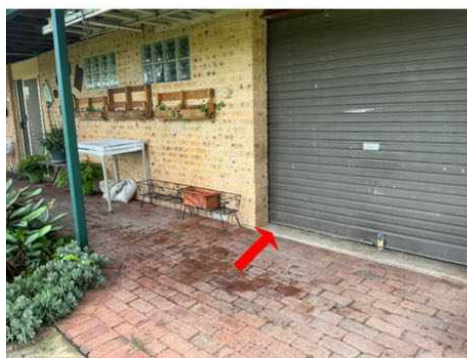
Finding 6.02

Building:	Main Building
Location:	Exterior walls - rear
Finding:	Bridging or Breaching of Termite Barriers - Adjacent Internal Flooring
Information:	Bridging is the spanning of a termite barrier or inspection zone so that subterranean termites are provided with passage over or around that barrier.

It is highly advised that a landscaper or relevant tradesperson be appointed to lower external grounds that are raised above or same as adjacent internal flooring. Alternatively if external grounds and internal flooring is level installation of a raised door sill may be appropriate in preventing any water pooling in the area. If the client wishes not to make any changes, then a qualified pest controller is recommended for termite treatment around the perimeter of the house and subfloor (if any) as soon as possible.

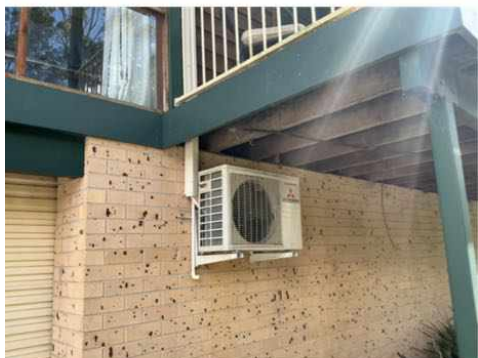
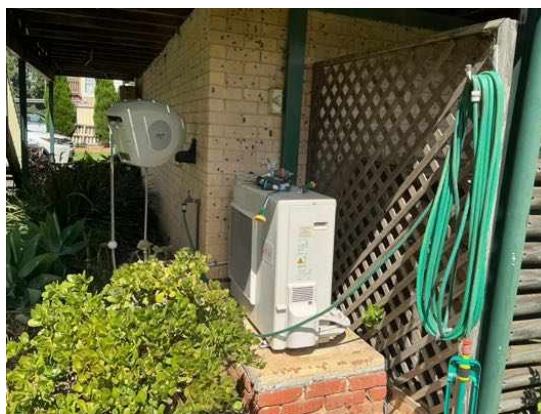
Finding 6.03

Building:	Main Building
Location:	All Areas
Finding:	Bridging Appliances - Attachment to Buildings
Information:	Bridging occurs when items against a building provide a concealed entry point for termites into the building or by passing around a termite management system.

Where any part of an attachment to a building is not isolated and is not provided with a clear gap of not less than 25mm from the building, bridging occurs. Attachments to buildings such as hot water services, downpipes, verandahs, decks, steps, fences, service conduits and the like provide the opportunity for concealed entry.

Building attachments of this nature need to be frequently inspected for termite activity by a qualified inspector.

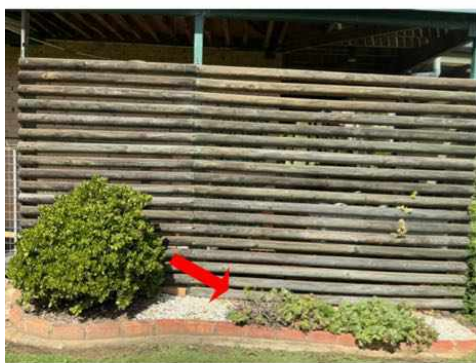
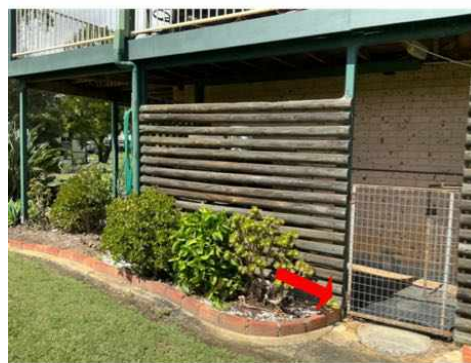
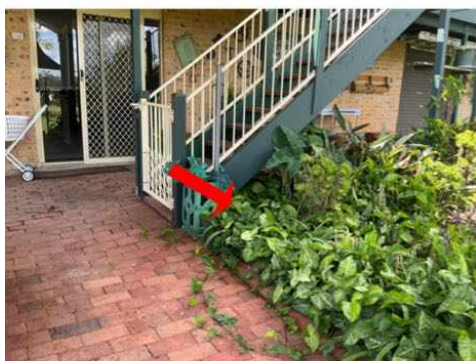
Finding 6.04

Building:	Yard
Location:	All Areas
Finding:	Building Materials in Direct Ground Contact - Conducive to Termites
Information:	Timber elements that are in direct contact with the ground and exposed to moisture or damp conditions are highly conducive to termite activity. This susceptibility arises because timber, when in contact with soil and dampness, creates an environment that is particularly attractive to termites, encouraging infestation and potential structural compromise. Whether the timber is used as a part of the building's construction or incorporated into fencing, its presence near or on the ground can become a pathway for termites to access and damage the property.

When exposed to excessive moisture, timber begins to deteriorate, developing conditions such as wood decay and rot. These compromised areas of timber are even more appealing to termites, as they are easier to infest and consume. This is especially true for untreated or non-durable timber, which lacks the protective treatments that can deter or withstand termite attacks. Termites can use these weakened, moisture-laden elements as a bridge into other parts of the structure, creating an entry point for potential infestations that can spread and cause extensive damage if left unchecked.

For any timber in direct contact with the external ground, special attention is required. The combination of moisture, untreated wood, and direct ground contact not only accelerates the decay process but also provides subterranean termites with a straightforward means of ingress into the structure. This entry can lead to termites moving undetected into other vulnerable areas, resulting in potentially significant structural issues and costly repairs.

To mitigate the risk of termite activity, it is imperative that any such materials or timber elements be appropriately treated or removed as soon as possible. Timbers that are necessary for use should be made durable through appropriate treatments and maintained to ensure they do not create conditions conducive to termites. Additionally, the client is advised to schedule regular termite treatments to maintain an effective barrier against infestations and ensure ongoing protection.

The client is strongly advised to assess the property for any timber elements that may be in direct contact with the ground and ensure prompt action is taken to remove or treat them effectively. Regular inspections, proactive maintenance, and consistent termite treatment are essential steps in minimising the risk of termite attack and protecting the structural integrity of the property. Taking these preventive measures is crucial for maintaining a termite-free environment and avoiding potentially costly damage and future repairs.

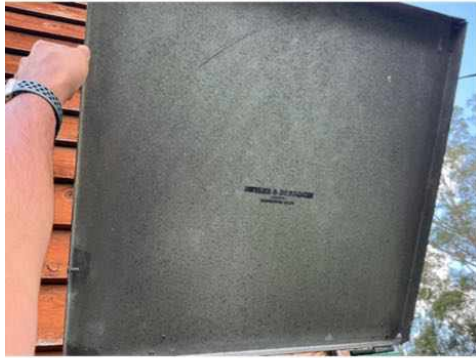
Finding 6.05

Building:	Main Building
Location:	Meter Box
Finding:	Termite Management System - No Evidence of Installation
Information:	The application of a post-construction chemical termite barrier is strongly recommended for all properties, especially if there has been any history of live termite activity on-site. These barriers are highly effective in protecting timber building elements throughout the property by preventing termite attacks. It is also advisable to install a durable notice within the switchboard unit, indicating the presence of any termite barriers for future reference.

licensed pest controller regarding the costs and procedures involved in the application of a termite barrier. Prioritizing this step in the short term is strongly advised to ensure long-term protection.

Additionally, the client may want to consult with the vendor to determine whether regular Timber Pest inspections, as per AS4349.3 or AS 3660.2, have been conducted in the past. This will provide further insights into any past termite management practices and help inform the appropriate course of action.

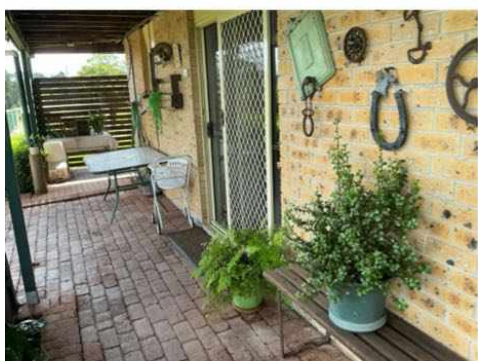
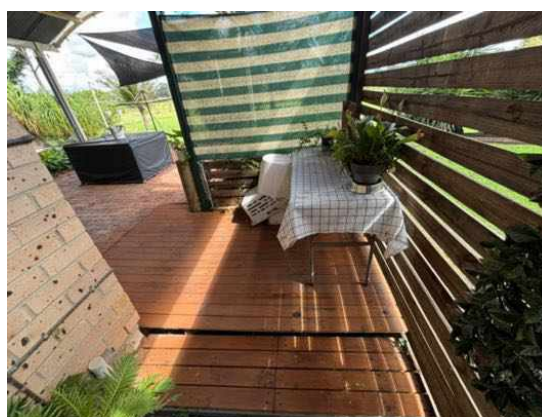
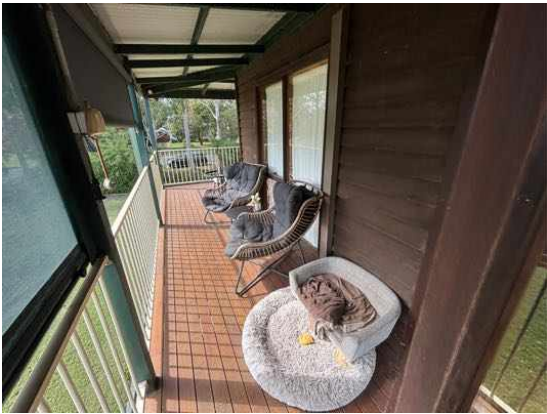
Building: Main Building
Location: All External Areas
Finding: Obstructions and Limitations - External Areas
Information: The attached photographs provide a visual representation of the obstructions and limitations that impeded a full inspection of the external areas of the property at the time of assessment. These obstructions, which may include vegetation, stored items, debris, or other physical barriers, can obscure potential defects and prevent a thorough evaluation of the property's condition. Obstructions of this nature can conceal a wide range of issues, such as structural damage, water ingress, pest infestations, or deteriorating building materials, which may not be visible during the initial inspection.

It is essential that these obstructions be cleared to allow for a comprehensive inspection of the external areas. Removing these barriers will enable a more accurate assessment of the property's condition and allow any hidden defects to be identified and addressed promptly. Failure to do so could result in undetected issues worsening over time, potentially leading to more costly repairs in the future.

Therefore, it is strongly recommended that the obstructions be removed and a re-inspection be scheduled once the affected areas are made fully accessible. This will ensure a complete evaluation of the property's exterior and provide the client with a clear understanding of any potential issues that may have been concealed during the initial inspection.

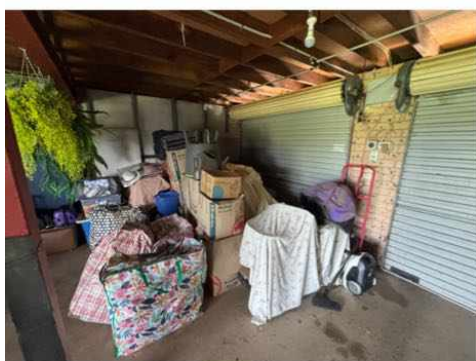
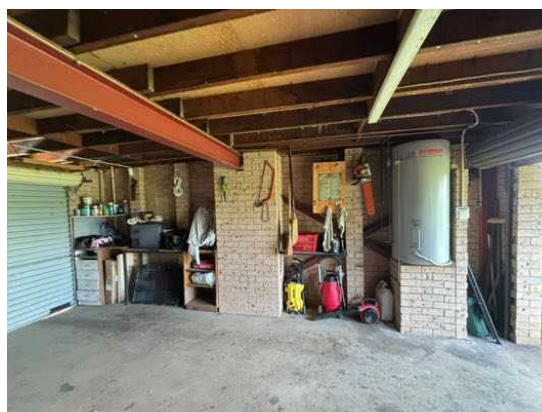
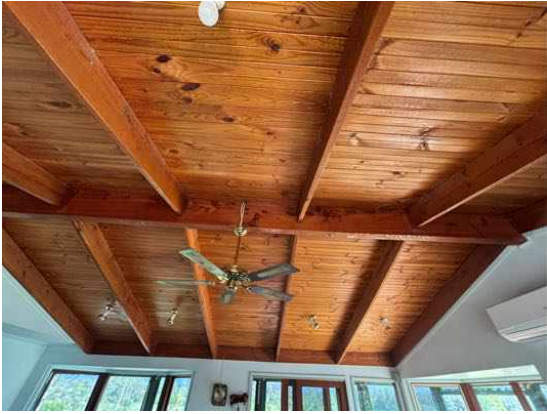
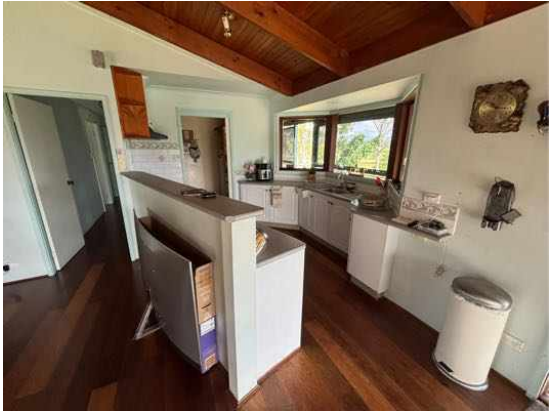
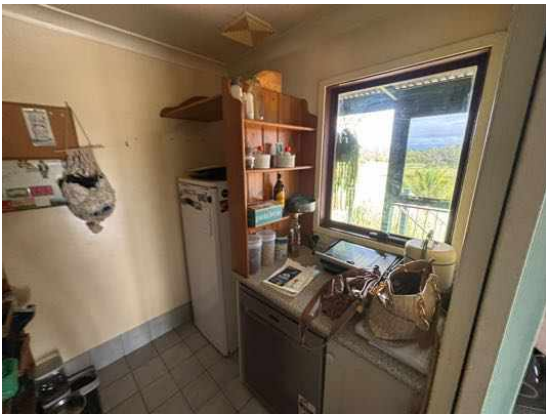
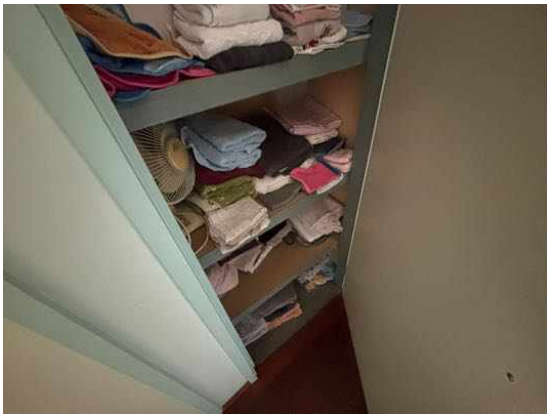
Building:	Main Building
Location:	All Internal Areas
Finding:	Obstructions and Limitations - Internal Areas
Information:	<p>The accompanying photographs provide clear evidence of the obstructions and limitations that restricted a comprehensive inspection of the internal areas of the property at the time of assessment. These obstructions, which may include furniture, personal belongings, stored items, or structural elements such as wall coverings and built-ins, significantly hindered the ability to thoroughly evaluate these areas. It is important to note that such obstructions can potentially conceal a wide array of defects, ranging from hidden structural damage, water leaks, pest infestations, or electrical issues, to deteriorating materials that may not be visible during the initial inspection.</p>

The presence of these impediments means that critical areas of the property were not accessible, and therefore, any underlying defects that may affect the integrity and safety of the property could remain undetected. These hidden defects, if left unaddressed, could worsen over time and may result in costly repairs or pose potential safety hazards to the occupants.

It is highly recommended that all obstructions be cleared to facilitate a complete and thorough inspection of the internal areas. Once the obstructions have been removed and full access is available, a re-inspection should be carried out to ensure that any previously concealed issues can be properly identified and rectified. This follow-up inspection will provide a more accurate assessment of the property's internal condition and help the client make informed decisions about any necessary repairs or maintenance.

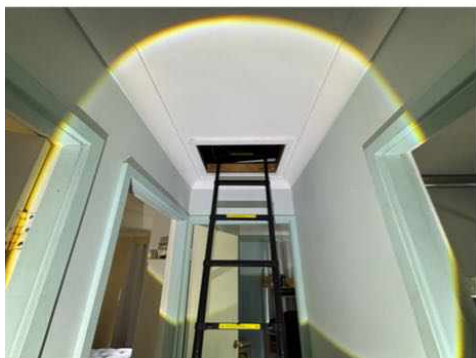
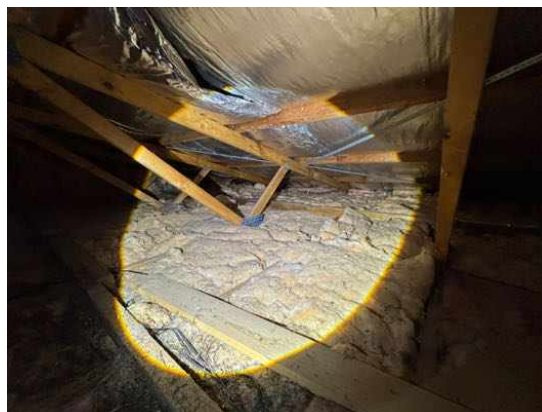
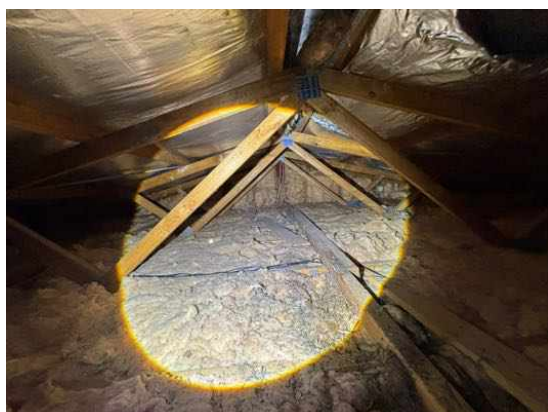
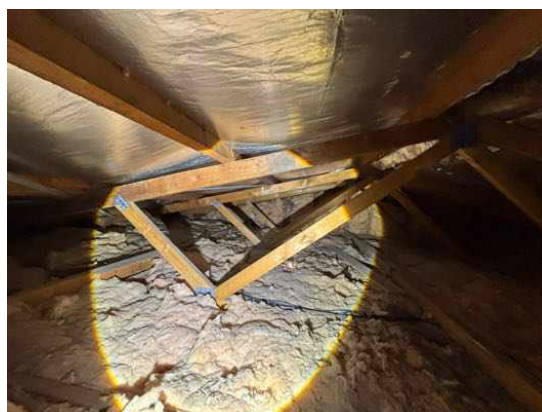
Building: Main Building
Location: Roof Void
Finding: Obstructions, Limitations, and General Roof Space Condition
Information: The photographs provided document both the general condition and the obstructions and limitations that were present in the roof cavity of the main building at the time of inspection. These obstructions—such as insulation materials, stored items, structural elements, or electrical wiring—restricted safe and adequate access to key areas within the roof space. As a result, a comprehensive inspection of all components could not be completed.

Obstructions of this nature may conceal a variety of potential defects, including damaged framing, compromised insulation, evidence of moisture ingress, pest activity, or electrical hazards. While no major issues were observed in the visible areas, the presence of these limitations means that some defects may remain undetected.

It is recommended that these barriers be removed or repositioned to facilitate full and safe access to the roof space. Once clear, a follow-up inspection should be conducted to allow for a thorough assessment of all concealed areas. This will help ensure that the condition of the roof cavity is accurately evaluated and any hidden issues are appropriately identified and addressed.

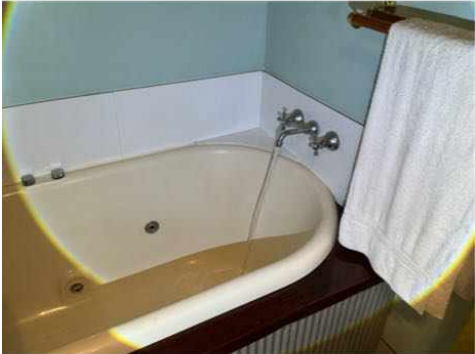
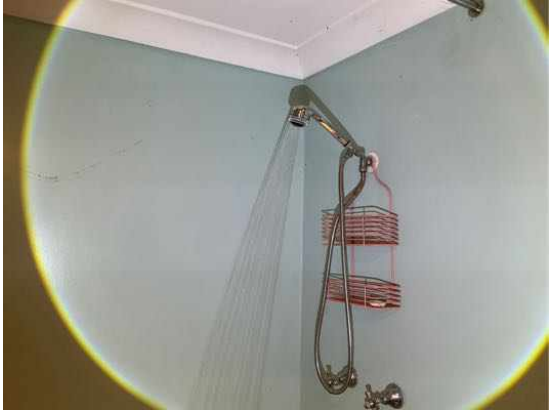
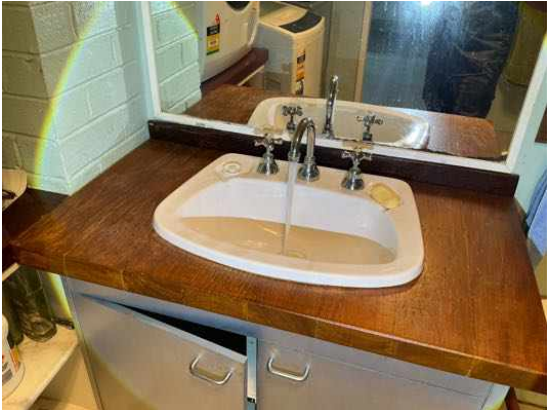
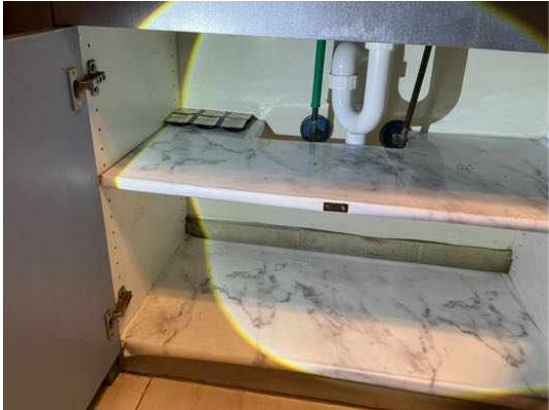
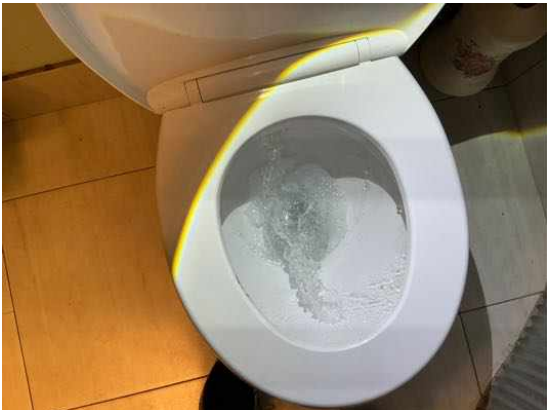
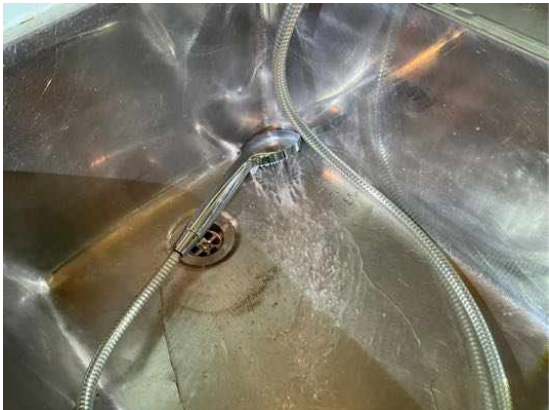
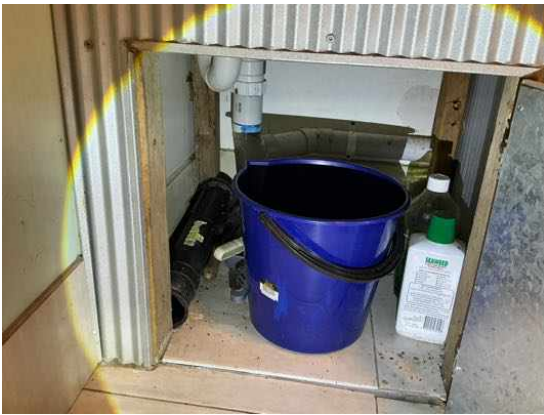
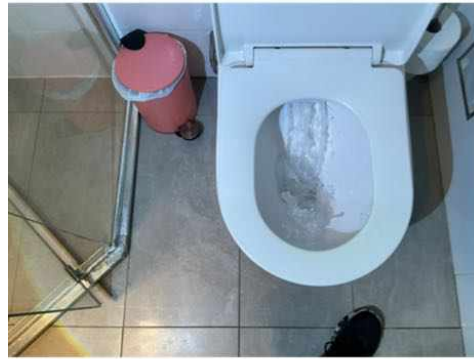
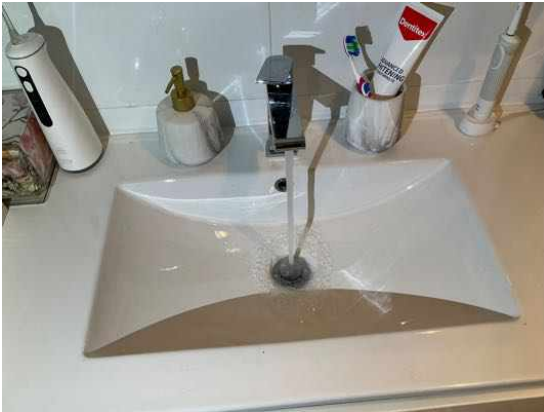
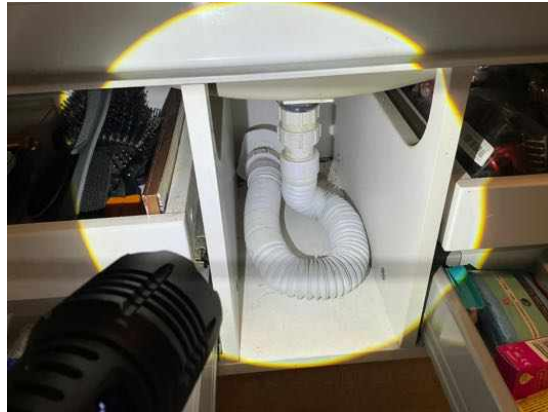
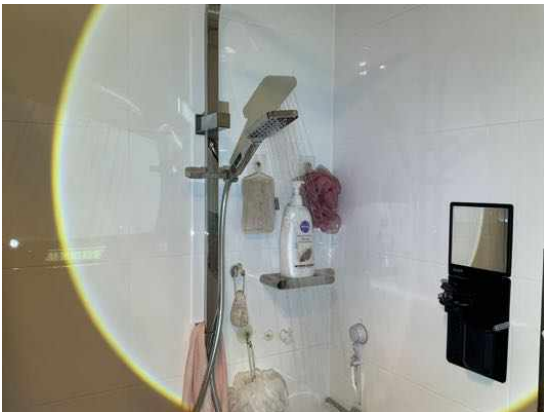
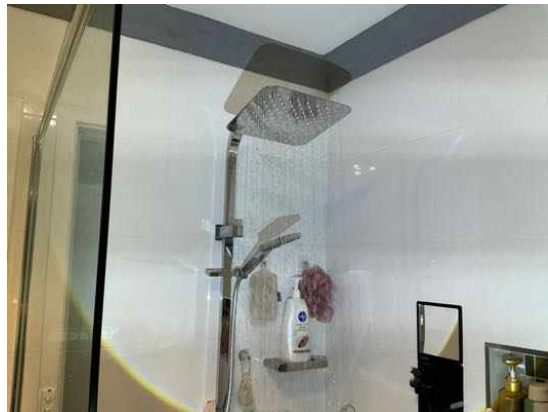
Building:	Main Building
Location:	All Areas
Finding:	FYI - Taps, Drainage & Toilets Tested and Cabinetry Obstructions
Information:	During the inspection, all accessible taps, drainage systems, and toilets were tested for water flow and drainage efficiency, and checked for any visible signs of leakage. At the time of the inspection, no issues were noted in these areas. Unless highlighted in a separate defect statement, no immediate remedial work appears necessary. Supporting images may be found in the additional photos section for reference.

It is important to note that while a visual inspection of cupboards and cabinetry beneath sinks and vanities was undertaken, stored personal items and fixtures presented obstructions that limited full visibility of the internal areas. As per standard inspection practices, inspectors are not permitted to move or disturb personal belongings during the inspection process. Therefore, only visible and accessible sections were inspected, and concealed water damage or plumbing defects may not

have been detected.

Given this, a re-inspection is recommended after all obstructions have been cleared to allow for a comprehensive assessment of these areas. Regular maintenance and monitoring of plumbing and drainage systems is also advised to ensure ongoing functionality and early detection of potential issues.
