Building and Timber Pest Inspection Report

Inspection Date: Mon, 16 Feb 2026

Property Address: 181 Cox St, South Windsor NSW 2756,
Australia

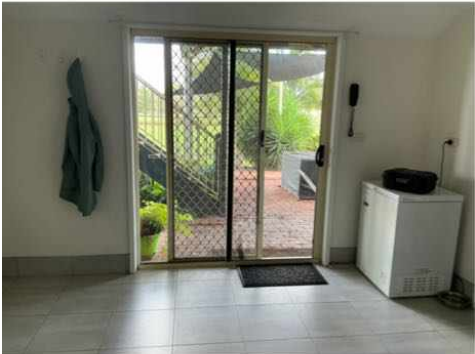
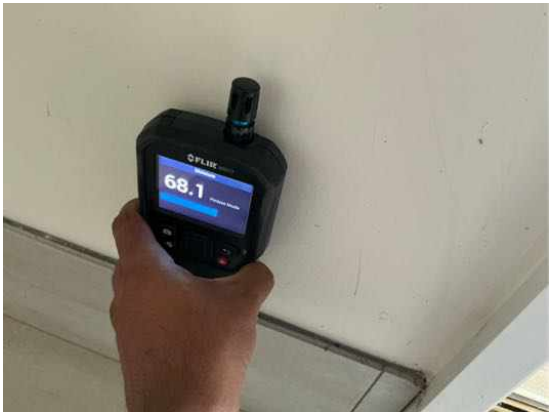
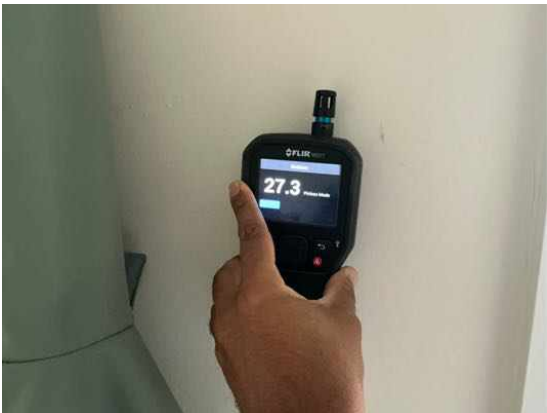
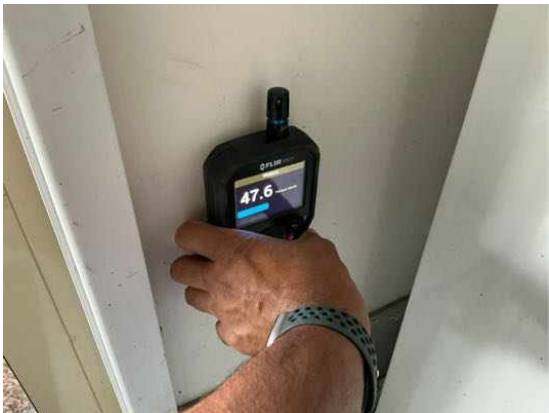
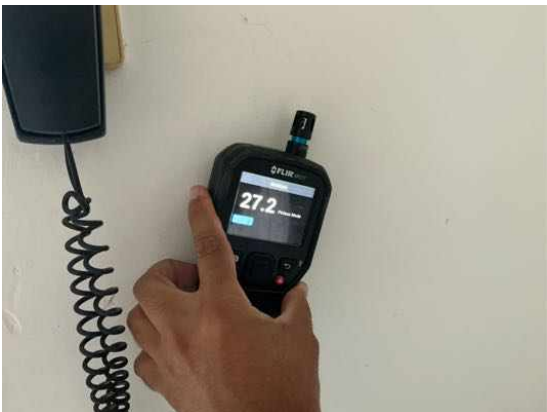
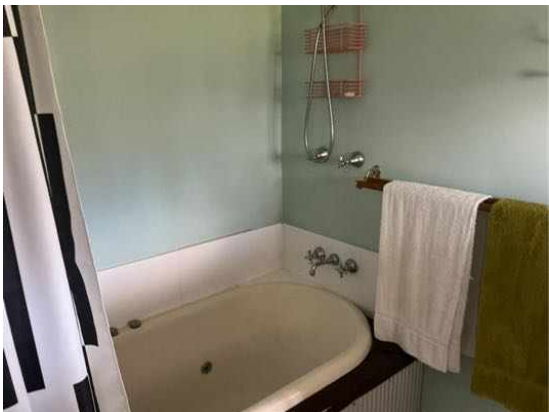
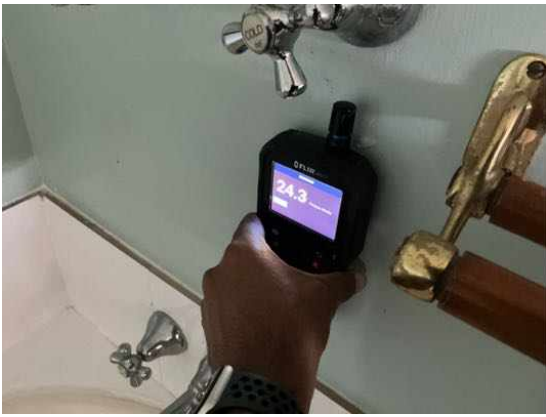
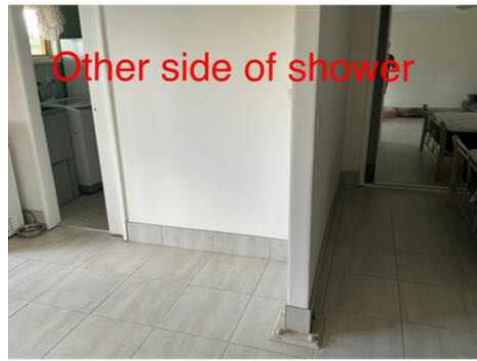
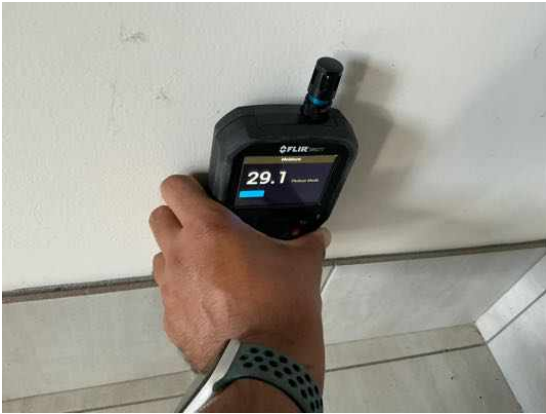
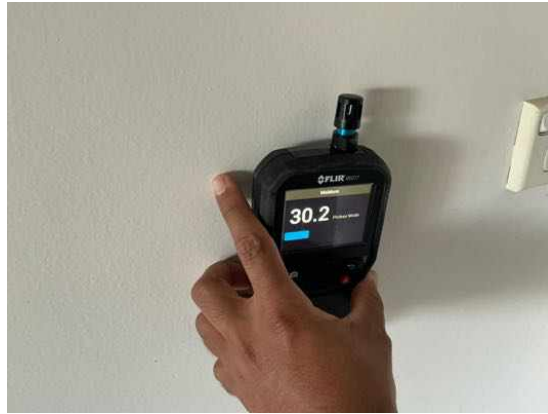
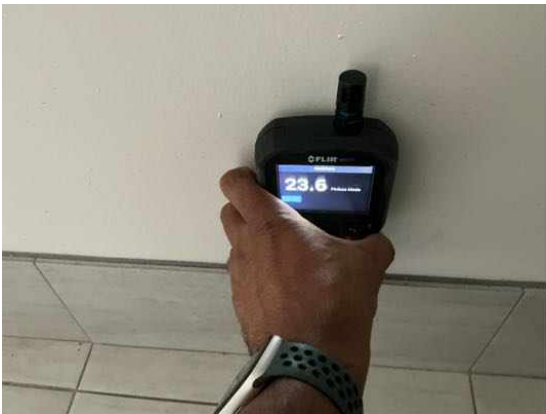
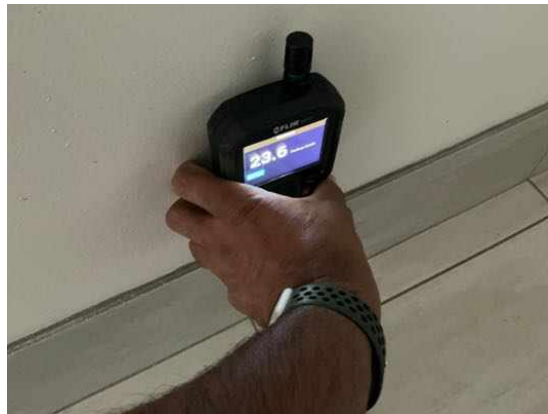
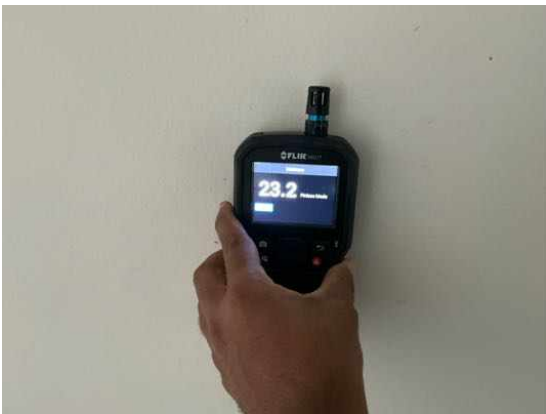
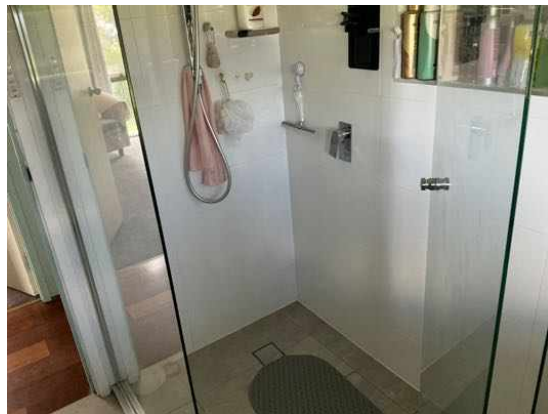
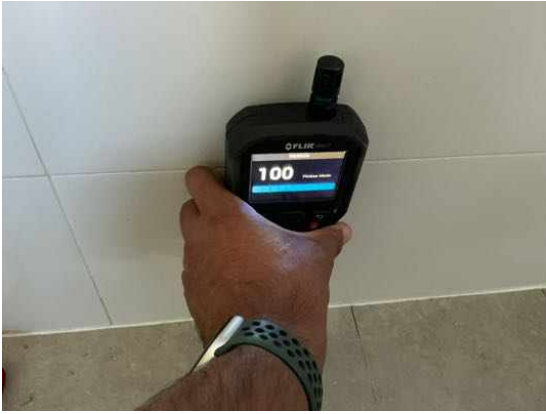
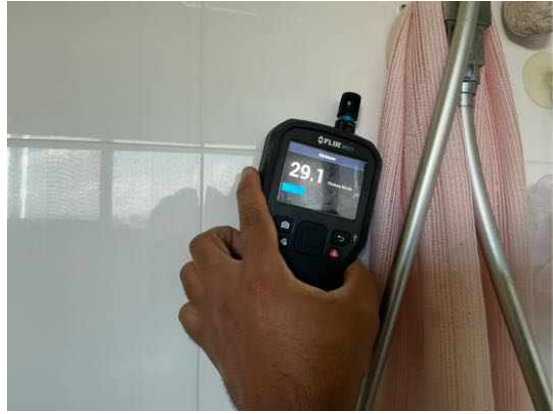
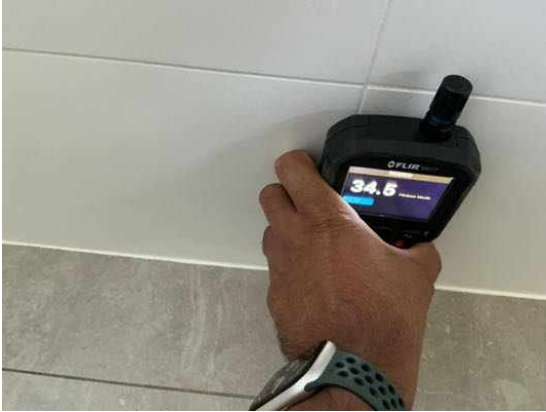
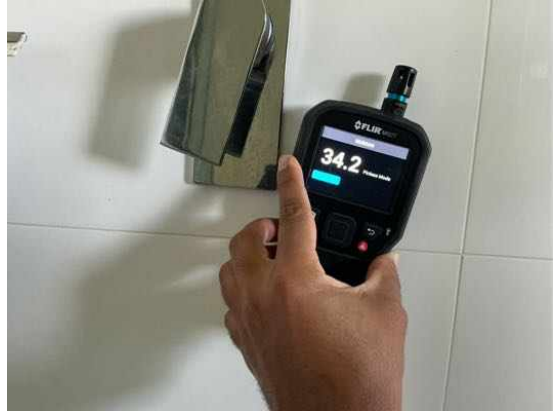
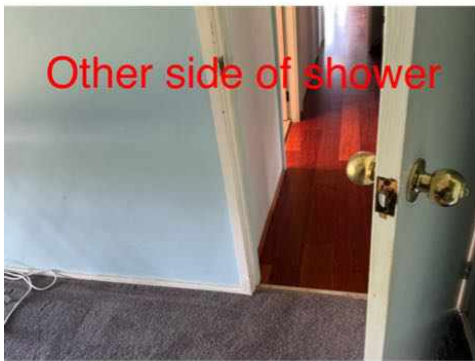
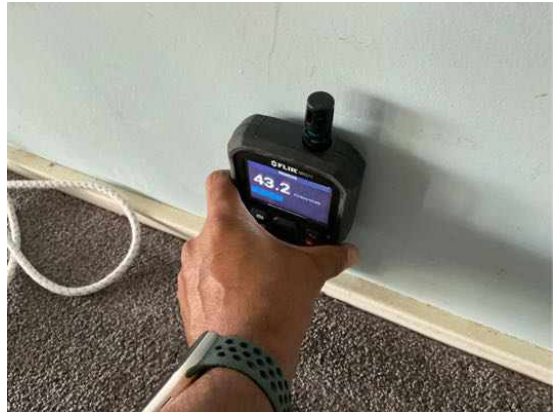
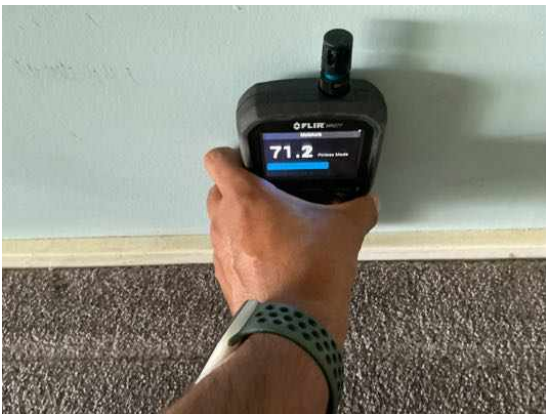
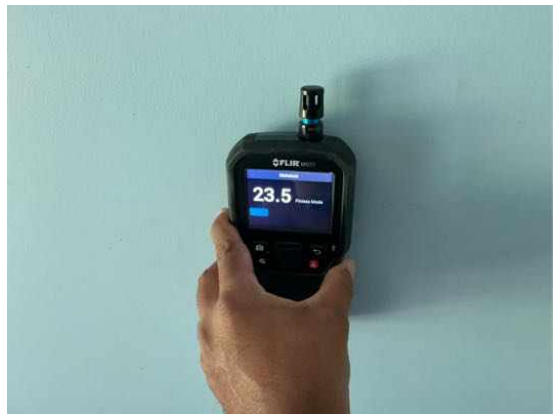
Finding: Additional Photos - Moisture Meter Readings

Information: Additional moisture meter reading photos have been provided for the property to offer further clarity on areas tested during the inspection. These photos are intended to give a visual reference for the specific locations where moisture levels were measured. These readings were taken at the time of the inspection to assess any potential moisture-related issues within the property. Any defects related to moisture that were identified during the inspection have been separately mentioned in the defect statements within the report.

It is important for the client to understand that moisture levels can fluctuate over time due to various factors, including changes in weather, humidity, and environmental conditions. While the readings reflect the property's moisture levels during the inspection, they may not represent future conditions, and increased moisture could lead to issues such as dampness, mould growth, or deterioration of building materials if left unmonitored.

For further clarification or additional information regarding the moisture readings, the client is encouraged to contact the building inspector directly. Regular monitoring of moisture-prone areas is recommended to ensure any emerging concerns are addressed promptly, particularly during wetter seasons or in high-humidity conditions.

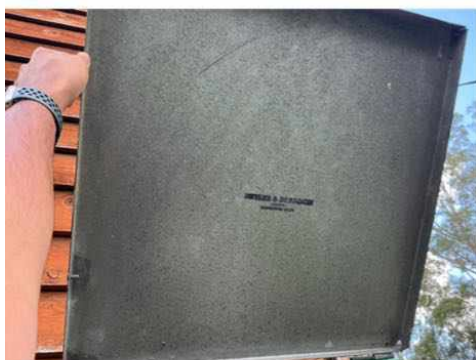
Building: Main Building
 Location: Meter Box
 Finding: Termite Management Recommendation – No Evidence of Chemical Installation
 Information: At the time of inspection, there was no visible evidence of a chemical termite management system installed around the property. Chemical barriers are a key component of termite protection and are particularly important in preventing concealed termite entry into timber elements of the structure.

In accordance with standard requirements, a durable notice should be located within the electrical switchboard to detail any termite protection systems applied, including chemical treatments. No such notice was observed during the inspection.

It is recommended that the client engage a licensed pest controller to assess the suitability of installing a chemical barrier, and to provide advice on associated costs and procedures. This should be considered a short-term priority, particularly if the property has any history of termite activity or is located in a high-risk area.

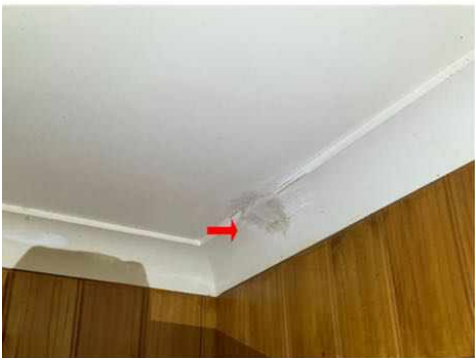
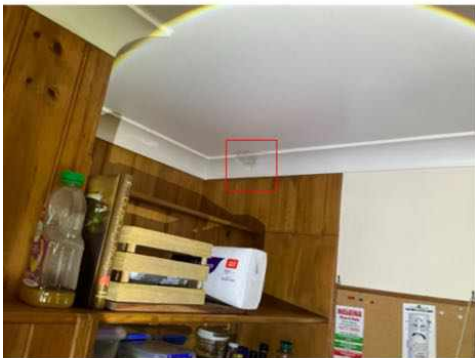
Building:	Main Building
Location:	Kitchen Pantry
Finding:	Previous Repairs
Information:	At the time of inspection, it was noted that some repair work has been previously undertaken in this area. It is advisable for the client to inquire with the previous owner regarding the nature and extent of these repairs, including the specific issues addressed and the methods used for remediation. Understanding the history of the repairs can provide valuable insights into any recurring problems or potential long-term implications.

Additionally, the client should request any available documentation from the current owner that pertains to these repairs. This documentation may include invoices, warranties, or detailed descriptions of the work performed. Such records can help verify the quality and scope of the repairs, ensuring that the necessary steps were taken to address the issues comprehensively. This information will be crucial for future maintenance planning and can provide peace of mind regarding the structural integrity and safety of the property.
