Building and Timber Pest Inspection Report

Inspection Date: Tue, 20 Jan 2026

Property Address: 55 McDougall Pl, Fernmount NSW 2454,
Australia

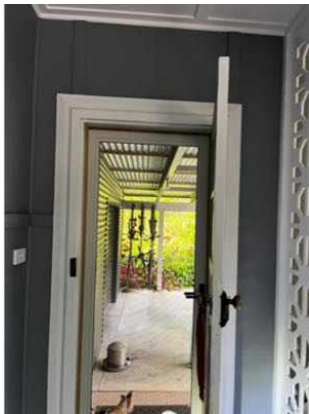
Finding 1.01

Building:	Main Building
Location:	Bungalow entry
Finding:	Bungalow entry - safety hazard
Information:	At the time of this inspection it was observed that the smoke detector to the bungalow entry was damaged or the battery had been removed, it is recommended that an electrician repair or replace the smoke detector as soon as possible as this has the potential to be a safety hazard.

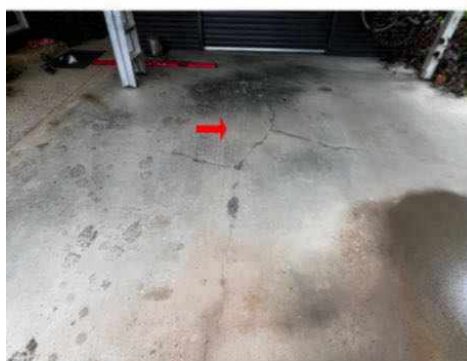
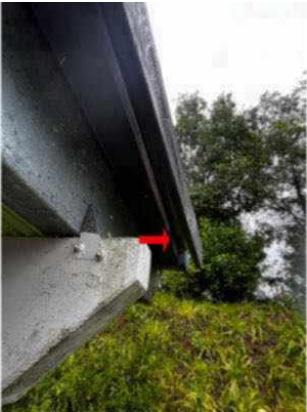
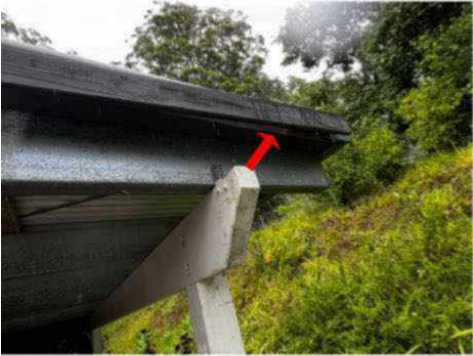
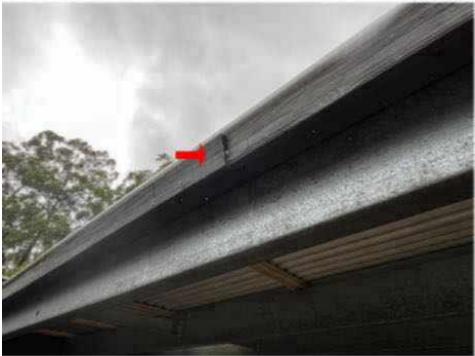
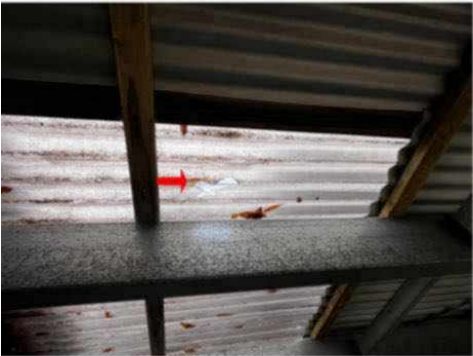
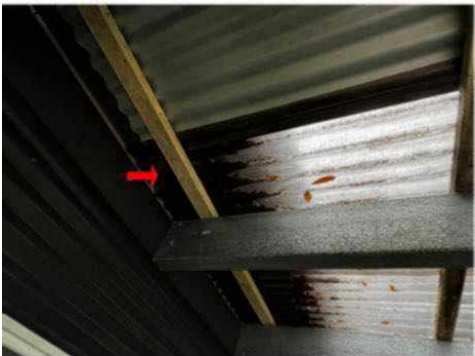
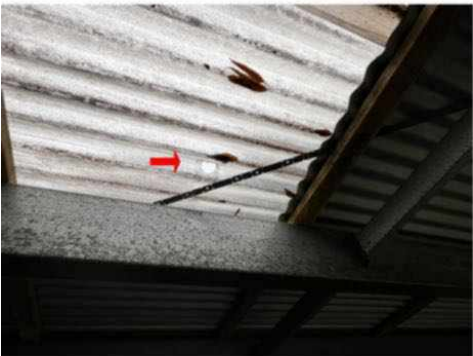
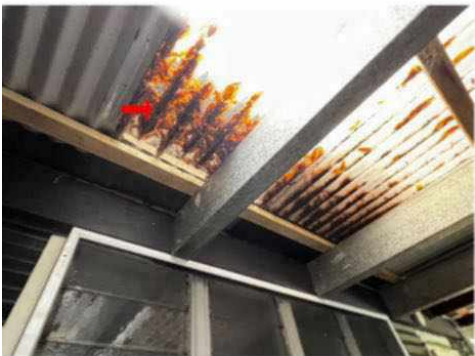
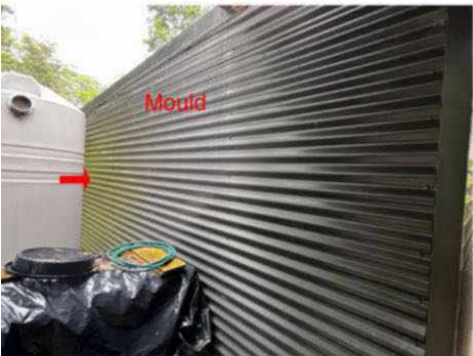
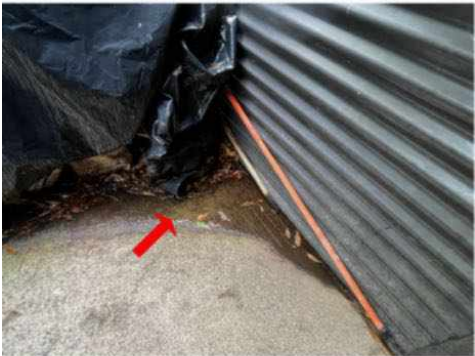
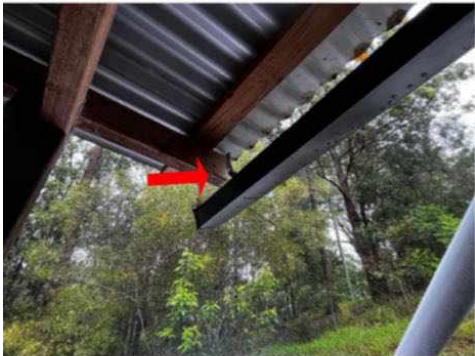
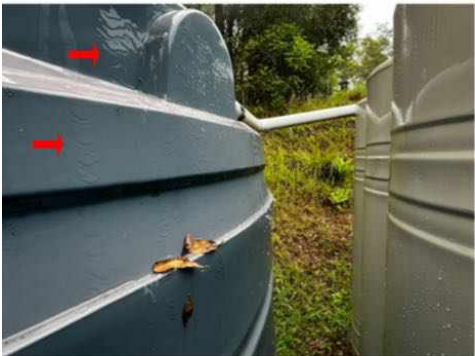
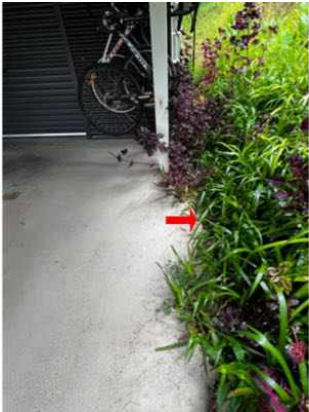
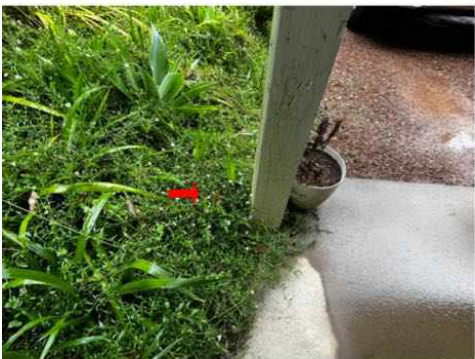
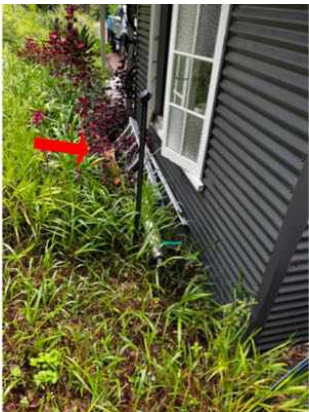
Finding 2.01

Building:	Main Building
Location:	Carport
Finding:	Carport - defects

Information: At the time of this inspection it was observed that the carport area had a number of defects,

1 - At the time of this inspection a number of significant cracks were evident in the concrete driveway.

A crack coded as Category 4 was identified in the slab.

A Category 4 crack is described as a crack that appears as a gap in the slab, with disturbing curvature or change in level affecting the slab.

The approximate width of the crack or gap is 4mm-10mm or a change in offset of greater than 25mm when a 3m straight edge is placed over the defect.

Category 4 cracking to slabs exceeds allowable Standards and Tolerances, and are therefore considered as major defects that require rectification..

2 - It was observed that there was minor fungal decay (wood rot) and damage to the carport timber fascia, it is recommended that the affected timber be repaired or replaced by a carpenter and all external timber elements be repainted.

3 - It was noted that there was damage to the clear roof sheeting, also noted was the excessive build up of leaves on the carport roof under the bungalow roof. All leaf litter should be removed and the damaged roof sheets replaced.

5 - It was further observed that the guttering to the walkway roof behind the carport had partially fallen off, also noted was that the water tank was over flowing. These issues has allowed water to pond at the rear of the carport. It is recommended that a plumber provide additional overflow drainage to the tank, repair or replace the damaged gutter and provide additional drainage to the rear of the carport if required.

6 - It was evident that there was excessive vegetation growth and stored items concealing areas of the external bungalow walls, this vegetation should be removed and the area be reinspected.

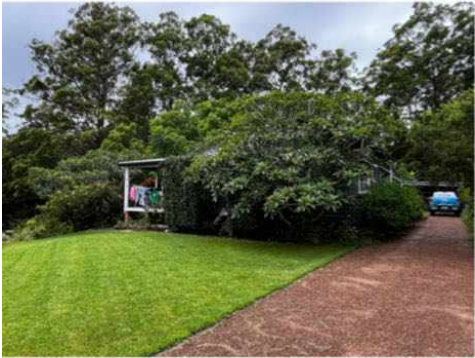
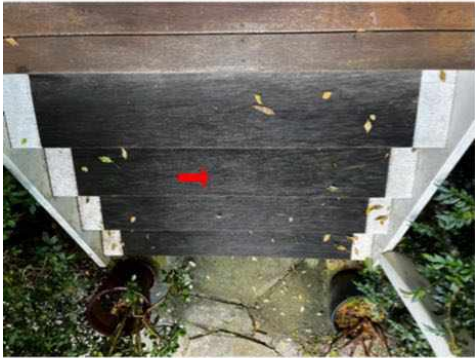
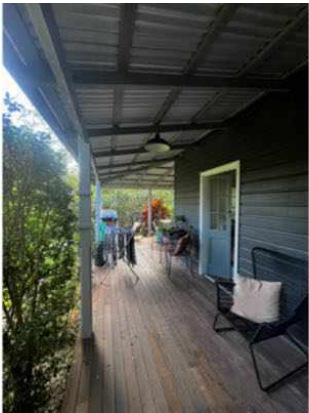
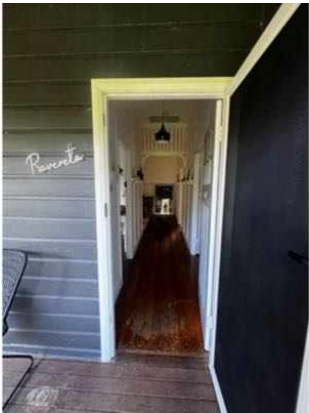
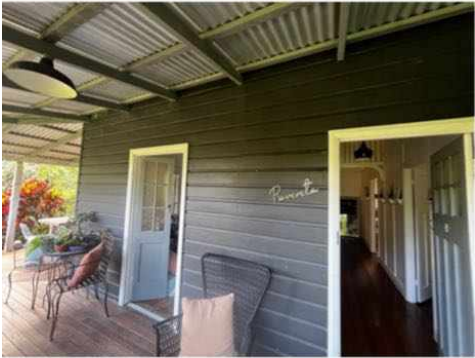
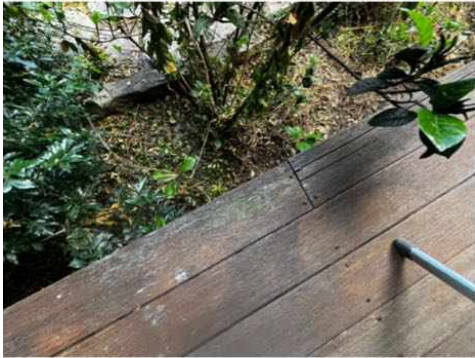
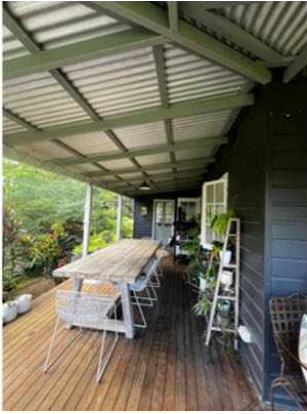
Finding 3.01

Building: Main Building
Location: Front deck
Finding: Front deck - defects

Information: At the time of this inspection, it was observed that there were several areas of the timber decking that were deteriorated, it is recommended that a painter prepare and coat the decking Timbers, this will increase the service life of the timber elements.

It was also observed that sections of the roof frame had mould growth evident, it is recommended that the mould be cleaned off the Timbers.

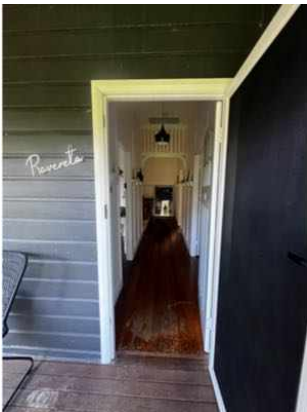
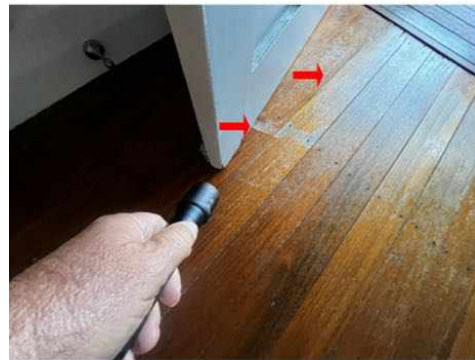
Finding 3.02

Finding: Entry - minor defects

Information: At the time of this inspection, it was observed that the front door was binding on the floor causing damage, it is recommended that a carpenter adjust the door for smooth operation.

It was also observed that a section of the flooring inside the entry door was faded and deteriorated, it is recommended that the flooring is re sanded and re polished at your discretion.

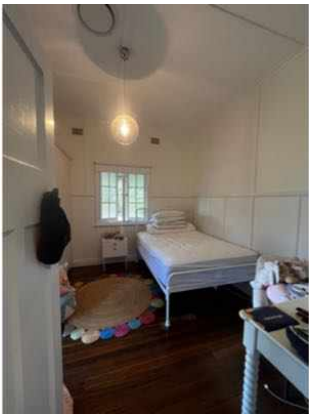
Finding 3.03

Finding: Bedroom 2 - defects

Information: At the time of this inspection, it was also observed that a section of the flooring inside the French doors and under the end of the bed were faded and deteriorated, it is recommended that the flooring be repaired as required, is re sanded and re polished at your discretion.

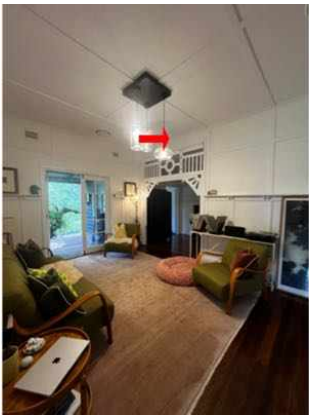
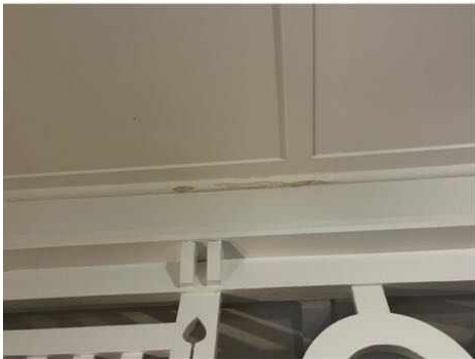
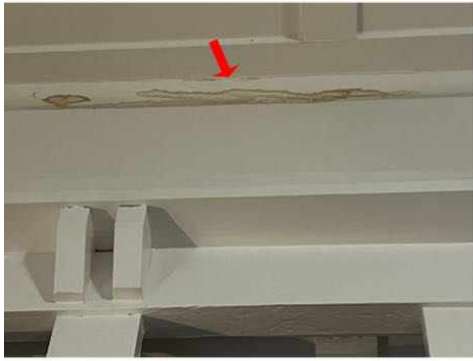
Finding 3.04

Building: Main Building
Location: Lounge Room
Finding: Lounge room - defects
Information: At the time of this inspection, it was observed that there was water staining evident to the timber scotia, it is recommended that a roofer thoroughly inspect the roofing and flashings over this area to determine if there is a leak in the roofing, once determined, a painter should repaint the affected area.

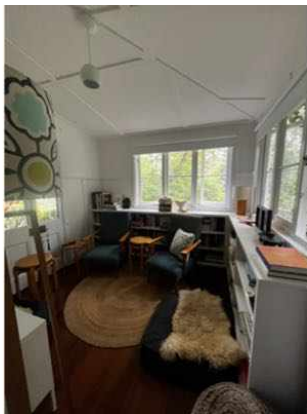
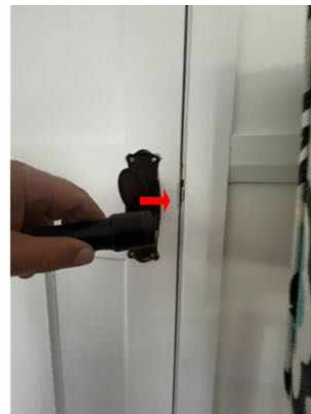
Finding 3.05

Finding: Sunroom - defects

Information: It was noted that the passage door was binding on the lock side door jamb, it is recommended that a carpenter adjust the door for smooth operation.

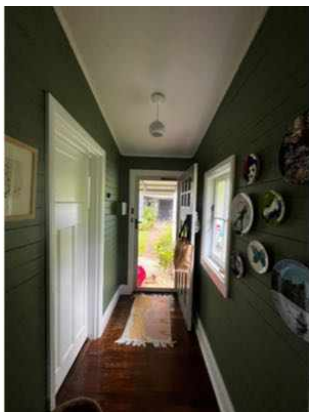
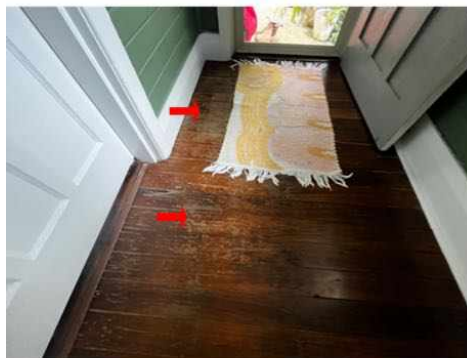
Finding 3.06

Finding: Rear entry - defect

Information: It was also observed that a section of the flooring inside the rear entry door was faded and deteriorated, it is recommended that the flooring is re sanded and re polished at your discretion.

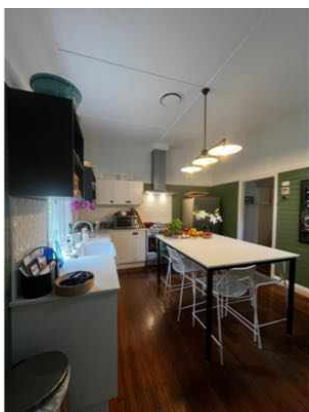
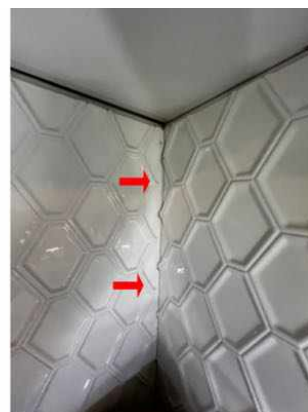
Finding 3.07

Building:	Main Building
Location:	Kitchen
Finding:	Kitchen - minor defects
Information:	At the time of this inspection, it was observed that there was cracking to the internal wall junction of the splash back tiles, it is recommended that a tiler re seal the junction with flexible sealant.

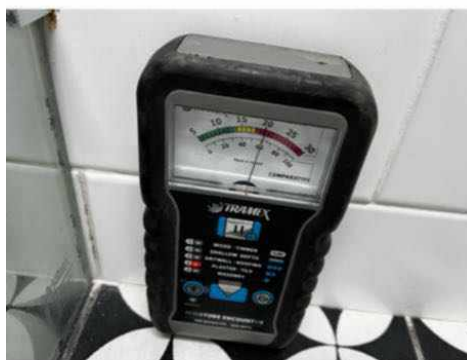
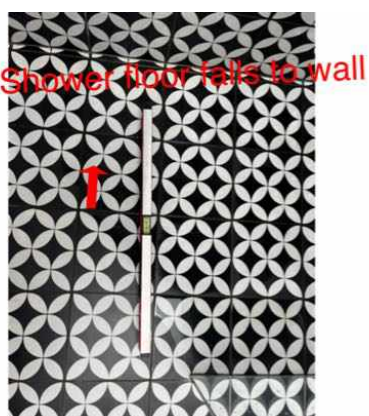
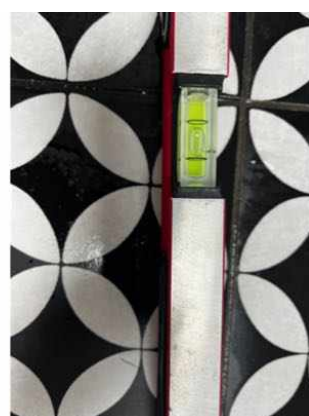
Building:	Main Building
Location:	Bathroom
Finding:	Moisture - ensuite excessive moisture evident
Information:	At the time of this inspection a moisture meter was used to take reading of moisture outside the shower cubicle on both tiled walls.

A higher than expected moisture reading was evident in the shower wall on the right side and the shower wall.

The moisture meter reading on the right side tile was 20 out of a maximum of 30 on the moisture meter.

No evidence of water damage to the underside of the shower floor was seen.

It was also noted that the shower floor falls towards the east wall, it was observed that there was a small amount of ponding water against the wall. Without re tiling the floor, there is not a lot can be done about this issue.

It is recommended that a builder and plumber investigate this issue further to determine the cause of the raised moisture content in the wall tiles and suggest required remedial works to be undertaken.

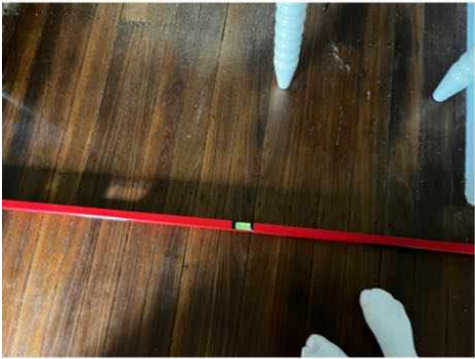
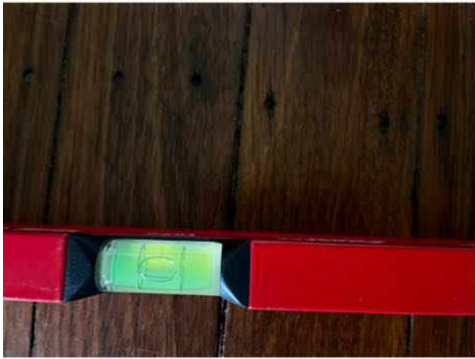
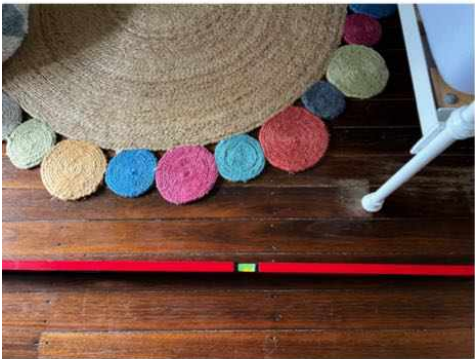
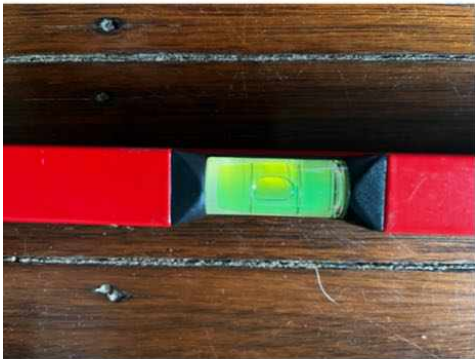
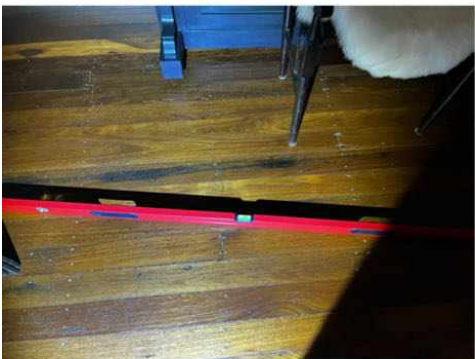
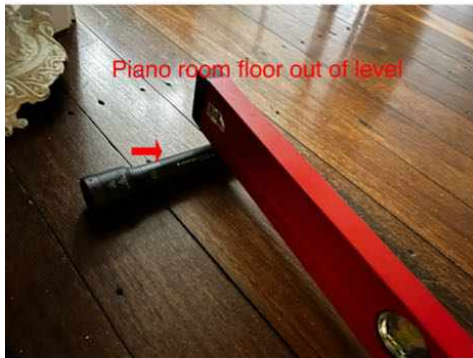
Finding 3.09

Building:	Main Building
Location:	All Internal Areas
Finding:	Timber floors - out of level
Information:	At the time of this inspection it was observed that the timber floors were generally reasonably level throughout the house.

It is assumed that this is as a result of movement in the subfloor piers and floor over time.

It is recommended that a builder thoroughly inspect the subfloor area to determine the cause of the movement and to recommended remedial works to level the floors if desired.

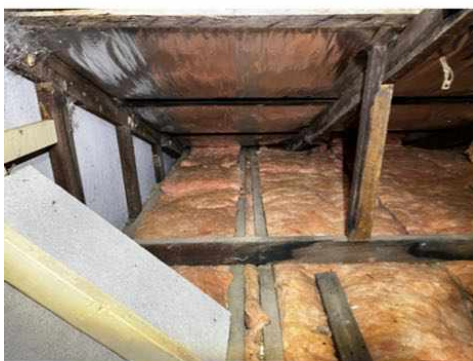
Finding 3.10

Building:	Main Building
Location:	Roof Void
Finding:	Roof void - excessive insulation
Information:	At the time of this inspection it was evident that numerous insulation batts extended over the top plate of the timber frame.

NOTE: It was also observed that possible asbestos containing sheets were visible in the roofing void, it is recommended that no work be carried out in this area until the sheeting has been sampled, tested and reported for asbestos.

It is recommended that any offending insulation be adjusted to allow full inspection.

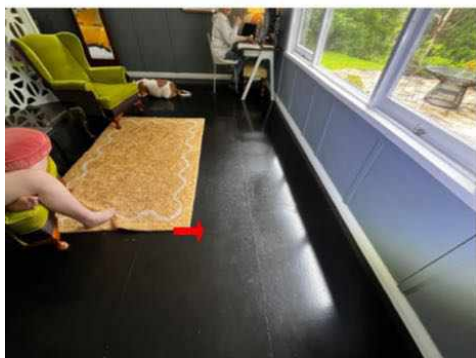
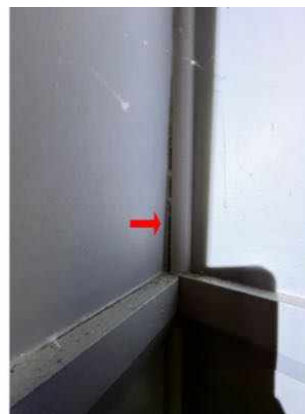
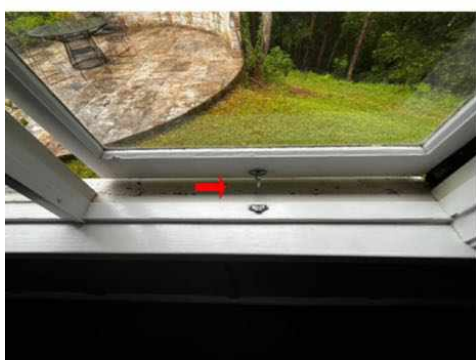
Finding 3.11

Building:	Main Building
Location:	Bungalow lounge
Finding:	Bungalow lounge room - defects
Information:	<p>At the time of this inspection it was observed that there were a number of defects in the bungalow lounge room,</p> <p>1 - There was deterioration to the timber window frames externally, a painter should sand and repaint the window frames.</p> <p>2 - It was observed that there was a crack to the timber trim/wall sheet junction to the North west corner of the lounge room.</p>

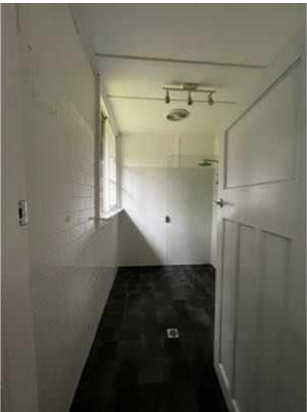
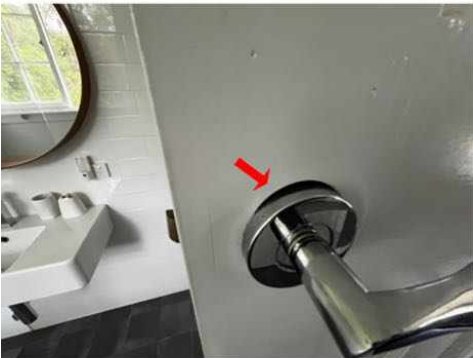
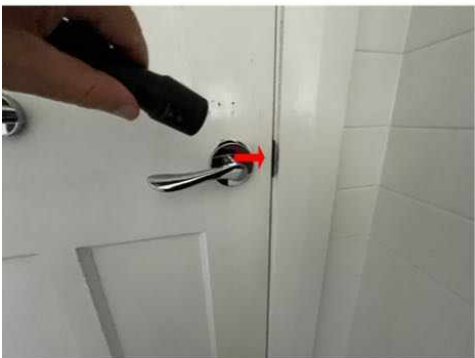
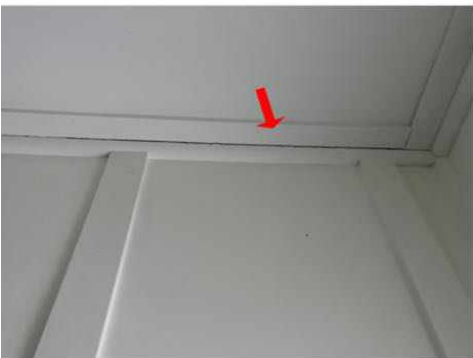
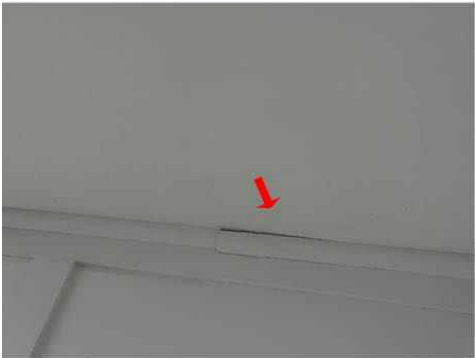
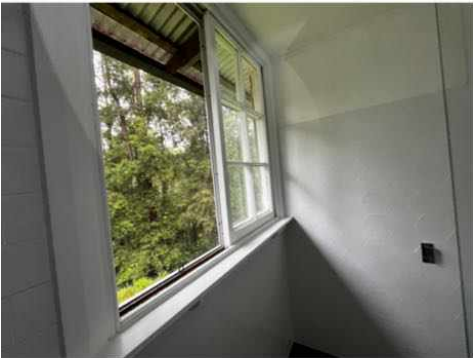
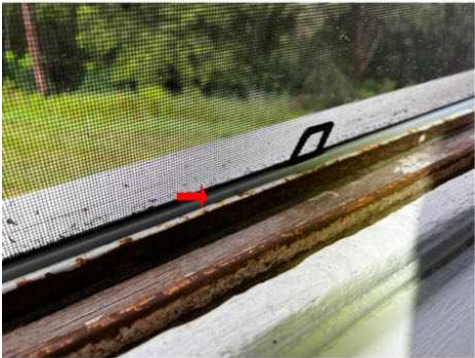
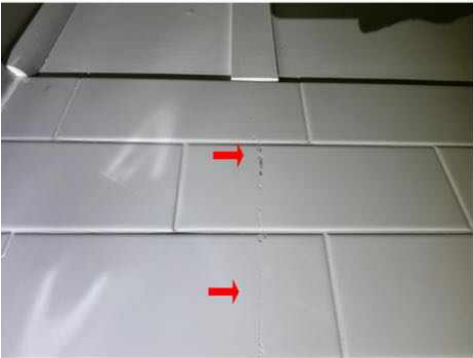
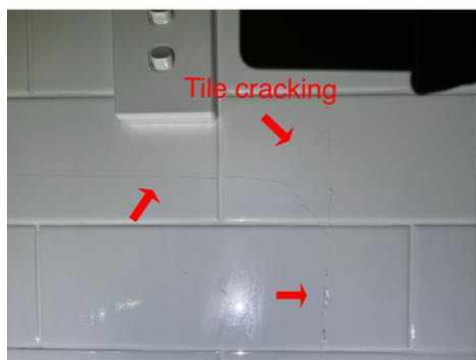
Finding 3.12

Building: Main Building
 Location: Bungalow bathroom
 Finding: Bathroom - defects
 Information: At the time of this inspection it was observed that there were a number of defects in the bungalow bathroom area,

1 - It was observed that the passage door lock did not cover the hole in the door, also noted was that the door lock did not latch when closed. It is recommended that a carpenter replace the lock with one that covers the hole.

2 - It was observed that there was minor cracking to the timber scotia trim around the cornice area, it is recommended that a carpenter re fix the trims and a painter fills any gaps and repaints as required.

3 - It observed that the sliding window track was rusted, it is recommended that the track be sanded and repainted or replaced.

4 - It was observed that there was a vertical crack through a number of tiles to the wall inside the passage door, it is assumed that the cracking has been caused by movement in the bungalow framing. It is recommended that a builder determine the

cause of the movement and a tiler replace the cracked tiles.

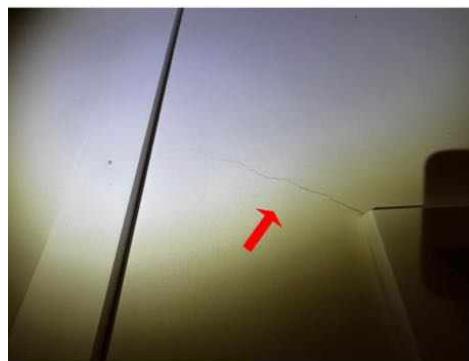
Finding 3.13

Building:	Main Building
Location:	Bungalow kitchen
Finding:	Kitchen - minor defects
Information:	At the time of this inspection, it was observed that there was a minor cracking to the wall sheeting above the southern kitchen passage door, it is recommended that a painter fill the crack and repaint the wall.

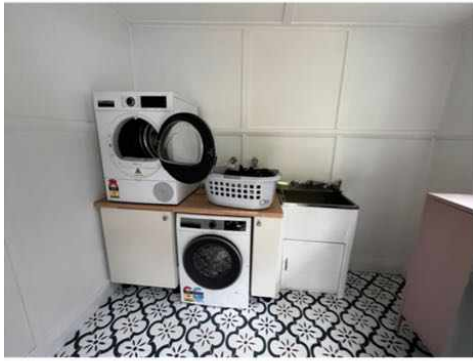
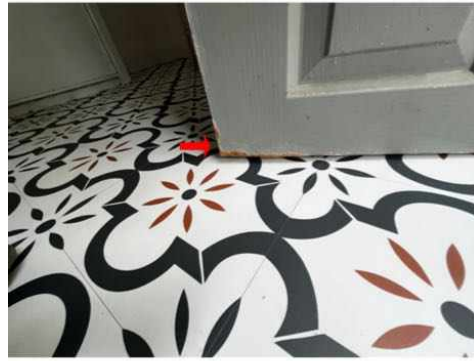
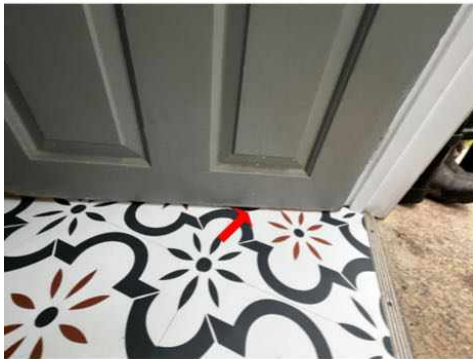
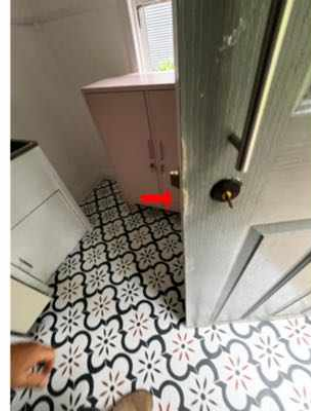
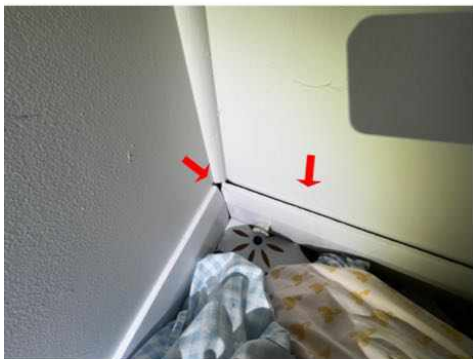
Finding 3.14

Building:	Main Building
Location:	Laundry
Finding:	Laundry - defects
Information:	At the time of this inspection, it was noted that the external door appeared to be an internal grade door and had moisture damage. It is recommended that a carpenter replace mother door with an external grade door as soon as possible.

It was also noted that there were gaps in the skirting and trims to the north west corner of the laundry, a painter should fill the gaps and repaint as required.

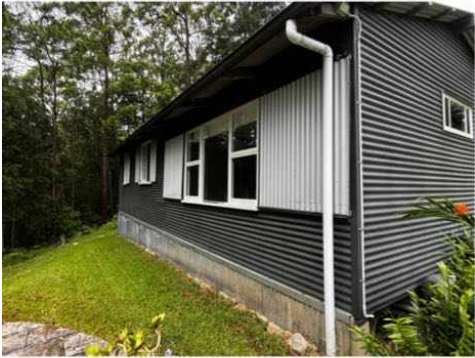
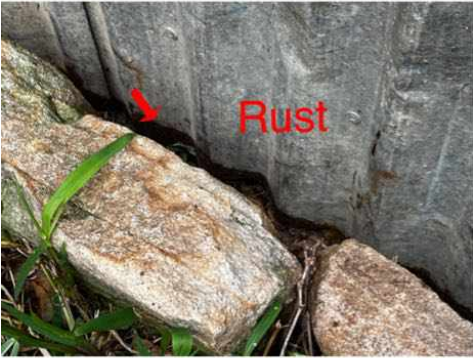
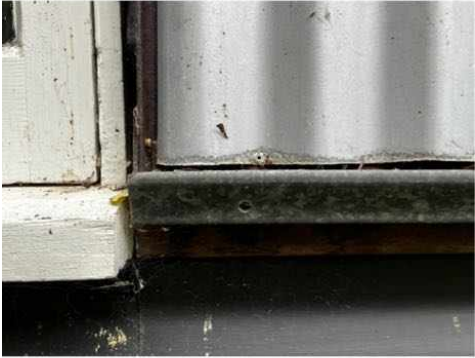
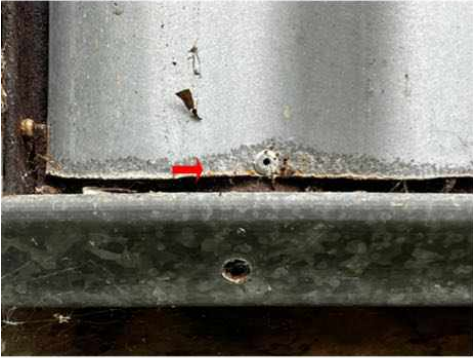
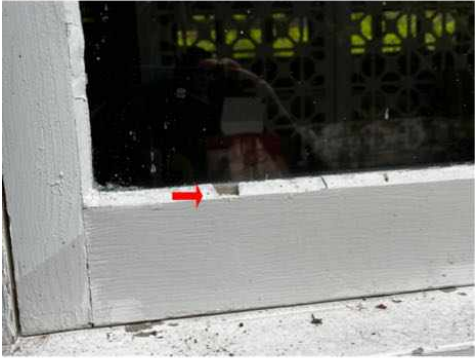
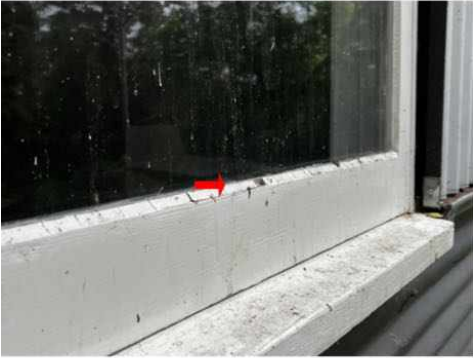
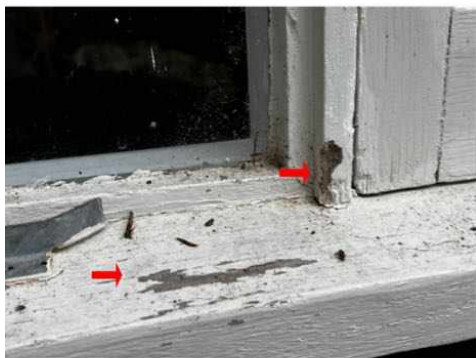
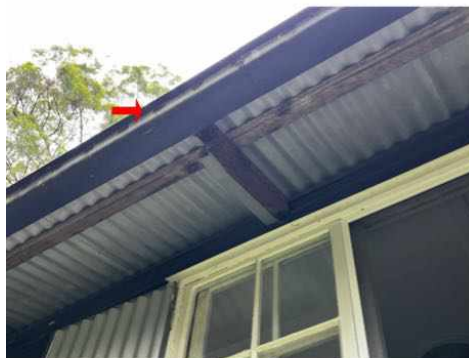
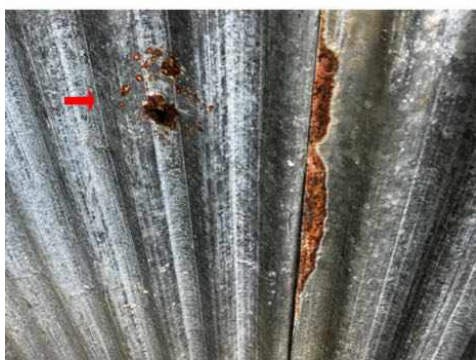
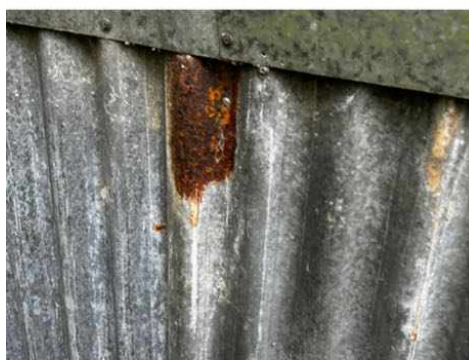
Finding 3.15

Building: Main Building
 Location: Bungalow exterior walls - rear
 Finding: Exterior rear - defects
 Information: It was observed at the time of this inspection that there were a number of minor defects to the rear of the house,

1 - There was rusting evident to the corrugated iron subfloor screening and minor corrosion to sections of the metal storm shutters. It is recommended that any rusted sheets be sanded and painted or replaced.

2 - It was evident that there was minor deterioration to sections of the timber window

exteriors, it is recommended that a painter sand, patch, putty and repaint all external timber elements to extend the service life of the timber.

3 - It was observed that the gutters had leaf litter evident, the gutters should be cleaned out and consideration given to fitting gutter guards.

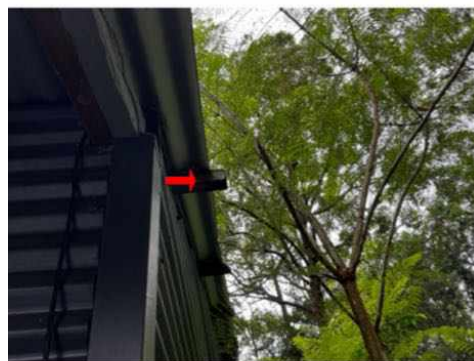
Finding 3.16

Building: Main Building
 Location: Bungalow exterior walls - right side
 Finding: Exterior area - right side
 Information: At the time of this inspection it was observed that there were several defects to the right side wall area of the house,

1.- It was observed that the end of several timber roof battens had minor fungal decay (wood rot) evident. It is recommended that a painter repaint all exposed timber elements for extended service life.

2 - It was observed that all surfaces of the end wall had areas of moss growth, this

3 - There was rusting evident to the corrugated iron subfloor screening and flashings, it is recommended that any rusted sheets be sanded and painted or replaced.

4 - It was observed that the air conditioning units were mouldy with vegetation growth around the units and sitting close to the ground, it is recommended that the vegetation be removed, the units cleaned and lifted up to gain airflow as soon as possible.

5 - It was observed that the rear paved area was overgrown with weeds and there were a number of sunken and damaged areas evident. It is recommended that a landscaper provide maintenance and cleaning to this area to level the pavers as soon as possible.

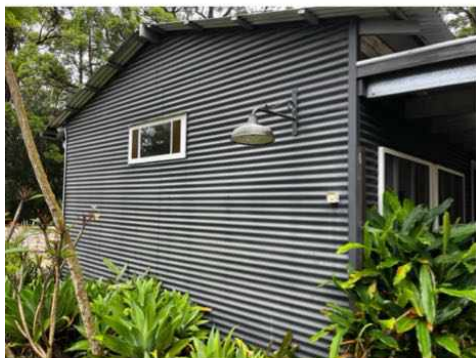
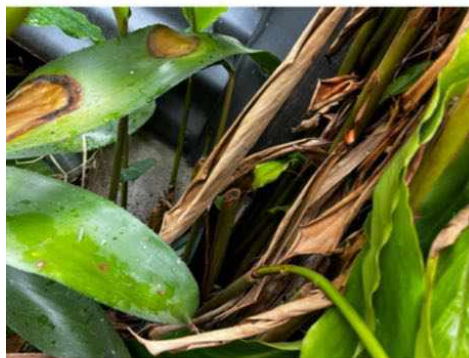
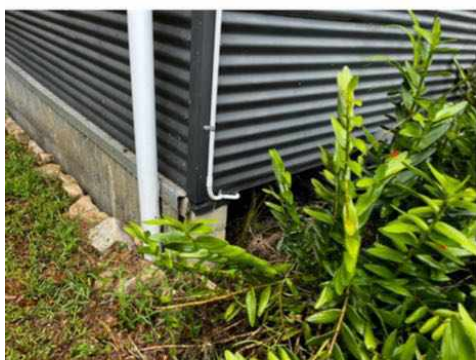
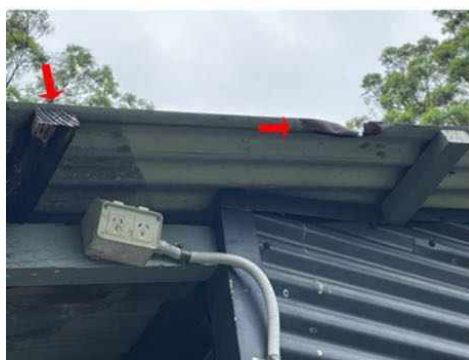
Finding 6.02

Building:	Main Building
Location:	Bungalow exterior walls - front
Finding:	Exterior area front - defects
Information:	At the time of this inspection it was observed that there were a number of minor defects to the external walls on the front of the house.

It was evident that there was excessive vegetation growth concealing areas of the external bungalow walls, this vegetation should be removed and the area be reinspected.

Also evident was that there was minor rust to the louvre window frames, it is recommended that the rust be sanded and the frames be painted or replaced at your discretion.

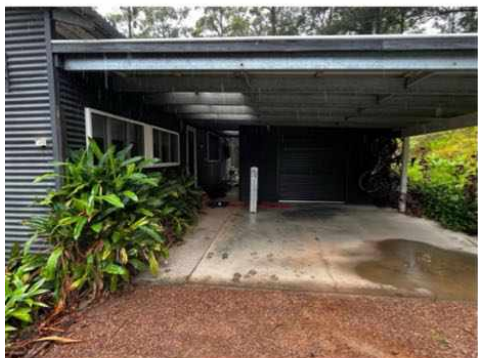
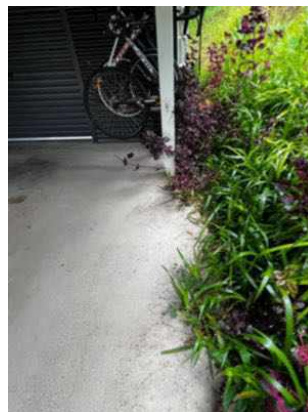
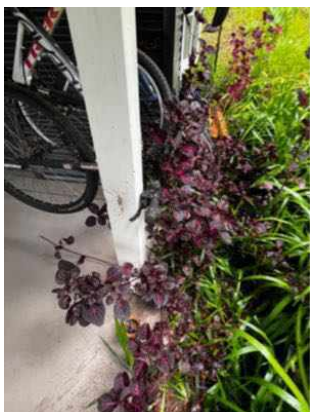
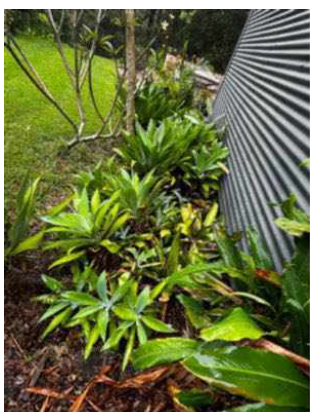
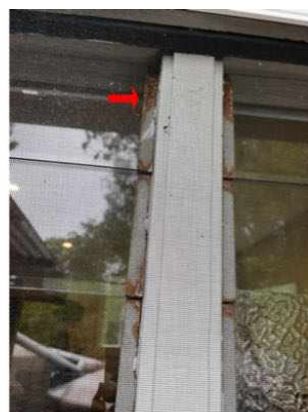
Finding 6.03

Building: Main Building
 Location: Exterior walls - right side
 Finding: Exterior area - right side
 Information: At the time of this inspection it was observed that there was excessive shrub and other vegetation growth obscuring the right side wall, it was observed that there was minor fungal decay (wood rot) evident in a number of the timber weatherboards it is recommended that the shrubs and other vegetation be thinned out or removed and the area be reinspected as soon as possible.

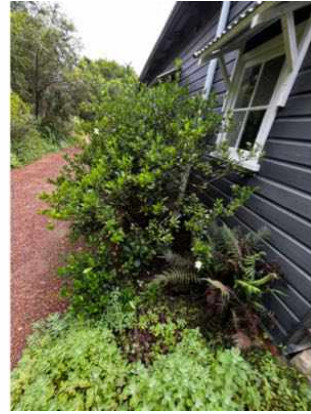
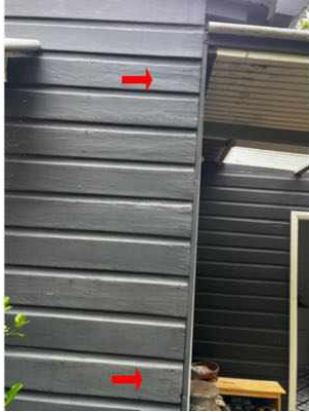
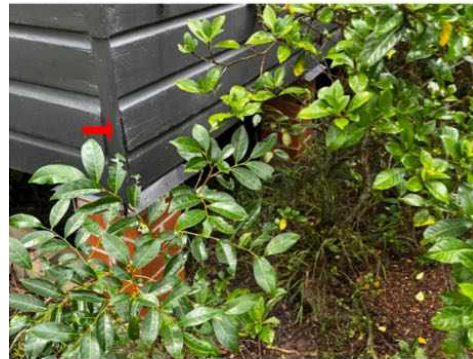
Finding 6.04

Building:	Main Building
Location:	Exterior walls - front
Finding:	Exterior area front - defects
Information:	It was observed at the time of this inspection that there were a number of defects at the front of the house,

At the time of this inspection it was observed that there was excessive shrubs, box hedges and other vegetation growth obscuring the front wall.

It was observed that the “crazy paved” path was overgrown and mouldy, it is recommended that the vegetation be cut back and the path be pressure cleaned.

It was also observed that the metal down pipe bracket was rusted and broken, it is recommended that a plumber replace the bracket as soon as possible.

It was observed that there was minor fungal decay (wood rot) evident in a number of the timber weatherboards. It is recommended that the shrubs and other vegetation be thinned out or removed and the area be reinspected as soon as possible.

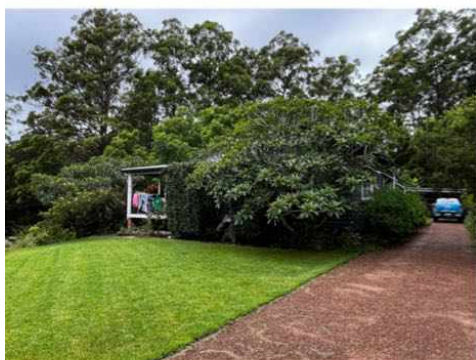
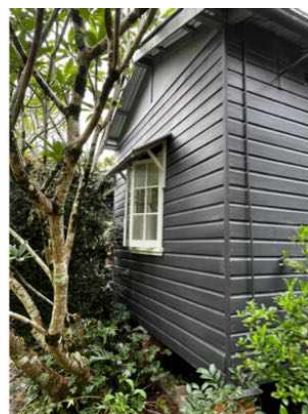
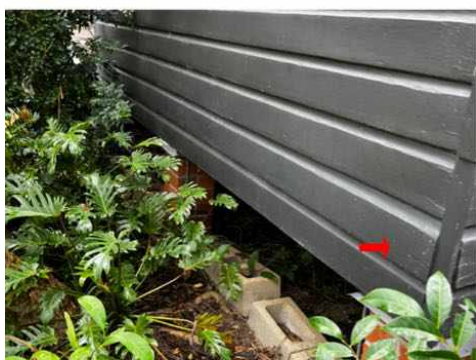
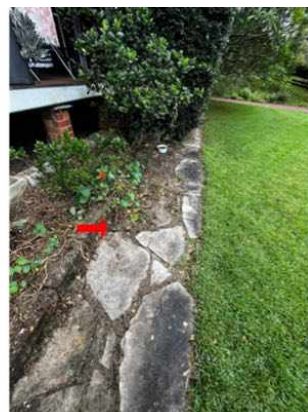
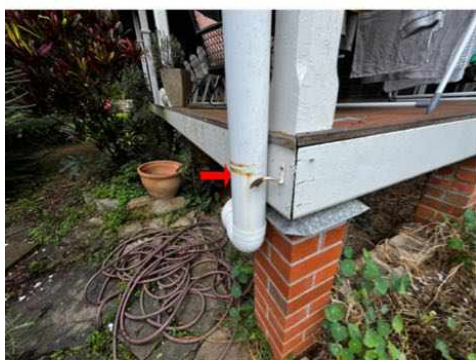
Finding 6.05

Building:	Main Building
Location:	Exterior walls - left side
Finding:	Exterior area - left side
Information:	At the time of this inspection it was observed that there was excessive shrub and other vegetation growth obscuring the right side wall and subfloor area, it was observed that there was minor fungal decay (wood rot) evident in a number of the timber weatherboards, It is recommended that the shrubs and other vegetation be thinned out or removed and the area be reinspected as soon as possible.

It was observed that a timber window had an unpainted edge visible, this edge should be painted as soon as possible.

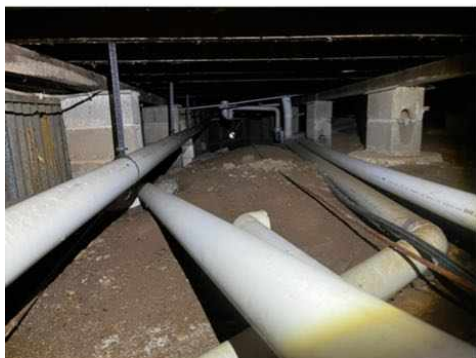
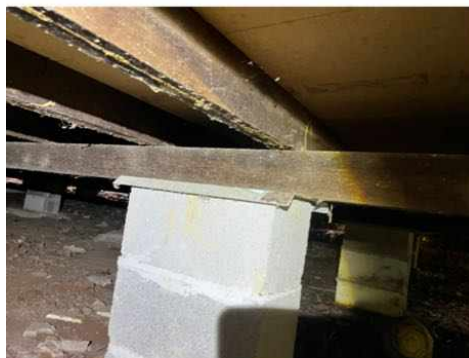
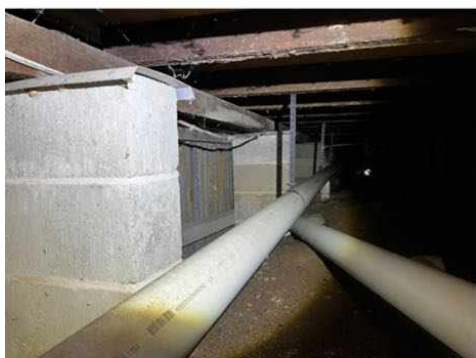
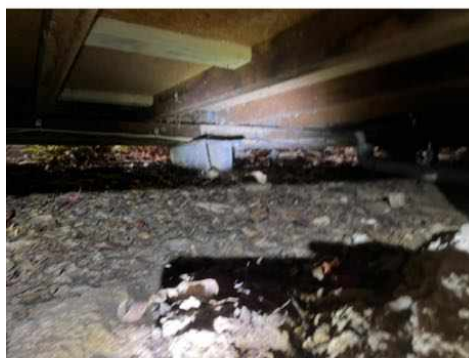
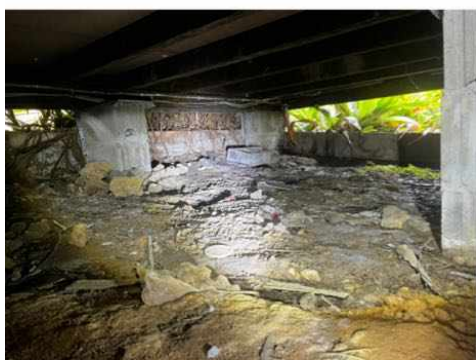
Finding 6.06

Building:	Main Building
Location:	Subfloor bungalow
Finding:	Subfloor space - defects
Information:	At the time of this inspection, it was observed that the subfloor area appeared to be in fair condition. Stored pipes were encountered, these should be removed. It was observed that the front side of the subfloor had low crawl space and excessive vegetation was obscuring the edges of the subfloor area. It is recommended that the vegetation be removed and the subfloor area be reinspected.

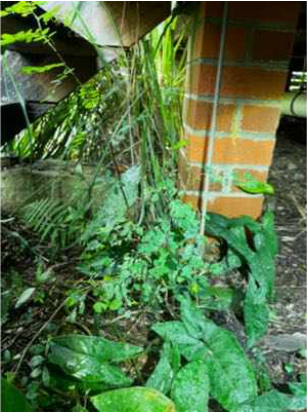
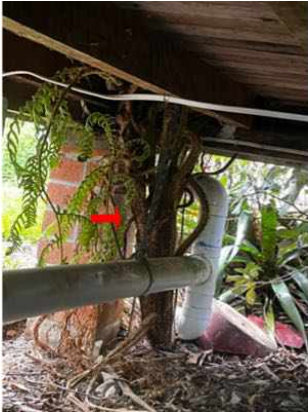
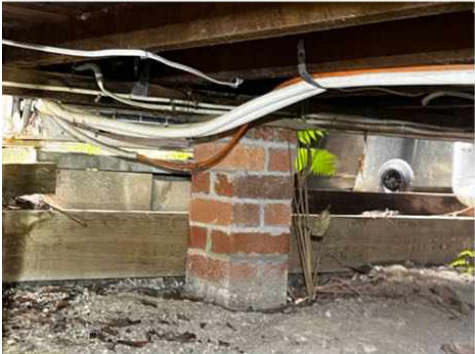
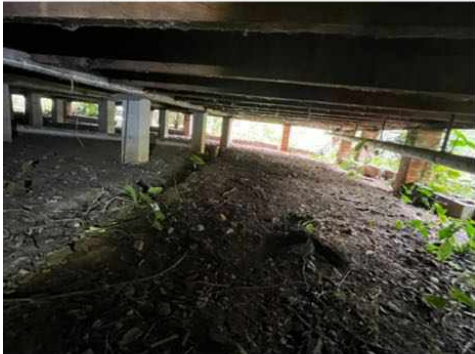
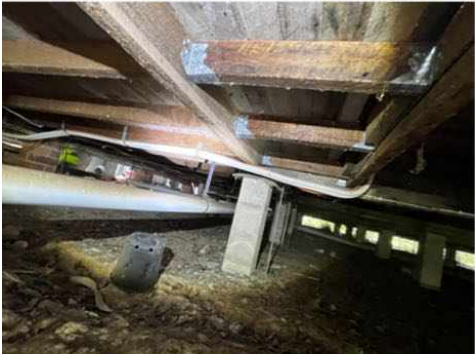
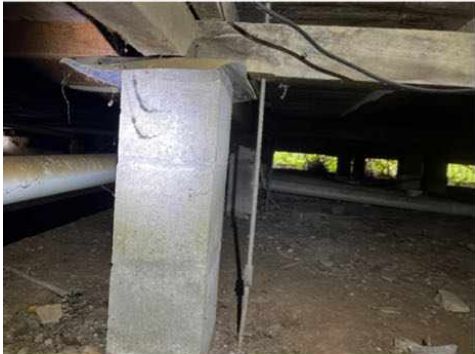
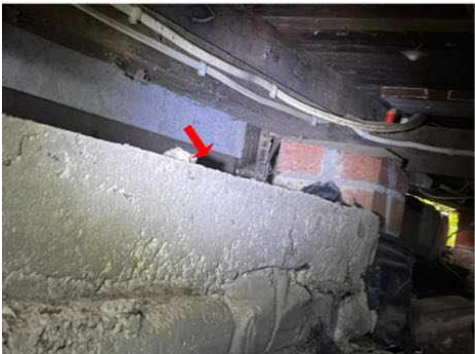
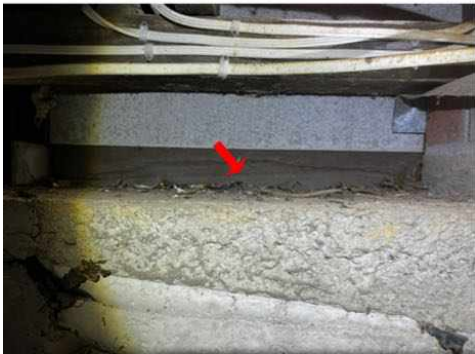
Finding 6.07

Building:	Main Building
Location:	Subfloor house
Finding:	Subfloor space - defects
Information:	At the time of this inspection, it was observed that the subfloor area appeared to be in fair condition. It was observed that excessive vegetation was obscuring some edges of the subfloor area. It is recommended that the vegetation be removed and the subfloor area be reinspected.

It was also observed that there was a section of timber framing in the bathroom area that appeared to have no termite protection, it is recommended that a timber pest

expert provide protection to this area of the subfloor.

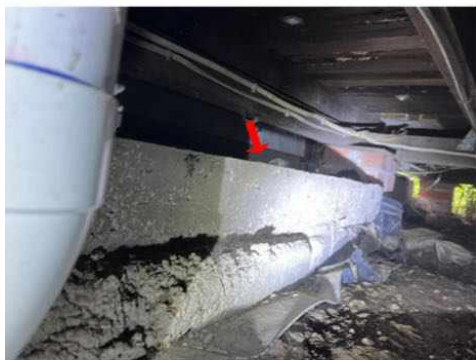
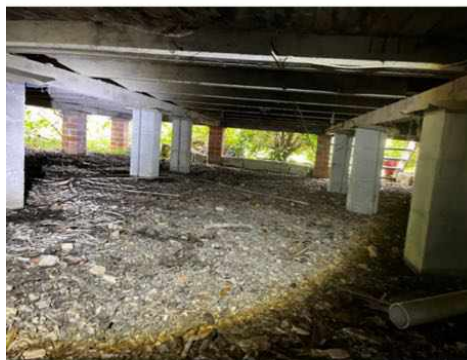
Finding 6.08

Building:	Main Building
Location:	All External Areas
Finding:	Evidence of previous termite management system was identified - metal ant caps
Information:	At the time of this inspection it was noted that there was a physical termite barrier installed to the sub floor area at the time of construction, this is in the form of metal ant caps.

As a consequence of the conducive conditions for the infestation or attack by timber pests that exist around the external of the building (excessive vegetation) and the sub floor area (low crawl space), it is highly recommended that a professional timber pest practitioner be engaged to complete a thorough timber pest inspection to all areas of the yard and buildings once the vegetation has been thinned out or cleared and provide and implement a suitable Timber Pest Management Plan and soon as possible.
