Building and Timber Pest Inspection Report

Inspection Date: Tue, 20 Jan 2026

Property Address: 55 McDougall Pl, Fernmount NSW 2454,
Australia

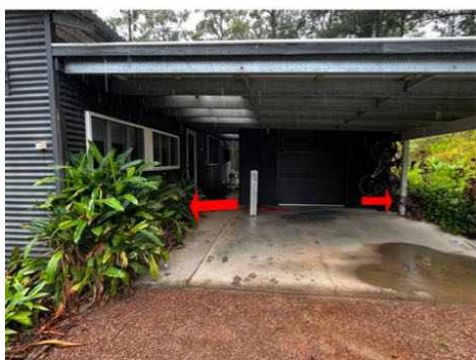
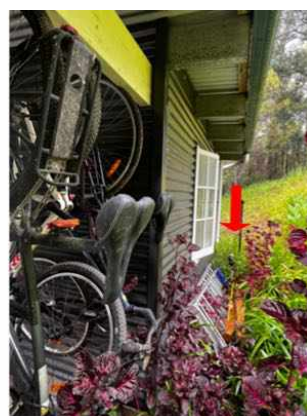
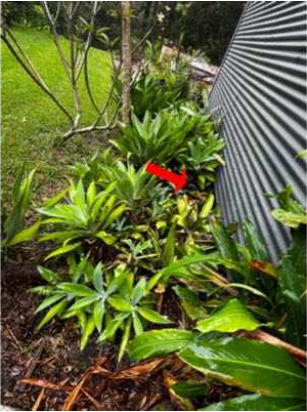
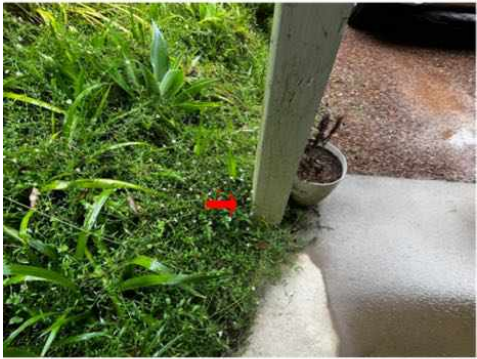
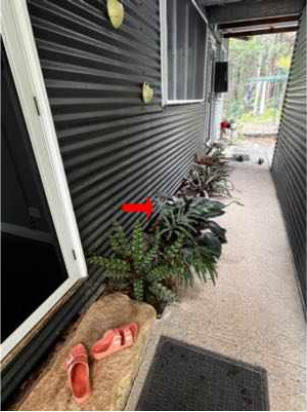
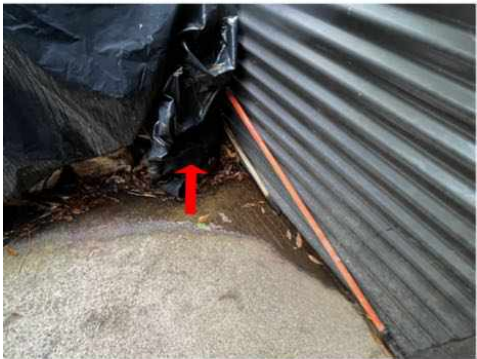
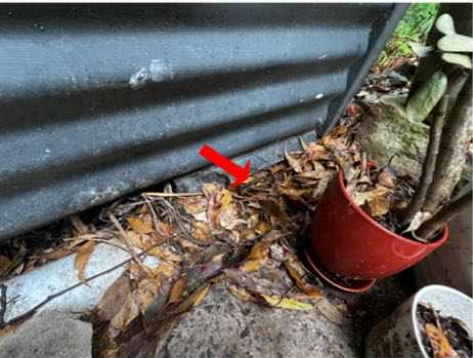
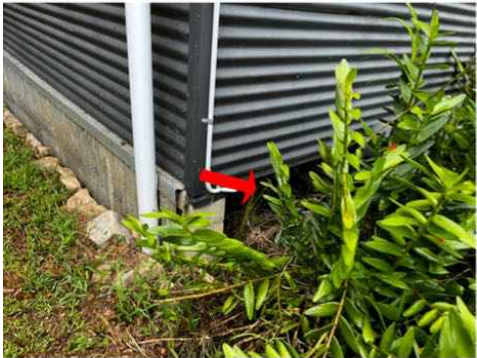
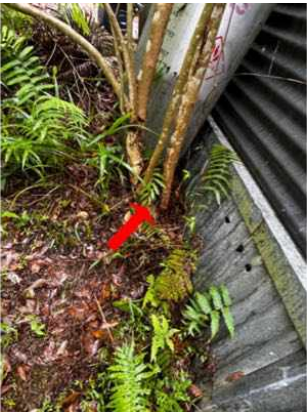
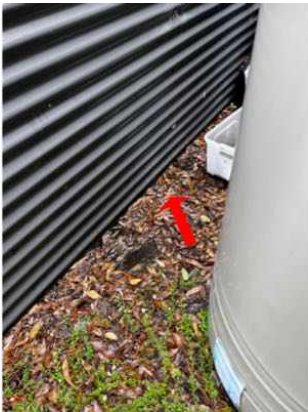
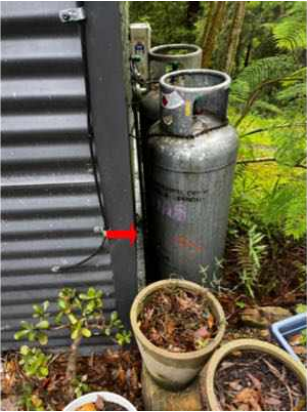
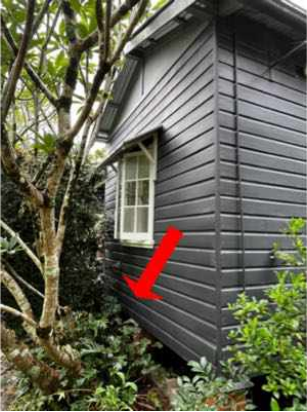
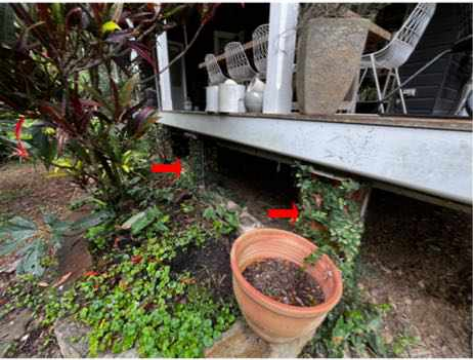
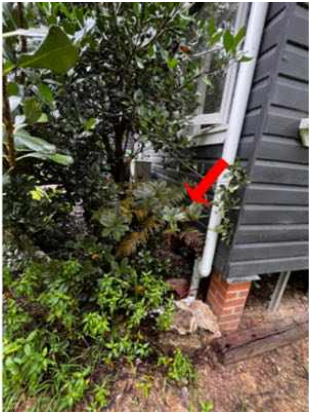
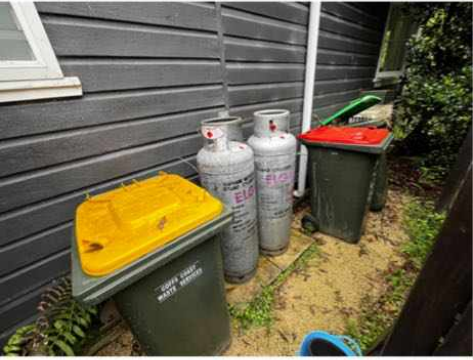
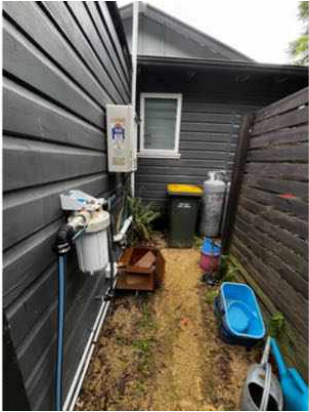
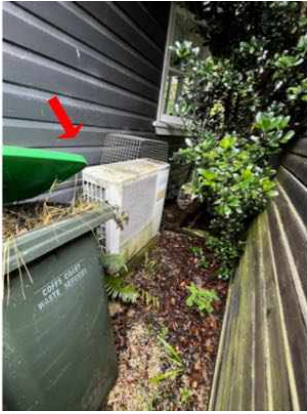
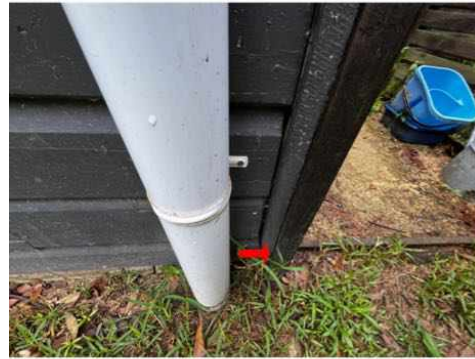
Building:	Main Building
Location:	All External Areas
Finding:	Possible concealed termite entry areas - conducive to termite attack
Information:	At the time of this inspection, numerous areas of possible concealed termite entry points were observed.

These areas are points on the exterior of the building where it is not possible to view the external cladding or slab/foundation edge because of close proximity of external members/features.

These areas should be cleared if possible and monitored regularly for termite infestation by a timber pest expert.

It is recommended that a timber pest expert provide and implement a Timber Pest Management Plan as soon as possible.

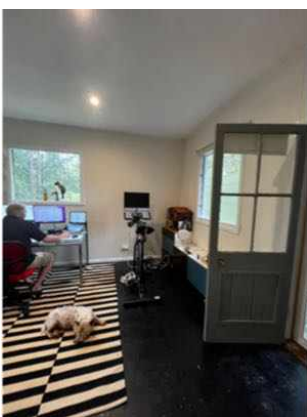
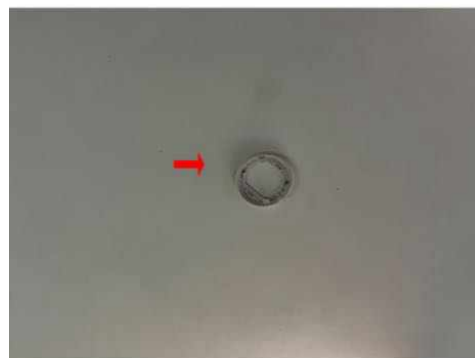
Finding 7.01

Information: At the time of this inspection it was noted that there were a number of minor defects in the office,

1 - At the time of this inspection it was observed that the smoke detector to the bungalow was missing, it is recommended that an electrician replace the smoke detector as soon as possible as this has the potential to be a safety hazard.

2 - The external office door had minor damage and the external timber door sill was severely deteriorated. It is recommended that a carpenter repair the damage to the door and replace the timber sill.

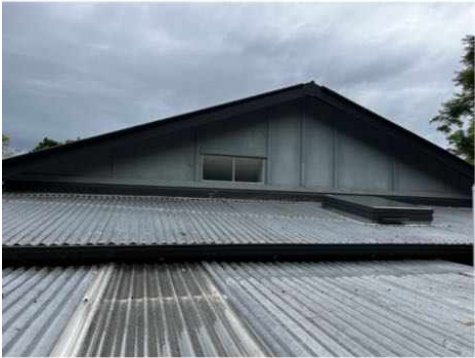
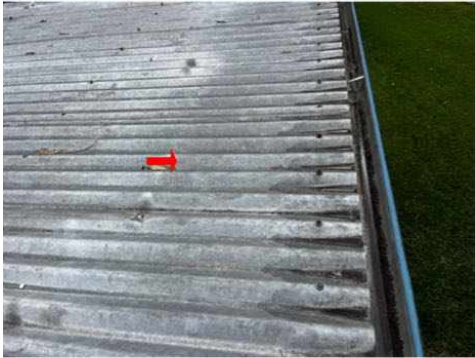
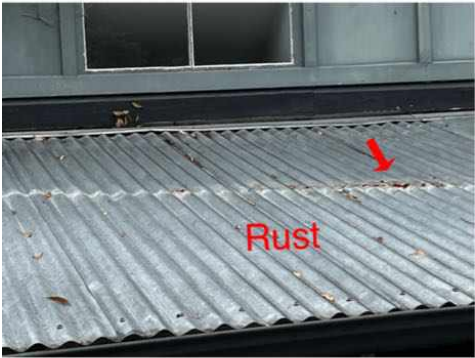
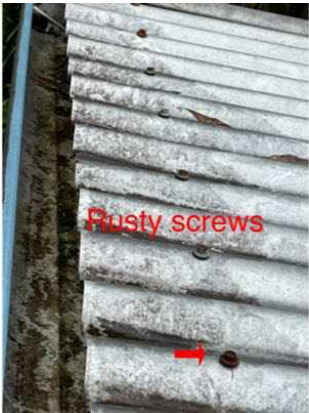
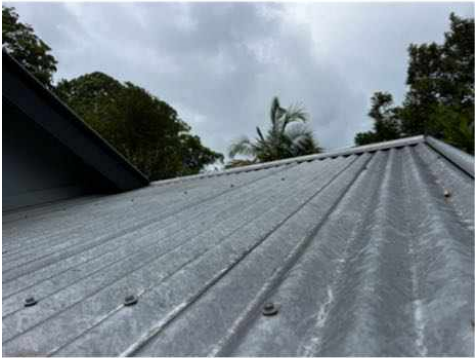
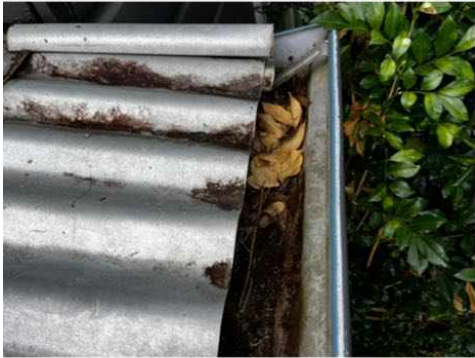
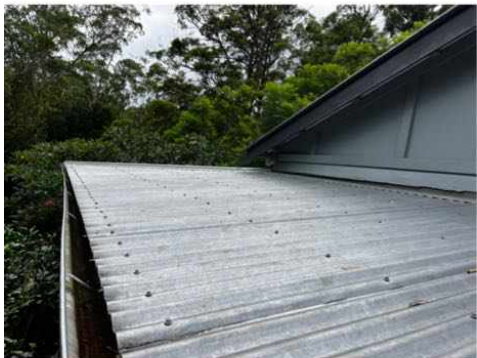
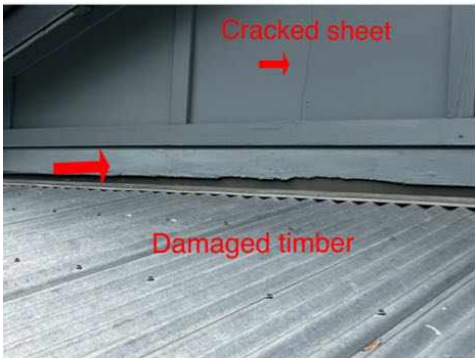
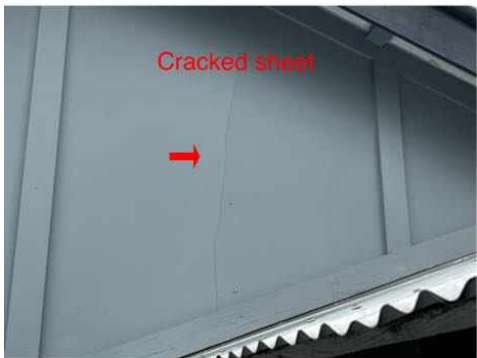
Building:	Main Building
Location:	Roof exterior house
Finding:	Roof exterior and guttering
Information:	At the time of this inspection, the roof sheeting and roof flashings appeared to be in a weathered condition with some deterioration, rust and mould growth evident. The roof sheets should be pressure cleaned.

Several roof sheets over the bathroom had minor rust evident and some of the roofing screws were rusted. It is recommended that a roofer replace any rusted element as soon as possible.

It was also noted that 2 of the walls sheets above the entry door roof were cracked and the timber trim to the bottom of the wall sheets had significant fungal decay (wood rot) evident. It is recommended that a carpenter replace the cracked sheets and timber trim and all new work be painted.

The front section of roof only, was inspected from a ladder, due to Workplace Health and Safety constraints and the placement of vegetation.

It is recommended that a roofer thoroughly inspect the roof sheets, roof flashings and guttering as soon as possible.

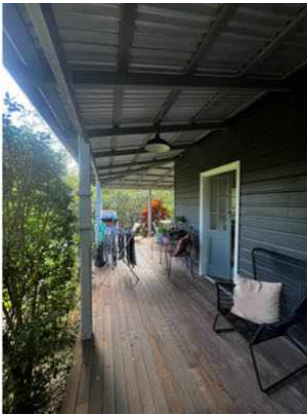
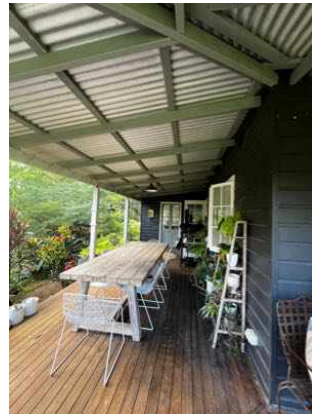
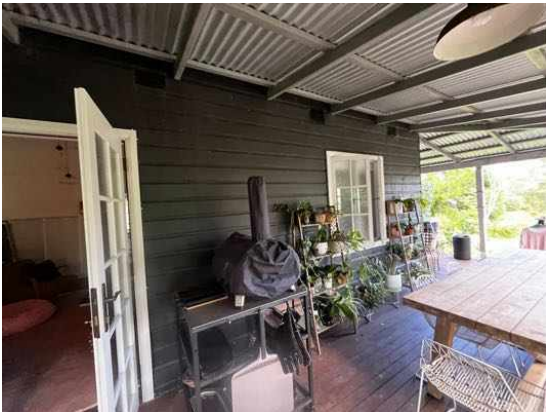
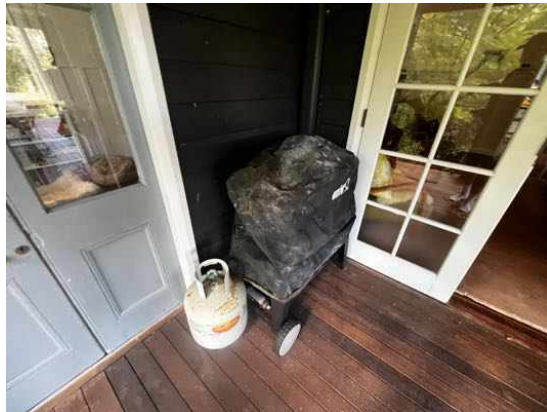
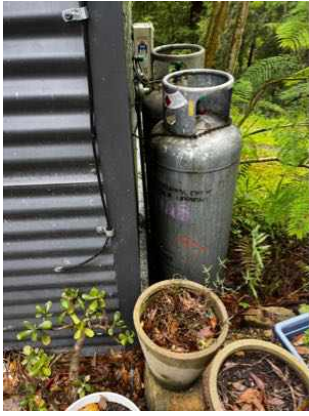
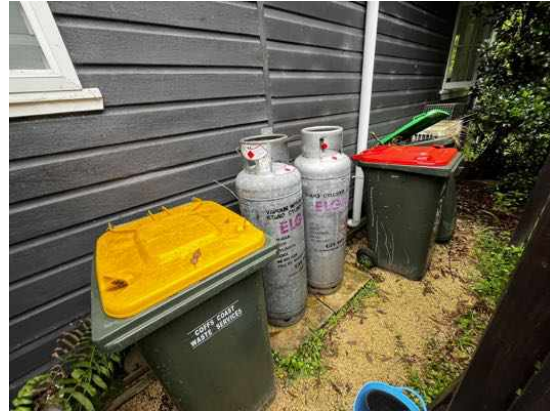
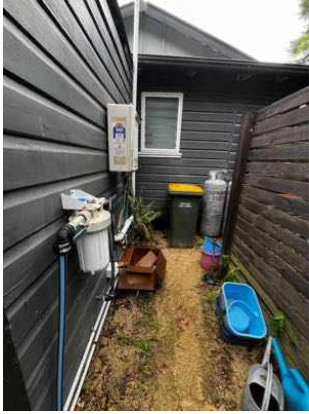
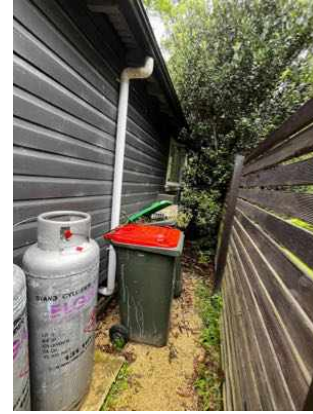
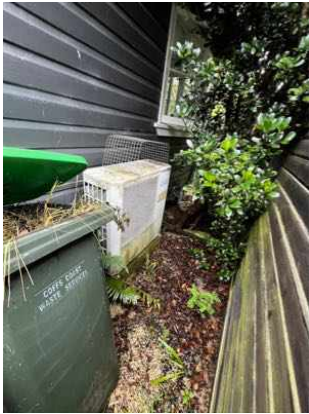
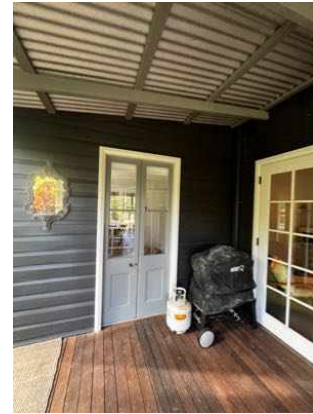
Building: Main Building
Location: All External Areas
Finding: Obstructions and Limitations External Areas
Information: These photographs are an indication of the obstructions and limitations which impeded full inspection of external areas of the property at the time of inspection. These obstructions can hide an array of defects and should be removed to allow full inspection to be carried out. A re-inspection is recommended once the areas are made accessible.

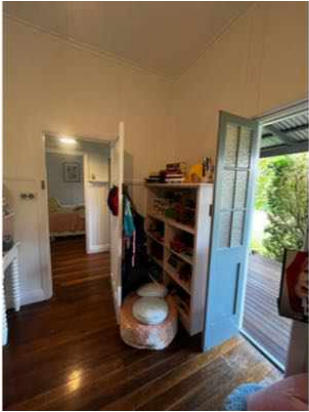
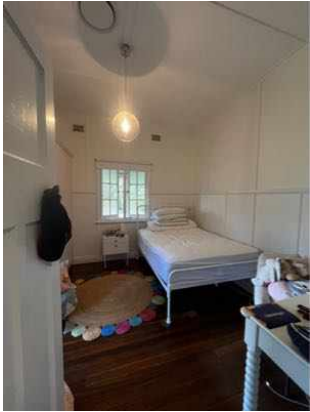
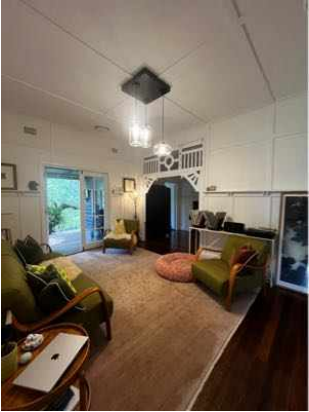
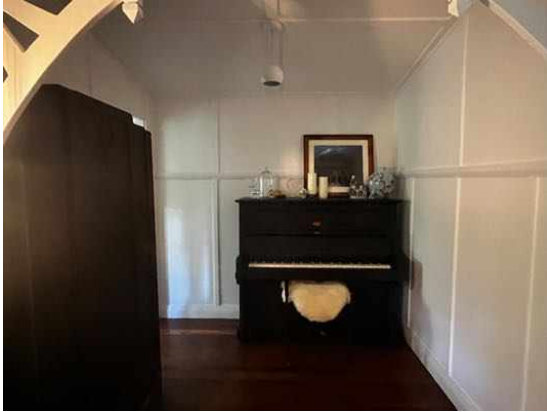
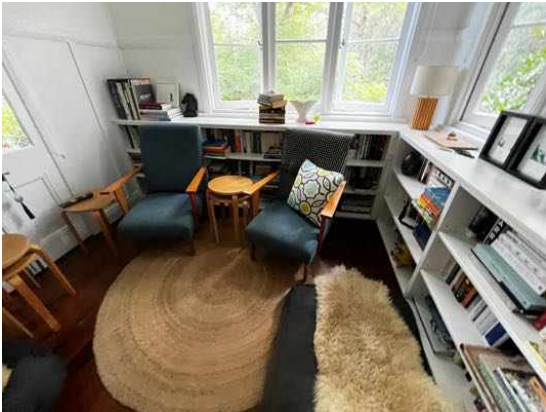
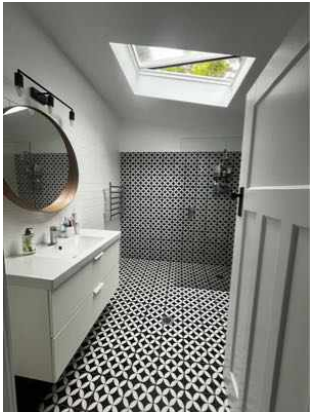
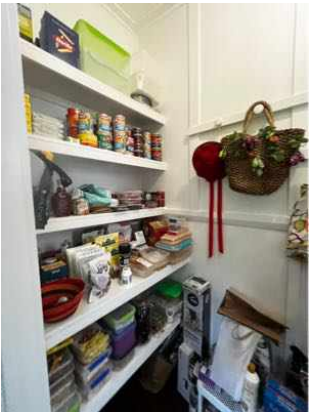
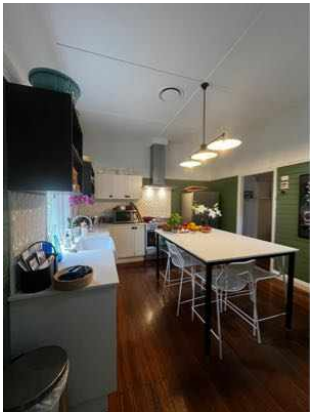
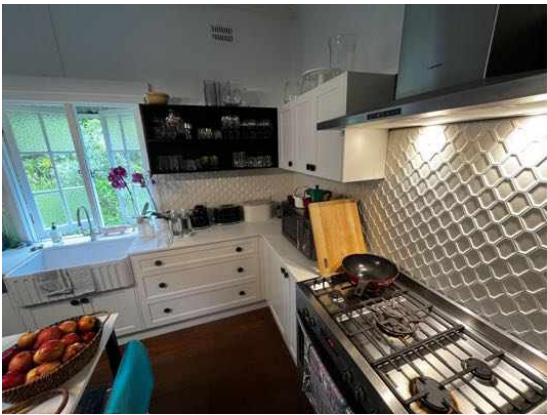
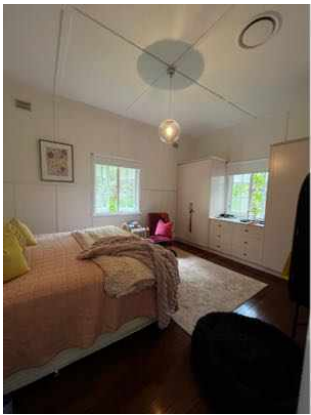
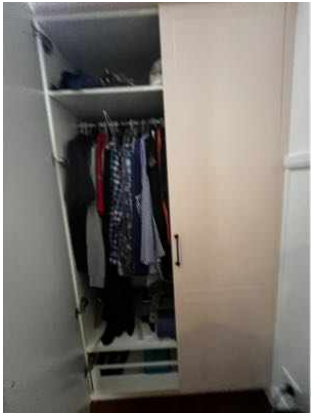
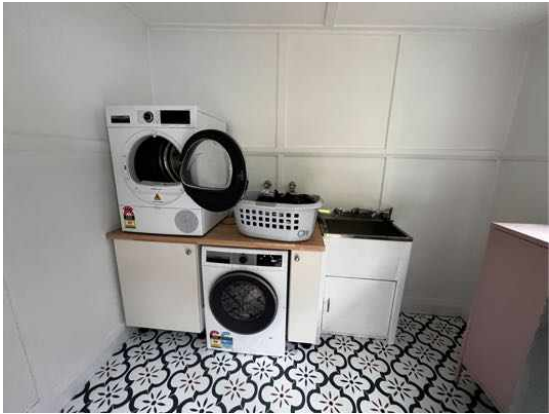
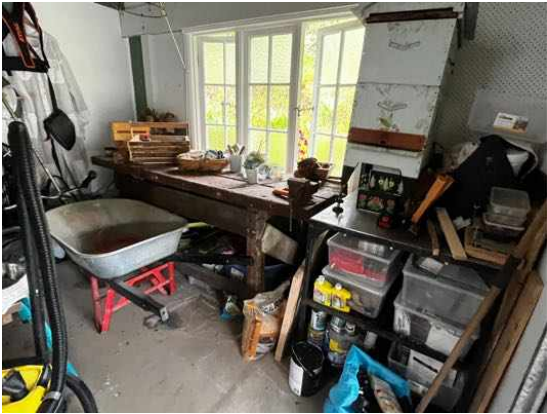
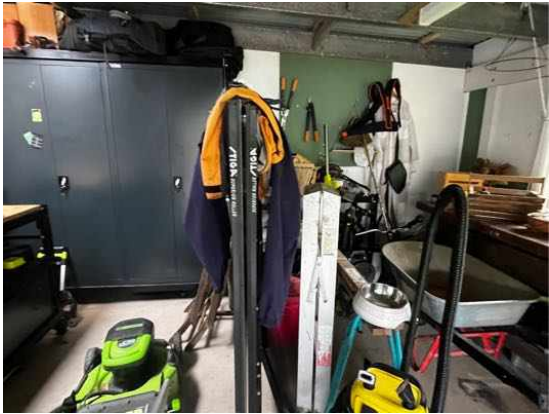
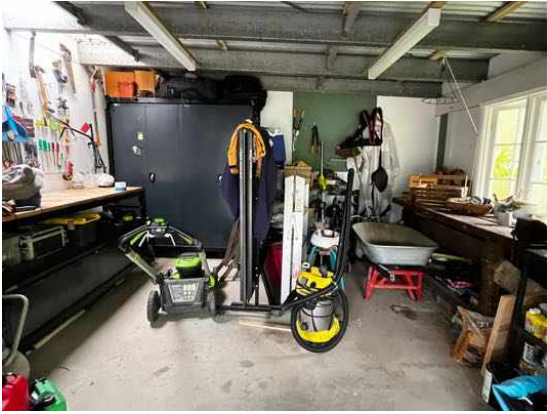
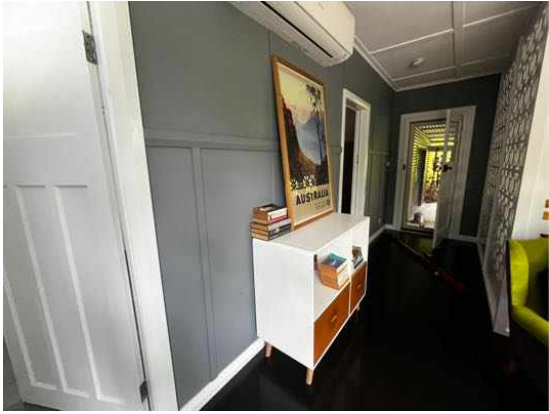
Building:	Main Building
Location:	All Internal Areas
Finding:	Obstructions and Limitations Internal Areas
Information:	<p>These photographs are an indication of the obstructions and limitations which impeded full inspection of internal areas of the property at the time of inspection. These obstructions can hide an array of defects and should be removed to allow full inspection to be carried out. A re-inspection is recommended once the areas are made accessible.</p>

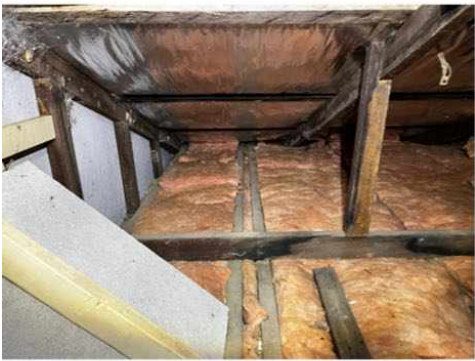
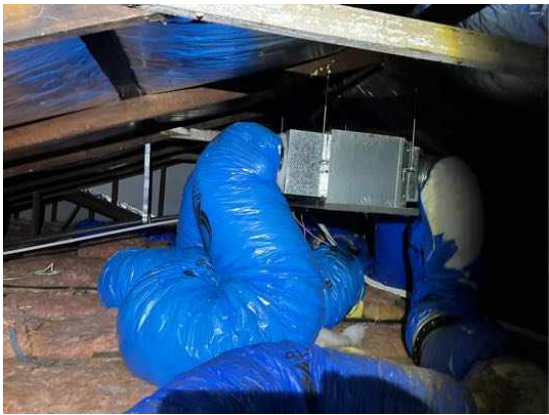
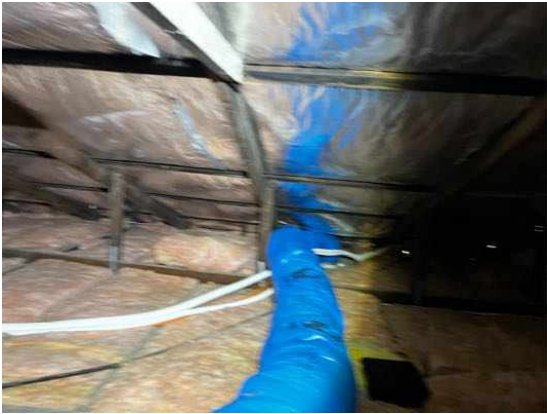
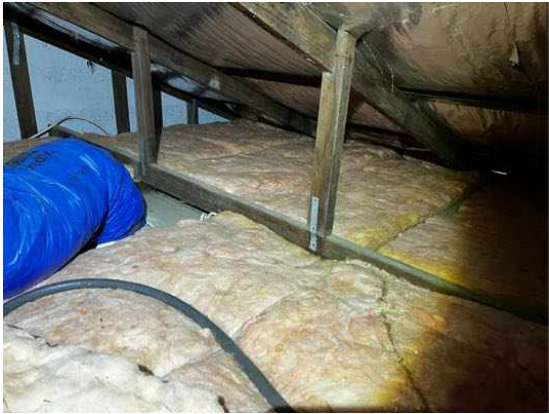
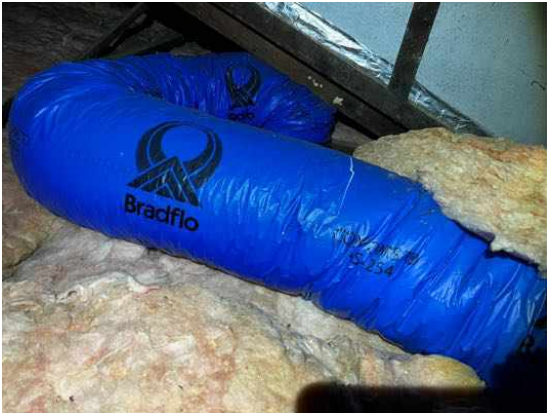
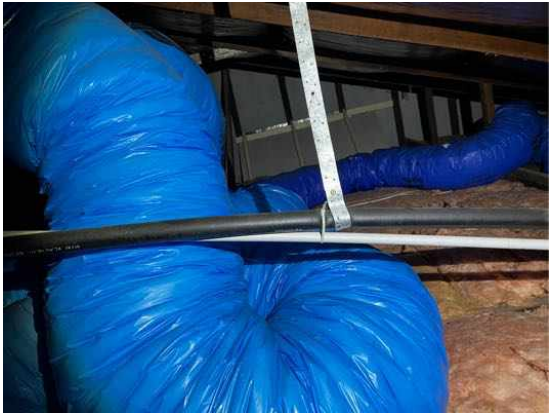
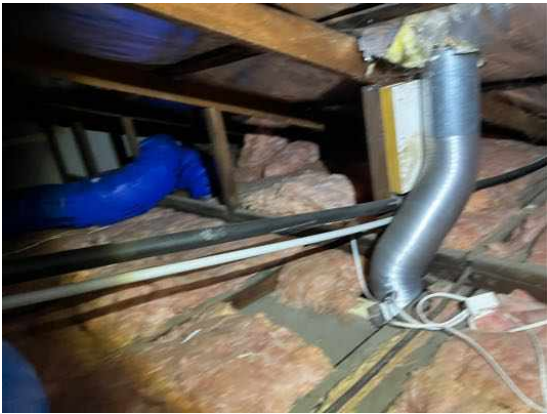
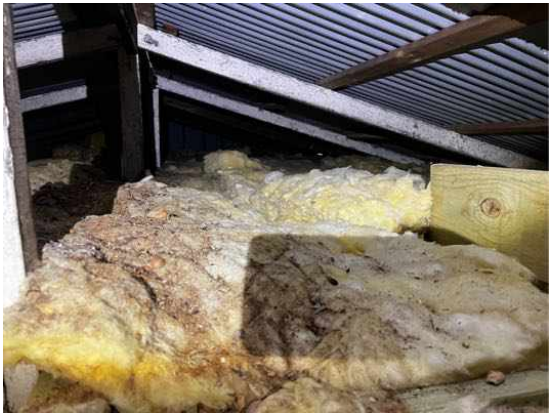
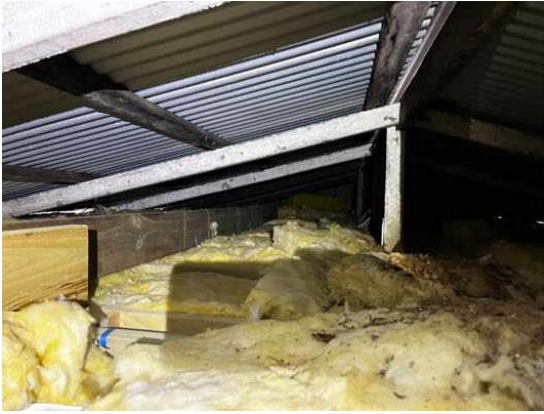
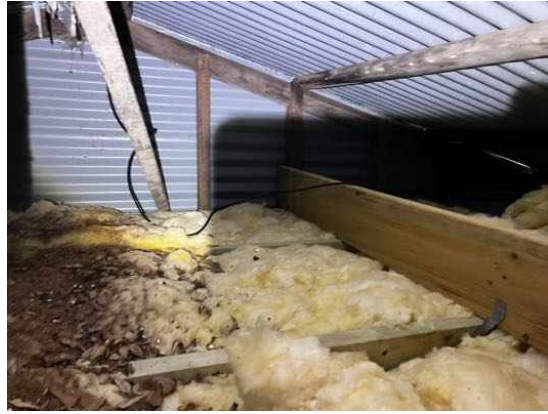
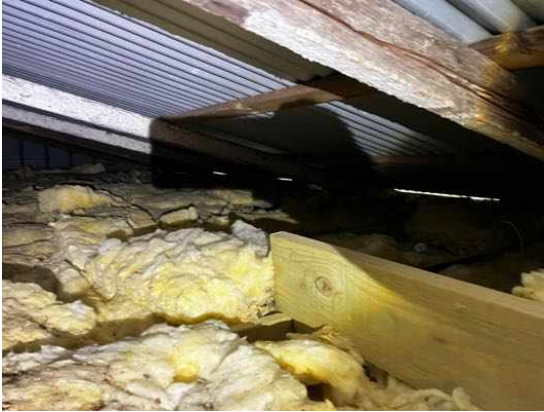
Building: Main Building
 Location: Roof Void
 Finding: Obstructions and Limitations Roof Space Areas
 Information: These photographs are an indication of the obstructions and limitations which impeded full inspection of roof space areas of the property at the time of inspection. These obstructions can hide an array of defects and should be removed to allow full inspection to be carried out. A re-inspection is recommended once the areas are made accessible.

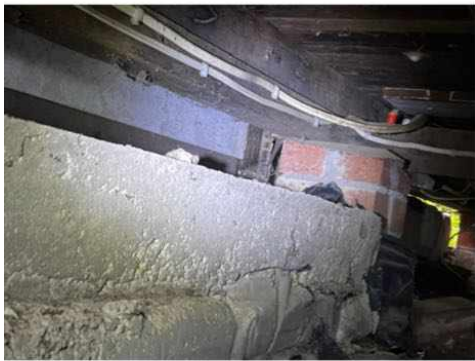
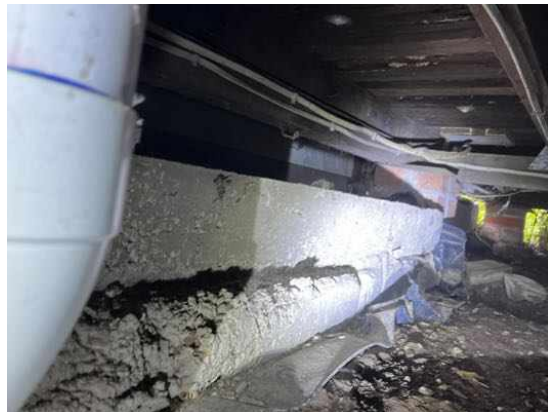
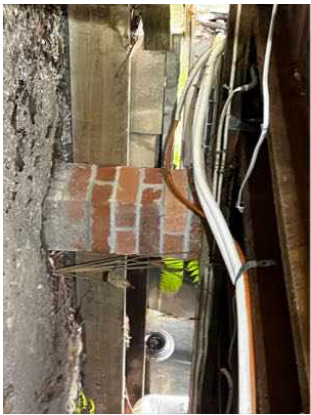
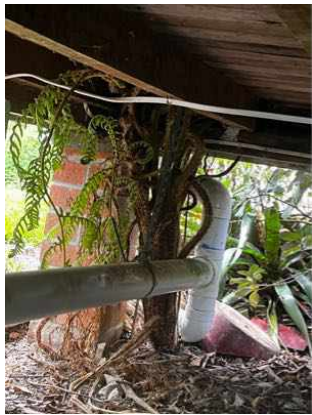
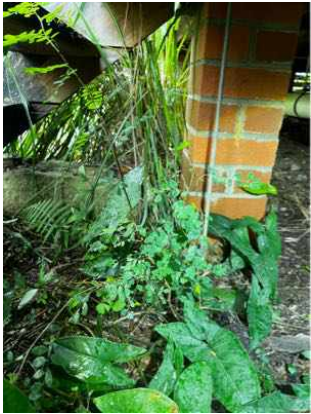
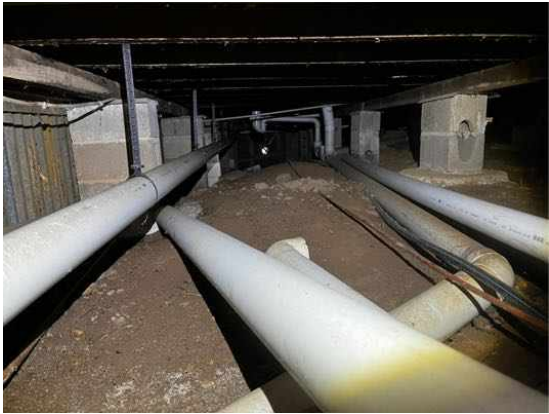
Building:	Main Building
Location:	Subfloor
Finding:	Obstructions and Limitations Sub Floor Areas
Information:	<p>These photographs are an indication of the obstructions and limitations which impeded full inspection of sub floor areas of the property at the time of inspection. These obstructions can hide an array of defects and should be removed to allow full inspection to be carried out. A re-inspection is recommended once the areas are made accessible.</p>
