Building and Timber Pest Inspection Report

Inspection Date: Mon, 9 Feb 2026

Property Address: 119B Waterdale Rd, Ivanhoe VIC 3079,
Australia

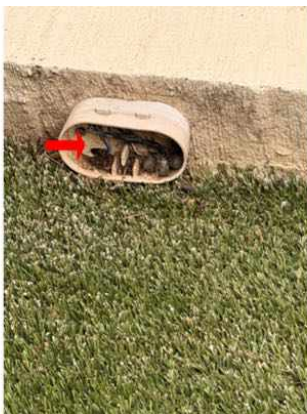
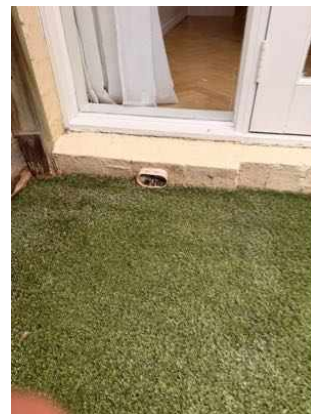
Building: Main Building
 Location:
 Finding: Exposed/ unconnected wire
 Information: Exposed / unconnected electrical wire (or cable) was observed at the external wall in back yard , with no fitting or termination visible.

This presents a potential electrical safety hazard (risk of electric shock if the cable is live, and risk of damage/deterioration from weather exposure). It may also indicate incomplete/abandoned wiring works.

Treat as urgent—do not touch. Arrange a licensed electrician to test and make safe (confirm if live, terminate in an approved enclosure/junction box, or remove/cap and isolate at the source).

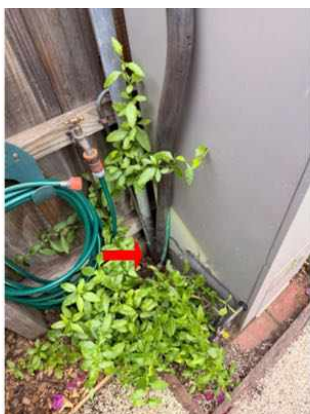
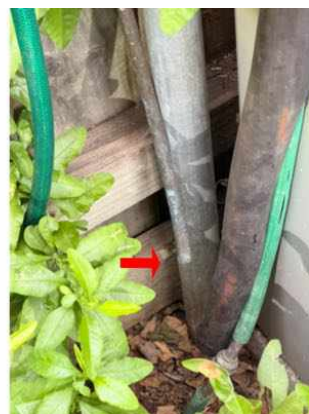
Finding 6.04

Building:	Main Building
Location:	Downpipe
Finding:	Damaged downpipe
Information:	A section of the external downpipe is damaged, with a visible hole/opening near the base causing stormwater to discharge directly at ground level adjacent to the building.

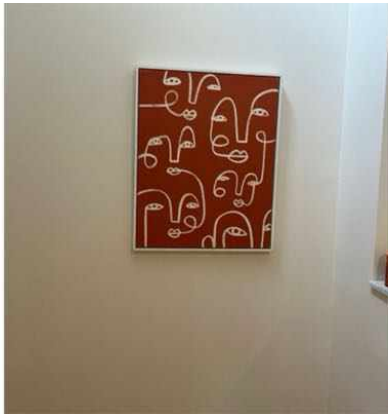
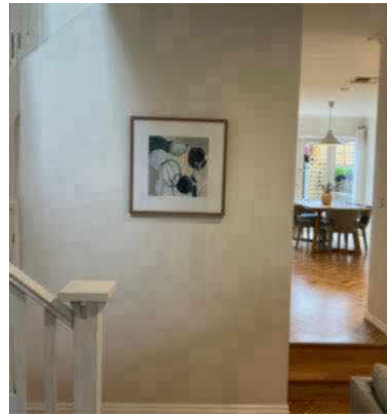
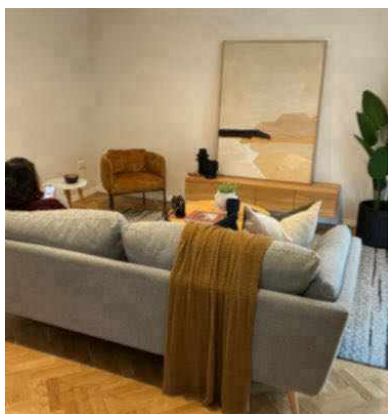
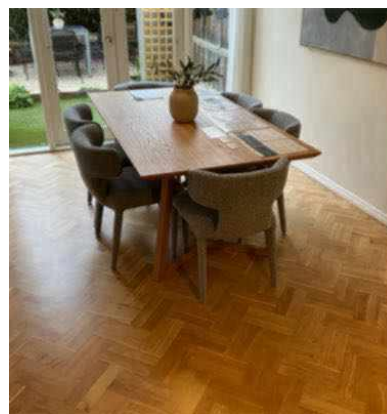
Building: Main Building
Location: All Areas
Finding: Additional Photos - Obstructions and Limitations
Information: These photographs are an indication of the obstructions and limitations which impeded full inspection of the property at the time of inspection. These obstructions can hide an array of defects and should be removed to allow full inspection to be carried out. A re-inspection is recommended once the areas are made accessible. Arrows and highlights have been included to identify minor defects. The purchaser can discuss further with the building inspector.
