Building Inspection Report

Inspection Date: Tue, 3 Mar 2026

Property Address: 204/14 Half St, Wentworth Point NSW
2127, Australia

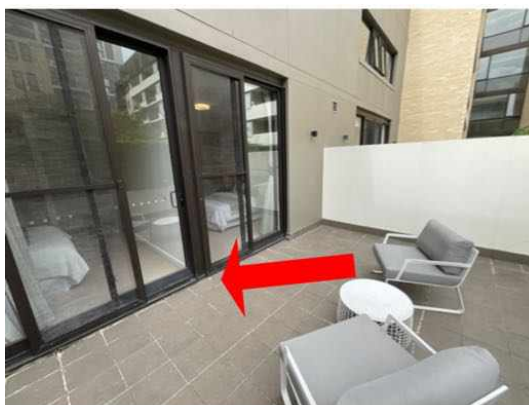
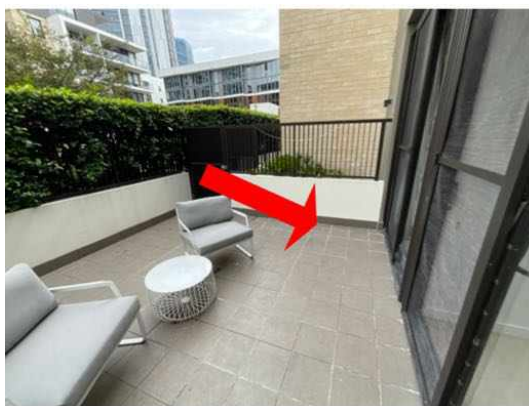
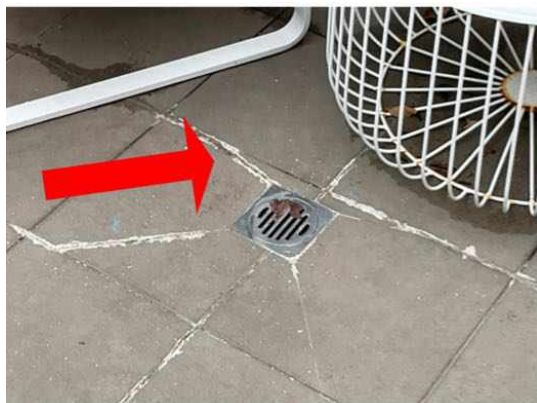
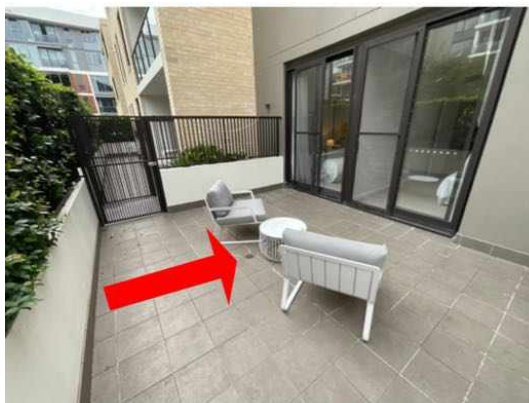
Defects 3.02

Building: Main Building
Location: Yard - Back
Finding: Alfresco – Tiling & Wall (Evidence of Moisture Ingress)
Information: Evidence of moisture-related deterioration was observed to the Alfresco area. Tile adhesive is lifting through grout joints, tiles show signs of debonding, and cracking is visible to the adjoining concrete wall. Water staining and efflorescence were noted to the base of the external brick wall.

The conditions observed are consistent with possible waterproofing failure and/or inadequate drainage to the balcony. Ongoing moisture ingress may result in further deterioration of tiling, substrate damage, and structural cracking over time.

An invasive inspection by a qualified waterproofing specialist is recommended to:

- Lift tiles as required
- Assess condition of waterproof membrane and substrate
- Check falls toward drainage point
- Rectify waterproofing and drainage defects as necessary

Monitoring is recommended to determine whether moisture intrusion is active.

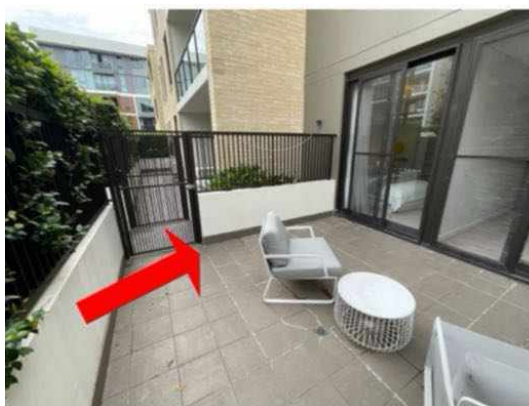
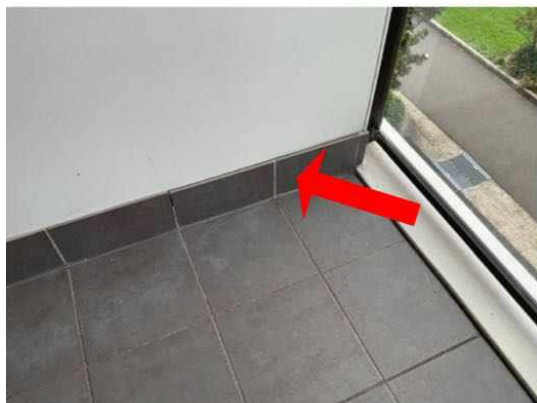
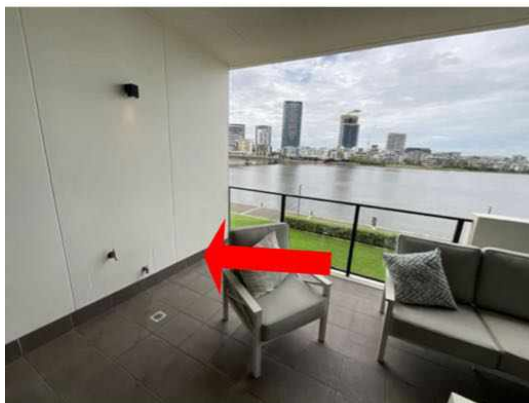
Defects 3.03

Building:	Main Building
Location:	Yard - Back / Balcony
Finding:	Tiles - Drummy
Information:	Drummy tiled areas were identified at the time of inspection. The term 'drummy' refers to tiles that have become detached from their fixing, despite otherwise being in relatively good condition. Such defects are generally caused by physical or moisture damage to the area. Drummy tiled areas may also be a direct result of poor workmanship during the construction process.

Tiled areas may swell and shrink with changes in air humidity if the area has sustained moisture damage. Any exposure to moisture is capable of causing tiled areas to become drummy and/or cracked over a prolonged period of time. Drummy tiled areas generally require removal and replacement of affected tiles, with adequate sealant and grouting.

Specialist trades are available for these types of services. A registered builder may be required to undertake works if damage is extensive or if secondary building defects have resulted. Otherwise, it is advised that a tiling contractor be appointed to perform works as necessary. Immediate action is recommended to ensure that no further damage is sustained in the affected area.

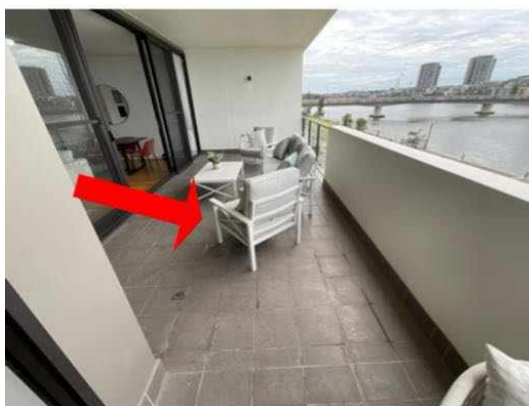
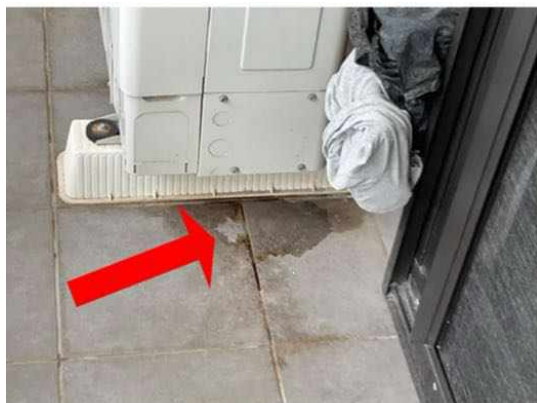
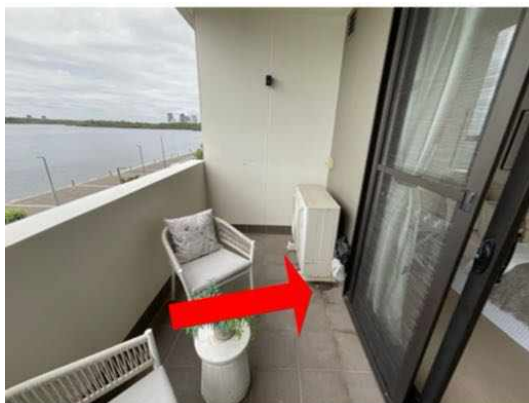
Defects 3.04

Building:	Main Building
Location:	Balcony
Finding:	Balcony - Water Pooling
Information:	Evidence of water pooling around the floor waste and on the floor in these wet area were noticed at the time of inspection. It is suspected that this excessive moisture is attributed to insufficient fall in the wet area floor tiles.

This pooling is minor overall but is still considered unsatisfactory, as standard tiling practices would not permit this situation to occur. Pooling water around floor wastes or on floor can create a slip hazard in extreme cases and create conditions that are conducive to mould growth over time. Where left unmanaged, the degradation of sealant and grouting is also likely to occur, possibly necessitating further repair works.

Remedial works may involve some sections of tiling and flooring repair and replacement. A tiling contractor should be appointed to provide further advice on reparation options and to perform works as necessary.

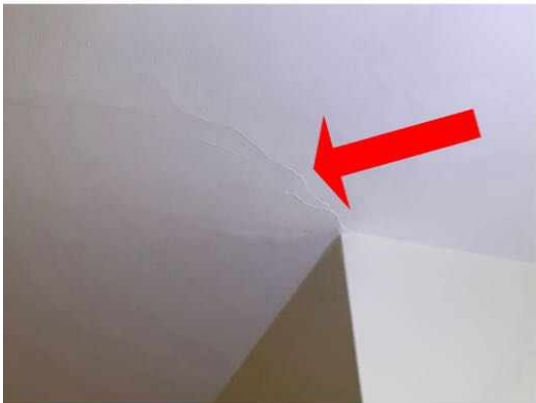
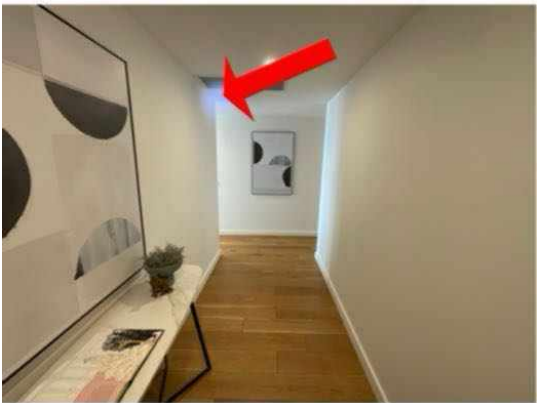
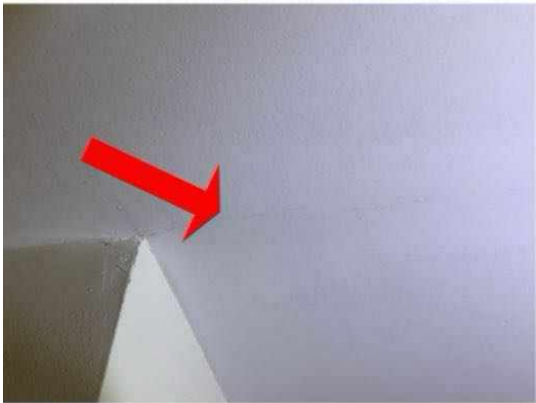
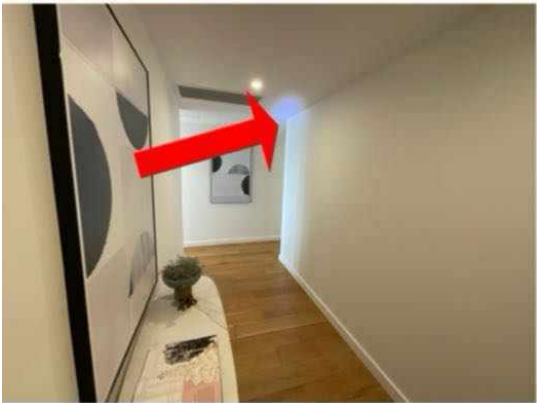
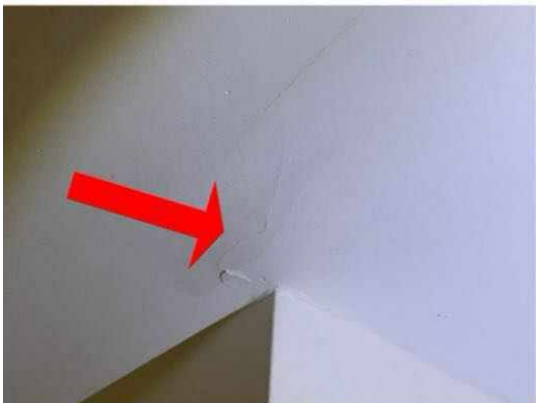
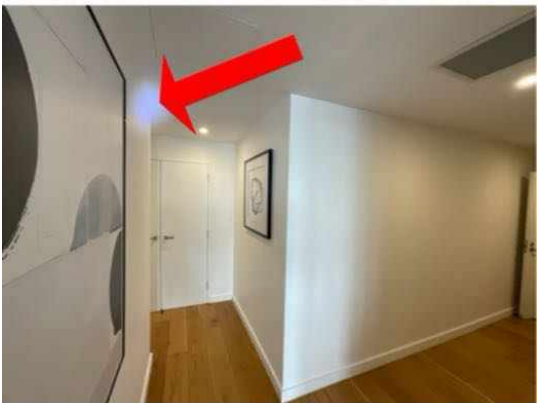
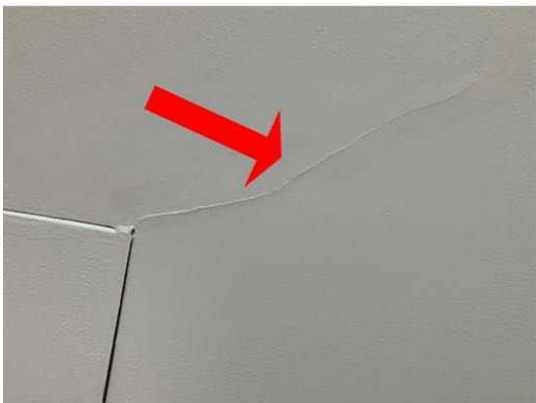
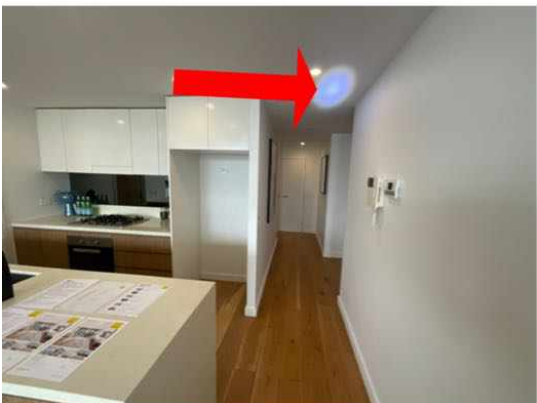
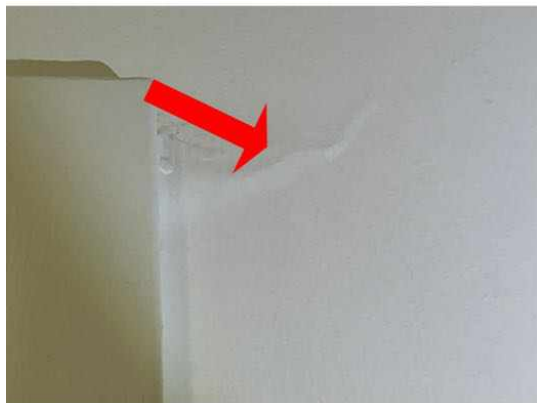
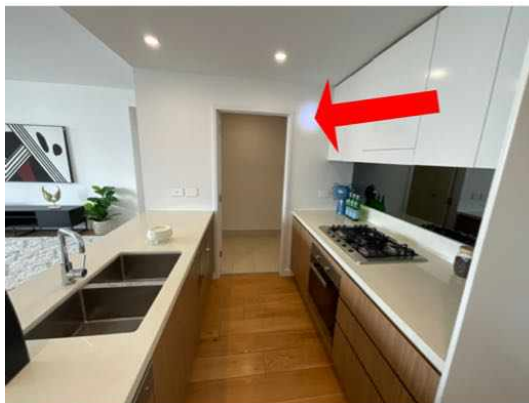
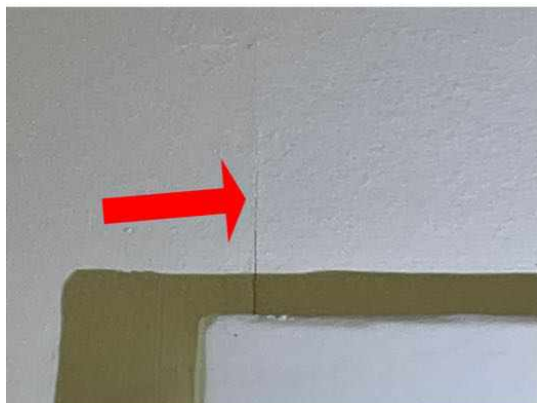
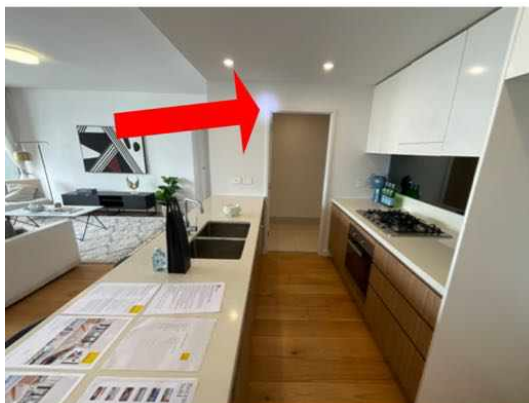
Defects 3.05

Building:	Main Building
Location:	All Internal Areas
Finding:	Cracking - Damage Category 1 - Fine (up to 1mm)
Information:	Although fine cracks are quite noticeable, they are often only considered to be an appearance defect, and usually do not indicate any structural damage. Generally, the cause of a fine crack is indicative of a separation between building materials and finishes (e.g. paint, plaster, etc.) along joints.

Cracking of this nature can generally be repaired with minor sanding, filling and/or repainting. Such works should be performed by a qualified painter or a general handyman.

Monitoring of all cracking should be conducted frequently. Always contact a building inspector should cracks widen, lengthen, or become more numerous.

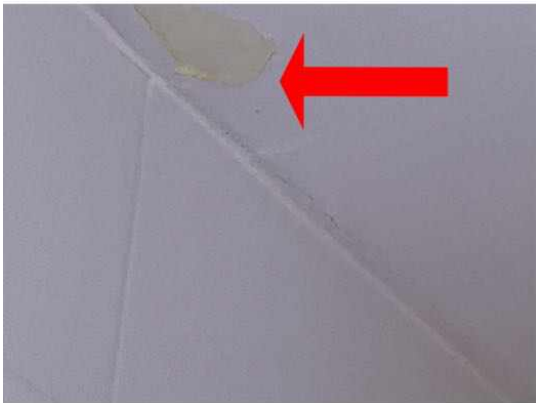
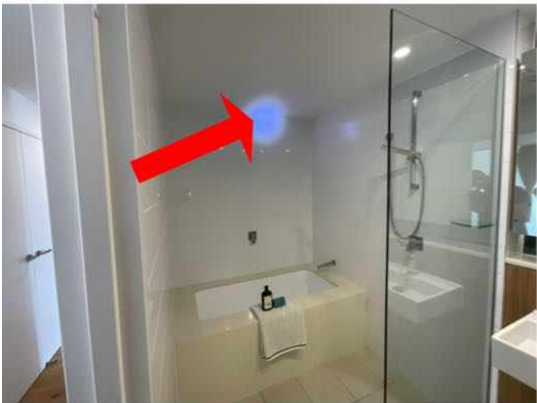
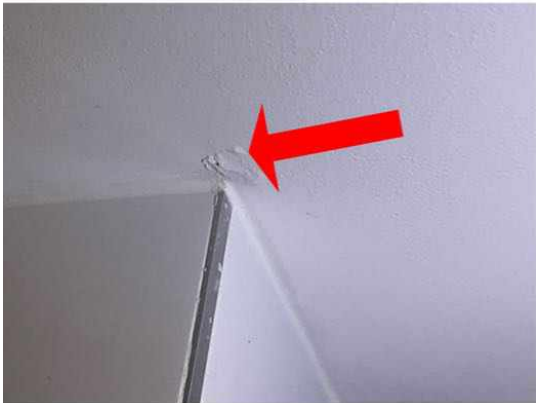
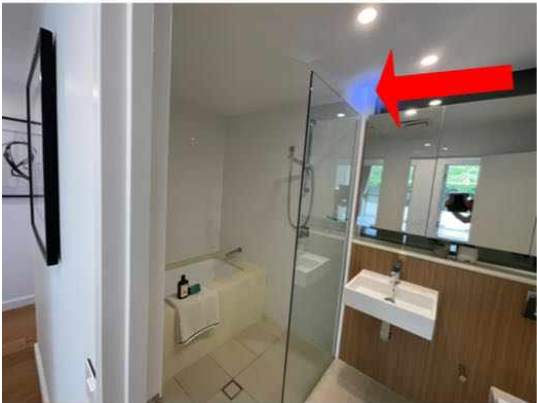
Defects 3.06

Building:	Main Building
Location:	Bathroom
Finding:	Painted surface - Bubbling
Information:	Sections of paint in this area was found to have bubbled and deteriorated. Paint bubbling is generally an indication of excessive moisture in the area, that is currently hidden by the painted surface.

The presence of excessive moisture can have major implications on associated building elements if left unattended. While only seemingly minor at this stage, the damage cannot be determined due to the paint obstructing any further inspection of the damage.

It is highly advised that the affected paint be cleaned to allow a further, more invasive inspection by a licensed plumber. Failure to act on this defect may necessitate major works in the future.

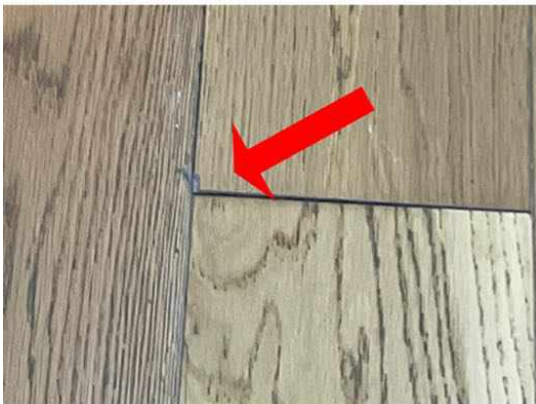
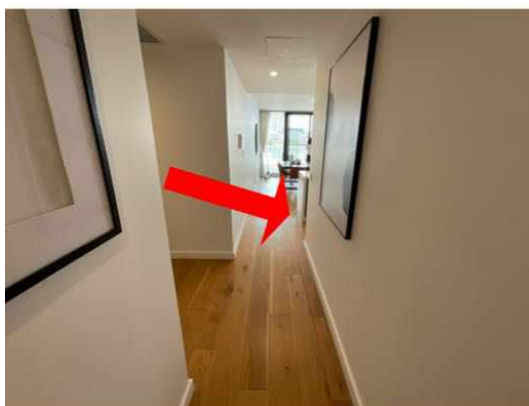
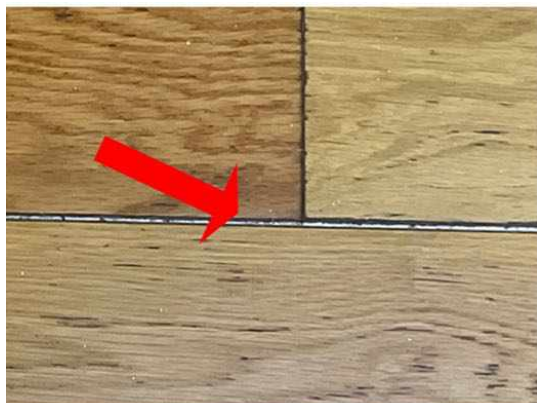
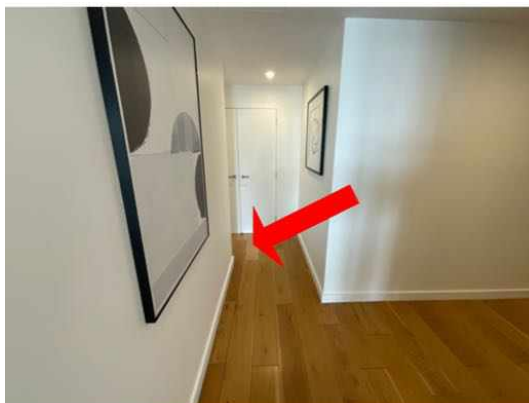
Defects 3.07

Building: Main Building
Location: All Internal Areas
Finding: Float Timber flooring - damaged / gap
Information: Damages / gaps to float laminate flooring were found during inspection. The laminate timber flooring is typically resistant to water damage, but standing water and large amount of moisture that gets under the floor (as the water has no place to evaporate) can eventually destroy the floor and delaminate the product.

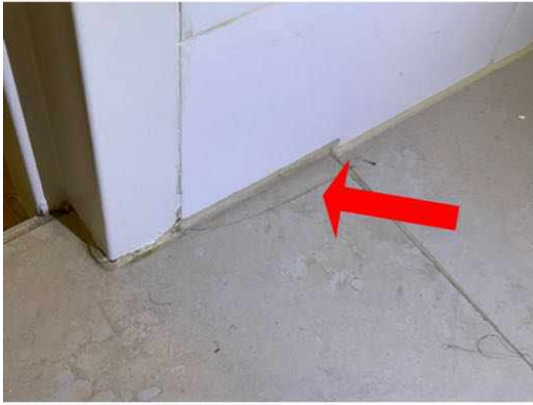
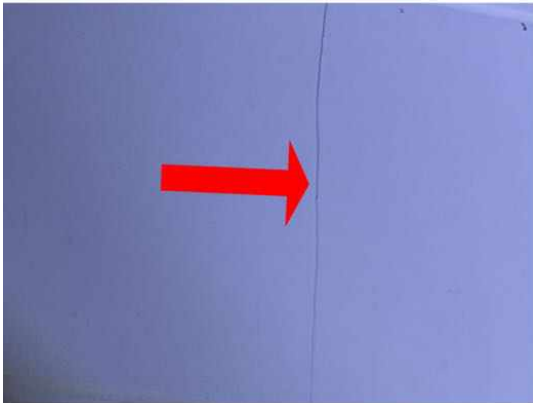
Defects 3.08

Building:	Main Building
Location:	Bathroom
Finding:	Tiles - Cracked or damaged
Information:	Cracking was evident to the tiling in this area at the time of inspection. While the cracking appears to be minor, this area is frequently exposed to water, allowing potential for water penetration into adjoining sections of walls or flooring.

If left unmanaged, water penetration to these areas may lead to subsequent water damage, which is likely necessitate repair work to affected building elements.

A tiling contractor should be appointed to ensure that no further water damage occurs. The re-application of silicone and grouting throughout remaining tile work is also advised, to further protect the area against water penetration.

Where water penetration has led to water damage, appointment of a relevant tradesperson may be required to repair damaged building elements.

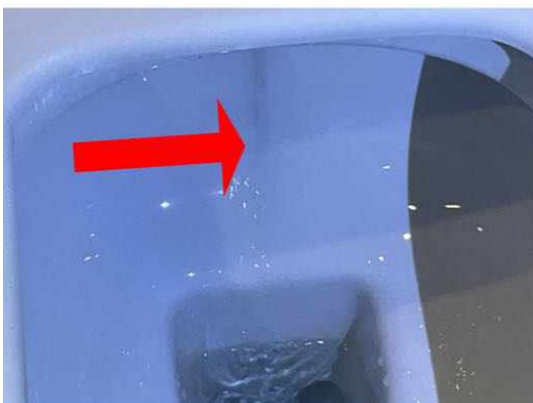
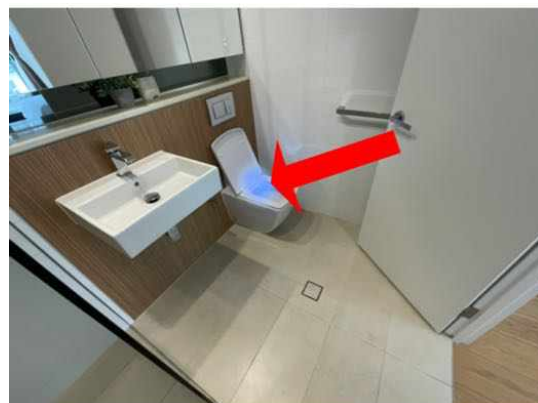
Defects 3.09

Building:	Main Building
Location:	Bathroom
Finding:	Toilet - Not functional
Information:	The toilet did not functional properly at the time of inspection.

Non-operational building elements such as this are vital to the function of the household and must be fixed.

A qualified plumber should be appointed immediately to repair the toilet and return it to an operational state.

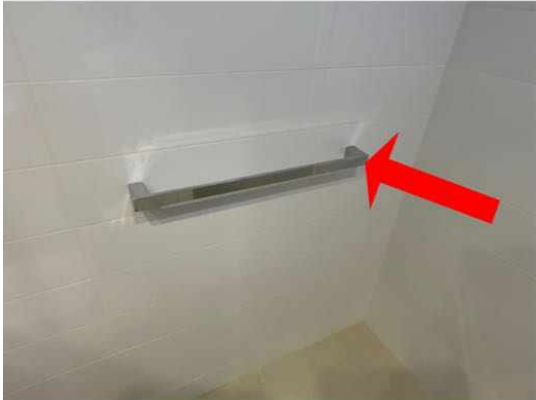
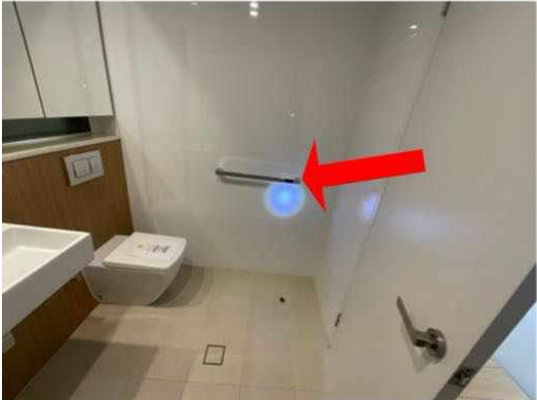
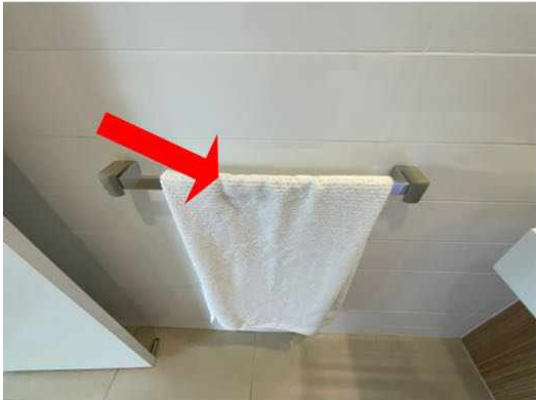
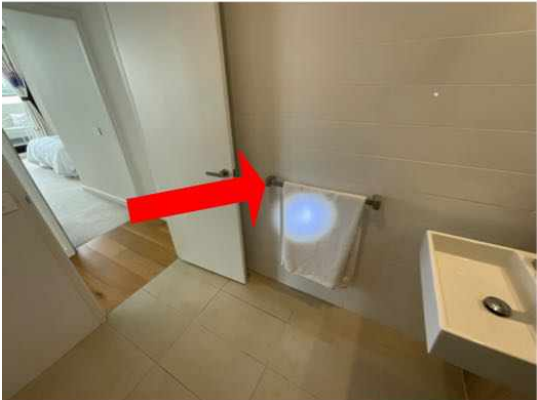
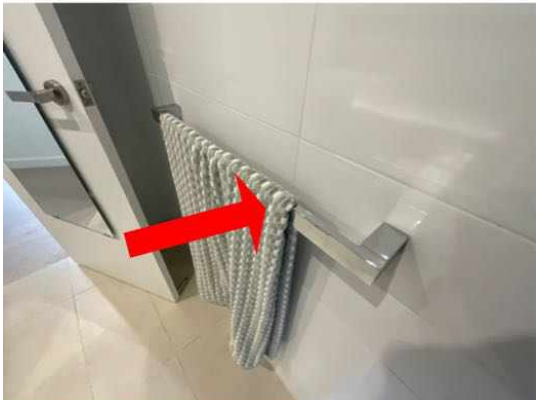
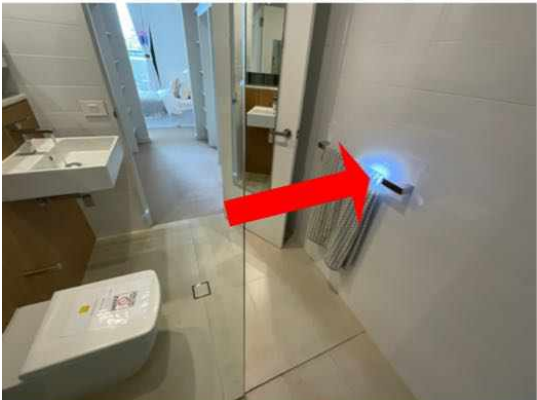
Defects 3.10

Building: Main Building
Location: Bathroom
Finding: Bathroom holders - Loose
Information:

The bathroom holder was found to be loose at the time of inspection. While not a major operational defect, function can deteriorate if the problem is left unmanaged.

It is advised that the homeowner performs remedial works to re-attach the bathroom holder to its original fixing. A general handyperson may be required to perform these works.

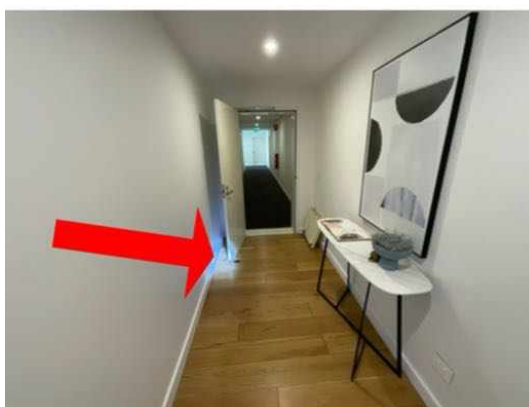
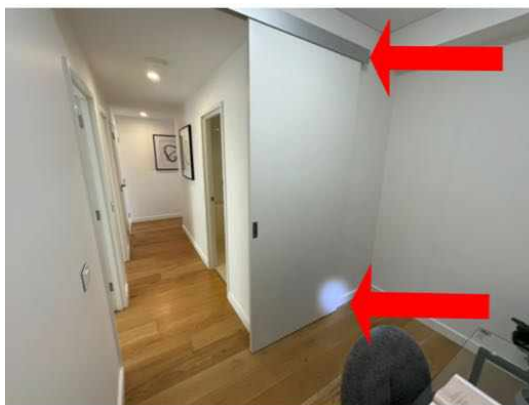
Defects 3.11

Building:	Main Building
Location:	All Internal Areas
Finding:	Door stop - inadequate
Information:	The door stop is missing or is inadequate to stop the door handle from damaging the wall. Although some building elements may seem irrelevant or unnecessary, all building elements play a key role in the operation and function of the overall structure and its performance.

Re-installation or replacement of the door stop is advised as soon as possible to prevent any subsequent damage to the door or associated structures. A general handyman may be appointed to perform these works at client discretion.

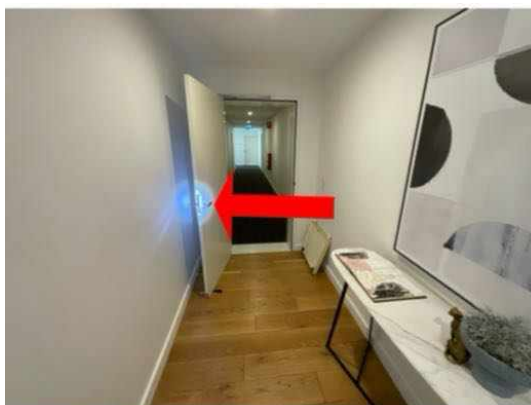
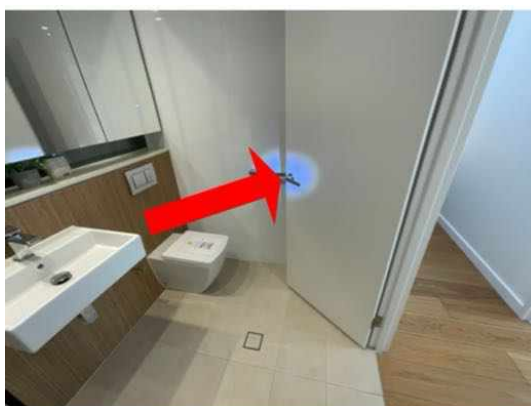
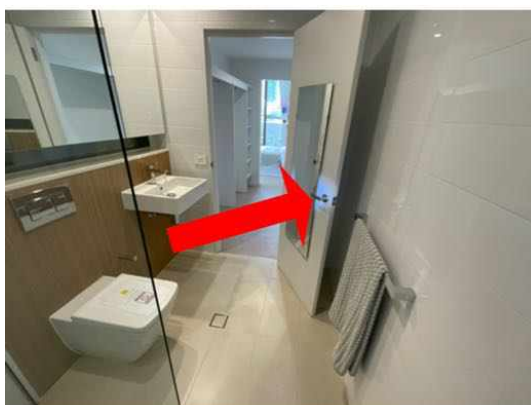
Defects 3.12

Building:	Main Building
Location:	All Internal Areas
Finding:	Fitting (door handle) - Loose
Information:	The fitting in this area is loose and requires adjustment to tighten.

If left unmanaged, the fitting may further deteriorate, causing potential for the development of other minor secondary defects.

A relevant tradesperson should be appointed to perform these rectification works at discretion of the client.

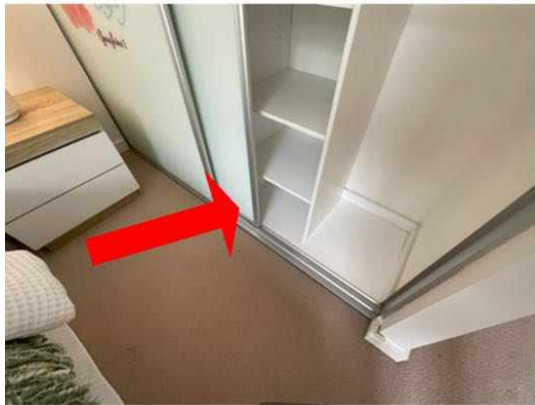
Defects 3.13

Building:	Main Building
Location:	Bedroom 2
Finding:	Misaligned Sliding Door – Wardrobe
Information:	The sliding door to the wardrobe was found to be misaligned. The door panels are not sitting level within the tracks and do not close flush, resulting in poor operation and uneven appearance.

The builder/tradesperson is to realign the sliding door panels by adjusting the rollers and track guides to ensure smooth operation and flush closure in accordance with manufacturer's installation requirements.

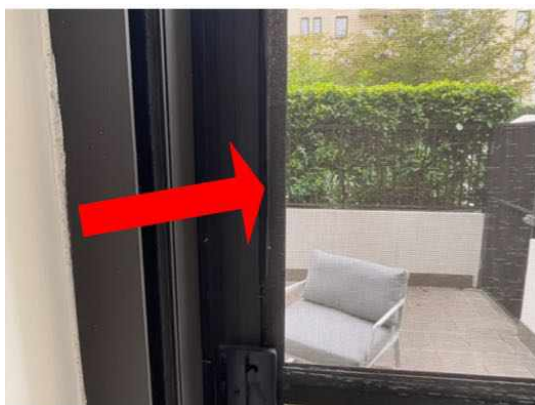
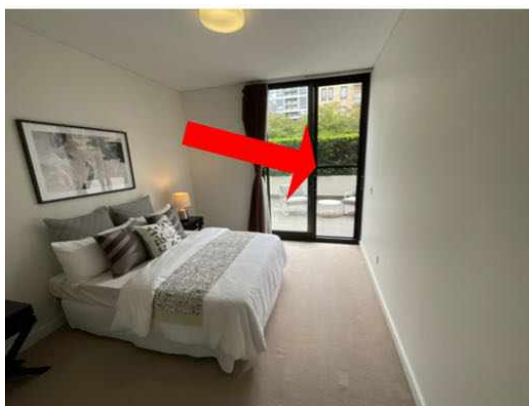
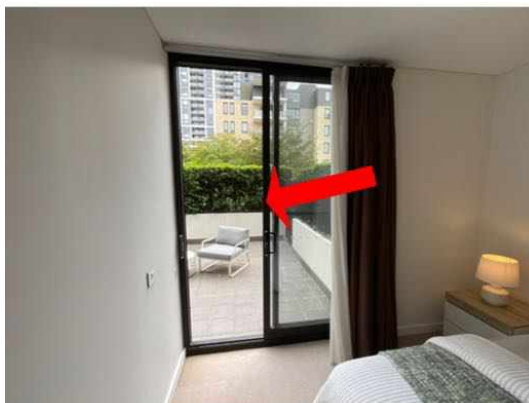
Defects 3.14

Finding: Flyscreens - Damaged

Information: Flyscreens were found to be damaged to the windows in this area at the time of inspection. This damaged building element detracts from the operational state of the window. Where not replaced, damaged flyscreens allow pest and insect ingress into the adjoining room/s. It is advised that all damaged building elements be replaced in order to ensure the full function of all building structures. A general handyperson may be appointed to replace flyscreens at the discretion of the client.

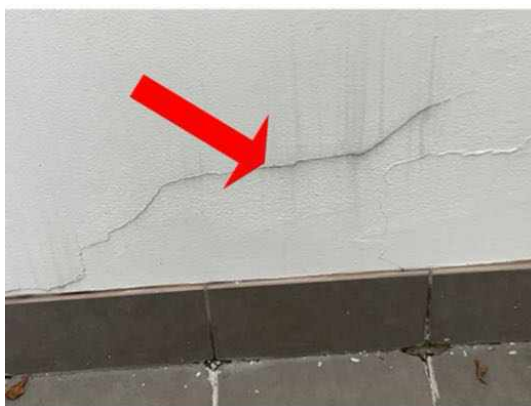
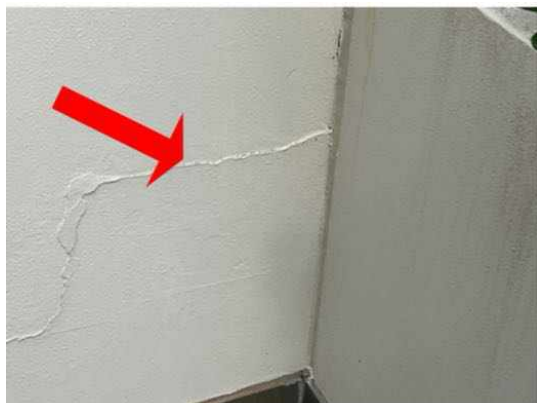
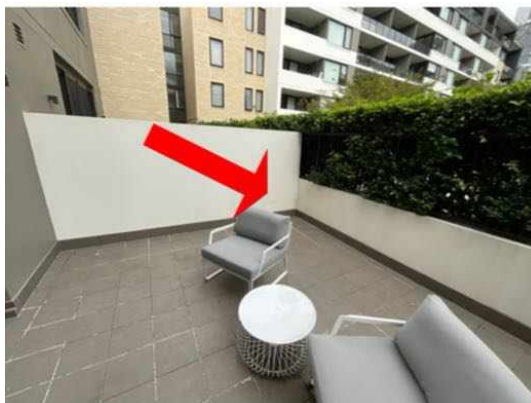
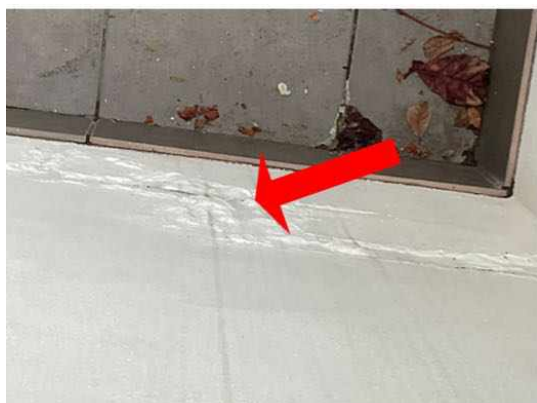
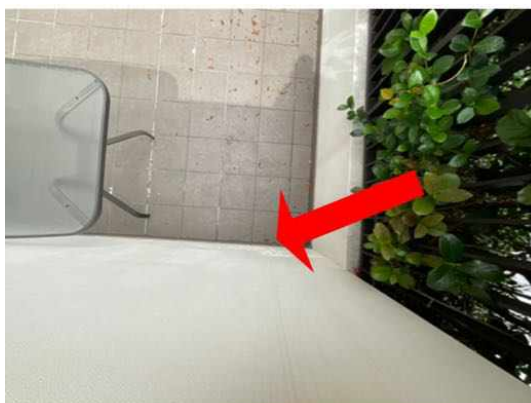
Defects 3.15

Building: Main Building
 Location: All Areas
 Finding: Cracking & moisture to Masonry Wall (Adjacent Planter)
 Information: Cracking & Moisture observed to the rendered masonry wall next to the planter box. Likely due to movement and/or moisture from planter drainage.

Classification: Minor defect (monitor).

Check planter drainage and waterproofing. Seal crack and monitor for further movement. Structural review recommended if cracking worsens.

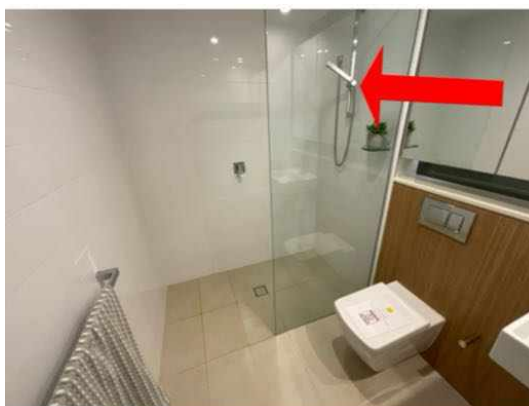
Defects 3.16

Building: Main Building
 Location: Ensuite
 Finding: Shower Head Leaking
 Information: The handheld shower head was observed leaking at the hose connection point. The fitting is not watertight, resulting in water escaping during use.

- NCC 2022 – Volume Two, P2.2.1 (Health and Amenity – Sanitary Facilities): Plumbing and sanitary fixtures must be installed to avoid water leakage and provide safe, sanitary conditions.
- AS/NZS 3500.1:2021 – Plumbing and Drainage (Water Services): Requires all plumbing fittings and fixtures to be installed in a way that prevents leakage and ensures durability.
- Guide to Standards and Tolerances 2017 (Section 11.02 – Plumbing Fixtures): Plumbing fixtures and fittings are defective if they leak when tested under normal operating conditions.

- Water wastage and increased utility costs.
- Risk of water damage to adjacent finishes and building elements.
- Reduced serviceability of the plumbing fixture.

The builder is to rectify the leaking shower head by checking the hose and fitting connections, ensuring they are correctly installed and sealed. If required, the faulty shower head or hose is to be replaced to achieve compliance with AS/NZS 3500.1.

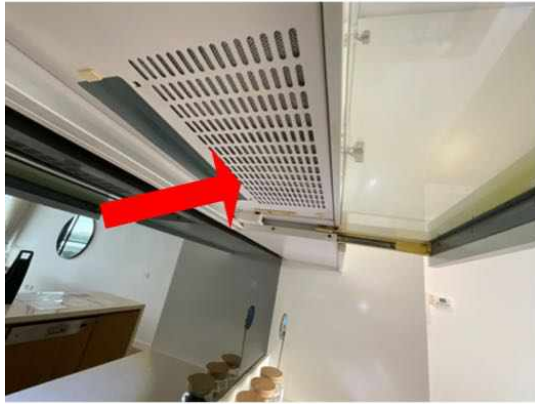
Defects 3.17

Building:	Main Building
Location:	Kitchen
Finding:	Rangehood - Fan not working properly
Information:	While the range hood appears to be working at a satisfactory level, the fan to the structure was not working at the time of inspection.

Without a functional fan, a build-up of grease and evaporative moisture is likely to accelerate deterioration of the range hood and associated flue. This potential build up

may also create a minor fire hazard, particularly if left uncleaned.

A licensed electrician should be appointed to replace the fan on the range hood to restore it to a fully operational state.

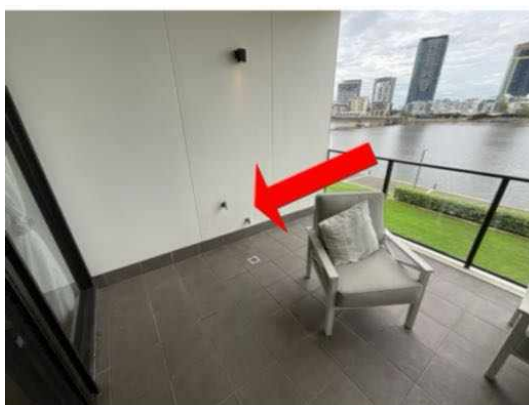
Building: Main Building
 Location: Balcony
 Finding: Patch Repair / Inconsistent Render Finish
 Information: A section of wall below the external tap fittings shows inconsistent render finish and patching, indicating previous repair works. The repaired area is visually distinct from surrounding wall surfaces.

This suggests prior damage or moisture-related defect has been rectified; however, workmanship is uneven and aesthetic finish is poor.

- NCC 2022 Vol 2 – H2D2 (Weatherproofing – protection from moisture)
- General workmanship requirements under the NSW Guide to Standards and Tolerances

Monitor for signs of recurring moisture. If dampness reappears, further investigation of plumbing or waterproofing is recommended. Re-rendering for uniform finish may be required.

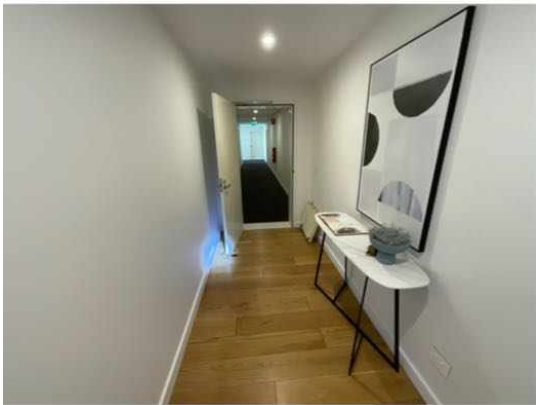
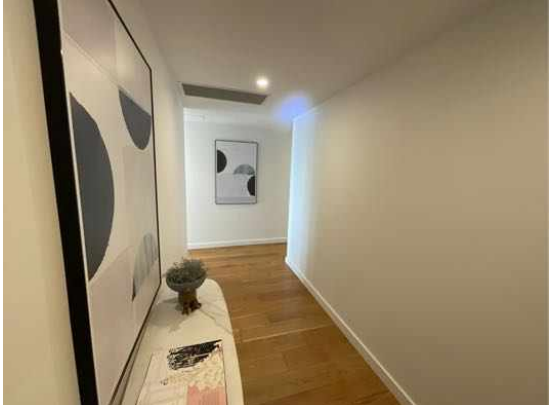
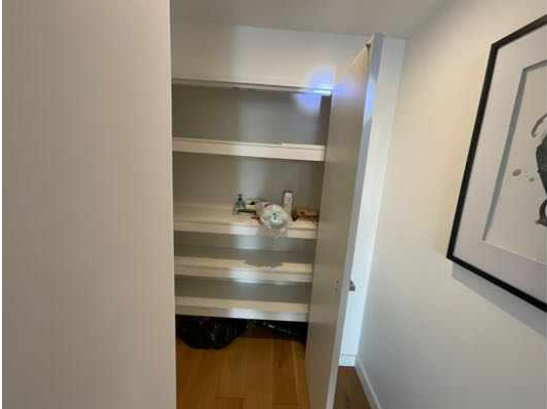
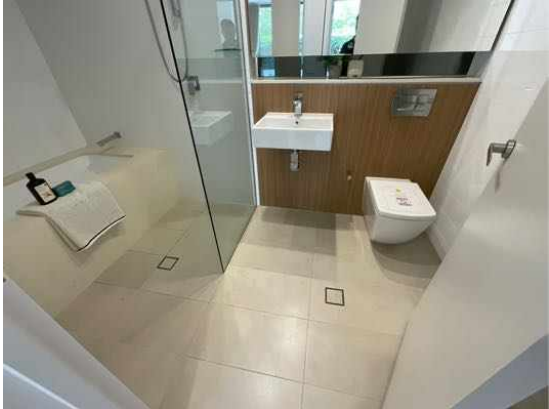
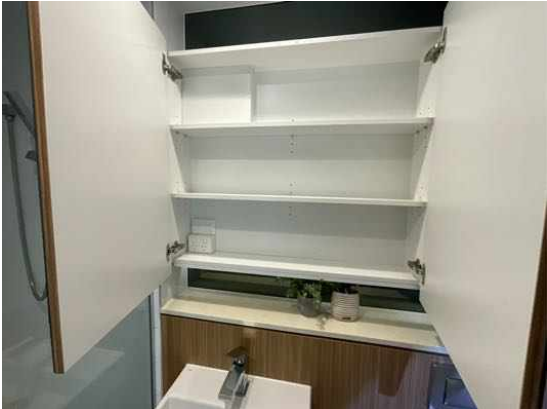
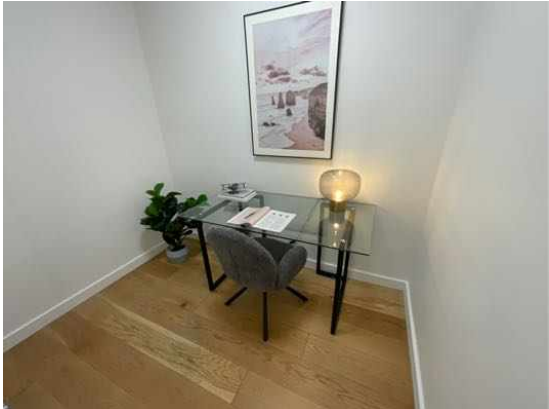
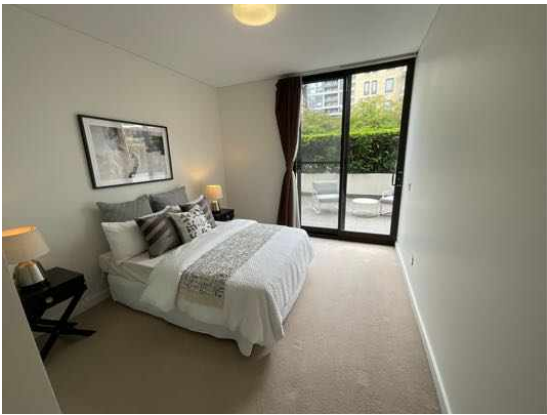
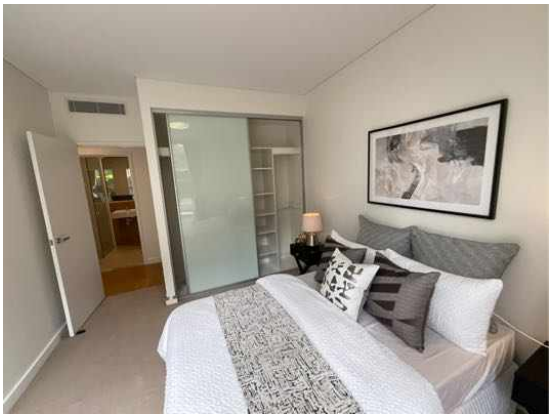
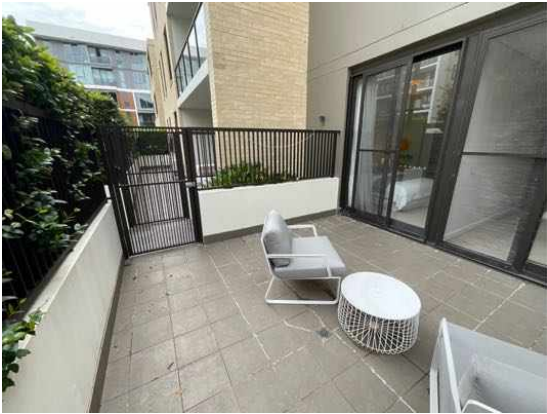
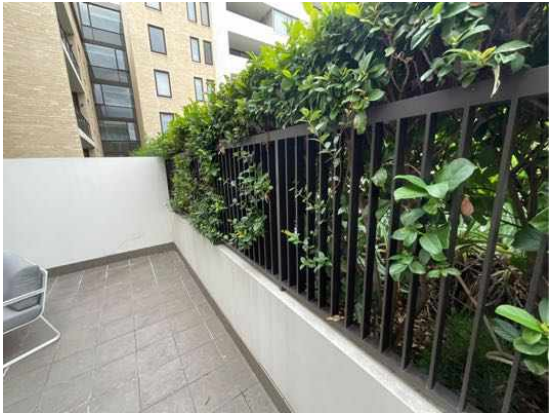
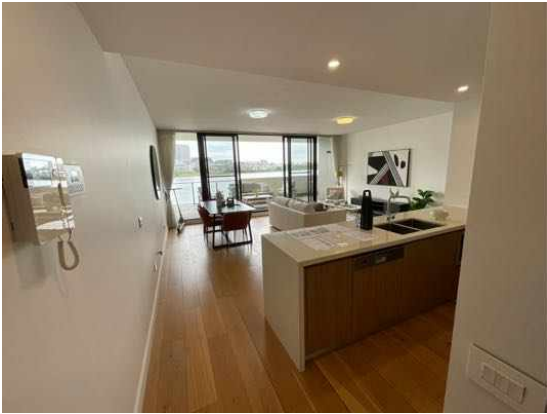
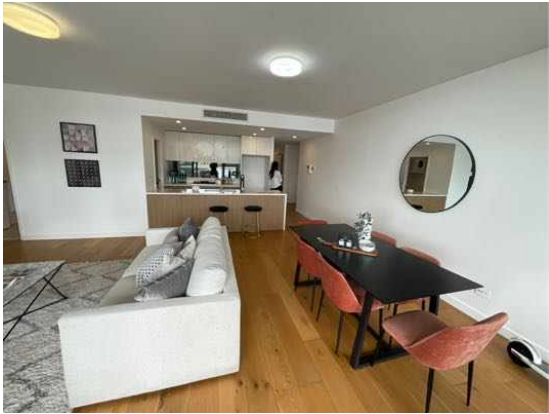
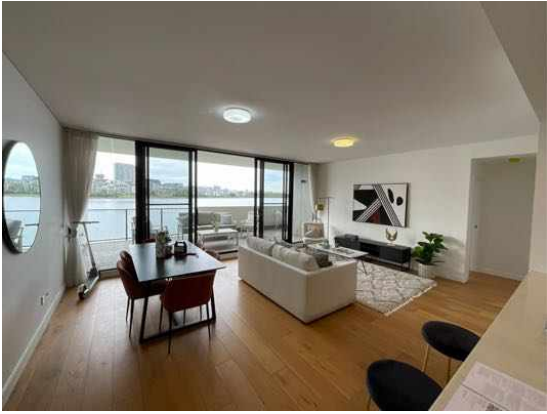
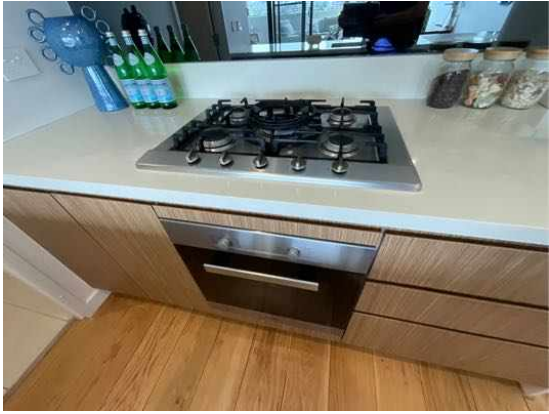
Building: Main Building
 Location: All Areas
 Finding: Additional Photos - Obstructions and Limitations
 Information: These photographs are an indication of the obstructions and limitations which

impeded full inspection of the property at the time of inspection. These obstructions can hide an array of defects and should be removed to allow full inspection to be carried out. A re-inspection is recommended once the areas are made accessible.
