Building Inspection Report

Inspection Date: Tue, 3 Mar 2026

Property Address: 204/14 Half St, Wentworth Point NSW
2127, Australia

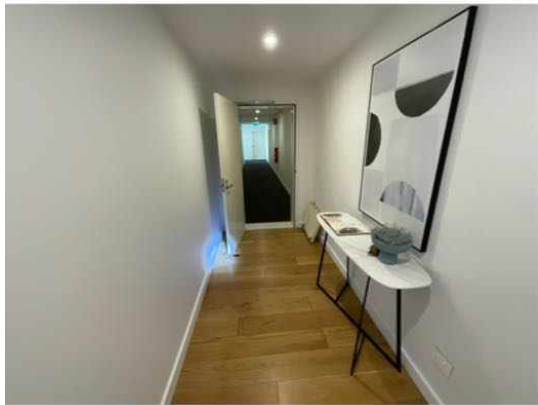
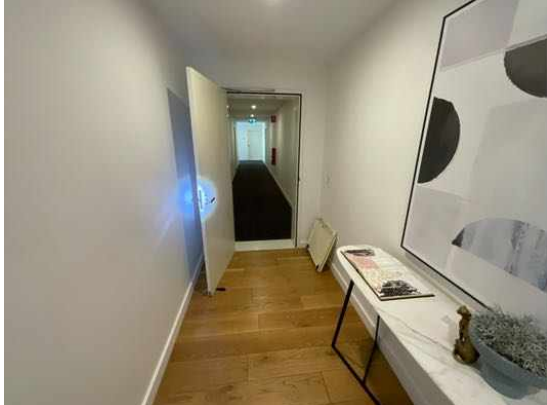
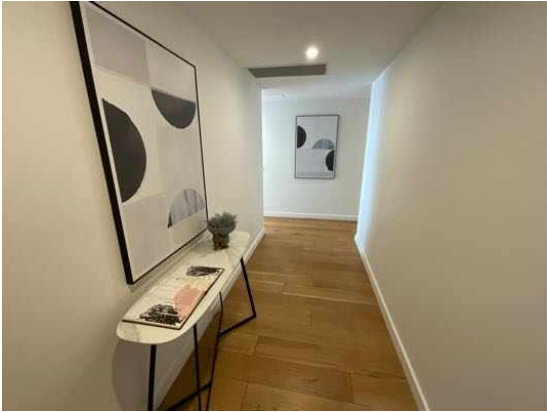
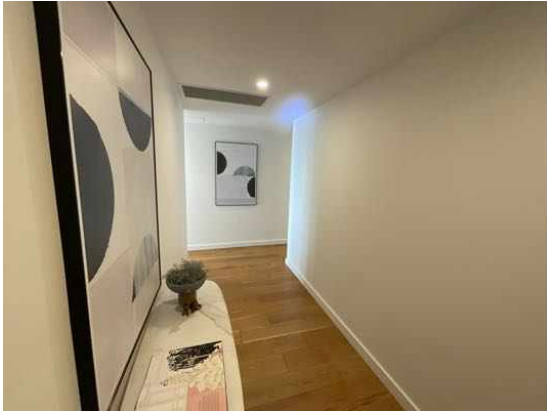
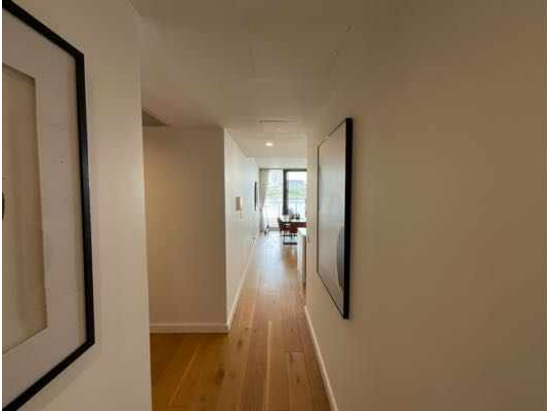
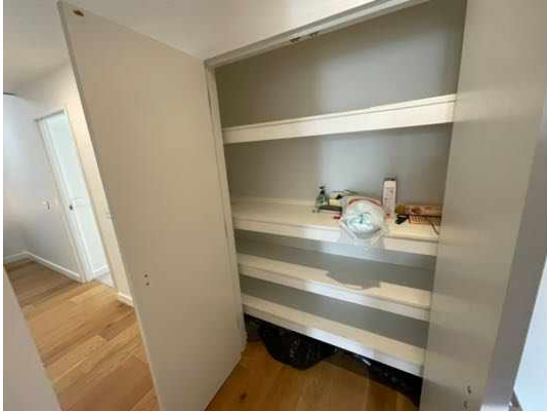
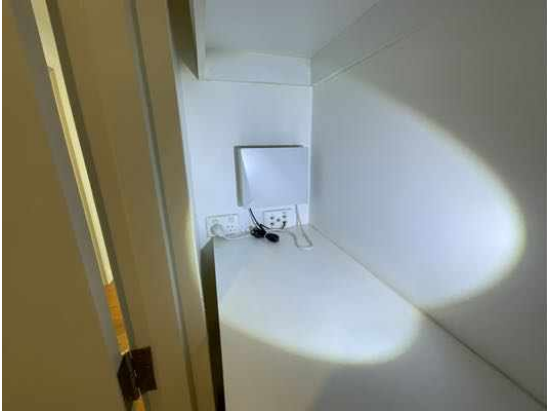
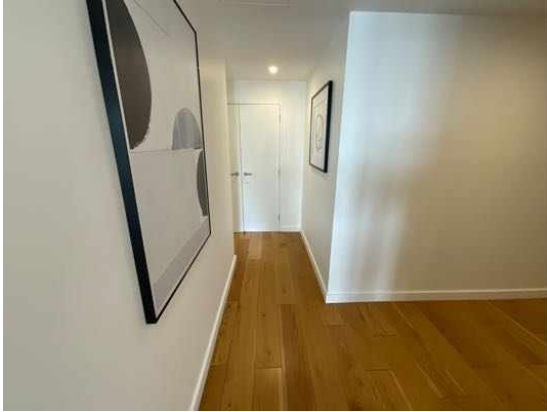
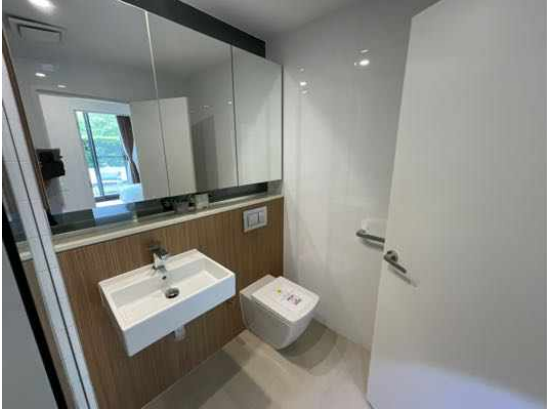
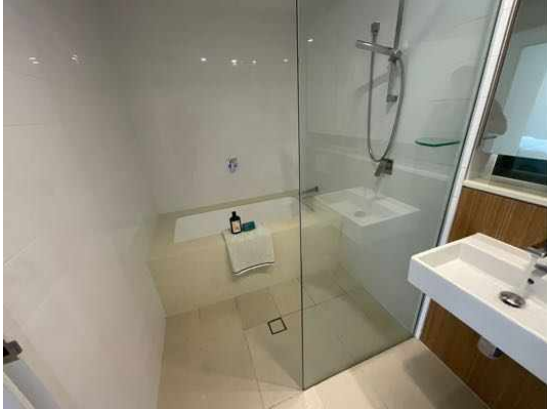
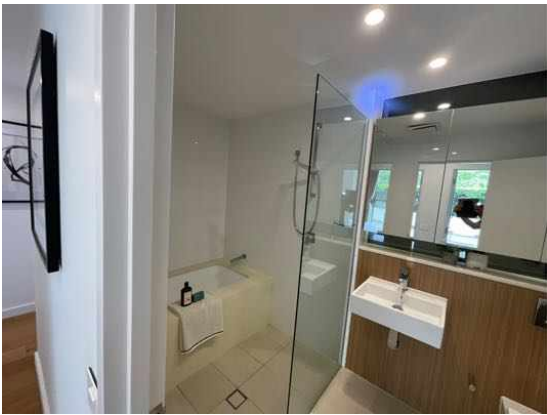
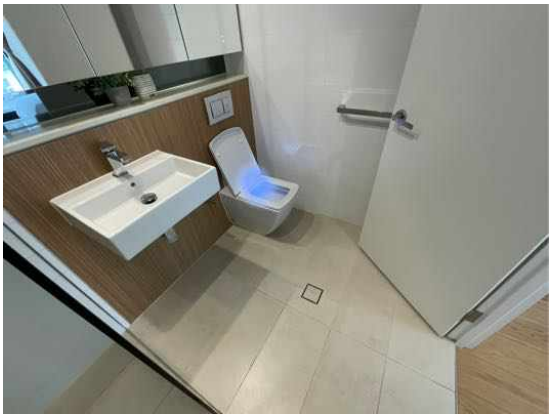
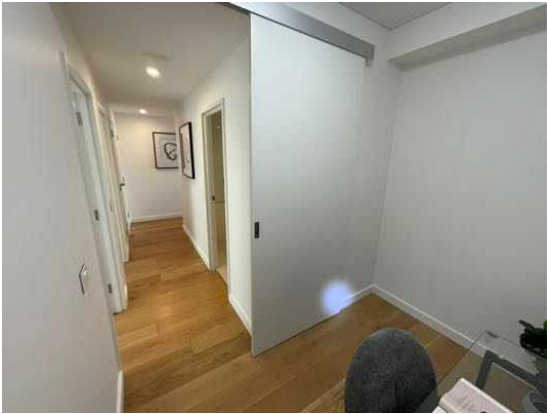
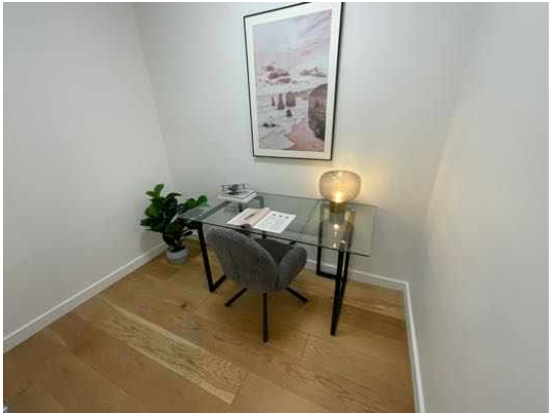
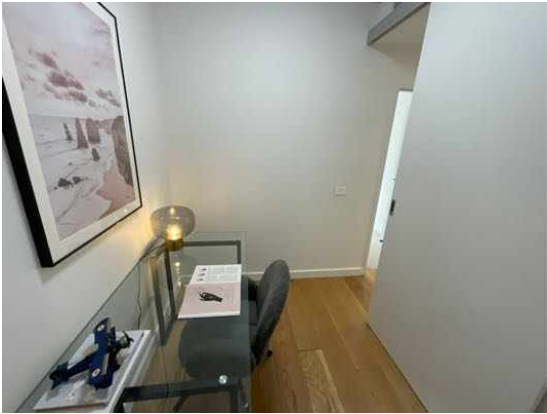
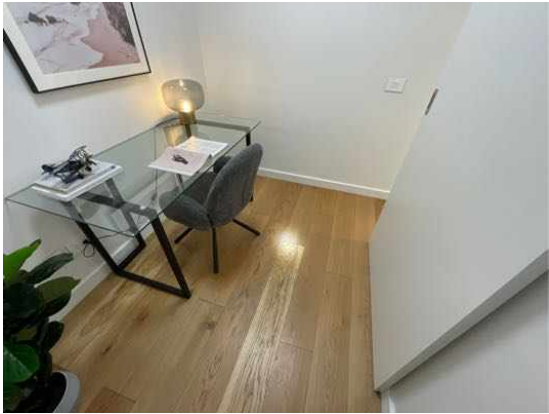
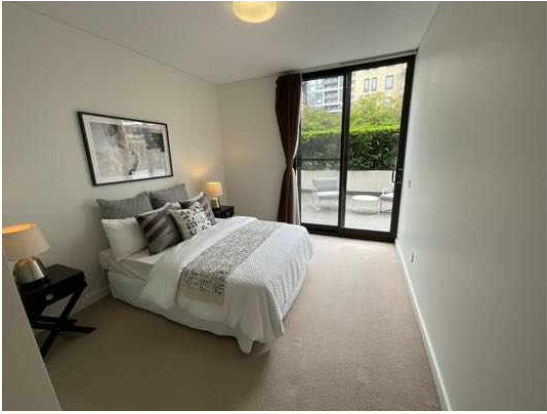
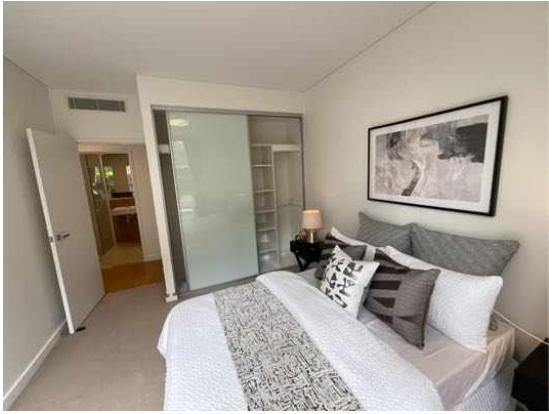
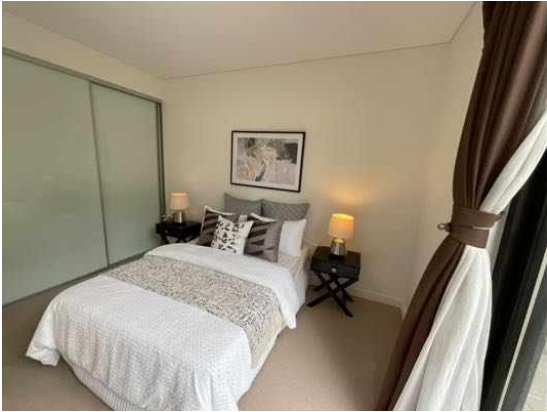
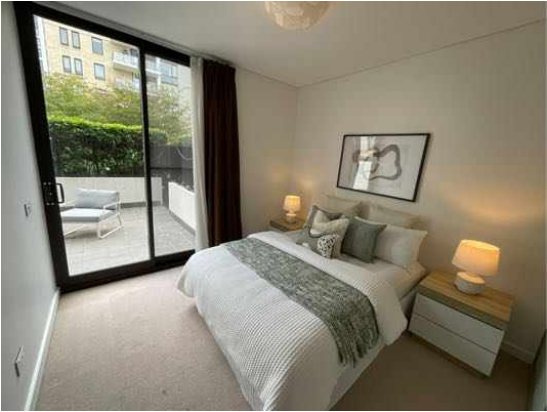
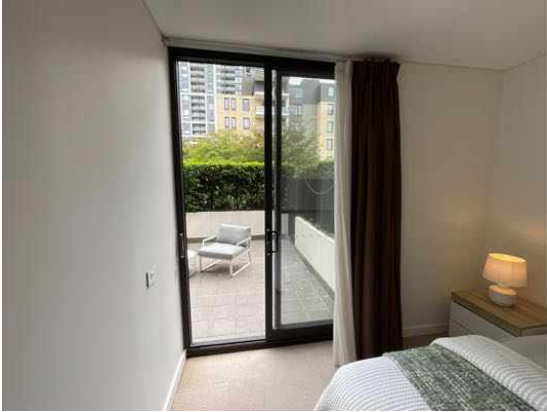
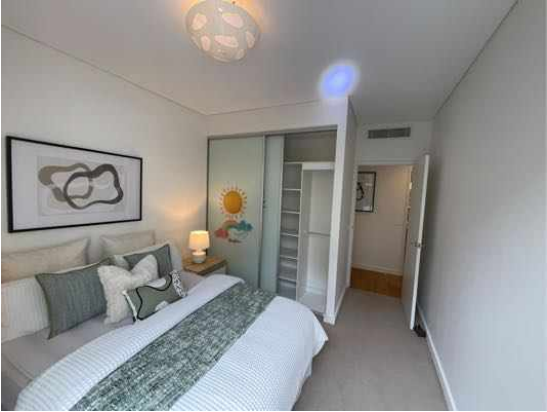
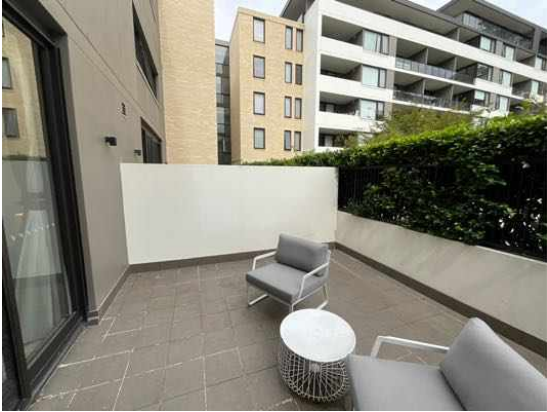
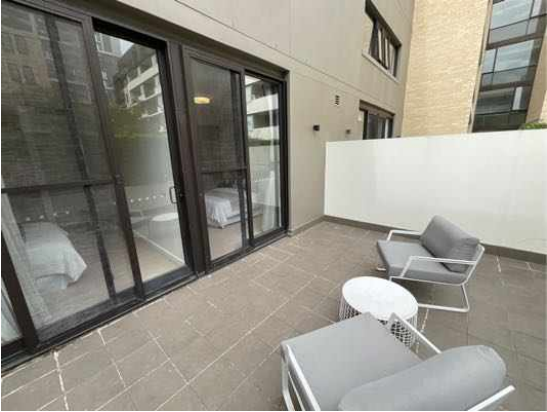
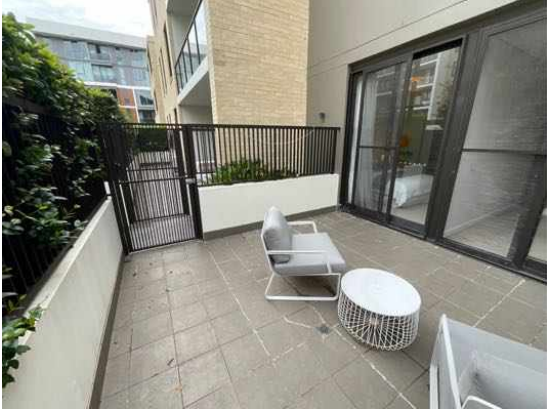
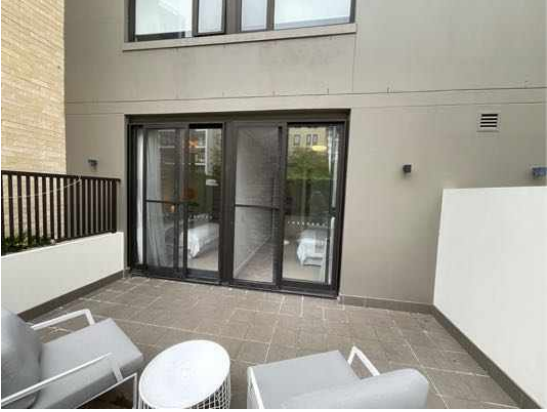
Building: Main Building
 Location: All Areas
 Finding: Additional Photos
 Information: Additional photos are provided for your general reference. Arrows have been included to highlight areas of importance. Please discuss these photos with your building consultant for clarification.

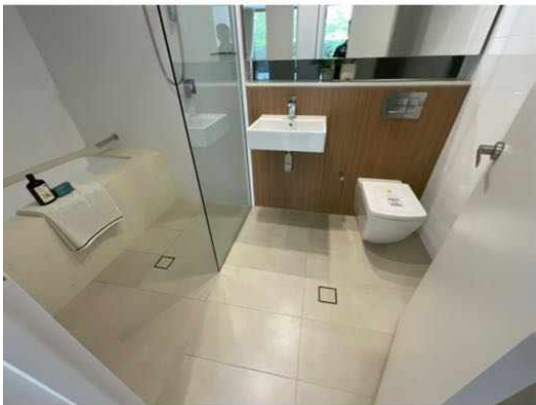
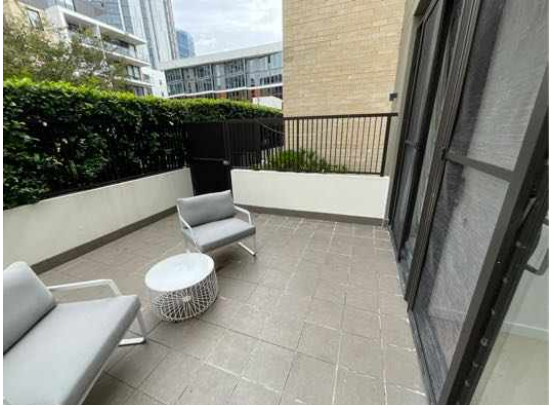
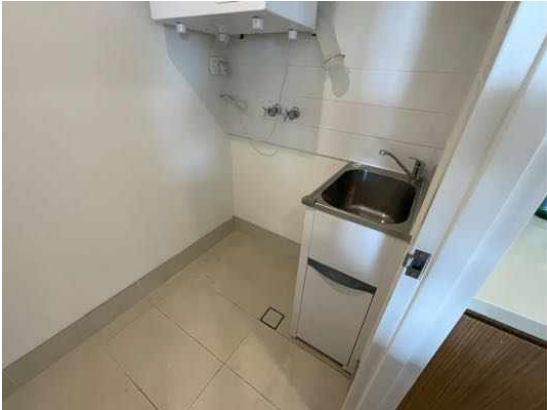
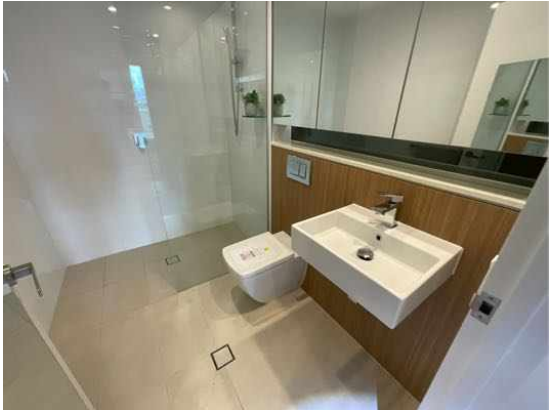
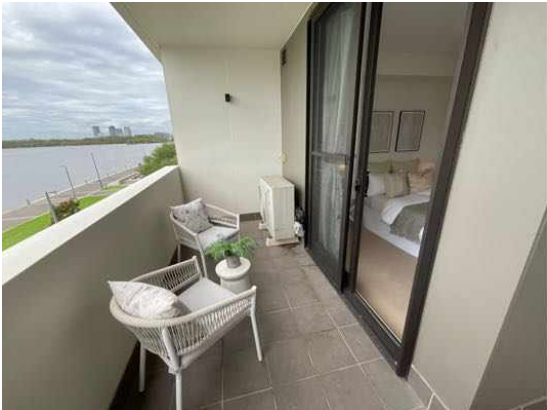
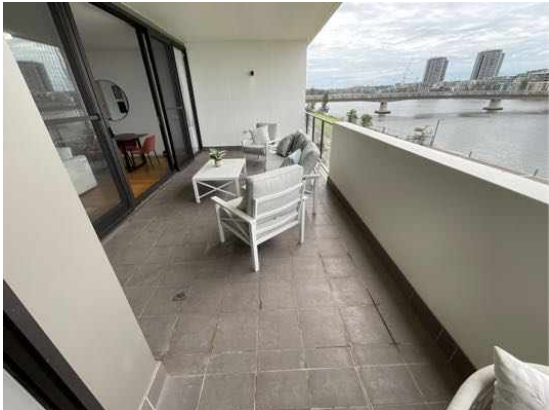
Noted Item

Building: Main Building
 Location: All Areas
 Finding: Water Proofing Membranes - Information Only
 Information: Internal Water Proofing Membranes, are crucial in preventing water ingress into the property is important to know that the Membrane System used is to Australian Standards and has been installed correctly. Please refer to the original Building Documents or Maintenance Schedule for the relevant information including; - Membrane used and Manufacturers Specifications. - The Installer and Installation Certification. Especially with older property's where this information is unavailable, all wet areas should be monitored. Generally new waterproofing with a certificate may

only have a guarantee of 8yrs. If any leaks, water staining, peeling or bubbling of the paint become evident to any adjacent walls or ceilings below a licensed builder or waterproofing specialist is recommended to investigate further.
