Building and Timber Pest Inspection Report

Inspection Date: Mon, 9 Mar 2026

Property Address: 28 Mahon Ave, Kennington VIC 3550,
Australia

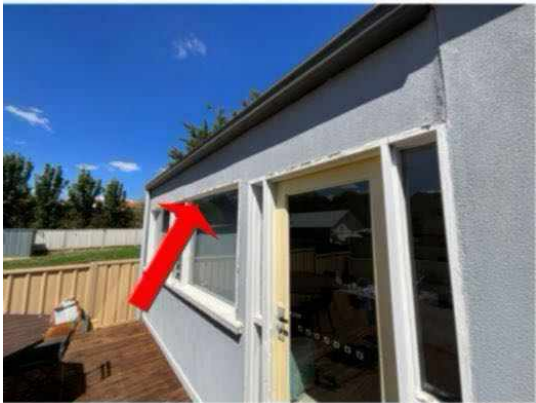
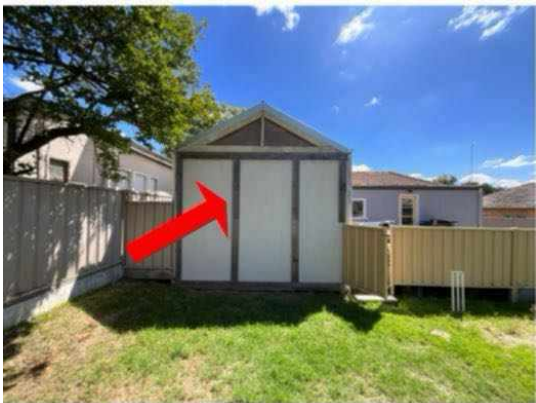
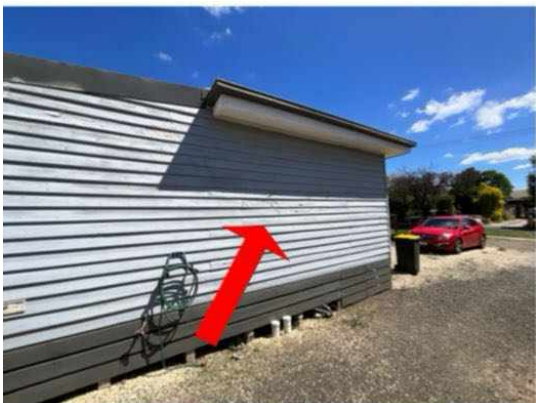
Building:	Building 1
Location:	All External Areas
Finding:	External painting deteriorated
Information:	Much of the external paintwork including but not limited to windows, fascias, guttering, veranda and other external fitments have been neglected and require attention to prepare and re-paint.

Whilst incomplete or missing paint finish is generally an appearance defect, it can also lead to the development of secondary building defects over time. Incomplete areas of paint finish expose the area to moisture, potentially accelerating the deterioration of underlying building materials.

Degraded paint finishes should be sanded back, filled, leveled and painted, as applicable. Where inadequate or missing paint protection has led to the deterioration of the associated building element, repair and/or replacement of this building element may be required.

A painting contractor should be appointed as soon as possible to perform necessary works to aid the appearance of the affected area and to ensure the area is protected against further deterioration. Alternatively, the homeowner following manufacturer instructions may perform these works.

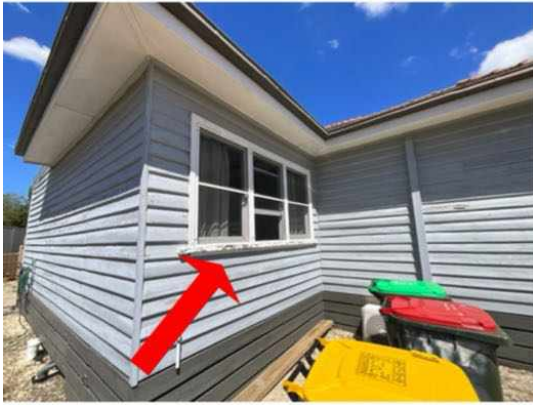
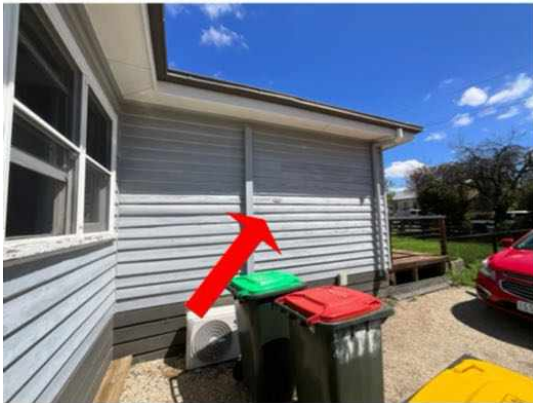
Finding 3.02

Building:	Building 1
Location:	Yard - Side
Finding:	Installation - substandard or incomplete
Information:	The installation of this building element appears to have been completed to a substandard level of workmanship or is incomplete. Generally substandard repairs or installation are related to poor workmanship, the use of inappropriate materials, or a failure to complete installation to a suitable standard.

Where installation is substandard and/or incomplete, the client should contact the responsible trade to undertake rectification. Unfinished and substandard building works are likely to degrade more quickly and may create potential for secondary defects to associated building elements.

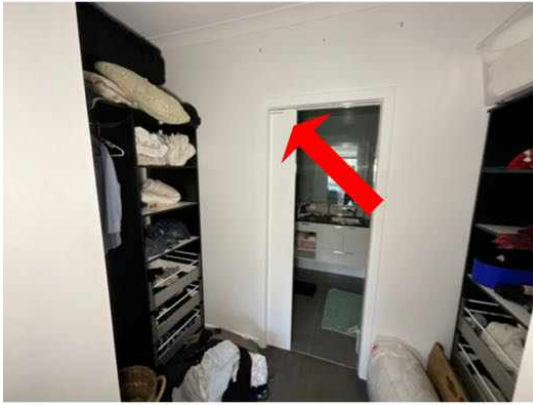
Building:	Building 1
Location:	Ensuite
Finding:	Door- Stiff to slide
Information:	The door in this area was jammed and difficult to slide along the associated tracks at the time of the inspection. Restricted function of the affected door may pose as a potential safety hazard if required for emergency egress from the building.

Generally, factors such as general age of the building element and a lack of maintenance are the usual causes for this type of defect.

Replacement of door hardware or tracks may be required, as well as minor repairs and cleaning. A registered builder or general handy person will be required to repair the affected doors.

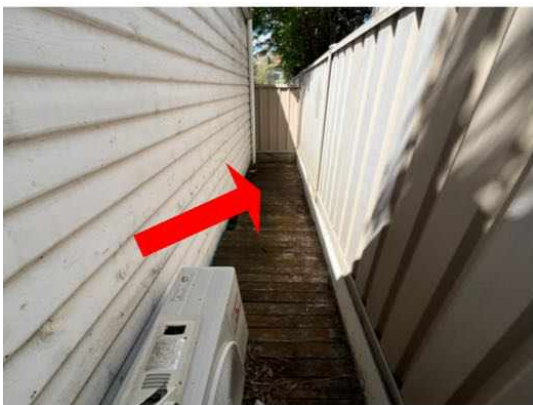
Finding 3.06

Building: Building 1
 Location: Yard - Side
 Finding: Floors/ deck - bouncy
 Information: The flooring in this area was identified as being bouncy at the time of inspection. A bouncy floor surface generally presents as a discernible change in level as they are walked across, in noisy or creaking flooring, or in consequent movement of surrounding furniture and fixtures.

Bouncy floors generally indicate that the floorboards or the subfloor structures are coming loose from the joists that they are installed on. Bouncy flooring may also be the result of gaps between flooring and stumps or joist structures, which require packing.

The client is advised to seek quotations for required repairs from a Registered Builder specialising in decking or flooring . The potential resolution may range from packing gaps in subfloor structures through to replacement of subfloors stumps and refixing of flooring.

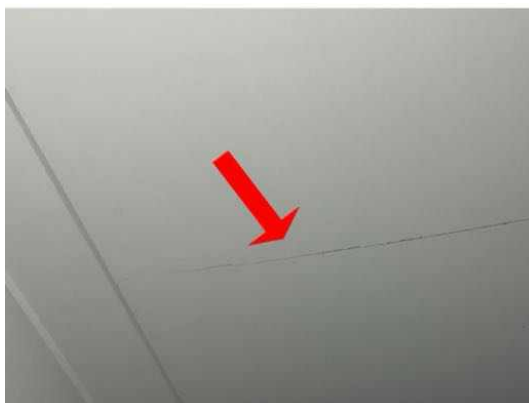
Building:	Building 1
Location:	Hall, bed 2,
Finding:	Cracking - Damage Category 1 - Fine (up to 1mm)
Information:	Although fine cracks are quite noticeable, they are often only considered to be an appearance defect, and usually do not indicate any structural damage. Generally, the cause of a fine crack is indicative of a separation between building materials and finishes (e.g. paint, plaster, etc.) along joints.

Cracking of this nature can generally be repaired with minor sanding, filling and/or repainting. Such works should be performed by a qualified painter or a general handyman.

Monitoring of all cracking should be conducted frequently. Always contact a building inspector should cracks widen, lengthen, or become more numerous.

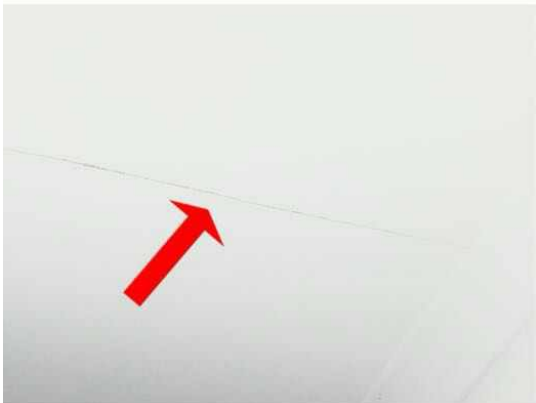
Finding 3.09

Building: Building 1
 Location: Garage
 Finding: Crack in concrete slab - Category 1
 Information: A crack coded as Category 1 was identified in the slab. A Category 1 crack is described as a fine but noticeable crack, with the slab at an otherwise reasonable level.

To be considered Category 1, the approximate width of the crack is less than 1.0mm, or a less than 10mm change in offset when a 3m straight edge is placed over the defect.

Category 1 cracks should be monitored for a period of 12 months. At the end of the monitoring period, identified cracks that are rated greater than Category 2 are considered defects, and require rectification.

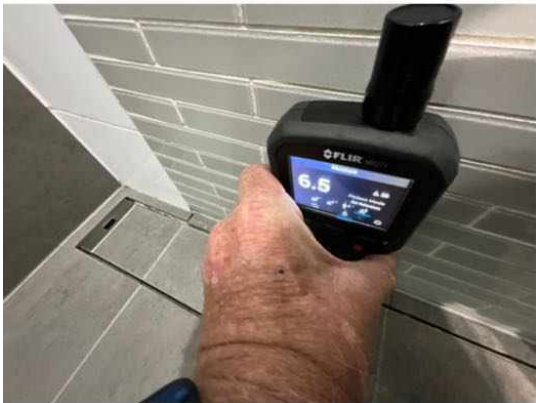
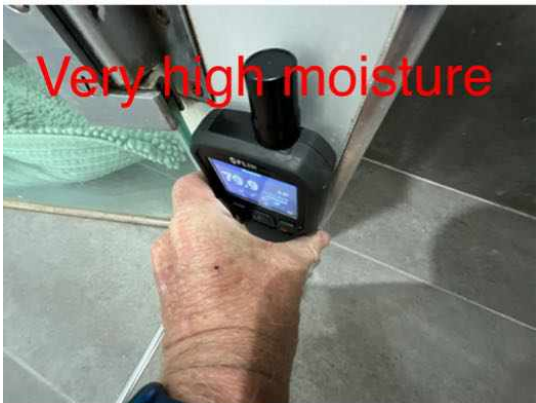
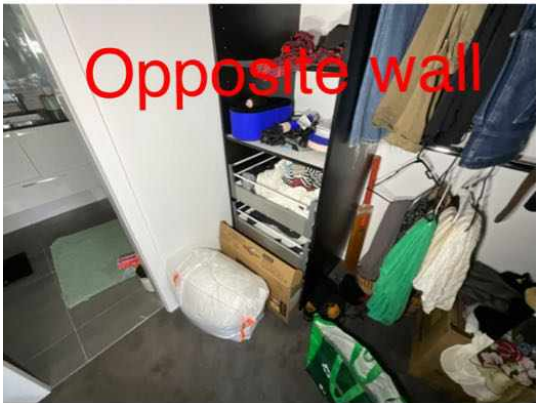
This defect is quite common, and is suspected to have been caused by moisture

permeating or leaching through the grouting and perhaps gaps in the sealant prior to repair.

Damp (or structural damp) refers to the presence of unwanted moisture in the structure of a building, either as the result of intrusion from outside, or condensation from within the structure. In the shower area, internal water leaks or other sources of excessive moisture are generally the cause of damp.

Always ensure that sealant and grout is in good condition to prevent any moisture issues occurring in the future.

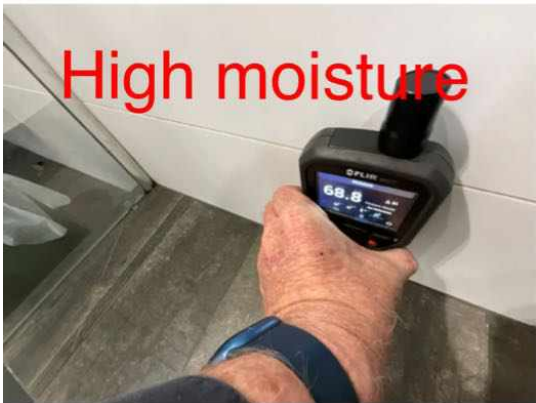
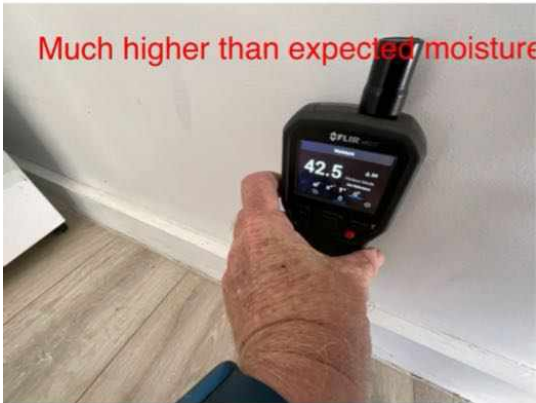
Finding 6.02

Building: Building 1
Location: Bathroom
Finding: Shower Damp- Significant
Information: Damp is evident to the lower wall to the Shower Alcove. This is suspected to have been caused by moisture permeating through the grouting in this area.

Relatively High levels of moisture were observed on the outside of the shower walls in the opposite wall.

Always ensure that sealant and grout is in good condition to prevent any moisture issues occurring in the future.

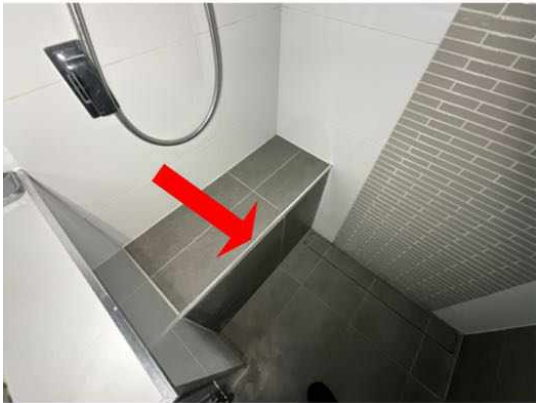
Finding 6.03

Building: Building 1
 Location: Ensuite
 Finding: Inadequate sealant or Grout
 Information: This area has a lack of effective Sealant or Grout. This is allowing the ingress of water to the structure inside the wall.

The presence of water encourages Termite attack, Mould and Fungal Decay.

A Tiler or General Handy person must be contacted as soon as possible to effect repairs and prevent further deterioration.

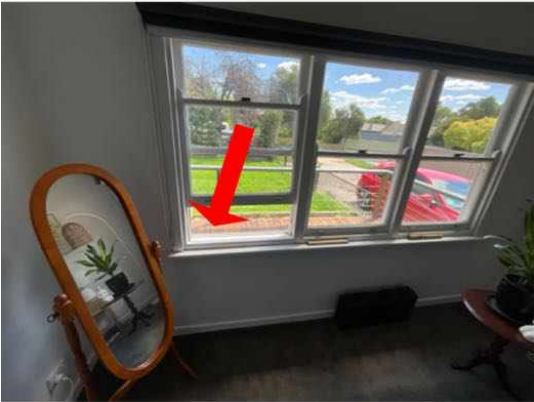
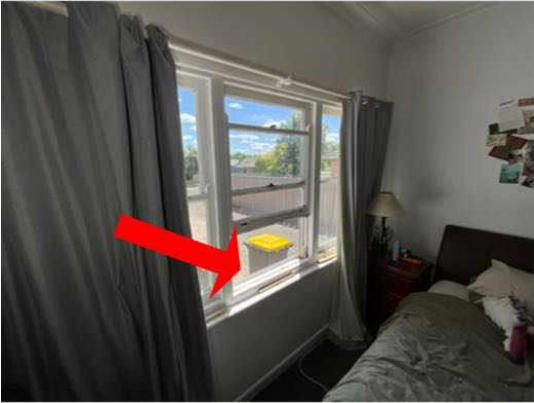
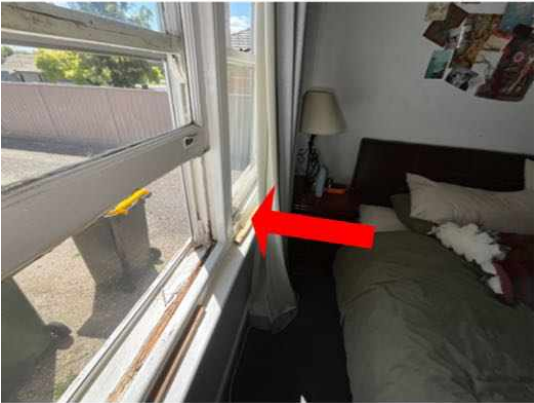
The development of fungal decay is accelerated by temperatures in the range of 5degreeC to 40degreeC as well as the presence of oxygen. Generally fungal decay develops on timber elements that are in use in an external environment which are exposed to rain penetration.

In this case although the affected timber element is in a decaying state the extent of any visible damage appears to be localised to a specific area and is yet to spread to other parts of the building element or affect adjoining structures. The fungal decay is therefore likely to be of a relatively superficial nature with minimal impact on the structural integrity or tensile strength of the timber element.

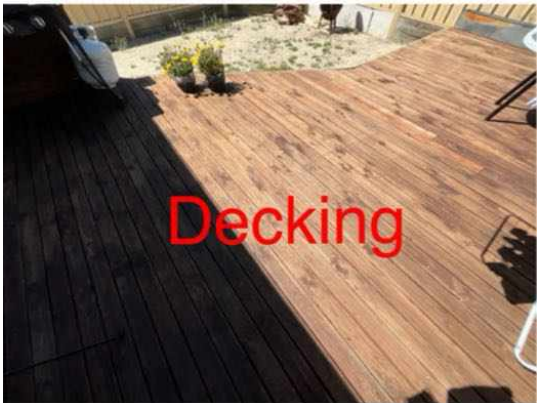
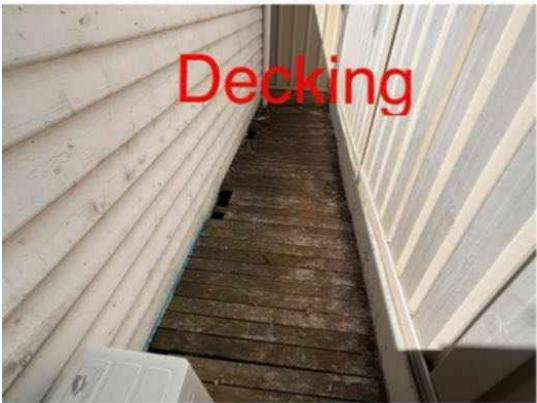
Building: Building 1
Location: All Areas
Finding: Additional Photos - Obstructions and Limitations
Information: These photographs are an indication of the obstructions and limitations which impeded full inspection of the property at the time of inspection. These obstructions can hide an array of defects and should be removed to allow full inspection to be carried out. A re-inspection is recommended once the areas are made accessible.
