Building Inspection Report

Inspection Date: Wed, 25 Mar 2026

Property Address: 37 Swinburne Ave, Mooroolbark VIC 3138,
Australia

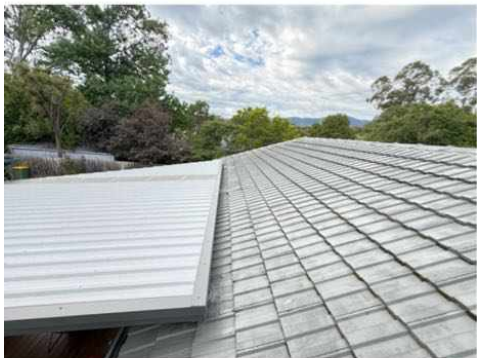
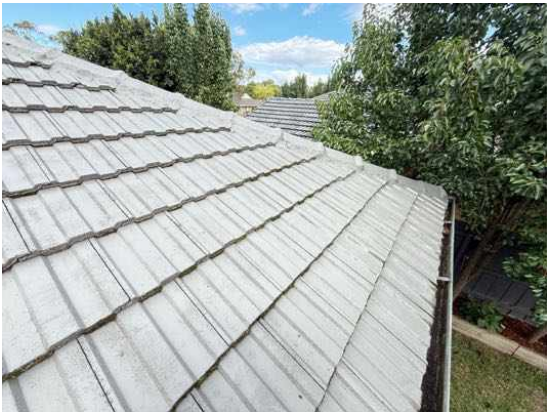
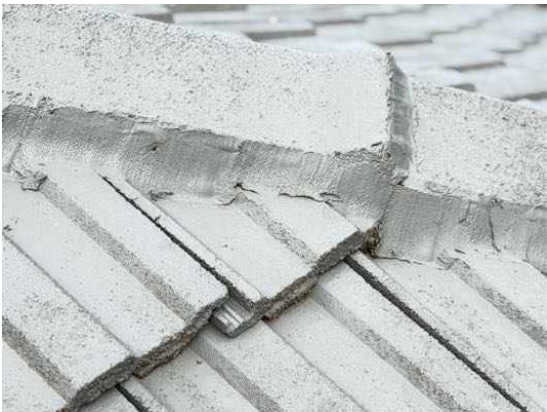
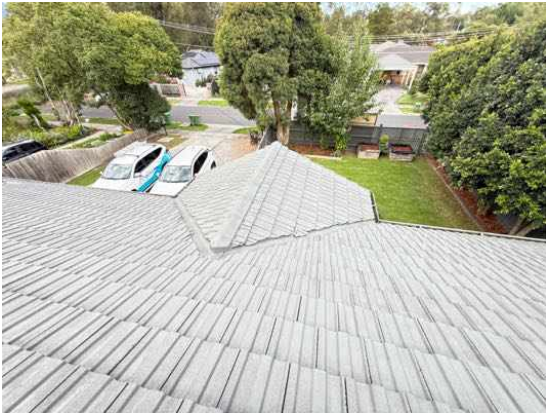
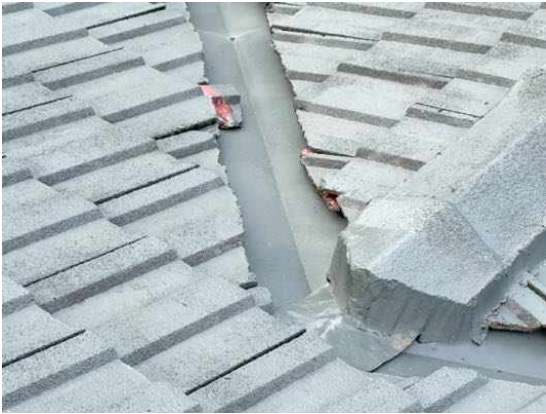
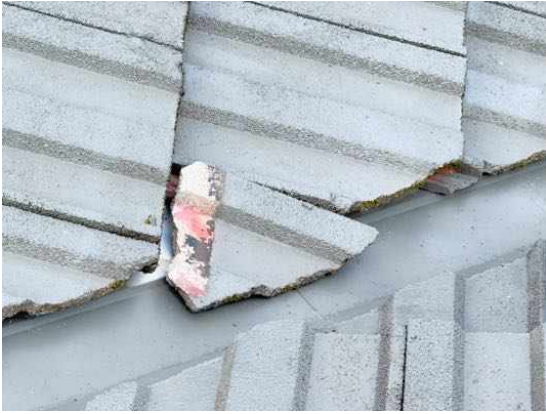
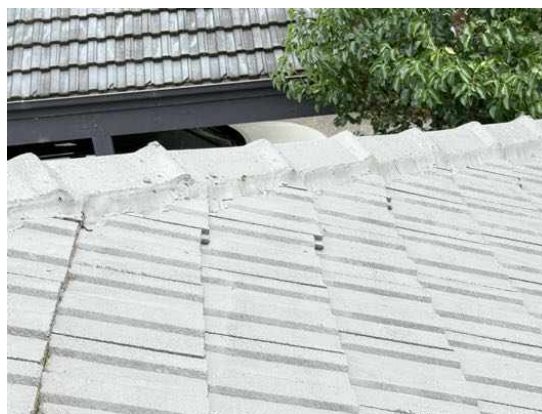
Defects 3.01

Building:	Building 1
Location:	All Areas > All Areas
Finding:	Roof tiles - Dislodge or slippage
Information:	Upon inspection of the roof tiles, it was observed that numerous roof tiles have either slipped or have been dislodged from their original positions. Roof tiles may slip over time due to a number of minor causes, including not placed correctly upon installation, not stuck down on the top of valley irons, flashings, roof tile chips and breakages, failings in the adjoining battens, or fixings that may have failed.

In this case I suspect that tiles have slipped or dislodged from they original positions, these roof tiles will require replacement and some form of fixing down or adhesive sash as a good quality silicon sealant, client may consider to add silicon to the bottom side of the tiles to stick them down to the top of the metal flashings. Roof tiles that have moved from their original position may allow water penetration into the roof void, exposing roofing structures to excessive moisture. This creates an environment that is conducive to water damage and accelerated deterioration of all associated building elements below.

Upon inspection of the roof tiles, it was observed that numerous roof tiles have either slipped or have been dislodged from their original positions. Roof tiles may slip over time due to a number of minor causes, including not placed correctly upon installation, not stuck down on the top of valley irons, flashings, roof tile chips and breakages, failings in the adjoining battens, or fixings that may have failed. In this case I suspect that tiles have slipped or dislodged from they original positions overtime. These roof tiles will require immediate attention for replacement and some form of fixing down or adhesive sash as a good quality silicon sealant, client may consider to add silicon to the bottom side of the tiles to stick them down to the top of the metal flashings. Roof tiles that have moved from their original position may allow water penetration into the roof void, exposing roofing structures to excessive moisture. This creates an environment that is conducive to water damage and accelerated deterioration of all associated building elements below. Replacement of broken, loose or missing roofing tiles is recommended immediately or in the short term future to prevent the development of any

Replacement of broken, loose or missing roofing tiles is recommended immediately or

in the short term future to prevent the development of any secondary defects. A roofing plumber or roof tiler should be appointed to complete such works as deemed to be necessary.

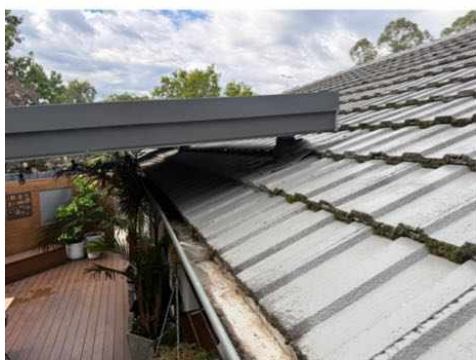
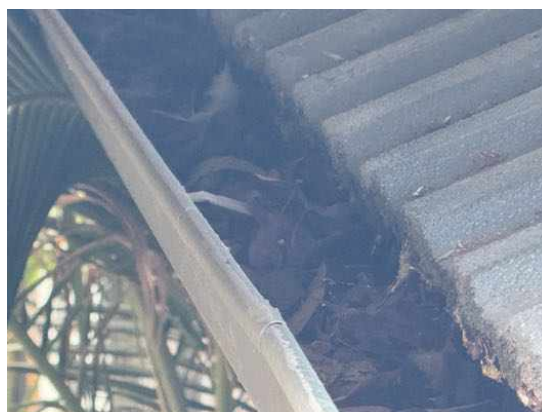
Defects 3.02

Building:	Building 1
Location:	All Areas > All Areas
Finding:	Gutters - Partially blocked
Information:	Roof plumbing structures, such as guttering and downpipes, should be free of all leaf matter and debris to prevent blockages. Blockages of the guttering and downpipes will lead to pooling and accumulated water overflows, which is likely to subsequently flood eaves and exterior walls. Blocked gutters are likely to lead to high levels of moisture in the affected areas. Such moisture will not only cause rust and decay of the associated building materials, but can also provide conditions that are conducive to termite and timber pest activity.

Blockages in gutters should therefore be removed immediately to ensure dry conditions are maintained. Client should consider the appointment of a gutter cleaning company to carry out these works or with a Licensed Plumber for further specific advice on remedial works that may be deemed to be required. In the interim, it is highly advised that blocked gutters be removed by the homeowner, gutter cleaning company or a general handy-person in the short term future.

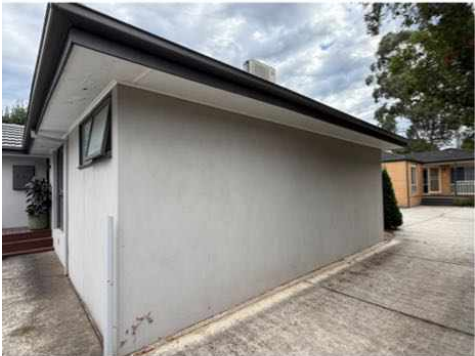
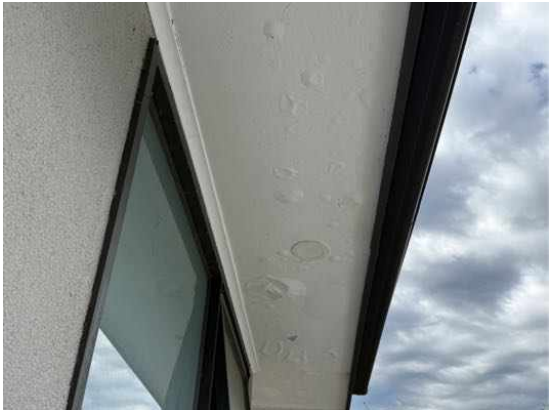
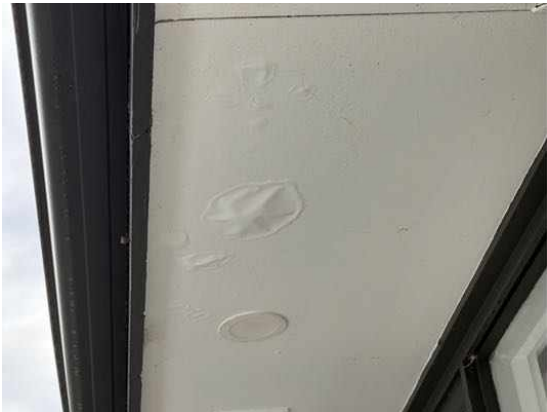
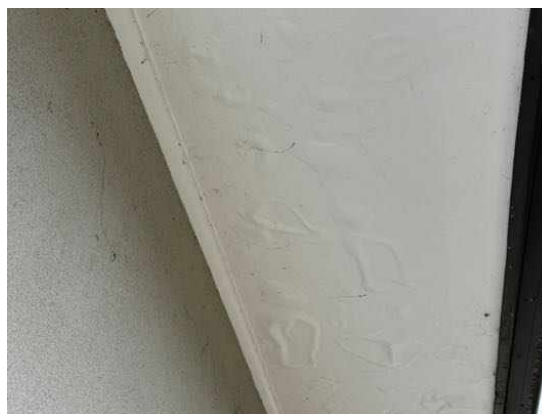
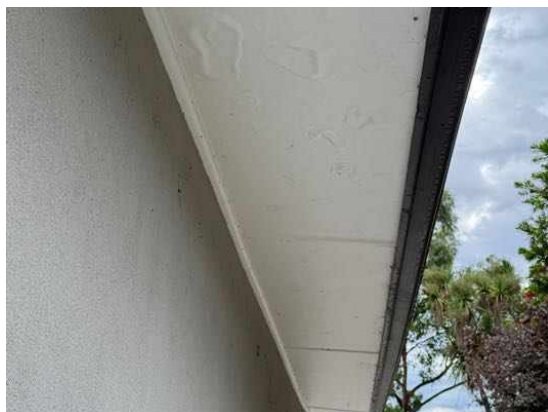
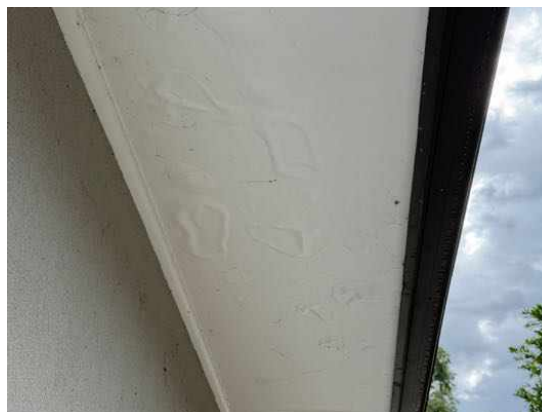
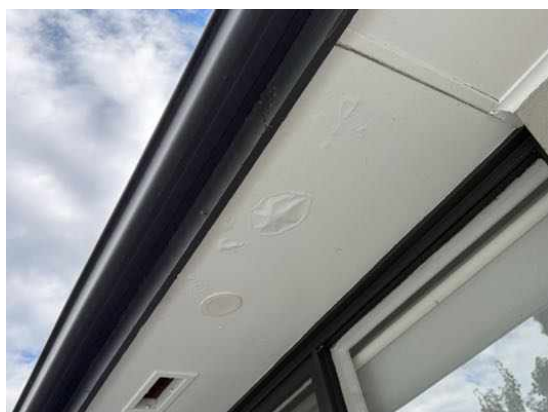
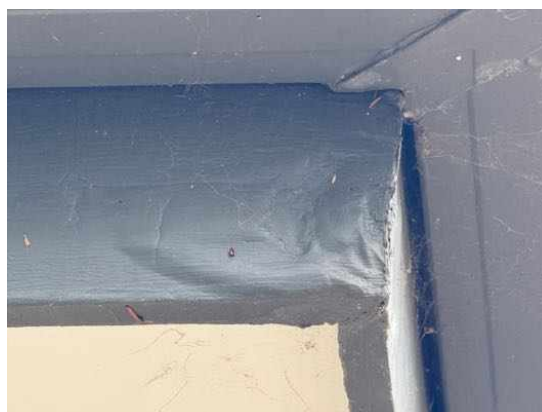
Defects 3.03

Building: Building 1
Location: All Areas > All Areas
Finding: Eaves paint bubbles from suspected moisture behind the paint
Information: Eaves paint bubbles primarily due to moisture trapping, typically caused by roof leaks, overflowing gutters, or high humidity, forcing the paint away from the surface. To fix, identify the moisture source, scrape off loose paint, sand, apply a high-quality primer, and repaint with exterior acrylic paint. The eaves linings to the front areas were observed to show bubbling paint, this is suspected to be from moisture under the paint. Where moisture damage is evident, the primary requirement is to ensure there are no leaks.

The damage to the eave linings in these areas detracts from the appearance of the structure and other adjoining building structures and framework in the roofing area. Where eaves show this type of damage, remedial works are suspected to be required in the short term future. Where water damage is suspected as being the underlying cause, appointment of a roofing contractor and or other relevant tradespersons is recommended to identify the exact source.

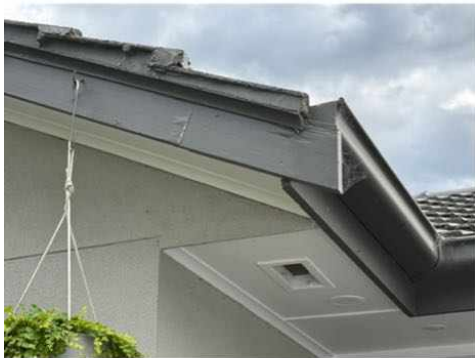
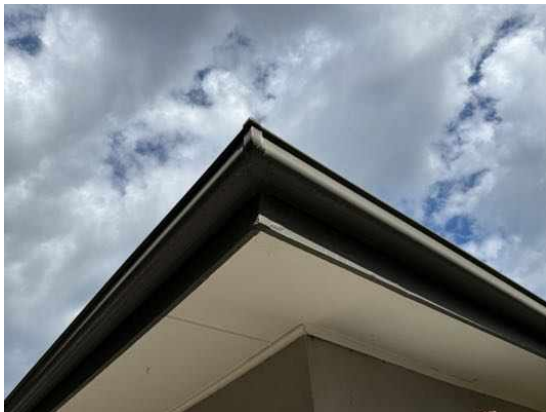
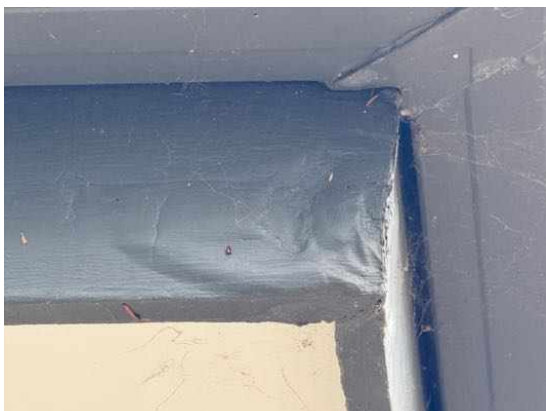
Defects 3.04

Building:	Building 1
Location:	Bedroom > All Areas
Finding:	Minor wood rot
Information:	Minor wood rot is suspected to be affecting some fascias around the exterior areas. Wood rot, also known as Fungal Decay, occurs when timbers and other cellulose building materials are exposed to damp conditions on an ongoing basis. The roof plumbing in these areas may be creating excessive moisture in this areas and or it may be due to frequent exposure to rain and other weather conditions also make fascias and windows and other building elements susceptible to accelerated deterioration.

Early intervention and regular maintenance such as painting will prolong the useful life of these building elements. Prior to any works being performed, the cause of the moisture that has created the visible wood rot should be identified and addressed in a suitable manner. It is advised that a licensed plumber be appointed to inspect all roof plumbing and subsequently identify the cause of the wood rot. Replacement of affected fascias or window elements and or other building elements may then be a necessary step in protecting surrounding areas from such deterioration. A qualified plumber may be appointed to assess the cause of excessive moisture and to provide advice on any remedial works as required. A qualified carpenter or registered builder may also be required to replace affected building materials.

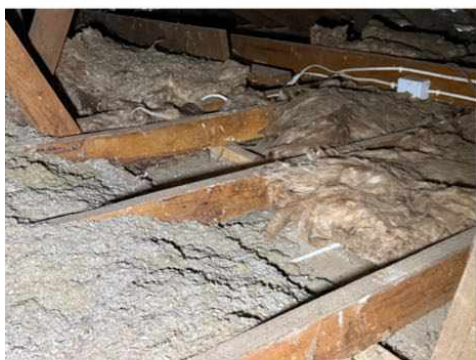
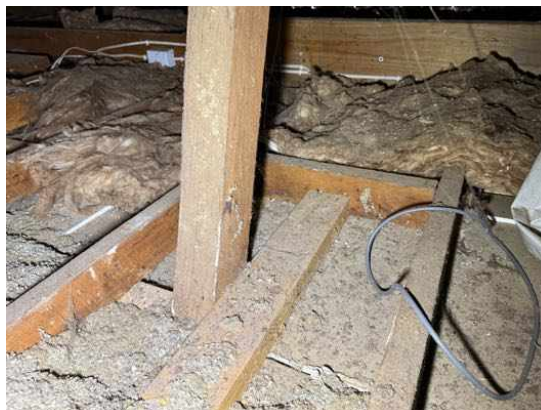
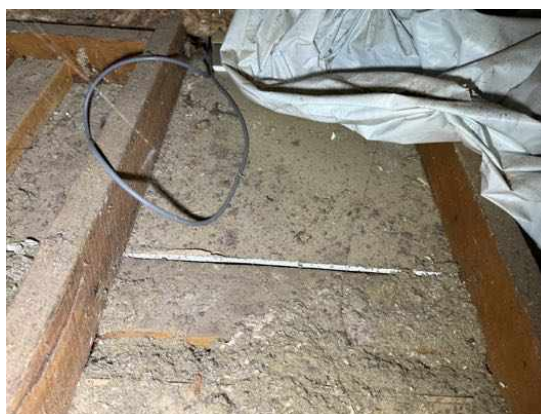
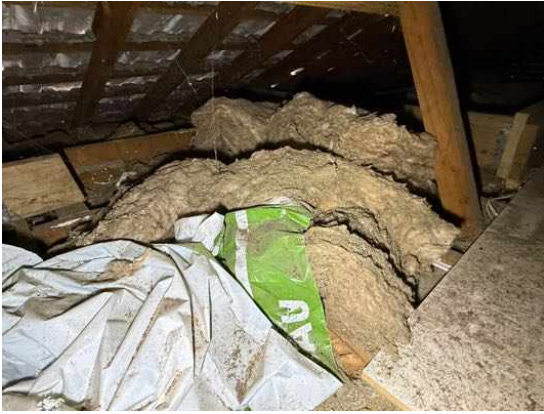
Defects 3.05

Building: Building 1
Location: All Areas > All Areas
Finding: Insulation - poorly installed - missing or moved
Information: Some areas of the roof insulation in the roof space is suspected to have been poorly installed, missing or have been moved from their original position. Insufficient insulation will result in a comparatively higher cost to heat and cool a property as there is a lack of Insulation (or uneven coverage of insulation) which works as a barrier to heat transfer. This helps to keep out unwanted heat in summer and preserves warmth inside your home in winter. It can also help soundproof your home from unwanted airborne noise transfer.

Example - Where there is a gap in coverage totaling 5% there is a potential for up to 50% of the energy efficiency to escape. Caution should always be exercised when accessing the roof void. Do not attempt to stand on the framework where cabling is crossing and especially be aware that there is a potential for electric shock if contact is made with exposed or faulty electrical wiring.

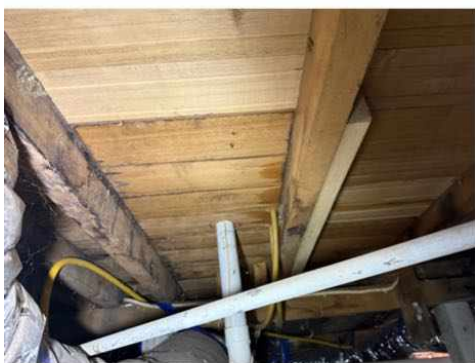
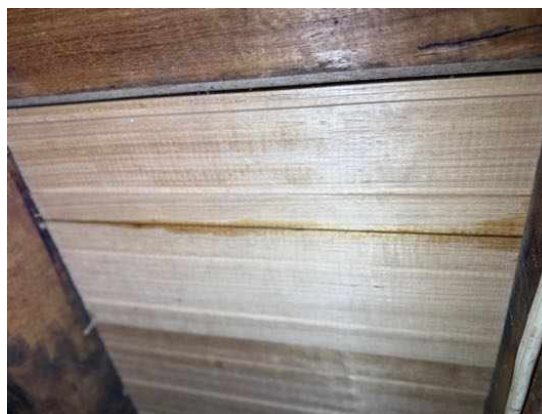
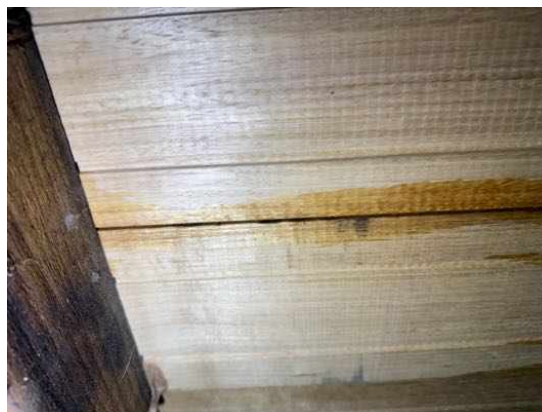
Defects 3.06

Building: Building 1
 Location: All Areas > All Areas
 Finding: Subfloor moisture and dampness
 Information: Some moisture and dampness was observed under the Laundry area in the subfloor. No conclusion for where the moisture was coming from at the time of the inspection and client is recommended to investigate further as to the cause of the moisture. Damp and moist conditions in the subfloor areas make these areas susceptible to wood rot, termite and pests and other secondary damage and defects.

Some moisture and dampness was observed under the Laundry area in the subfloor. No conclusion for where the moisture was coming from at the time of the inspection and client is recommended to investigate further as to the cause of the moisture. Damp and moist conditions in the subfloor areas make these areas susceptible to wood rot, termite and pests and other secondary damage and defects. Remedial work to rectify the moisture from these areas of the subfloor is recommended to ensure further damage and deterioration and better over all conditions in the subfloor areas, this types of defects should be rectified in the short term future. It is recommended that the client appoint a licensed plumber to inspect these areas and provide advice to eliminate moisture and dampness from the subfloor areas.

Remedial work to rectify the moisture from these areas of the subfloor is recommended to ensure further damage and deterioration and better over all conditions in the subfloor areas, this types of defects should be rectified in the short term future. It is recommended that the client appoint a licensed plumber to inspect these areas and provide advice to eliminate moisture and dampness from the subfloor areas.

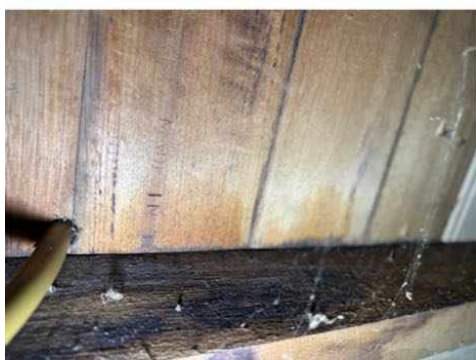
Defects 3.07

Building:	Building 1
Location:	All Areas > All Areas
Finding:	Subfloor - Debris
Information:	A minor array of debris was found in the subfloor area at the time of inspection. Debris in this area restricts subfloor ventilation and creates potential for concealed pest entry. Stored household goods and other materials may also make these areas susceptible to termite activity, insects and vermin. A clear and empty subfloor will be better ventilated and easier to maintain in a dry condition. The removal of any debris is vital in minimising the risk of termite, insects, rats, mice or wood borer activity.

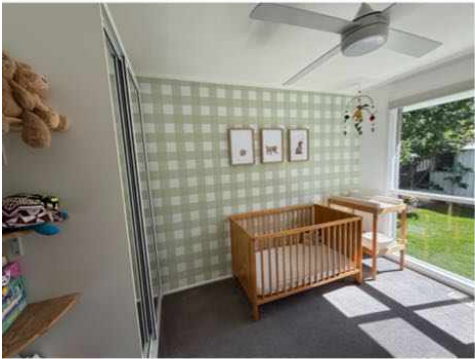
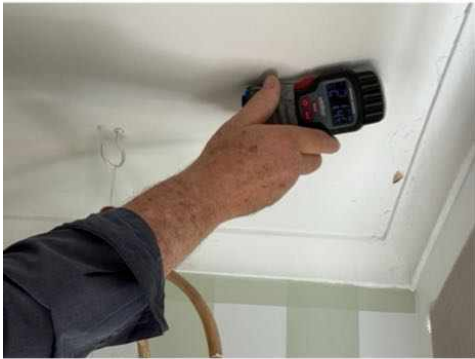
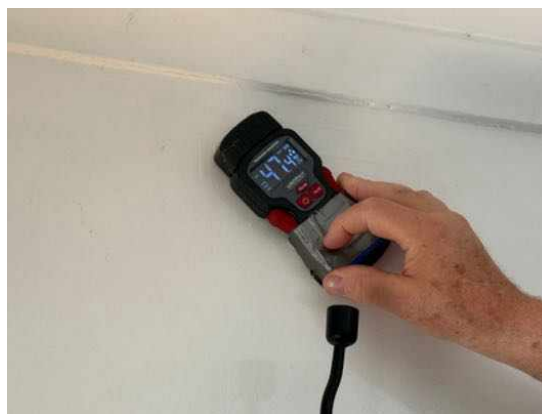
Defects 3.08

Building:	Building 1
Location:	All Areas > All Areas
Finding:	Bedroom and family ceiling and wall plaster showed suspected moisture
Information:	The bedroom and family room ceilings, walls showed suspected moisture and moisture damage. These areas were both checked via a moisture meter, showing a suspected active moisture. No conclusive answer at the time of the inspection as to where the leak was coming from, however it is likely to be from either overwhelmed gutters or roof above. It is highly recommended that a further investigation of these areas be carried out in the short term future. The primary requirement is to identify and rectify the source of the moisture and or leaks.

If left unmanaged any damage sustained while the moisture is active, could potentially compromise the adjoining framing structural and other building elements in the roof, ceiling and walls in these areas. The plaster wall and ceiling linings may be currently concealing damage and deterioration in the roof space and wall framing and other adjoining building elements, which will graduate to secondary defects, further damage and deterioration if left unmanaged.

The bedroom and family room ceilings, walls showed suspected moisture and moisture damage. These areas were both checked via a moisture meter, showing a suspected active moisture. No conclusive answer at the time of the inspection as to where the leak was coming from, however it is likely to be from either overwhelmed gutters or roof above. It is highly recommended that a further investigation of these areas be carried out in the short term future. The primary requirement is to identify and rectify the source of the moisture and or leaks.

If left unmanaged any damage sustained while the moisture is active, could potentially compromise the adjoining framing structural and other building elements in the roof, ceiling and walls in these areas. The plaster wall and ceiling linings may be currently concealing damage and deterioration in the roof space and wall framing and other adjoining building elements, which will graduate to secondary defects, further damage and deterioration if left unmanaged. Remedial works are suspected to be required in the immediate future to further investigate, repair and make good. Where water damage is suspected as being the underlying cause, this moisture will eventually produce mould and mildew on the inside plaster, making it necessary to remove and replace these areas of plaster. Client should appoint of a Registered builder and or licensed plumber to identify the source of any water and moisture leaks immediately.

Remedial works are suspected to be required in the immediate future to further investigate, repair and make good. Where water damage is suspected as being the underlying cause, this moisture will eventually produce mould and mildew on the inside plaster, making it necessary to remove and replace these areas of plaster. Client

should appoint of a Registered builder and or licensed plumber to identify the source of any water and moisture leaks immediately.

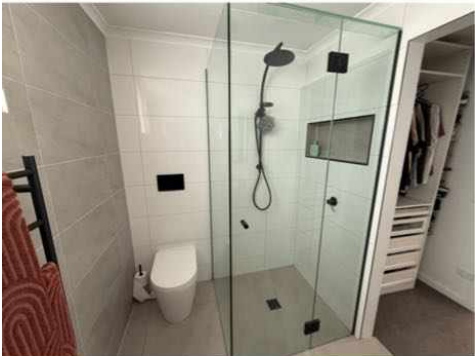
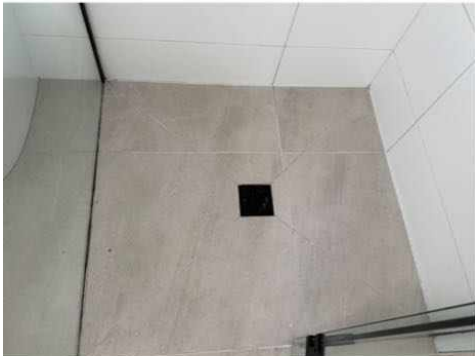
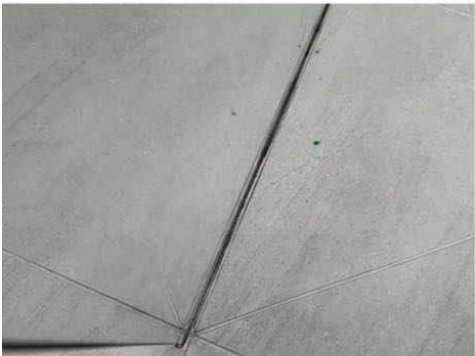
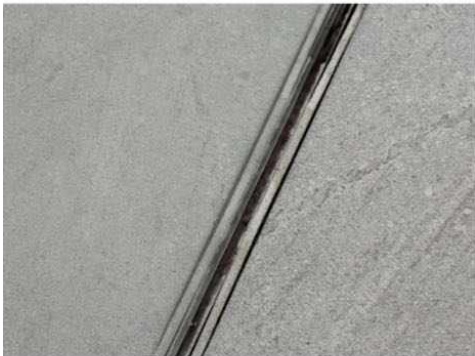
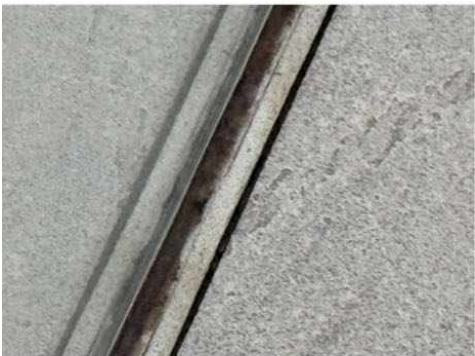
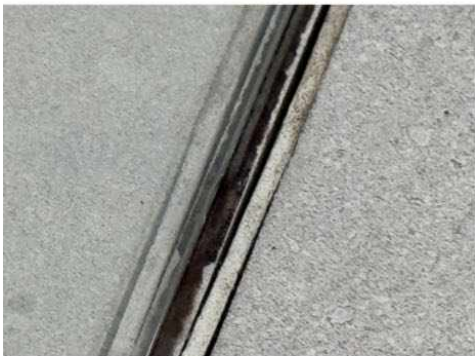
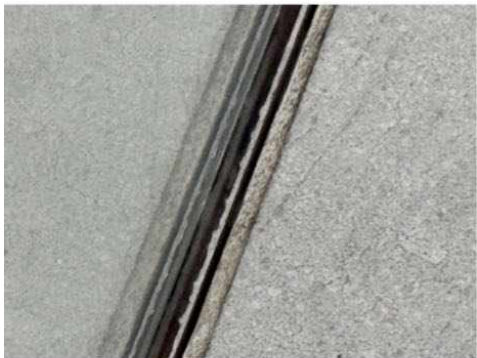
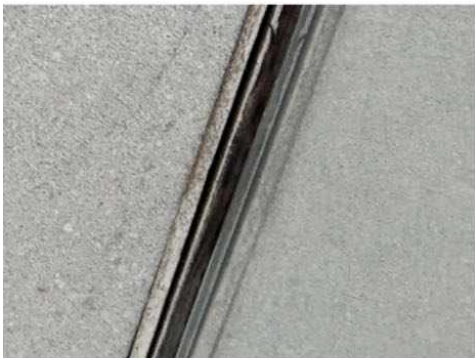
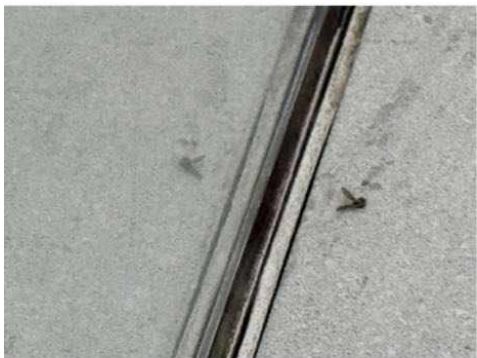
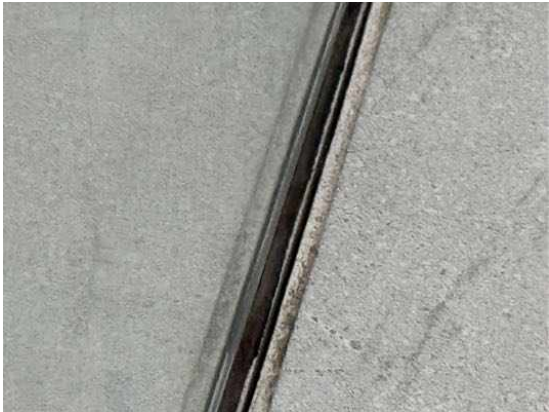
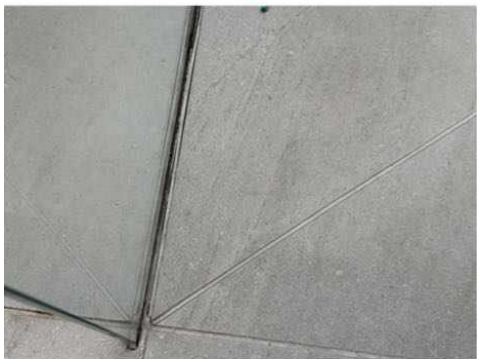
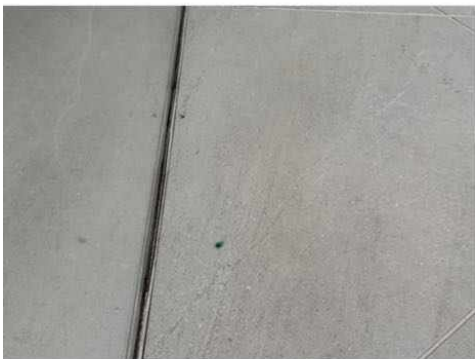
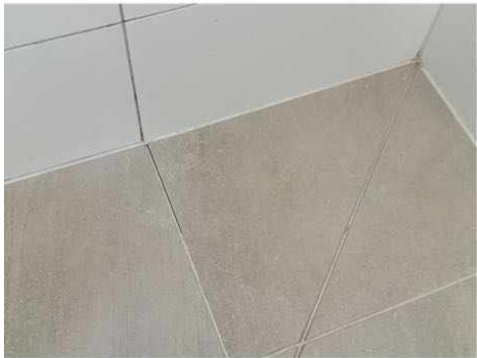
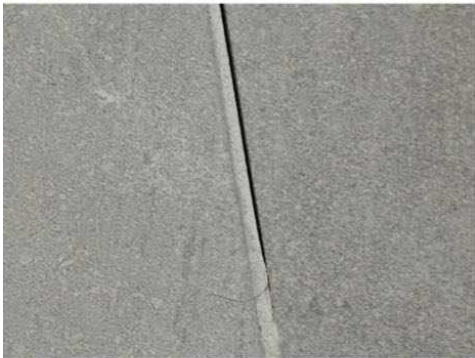
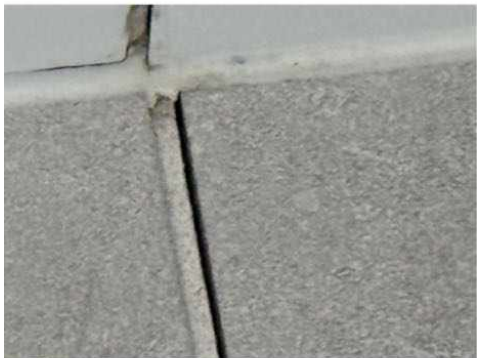
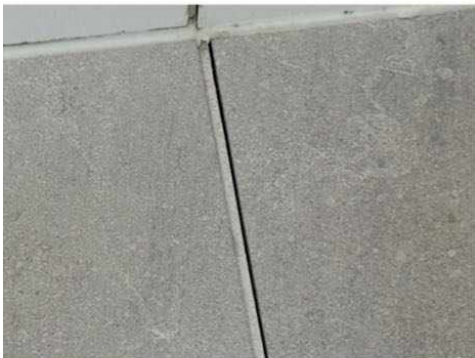
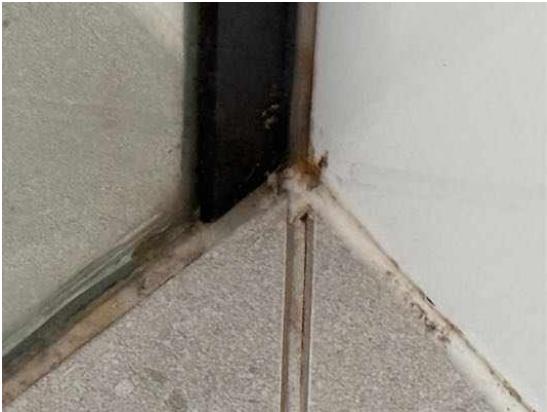
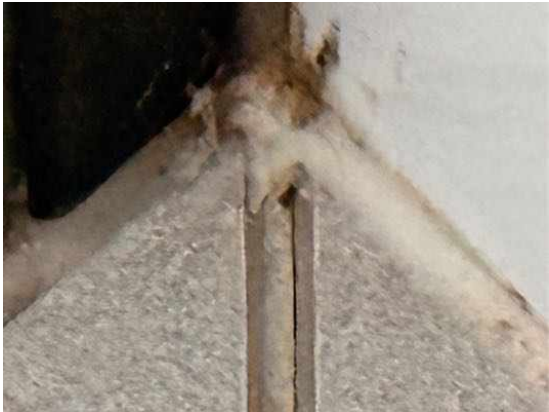
Defects 3.09

Building:	Building 1
Location:	Ensuite > All Areas
Finding:	Grout - Missing - sealant and grout maintenance
Information:	Grout is missing in the bathroom shower alcove base. Grout is used to protect gaps and crevices in building materials to ensure that they are water-tight and prevent water penetration to the associated structures. Where grout or sealants are found to be degraded or missing, a tiling contractor should be appointed immediately to apply grout and re-apply any silicone where necessary. Failure to do so is likely to lead to water and moisture damage to the surrounding area.

Maintenance on sealant and grout throughout the wet areas. Different materials on the balcony areas will move at different rates, generally causing the sealant move and crack at these junctions and joints over time. It is essential that maintenance is kept up in these areas with the appropriate flexible sealants and materials where deemed to be required to allow for expected expansion and contraction, while keeping the joint water tight and protective of all associated building materials. Flexible and mould resistant materials should be applied to any affected areas to prevent any subsequent water damage that is likely to occur if not maintained.

Regular maintenance and replacement of any missing or damaged sealant and grout is highly recommended to the wet areas, as this is a regular wear and tear defect. Sealant and grouting in areas that come into regular contact with water should be

maintained for the long term care of your property. A sealant specialist or tiling contractor should be appointed to complete these works where deemed to be necessary.

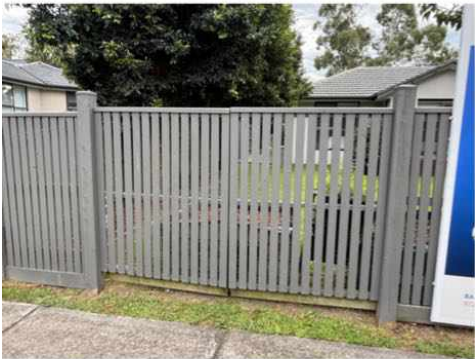
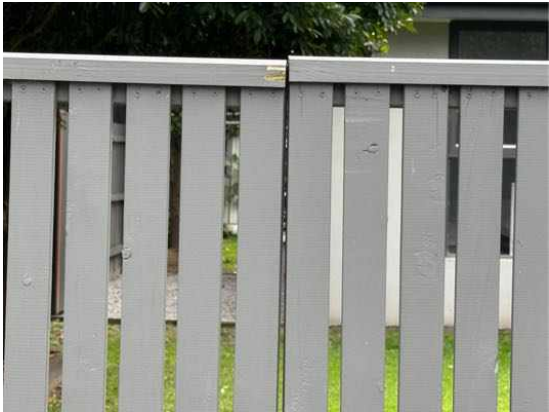
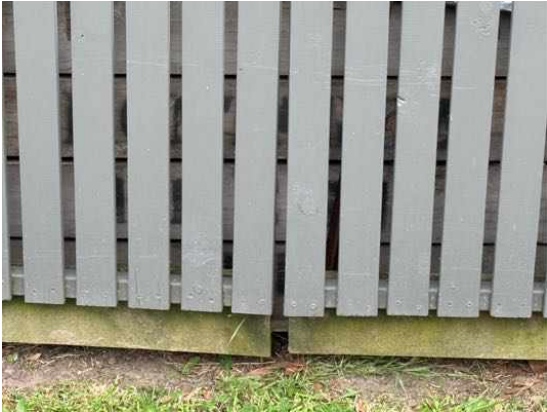
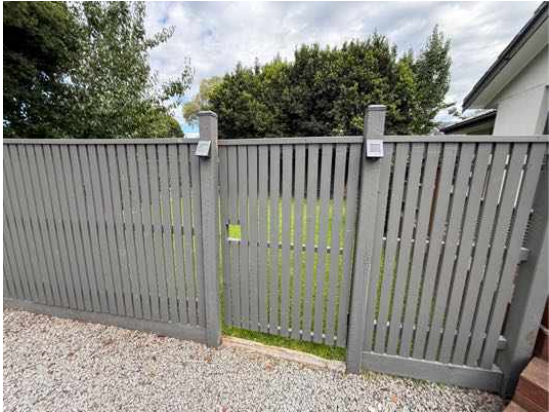
Noted Item

Building: Building 1
Location: All Areas > All Areas
Finding: Additional Photos
Information: Additional photos are provided for either future maintenance items for clients attention and or general reference. Arrows may have been included to highlight areas of importance. Please discuss these photos with your building consultant for clarification.
