Building Inspection Report

Inspection Date: Wed, 25 Mar 2026

Property Address: 37 Swinburne Ave, Mooroolbark VIC 3138,
Australia

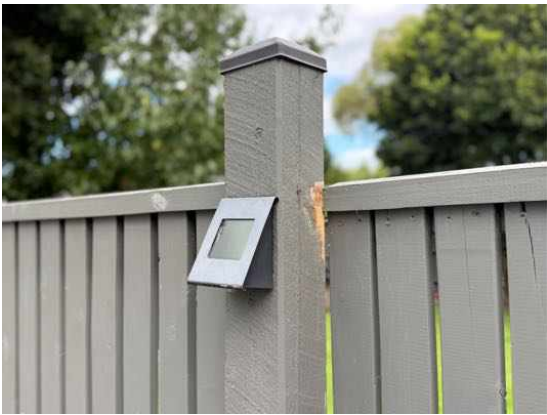
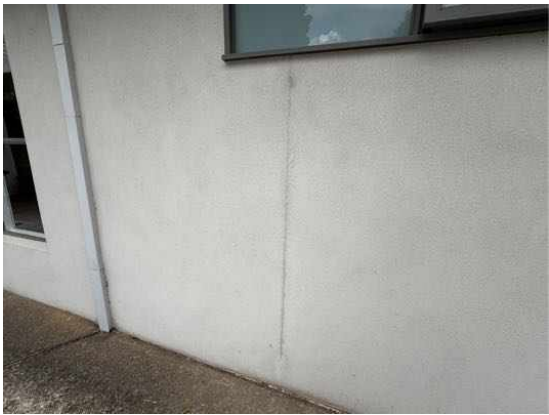
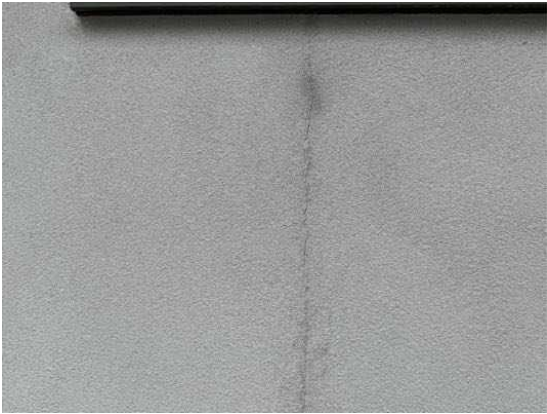
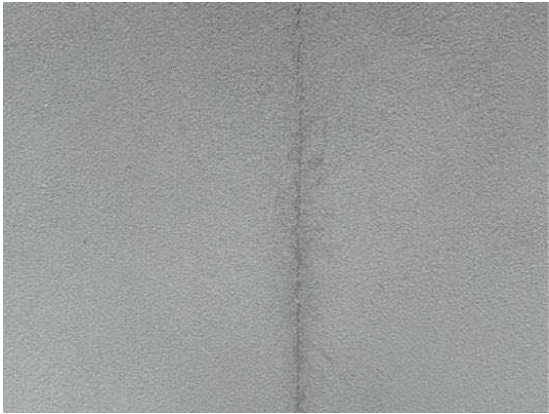
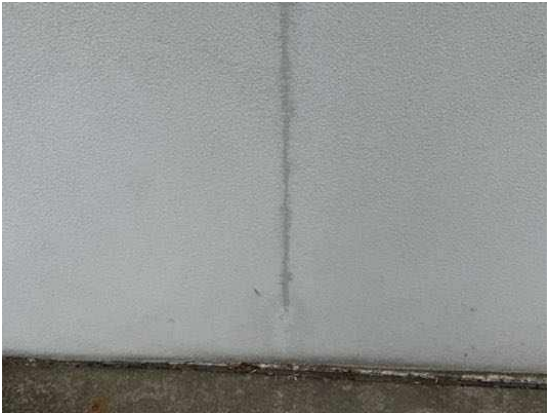
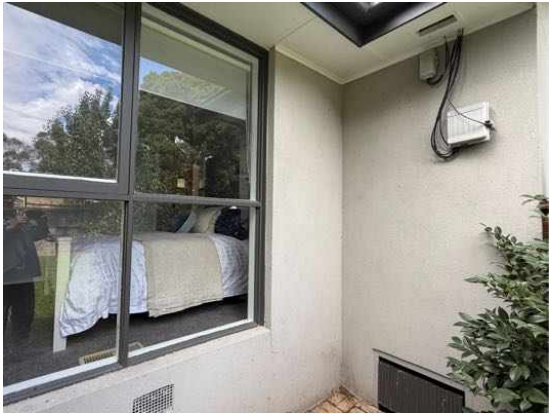
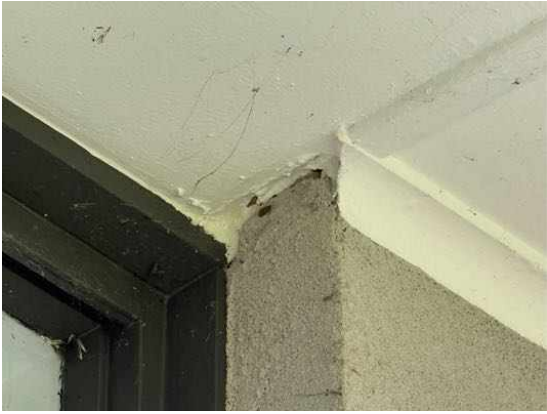
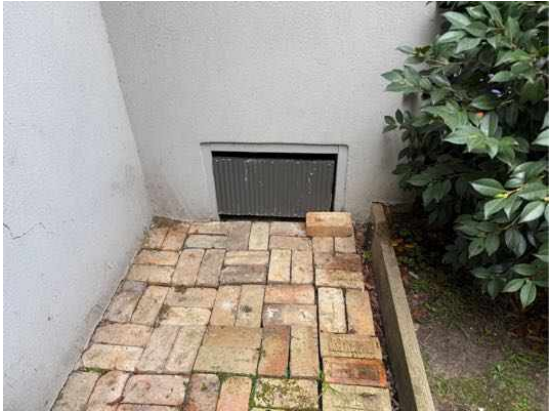
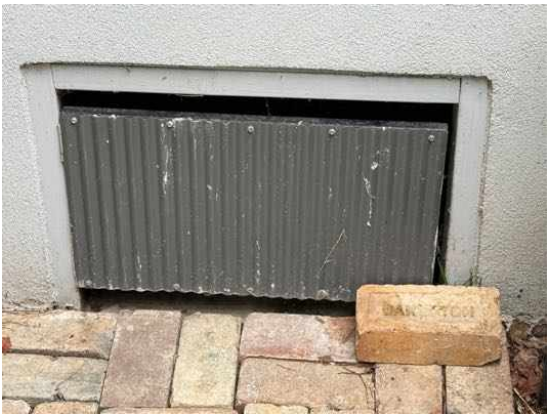
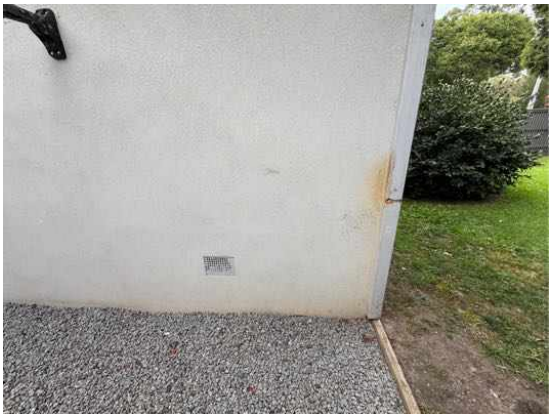
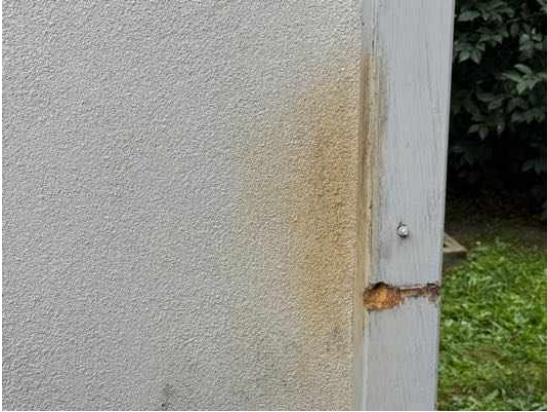
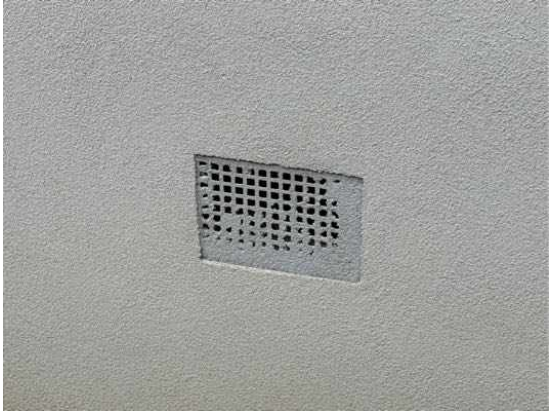
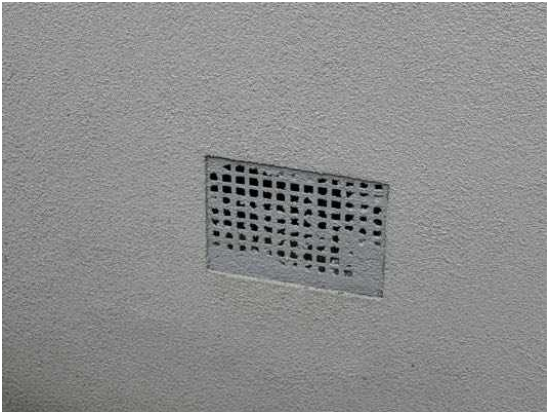
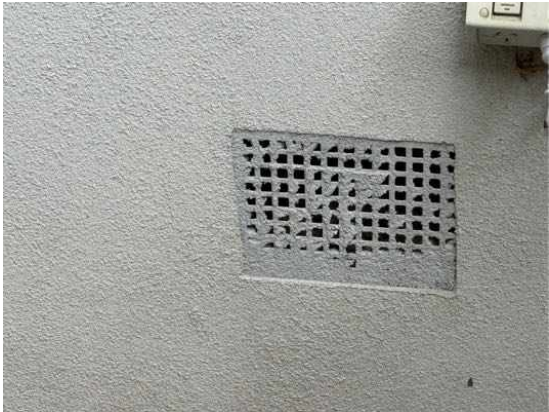
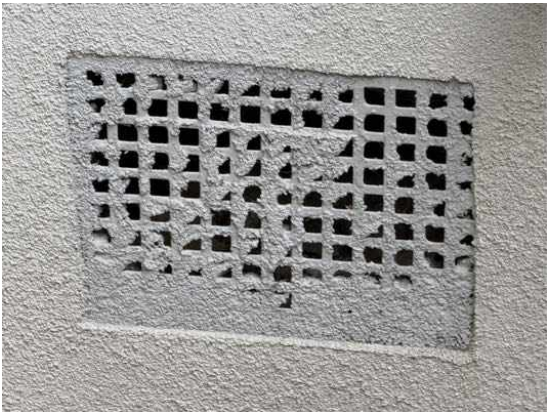
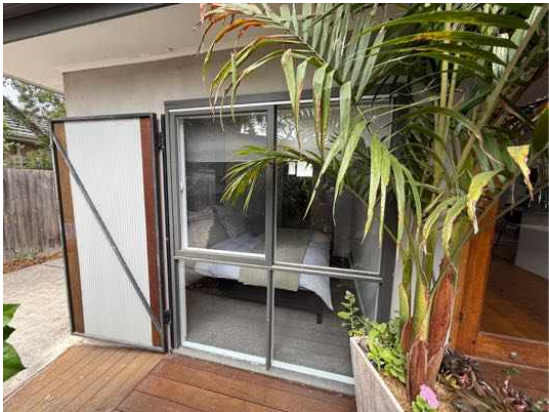
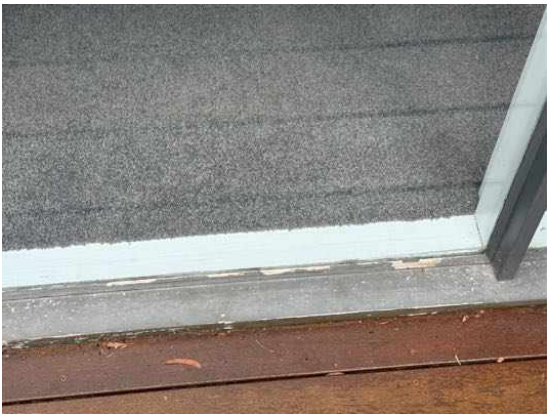
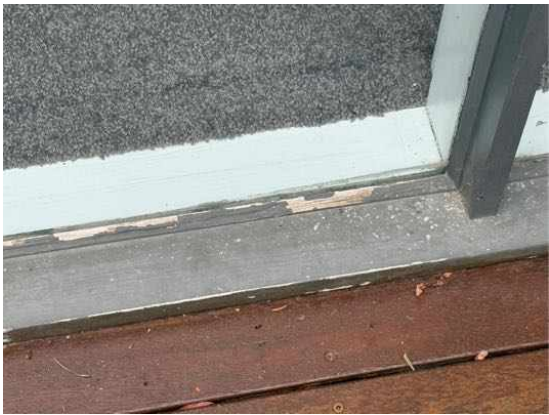
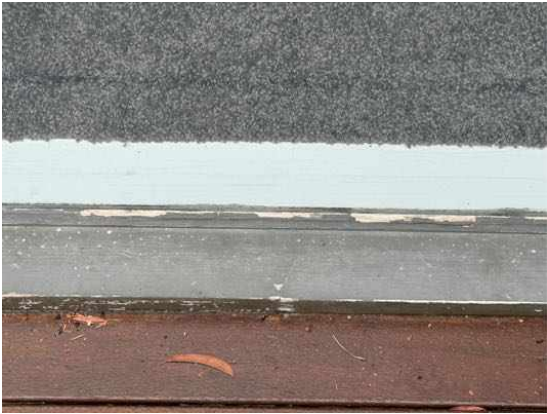
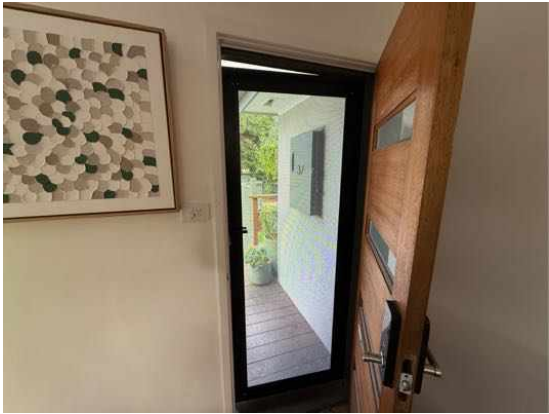
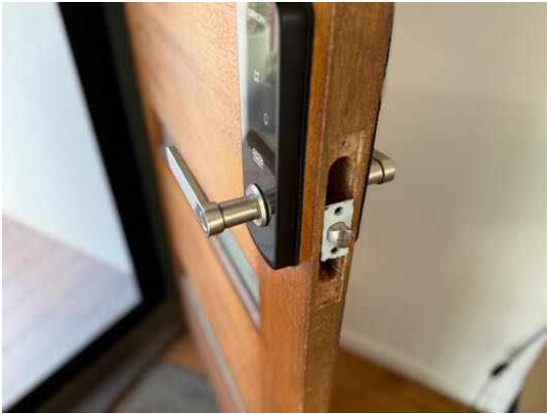
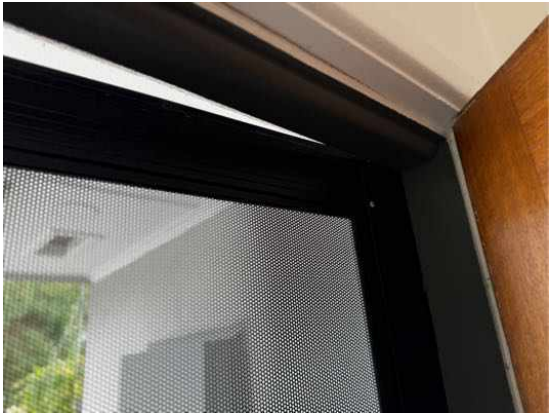
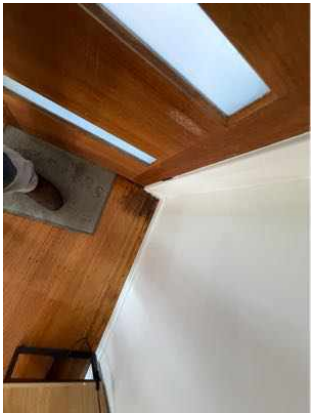
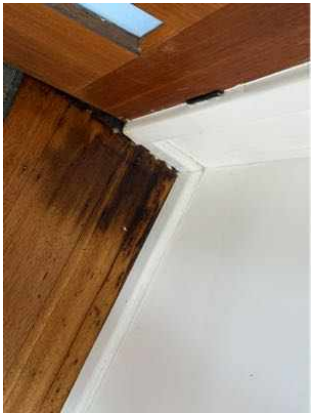
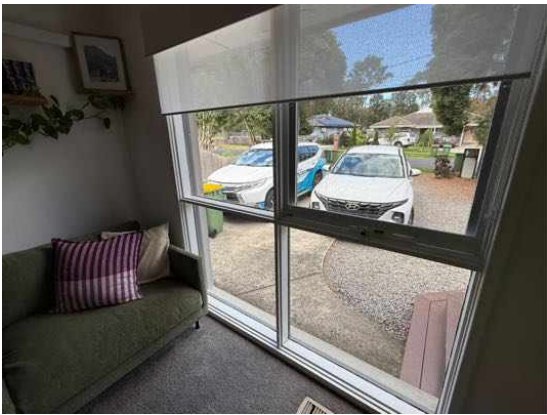
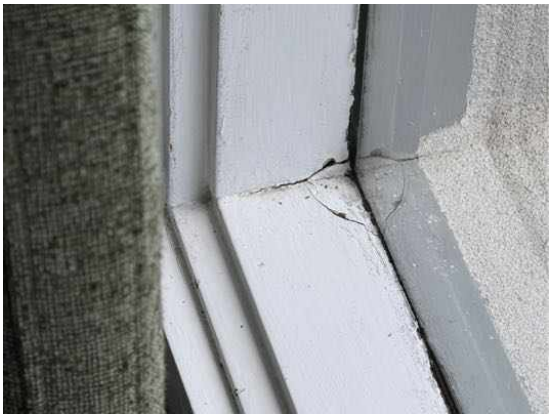
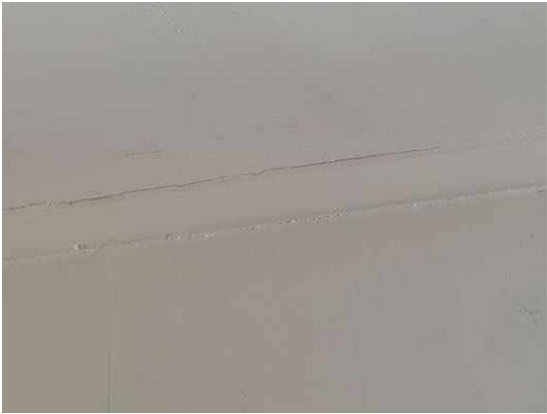
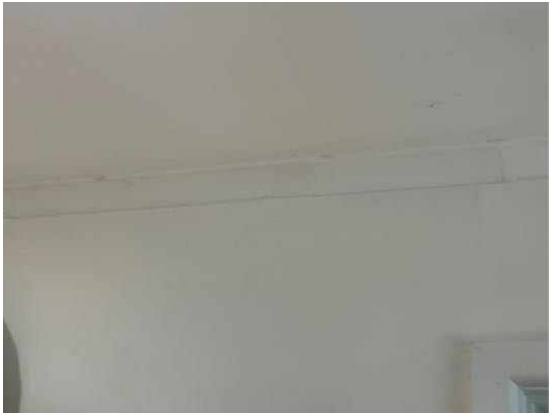
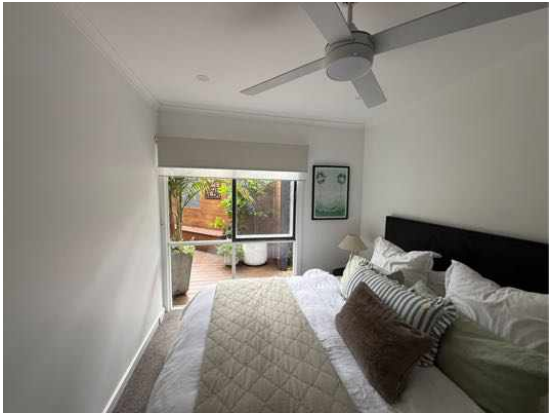
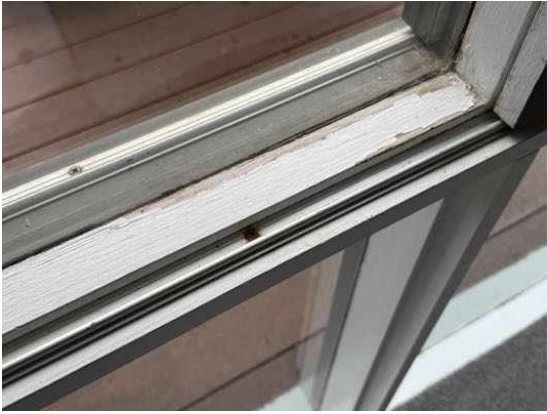
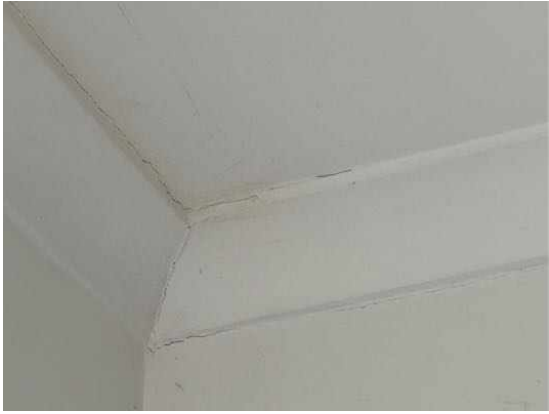
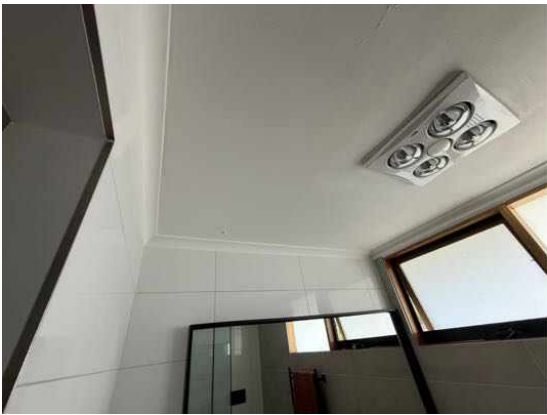
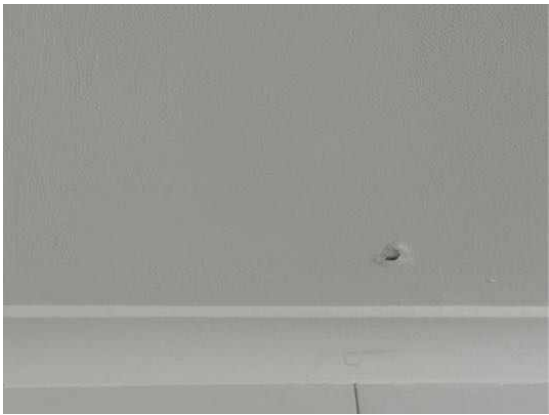
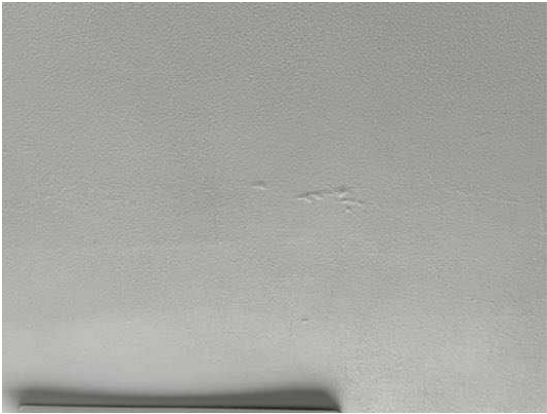
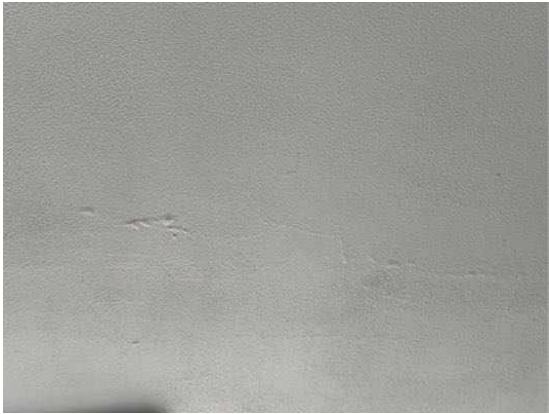
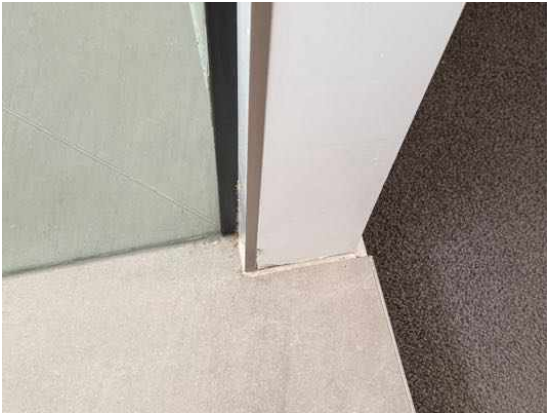
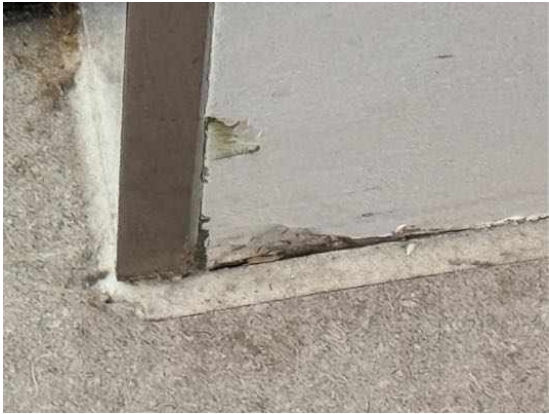
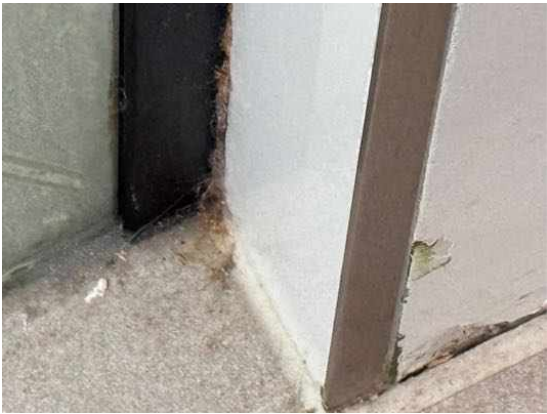
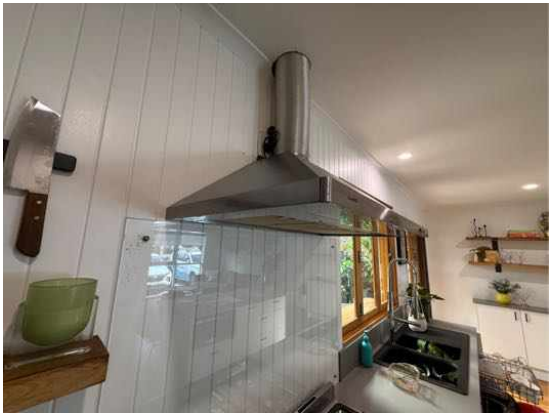
Building: Building 1
Location: All Areas > All Areas
Finding: Additional Photos
Information: Additional photos are provided for either future maintenance items for clients attention and or general reference. Arrows may have been included to highlight areas of importance. Please discuss these photos with your building consultant for clarification.

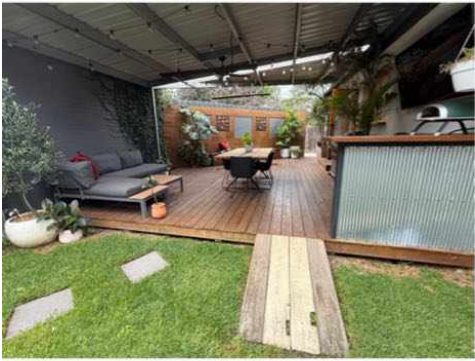
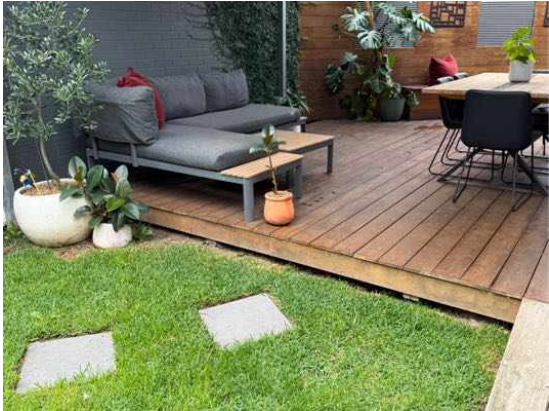
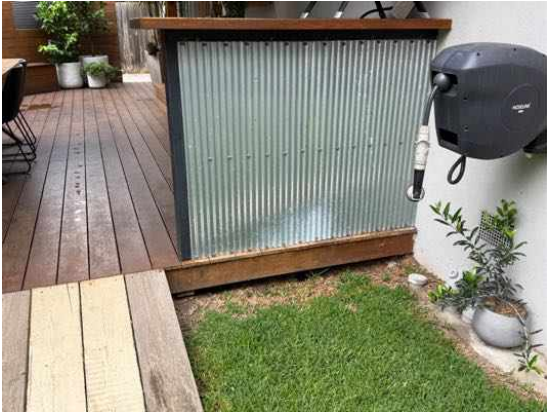
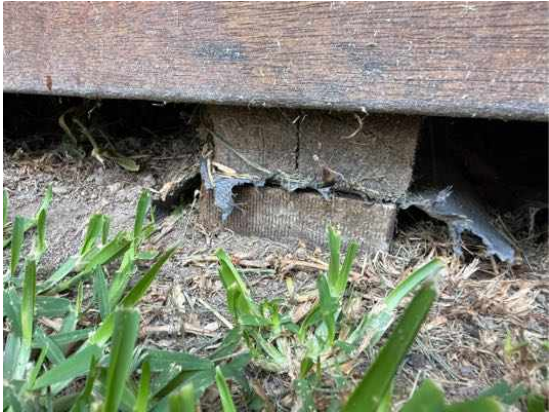
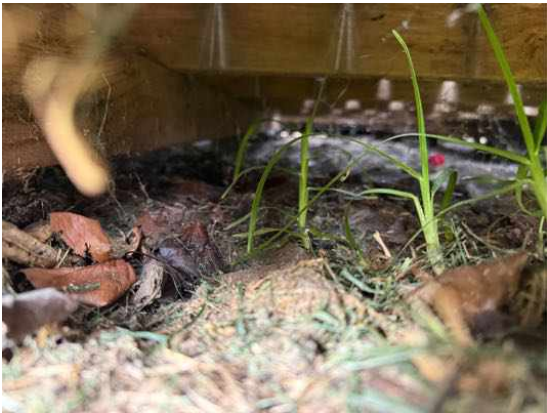
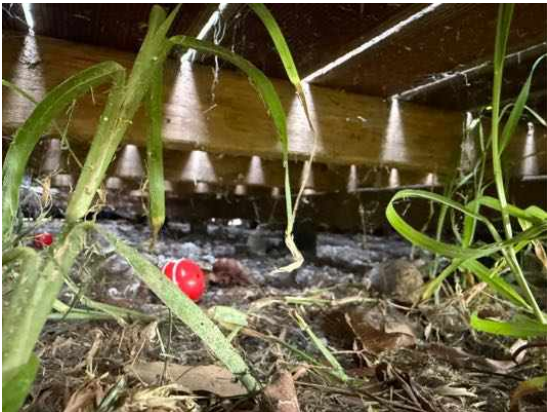
Building:	Building 1
Location:	All Areas > All Areas
Finding:	Timber deck too close to the ground and soil
Information:	It was observed that the rear timber deck structure was sitting in the ground soil or too close to the ground which exposes these timbers to accelerated damage and deterioration over time. It is good practice to have a minimum of at least 200mm away from the ground soil to the timber. Due to the susceptibility to wood rot and deterioration over a prolonged period of time. Good airflow through the subfloor areas should also be maintained. The client should be prepared that in purchasing a property, that some remedial work in the near future will be required to preserve these areas that are susceptible to excessive moisture.

External timbers that are frequently exposed to harsh and extreme weather conditions and sitting in the ground or close to the soil will require adequate protection and maintenance in order to maintain their condition. Any timbers that are exposed to harsh weather conditions and moisture from ground contact, exposes these areas to accelerated damage and deterioration. Where timbers have not been painted or protected properly or treated adequately, will show signs of general deterioration which is likely to occur at an accelerated rate. If left unattended, replacement of these timbers is likely to be necessary in the future. Adequate treatment of these timbers is required as soon as possible by a painting contractor, home owner or general handyman.
