## Building Inspection Report

Inspection Date: Wed, 14 Jan 2026

Property Address: 212/11B Conferta Ave, Tallawong NSW  
2762, Australia

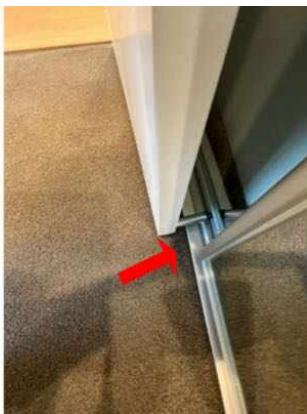
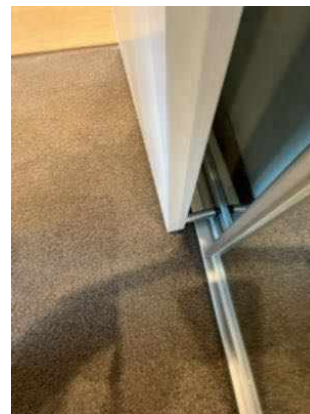
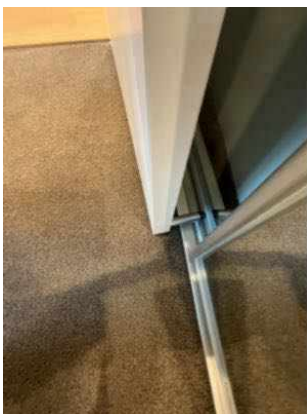
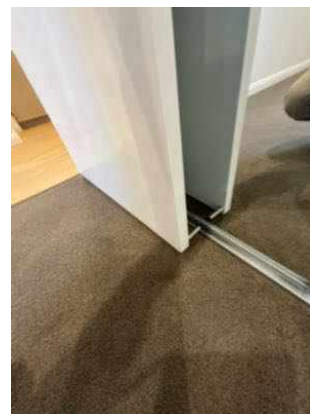
#### Defects 1.01

Building: Main Building  
Location: Bedroom 1  
Finding: Door Stopper – Impacting Wardrobe Track / Glass  
Information: The door stopper was observed to impact the wardrobe track and glazed panel when the door is opened. While no damage was noted to the wardrobe track or glass at the time of inspection, the current arrangement presents a safety risk.

Risk: Repeated impact may damage the wardrobe track or glass, increasing the risk of glass breakage and potential injury to occupants.

Recommendation: A qualified carpenter or handyman should relocate or replace the door stopper, or install an alternative door restraint, to prevent contact with the wardrobe track or glass and reduce safety risks.

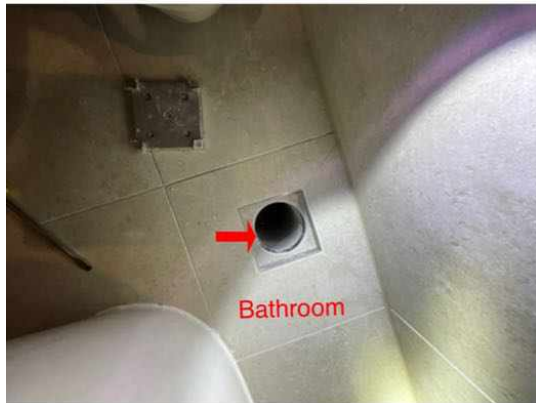
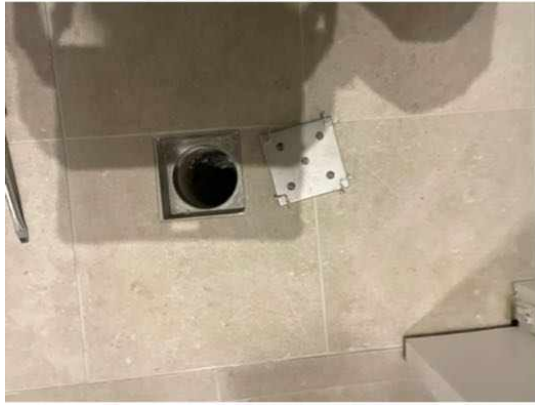
### Defects 3.02

Building: Main Building  
Location: All Areas  
Finding: Floor waste- missing internal grill component (strainer or insert)  
Information: The drain cover in the tiled floor area is missing its internal grill component (strainer or insert), exposing a direct opening into the drain pipe. This is considered a non-compliant installation as the drain cover is incomplete.

- AS/NZS 3500.2:2021 – Plumbing and Drainage – Sanitary plumbing and drainage requires that all plumbing fittings and fixtures must be installed in a manner that prevents debris from entering the drainage system and ensures the safe operation of the drain.
- The Guide to Standards and Tolerances 2017, Section 13 (Plumbing and Drainage), notes that drainage systems should be installed in accordance with relevant standards, including correct fitting of drain covers and grates to ensure hygiene, safety, and protection from blockages.

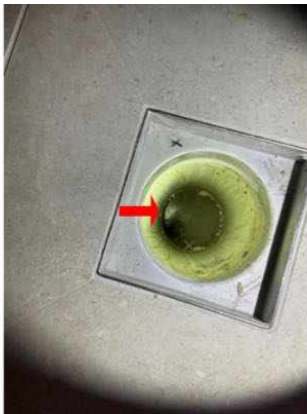
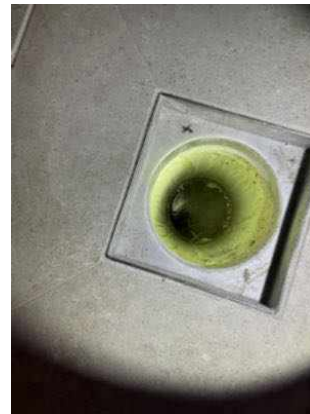
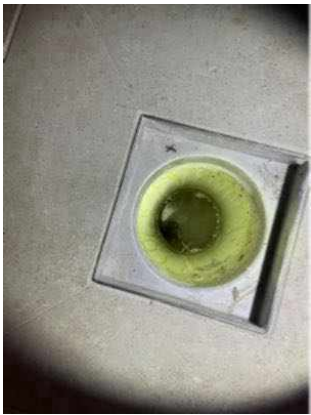
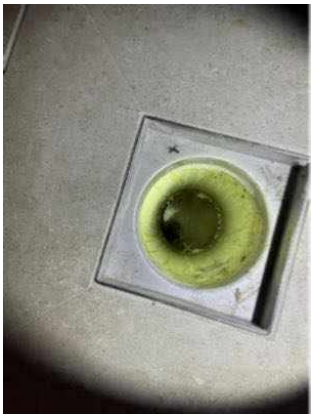
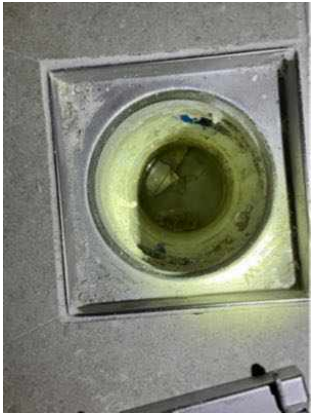
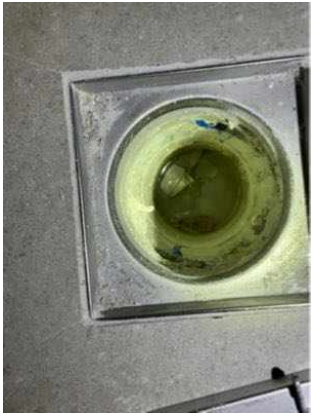
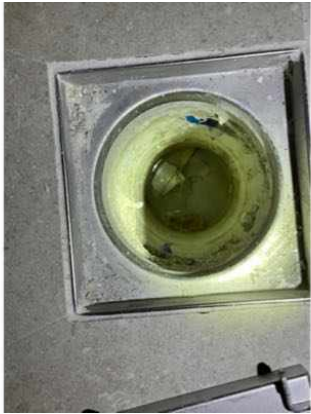
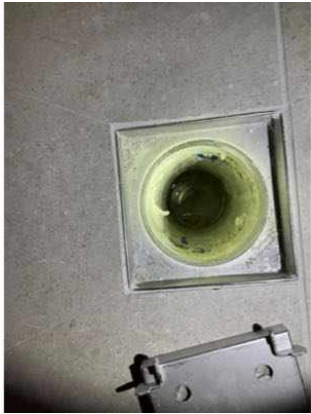
### Defects 3.03

Information: It was noted that there is builder debris in the floor waste drainage. Debris in the plumbing system may lead to blockages in the future.

This is referenced against the Australian Standards and Tolerances clause 19.8 Cleaning - Owners are entitled to expect that the building site and works are clean and tidy on completion.

Building sites are defective if they are not clear of building debris. All floor wastes need to be checked and cleared prior to handover.

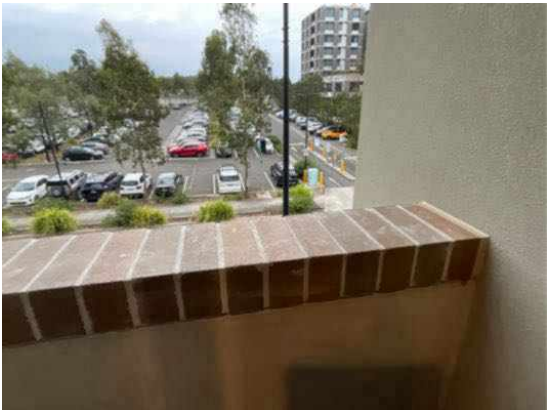
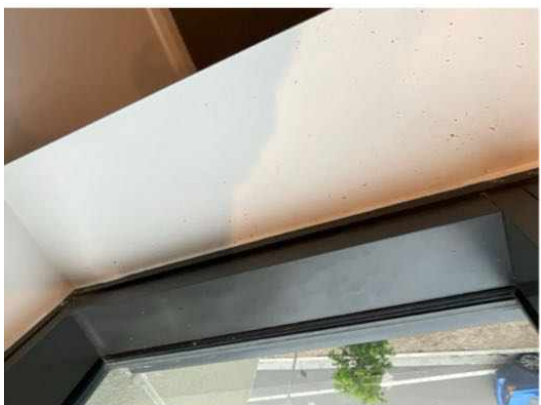
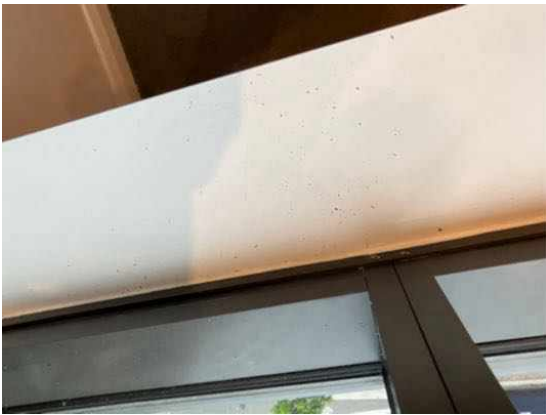
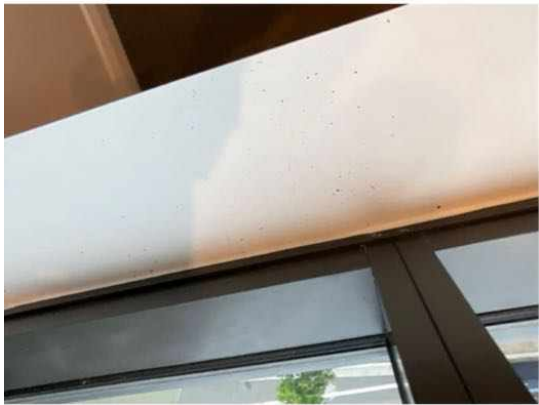
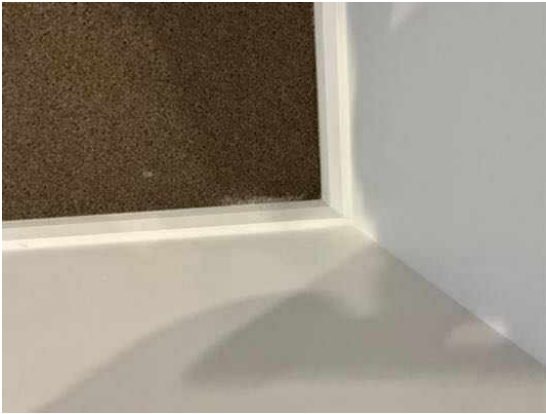
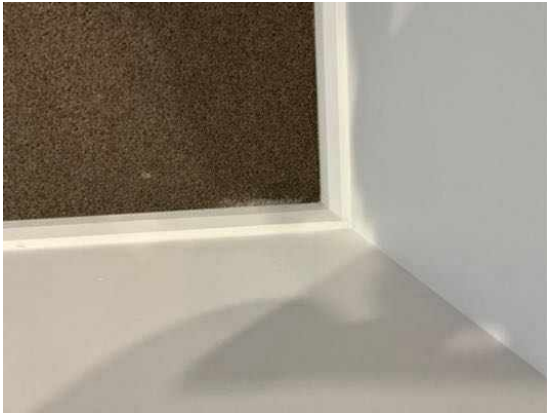
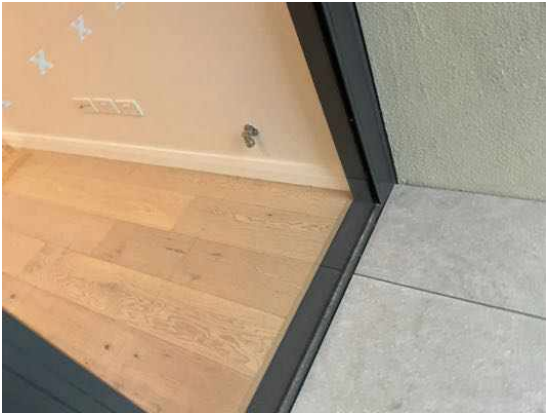
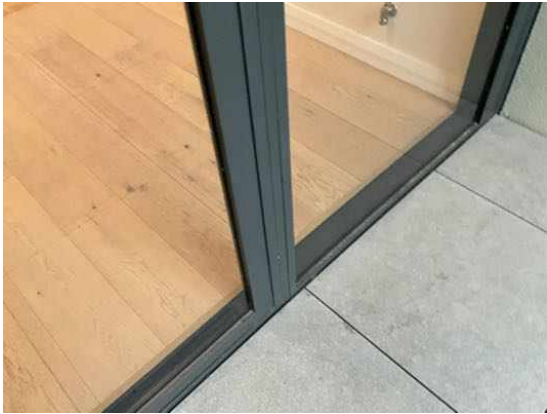
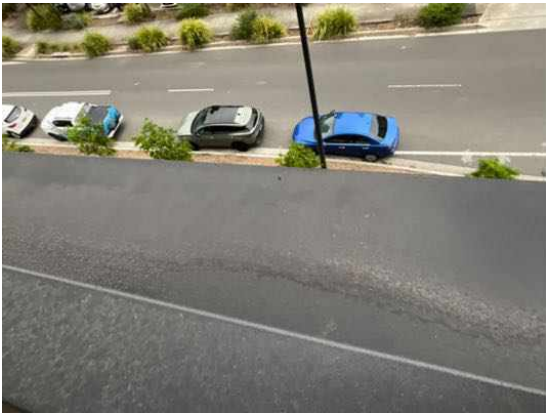
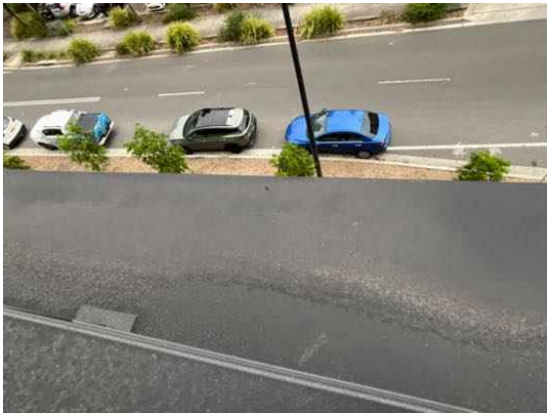
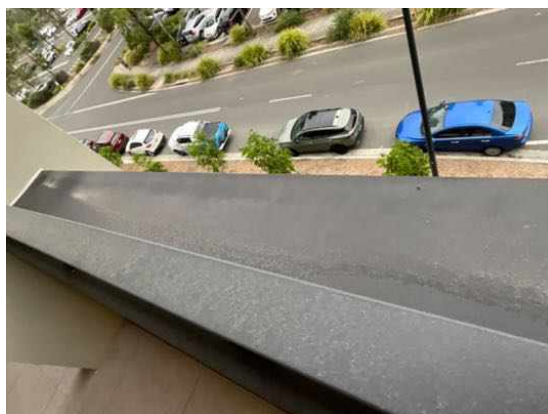
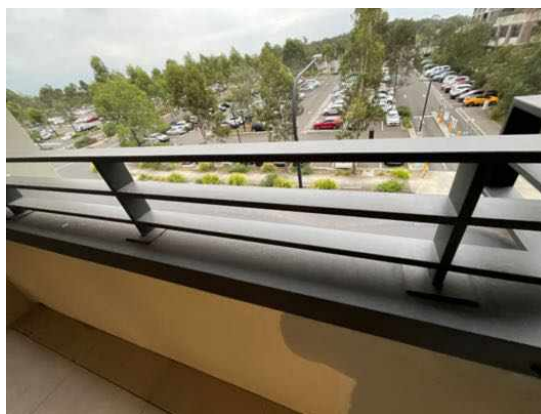
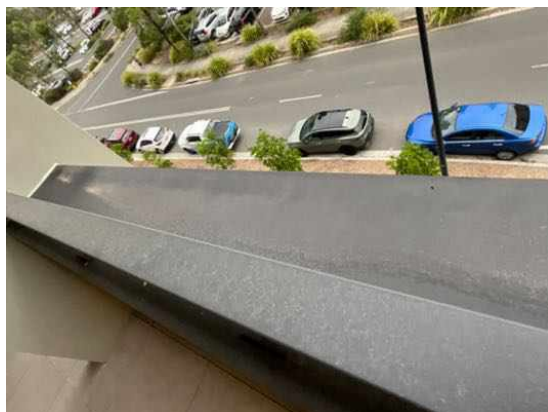
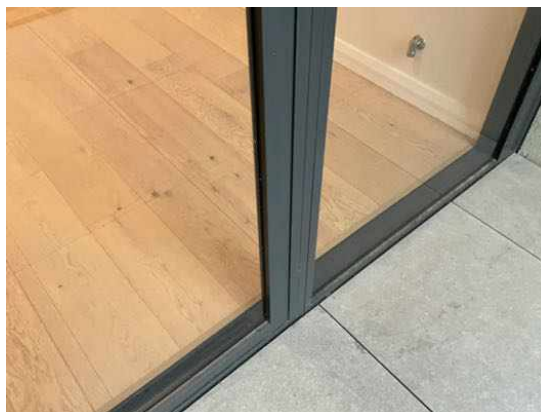
**Defects 3.04**

Building: Main Building  
Location: All Areas  
Finding: Cleaning  
Information: At the time of inspection all areas and surfaces were found to be dirty with dust, leaf litter and spider webs evident throughout internal and external surfaces.

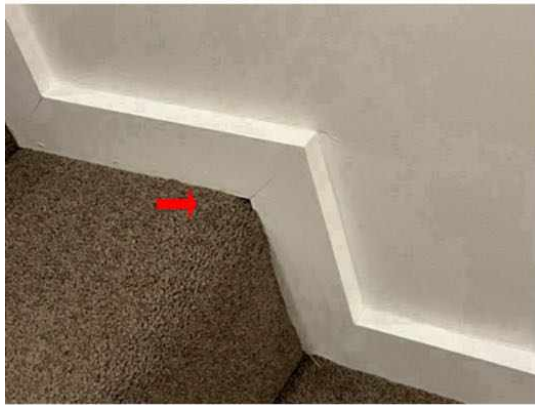
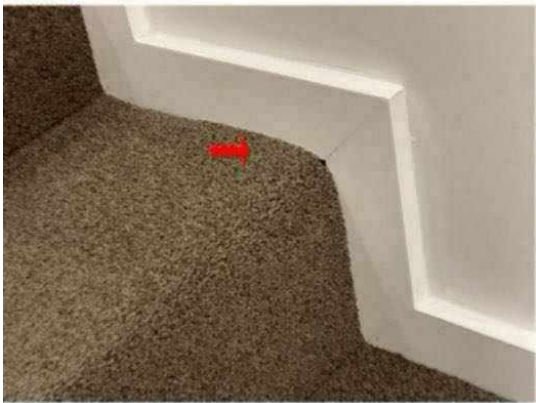
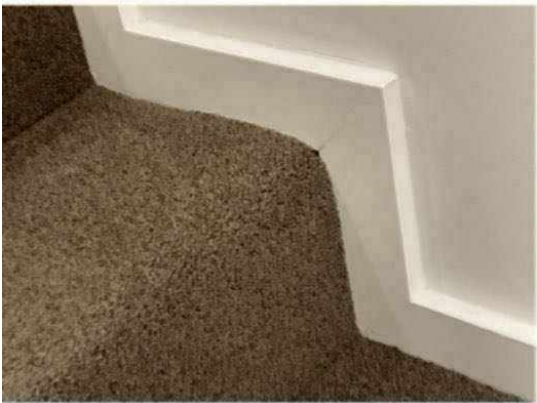
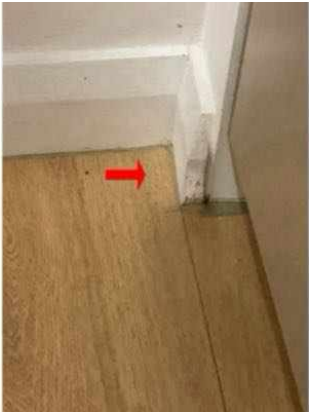
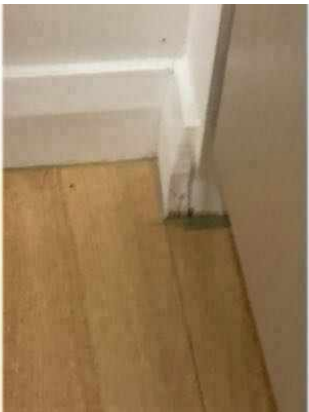
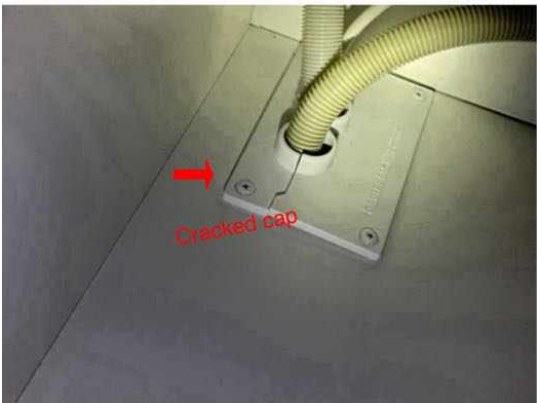
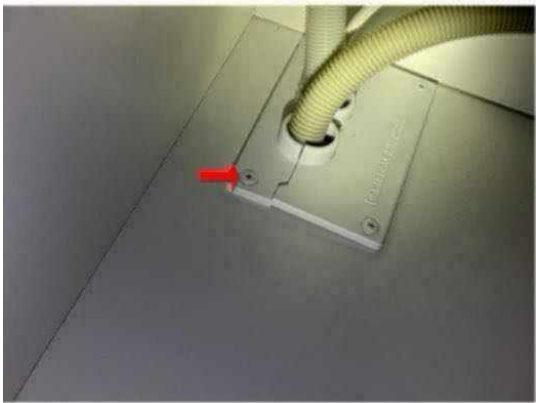
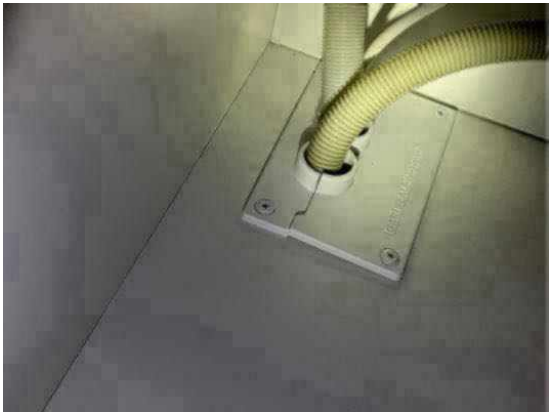
### Defects 3.05

Building:	Main Building
Location:	All Areas
Finding:	Substandard Work- Various Areas of the Building
Information:	Substandard work has been identified in multiple areas throughout the building, failing to meet the requirements specified by Australian Guides and Tolerances.

- **\*\*Surface Preparation:\*\*** Poor surface preparation resulting in inadequate paint adhesion and flaking.

- **\*\*Fixtures and Fittings:\*\*** Misaligned or improperly installed fixtures and fittings, not meeting the standard requirements for level and alignment.

- Accelerated deterioration and reduced durability of the affected elements.
- Compromised aesthetic quality and overall value of the property.
- Potential safety hazards and increased maintenance costs.
- Negative impact on the building's functionality and usability.

A comprehensive inspection should be conducted post-repairs to ensure all rectifications comply with the required standards.

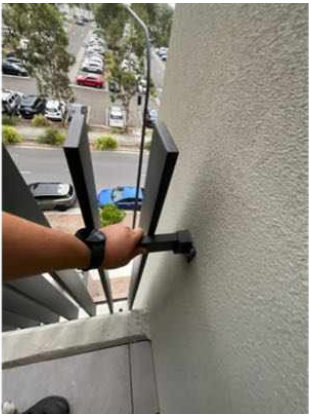
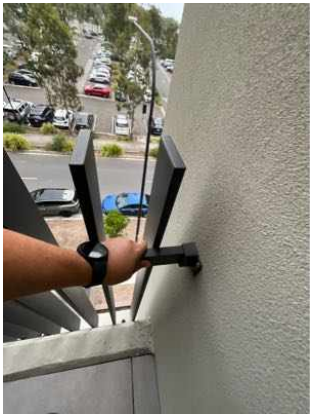
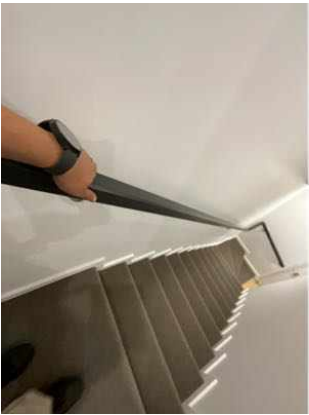
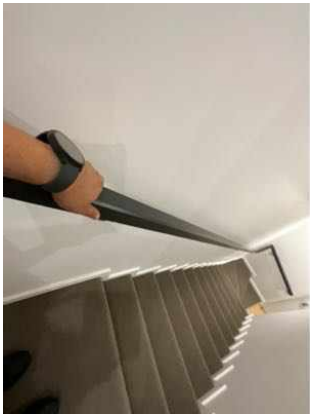
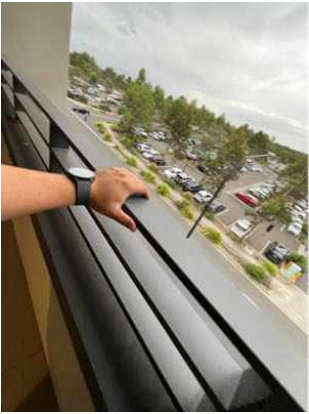
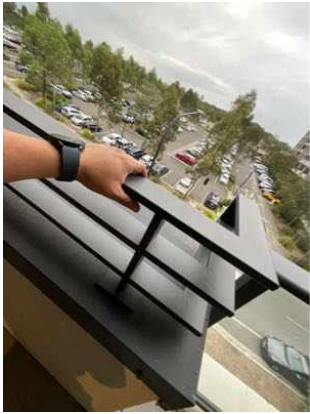
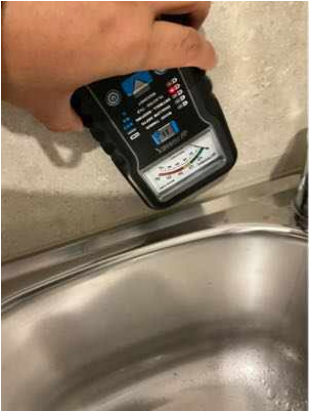
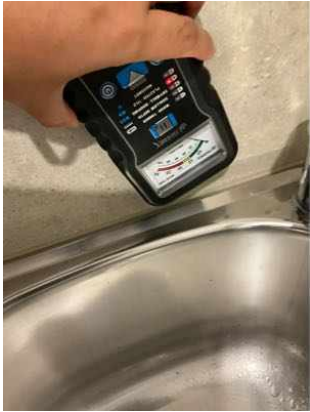
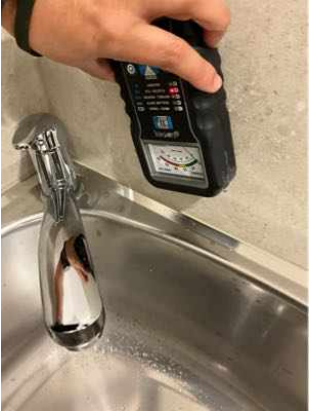
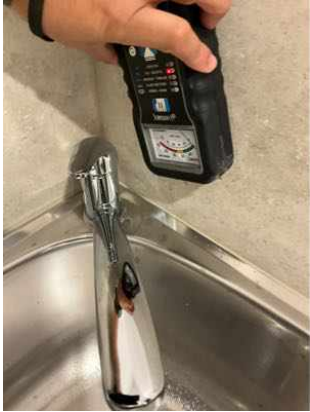
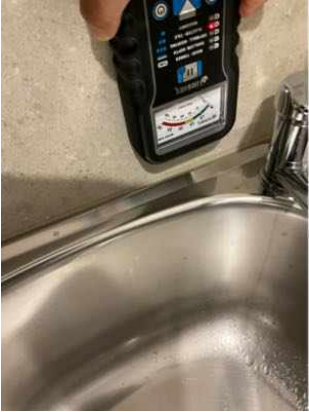
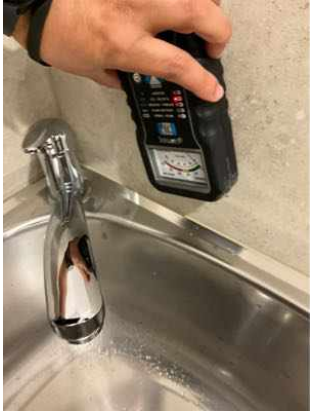
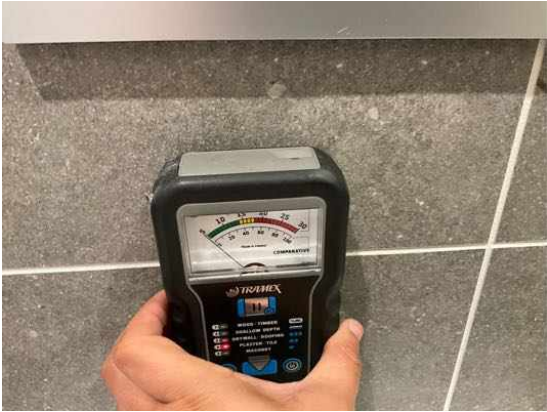
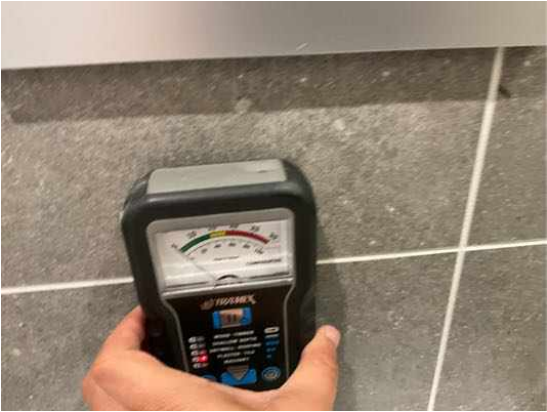
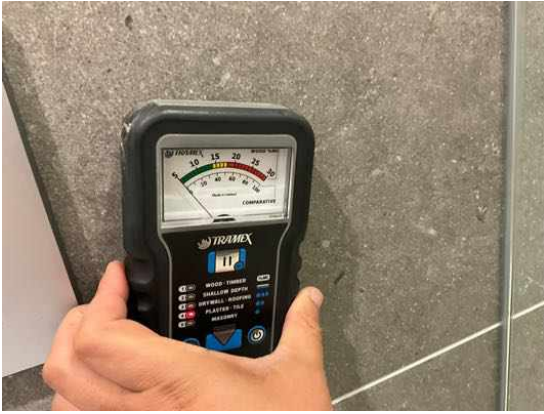
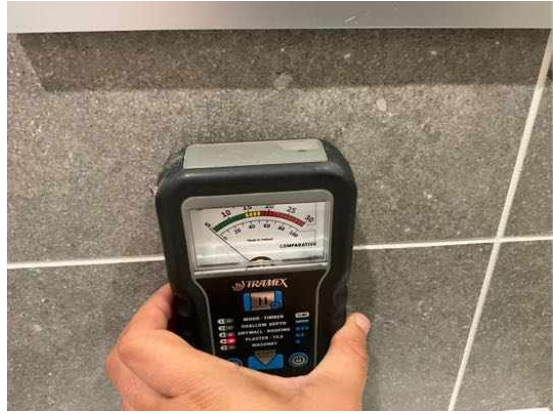
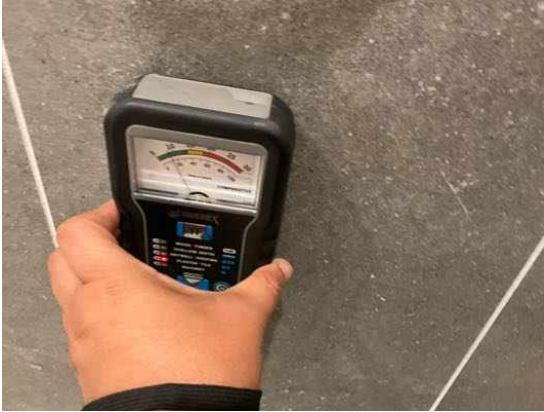
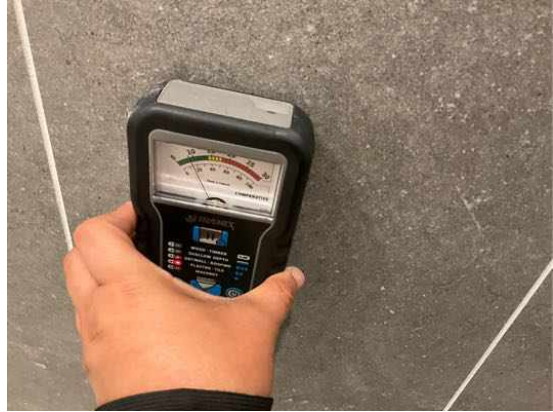
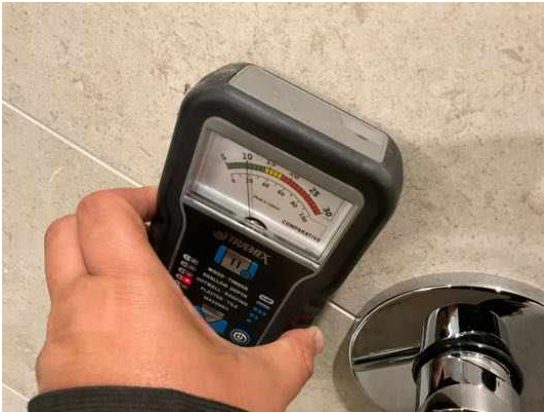
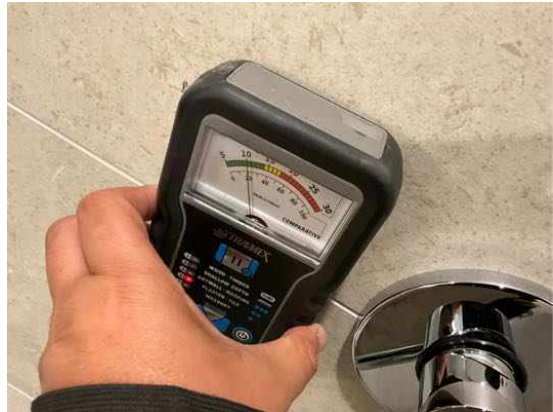
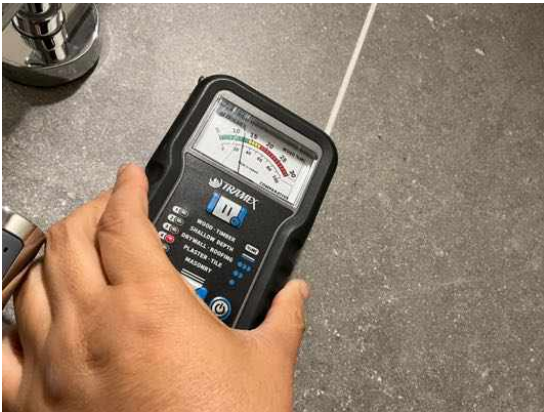
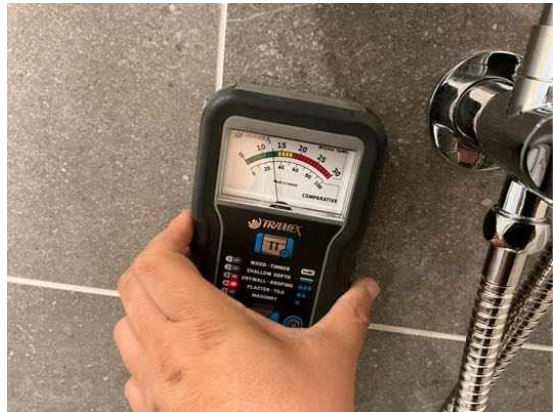
#### Noted Item

Building: Main Building  
Location: All Areas  
Finding: Additional Photos  
Information: Additional photos are provided for your general reference
